Not in Traffic Surveillance Roll Away Investigation / Vehicle to Non Motorist
Dynamic Science, Inc. / Case Number: DS07042
1998 Ford Expedition
Utah
September 2007

1. Report No. DS07042		2. Government Accession No.		3. Recipient Catalog No.	
4. Title and Subtitle Not in Traffic Surveillance Roll Away Investigation				5. Report Date April 10, 2008

Dynamic Science, Inc.
Crash Investigation
Case Number: DS07042
TABLE OF CONTENTS

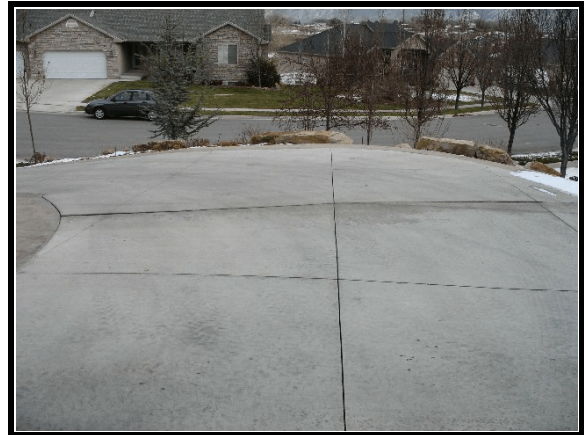
Figure 2. View down driveway (northeast)

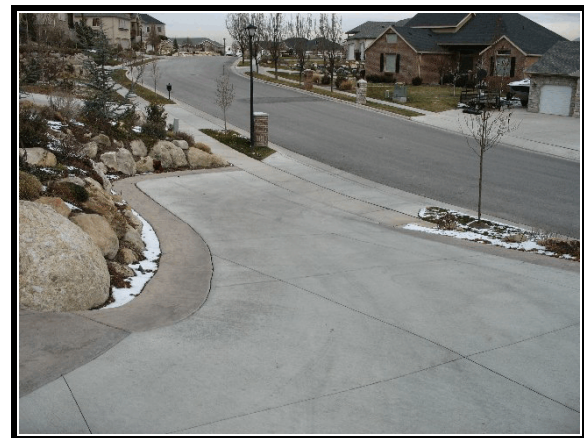
Figure 3. Path to area of impact (north)

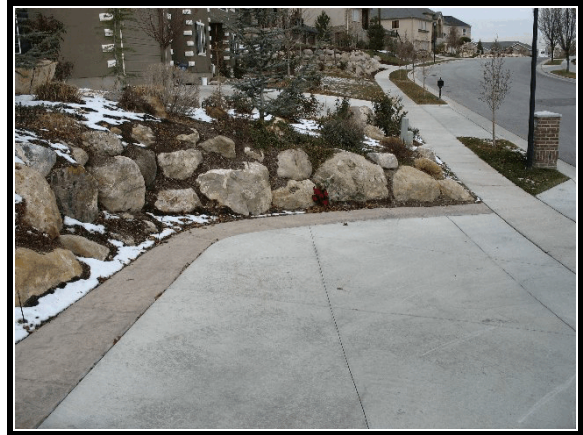
Near the bottom of the driveway (**Figure 4**), the Ford impacted the 4-year-old female, and the left rear tire rolled over the child's head. The vehicle then struck some landscaping rocks, where it came to final rest.

Figure 4. Area of impact with child and rock wall (north)

The SCI investigator located a street with a grade change similar to the driveway in this case. Three free-rolling test runs were made from a stop to a distance of 18.6 m (60.9 ft) from the stopped point. The average time to travel the distance was 9.4 seconds. Based on this time, the Ford's speed at impact with the child was approximately 7.0 km/h (4.4 mph).

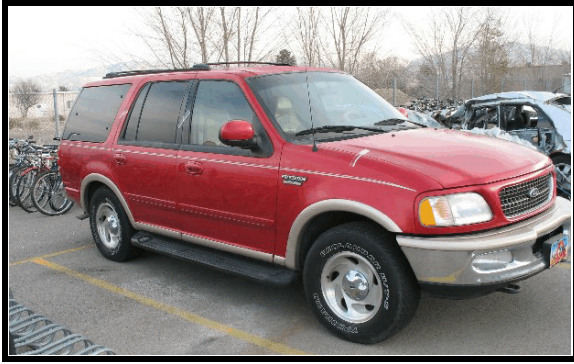
The involved vehicle in the roll away fatality incident was a 1998 Ford Eddie Bauer Edition Expedition four-door large sport utility vehicle. The Ford was identified by the Vehicle Identification Number (VIN): 1FMPU18LXWLxxxxxx. The Expedition was powered by a 5.4 liter V-8 engine linked to a 4-speed automatic transmission with a column mounted transmission selector lever. The Expedition was equipped with four-wheel drive. There were 240,098 kilometers (149,190 miles) on the odometer. The Expedition was configured with Yokohama Geolandar H/T-S P265/70R17 tires. The outside diameter and tread width of these tires was 75.4 cm (29.7 in) and 20.5 cm (8.1 in), respectively.

Figure 5. Overall view of the 1998 Ford Expedition

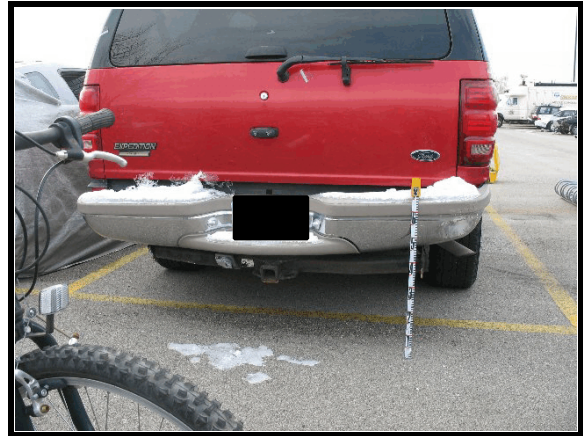
Figure 6. Rear bumper height

Ground to belt line:	128.0 cm (50.4 in)
Ground to top of trunk/tailgate:	128.0 cm (50.4 in)
Ground to top of rear bumper:	64.0 cm (25.1 in)
Ground to bottom of rear bumper:	36.0 cm (14.1 in)
Ground to sway bar:	N/A
Ground to axle:	N/A
Overall vehicle height:	194.0 cm (76.4 in)
Overall vehicle width:	200.0 cm (78.7 in)
Overall vehicle length:	520.0 cm (204.7 in)
Rear overhang:	119.0 cm (46.9 in)
Track width:	166.0 cm (65.4 in)
Longitudinal distance between rear most projection and front door latch pillar:	247.0 cm (97.2 in)

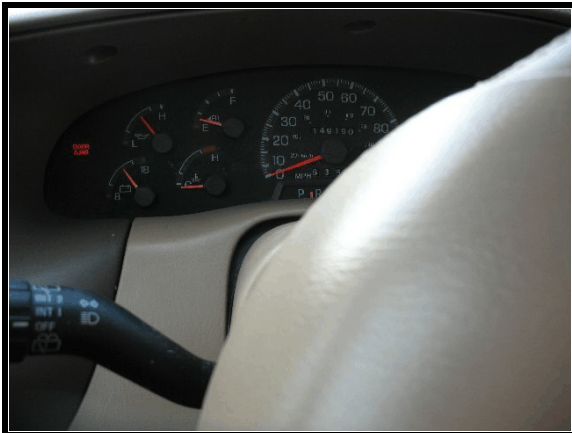
According to the driver, she parked the Ford Expedition on the top of the driveway. She put the Expedition into PARK and exited the vehicle with the engine running. The driver was aware of a problem with the transmission shifter. As can be seen in Figures 7 through 10, the selector was one detente off from the actual transmission position (i.e., if the vehicle is in PARK then the selector indicates Reverse). Shortly after the incident, the vehicle was taken to a local Ford dealership for examination. The technicians were able to see that the gear shifter was not working properly. The police agency located and hired an independent expert to examine the shifter. The expert arrived several days later to do his examination. During the examination, there were a number of attempts to replicate the problem but they were unable to cause the shifter to move from one position to another. During the DSI inspection, this same process was also attempted without any success. The vehicle could not be shifted from PARK to Reverse without pulling the shifter lever toward the driver. It was the expert's final opinion that there was no mechanical reason for the vehicle slipping out of PARK and the cause of the incident was operator error.

Figure 7. Vehicle in PARK, selector in Reverse.

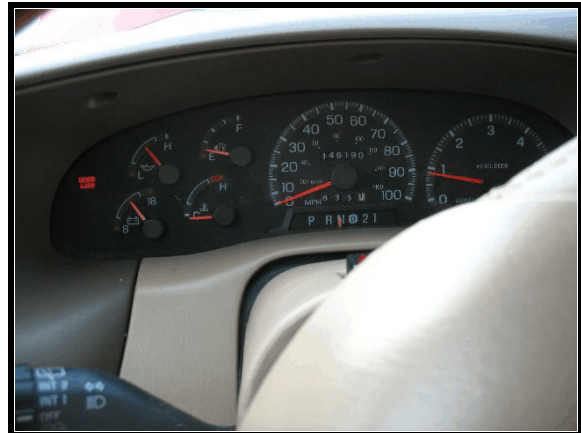
Figure 8. Vehicle in Reverse, selector in Neutral.

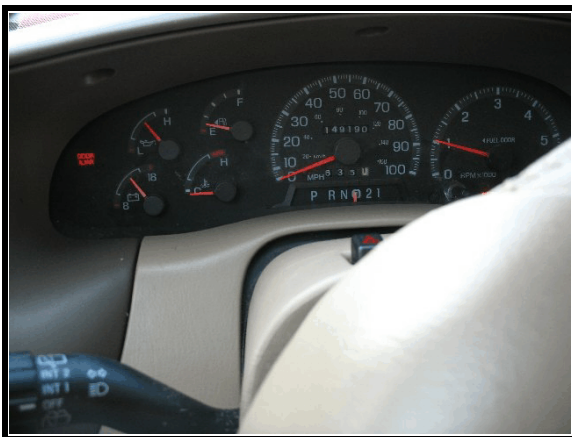
Figure 9. Vehicle in Neutral, selector in Drive.

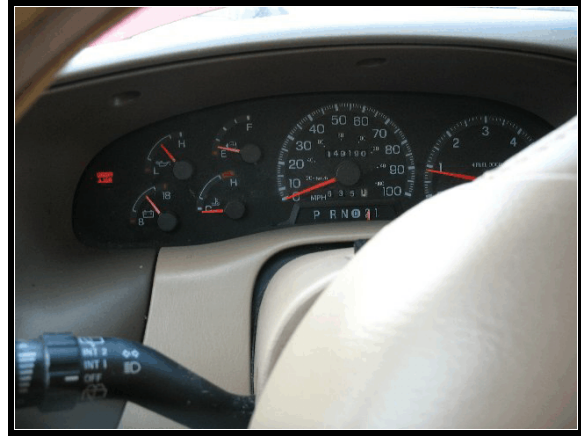
Figure 10. Vehicle in Drive, selector in 2nd.

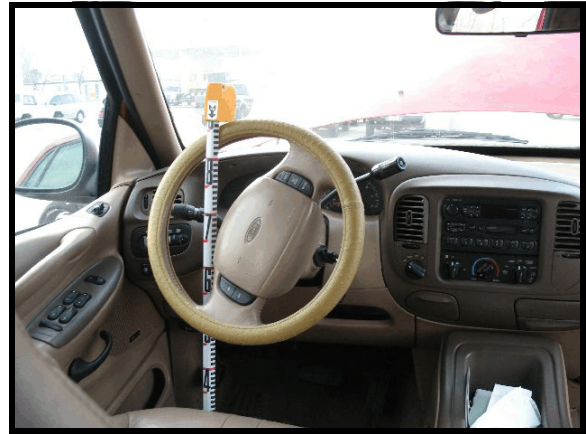
Figure 11. Frontal view of steering wheel and shifter (in PARK).

There was a NHTSA recall related to the transmission gear position. The ID number was 97V171000 and was entitled: 1998 Ford Expedition Power Train:Automatic Transmission Gear Position Indication (PRNDL). The recall date was 10/07/1997. According to the recall, "If the automatic transmission shift cable assembly was not fully attached to the steering column bracket, the shift cable assembly can come off the bracket, the vehicle operator would then not be able to shift the transmission from of the drive gear positions into the park position even though the gear selector would indicate park". The remedy was to make the proper attachment of the transmission shift control cable to the steering column bracket and add a tie strap to that connection. According to the Ford dealership consulted by the police, the proper remedy had been completed.

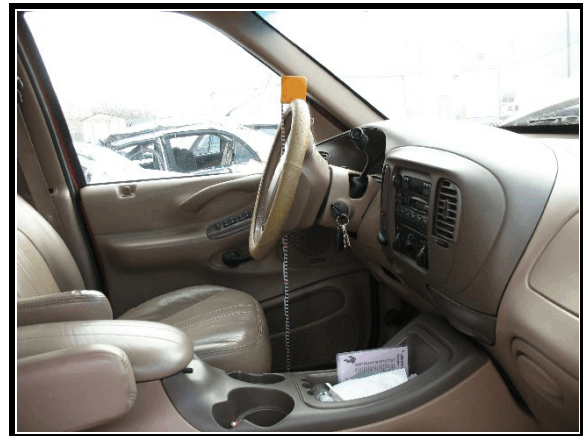
Figure 12. Side view of steering wheel and shifter.

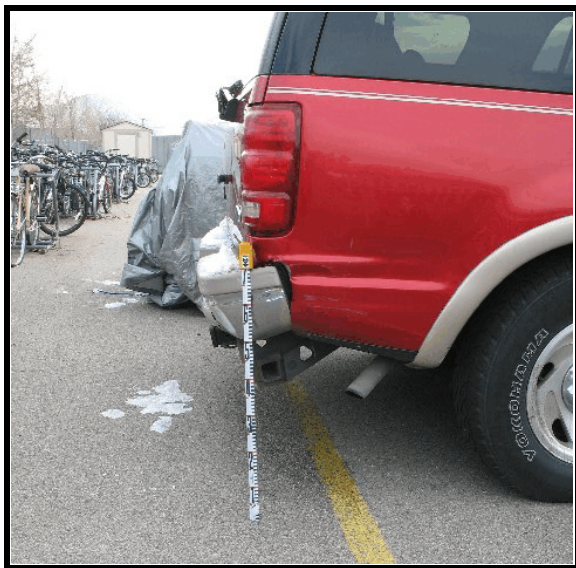
The Expedition sustained minor rear end damage as a result of the impact with the landscaping rocks on the north side of the driveway (**Figures 13-15**). There was 17.0 cm (6.7 in) of direct contact to the bumper beginning at the right rear bumper corner. There was 4.0 cm (1.6 in) of direct contact to the receiver hitch on the right side and a slight amount of contact to the left side of the hitch. The bumper was rotated downward. The maximum crush was located at C6 and measured 2.0 cm (0.8 in). The CDC was estimated to be: 06BDLW1.

Figure 13. Right side view of rotated bumper

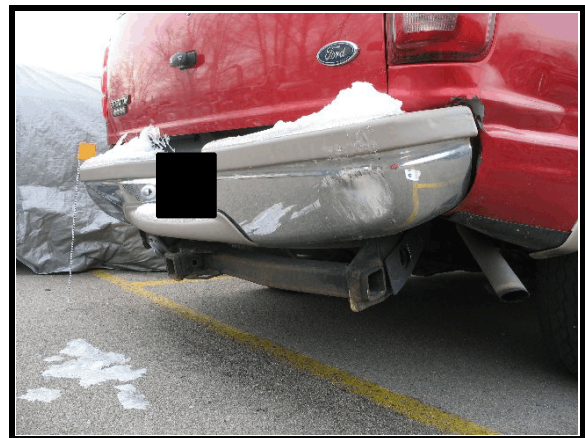
Figure 14. Right rear bumper and hitch contact

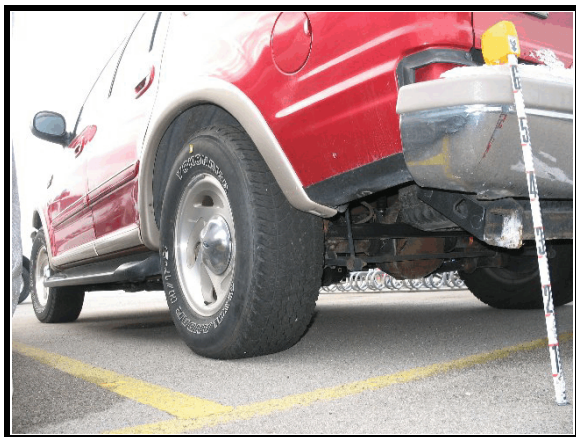
Figure 15. Left side hitch contact
