Remote SCI/NASS Combination Side Air Bag Investigation
Dynamic Science, Inc. (DSI), Case Number 2008-73-055J
2007 Honda Civic
Indiana
April 2008

1. Report No. 2008-73-055J	2. Government Accession No.		3. Recipient Catalog No.	
4. Title and Subtitle Remote SCI/NASS Combination Side Air Bag Investigation			5. Report Date January 23, 2009

Dynamic Science, Inc.
Crash Investigation
Case Number: 2008-73-055J

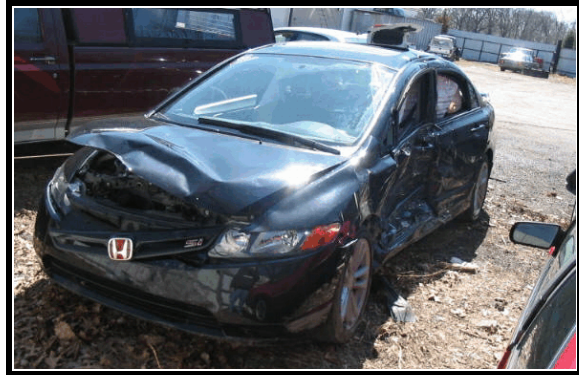
Figure 1. Subject vehicle, 2007 Honda Civic

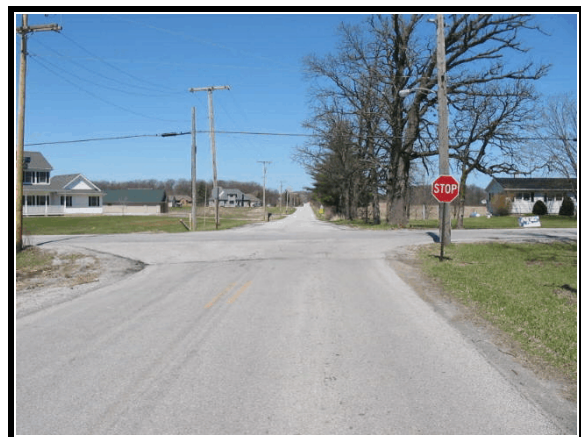
This two-vehicle crash occurred at a four-leg intersection of two straight rural roadways in April 2008. At the time of the crash, there were no adverse weather conditions and the asphalt roadway surfaces were level and dry. The north/south roadway was configured with single lanes in each direction that were separated by a dashed yellow painted centerline (**Figure 2**). The roadway was controlled by stop signs in each direction. The posted speed limit was 48 km/h (30 mph). The east/west roadway was configured with single lanes in each direction that were separated by solid yellow painted centerlines (**Figure 3**). The speed limit was 64 km/h (40 mph).

Figure 2. Approach north, 2007 Honda Civic

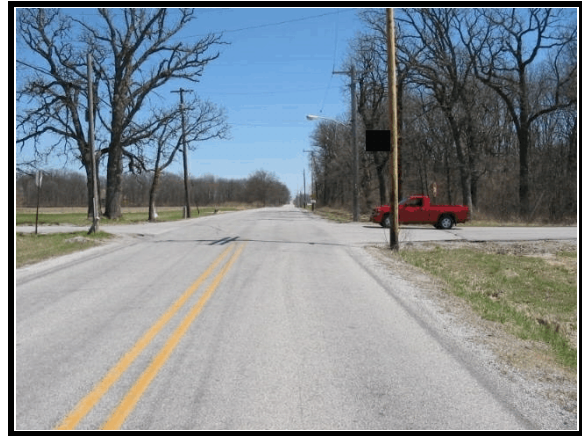
The 2007 Honda Civic was traveling northbound through the four-leg intersection. The driver brought the Honda to a controlled stop at the intersection, and then proceeded into the intersection. There were no indications that she ever saw the other vehicle. The 1994 Chevrolet C1500 pickup was traveling eastbound. The truck's pre-crash speed is unknown. As the Honda entered the intersection, the driver of the Chevrolet steered to left but could not avoid the impact.

Figure 3. 1994 Chevrolet pickup approach, west

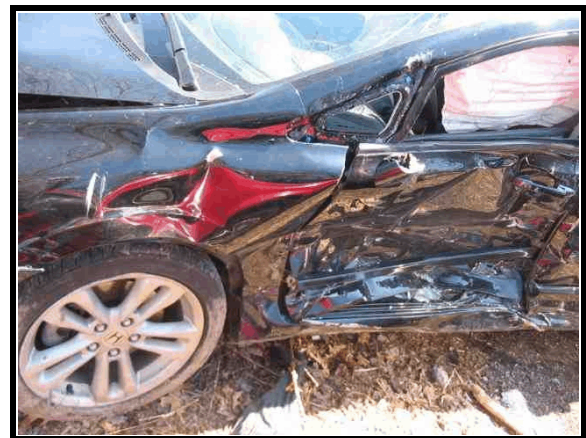
The 2007 Honda Civic sustained moderate left side plane damage from the impact with the Chevrolet pickup (**Figure 4**). The direct damage began 15 cm (5.9 in) forward of the left front axle and extended 200 cm (78.7 in) rearward along the left side plane. The direct and induced damage began 28 cm (11.0 in) forward of the left front axle and extended rearward 218 cm (85.8 in). Both left side door were jammed shut and left side glazing disintegrated. The left side mirror was missing. Six crush measurements were documented at the mid door level as follows: C1 = 3 cm (1.2 in), C2 = 22 cm (8.7 in), C3 = 24 cm (9.4 in), C4 = 21 cm (8.3 in), C5 = 6 cm (2.4 in), C6 = 3 cm (1.2 in). The Collision Deformation Classification (CDC) for the impact with the truck was 10LYAW3.

Figure 4. Left side damage

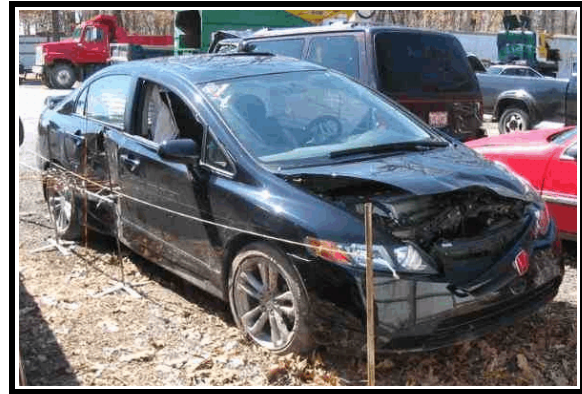
The Honda sustained moderate right side plane damage, primarily at the right rear door area, from the impact with the tree (**Figure 5**). The direct damage began 67 cm (26.3 in) forward of the right rear axle. The direct and induced damage began 34 cm forward of the right rear axle. Both right side doors were jammed shut and the right front door glazing was disintegrated.

Six crush measurements were documented at the mid door level as follows: C1 = 2 cm (0.8 in), C2 = 4 cm (1.6 in), C3 = 6 cm (2.3 in), C4 = 8 cm (3.1 in), C5 = 7 cm (2.8 in), C6 = 1 cm (0.4 in). The CDC for the impact with tree was 02RPEN2.

The Honda also sustained moderate damage to the front end from the impact with the tree. The hood was displaced rearward and to the left. The grille was deformed downward. The CDC for the impact with the tree was 02FYEN1.

Figure 5. Front and right side damage

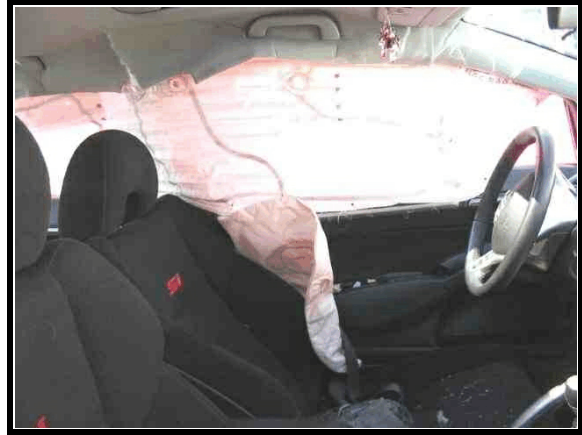
The left side curtain air bag and left seat mounted side air bag deployed during the impact with the Chevrolet pickup (**Figure 6**). The curtain air bag deployed from the roof cladding. The right side curtain and right seat mounted side air bag deployed during the impact with the tree (**Figure 7**). The curtain air bag deployed from the roof cladding. There were no reports of any damage or contact to the air bags.

Figure 6. Driver's side curtain air bag and seat mounted side air bag

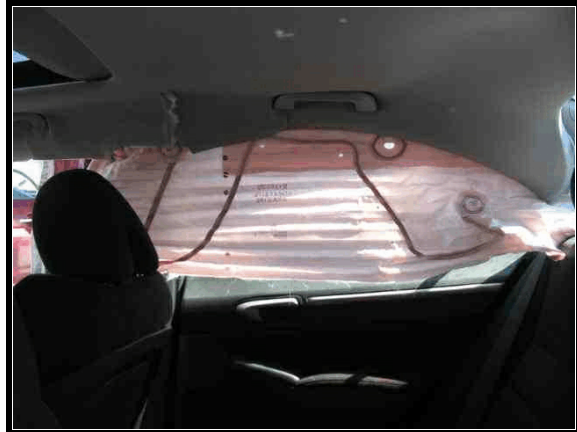
Figure 7. Right side curtain air bag
