Remote Passenger Air Bag Fatality Investigation
Dynamic Science, Inc. (DSI), Case Number DS08007
1996 Geo Metro
California
November 2005

**Dynamic Science, Inc.
Crash Investigation
Case Number: DS08007**

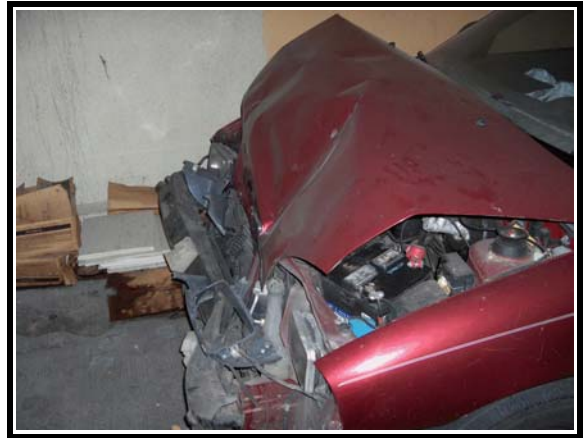
Figure 1. Subject vehicle, 1996 Chevrolet Geo Metro

This remote passenger air bag fatality investigation was initiated in response to a police reported description of an air bag related child fatality in the front right seat of a 1996 Geo Metro (**Figure 1**). This three-vehicle, chain-reaction crash occurred in November 2005 on a five-lane divided interstate highway. The subject vehicle was a 1996 Geo Metro that was being driven by a 35-year-old female. There were five additional occupants in the vehicle. The front right seat was occupied by a 27-year-old male and a 5-year-old female. The 5-year-old was seated in the lap of the adult male. The lap and shoulder belt in the front right seating position was being used by both occupants. There were two additional vehicles involved in this crash:

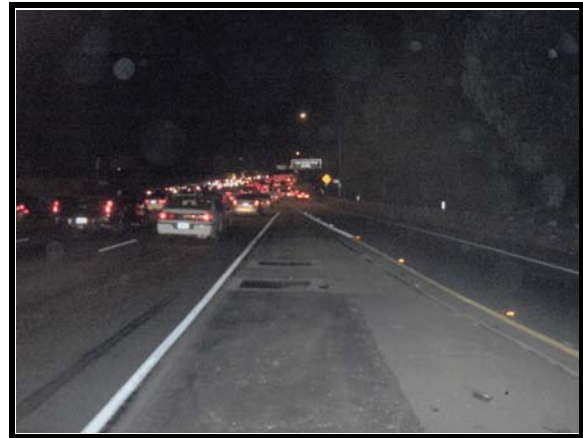
Figure 2. Overview of crash scene - looking west

This three-vehicle crash occurred on a north/south designated US highway (**Figure 2**). However, in the area of the crash the highway actually runs east and west. All references will be made in the true compass direction. The roadway consisted of five traffic lanes on the westbound side. The asphalt roadway was straight and level. The lanes were bordered on the south by a solid yellow line and a concrete center median barrier. The five lanes of traffic were delineated with broken painted white lines with raised ceramic tiles and raised reflectors. The traffic lanes were bordered on the north by a solid painted white fog line. The weather was cool and the crash occurred during the hours of darkness with minimal overhead lighting provided by light poles. The lights were working at the time of the crash. There were no roadway defects noted. The posted speed limit was 105 km/h (65 mph). The scene schematic is included as Attachment 1 to this report. A satellite

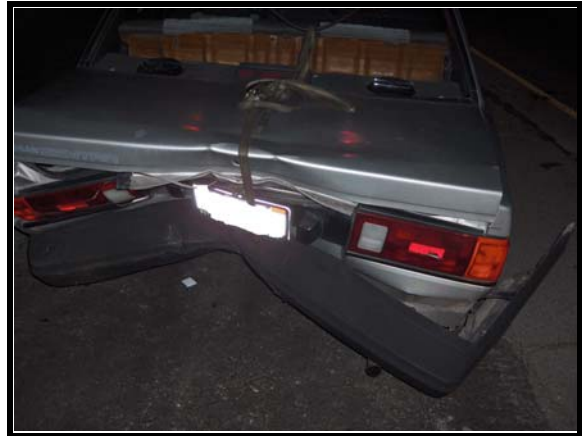
Figure 3. Rear damage to Nissan Sentra

The driver of the Geo did not notice that traffic was stopped ahead until it was too late to stop. She braked but the front of the Geo struck the rear of the Sentra (**Figure 3**). The impact was moderate and resulted in the deployment of the frontal air bag system in the Geo. The CDC Only algorithm of the WinSmash program computed a total delta V of 15 km/h (9.3 mph) based on the frontal damage to the Geo. The longitudinal and lateral components were -15 km/h (-9.3 mph) and 0 km/h, respectively. After the initial impact, the Sentra was pushed forward into the rear of the stopped Corolla (**Figures 4-5**).

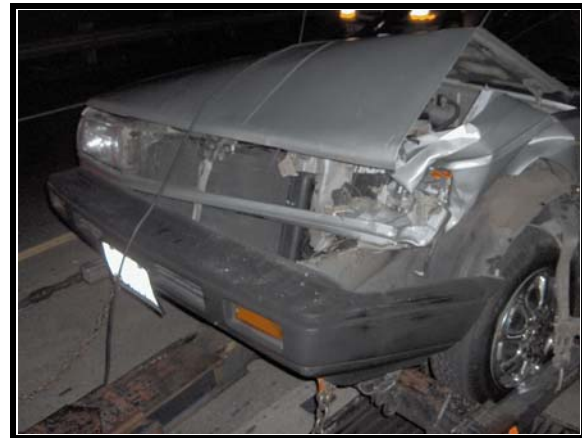
Figure 4. Frontal damage to Nissan Sentra

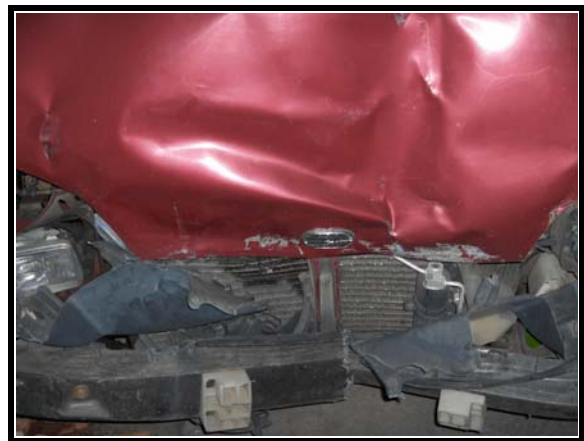
The Geo Metro sustained moderate frontal damage as a result of the impact with the rear of the Nissan Sentra (**Figure 6**). The hood was crushed rearward, the front bumper fascia was broken off, the plastic bumper backing bar was fractured and the right front fender was buckled. The police reported that the vehicle had prior damage to the left rear fender. The Collision Deformation Classification (CDC) for the impact with the Nissan Sentra was 12FDEW1.

Figure 6. View of frontal damage to Geo Metro

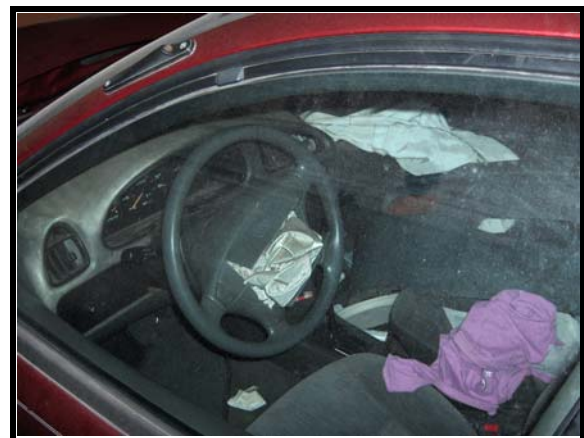
Figure 7. Driver's air bag

The driver's air bag deployed from the center of the steering wheel hub through H-configuration module cover flaps (**Figure 7**). It is not known if there were any contacts to the air bag or any damage to either the air bag or the cover flaps.

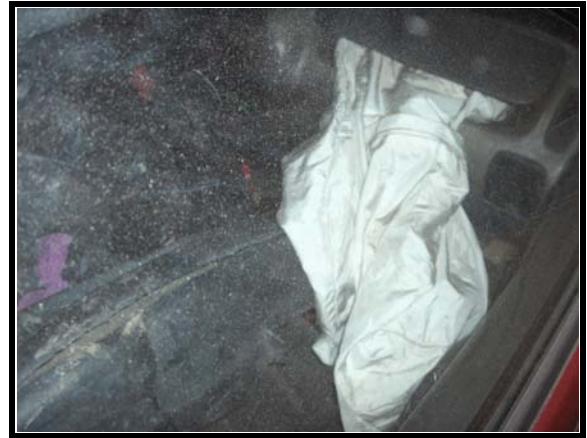
The front right passenger's air bag deployed from a top-mount module with a rectangular cover flap that was hinged at the forward aspect (**Figure 8**). It is not known if there was any residual contact evidence to the air bag or any damage to the cover flap.

Figure 8. Front right passenger air bag
