Remote Not In Traffic Surveillance Hyperthermia Investigation
Dynamic Science, Inc. (DSI), Case Number DS08014
2007 Ford Focus
Utah
April 2008

**Dynamic Science, Inc.
Crash Investigation
Case Number: DS08014**

BACKGROUND

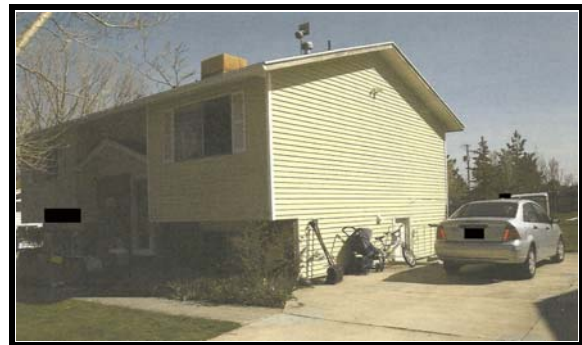
Figure 1. Parked 2007 Ford Focus

This hyperthermia related death occurred in a private driveway (**Figure 1**). The driveway was of concrete construction and was located to the west of the residence. The death occurred in April 2008 between 1230 and 1540 hours. According to the nearest reporting station, the temperature ranged from 23 degrees C (73 degrees F) at 1253 hours to 24 degrees C (76 degrees F) at 1553 hours. The driveway was exposed to the sun throughout this time period.

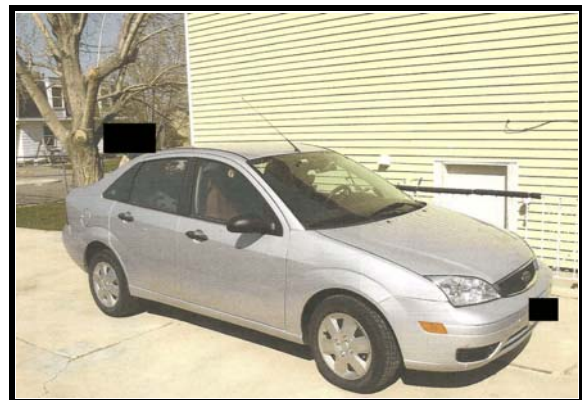
Figure 2. Front right, 2007 Ford Focus

The subject vehicle was a gray-colored 2007 Ford Focus four-door sedan that was parked facing south in the driveway of the driver's residence (**Figure 2**). The vehicle was not equipped with a sunroof. The interior color was light gray. There were maroon colored seat covers on the front bucket seats. There appeared to be a blue colored

seat cover on the rear seat. A forward facing CSS was located in the left rear seating position. The police reported that the front and rear door windows were fully closed throughout the duration of this incident.

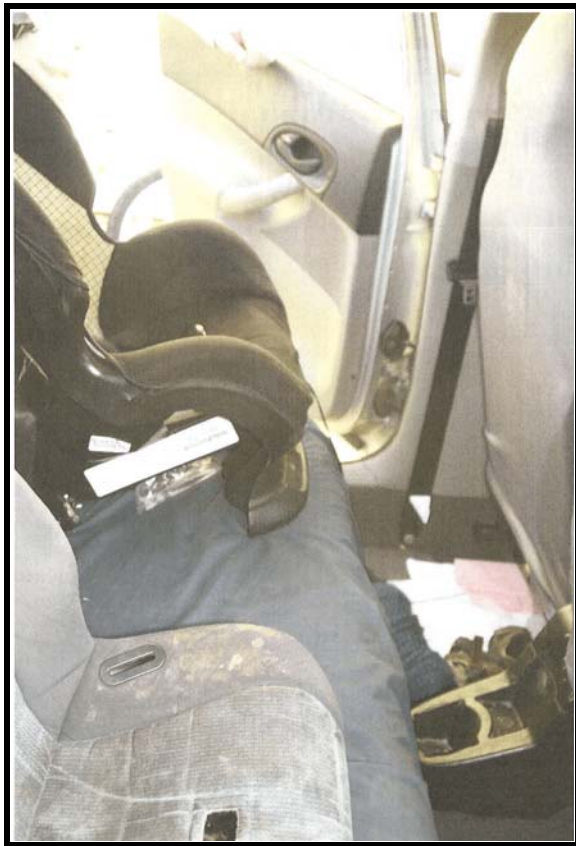
Figure 3. Forward facing CSS, view from right

The 19-month-old male child was the driver's son. The child was wearing a pair of pants, a T-shirt, a onsie¹, a light jacket, and sandals. He weighed 10 kg (22 lbs) and was 76 cm (30 in) tall. The child was seated in the left rear seat of the vehicle in a forward facing child safety seat (**Figures 3-4**).
