### ON-SITE NOT IN TRAFFIC SURVEILLANCE BACK OVER INVESTIGATION

CASE NUMBER - IN08025  
LOCATION - KANSAS  
VEHICLE - 1994 FORD BRONCO  
CRASH DATE - May 2008

16. <i>Abstract</i> This report covers an on-site not in traffic surveillance back over investigation involving a 1994 Ford Bronco and a pedalcyclist, who was backed over in a driveway. The Ford was parked on a level residential driveway. After entering the vehicle and conversing with her two passengers and another adult that was standing adjacent to the left front door, the driver checked her mirrors and began to back the vehicle. She was looking over her right shoulder and continuing to converse with the front right passenger as she backed up. Unknown to the driver, the pedalcyclist was riding a toy tricycle behind and to the right of the Ford. His specific location relative to the Ford when the driver prepared to back up was unknown. As she backed up and to the right, the back bumper impacted the pedalcyclist, the vehicle's right rear tire rolled over him, and he sustained fatal head injuries.

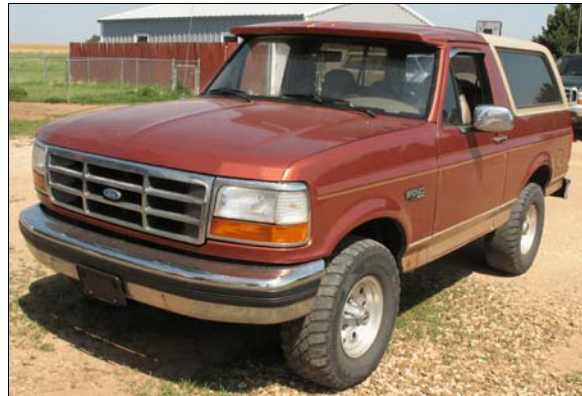
**Figure 1:** The 1994 Ford Bronco

The 1994 Ford Bronco was a four wheel drive, two-door sport utility vehicle (VIN: 1FMEU15HXRL-----) equipped with a 5.8L, V-8 engine and automatic transmission. The back windows and backlight were tinted (AS-3). The vehicle's recommended tire size was P265/75R15 and the vehicle was equipped with 22x11.50R15LT size tires. The Ford was not equipped with a back up/parking aid. The Ford's specified wheelbase was 266 centimeters (104.7 inches), the specified rear overhang was 120 centimeters (47.2 inches), and the specified overall length was 466 centimeters (183.6 inches). The distance from the ground to the bottom of the back bumper was 44 centimeters (17.3 inches). The distance from the ground to the top of the tailgate was 131 centimeters (51.6 inches). The height of the beltline was 128 centimeters (50.4 inches).

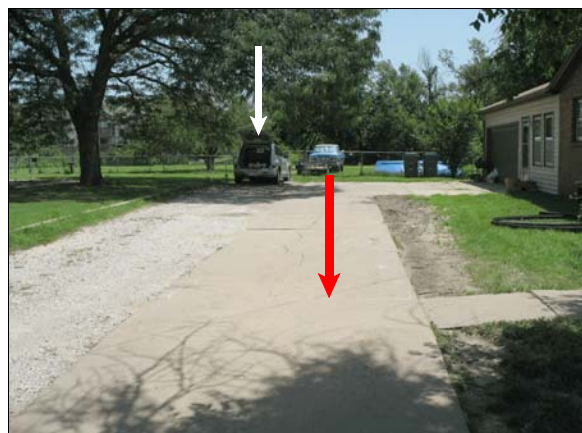
**Figure 2:** Parked vehicle (left arrow) represents initial position of Ford; right arrow shows area of impact

**Crash Environment:** The Ford was parked, heading east at the east end of a residential driveway (**Figure 2**) that traversed east/west and was located on the north side of the driver's residence. The Ford was parked on the gravel portion of the driveway and another car was parked immediately to the Ford's right, on the concrete portion of the driveway. The gravel did not extend to the street. At the time of the incident, the light condition was daylight, the atmospheric condition was clear, and the driveway

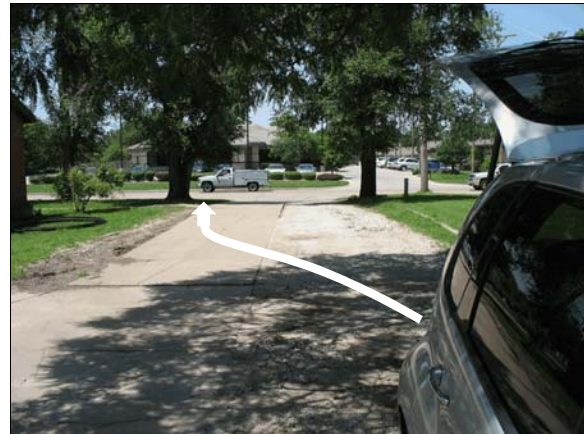
**Figure 3:** Arrow indicates estimated path of Ford to impact area

**Pre-Crash:** The Ford's driver (18-year-old, female) stated during the interview that she was conversing with several other adults and children at the east end of the driveway. She left this group and approached the vehicle from the front right but could not remember if she walked around the front or the back end to enter. She estimated that she sat in the vehicle for 30 seconds-1 minute before the front right passenger (19-year-old, female) entered. The driver's brother (17-year-old, male) approached the Ford and stood near the right front door and conversed with the occupants for 1-2 minutes before entering the vehicle and sitting in the middle of the second seat. At this point, the pedalcyclist's father (driver's stepfather) came to the driver's door and spoke with the occupants for 30 seconds-1 minute. When the conversation ended, the driver prepared to back up by looking at the rearview mirror and left side view mirror. She could not recall if she also looked at the right side view mirror. She then looked over her right shoulder out of the backlight and began to back the vehicle while engaged in a conversation with the front right passenger. Unknown to the driver, the pedalcyclist (driver's stepbrother) was riding a toy tricycle on or near the concrete portion of the driveway, behind and to the right of the Ford. His position and movement was not known because the driver nor other people at the scene saw him just prior to the incident. The driver's intention was to back the vehicle to the right and onto the concrete (**Figure 3**) because the gravel portion of the driveway did not extend all the way to the street.

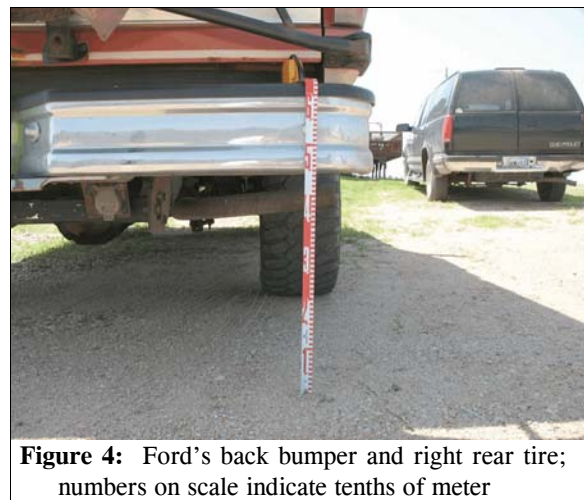
**Figure 4:** Ford's back bumper and right rear tire; numbers on scale indicate tenths of meter

The vehicle inspection revealed no damage or contact evidence to the Ford's back bumper, undercarriage, or right rear tire. Based on the vehicle inspection and the Collision Deformation Classification (CDC) guidelines for pedestrian impacts, the CDC was **06-BRLN-1 (180 degrees)**.

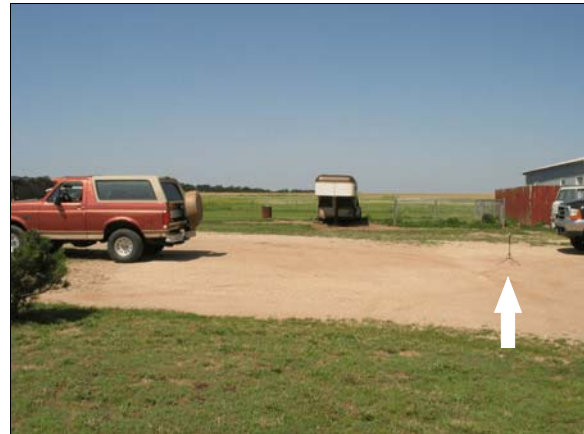
**Figure 5:** Arrow at target shows extent of blind zone with driver looking over shoulder

The initial set of observations was made with the driver looking over her right shoulder out of the backlight as she did at the time of the incident. The target was moved rearward from the back bumper along the Ford's centerline 6.9 meters (22.6 feet) before it came into the driver's view (**Figures 5 and 6**). When the target was moved 1.1 meters (3.6 feet) to the right of the centerline, it became obstructed by the spare tire, which was mounted on the Ford's tailgate. The target had to be moved 2.8 meters (9.2 feet) further to the right to become visible to the driver on the right side of the spare tire. When the target was moved 1.4 meters (4.6 feet) further to the right, it became obstructed by the right C-pillar and second row center passenger (**Figure 7**). The target had to be moved an additional 7 meters (23 feet) before it became visible on the right side of the second row center passenger. The target was repositioned at the centerline and when moved to the left 1.5 meters (4.9 feet), passed beyond the driver's view because it was unnatural to turn her head further to the right.

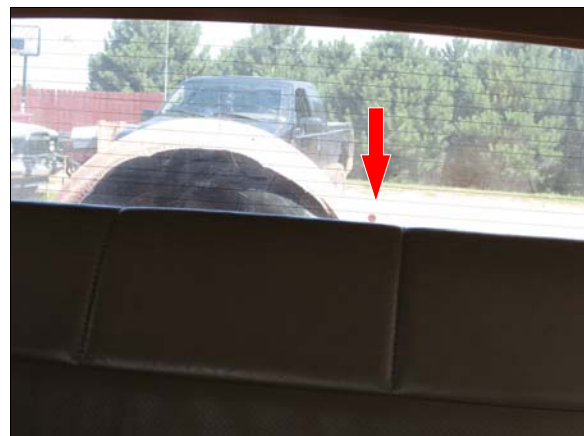
**Figure 6:** Arrow at target shows driver's over right shoulder view

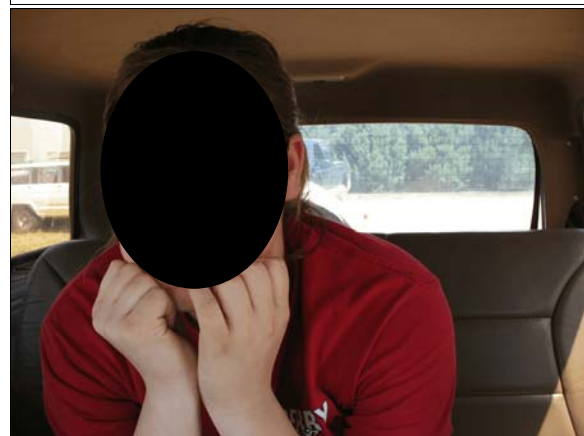
**Figure 7:** Surrogate second row center passenger obstructing view of driver; camera view does not accurately represent driver's view

and moved left. The target immediately went out of the driver’s view, dropping below the second row seat back. This was due to a depression in the gravel driveway where the target was positioned. The Ford was not driveable at the time of inspection and could not be moved.

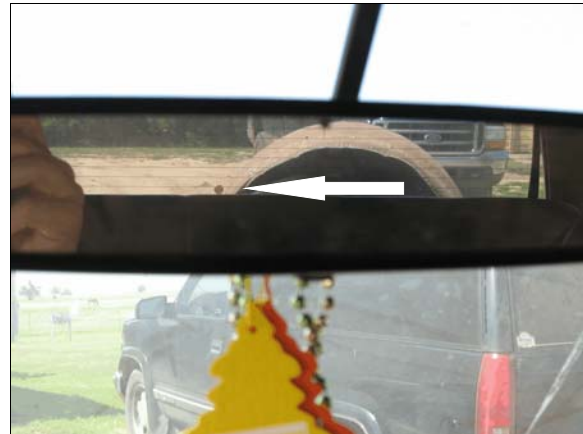
Figure 8: Close view of target through rearview mirror (arrow shows target)

The Ford's driver was asked to view behind the vehicle through the rearview mirror. The target was moved rearward from the back bumper 7.1 meters (23.3 feet) before the driver could see it (**Figure 8**). The target was moved 0.3 meter (1 foot) to the right of the centerline where it became obstructed by the second row center passenger and spare tire. The target did not become visible again until it was moved 2.1 meters (6.9 feet) further to the right, and when moved another 1.1 meters (3.6 feet), the target became obstructed by the right C-pillar. When moved another 0.7 meter (2.3 feet) to the right, the target became visible to the driver on the right side of the C-pillar. The target was moved another 0.6 meter (2 feet) it was no longer visible because it went out of the mirrors's field of view. The target was returned to the initial location at the centerline

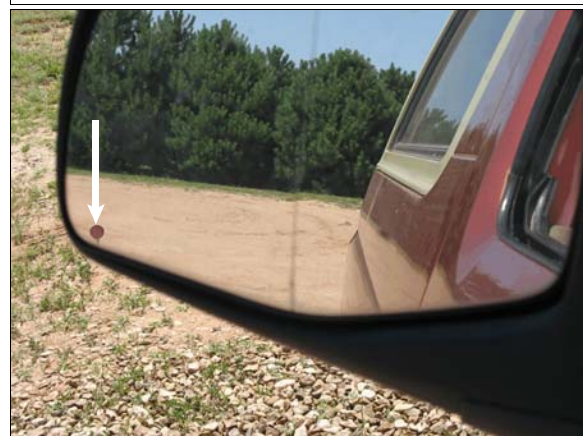
Figure 9: Close view through left side view mirror; arrow shows target

The target was placed at the back left bumper corner while the driver viewed through the left side view mirror. It was necessary to move the target rearward 3.2 meters (10.5 feet) before the driver could see it. The target was moved left 1.3 meters (4.3 feet) where it went out of the mirror’s field of view and the driver could no longer see it (Figure 9). The target was positioned at the back right bumper corner and the same process was repeated for the right side view mirror. It was necessary to move the target rearward from the back bumper 2.5 meters (8.2 feet) before the driver could see it. The target was then moved to the right 1.9 meters (6.2 feet) where it went out of the right side view mirror’s field of view and the driver could no longer see it (Figure 10).

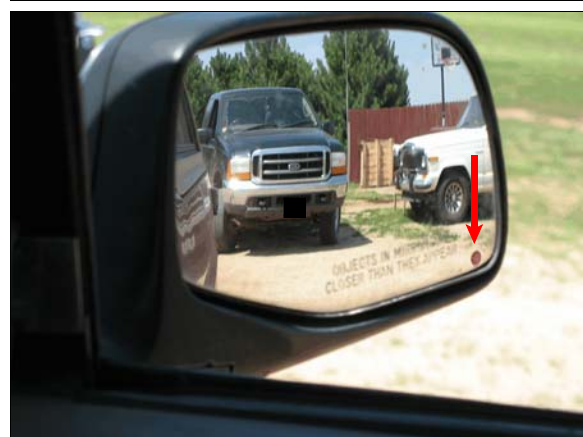
Figure 10: Close view through right side view mirror; arrow shows target
