## REMOTE NOT IN TRAFFIC SURVEILLANCE CARBON MONOXIDE POISONING INVESTIGATION

CASE NUMBER - IN09014

LOCATION - NEBRASKA

VEHICLE - 2007 CHEVROLET MONTE CARLO LT

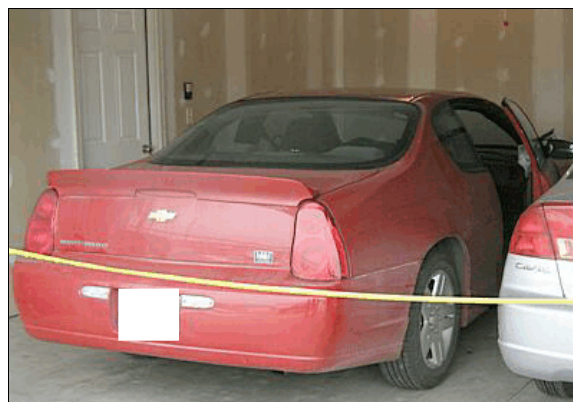
**Figure 1:** Police photograph of the 2007 Chevrolet Monte Carlo LT

The 2007 Chevrolet Monte Caro LT was a front wheel drive, 2-door coupe (VIN: 2G1WK15N579-----) equipped with a 3.5 L, V-6 engine and an automatic transmission.

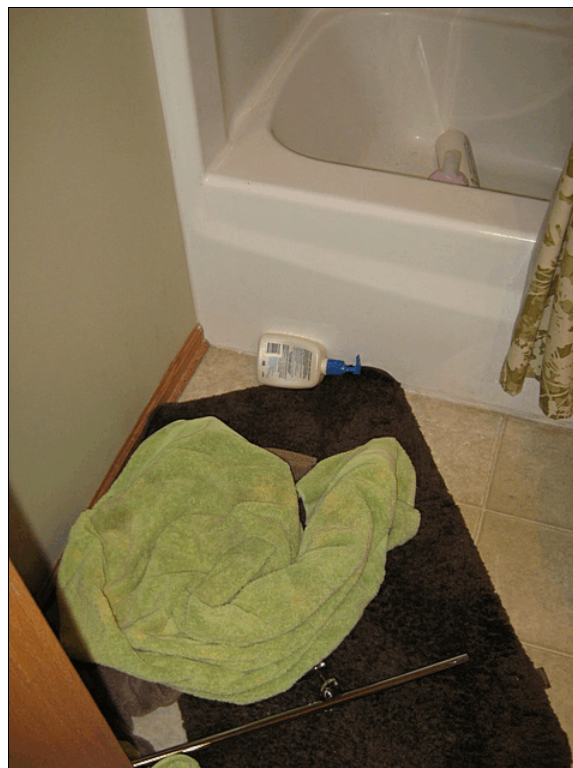
**Figure 3:** 21-year-old victim dislodged a towel rack when she was initially overcome in the shower and collapsed onto the floor

**Incident:** In the morning, the 21-year-old awoke at approximately 0700 hours and went into the bathroom to take a shower. The bathroom was directly across the hall from her bedroom. While she was showering, she began to feel dizzy and lost consciousness. She fell against a wall, dislodged a towel rack (**Figure 3**), and collapsed onto the floor. She regained consciousness at approximately 0745 hours and went into her bedroom and sat down on the bed. At approximately 0800 hours, she called out to the 22-year-old to come upstairs to the bedroom because she was feeling ill. Upon arrival at the bedroom, the 22-year-old noticed a strong smell. The 21-year-old asked the 22-year-old to call her father. The 21-year-old was having trouble talking and could not make the call herself. While still in the bedroom, the 22-year-old attempted to contact the 21-year-old’s father by phone, but she too began to feel ill. The 22-year-old left the bedroom and went back downstairs where she too was overcome and lost consciousness. The 21-year-old, while still in her bedroom, managed to call her boyfriend. As she was attempting to talk to him, she was overcome for a second time and lost consciousness. The boyfriend heard her collapse and called 911. The third roommate had departed the residence at approximately 0700 hours. She had suffered no adverse effects but went to the hospital later that day as a precautionary measure. She was examined in the emergency room and released.

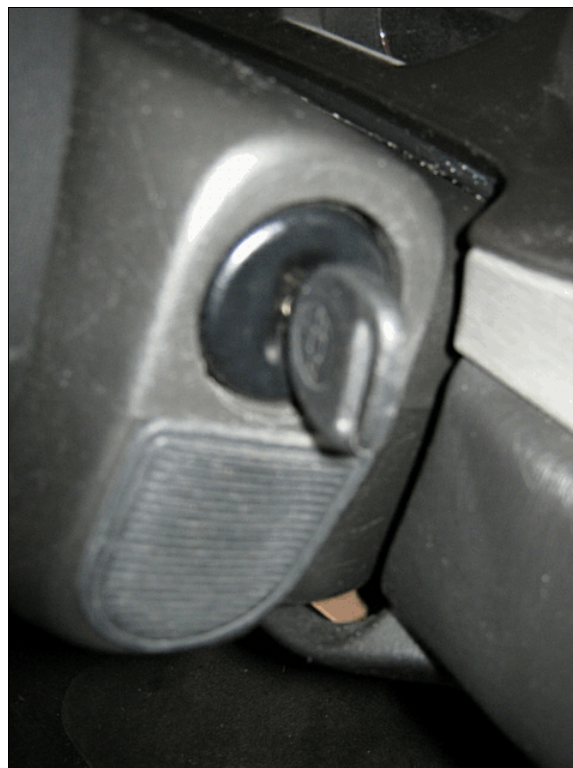
**Figure 4:** Police on-scene photograph showing the status of the Chevrolet’s ignition key

The fire rescue personnel found the Chevrolet in the garage. It was no longer running, but the key was in the ignition (**Figure 4**) in the “on” position and the engine was still hot. One of the on-scene photographs also showed a key chain on the driver’s seat cushion (**Figure 5**). According to the 22-year-old, it had come off the ignition key when fire rescue personnel attempted to remove the key from the ignition and had been placed by them on the seat cushion. There was no gasoline remaining in the vehicle’s fuel tank and the battery had discharged. The CO level within the victim’s residence was measured by fire rescue personnel and it registered at the peak of the measuring instrument, which was 9999 parts per million (ppm). Based on information from the Consumer Product Safety Commission<sup>1</sup>, most people will not experience any symptoms from prolonged exposure to CO levels of 1 to 70 ppm. As CO levels increase and remain about 70 ppm, symptoms become more noticeable and can include headache, fatigue, and nausea. At sustained CO concentrations above 150 to 200 ppm, disorientation, unconsciousness, and death are possible. The fire rescue personnel opened all the windows and doors and used a large fan to evacuate the CO gas from the victim’s residence. This was referred to as the positive pressure method.

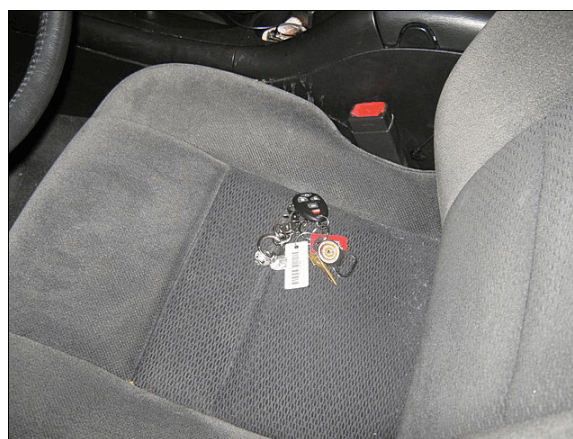
**Figure 5:** Police on-scene photo showing key chain on Chevrolet driver’s seat cushion

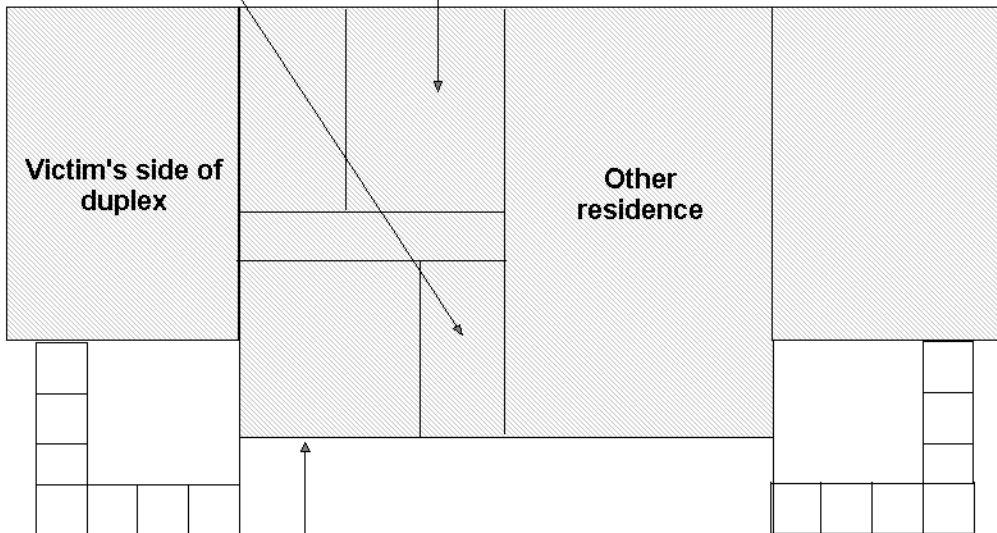
## Sketch of Incident Location

Bathroom where  
21-year-old initially  
lost consciousness

21-year-old  
victim's bedroom
