ON-SITE NOT IN TRAFFIC SURVEILLANCE BACK OVER INVESTIGATION

CASE NUMBER - IN09021

LOCATION - MINNESOTA

VEHICLE - 2000 CHRYSLER TOWN & COUNTRY LIMITED

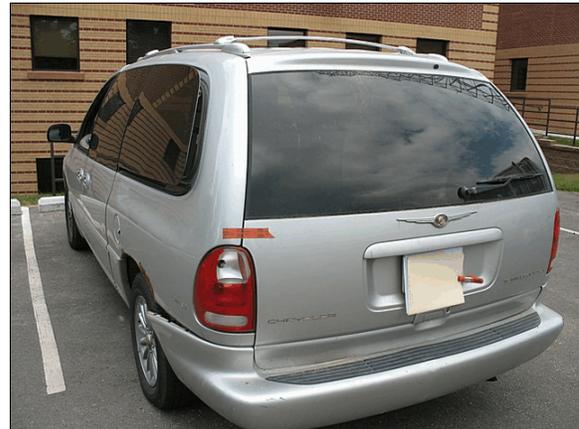
Figure 1: The 2000 Chrysler Town & Country Limited

This on-site investigation focused on the circumstances of a back over incident involving a 2000 Chrysler Town & Country Limited minivan (**Figure 1**) and three nonmotorists. The vehicle was being driven in reverse and backed over a 21-year-old female and her 3-month-old male child who were located inside a tent. The vehicle also impacted a 27-year-old male (father of the child) who was entering the tent. This incident was brought to our attention by the National Highway Traffic Safety Administration (NHTSA) on July 7, 2009 through an on-line news story. This investigation was assigned on July 7, 2009. The incident occurred in July, 2009, at 0830 hours, in Minnesota and was investigated by the county sheriff's department. A Minnesota Officer's Standard Crash Report was completed and a copy was submitted to the state. The incident scene and the Chrysler were inspected on July 9, 2009. An interview with the Chrysler's driver was attempted but refused by her attorney. An interview with the adult nonmotorists was conducted on July 24 and December 18, 2009. This report is based on inspections of the incident scene and vehicle, police crash report, discussions with the investigating deputy, interview information, on-scene photographs, and evaluation of the evidence.

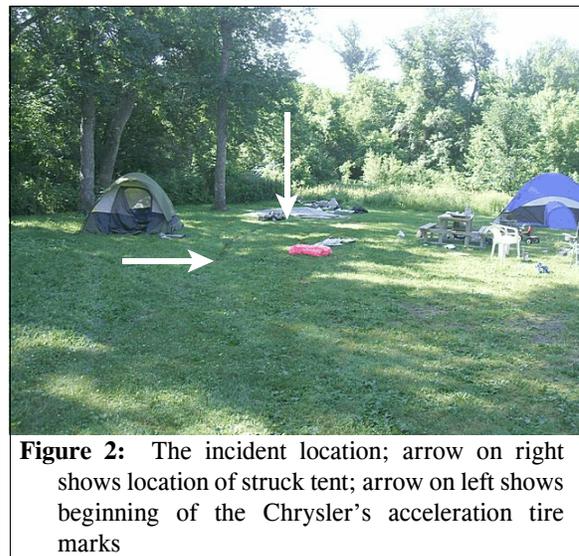
Figure 2: The incident location; arrow on right shows location of struck tent; arrow on left shows beginning of the Chrysler's acceleration tire marks

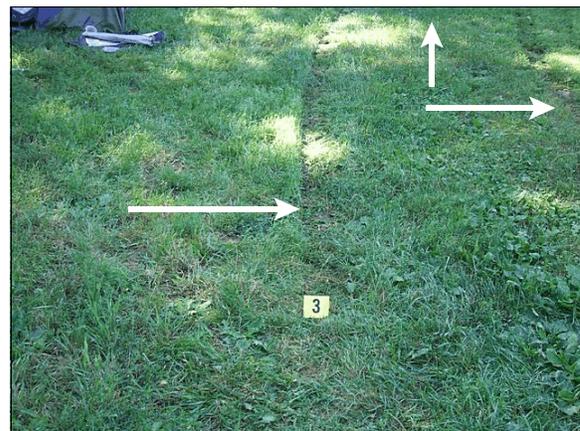
Figure 3: Police on-scene photo; arrows in foreground show the Chrysler's front wheel acceleration marks in the grass; arrow in background show direction of travel toward tent

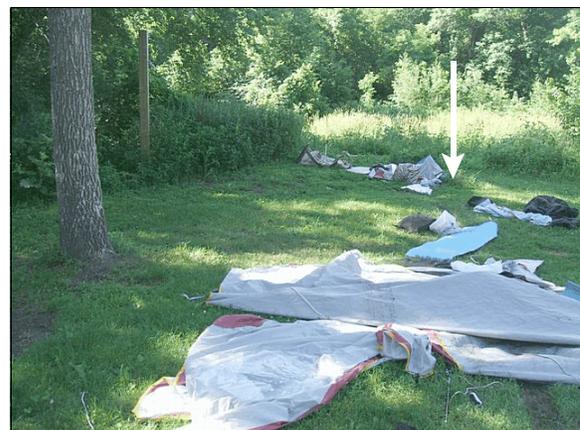
Figure 4: Path to impact with wooden post and area of final rest; arrow shows location of wooden post and area of the Chrysler's final rest

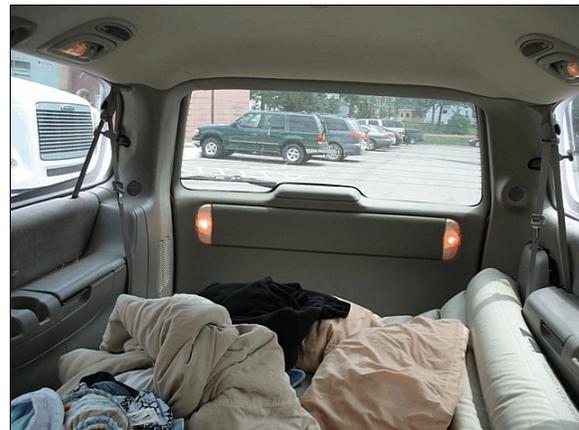
Figure 5: Chrysler's second and third row seats removed and an air mattress, pillows, and bedding were present in the area

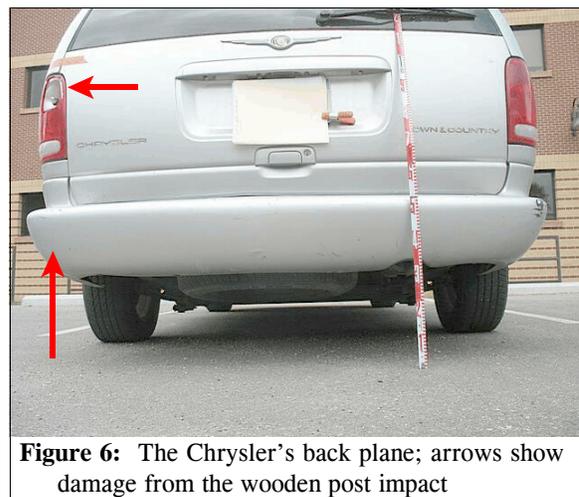
The inspection of the Chrysler revealed scratches and on the back left bumper corner, a broken left tail light, and displacement of the left rear bumper fascia (**Figure 6**). While the scratches did not appear related to the wooden post impact, the broken tail light and displaced bumper fascia were probably caused by this impact. There was no residual crush to the back bumper. A few scratches and small dents were also present on the vehicle's back plane, but they

Figure 6: The Chrysler's back plane; arrows show damage from the wooden post impact

appeared to be previous damage. There was no discernable evidence of damage or contact on the back plane or undercarriage from the impacts with the tent and the nonmotorists. The Collision Deformation Classification (CDC) for the impact with the tent (event 1) was estimated as **06-BDEU-1 (180 degrees)**. The CDCs for the impacts with the two nonmotorists within the tent (events 2 and 3) were both estimated as **06-B9LU-1 (180 degrees)**. The CDC for impact with the nonmotorist who was entering the tent (event 4) was estimated as **06-BLLU-1 (180 degrees)**. The CDC for the wooden post impact (event 5) was **06-BLES-1 (180 degrees)**.

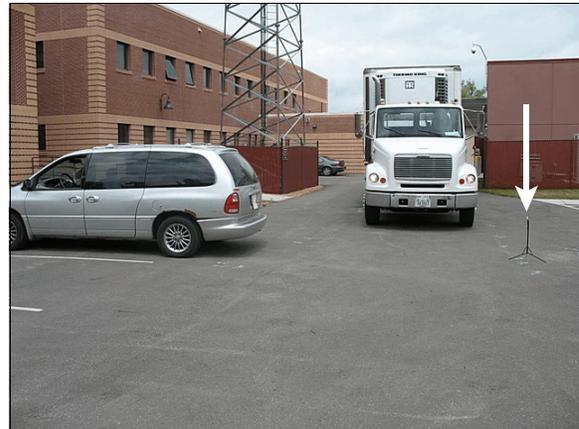
The initial set of observations was made with the surrogate looking over his right shoulder out of the backlight. The target was moved rearward from the back bumper along the Chrysler's centerline 4.2 m (13.8 ft) where it came into the surrogate's view (**Figure 7**), just to the left of the Center High Mounted Stop Lamp (CHMSL). When the target was moved 0.4 m, (1.3 ft) to the right of the centerline, it became obstructed by the CHMSL. The target became visible again when the target was moved another 1.6 m (5.2 ft) to the right, just to the right of the CHMSL. The target was then moved further to the right 1 m (3.3 ft) where it became obstructed by the right C-pillar. When it was moved another 1.4 m (4.6 ft), it became visible on the right side of the right C-pillar. The target was then placed back at the centerline. When moved to the left 1 m

Figure 7: Arrow shows location where target could first be seen by surrogate as he looked over his right shoulder out of the backlight; distance from back bumper to target was 4.2 m (13.8 ft)

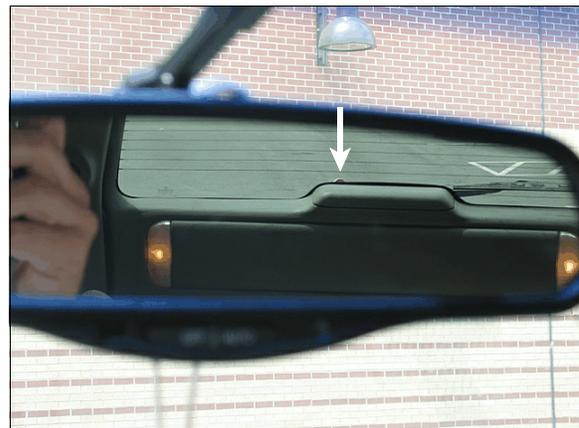
The surrogate was asked to view behind the vehicle through the rearview mirror. The target was moved rearward from the back bumper 5.1 m (16.7 ft) before the surrogate could see it, just over the CHMSL (Figure 8). The target was moved to the right 3.7 m (12.1 ft) where it went out of the mirror's field of view. The target was placed back at the centerline and was moved to the left 1.6 m (5.2 ft) where it became obstructed by the left D-pillar. When moved 2.3 m (7.5 ft) further left, the target became visible on the left side of the D-pillar. The target remained visible until it was moved 2.5 m (8.2 ft) further to the left where it went out of mirror's field of view.

Figure 8: View through rearview mirror from driver's seat; arrow shows target

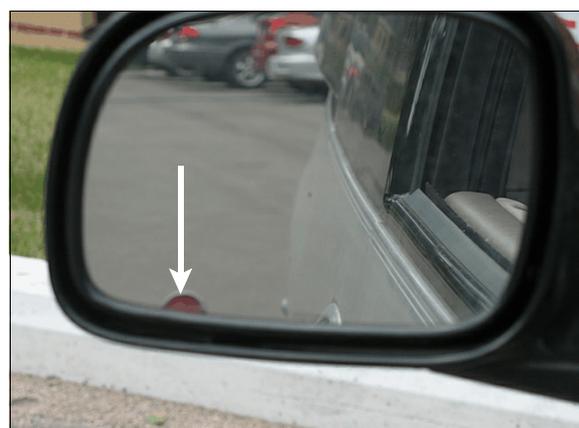
A similar procedure was conducted to assess the blind zones of the left and right side view mirrors. For each side view mirror, the target was moved rearward along the side of the vehicle until it first became visible at the bottom of the mirror (Figures 9 and 10). For the left side view mirror, the target came into the view at 0.3 m (1.0 ft) forward of the back bumper. It was repositioned at the back left bumper corner and moved to the left 0.6 m (1.0 ft) where it went out of the mirror's field of view. For the right side view mirror, the target was moved 0.5 m (1.6 ft) rear of the back bumper before it became visible. It was moved to the right 0.5 m (1.6 ft) where it went out of the mirror's field of view. Please see the Nominal Visibility Diagram on page 9 of this report for a depiction of the Chrysler's blind zones.

Figure 9: View through left side view mirror from driver's seat; arrow shows target where it first came in surrogate driver's view

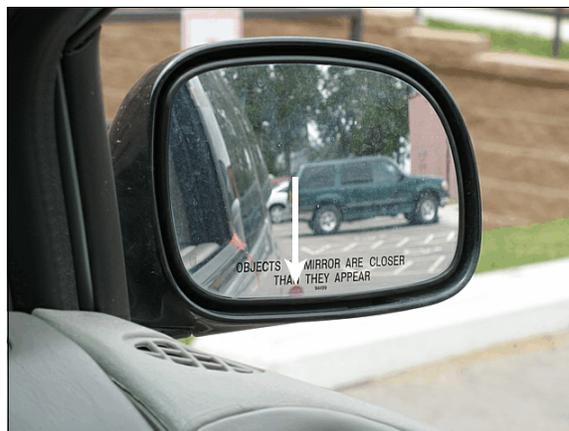
Figure 10: View through right side view mirror from driver’s seat; arrow shows target where it first came into surrogate’s driver’s view

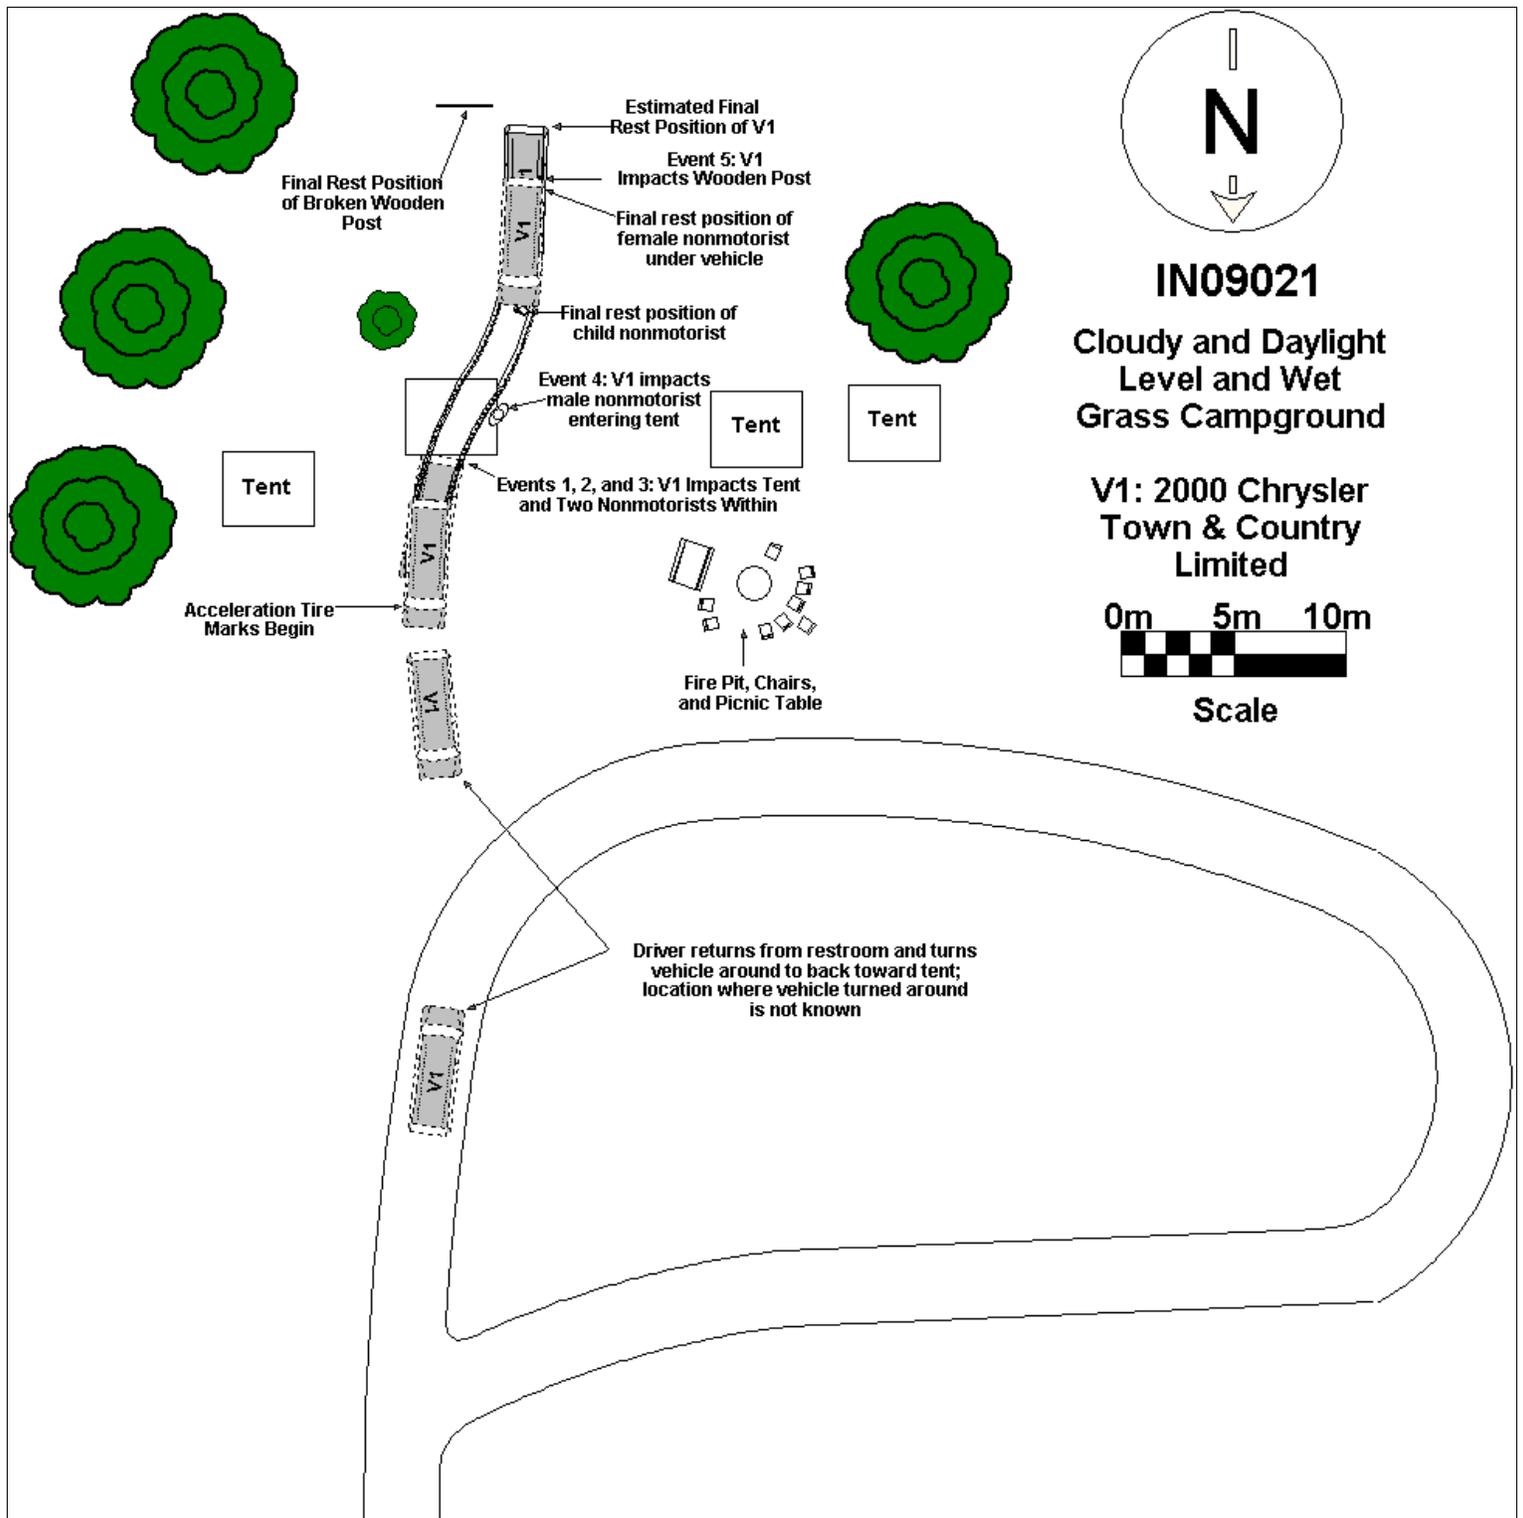
IN09021
Cloudy and Daylight
Level and Wet
Grass Campground

**V1: 2000 Chrysler
Town & Country
Limited**

daylight. The atmospheric condition was cloudy and the temperature was 17 degrees C (63 degrees F). The campground and adjacent driveway were level. There were no vision obstructions between the Chrysler and the tent that was backed over. The driver was aware of the location of the tent and its proximity to the back of the vehicle. The Scene Diagram is on page 8 of this report.

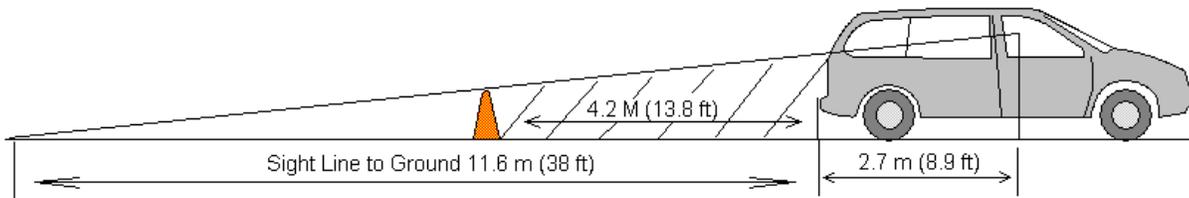
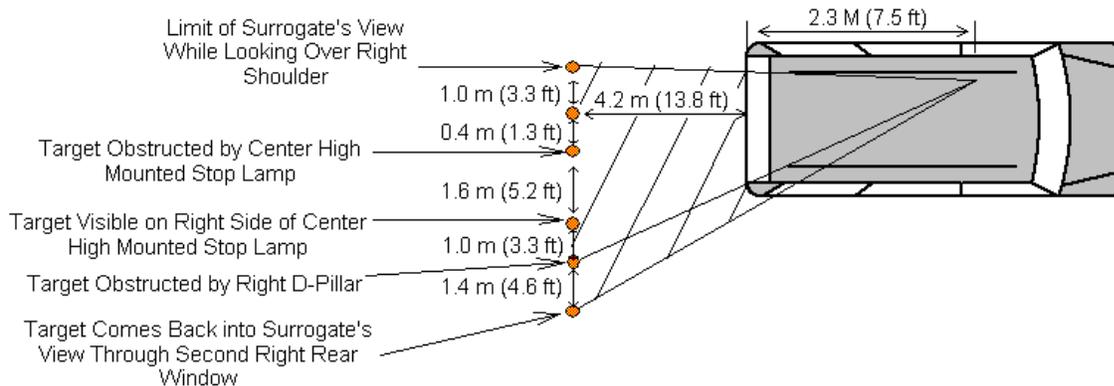
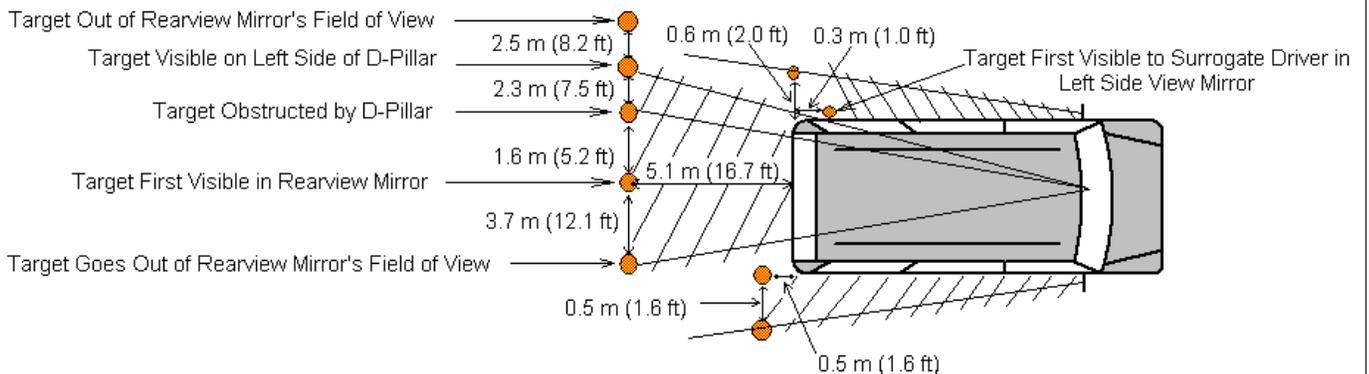
Nominal Visibility Diagram
Case Vehicle = 2000 Chrysler Town & Country Limited Minivan

Surrogate Driver's Eye Height From Ground = 133 cm (52.4 in)

1. Distance Back of Ford
To Point a 71 cm (28 in) High Reference Target
Comes Into View as Surrogate Driver Looks Over Right Shoulder Out of Backlight

2. Rearview Mirror and Side View Mirror Blind Zones
