TRANSPORTATION RESEARCH CENTER

REMOTE NOT IN TRAFFIC SURVEILLANCE HYPERTHERMIA INVESTIGATION

CASE NUMBER - IN09030
LOCATION - FLORIDA
VEHICLE - 2007 FORD EDGE SEL
INCIDENT DATE - July 2009

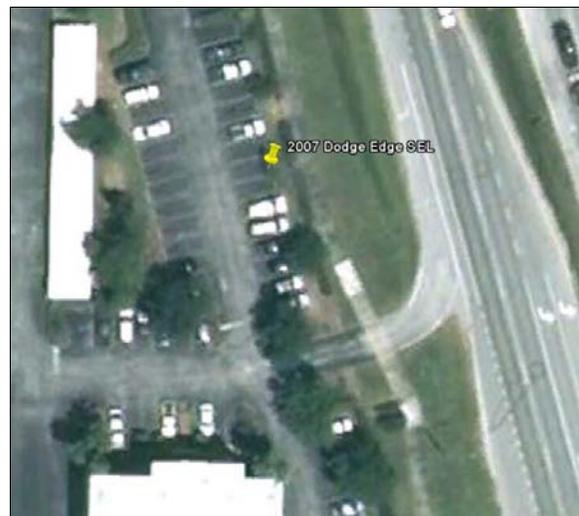
Figure 1: Overhead view of bank building and surrounding parking lot where child occupant was found deceased inside Ford

Incident Environment: The incident occurred on the east side of a parking lot, north of a three story office building. The building and parking areas occupied an entire city block with the building located in the southern part, and there was a large parking lot north of the building (Figure 1). There were parking stalls on both the south and east sides of the building. The Ford was parked in the east aisle of the southern section of the northern parking lot. The vehicle was parked heading in an east-northeast orientation the eastern side of the isle and was situated midway between the north and south boundaries of this section (Figures 2 through 4). During the day of the incident, the light condition was daylight, the atmospheric condition was clear, and the parking lot pavement was dry. The site of the incident was urban commercial. The INCIDENT DIAGRAM is on page 5.

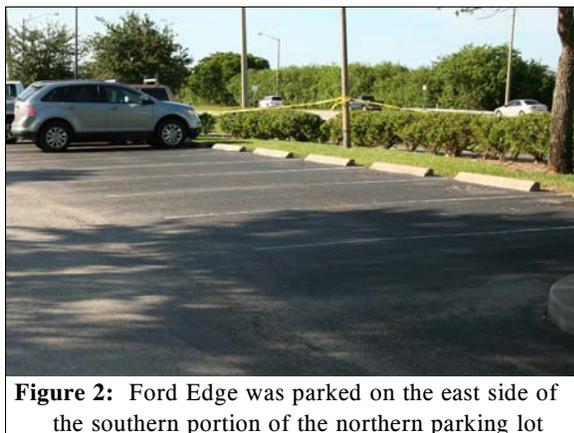
Figure 2: Ford Edge was parked on the east side of the southern portion of the northern parking lot

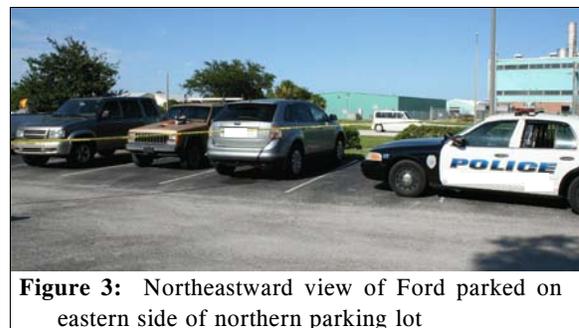
Figure 3: Northeastward view of Ford parked on eastern side of northern parking lot

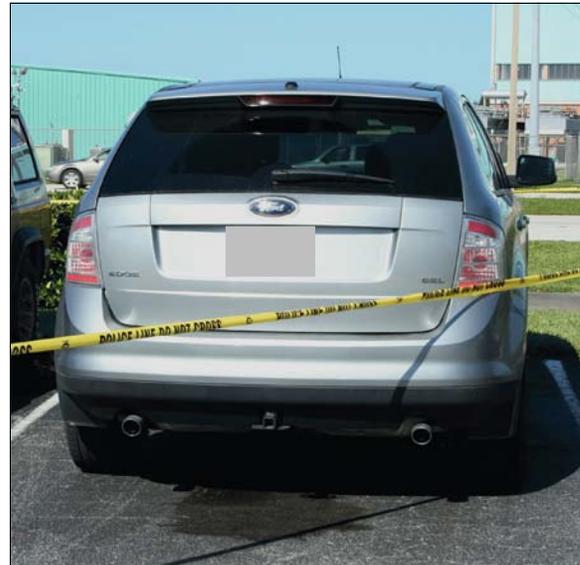
Figure 4: East-northeast view of back surface of Ford

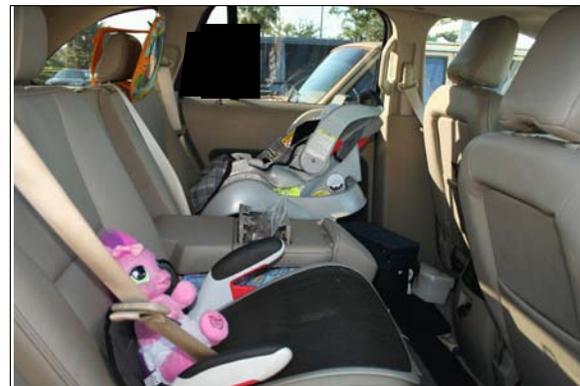
Figure 5: Second row of Ford showing booster CSS (foreground) normally used by driver’s 5-year-old and rear-facing CSS (background) in which deceased occupant was secured; Note: mirror attached to second row left head rest positioned designed to enable driver to observe infant child through windshield mounted rearview mirror

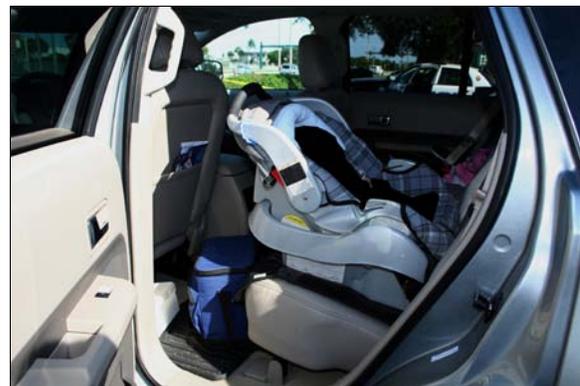
Figure 6: Rear-facing CSS secured in second row left position of Ford; deceased child is position in CSS but has been sanitized in this police photo

Incident: At approximately 1700 hours, after working all day without taking a lunch break, the driver indicated that she entered her vehicle, looked in the rearview mirror, and “saw him”. Her child was unconscious, unresponsive, and very hot. The child was still seated and secured in the child safety seat (Figure 6). A co-worker who had worked most of the day with the driver, was also going to his vehicle and witnessed the discovery. A passerby notified police.

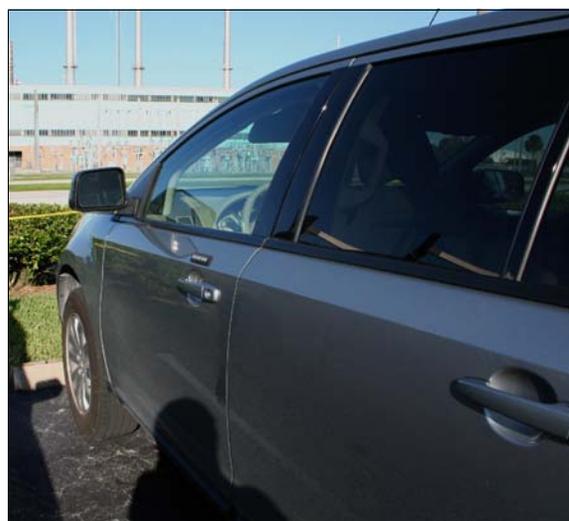
Figure 7: Left side of Ford showing tint to glazing of second row left window where deceased child occupant was seated

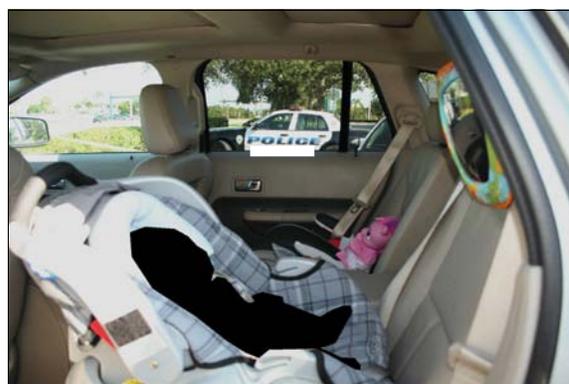
Figure 8: On-scene police photo showing deceased child (sanitized) inside rear-facing CSS located in second row left position of Ford

The second row left passenger of the Ford (5-month-old, male) was restrained in a rear-facing child safety seat which was secured by the vehicle’s lap-and-shoulder, safety belt system (Figure 8).
