CALSPAN ON-SITE CHILD RESTRAINT SYSTEM CRASH INVESTIGATION
SCI CASE NO: CA10017

VEHICLE: 2002 TOYOTA RAV4

LOCATION: OHIO

DATE: MAY, 2010

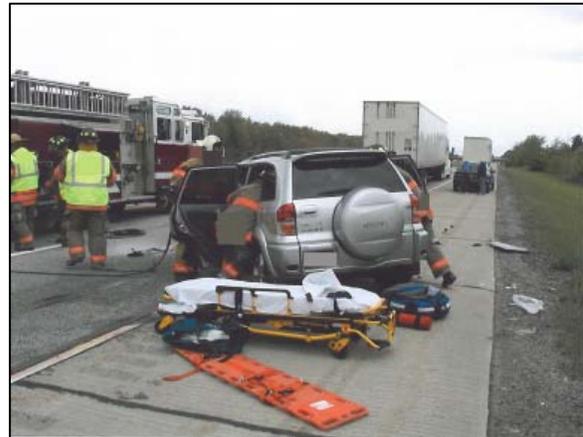
Figure 2: On-scene police image of the crash site depicting the final rest position of the Toyota.

The crash occurred during the daylight hours in May 2010. At the time of the crash, the weather and sight visibility were not factors. The crash occurred in the outboard westbound lane of a 2-lane divided interstate highway. The interstate was straight and level in the area of the crash. The westbound traffic lanes measured 3.6 m (12 ft) in width and were separated by broken centerlines representing a passing zone. A 3.0 m (10 ft) wide shoulder bordered the outboard lane. The posted speed limit in the area of the crash was 105 km/h (65 mph). There was a construction zone located several miles west of the crash site that influenced the traffic flow at the time of the crash. **Figure 2** is an on-scene police image of the crash site. The relationship between the point of impact and final rest locations of the vehicles was not determined by the police investigator. A schematic of the crash is attached to the end of this report as **Figure 8**.

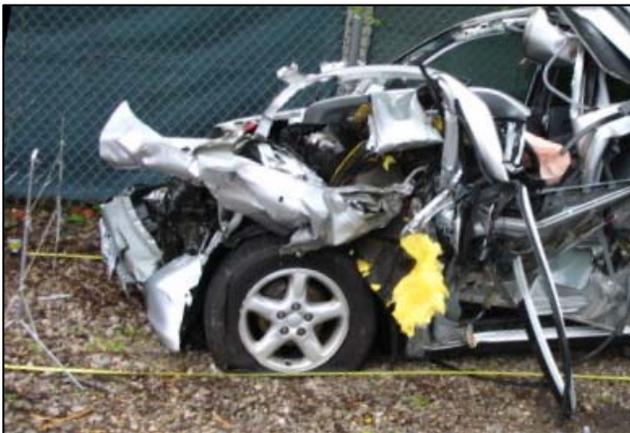
The Toyota sustained severe damage as a result of the underride impact. The extent of the damage was biased to the left consistent with the offset impact configuration. **Figure 3** is a left lateral view depicting the extent of crush. The width of the direct and induced damage extended across the entire 150 cm (59 in) frontal end width. The direct contact damage began 48 cm (19.0 in) right of center and extended to 123 cm (48.5 in) to the left front corner. The residual crush measured along the bumper reinforcement bar was as follows: C1 = 25 cm (9.8 in), C2 = 29 cm (11.4 in), C3 = 27 cm (10.6 in), C4 = 23 cm (9.1 in), C5 = 20 cm (7.9 in), C6 = 0. [It should be noted that the measurement baseline depicted in the Figure 3 required a negative 27 cm (10.7 in) stand adjustment.] As the vehicle underrode the back plane of the trailer, the Toyota's structures and components above the floor elevation of the trailer were sheared and deformed rearward. The right hinge and center latch of the hood had separated. The greenhouse area of the vehicle impacted the back plane. The maximum longitudinal crush of the header measured 44 cm (17.5 in). The maximum header crush was located 77 cm (12 in) inboard of the right roof side rail. Refer to **Figure 4**. The location of the maximum header deformation was attributed to the right rear corner of the trailer at maximum engagement. The left A-pillar was deformed to a vertical orientation. The left front door buckled in compression and was jammed shut. The left rear door and both right doors remained closed during the crash and were operational post-crash. The windshield was completely fractured. All the roof support pillars were cut and the roof was removed during the extrication. The left and right window glazings in rows 1 and 2 disintegrated in the crash. The side glazing and backlight that surround the cargo area disintegrated as a function of the extrication. There was no change in the wheelbase dimensions. The Collision Deformation Classification was 12FYAA7.

Figure 3: Left lateral view of the Toyota depicting the extent of frontal crush.

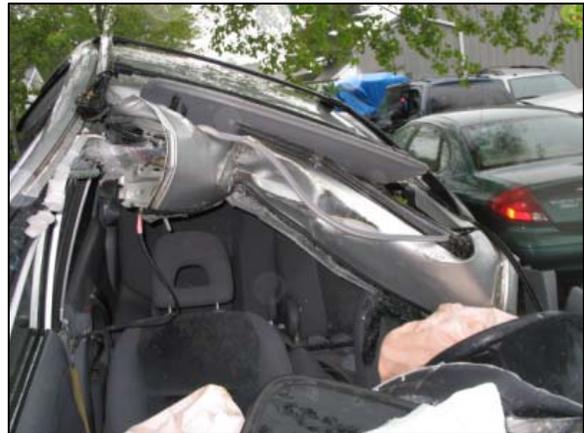
Figure 4: View of the deformed windshield header.

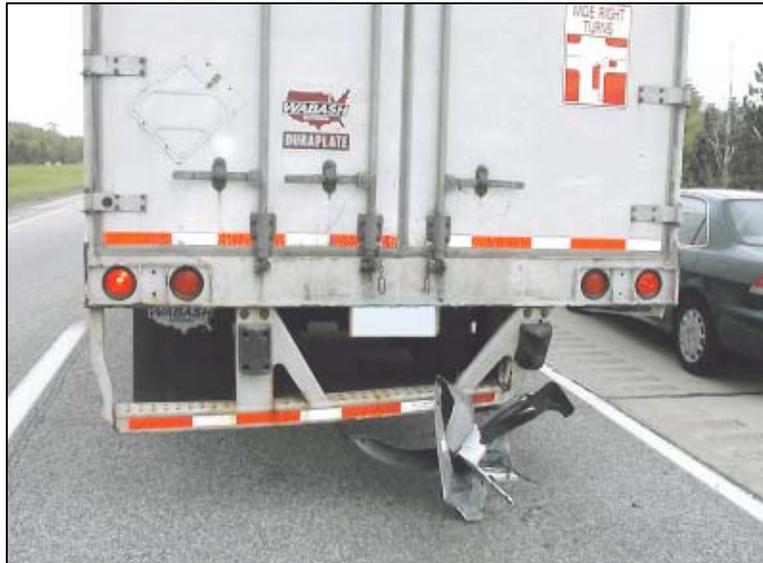
Figure 5 is a rear view of the Wabash trailer depicting the damage to the rear impact guard. The rear impact guard was attached to the back plane of the trailer by four vertical supports. The supports were symmetrical about the centerline of the trailer. The center supports were

constructed from what appeared to be a tapered I-beam section reinforced with by a V-shaped support. The ends to the rear impact guard were supported by a channel section that was welded to the end of the guard. The Toyota's avoidance maneuver resulted in the offset impact to the right aspect of the guard. The right end support separated in the crash due to overload and the guard deflected forward, cantilevered by the right central support. The trailer was released prior to SCI involvement and was not inspected. The Truck Deformation Classification was 06BZEWA.

Figure 5: Rear view of the trailer depicting the deformed rear impact guard.

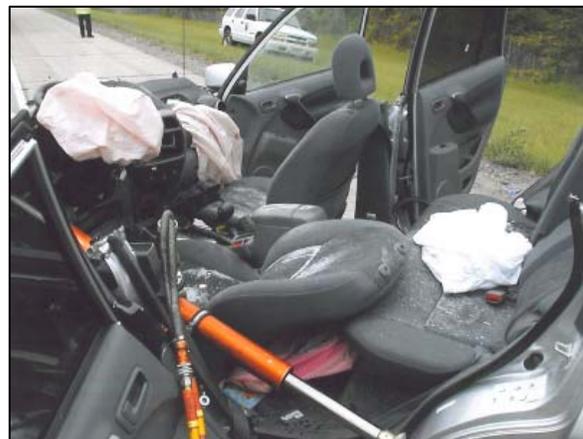
The crash resulted in severe intrusion into the driver's position that entrapped the driver. Extensive extrication was required to remove the driver for medical transport. These rescue efforts involved the hydraulic lifting and repositioning of the instrument panel to free the driver. Refer to **Figure 6**. For reference, the occupant compartment intrusion was measured; however, the measured values are thought be a minimum value. The roof removal hampered the proper documentation of roof and windshield header intrusion. The windshield header intrusion was estimated. The intrusion is listed in the following table:

Figure 6: On-scene police image depicting the extrication required to remove the driver.
