On-Scene / Vehicle to Vehicle / Front to Rear
Dynamic Science, Inc. / Case Number: DS97002
1996 Dodge Grand Caravan
California
February/1997

1. Report No. DS97002		2. Government Accession No.		3. Recipient Catalog No.	
4. Title and Subtitle In-Depth Accident Investigation				5. Report Date April/1997

This case was initiated in response to a report of airbag-related serious head injuries to a child in the right front passenger seat.

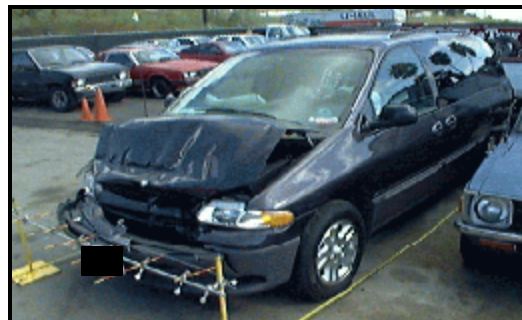
Description:	1996 Dodge Grand Caravan LE	
VIN:	1B4GP54L6TBXXXXXX	
Odometer:	Unknown. Digital style, battery dead.	
Engine:	3.8 L V6	
Reported Defects:	None	
Cargo:	None	
Damage Description:	Minor contact across top of bumper, minor rearward crush to grille.	
CDC:	12FDEW1	
Delta V: ¹	Total	13.8 km/h
	Longitudinal	-13.8 km/h
	Latitudinal	0.0 km/h
	Energy	15118 joules

Figure 1. Vehicle 1, 1996 Dodge Grand Caravan

This vehicle is equipped with three rows of seats. The front seats are both bucket seats. The seat tracks were in the mid position and the seatbacks were slightly reclined. The driver's side airbag had a single tether and no vents. The passenger side airbag was enclosed in a mid-mount module. The airbag had no tethers and no vents. It had a maximum deployed excursion of 69 cm. Neither airbag sustained any damage. There is some indication of passenger side airbag contact to the windshield near the right A-pillar. There was a single, post-deployment blood drop on the passenger side airbag, but no other indications of contact. There was no intrusion nor any integrity loss.

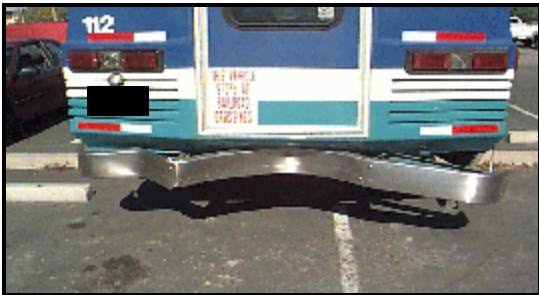
Description: 1989 Ford Econoline 4 x 2 RV cutaway
VIN: 1FDKE30M6KHCXXXXX
Odometer: Unknown
Engine: 7.3 L V8
Reported Defects: None
Cargo: None
Damage Description: Minor crush to rear crush. Maximum crush = 8 cm (3.1 in.)
CDC: 06BDLW1
Delta V:

Figure 2. Vehicle 2, 1989 Ford bus

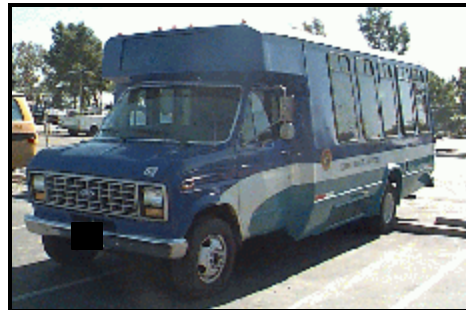
Figure 3. Vehicle 2, 1989 Ford bus
