**CALSPAN FRONT RIGHT AIR BAG DEPLOYMENT/CHILD
FATALITY INVESTIGATION**

CALSPAN CASE NO. CA97-047

SUBJECT VEHICLE - 1996 PLYMOUTH NEON

LOCATION - STATE OF NORTH CAROLINA

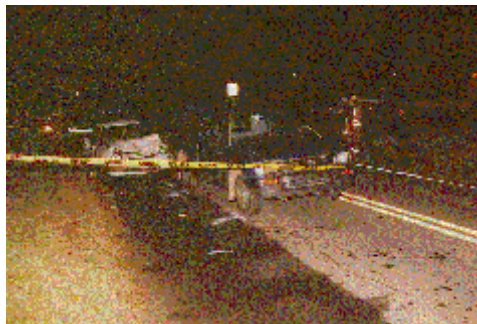
Figure 1. On-scene image of the involved vehicles' final rest position.

The Grand Am was stopped in front of the pick-up truck waiting to initiate a left turn. **Figure 1** identifies the on-scene final rest position of, and damage to the Neon and the Tacoma. The driver of the Neon removed the three year old child from the vehicle, noticed that she was not breathing, and stopped a passing vehicle to transport the child to the local emergency rescue team located approximately 0.40 kilometer (0.25 mile) west of the crash scene. The child was then transferred to a hospital where she expired approximately 30 minutes post-crash. The child sustained medically reported injuries which included a C3/C4 anterior subluxation (AIS-2), herniation of the brain stem (AIS-5), anterior neck contusions (AIS-1) and abrasions (AIS-1), and right face contusions (AIS-1) which resulted from contact by the deploying front right air bag. Right arm contusions (AIS-1) were resultant of contact with the front right module cover flap and right dorsal hand lacerations (AIS-1) and hematoma (AIS-1) were attributed to contact with the right aspect of the Neon's windshield. Contusions over the pleural surface of the lungs (AIS-4) were attributed to compression of the child's chest between the right front seated adult passenger and the deployed air bag. The unrestrained male driver of the Neon sustained bilateral forearm abrasions (AIS-1) and epistaxis (nose bleed). The unrestrained right front seated female passenger of the Neon sustained a fractured right wrist (AIS-1) and a right cheek laceration (AIS-1). Occupants in the pick-up truck and Grand Am were not injured as a result of the crash.

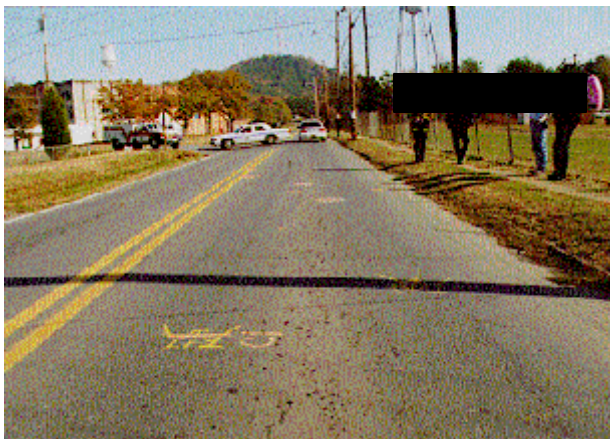
The crash occurred during the evening hours on a suburban east/westbound two-lane asphalt roadway with a posted speed limit of 56 km/h (35 mph). The level roadway was wet due to rainy conditions at the time of the crash and viewing conditions were reported as fair by the investigating police officer. The south shoulder of the roadway was bordered by a deteriorating concrete curb which had a maximum height of 15.2 cm (6.0 in), a grass berm, sidewalk and fence. The north shoulder of the roadway was bordered by grass and a drainage ditch. **Figure 2** identifies the crash scene and the initial direction of travel for the Neon.

Figure 2. View of the Neon's direction of travel and the crash scene.

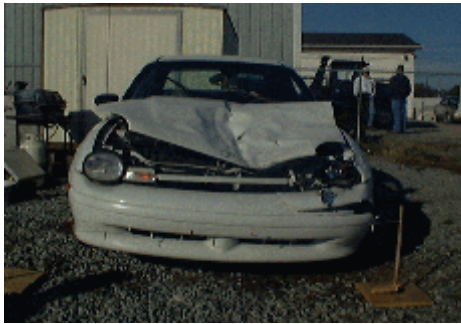
The impact to the Plymouth Neon generated direct contact damage that began at the front left bumper corner and fender area and extended 120 cm (47 in) right. Underriding damage was located on the center aspect of the hood face that consisted of blue paint transfers and longitudinal abrasions. Maximum crush was located at the radiator support level with a value 13 cm (5 in) and measured 26.8 cm (10.5 in) right of the left front bumper corner. Crush Values are reported in **Table 1**. The damage resulted in an 12 o'clock direction of force and a Collision Deformation Classification (CDC) of 12-FYMW-1. Damage sustained by the Neon is identified in **Figures 3 and 4**.

Figure 3. Frontal damage sustained by the Plymouth Neon.

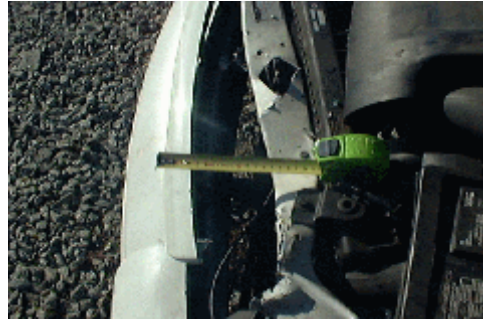
Figure 4. Identification of upper radiator support damage.

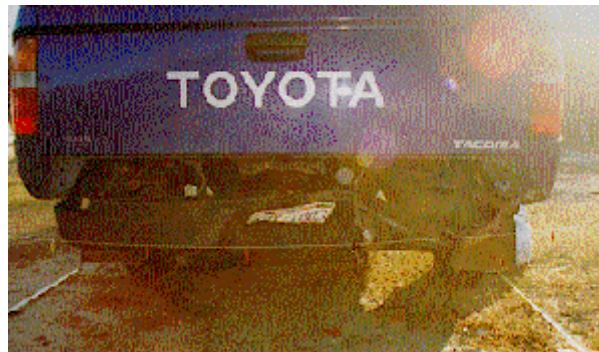
The initial impact to the Toyota Tacoma pick-up truck generated direct contact damage that began at the rear right bumper corner and extended 65 cm (26 in) left. The rear bumper was displaced under the tailgate and bed of the pick-up truck. Maximum crush value at bumper level was approximately 62.0 cm (24.4 in) located 57.2 cm (22.5 in) left of the rear right bumper corner. Rear bumper crush measurements are reported in **Table 2**. The rear aspect of the right side quarter panel sustained 1.5 cm (0.6 in) of crush. The damage resulted in a 6 o'clock direction of force and a CDC of 06-BZLW-3. Damage to the Tacoma is identified in **Figure 5**.

Figure 5. Damage sustained by the rear plane of the Toyota pick-up truck.

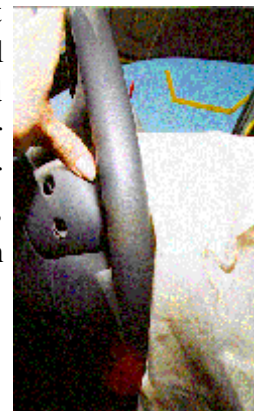
The posterior aspect of the steering wheel hub was equipped with plastic covers at the 3 and 9 o'clock positions. They were designed to house vehicle cruise control switches and some of their electronics. Although the case vehicle was not equipped with cruise control, the plastic covers were still available. The cover on an exemplar vehicle displayed the part number: 23199 223 5 4565347, and a white sticker was adhered to the cover which listed the identification: 4793490. The plastic covers were dislodged from the steering hub when the front left air bag of the Neon deployed. **Figure 6** identifies the left side plastic cover which dislodged when the front left air bag deployed.

Figure 6. Dislodged plastic cover in position.

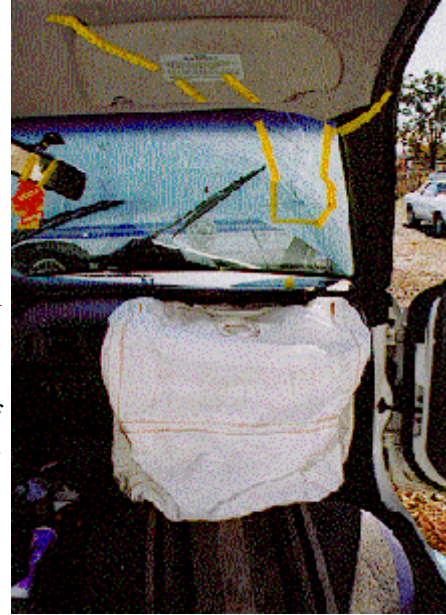
A windshield glazing fracture was located 16.0 cm (6.3 in) left of the right A-pillar and 45.0 cm (17.7 in) below the windshield header. The spiderweb fracture was surrounded by an heavy skin oil transfer which extended to the windshield header. This fracture resulted from contact with the adult right front passenger's dorsal right hand and the dorsal right hand of the child female right front seated passenger. Several scattered small abrasions were noted to the lower aspect of the glove compartment door from probable contact with the lower aspect of the front right child seated passenger. **Figure 7** identifies the front right passenger compartment area and the fractured windshield.

Figure 7. Overall view of the front right passenger compartment of the Neon and the fractured windshield.

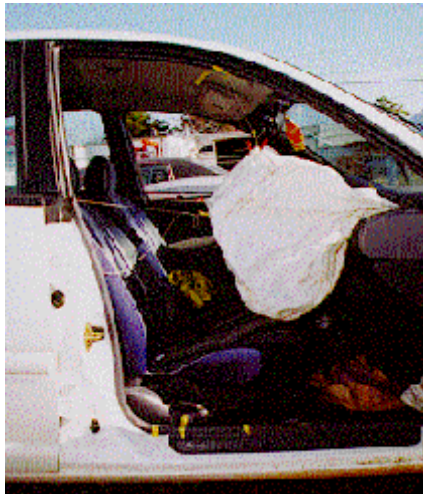
The front right air bag module was top-mounted in the right instrument panel area. The module cover flap had a measured height of 15.0 cm (5.9 in) and width of 34.5 cm (13.6 in). The acronym SRS and the word “AIRBAG” were molded in the lower right aspect of the module cover flap. The module cover flap did not sustain crash damage, however, a right hand transfer was evident on the center right aspect of the flap. This was resultant of the adult passenger’s right hand as she attempted to brace during the pre-crash sequence. Figure 7 identifies the front right passenger compartment area of the Neon. The right front air bag was equipped with four tethers, two were located at the top seam of the air bag on the right and left aspects and two were located at the bottom seam of the air bag also attached to the right and left side. One vent port was located at the 12 o’clock position. The deflated air bag had a seam to seam measured height of 34 cm (13.4 in). Rearward excursion of the front right air bag was 41 cm (16 in) from the leading edge of the instrument panel. The rearward excursion point was 32.0 cm (12.6 in) from the right front seat back in the mid to full back track position. This was the position of the seat track at crash. **Figure 8** identifies the right lateral view of the deployed front right air bag and passenger compartment of the Neon.

Figure 8. Right lateral view of the deployed front right air bag of the Neon and the passenger compartment.
