**REDESIGNED AIR BAG SPECIAL STUDY (RABSS)
SCI TECHNICAL SUMMARY REPORT**

NASS CDS CASE NO. 1998-12-165E

RABSS VEHICLE - 1998 CHEVROLET CAVALIER LS

CRASH DATE - AUGUST, 1998

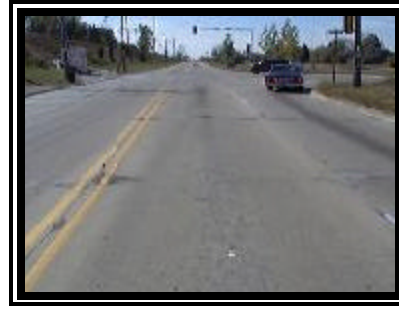
Figure 2. Westbound approach for the 1991 Pontiac LeMans.

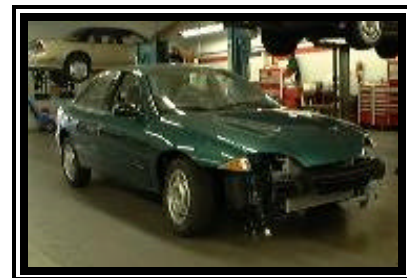
The 1998 Chevrolet Cavalier LS sustained moderate frontal damage as a result of the impact with the Pontiac LeMans (**Figure 3**). Exterior documentation was limited as the vehicle was under repair at the time of the NASS inspection. The bumper assembly, hood and fenders were replaced. Reduction in the right side wheelbase measured 6.0 cm (2.4 in). The right mid-windshield area was fractured from the interior passenger air bag flap (only).

Figure 3. 1998 Chevrolet Cavalier LS (under repair).

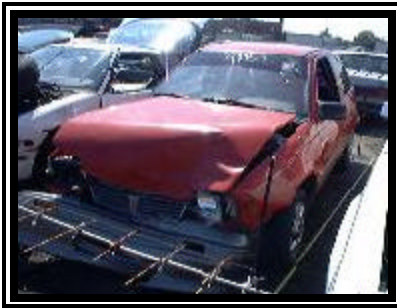
Figure 4. Frontal damage to the 1991 Pontiac LeMans.

The 1991 Pontiac LeMans 2-door hatchback sustained moderate frontal damage as a result of the impact with the Chevrolet Cavalier (**Figure 4**). The direct contact damage began at the front left bumper corner and extended 75.0 cm (29.5 in) inboard. The impact deformed the entire frontal width resulting in a combined direct and induced damage length (Field L) of 136.0 cm (53.5 in). A maximum crush value of 36.0 cm (11.4 in) was documented at the C3 position. The Collision Deformation Classification (CDC) for this impact to the Pontiac was 12-FYEW-2 with a principal direction of force of (-)10 degrees. The hood and left fender were deformed slightly rearward from the impact force. The windshield was fractured from interior occupant contact (only).

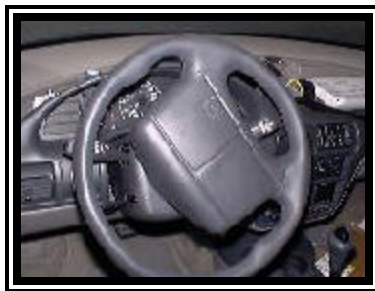
The 1998 Chevrolet Cavalier was equipped with redesigned frontal air bags for the driver and front right passenger positions. The air bags had deployed as a result of the crash. The driver air bag was housed in the center of the steering wheel (**Figure 5**) with a vertically oriented flap tear seam (I-configuration). The front right passenger air bag deployed from the right top instrument panel (**Figure 6**) with a single cover flap design hinged at the forward aspect. No dimensions were obtained as the vehicle was under repair at the time of the NASS inspection.

Figure 5. 1998 Chevrolet Cavalier redesigned driver air bag module (replaced).
