SCI/NASS COMBINATION CASE REPORT

CASE NUMBER - NASS-98-41-004A
LOCATION - Florida
VEHICLE - 1998 MERCURY TRACER
CRASH DATE - January 1998

1. <i>Report No.</i> NASS-98-41-004A		2. <i>Government Accession No.</i>		3. <i>Recipient's Catalog No.</i>	
4. <i>Title and Subtitle</i> Combination SCI/NASS Air Bag Deployment Investigation Vehicle - 1998 Mercury Tracer 4-door sedan Location - Florida				5. <i>Report Date:</i> June 13, 2000

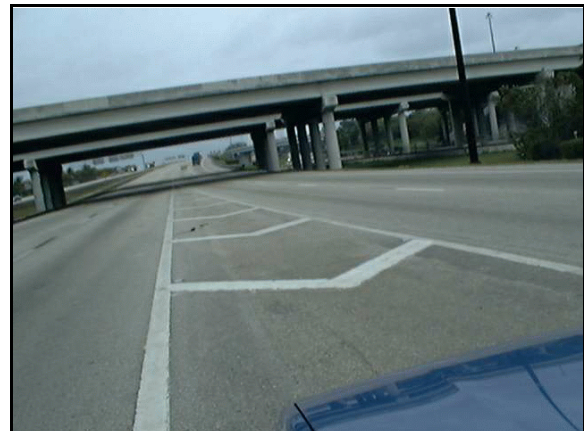
The case vehicle was traveling west at high speed in a westbound, two-lane, one-way entrance ramp where the ramp merged from the left with another two-lane limited-access roadway to create an urban interstate with four westbound lanes. The case vehicle failed to negotiate the area where the two roadways merged and traveled essentially straight down the ramp, crossed the gore and the two lanes of the joined roadway, departed the right (north) road edge and traveled across the shoulder onto the roadside (**Figure 1**). There is no evidence that the case vehicle driver attempted any avoidance actions.

Figure 1: Case vehicle’s westbound approach toward impact with bridge pillar on right

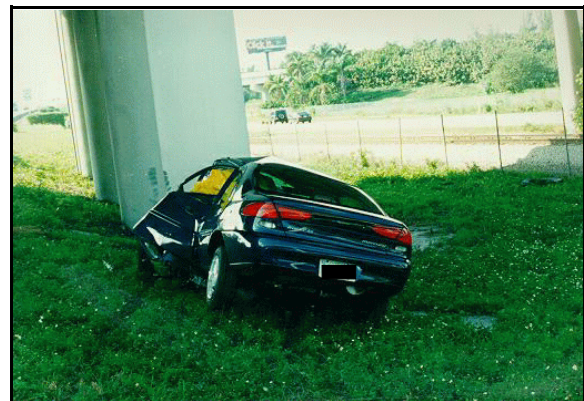
The crash occurred on the roadside, under an overpass for another roadway (**Figure 2**). The front of the case vehicle impacted a very large concrete bridge pillar, causing the case vehicle’s driver and front right passenger air bags to deploy. The case vehicle rotated a few degrees counterclockwise and came to rest lodged against the bridge pillar. The Police Crash Report includes an estimate that the case vehicle was traveling approximately 113 km.p.h. [70 m.p.h.] at impact. The coroner’s report includes witness statements that the case vehicle had been traveling 48 - 64 km.p.h. [30 - 40 m.p.h.] and appeared to accelerate toward the bridge pillar.

Figure 2: On-scene, case vehicle’s off-road path into impact and final rest

The case vehicle impacted a round concrete bridge pillar with diameter approximately 1.5 meters [5 feet]. The column was part of a large system of piers supporting a deck for a multi-lane roadway overhead (**Figure 2**, above). The column was not damaged except for some light gouging and paint transfers. (Note, the on-scene photos show a large black scrub on the pillar that was impacted and another scrub on the next pillar in line -- these are not related to this crash.)

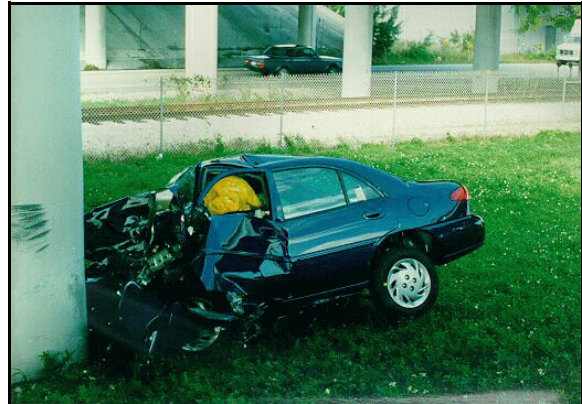
The case vehicle sustained heavy direct contact damage across the entire front plane (**Figures 3 - 5**), with maximum crush 120 centimeters [47.2 inches] at the center of the front bumper. The front bumper was pushed back against the front wheels, the wheels were pushed against the left and right lower A-pillars and the pillars were displaced rearward. The wheelbase was shortened by 58 centimeters [23 inches] on the left and 46 centimeters [18 inches] on the right. The engine hood was folded double and pushed against the windshield, causing extensive fracturing across the entire windshield. The front doors were distorted and bent outward, but the latches and hinges did not fail and the doors did not come open (the NASS case indicates that it is unknown whether the doors came open because of damage incurred during extrication efforts). The roof was buckled in the area of the B-pillars. The CDC is **12-FDEW-4** (direction of principal force 0 degrees). The WinSMASH reconstruction program indicated total, longitudinal and lateral Delta V, respectively: 94 km.p.h. [58 m.p.h.], -94 km.p.h. [-58 m.p.h.] and 0. The coded NASS case does not include these Delta V estimates because the crash was judged as being beyond the scope of the WinSMASH program due to the very great amount of crush.

Figure 3: On-scene, left side of case vehicle at final rest, prior to extrication of victim

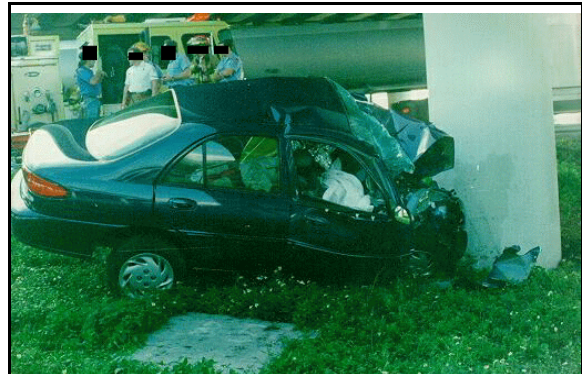
Figure 4: On-scene, right side of case vehicle at final rest, prior to extrication of victim

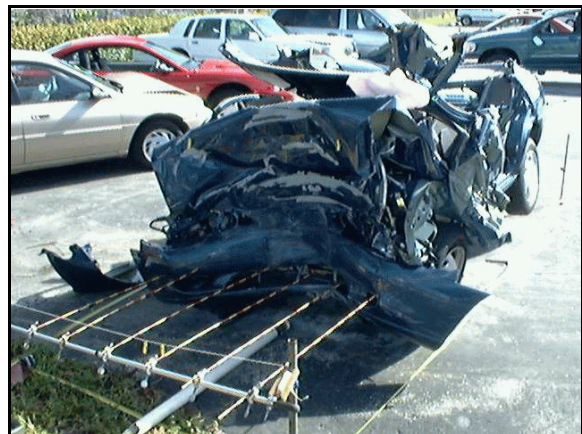
Figure 5: Front left view of damage measurement

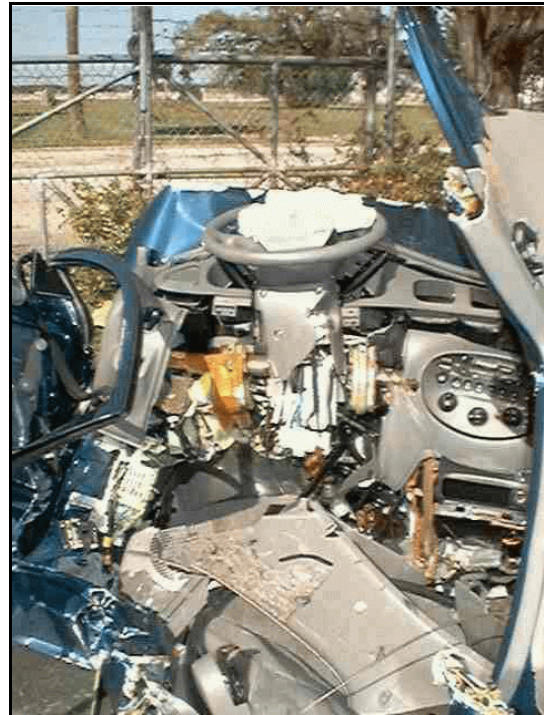
The case vehicle was equipped with redesigned front air bags for the driver and front right passenger seat positions. The driver air bag was located in the steering wheel hub. The module cover flaps opened along the seams with no evidence of damage to the flaps or the air bag. The driver air bag was round with diameter 50 centimeters [20 inches], with two tethers and two vent ports at the 11 and 1 o'clock positions. There was a small blood splatter in the front lower left quadrant and no other evidence of contact. The front right passenger air bag was located in the top of the instrument panel. The module's single cover flap opened along the seams and there was no evidence of damage to the flap or the air bag. The front right passenger air bag was rectangular, 40 centimeters [16 inches] wide and 50 centimeters [20 inches] high. It had no tether and two vent ports, at the 9 and 3 o'clock positions. There was no evidence of contact.

Figure 6: Case vehicle's instrument panel viewed from right door opening, after extrication

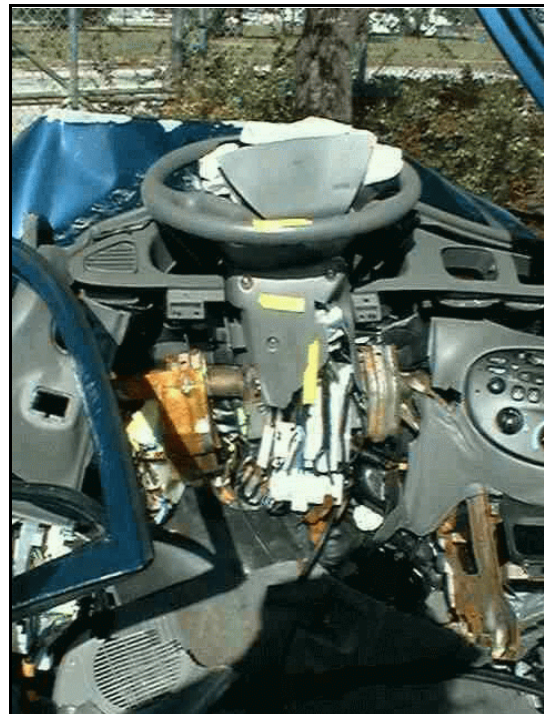
Extrication activities resulted in the case vehicle being extensively altered from its post-crash condition and the available photographs do not enable an assessment of the interior prior to extrication activities, but it is apparent that the entire front seat row sustained heavy intrusion by the instrument panel and floor (**Figure 6**). The NASS researcher documented intrusion of 55 centimeters [22 inches] by the left toe pan and 25 centimeters [10 inches] by the mid instrument panel. The steering column was forced into a nearly vertical configuration and the left instrument panel was separated from its mountings and lifted upward. The steering wheel rim appears to be intact, with no evidence of rim/spoke damage except a possible contact point at the bottom of the rim (**Figure 7**). (The NASS case indicates complete steering wheel collapse, but this reflects the NASS researcher's assessment of the steering assembly as a whole.)

Figure 7: Case vehicle's steering assembly with contact points marked, after extrication
