**REDESIGNED AIR BAG SPECIAL STUDY (RABSS)  
SCI TECHNICAL SUMMARY REPORT**

**NASS RABSS CASE NO. 1998-41-801E**

**RABSS VEHICLE - 1998 TOYOTA COROLLA CE**

14. <i>Sponsoring Agency Code</i>	
15. <i>Supplementary Notes</i> NASS investigation of a frontal collision (into a fixed object) that involved a 1998 Toyota Corolla 4-door sedan equipped with redesigned frontal air bags.

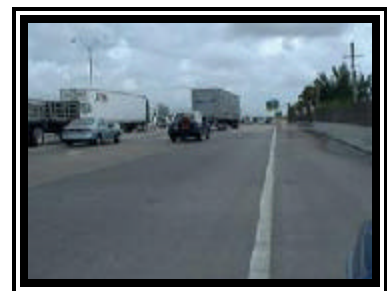
The 54 year old female driver of the 1998 Toyota Corolla was operating the vehicle northbound (**Figure 1**) in the center travel lane at a (driver reported) speed of 105 km/h (65 mph) when she looked to the right to change lanes and allowed the vehicle to depart the left (west) shoulder. Upon recognition of the impending harmful event, the driver braked in avoidance.

**Figure 1. View north of the crash site.**

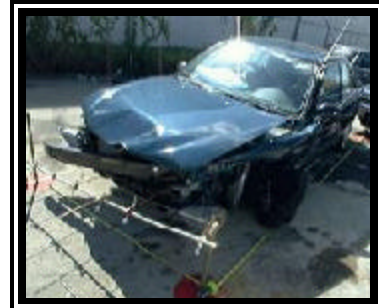
The 1998 Toyota Corolla sustained moderate frontal damage as a result of the impact with the concrete barrier (**Figure 2**). The direct contact damage began at the front left bumper corner and extended 55.0 cm (21.7 in) inboard. The impact deformed the full frontal width resulting in a combined direct and induced damage length (Field L) of 130.0 cm (51.2 in). Six crush measurements were documented at the level of the reinforcement bar (*bumper fascia separation*): C1= 21.0 cm (8.3 in), C2= 15.0 cm (5.9 in), C3= 12.0 cm (4.7 in), C4= 8.0 cm (3.1 in), C5= 1.0 cm (0.4 in), C6= 0 cm. The Collision Deformation Classification (CDC) for this impact to the Toyota was 01-FYEW-1 with a principal direction of force of (+)20 degrees. The grille and headlight assemblies fractured and separated from the vehicle during the collision sequence. The hood was displaced up and rearward from engagement against the concrete barrier. The windshield was fractured from (exterior) impact forces and the (interior) front right air bag. Reduction in the left side wheelbase measured 19.0 cm (7.5 in) while reduction in the right side wheelbase measured 4.0 cm (1.6 in). Additional direct contact damage was identified at the left front door (jammed) and fender area. This damage resembled a W-beam guardrail pattern indicative of a subsequent impact; and may necessitate assignment of another event in the NASS case file. The left fender was displaced laterally to the right with associated severe left front wheel/tire damage (restricted/deflated). Although the left front window glazing was disintegrated with direct contact damage present at the lower door area (jammed), it was probably from occupant contact given the height of the damage below the beltline.

**Figure 2. Front left damage to the 1998 Toyota Corolla.**

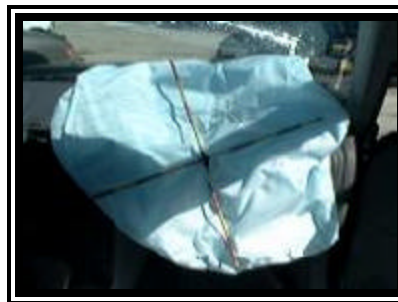
The front right passenger air bag deployed from the right top instrument panel area with a horizontally oriented flap tear seam (H-configuration). No contact evidence was identified on the air bag or exterior surface of the module cover flaps. The cover flaps were rectangular in shape as the forward flap measured 23.0 cm (9.1 in) in width and 3.0 cm (1.2 in) in height while the aft flap measured 23.0 cm (9.1 in) in width and 7.0 cm (2.8 in) in height. The NASS researcher measured the passenger air bag at 70.0 cm (27.6 in) in width and 60.0 cm (23.6 in) in height in its deflated state (**Figure 5**). No internal tether straps were present. The bag was vented by two ports located at the 9 o'clock and 3 o'clock sectors on the side aspect of the air bag. No cutoff switch was found for the front right air bag.

**Figure 5. 1998 Toyota Corolla redesigned passenger air bag.**
