Remote, Redesigned Air Bag Special Study

Dynamic Science, Inc., Case Number (1998-073-801G)

1998 Dodge Neon

Summary

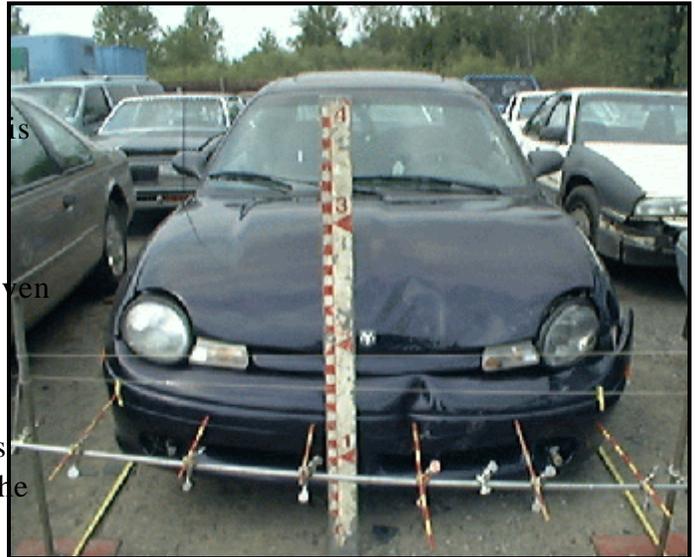
Figure 1. Exterior, Vehicle 2, 1998 Dodge Neon

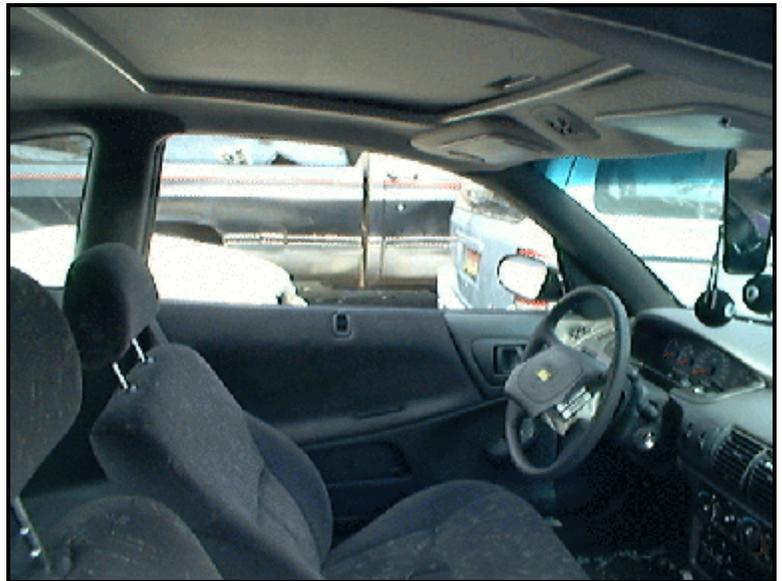
This vehicle is equipped with front bucket seats with folding backs with adjustable head restraints. There was no indication of any damage. The seat was adjusted to the between the middle and rear most track position. Both the left and right side windows disintegrated due to the impact forces. There was no intrusion. The vehicle was equipped with a fixed steering column. There was no rim damage nor any compression noted. The lower instrument panel was equipped with a rigid plastic knee bolster. There was no damage to the bolster.

Figure 2. Interior, Vehicle 2

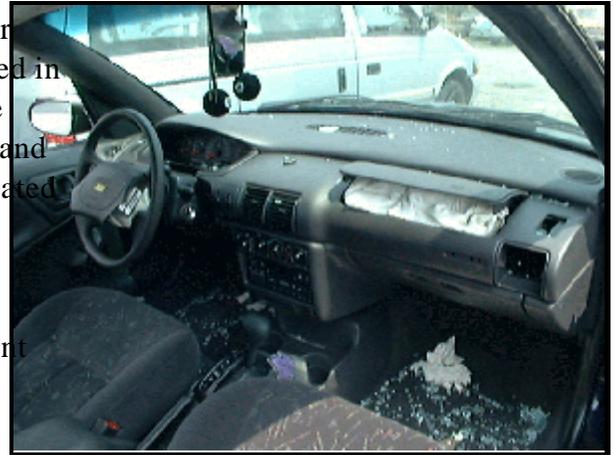
The Dodge Neon was equipped with “Next Generation” driver and front-passenger air bags. The front left air bag was housed in the steering wheel hub and was concealed by a single module cover. The circular air bag was tethered by two tether straps and contained two vent ports. There was an occupant contact located on the right side of the face of the air bag, but there was no damage to the air bag.

The front right passenger air bag was located on the instrument panel, top surface plane. There was a single, essentially rectangular module cover.

Figure 3. Interior, Vehicle 2

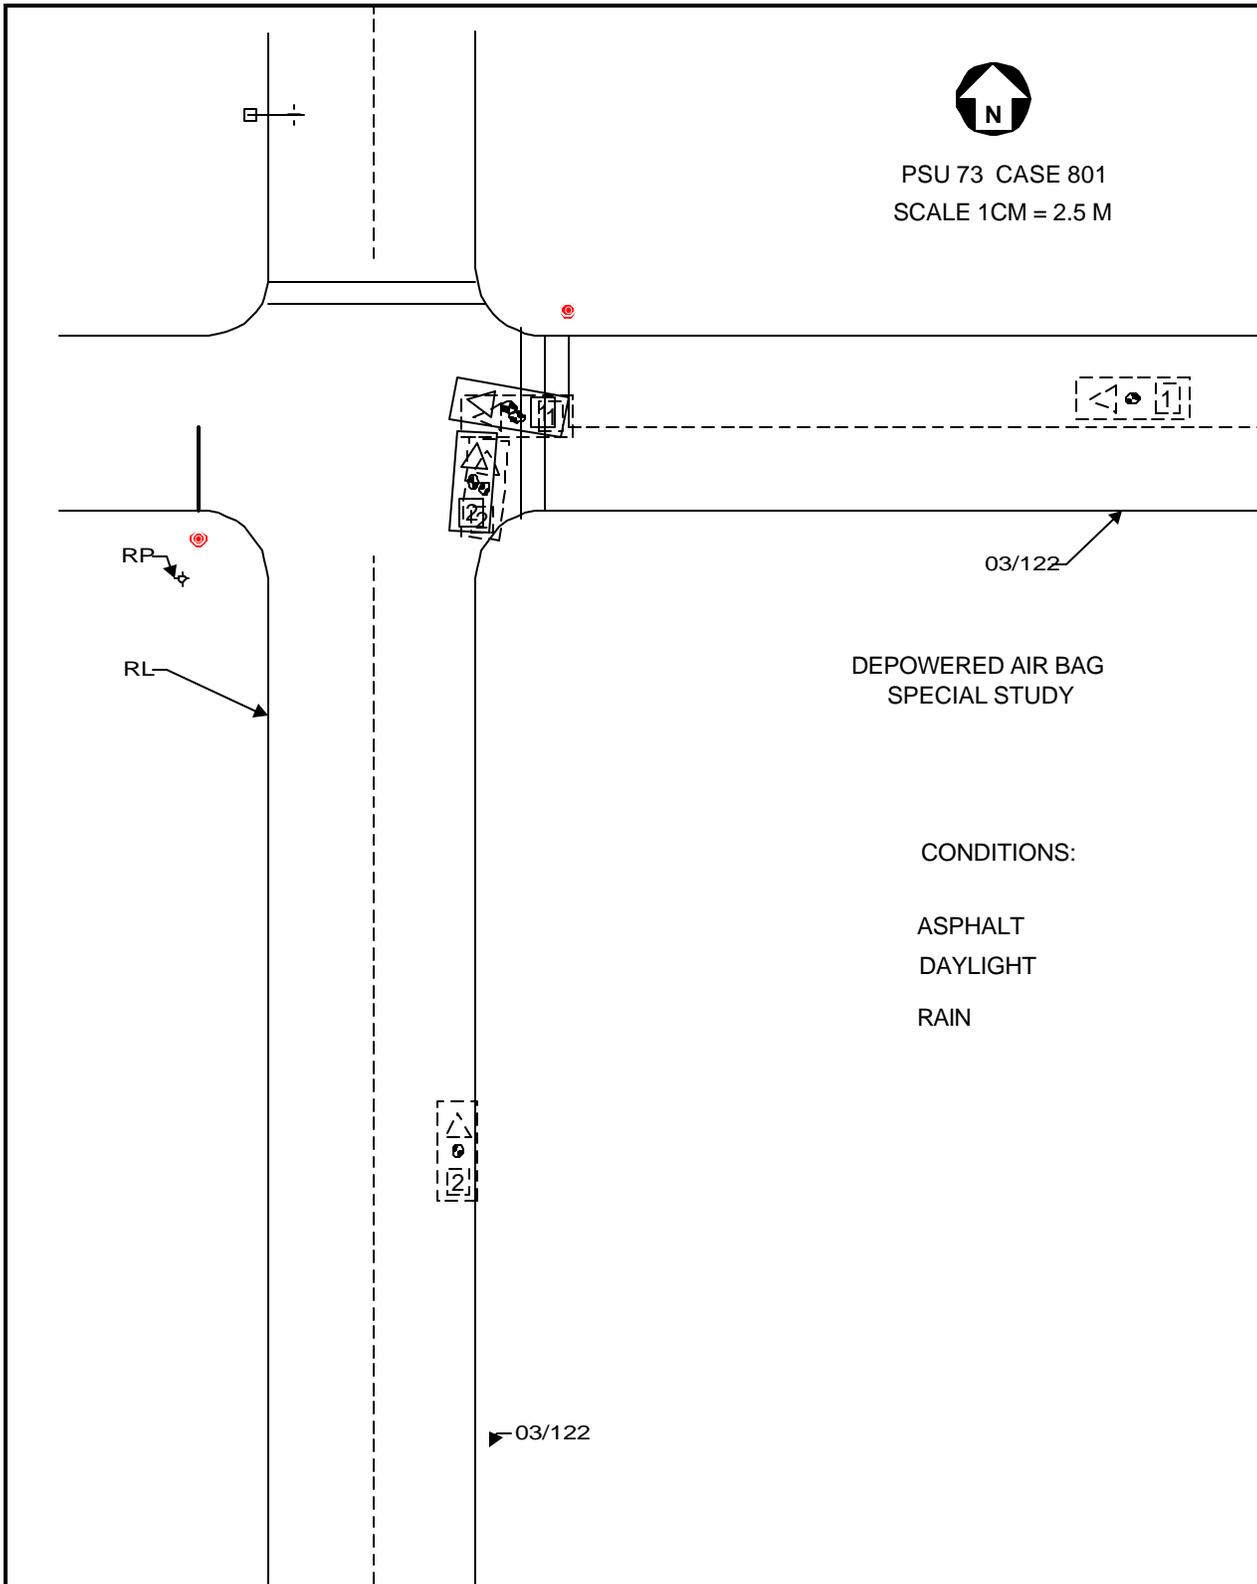
Figure 4. Scene Diagram

As Vehicle 2 approached the intersection, Vehicle 1 pulled out from the stop sign into the intersection. The driver of Vehicle 1 braked but was unable to stop in time and struck the left side of Vehicle 2 with the front of Vehicle 1. (CDC=12FDEW1). The impact was of sufficient magnitude to deploy both the driver and passenger side air bags. Vehicle 2 was redirected slightly in a counterclockwise direction while Vehicle 1 was redirected slightly in a clockwise direction. Both vehicles came to rest in the intersection.
