Remote, Redesigned Air Bag Special Study

Dynamic Science, Inc., Case Number (1998-82-803G)

1998 Honda Civic

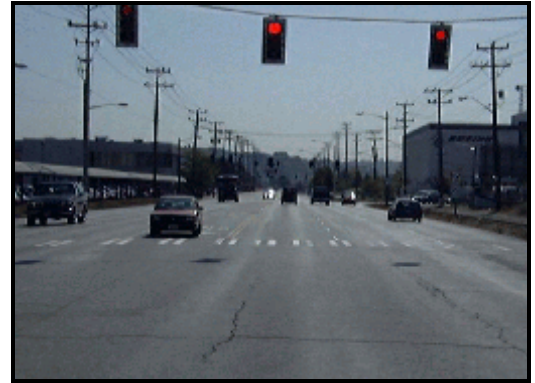
Figure 1. Pre-impact trajectory of Vehicle 1 and area of impact

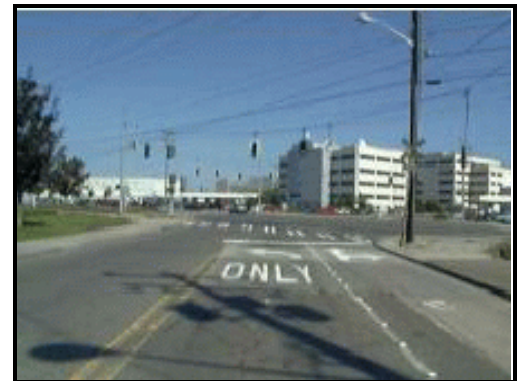
Figure 2. Pre-impact trajectory of Vehicle 2 (1998 Honda Civic)

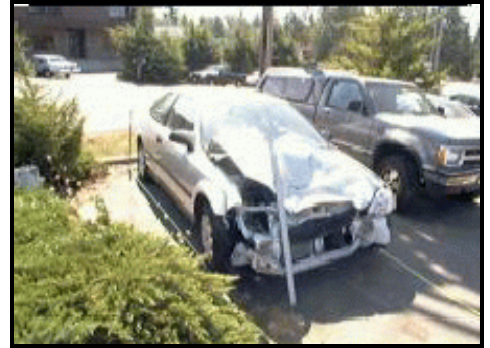
Driver 2 was intending to turn left when the front of Vehicle 2 (01FDEW2)¹ impacted the right fender area of Vehicle 1 (vehicle was not inspected). The calculated delta V for Vehicle 2 (Honda) was 14.4 km/h (8.9 mph) with a longitudinal delta V of -12.5 (-7.8 mph) which is at the lower end of the threshold necessary for air bag deployment. The calculated delta V for Vehicle 1 (Ford Ranger) was 11.6 km/h (7.2 mph)². Vehicle 1 was deflected slightly to the right and came to rest facing south. Vehicle 2 rotated clockwise and came to rest facing in an easterly direction.

Figure 3. Exterior view of Vehicle 2 showing frontal damage

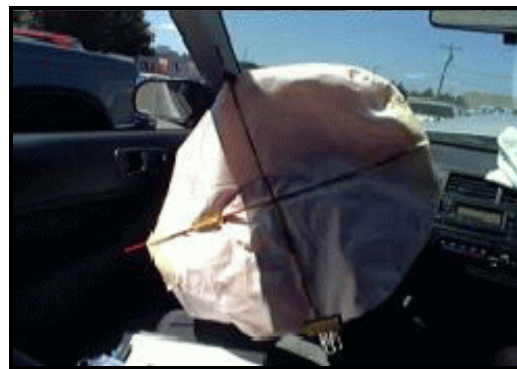
The driver's air bag is housed in the steering wheel hub and encases the nylon air bag unit. The double, horizontal module cover flaps are asymmetric in design and opened at their designated tear points. The circular air bag is 63 cm (24.8 in.) in diameter and is equipped with two exhaust vent port holes. The vent ports are located at the 11 and 1 o'clock positions respectively. The rigid plastic knee bolster was undamaged and did not reveal any detectable occupant contacts.

Figure 6. View showing deployed driver's air bag

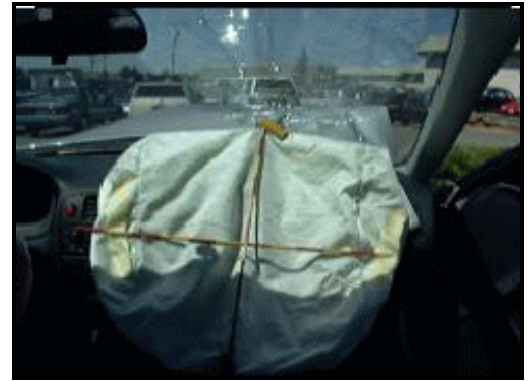
The front, right passenger air bag is located on the instrument panel (top mount). The module deployment door is rectangular in design and is equipped with double horizontal cover flaps that are symmetrical in design (23 cm wide x 5 cm in height). Upon deployment, the encased air bag fully deployed. The non-tethered air bag was undamaged and was equipped with two vent port holes which are at the 9 and 3 o'clock positions. Upon deployment, the front passenger air bag contacted and broke the laminated windshield.

Figure 7. View showing deployed front right passenger's air bag

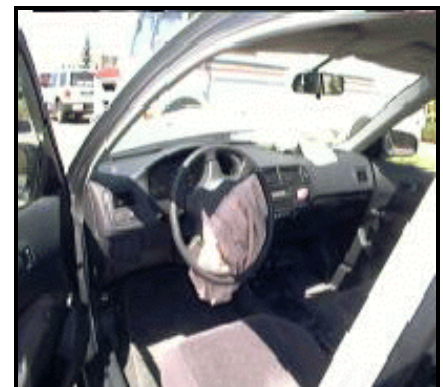
The 43 year-old-male driver of the 1998 Honda Civic was restrained by the available three-point manual lap and shoulder belt. He responded to the 1 o'clock principle direction of force by moving forward and to his right. The interior was void of occupant contact evidence and there is no evidence to suggest that his knees contacted the knee bolster. He loaded the applied lap belt which held his lower torso in place while the applied shoulder belt webbing prohibited extended movement of his upper torso. His right forearm was contacted by the deploying driver's air bag which resulted in an abrasion (AIS-1) to the ventral aspect of the forearm. The driver reported that his nose was numb as a result of his facial interaction with the driver's air bag. He was maintained in his respective seated position and did not require any medical attention.

Figure 9. Front, three-quarter view showing driver's position
