**REMOTE AIR BAG RELATED CHILD FATALITY INVESTIGATION
SCI TECHNICAL SUMMARY REPORT**

VERIDIAN CASE NO. CA99-038

VEHICLE - 1998 MITSUBISHI ECLIPSE RS

CRASH DATE - FEBRUARY 1998

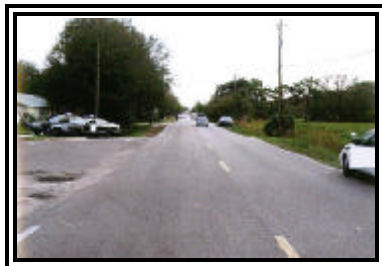
Figure 1. Direction of travel for the Dodge pickup truck

The 25-year-old female driver of the 1998 Mitsubishi Eclipse was operating the vehicle northbound on approach to the 3-leg intersection at a police-reported speed of 48 km/h (30 mph). The 27-year-old male driver of the Dodge Ram pickup truck was operating the vehicle southbound at a police-reported speed of 24 km/h (15 mph) on approach to the 3-leg (T) intersection (**Figure 1**). He initiated a left turn at the intersection and failed to recognize the close proximity of the approaching 1998 Mitsubishi Eclipse traveling in the opposite direction in the northbound lane. The driver of the Eclipse, realizing the impending harmful event, steered right and braked with sufficient force to lock the front wheels of the vehicle. The investigating officer documented 15 m (48') of skid marks from the right front tire and 8 m (27') of skid marks from the left front tire of the Eclipse (**Figure 2**). The driver's steering input redirected the Mitsubishi across the southeast quadrant of the intersection and onto the intersecting roadway where the impact occurred.

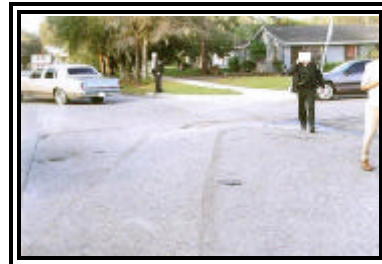
Figure 2. Point of impact and pre-impact skid marks from the Mitsubishi Eclipse

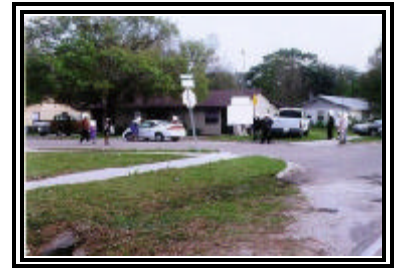
Figure 3. Final rest positions of both vehicles

the two vehicles to rotate clockwise (CW) approximately 45 degrees before disengaging. The resultant directions of force for the Mitsubishi and Dodge pickup truck were in the 11 o'clock and 2 o'clock sectors, respectively. Impact resulted in minor damage to the Dodge pickup truck and moderate damage to the Eclipse. The impact induced deceleration was sufficient to deploy the frontal air bag system in the Eclipse. The deployment probably did not occur until the grille area of the Eclipse contacted the sill of the pickup truck, therefore resulting in a late deployment of the frontal air bag system. The damage algorithm of the WinSMASH program computed total velocity changes of 18.2 km/h (11.4 mph) for the Eclipse based on the estimated crush profile. The specific longitudinal and lateral components were -17.9 km/h (-11.2 mph) and 3.2 km/h (2 mph) respectively. The damage algorithm of the WinSMASH program computed total velocity changes of 12.4 km/h (7.8 mph) for the Dodge pickup truck based on the estimated crush profile. The specific longitudinal and lateral components were -2.2 km/h (-1.4 mph) and -12.2 km/h (-7.7 mph) respectively. The Eclipse came to rest in the intersection immediately after the disengagement with the Dodge pickup truck. The pickup truck continued to travel in a southeast direction and came to rest onto the grassy area adjacent to the southeast corner of the intersection. The Eclipse was then driven to the right road edge approximately 8 m (25') from the point of impact along the curb edge (**Figure 3**).

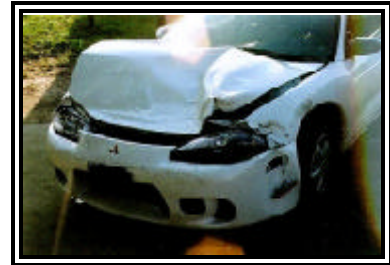
Figure 4. View of frontal and left side damage for Mitsubishi Eclipse

The 1998 Mitsubishi Eclipse sustained moderate frontal damage as a result of the impact with the Dodge Ram pickup truck (**Figure 4**). The direct contact damage began at the front left bumper corner and extended laterally approximately 130 cm (51") across the bumper fascia. Direct contact damage was also noted at the level above the bumper from the under ride with the Dodge pickup truck, which caused the front edge of the hood to crush rearward. The left headlight was displaced rearward, and slight buckling was noted on the left aspect of the bumper fascia and left front fender (**Figure 5**). A scuff mark from the right rear wheel of the Dodge was also identified on the left front fender above the wheel, which resulted from the pocketing and rotation prior to disengagement. The Collision Deformation Classification (CDC) for this impact to the Mitsubishi Eclipse was 11-FDEW-1. Six crush measurements were estimated along the frontal plane above the bumper as were as follows: C1 = 10 cm (4"), C2 = 8 cm (3"), C3 = 7 cm (3"), C4 = 7 cm (3"), C5 = 7 cm (3"), C6 = 5 cm (2").

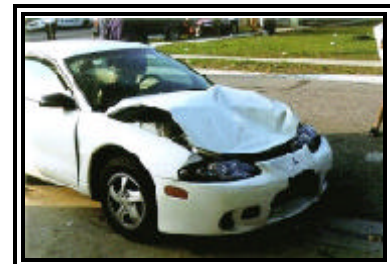
Figure 5. Frontal damage to Mitsubishi Eclipse

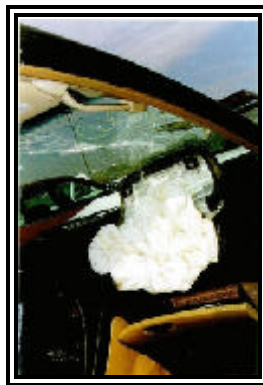
Figure 6. Front right passenger's air bag and spider web on windshield

Interior damage to the 1998 Mitsubishi Eclipse was attributed to occupant contact. There was no damage associated with exterior deformation or intrusion of interior components. A tissue transfer was identified on the upper left aspect of the front right passenger air bag module cover flap. The windshield directly above the cover flap was cracked in a spider-web fashion (**Figure 6**). The glove compartment door was open. Blood smears were visible on the rear aspect of the driver seat and head restraint (**Figure 7**), the rear left seat cushion, rear left seat back, rear left side panel, rear left seat belt webbing and latch plate, rear center seat cushion (**Figure 8**), and rear aspect of the front right seat head restraint.

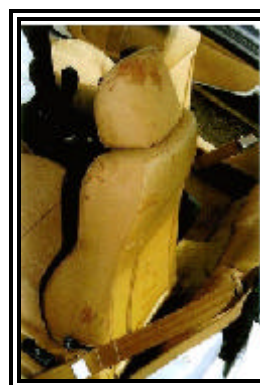
Figure 7. Rear aspect of front left seat back

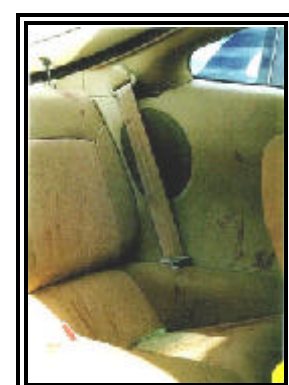
Figure 8. Rear left seat

The 6-year-old male rear passenger was probably out-of-position due to pre-impact braking. At impact, he initiated a forward trajectory in response to the frontal crash forces. Based on injuries sustained, he probably struck his face on the rear aspect of the front seat backs. Numerous blood stains were noted on the rear aspect of the front left seat back, rear left seat, and rear left seat belt webbing. He sustained a fractured nose, a left orbital contusion, and unspecified fractures of the jaw. He was transported by ambulance to a local hospital and admitted.

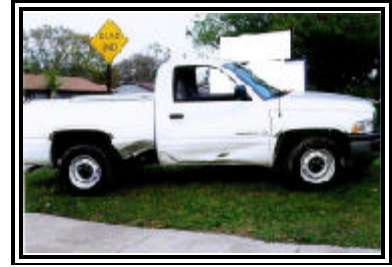
Figure 9. Damage to 1997 Dodge Ram pickup truck

The 1997 Dodge Ram pickup truck sustained moderate damage as a result of the impact with the Mitsubishi Eclipse (Figure 9). The direct damage was concentrated below the side body line, and extended longitudinally from the front of the right door to the right rear wheel. Pocketing of the sheet metal was noted forward of the right rear wheel from the engagement and rotation of the vehicles. The CDC for the impact to the Dodge Ram pickup truck was 02-RZLW-3.

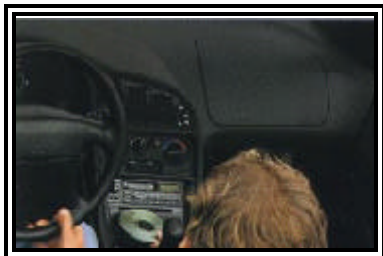
Figure 10. Photo from 1998 Mitsubishi Eclipse brochure showing the front right passenger air bag cover flap

The front right passenger’s air bag deployed from the right mid-instrument panel area with a single cover flap design hinged at the top aspect (Figure 10). The cover flap was rectangular in shape. A large tissue transfer was noted on the upper left portion of the air bag module cover flap, indicating the front right child passenger was possibly positioned above the cover flap when it deployed (Figure 11). Black (probably vinyl) transfers were noted on the left, top, and bottom aspects of the air bag surface indicating an impeded deployment (Figure 12). Contact evidence, possibly a clothing transfer, was noted on the left aspect of the air bag.

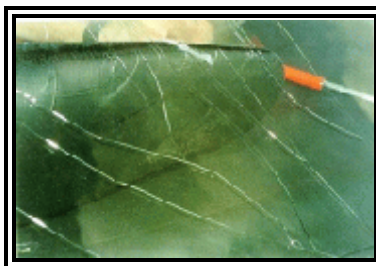
Figure 11. View through the windshield showing the tissue transfer on the cover flap

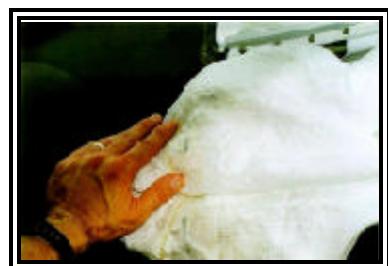
Figure 12. Front right passenger’s air bag showing black vinyl transfers
