On-site Investigation
Vehicle vs Vehicle vs Vehicle–Rear End Chain Collision
Dynamic Science, Inc. / Case Number: DS99047
1995 Geo Prizm 4-door
Colorado
September 1999

**Dynamic Science, Inc.
Accident Investigation
Case Number: DS99047**

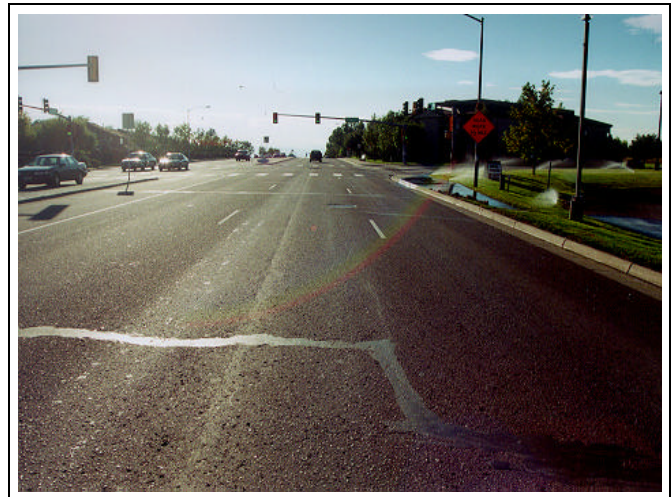
Figure 1. Direction of travel towards the impact area—westbound.

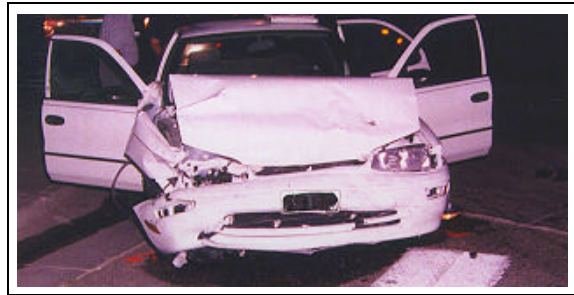
Figure 2. Exterior damage to the case vehicle at the scene.

The case vehicle sustained major damage to its front end and was towed from the scene due to damage. The Mitsubishi sustained major damage to its back end and moderate damage to its front end. It was towed from the scene due to damage. The police report indicates that the Nissan sustained moderate damage to its back end and was driven from the scene by the driver.

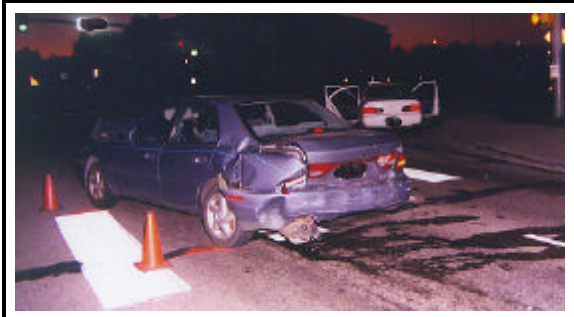
Figure 3. Back end damage to other vehicle at scene.

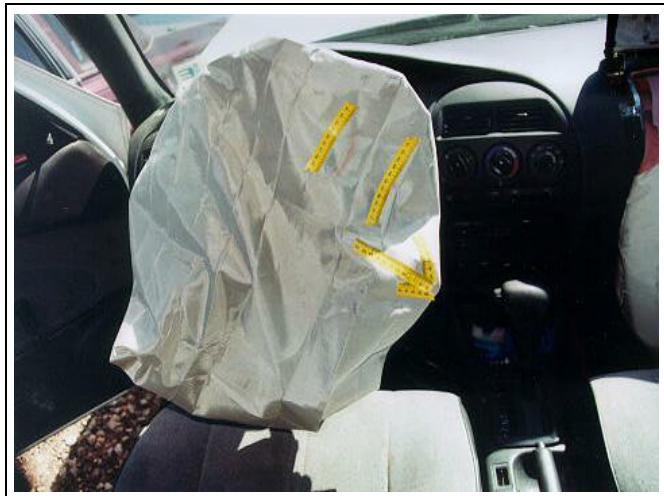
The case vehicle was equipped with a driver's side supplement restraint system that deployed as a result of the case vehicle's frontal impact with the back of the Mitsubishi. The driver's air bag deployed from the module assembly that was contained within the four-spoke steering wheel. The module cover flaps were of typical Chevrolet design with a large upper flap and smaller lower flap. These flaps opened in an H-configuration at the designated tear points. There was no damage or evidence of driver contact to the module covers. The driver's air bag measured 57 cm (22.4 in.) in diameter. There was a 9 cm (3.5 in.) long lipstick contact to the left upper quadrant of the air bag and a 8 cm (3.1 in.) long makeup transfer in the same area. The air bag itself was not damaged. The air bag had nine vertical folds, was not tethered, and had two rear vent ports. The post deflated maximum air bag excursion was measured at 44 cm (17.3 in.), and the distance from the maximum air bag excursion to the seat back was 37 cm (14.6 in.).

Figure 4. Case vehicle's driver's air bag and lipstick contact.

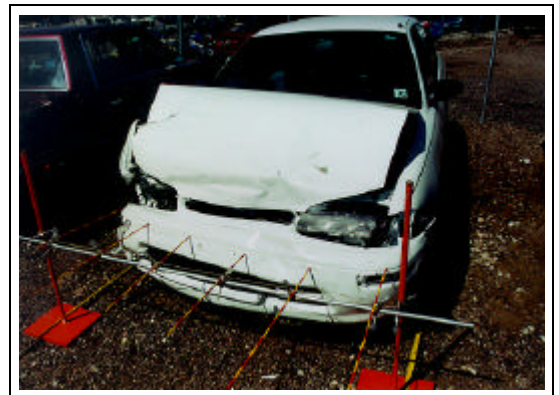
Description:	1995 Geo Prizm 4-door	
VIN:	1Y1SK5265SZXXXXXX	
Odometer:	68,149 km (42,347 miles)	
Engine:	V4	
Reported Defects:	None reported	
Cargo:	None	
Damage Description:	Major damage to front bumper, hood and grille area. Both of the front fenders were deformed.	
CDC:	Impact 1 (case vehicle vs. Mitsubishi) - 12FDEW2	
Delta V:	Total	28.2 km/h (17.6 mph)
	Longitudinal	-28.2 km/h (-17.6 mph)
	Latitudinal	0 km/h (0 mph)
	Energy	27,970 joules (20,649 ft-lbs)

Figure 7. Exterior damage.

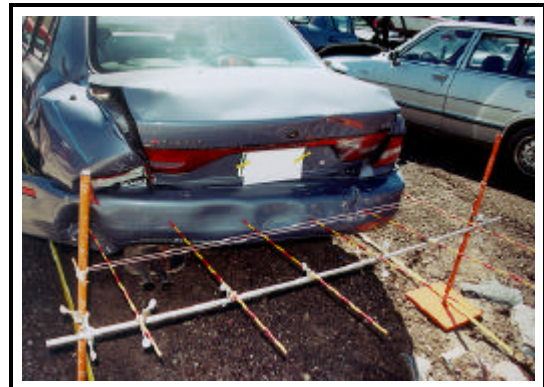
Description: 1995 Mitsubishi Galant LS 4-door
 VIN: 4A3AJ56G6SEXXXXXX
 Odometer: 144,309 km (89,672 miles)
 Engine: 2.4L SOHC MPI
 Reported Defects: None noted
 Cargo: None
 Damage Description: Major damage to its rear bumper, rear hood, and both rear fenders. Moderate damage to the front bumper, hood, and grille area. Both front fenders were deformed.
 CDC: Impact 1 (vs. case vehicle) - 06BDEW3
 Impact 2 (vs. 3rd vehicle) - 12FDEW1
 Delta V (Impact 1 vs. case vehicle):
 Total 24.2 km/h (15.0 mph)
 Longitudinal 24.2 km/h (15.0 mph)
 Latitudinal 0 km/h (0 mph)
 Energy 36,011 joules (26,576 ft-lbs)
 Delta V (Impact 2 vs. 3rd vehicle Nissan):
 Total 11.1 km/h (6.9 mph)
 Longitudinal -11.1 km/h (-6.9 mph)
 Latitudinal 0 km/h (0 mph)
 Energy 3,374 joules (2,487 ft-lbs)

Figure 8. Exterior back damage.
