**SwRI AIRBAG DEPLOYMENT
INVESTIGATION
FULL SCOPE**

CASE NO. 9001AB

FINAL REPORT

SwRI Project 06-1977
DTNH 22-87-C-37169

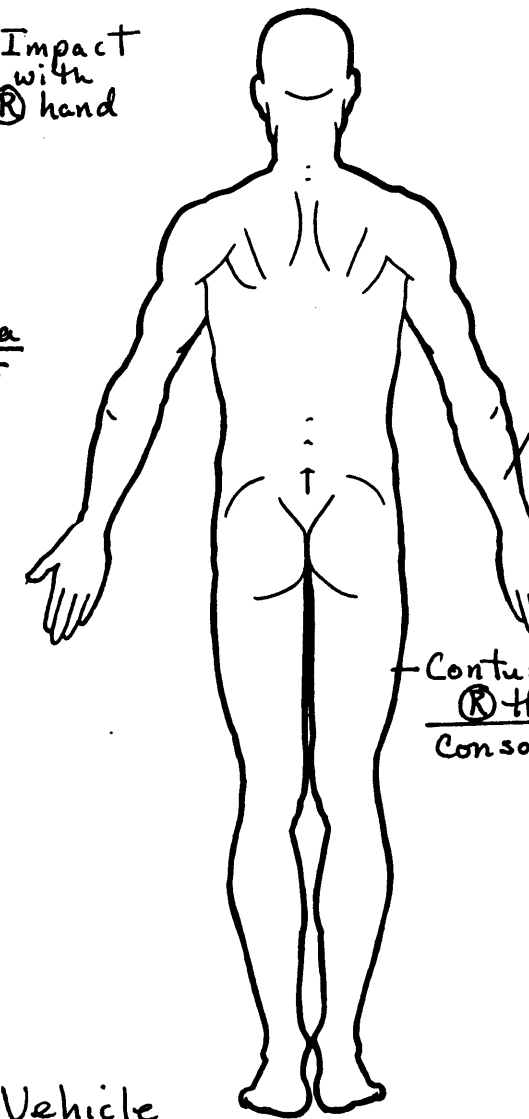
Driver - Airbag Vehicle
9001 AB

Unspecified injury
trigeminal nerve
Ⓜ maxillary branch

Laceration
Ⓜ eyebrow
Severe Contusion
Ⓜ orbit
Detached retina
Ⓜ eye
Abrasion
Ⓜ cornea

Impact with
Ⓜ hand

Contusion
Ⓜ clavicle area
Torso belt

Abrasions
Ⓜ forearm
Airbag
