LEVEL 1 AIRBAG INVESTIGATION
REMOTE CASE NO. [REDACTED]
[REDACTED], ARKANSAS

NCSI LEVEL 1 AIRBAG REPORT
Non-deployment Investigation
██████████ Arkansas
Case No. 90-15

SUMMARY

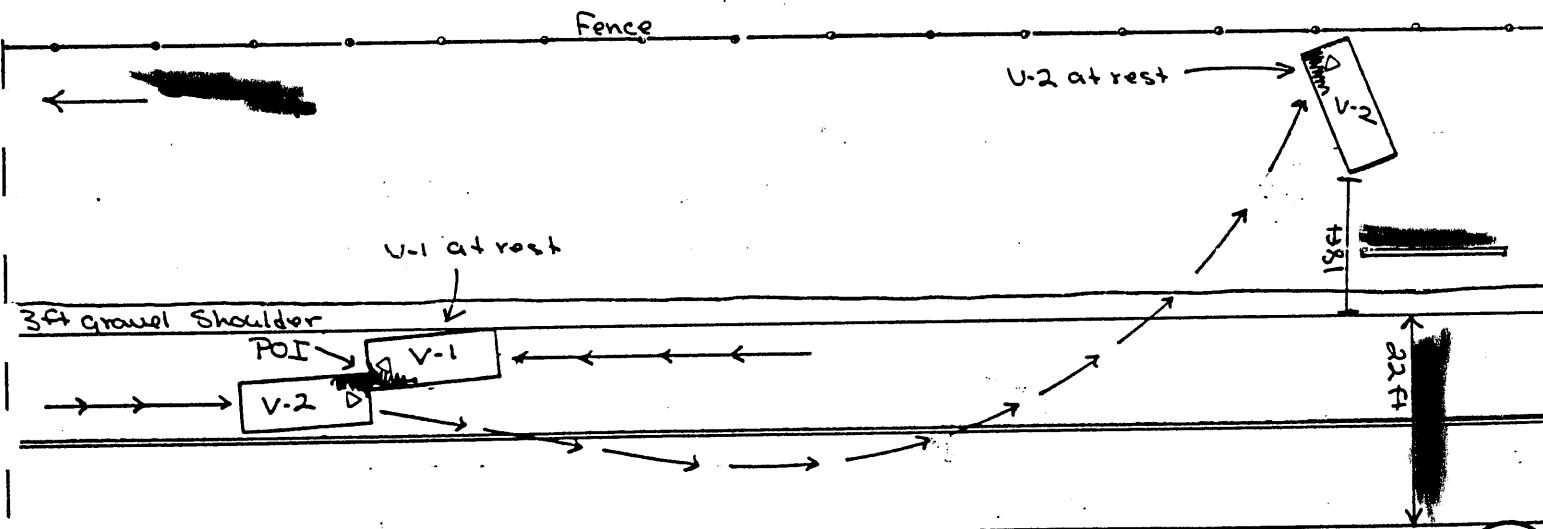
DIAGRAM: *not to scale (if space adequate)

V-1, operated by [redacted], was traveling west on S.H. [redacted] when it was struck nearly head on by the East bound V-2, operated by [redacted]. POI was approximately 4 feet 11 inches from the center of the highway in the west bound lane. After impact V-1 came to rest in the west bound lane almost at the point of impact. V-2 traveled approximately 170 feet after impact, coming to rest in a shallow road ditch 18 feet from the road edge. Driver V-1 states he saw V-2 approaching him weaving from one side of the road to the other and had come to a halt in an effort to avoid impact with V-2. Witness' state V-2 had almost run them off of the highway as they had met it further west on S.H. [redacted] witness' further state they turned around and began to try get the driver to stop. Both witness' state that V-2 was swerving back and forth in the highway and ran at least one other vehicle off of the road before striking V-1. An odor of alcohol was present in the vehicle along with a partially empty 1/2 gal whiskey bottle.
