**CALSPAN REMOTE AIR BAG DEPLOYMENT INVESTIGATION**

**CALSPAN CASE NO. 93-11**

**VEHICLE - 1992 TOYOTA CAMRY  
LOCATION - [REDACTED] PA  
ACCIDENT DATE - [REDACTED] 1993**

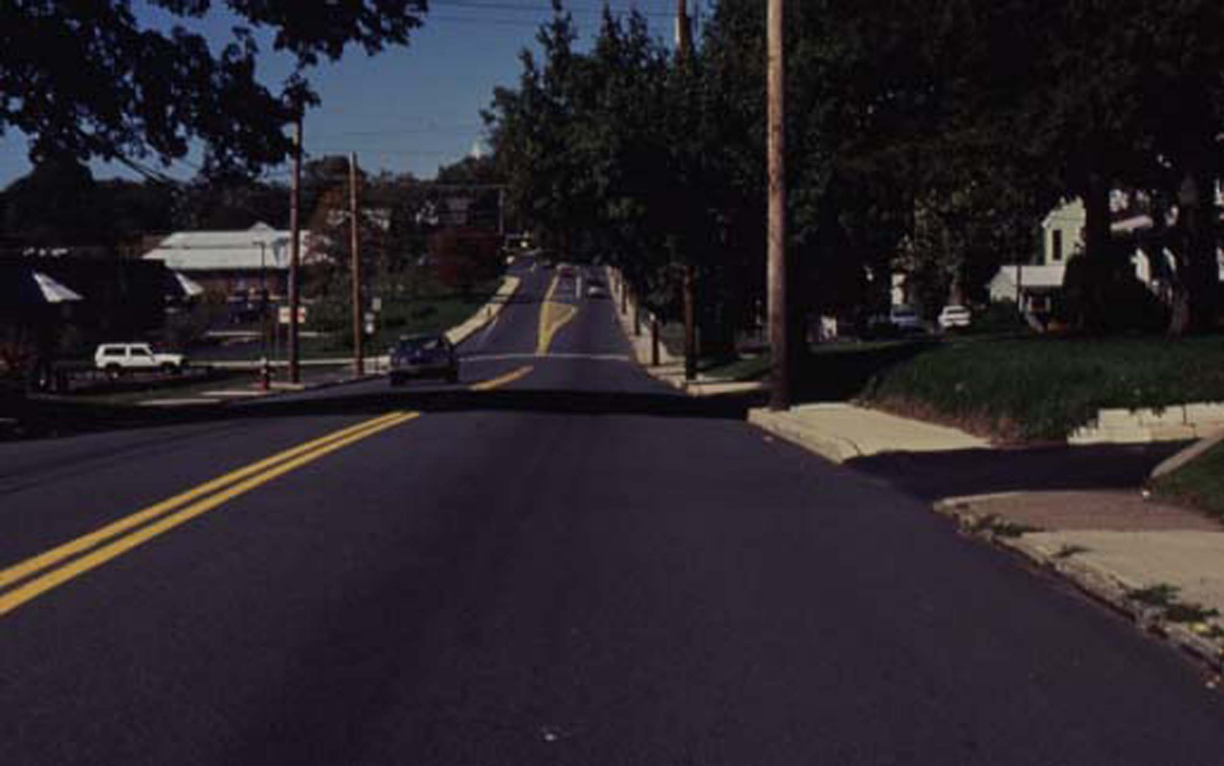
<u>Slide No(s).</u>	<u>Description</u>
1	Pre-crash trajectory of the Toyota Camry
2	Vehicle drifts off right road edge
3	Struck utility pole
4	Frontal views of the Toyota Camry
5	Close-up view of the impact damage
6	Lateral displacement at the left front corner
7	Rearward displacement of hood, right front fender, and right front wheel
8	Right front three-quarter view
9	Overall view of the interior
10	Left knee contact to the knee bolster and left hand contact to the turn signal lever
11,12	Facial contact (makeup transfers) to the deployed air bag
13	Upper air bag module cover flap and air bag vent ports
14	Identification numbers on air bag
15	Identification numbers on inside surface of upper module cover flap
16	Steering and air bag module assembly
17	Driver's shoulder belt webbing
18	Driver's seat position
19	Steering column shear capsule compression
20	Overall view of the interior from the right door area

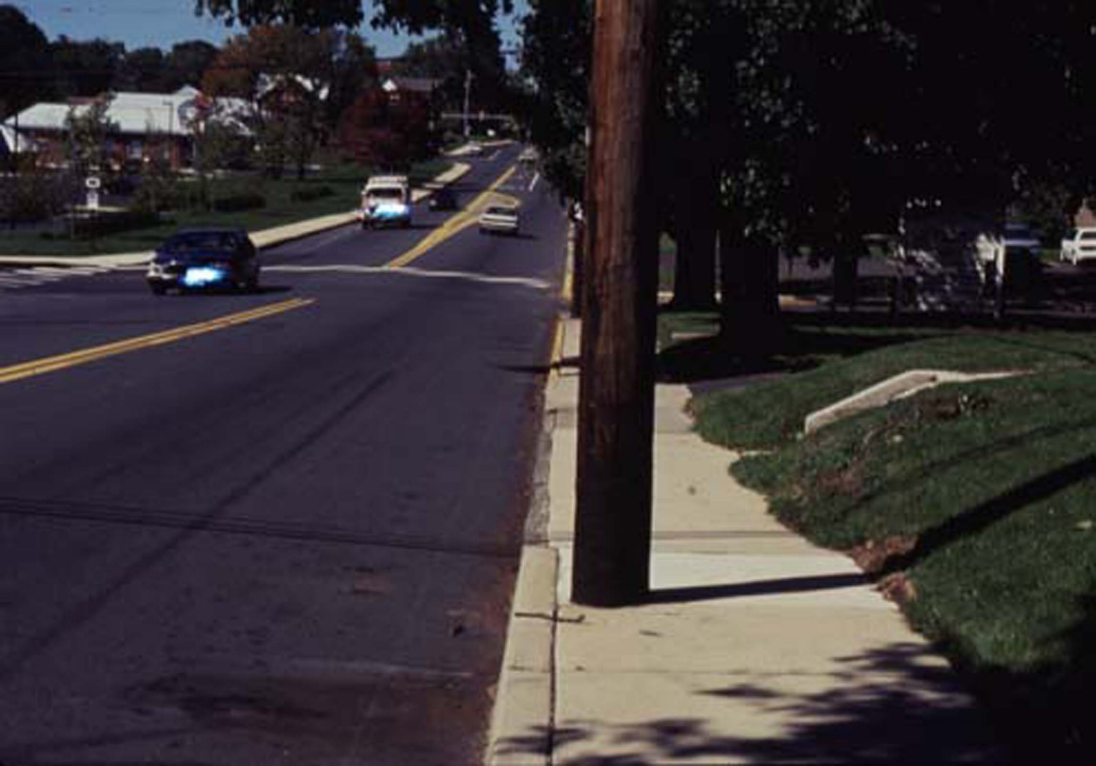
The right frontal area of the Toyota Camry impacted a 30.5 (12") diameter wooden utility pole that was located approximately 0.6 m (2') outboard of the north (right) curbline. Impact speed was computed by the damage and trajectory mode of the CRASHPC program at 53 KPH (33 mph). The vehicle sustained 83 cm (32.7") of front bumper crush as a result of the 12 o'clock direction of force impact. The Camry underwent a velocity change of 46 KPH (29 mph) which deployed the supplemental driver's side air bag system.
