DYNAMIC SCIENCE, INC.
In-Depth Accident Investigation

Contract DTNH22-94-D-27058
Case DSI-94-EV-14

TECHNICAL SUMMARY

**DYNAMIC SCIENCE, INC.
ACCIDENT INVESTIGATION
CASE NUMBER: DSI-94-EV-14**

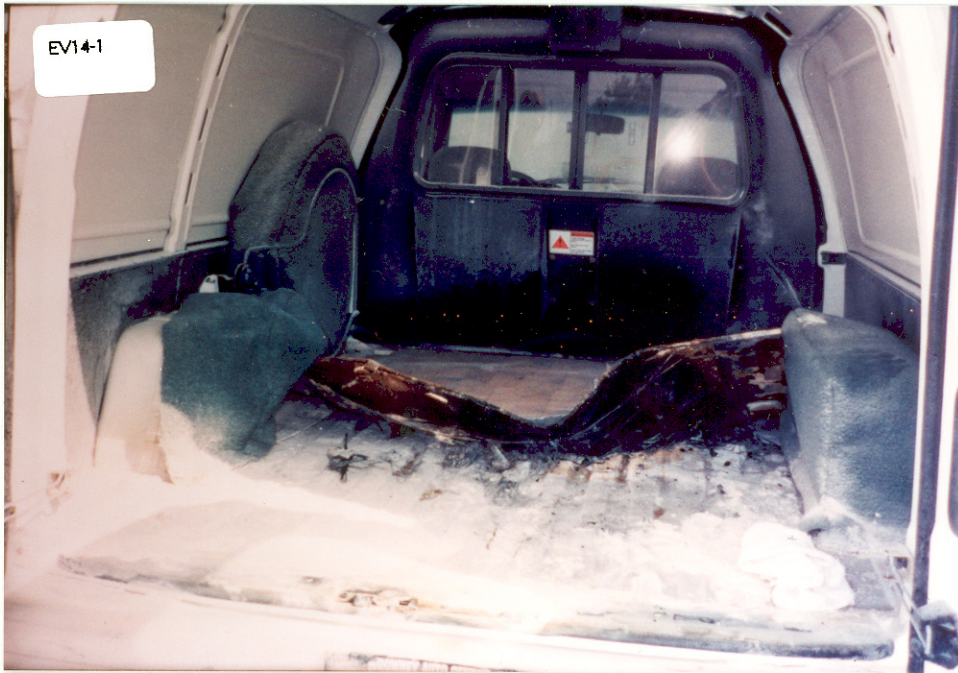
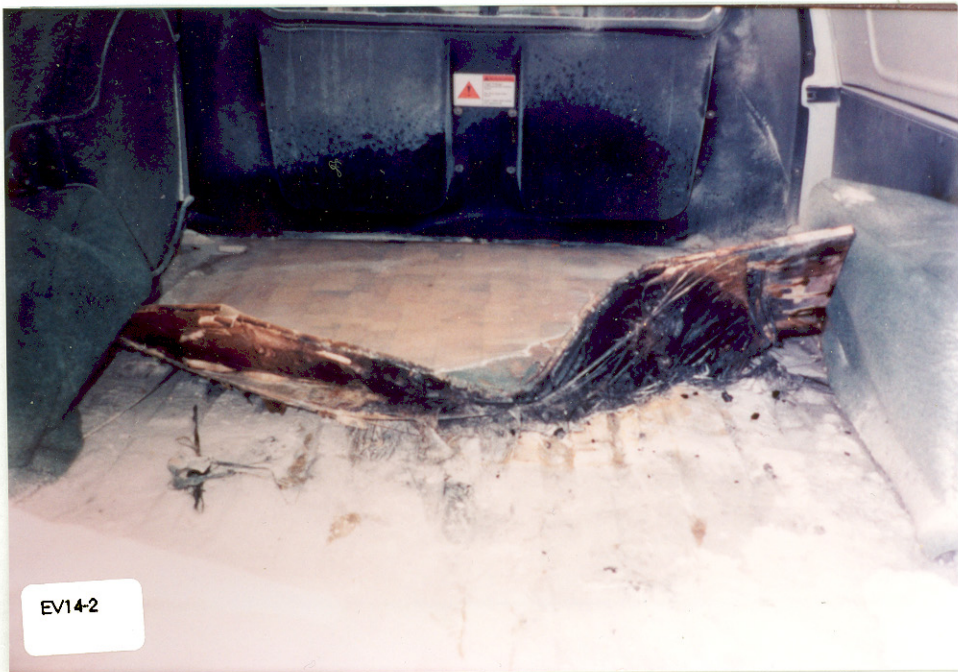
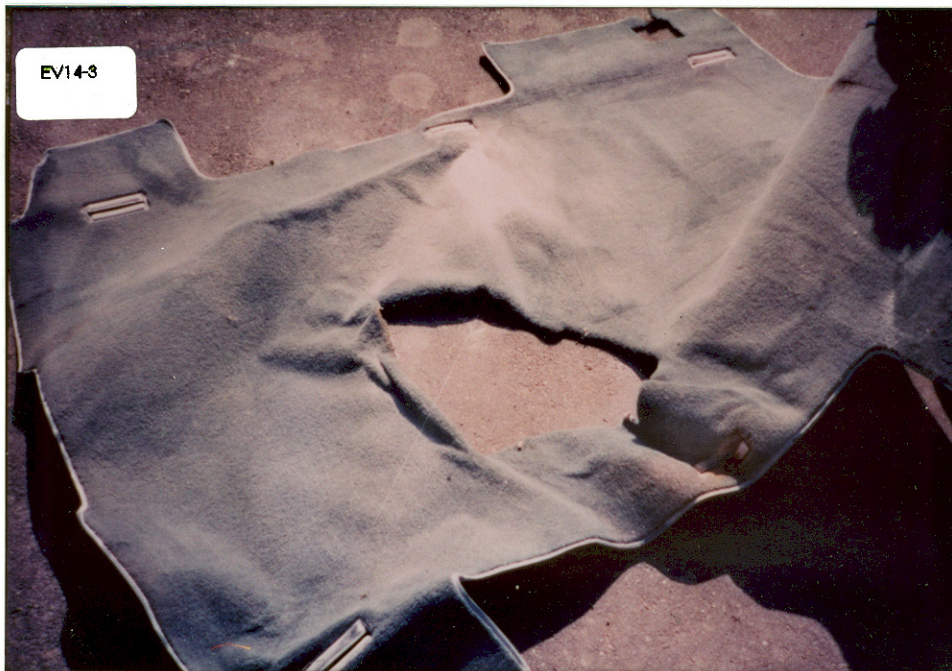
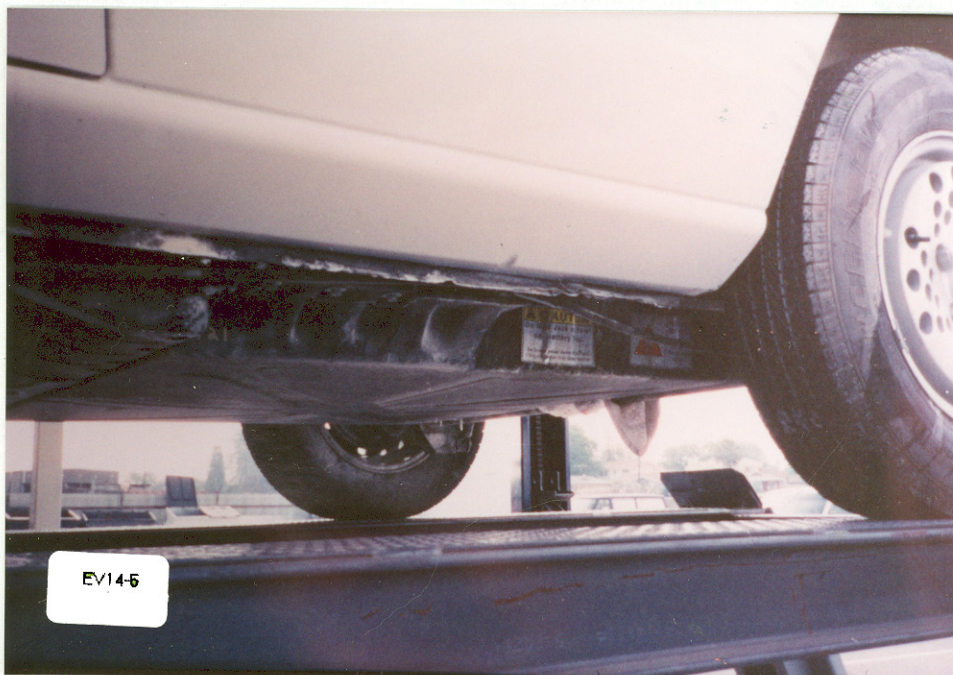
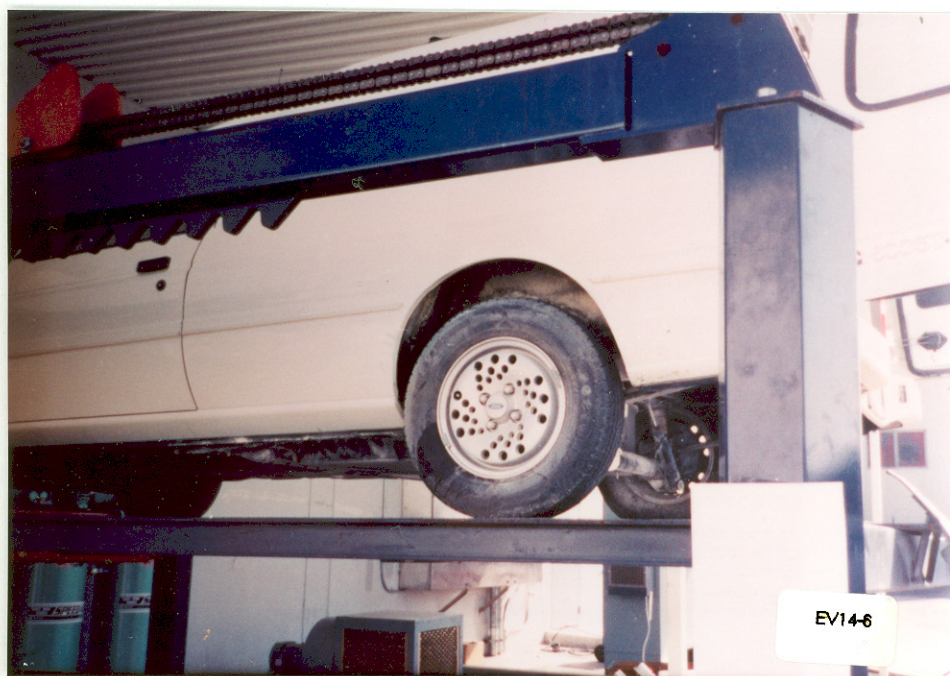
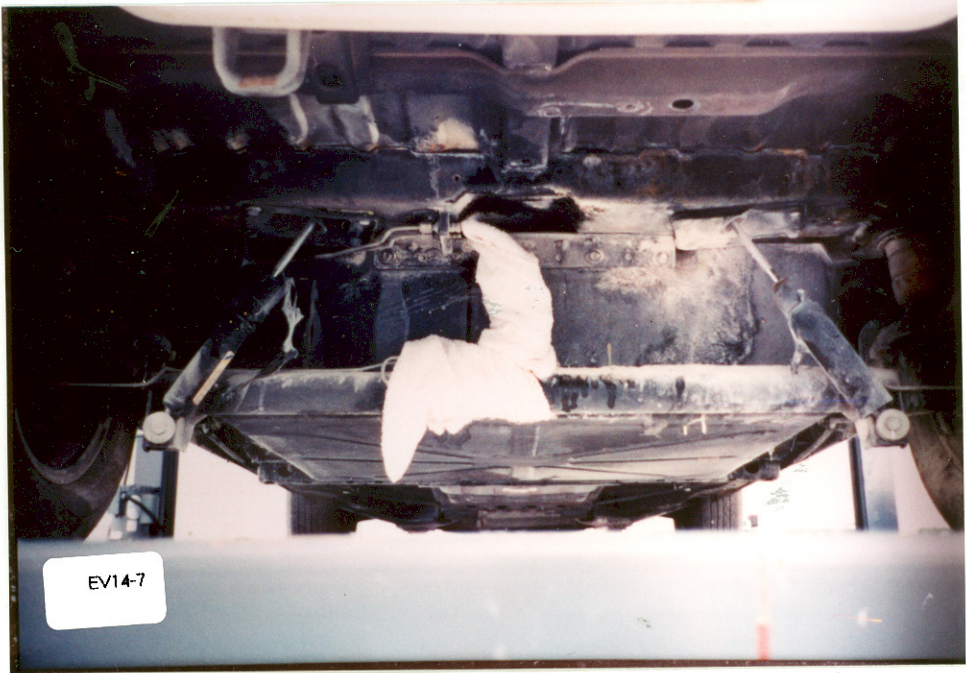
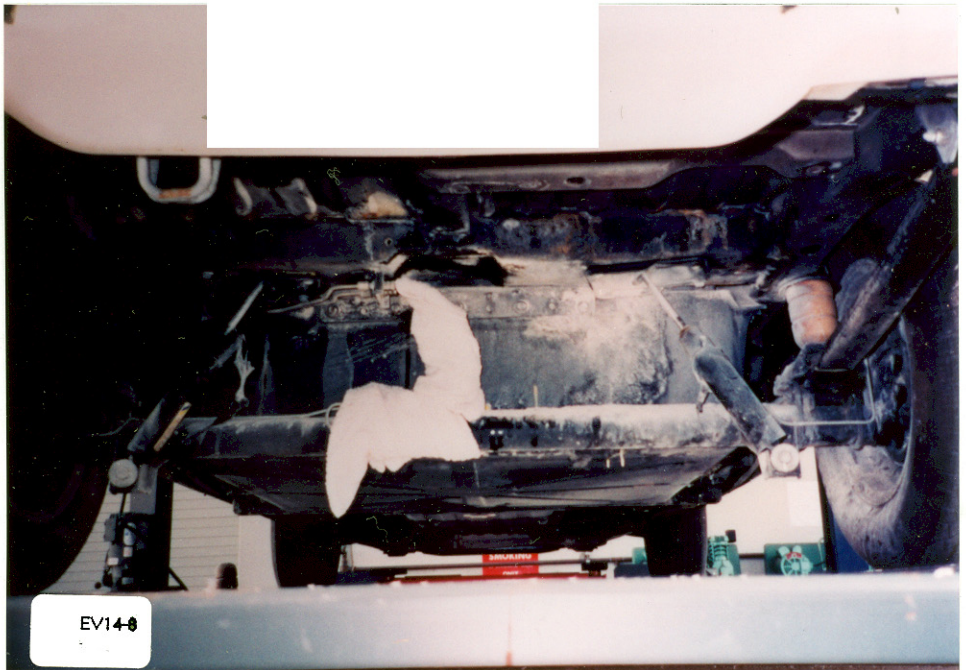
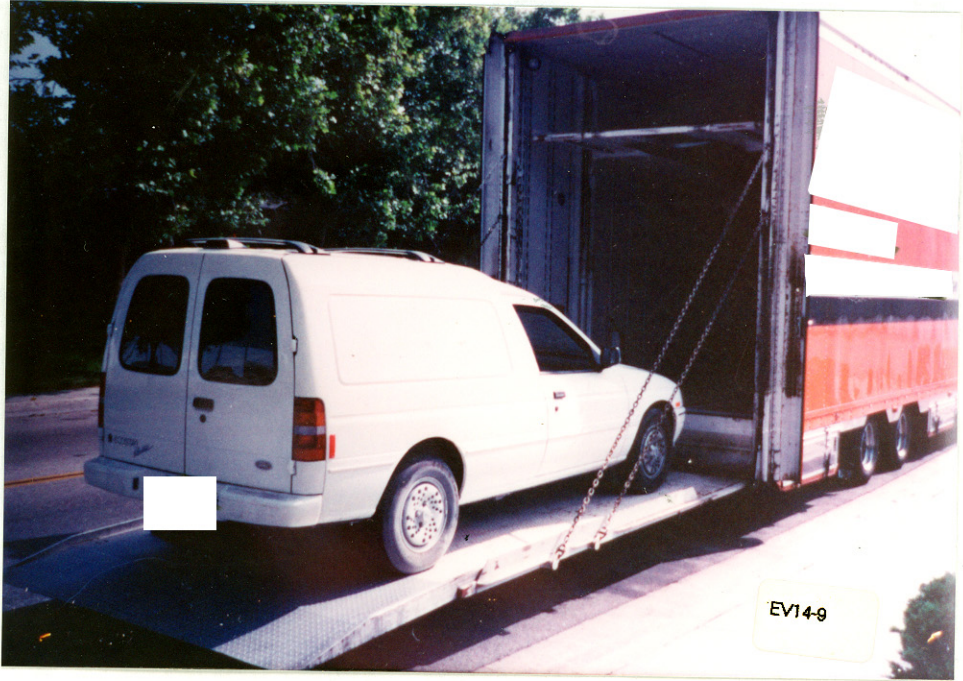
PHOTO INDEX

Vehicle 1 sustained moderate interior damage, including the carpet and floor board. The level of damage to the battery itself is not known, but it can be assumed that it is no longer usable. Vehicle 1 was eventually removed from the scene by an enclosed moving van and presumably transported from _____ to _____

PHOTO NO.	VEHICLE NO.	DIRECTION OF PICTURE	SUBJECT MATTER
1	1	NA	Interior view showing cargo area facing rear of vehicle.
2	1	NA	Interior view showing cargo area facing front of vehicle.
3-4	1	NA	Views of burned carpet.
5-6	1	NA	Views of vehicle undercarriage as viewed from left side.
7-9	1	NA	Views of damaged battery as viewed from rear of vehicle.
10	1	NA	Exterior of case vehicle.
