REPORT NUMBER: 220-MGA-03-001

SAFETY COMPLIANCE TESTING FOR
FMVSS NO. 220
SCHOOL BUS ROLLOVER PROTECTION

2003 Blue Bird
All American School Bus
NHTSA No.: C30900

PREPARED BY:
MGA RESEARCH CORPORATION
5000 WARREN ROAD
BURLINGTON, WI 53105

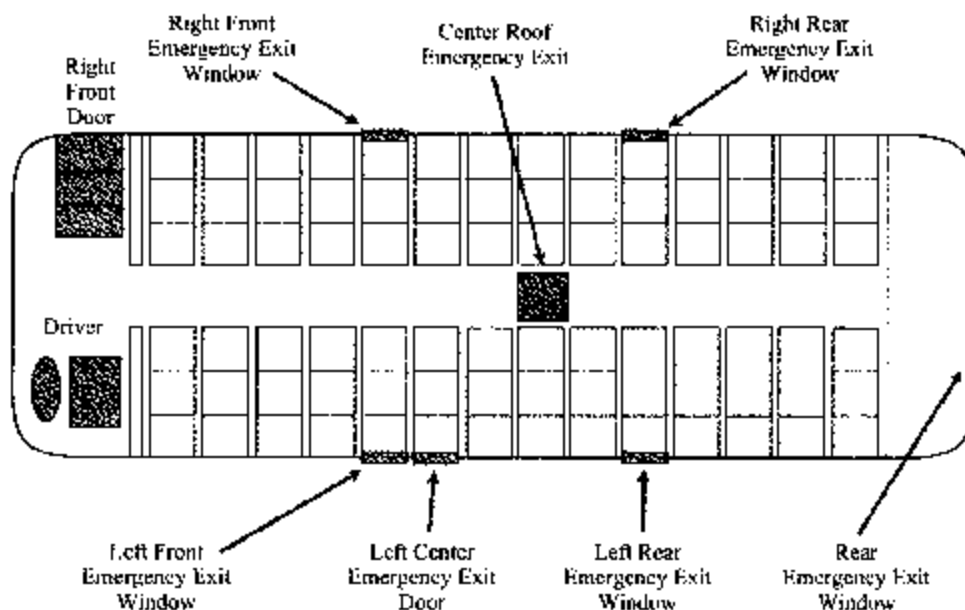
Height (mm)	Width (mm)	Passage of Ellipsoid or Parallelepiped	PASS/FAIL
1	Left Front Exit Window	505	612	Ellipsoid	PASS
2	Left Rear Exit Window	505	612	Ellipsoid	PASS
3	Right Front Exit Window	505	612	Ellipsoid	PASS
4	Right Rear Exit Window	505	612	Ellipsoid	PASS
5	Rear Exit Window	578	1,359	135 cm x 57 cm Area	PASS
6	Left Side Exit Door	1,295	610	129 cm x 61 cm Area	PASS
7	Roof Exit – Rear	580	585	Ellipsoid	N/A

COMMENTS: Parallelepiped dimensions are 114 cm x 61 cm x 30 cm.

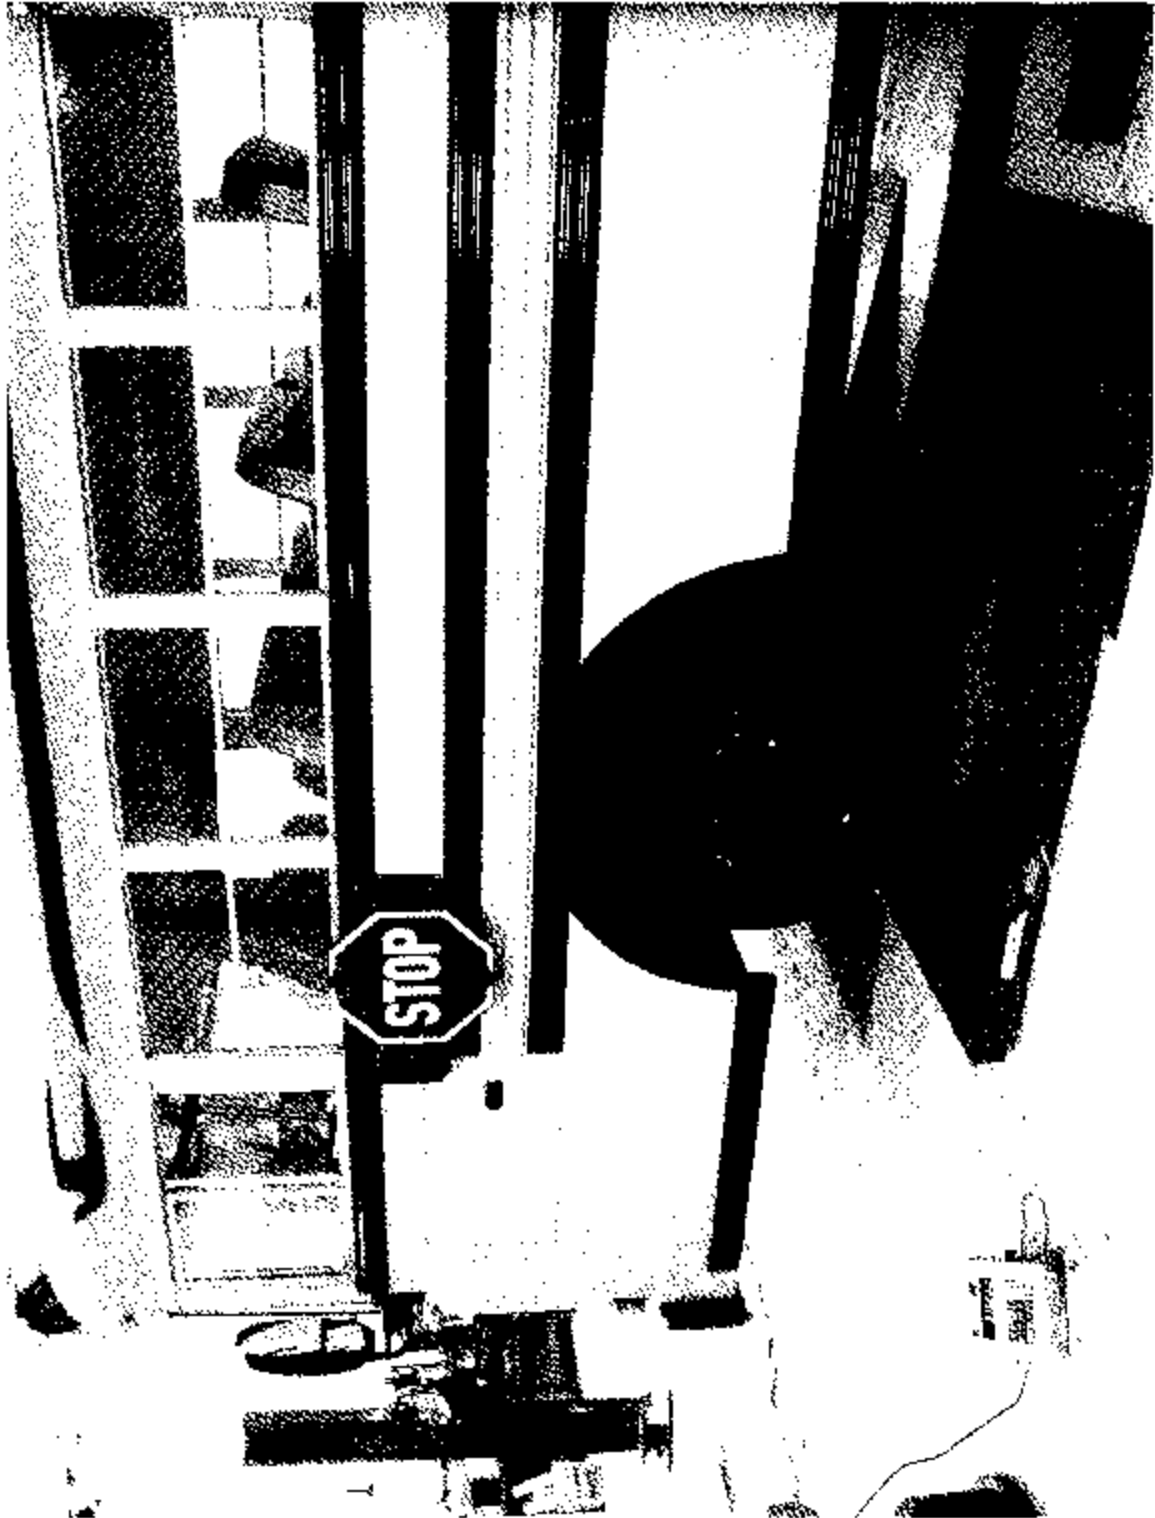
School Bus Front Axle Being Weighed

Units	LF	RF	LR	RR	TOTAL
Kg	1,648	1,560	3,006	2,824	9,038

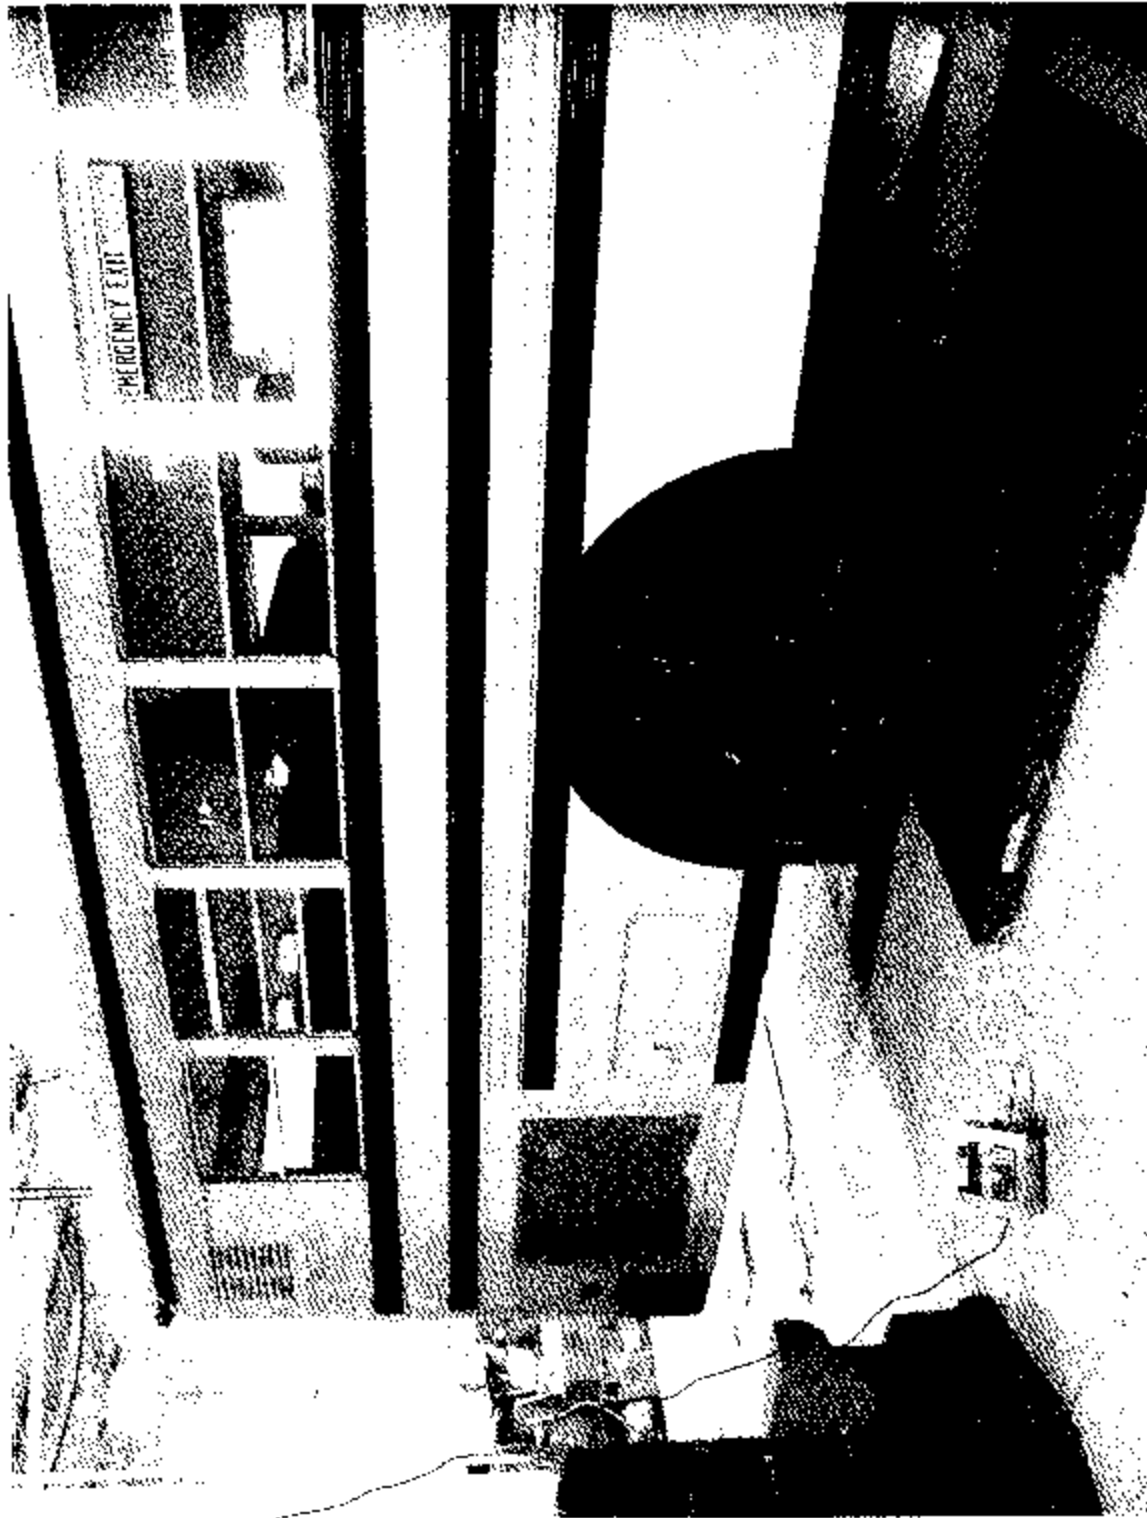
School Bus Rear Axle Being Weighed

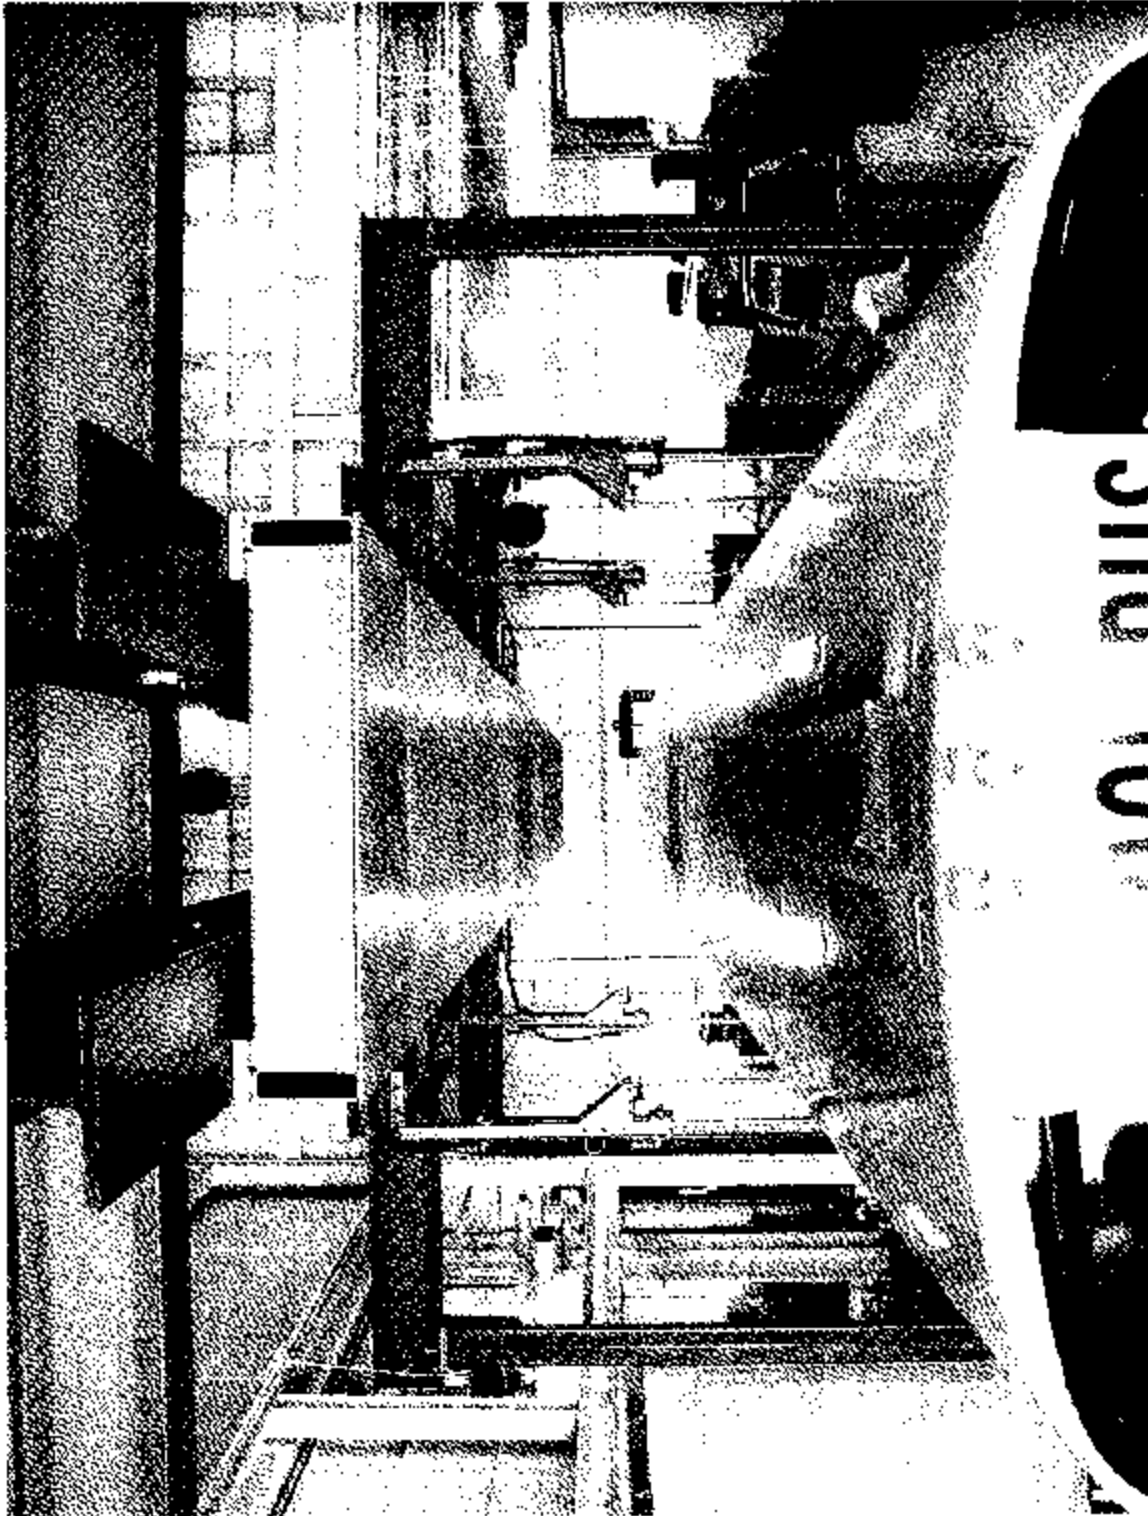
View of Bus Roof From Front Before Testing

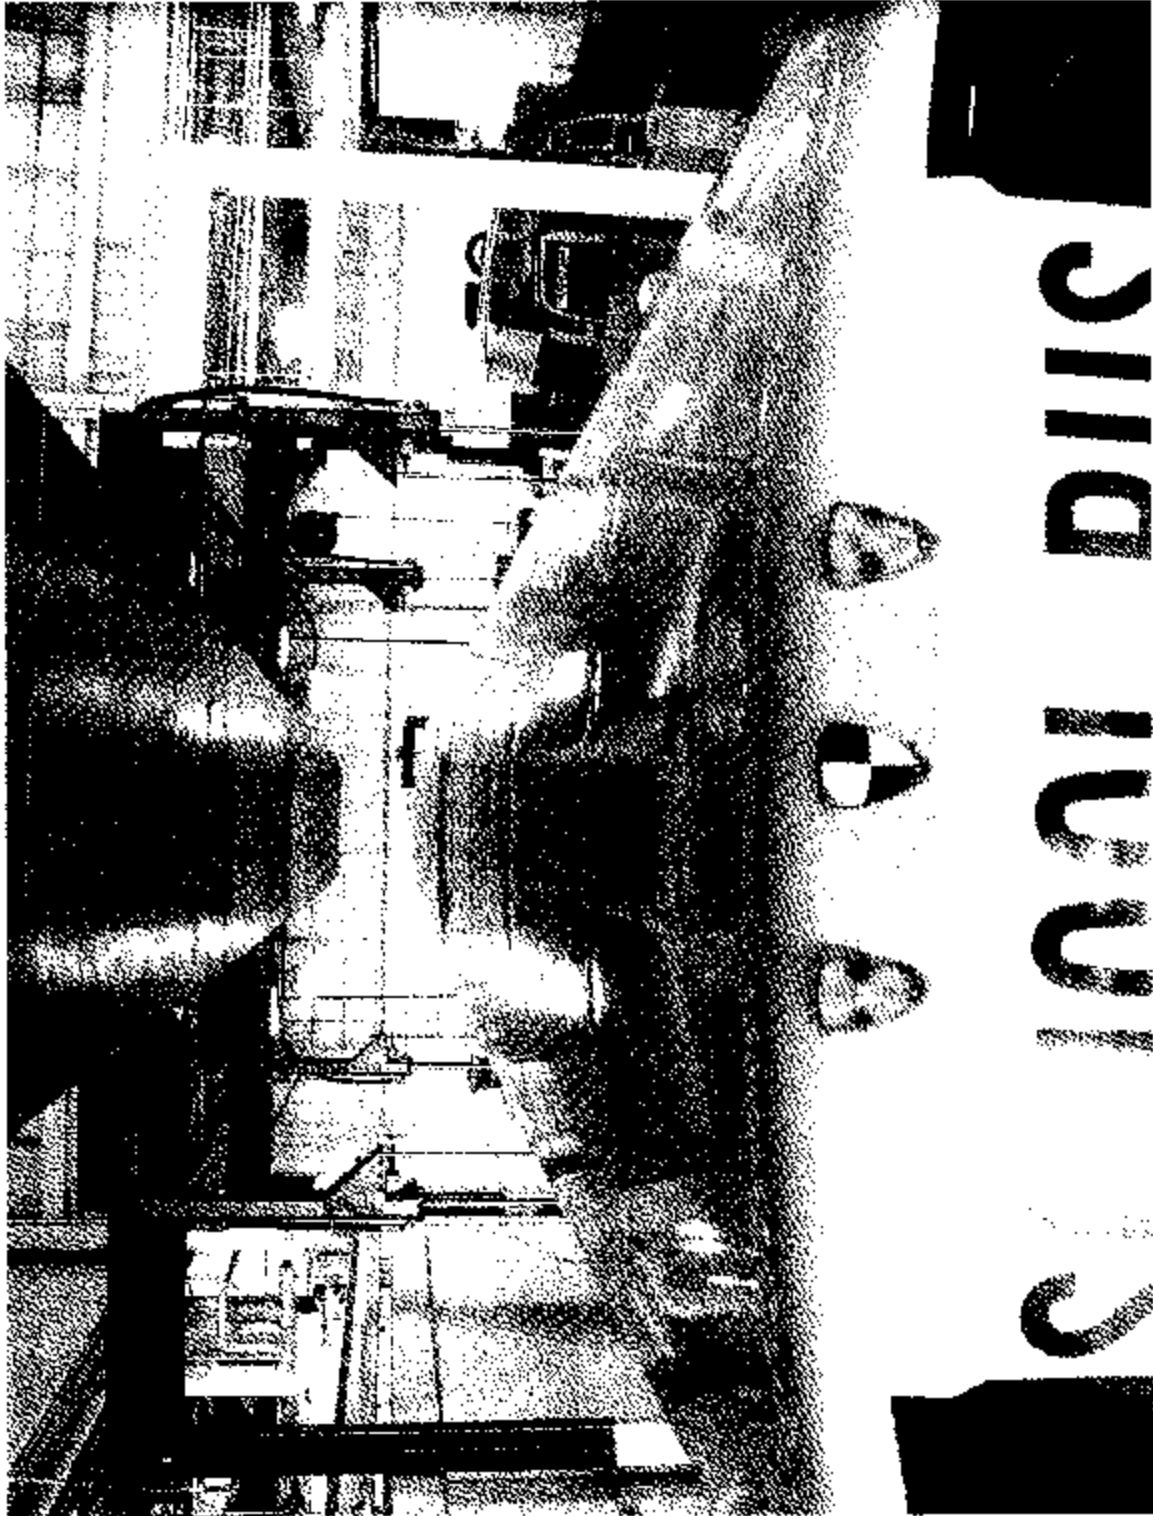
View of Bus Roof From Front After Testing

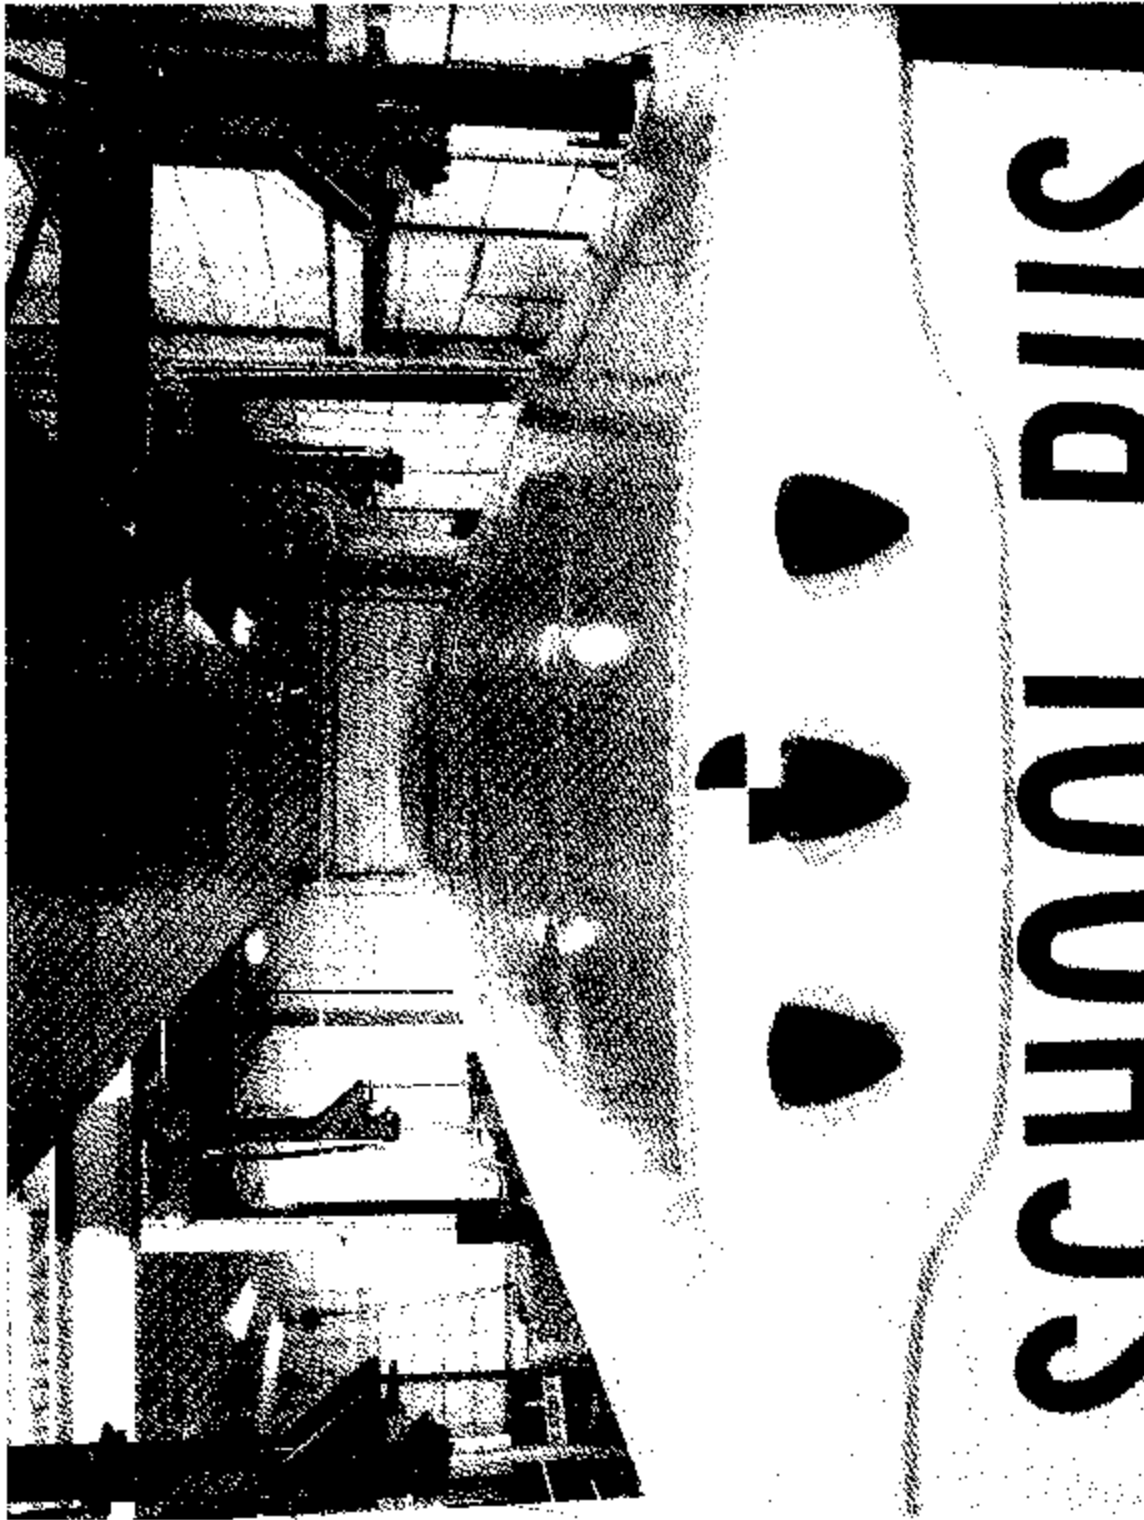
View of Bus Roof From Rear After Testing

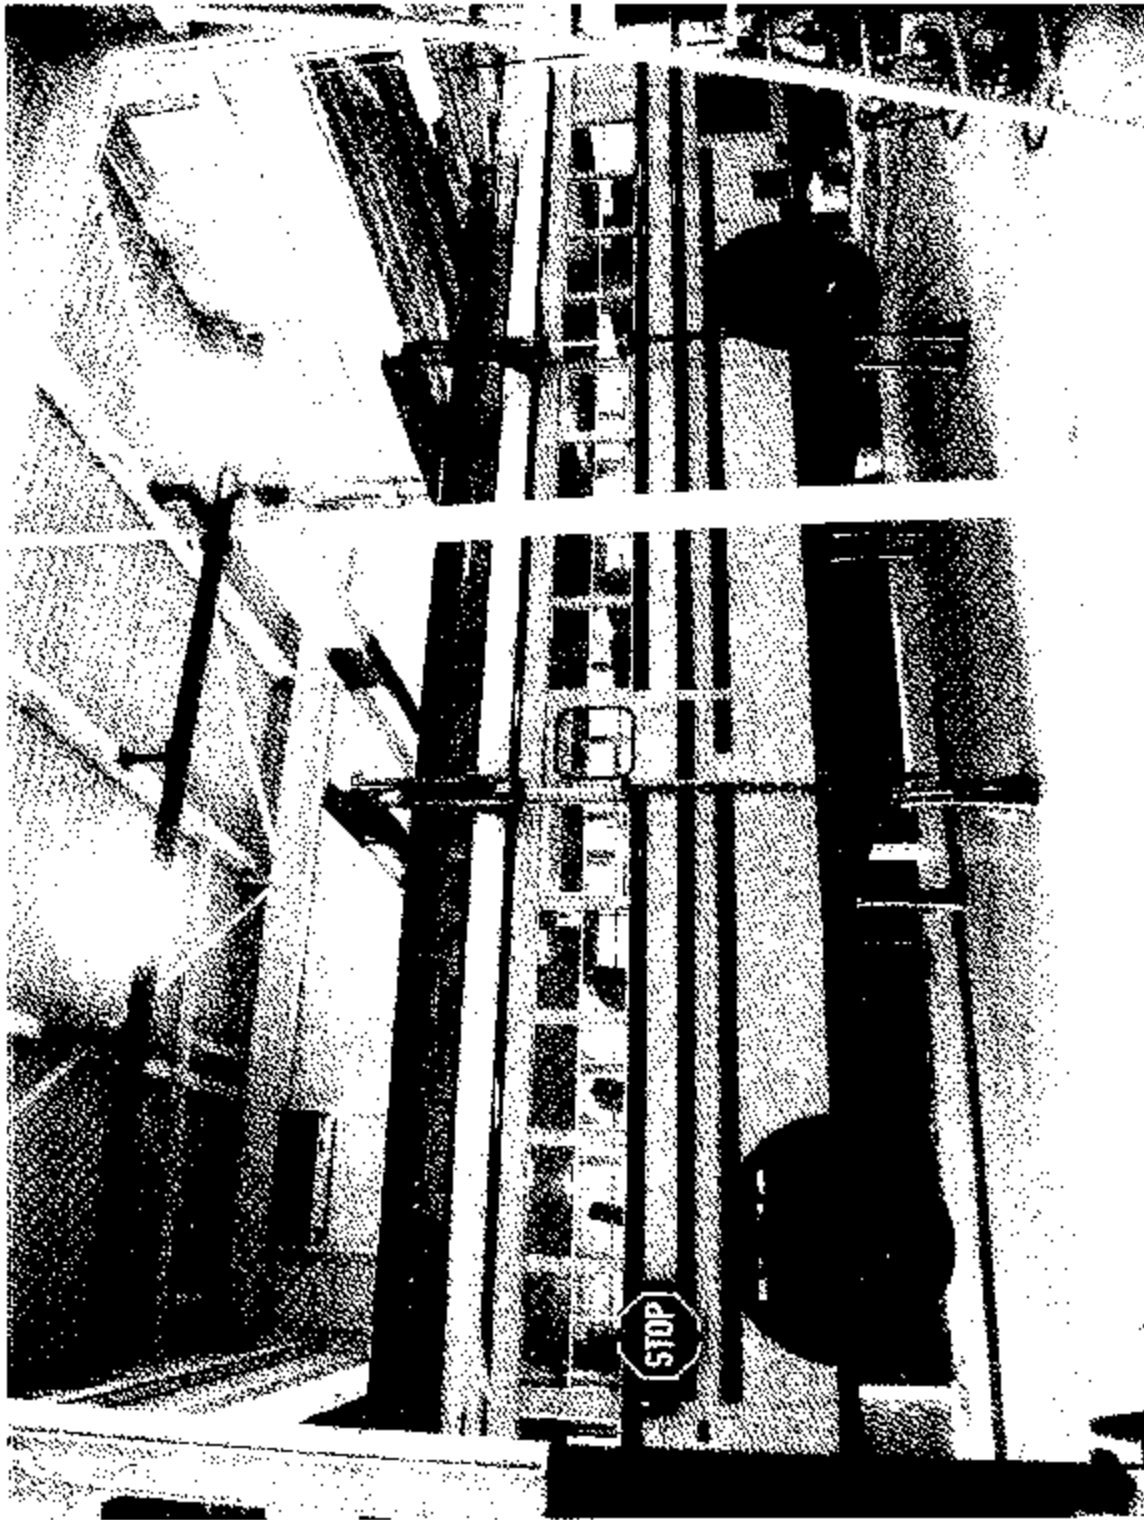
Loading Device Placed Against Bus Roof At Start of Test

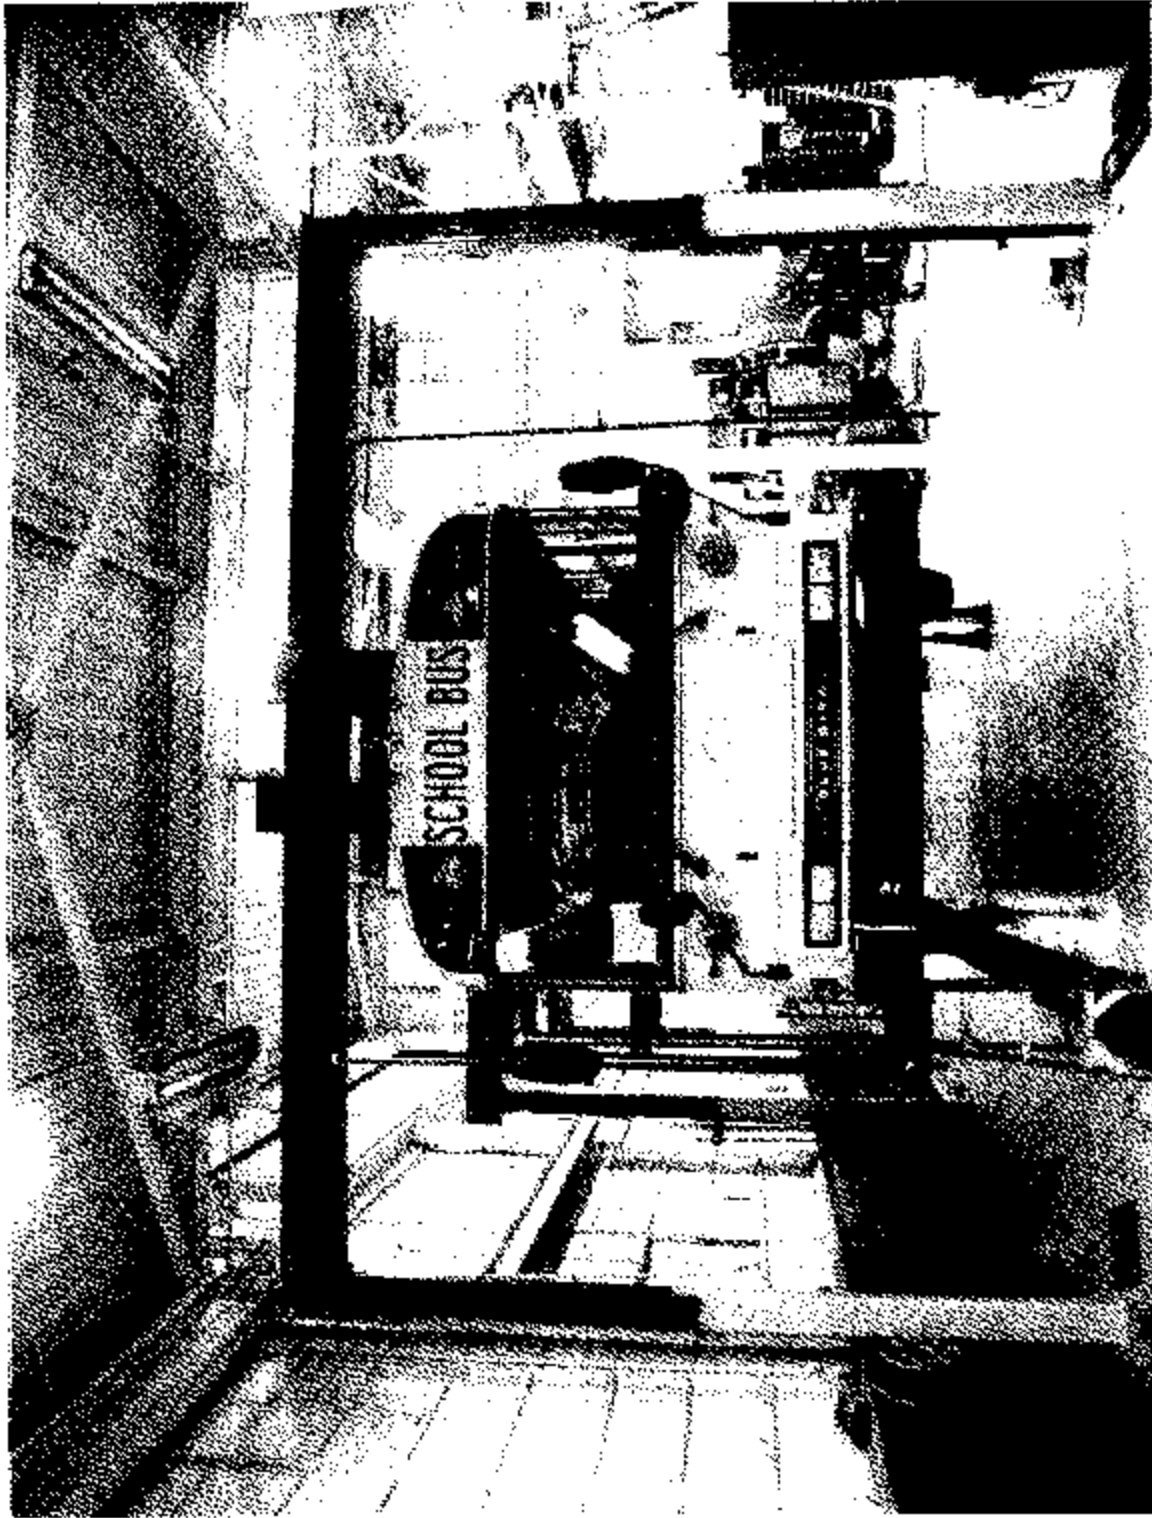
Loading Device Placed Against Bus Roof at Maximum Load (Front View)

Pre-Load (227 kg) Deflection (mm)	Max. Load		PASS/FAIL
			Deflection (mm)	Load (kg)	
Cylinder	1	0	76.3	3201	PASS
	2	0	70.6	3394	PASS
	3	0	90.7	3393	PASS
	4	0	72.7	3406	PASS
Total Load				13,394	
Average Deflection			77.6		
Backup Measurement	1	0	21.0		
	2	0	13.0		
	3	0	51.0		
	4	0	43.0

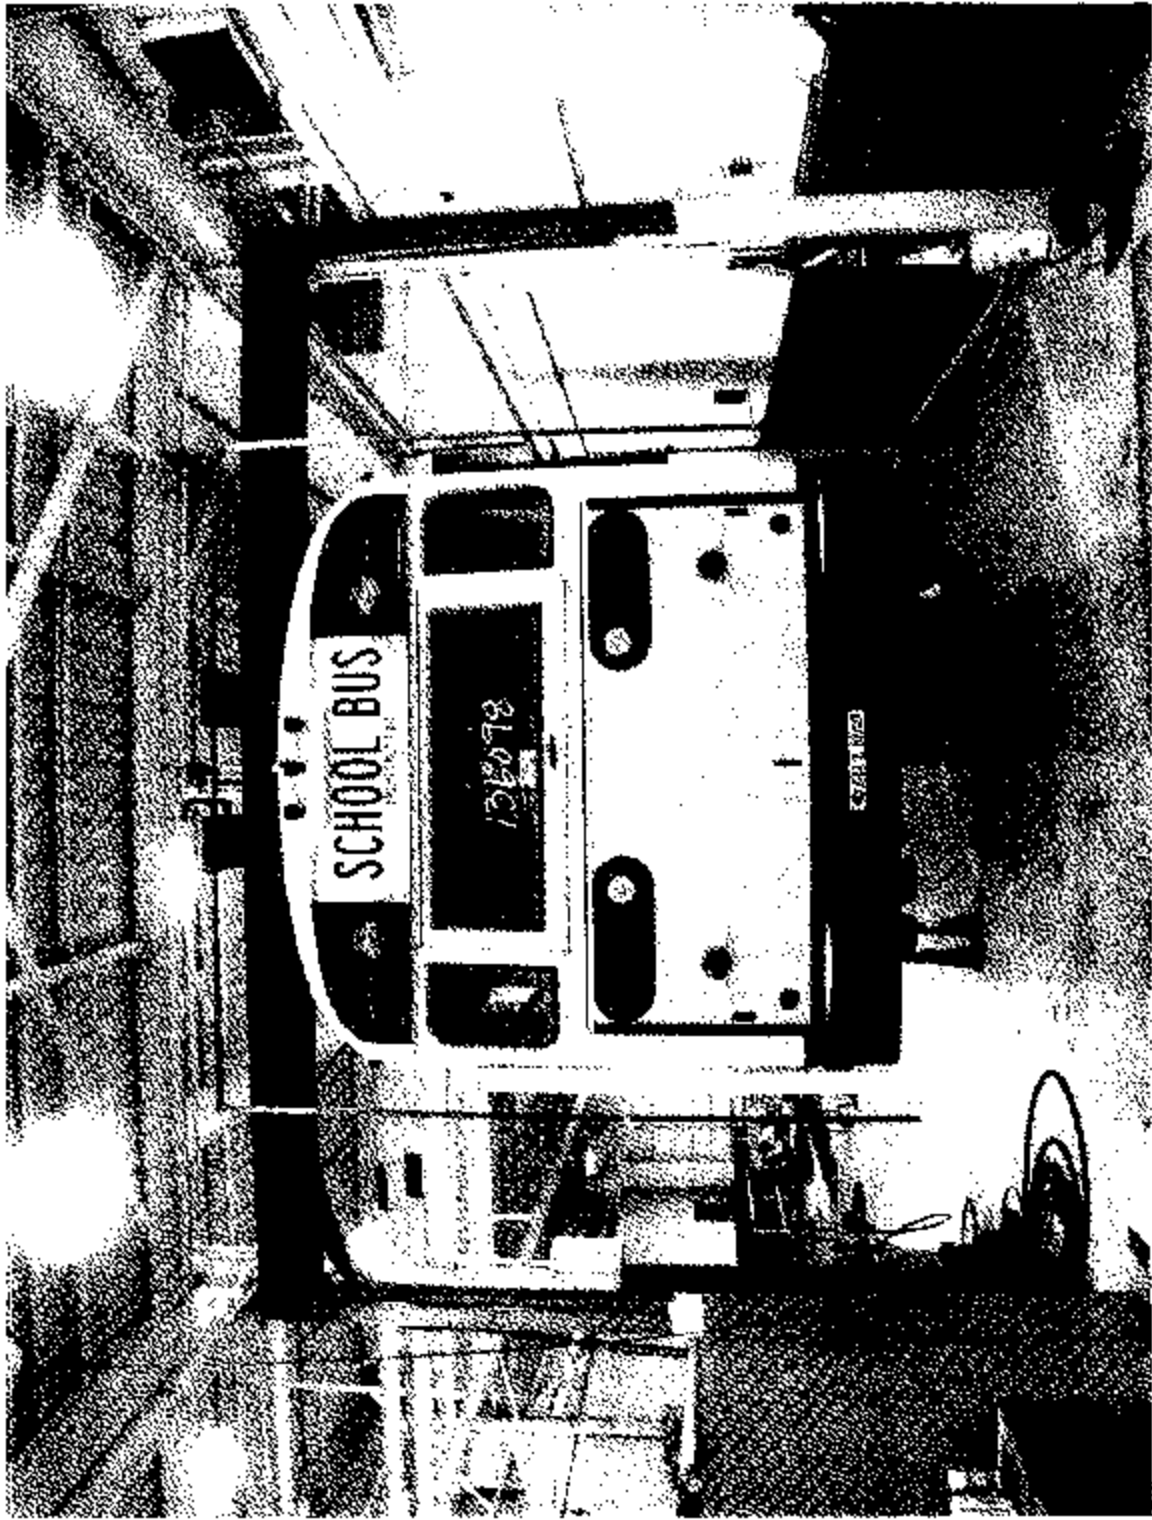
Loading Device Placed Against Bus Roof at Maximum Load (Rear View)

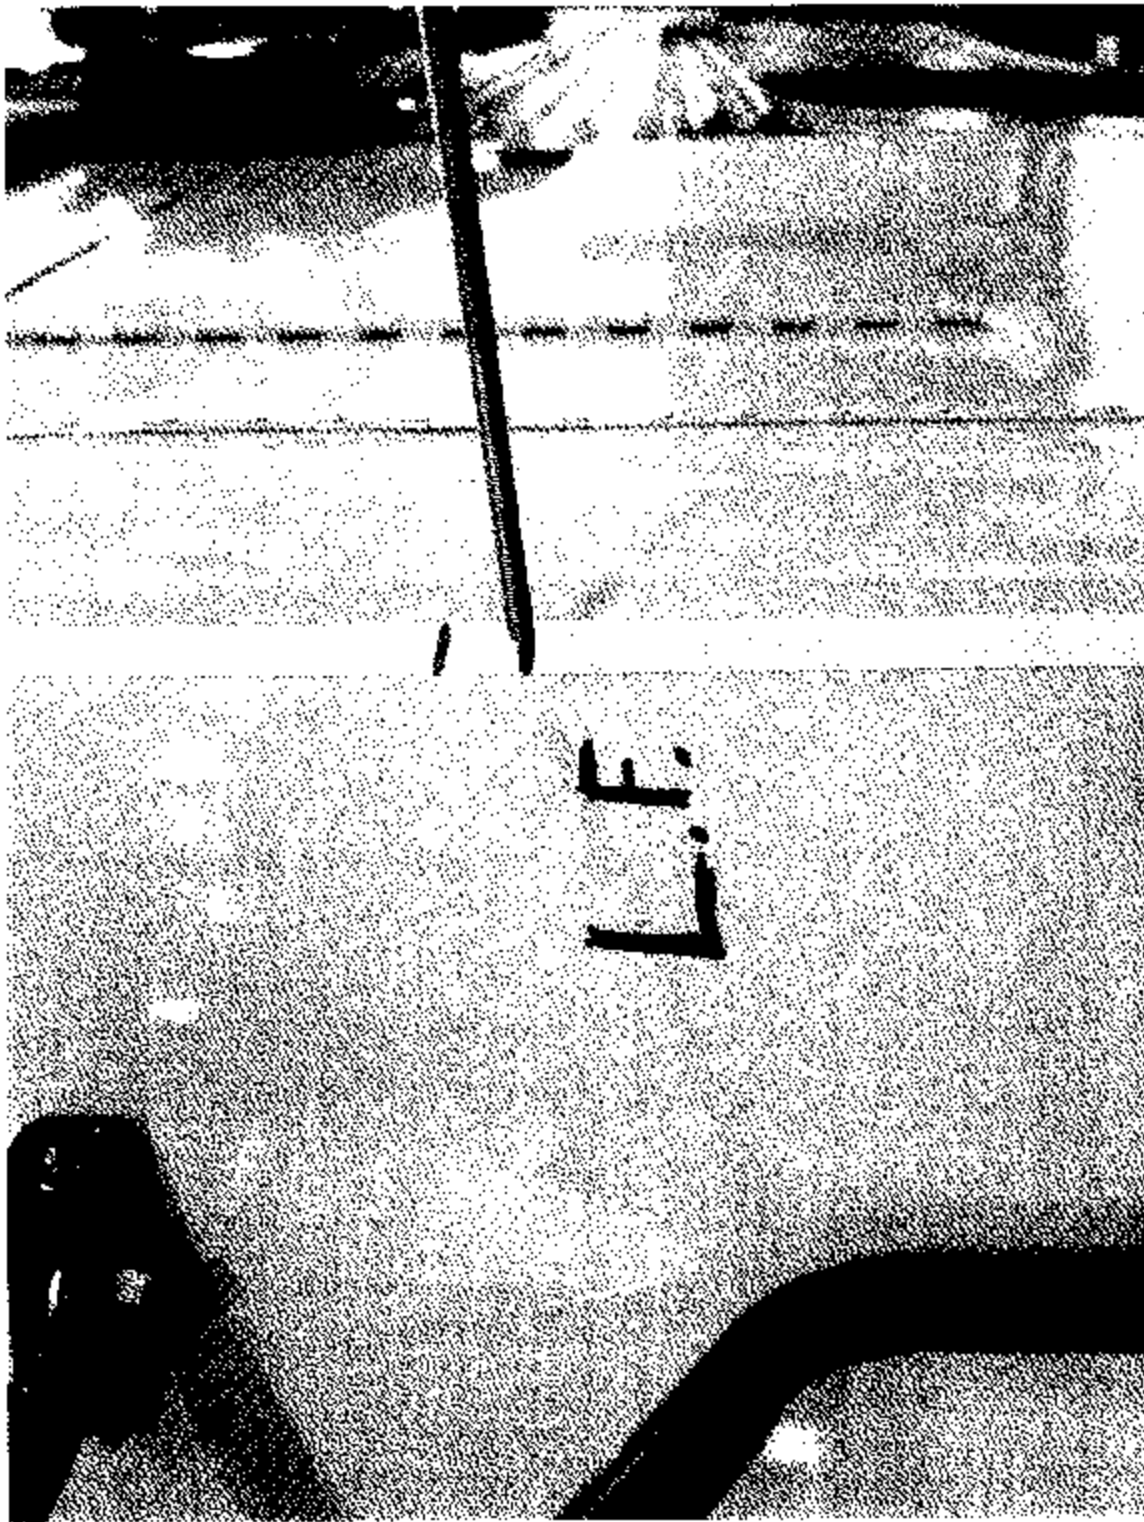
Back-up Roof Deflector: Measuring Device at LF Corner of Bus at Full Load

COMMENTS: 1) Backup measurements taken at four most outboard and longitudinal locations on the bus. Primary cylinder deflections were measured at the locations identified in the diagram on page 5. Maximum deflection allowed = 130 mm.

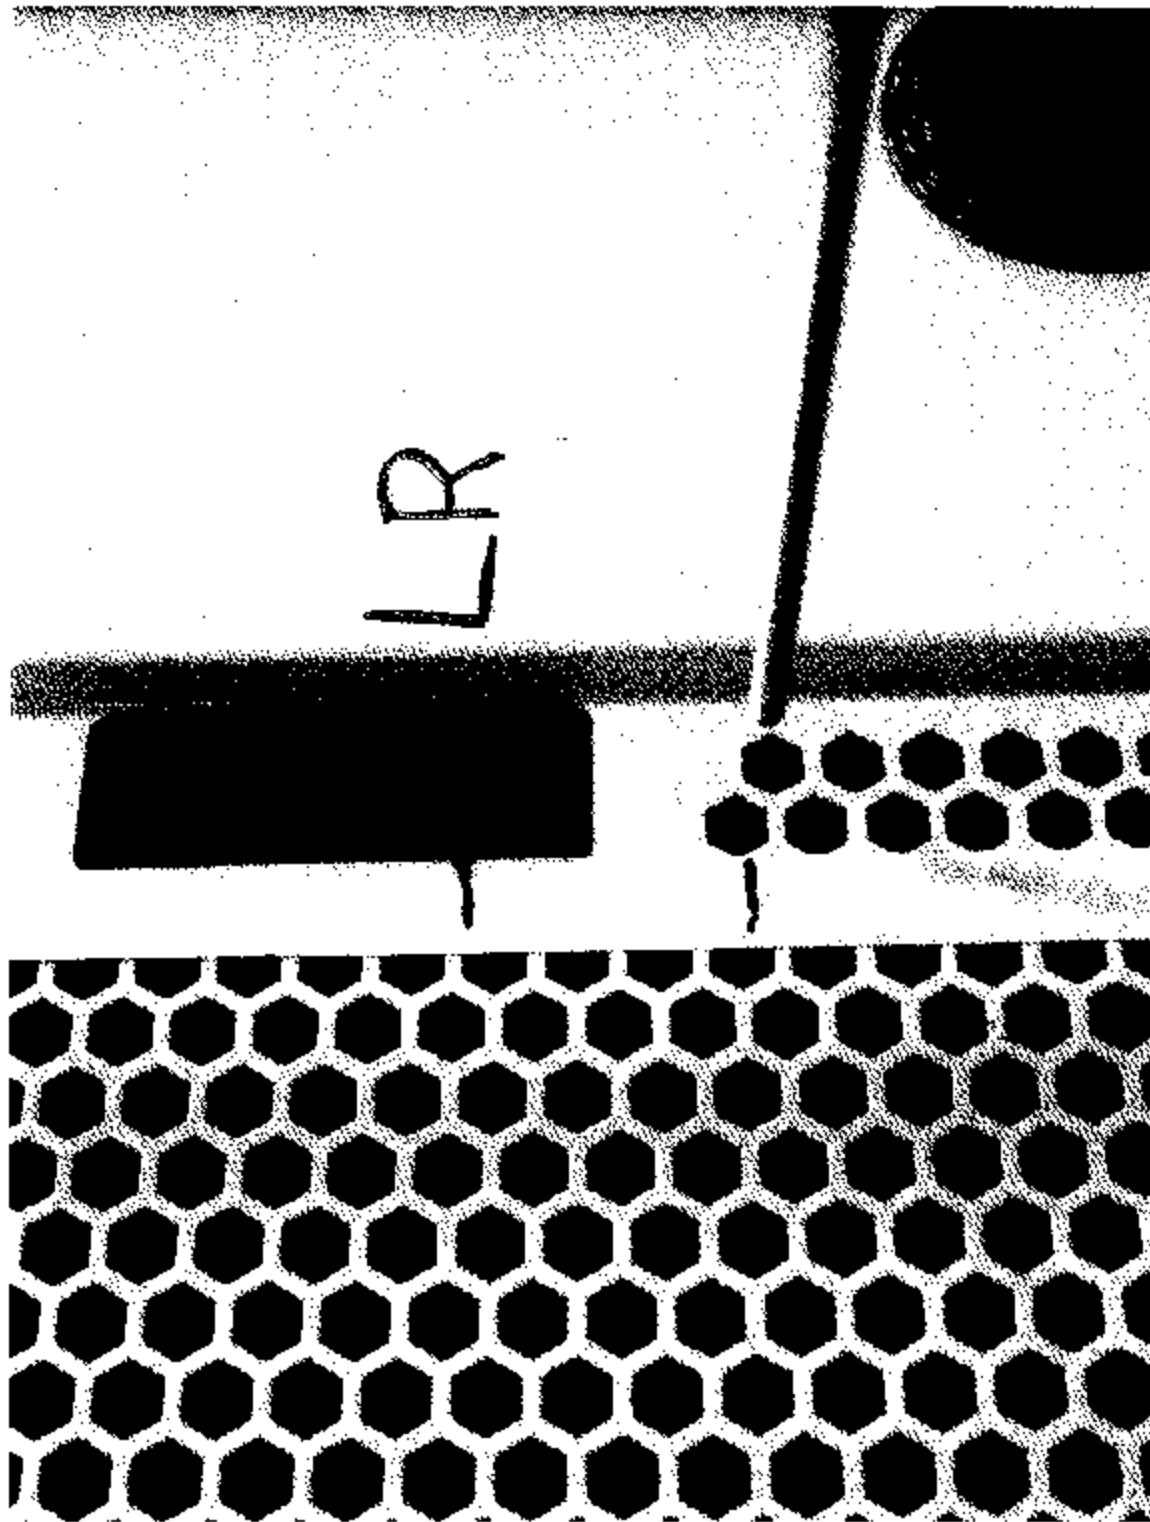
Back-up Roof Deflection Measuring Device at LR Corner of Bus at Full Load

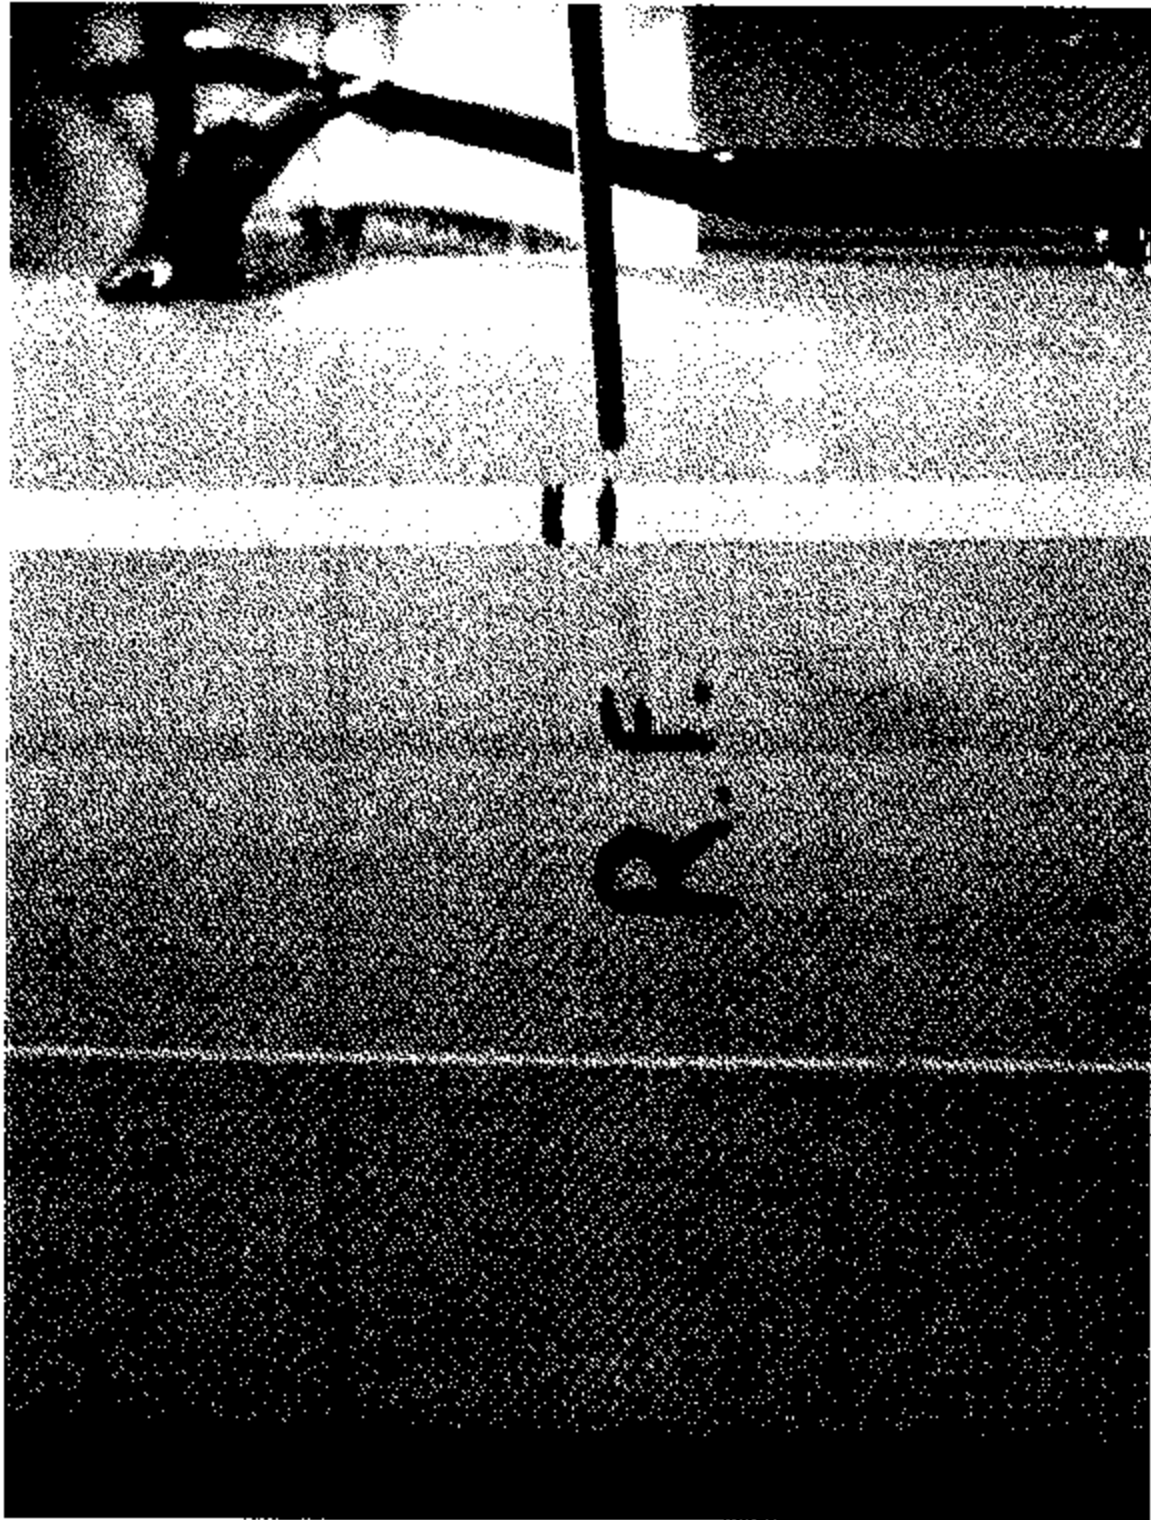
Back-up Roof Deflection Measuring Device at RF Corner of Bus at Full Load

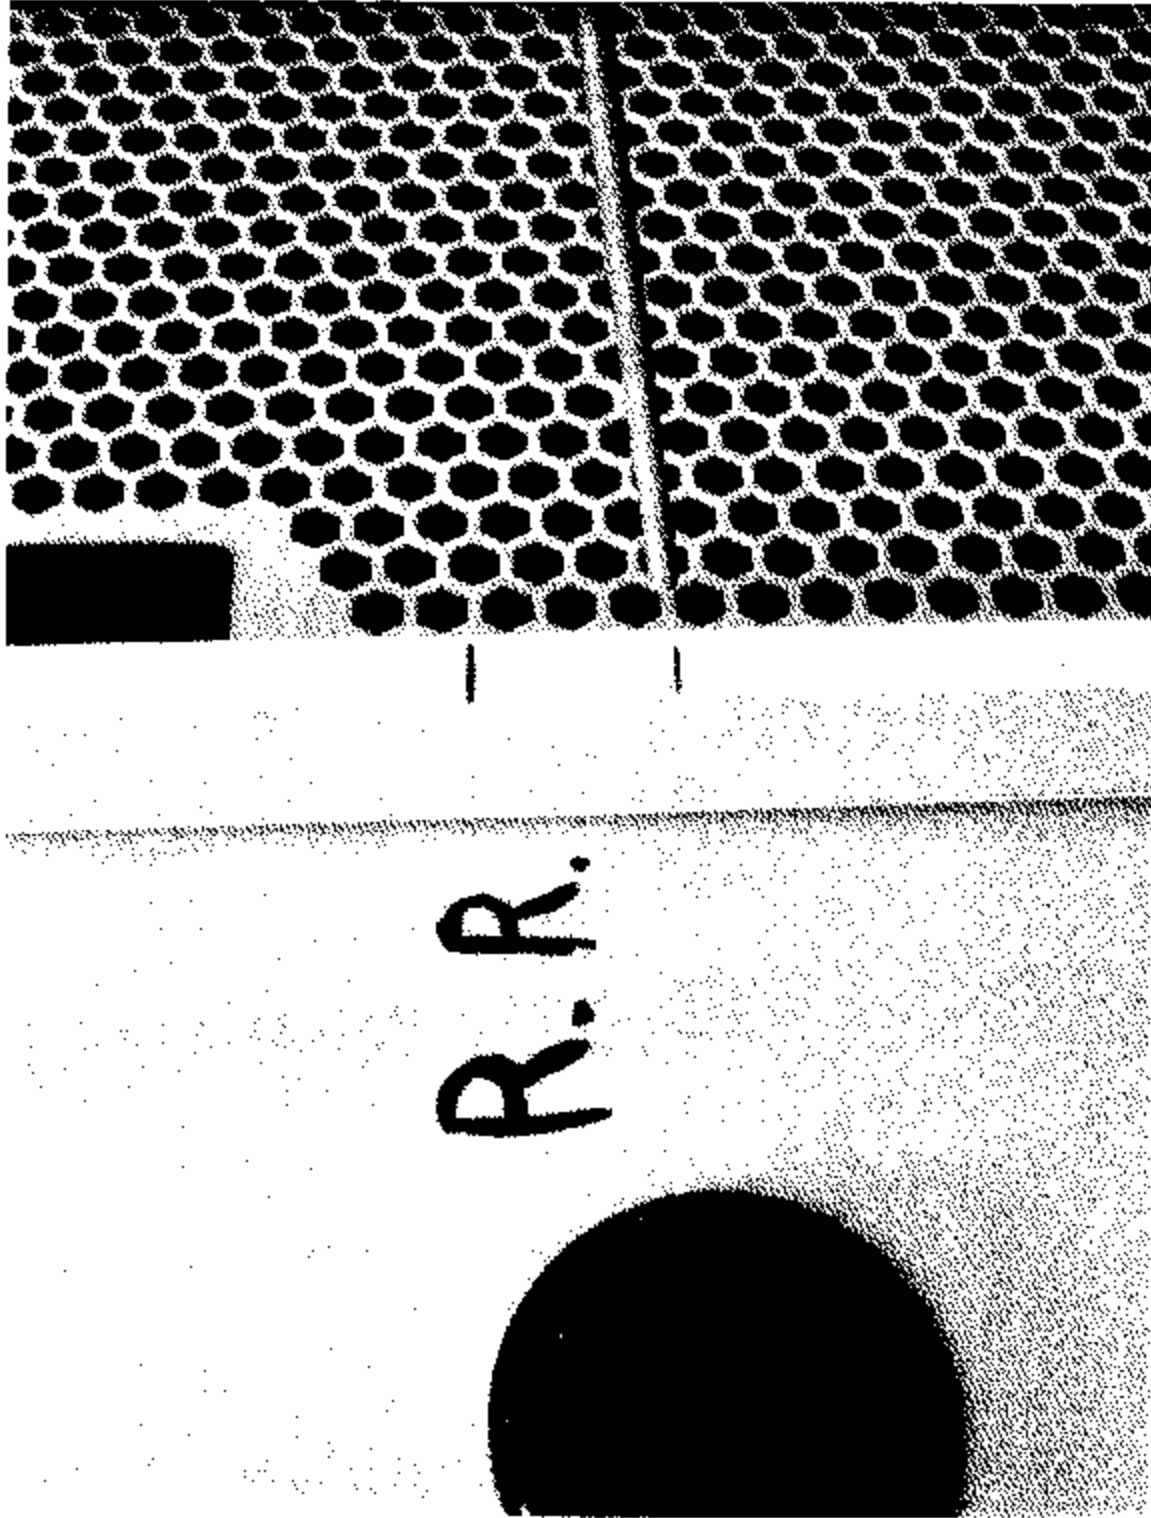
Back-up Roof Deflection Measuring Device at RR Corner of Bus at Full Load
