REPORT NUMBER: 220-MGA-03-001

SAFETY COMPLIANCE TESTING FOR
FMVSS NO. 220
SCHOOL BUS ROLLOVER PROTECTION

2003 Blue Bird
All American School Bus
NHTSA No.: C30900

PREPARED BY:
MGA RESEARCH CORPORATION
5000 WARREN ROAD
BURLINGTON, WI 53105

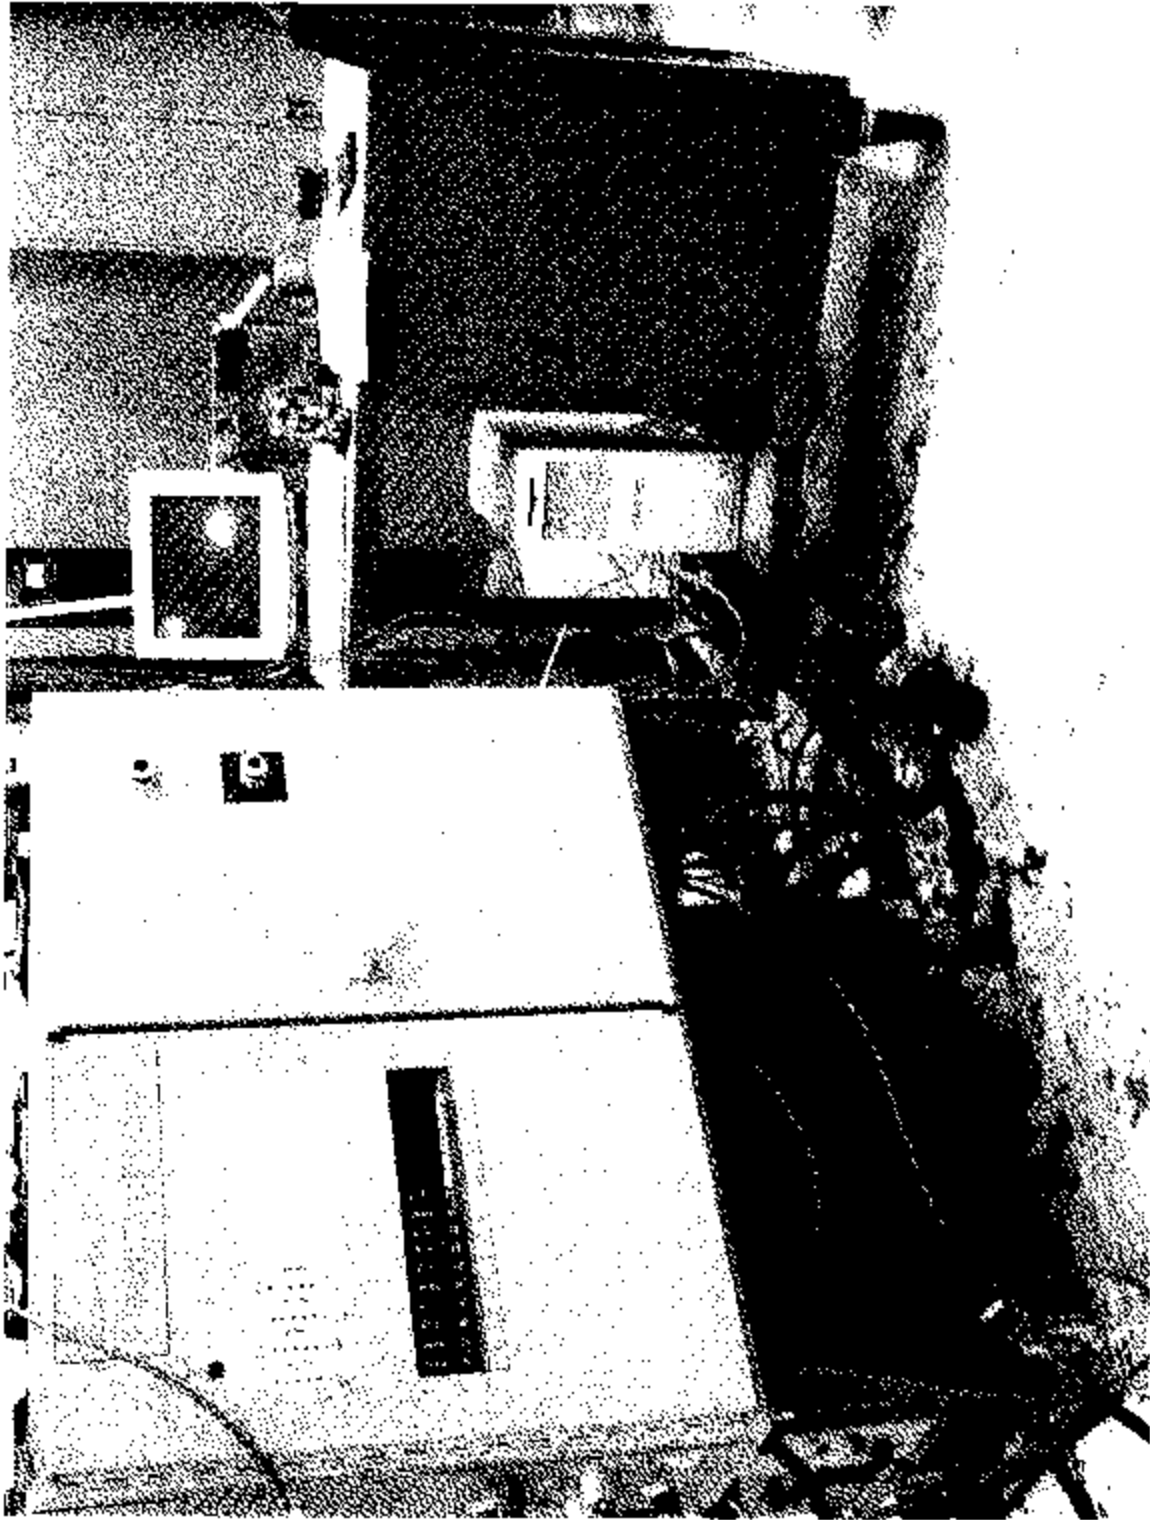
Photo of Actual Instrumentation Setup

Equipment	Description	Model/Serial No.	Cal. Date	Next Cal. Date
Computer	HP	Vectra / US03263612	---	---
Steel Tape	Stanley	Powerlock / 148	5/30/03	11/30/03
Scale	GSE	PRO-WEIGH 84 212091/212092	6/9/03	12/9/03
Cylinder #1 Load Cell	Interface	137782	5/1/03	11/1/03
Cylinder #1 Displacement Pot.	Patriot	20650	7/21/03	1/21/04
Cylinder #2 Load Cell	Interface	137781	5/1/03	11/1/03
Cylinder #2 Displacement Pot.	Interface	1202-19368	7/21/03	1/21/04
Cylinder #3 Load Cell	Interface	137778	5/1/03	11/1/03
Cylinder #3 Displacement Pot.	Interface	1102 19181	7/21/03	1/21/04
Cylinder #4 Load Cell	Interface	137783	5/1/03	11/1/03
Cylinder #4 Displacement Pot.	Interface	1202-19364	7/21/03	1/21/04
Ellipsoid	MGA	ELLIP - 1A	12/4/02	12/4/03
Parallelepiped	MGA	PARA - 1A	12/4/02	12/4/03
Force Gauge	CHATILLON	DFGS-R-ND/ F31754	6/17/03	12/17/03
Temperature Recorder	DICKSON	TR320 S/N: 03039010	2/2003	2/2004

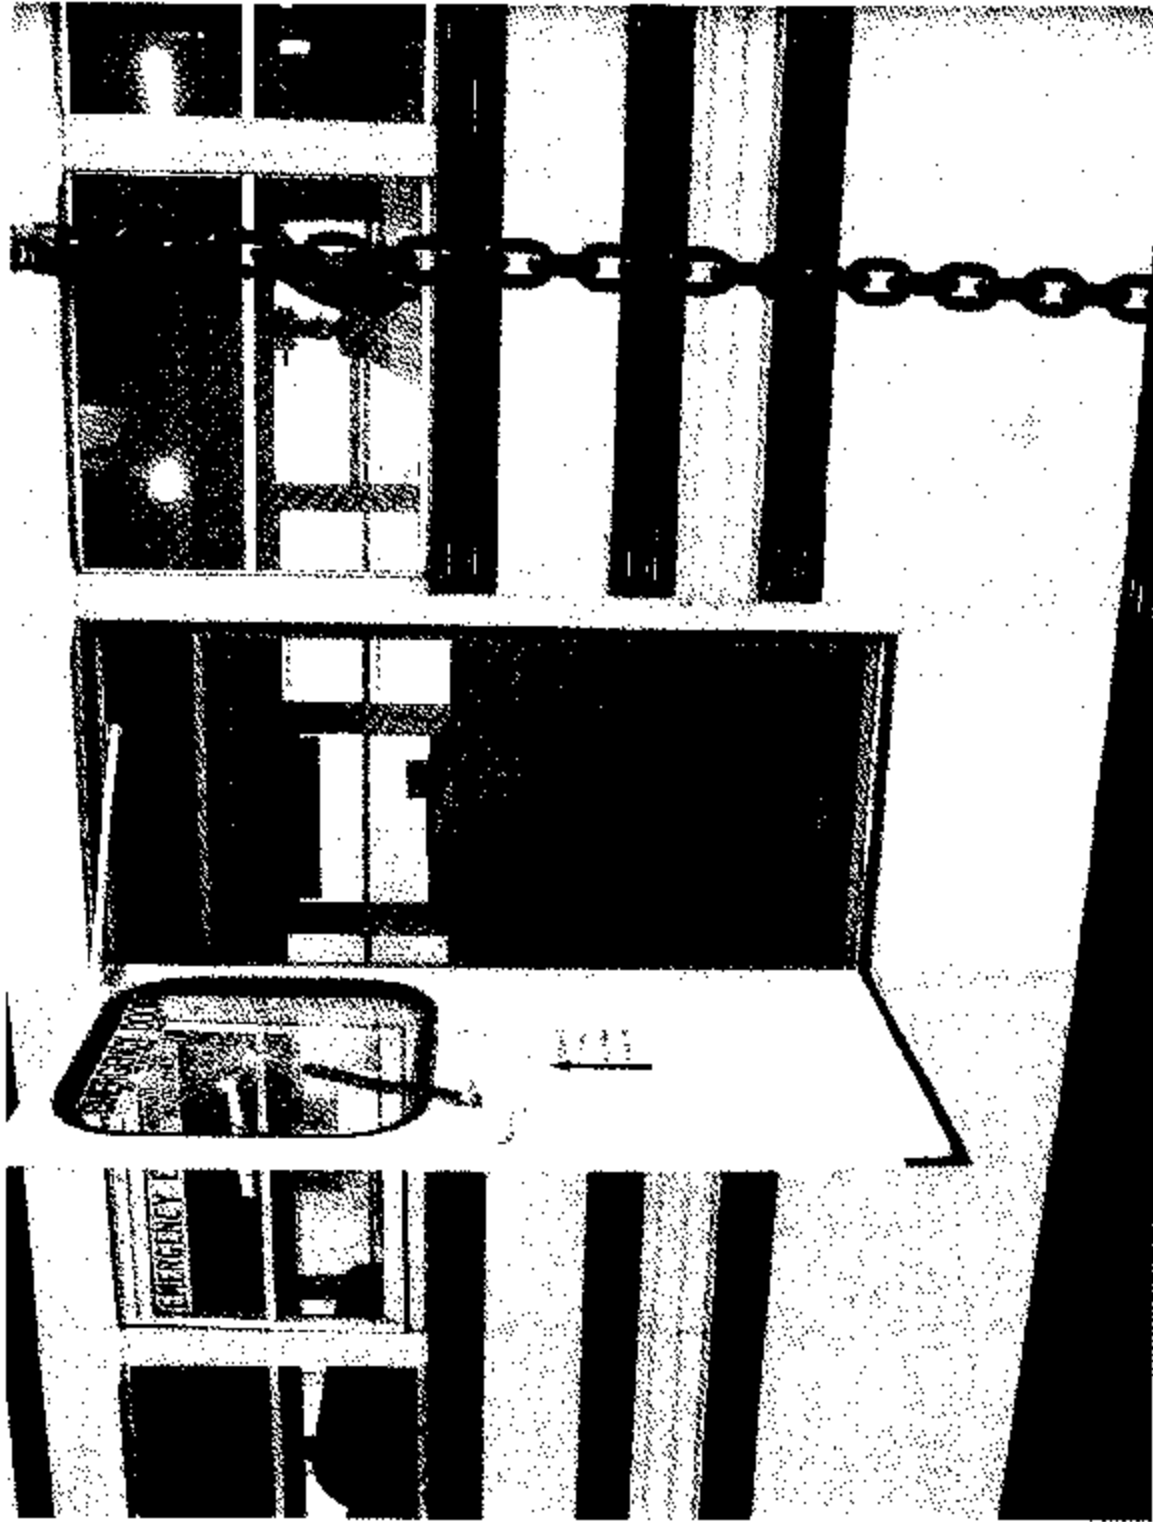
Exit Opened After Roof Loading is Attached with Parallelepiped in Place

COMMENTS: Parallelepiped dimensions are 114 cm x 61 cm x 30 cm.

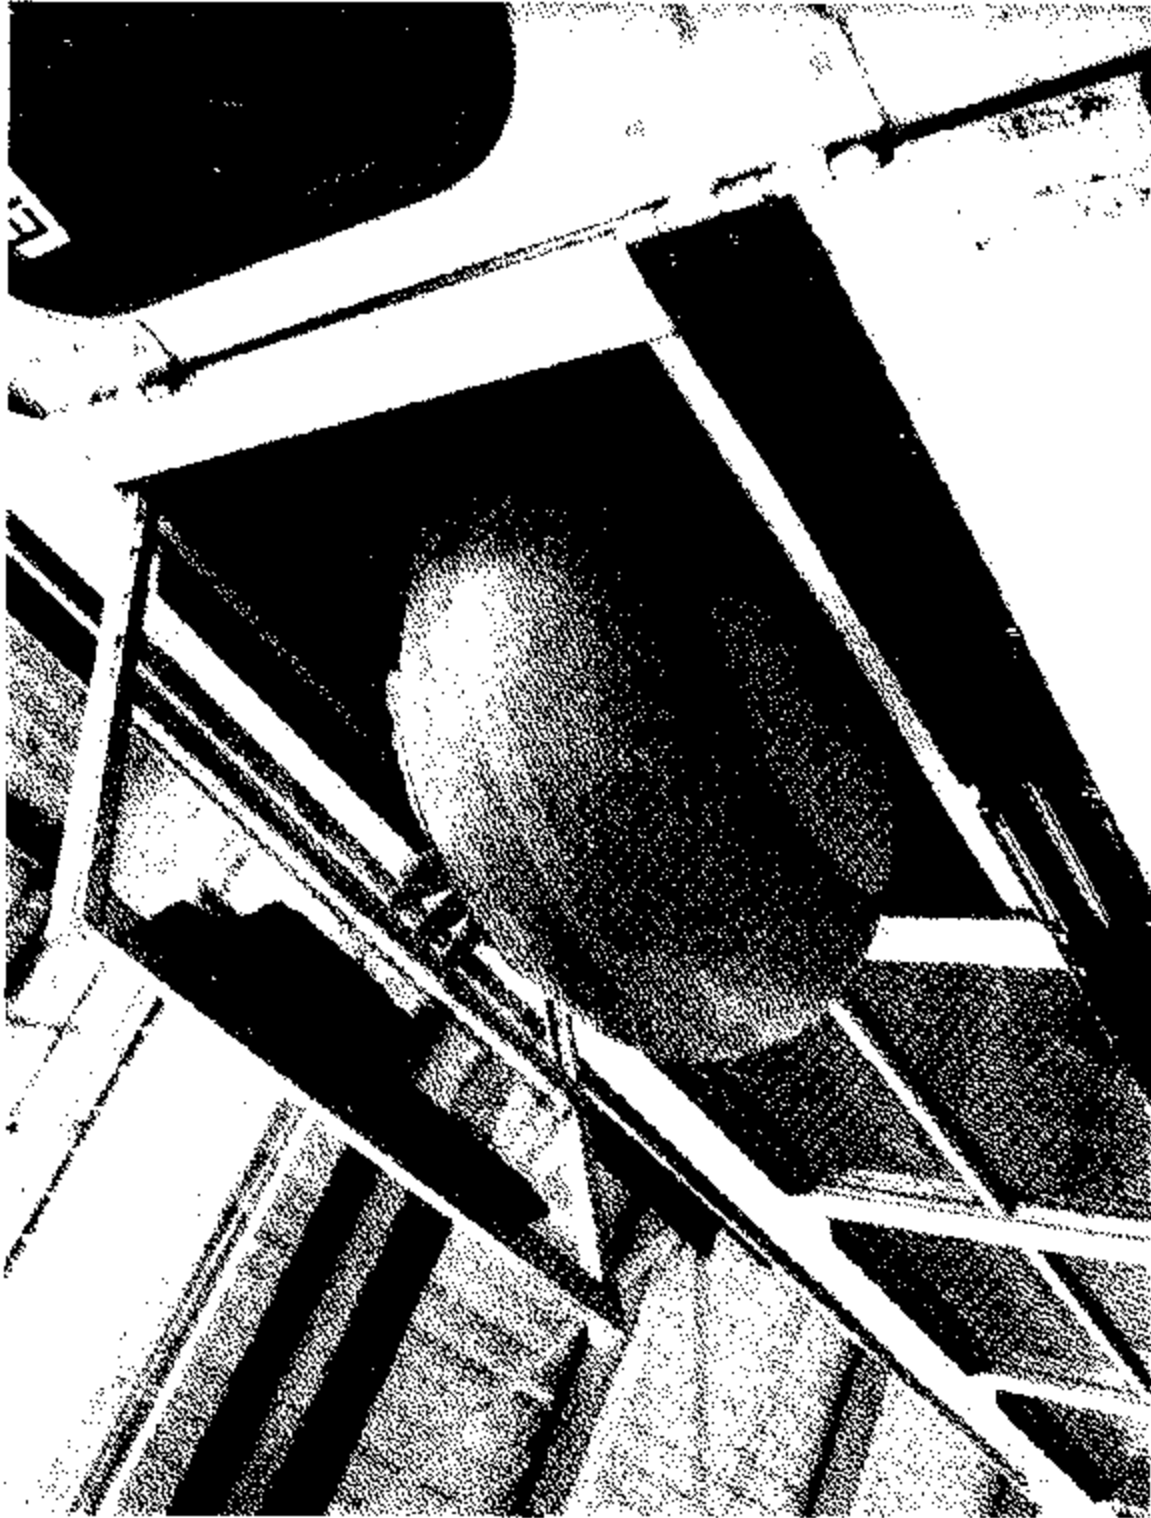
LF Exit Opened After Roof Loading is Attained with Measuring Device in Place

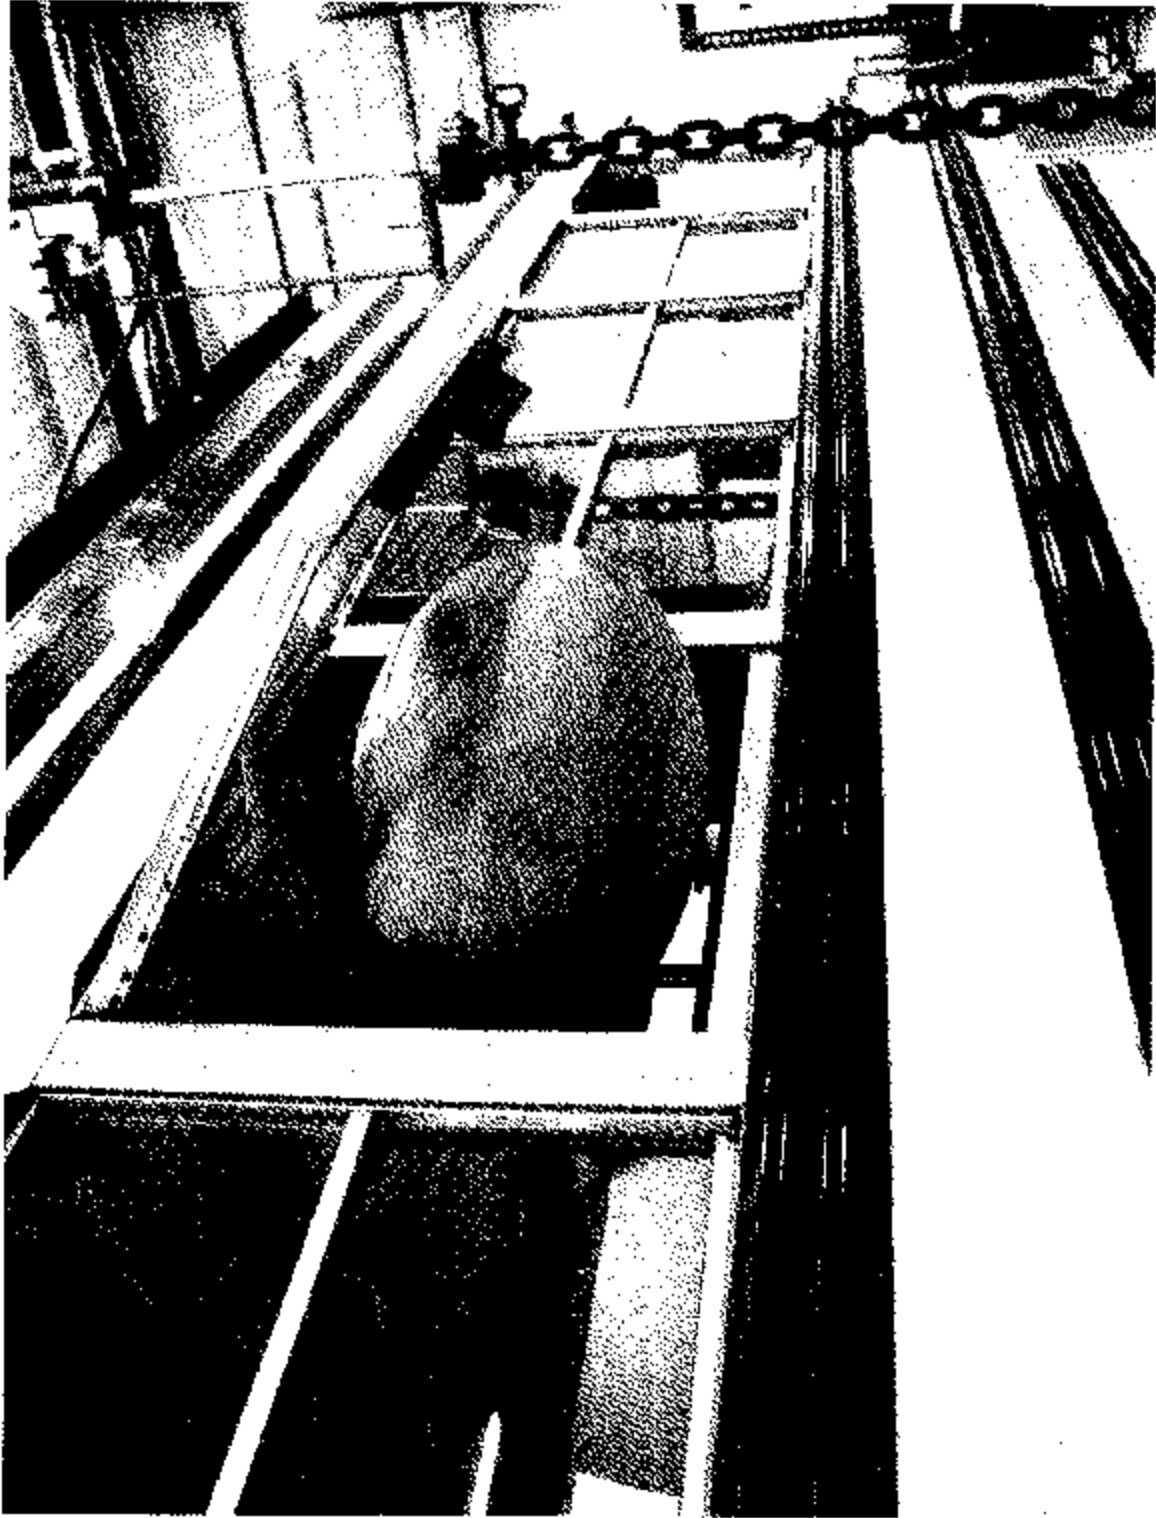
LR Exit Opened After Roof Loading is Attained with Measuring Device in Place

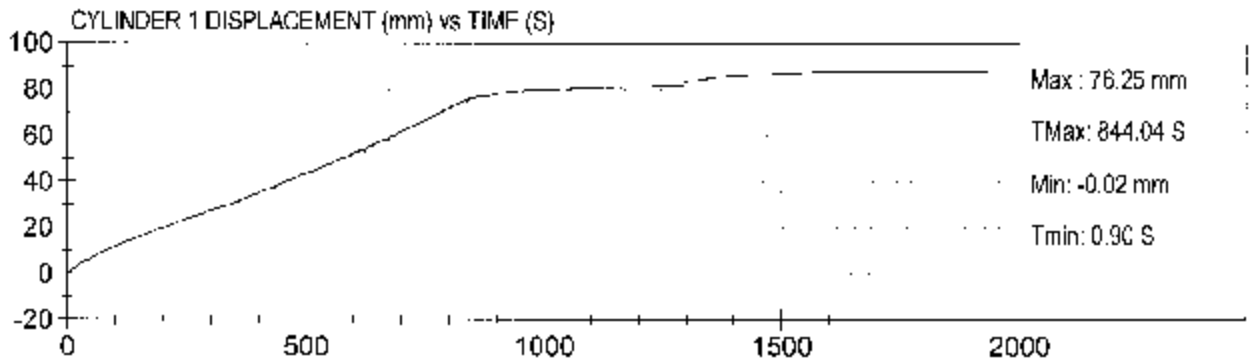
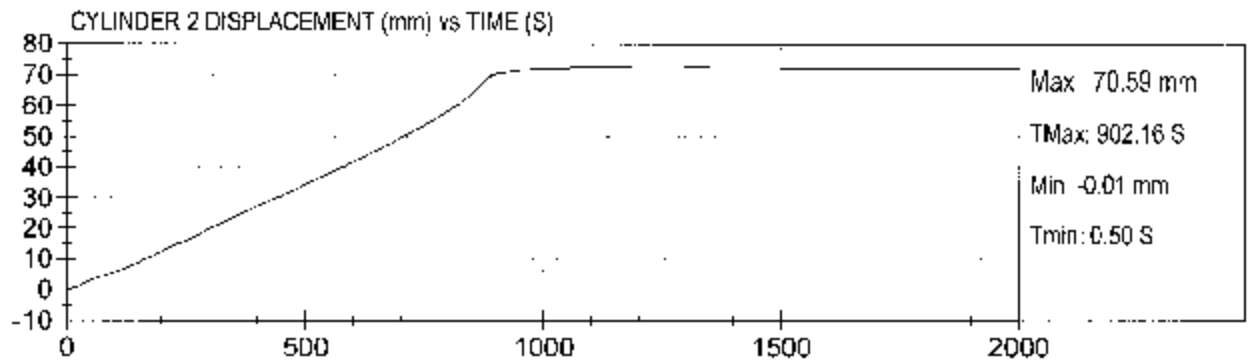
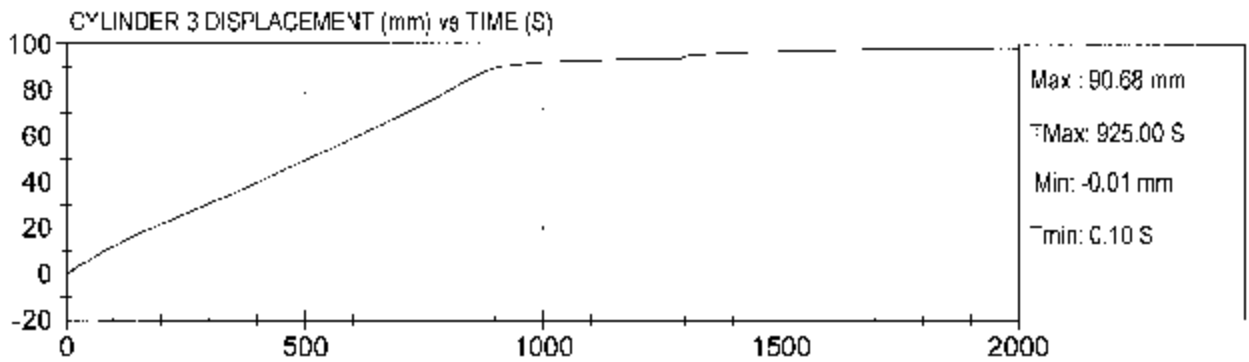
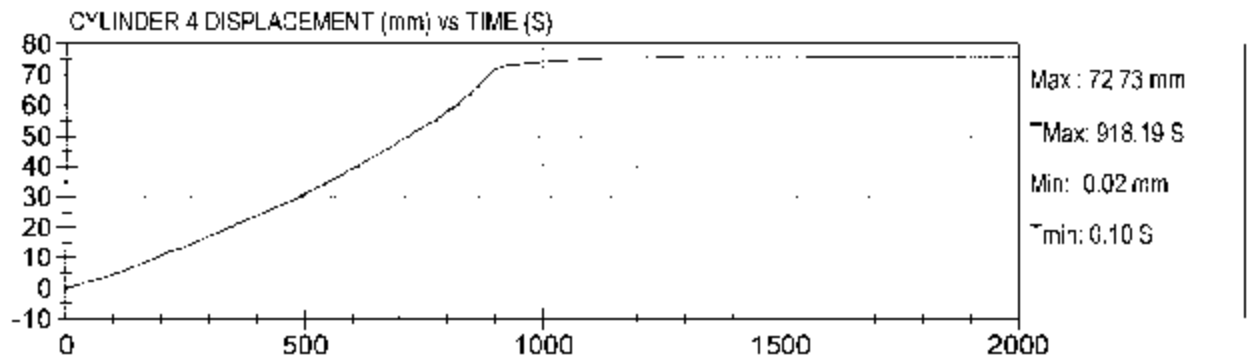
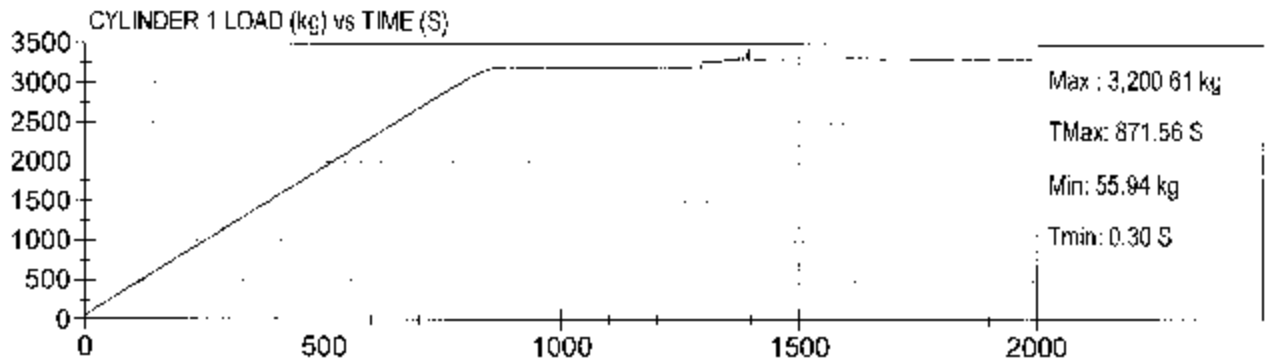
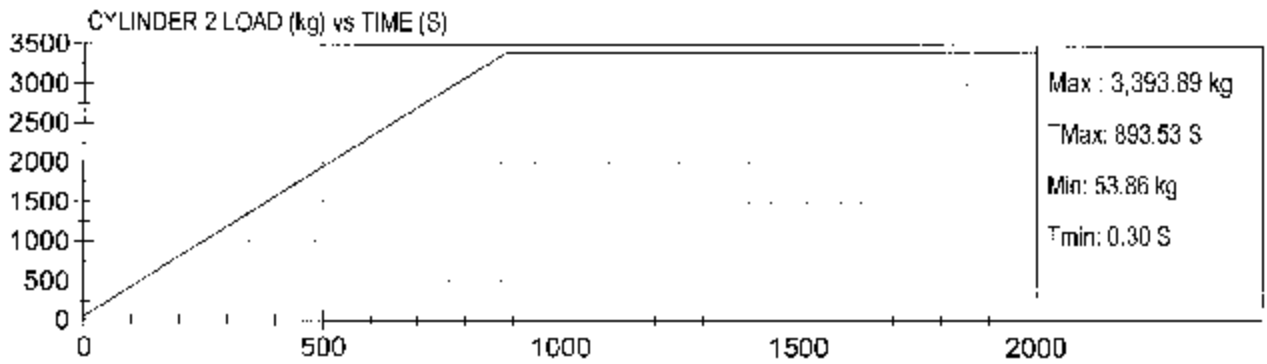
**SECTION 6
TEST PLOTS**

Test Desc: FMVSS 220
NHTSA NO: C30900

Test Date: 8-7-03
Vehicle ID: Blue Bird

Pre-Load (227 kg) Deflection (mm)	Max. Load		PASS/FAIL
			Deflection (mm)	Load (kg)	
Cylinder	1	0	76.3	3201	PASS
	2	0	70.6	3394	PASS
	3	0	90.7	3393	PASS
	4	0	72.7	3406	PASS
Total Load				13,394	
Average Deflection			77.6		
Backup Measurement	1	0	21.0		
	2	0	13.0		
	3	0	51.0		
	4	0	43.0
