Report No. 217-NVS-04-07

Compliance Test Report

2004 Orion V, 29 Passenger Transit Bus

NHTSA No. C40806

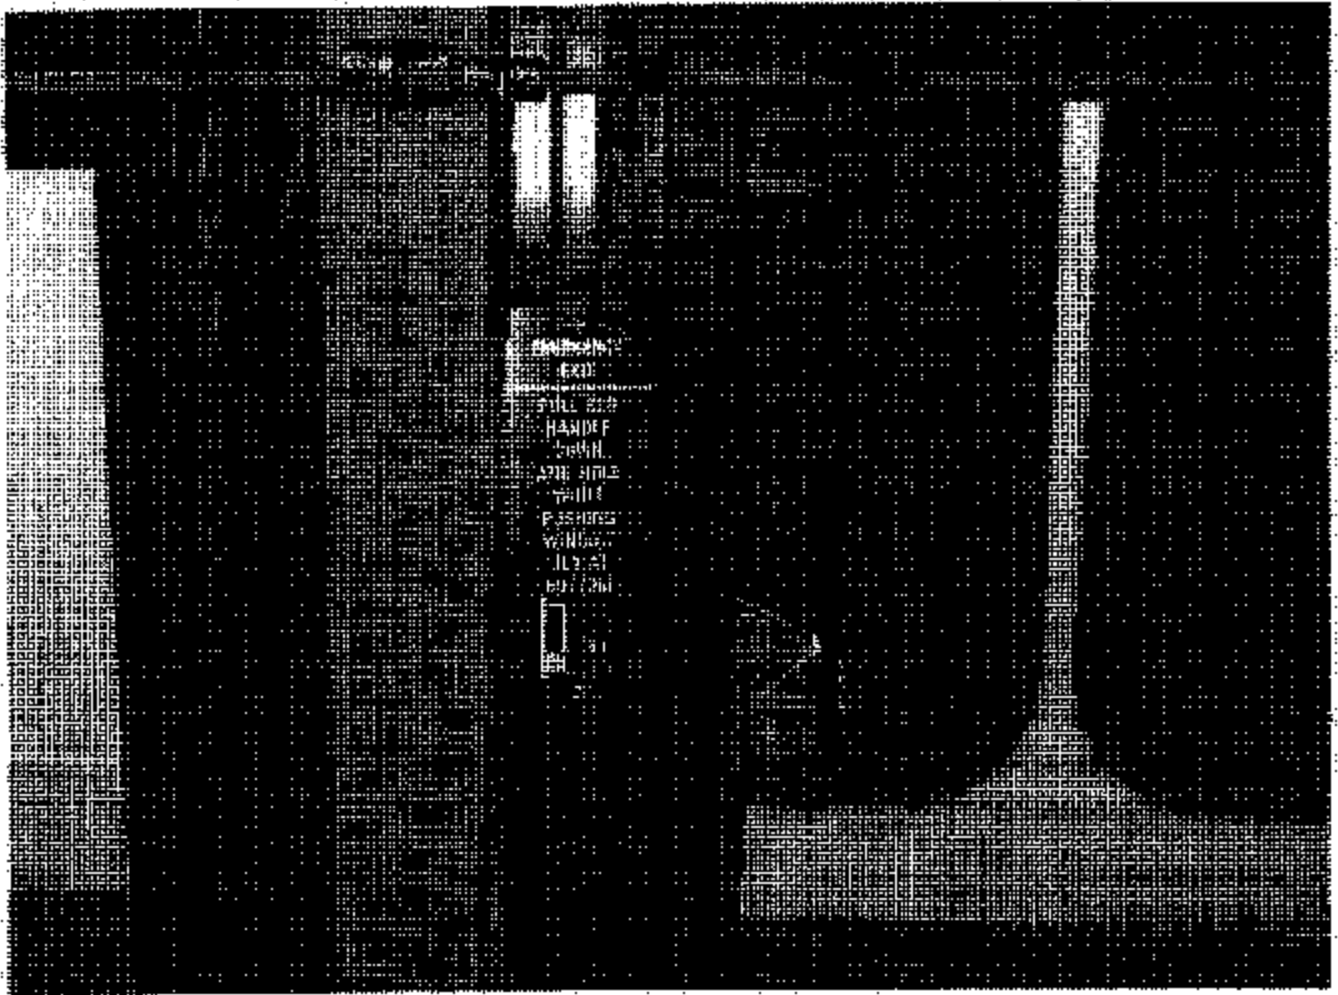
Photo 5 - Emergency Exit Label

1. Each emergency exit has a permanently affixed, legible label or placard with the designation "Emergency Door" or "Emergency Exit." **PASS**

2. Each emergency exit has a permanently affixed, legible label or placard describing the motion necessary to release (unlatch) and open the exit. **PASS**

3. The label is within 16 cm of the nearest release mechanism. **PASS**
