REPORT NUMBER 103-GTL-06-002

**SAFETY COMPLIANCE TESTING FOR
FMVSS NO. 103
WINDSHIELD DEFROSTING AND
DEFOGGING SYSTEMS**

**FORD MOTOR CO.
2006 FORD MUSTANG, PASSENGER CAR
NHTSA NO. C60203**

**GENERAL TESTING LABORATORIES, INC.
1623 LEEDSTOWN ROAD
COLONIAL BEACH, VIRGINIA 22443**

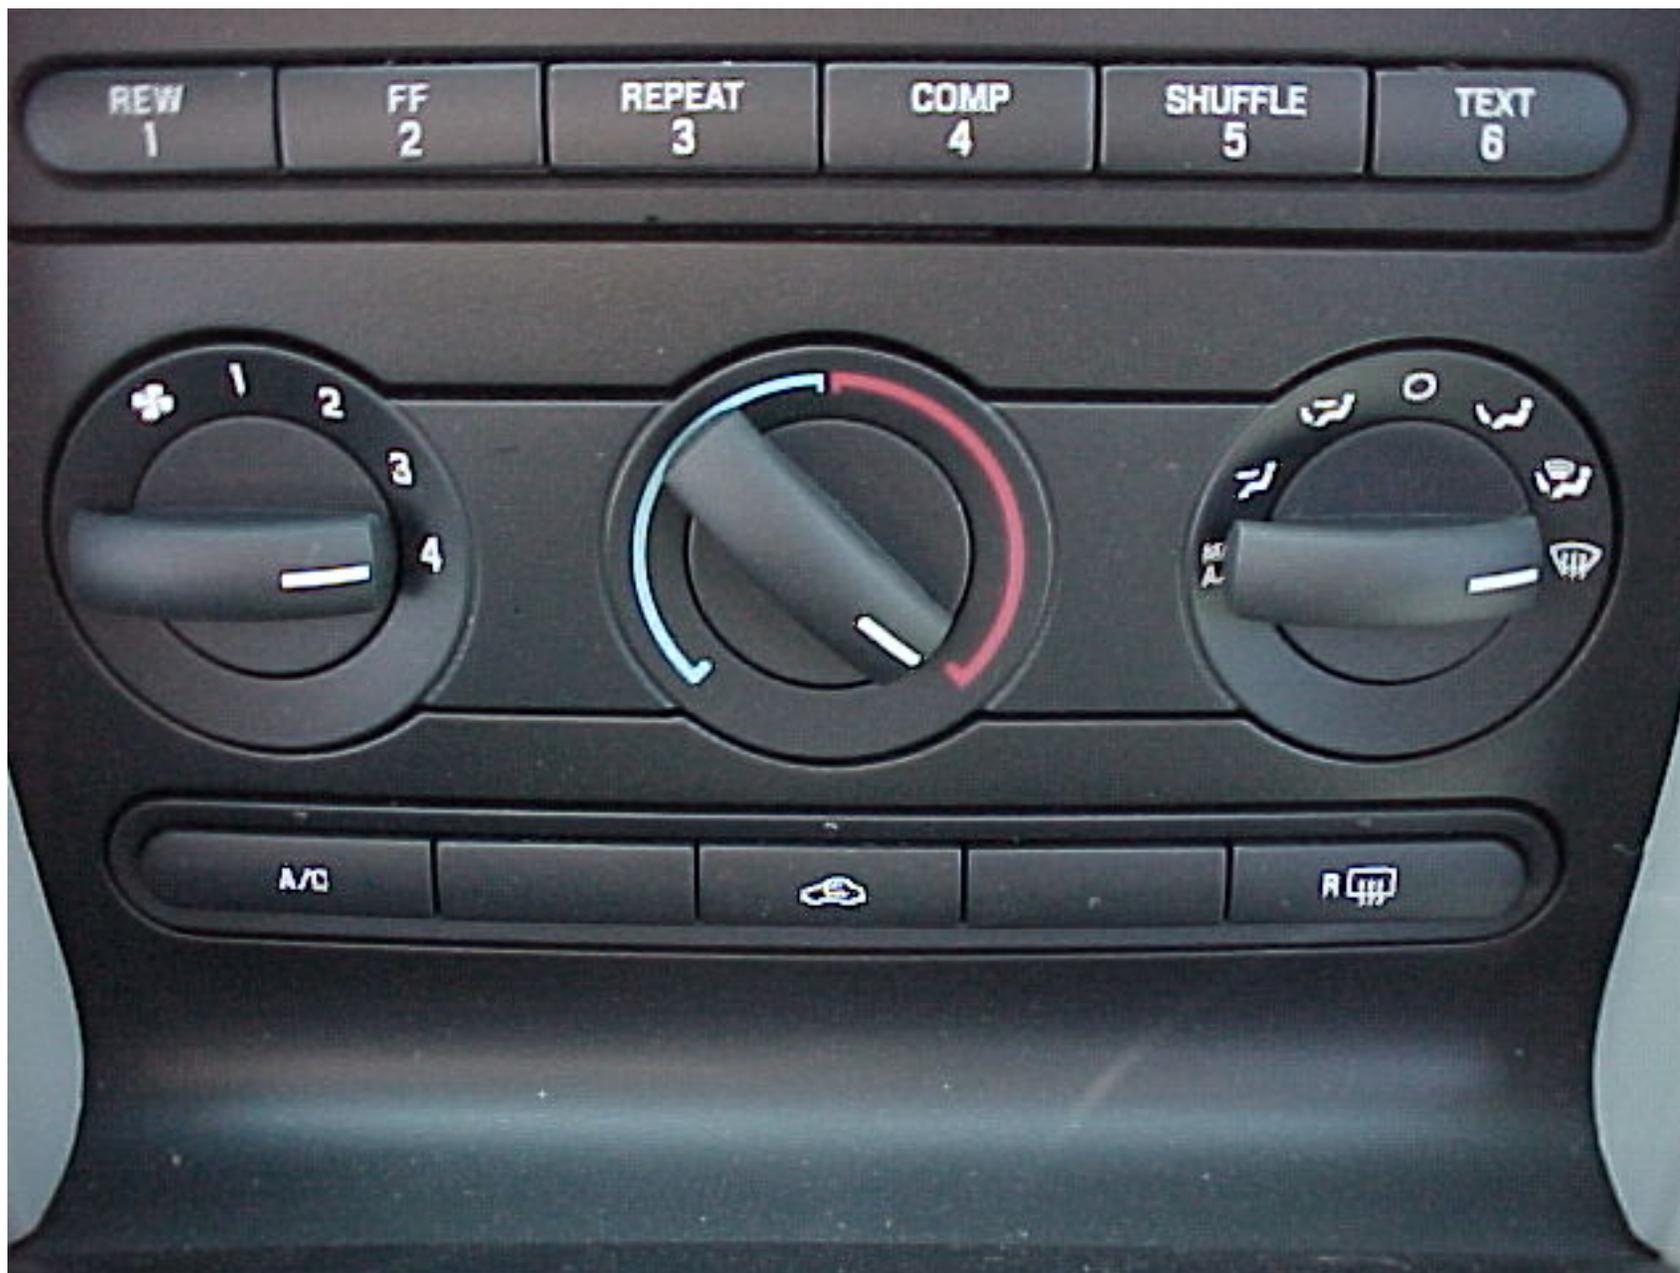
FIGURE 5.7
CLOSE-UP VIEW OF DEFROSTER CONTROL
SETTING ON DASH

At the conclusion of the additional soak time the vehicle's engine was started and operated at a target speed of 1500-1600 rpm or at the manufacturer's specification if different as noted on data sheets. The defroster blower was turned on to the high speed setting with the heater selector in the de-ice (defrost) position, and the temperature control in the maximum temperature position. All doors and windows were closed. The heater air intake was fully open and the vehicle's hood closed. At no time during the test were the windshield wipers used.

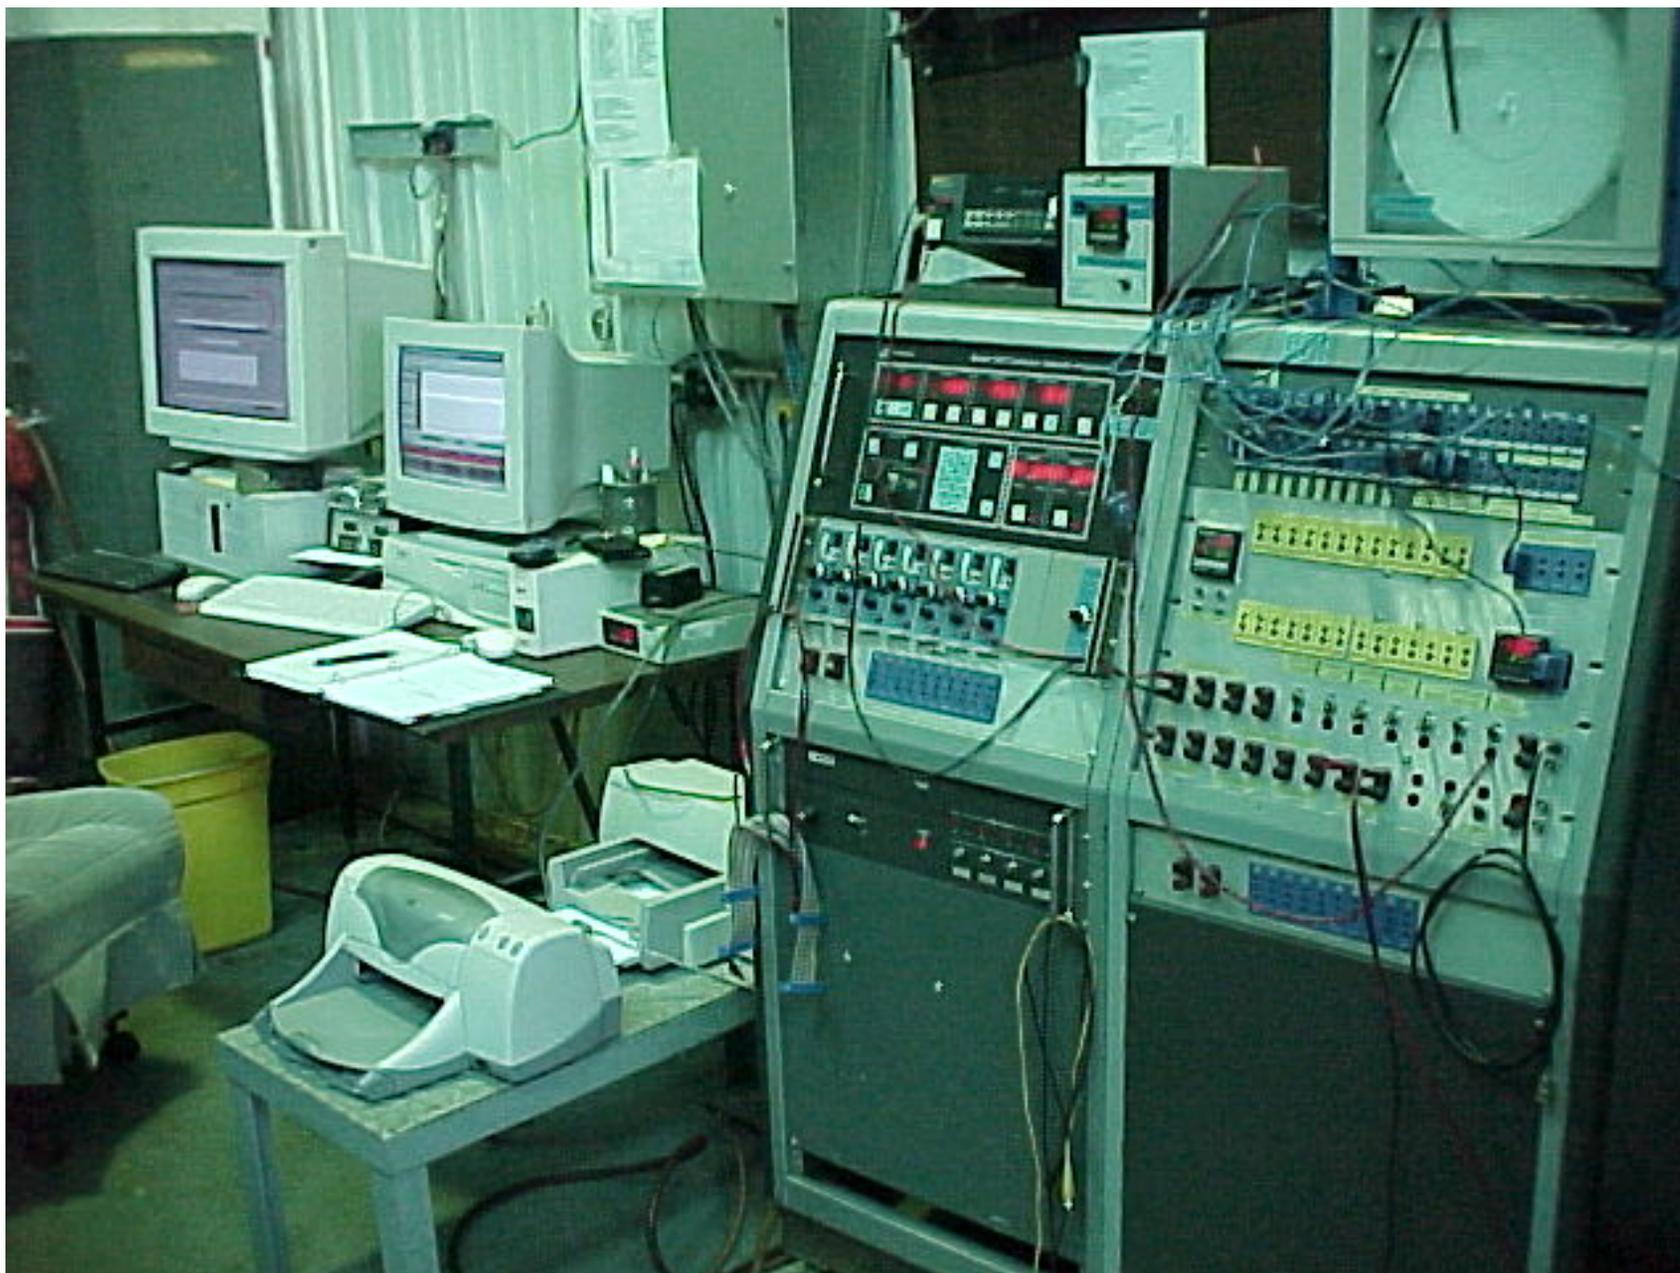
FIGURE 5.8
INSTRUMENTATION SET-UP

At start of testing and during test, at each 5-minute interval after engine start, cold chamber, engine coolant, heater coolant in and defroster air left/defroster air right temperatures were recorded. Likewise at each 5-minute interval the boundary of the defrosted area was marked on the inside surface of the windshield. The test was run for a maximum of 40 minutes from engine start, or until such time as 100 percent windshield clearance was achieved. Photographs were made of the windshield at the pre-test frosted state and 20-minute and 25-minute intervals. Post test actions included placing a vellum pattern on the windshield and tracing the windshield's 5-minute interval defrosted area boundary lines onto the vellum pattern.

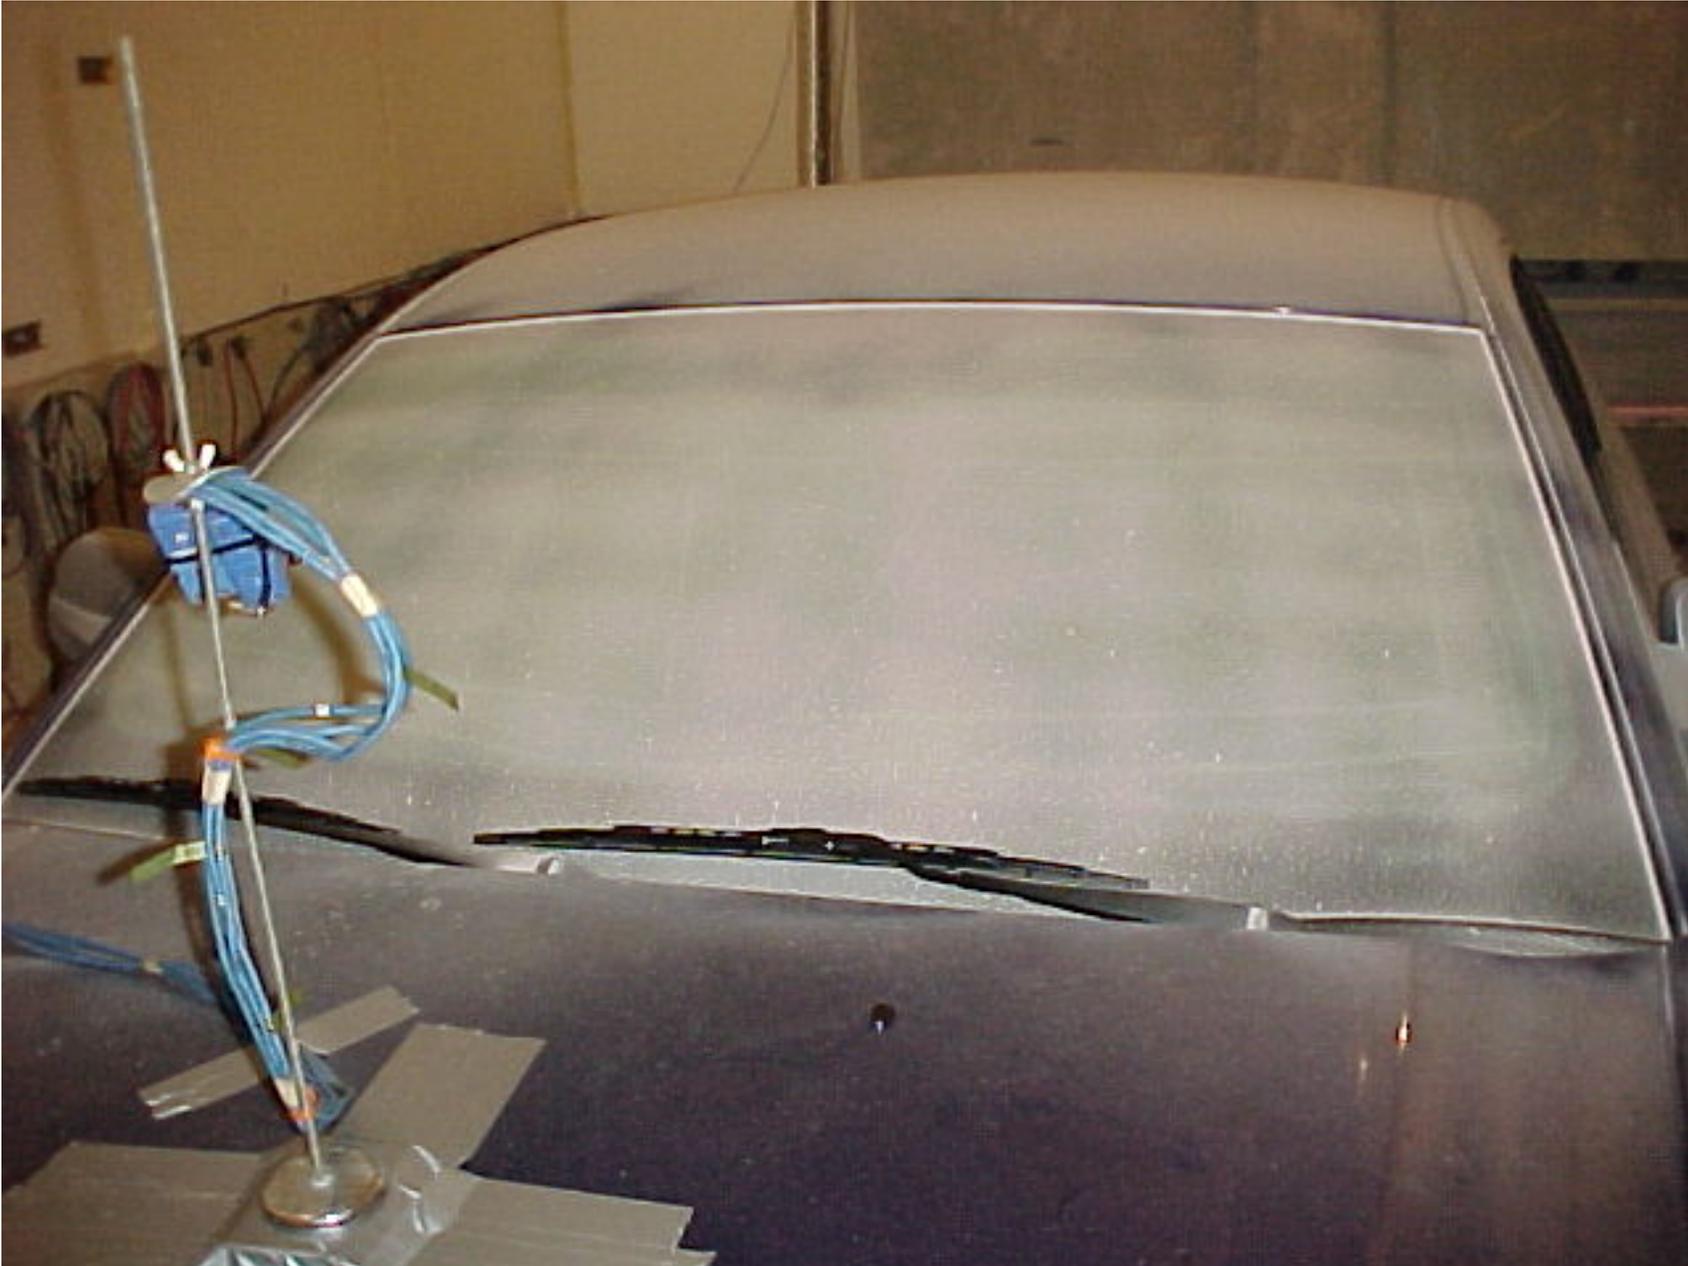
FIGURE 5.9
WINDSHIELD, PRE-TEST FROSTED STATE
TEST #1

At the end of the 2-hour minimum stabilization period, the entire windshield was sprayed evenly with 0.010 ounces of water per square inch of glass area. Refer to Section 3, Compliance Test Data, for test specifics such as total amount of water sprayed, spray gun identification, and air pressure regulation. The vehicle soak continued for an additional 30 minutes minimum but no more than 40 minutes after the windshield was sprayed.

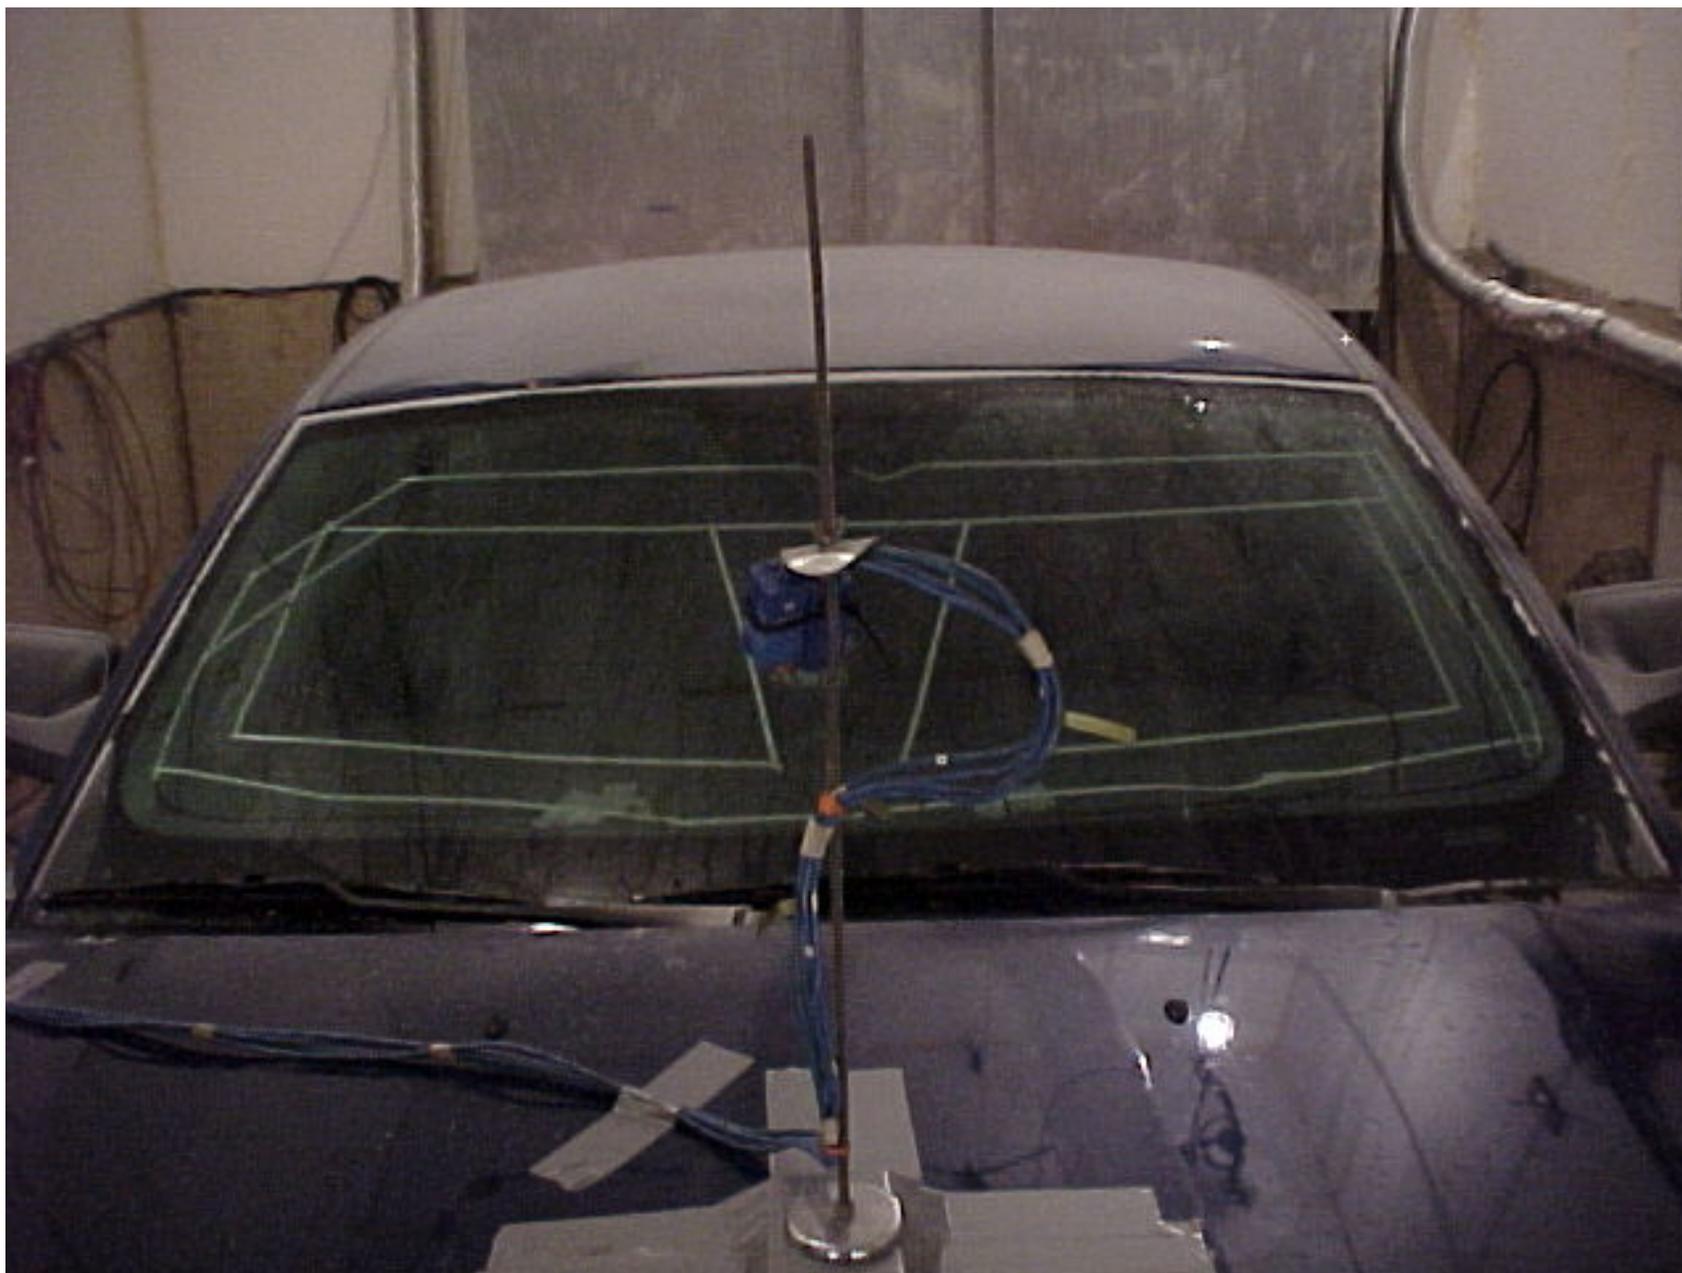
FIGURE 5.10
DEFROSTED AREA AT 20 MINUTES TEST #1

TIME FROM START (minutes)	MOTOR VOLTAGE (volts)	TEMPERATURE, °F					DEFROSTED AREA, %		
		TEST ROOM	ENGINE WATER	HEATER WATER IN	DEFROSTER AIR		A	C	D
					DRVR	PSGR			
0	13.4	-4.0	-4.0	-4.0	-4.0	-4.0	0%	0%	0%
5	14.6	-4.0	-3.5	89.2	62.8	62.5	2%	0%	0%
10	14.6	-3.0	0	129.7	95.2	96.2	44.0%	44.4%	54.2%
15	14.6	-2.0	3.9	155.2	118.1	120.7	95.8%	98.9%	99.4%
20	14.6	0	7.3	170.4	132.3	136.6	100%	100%	100%

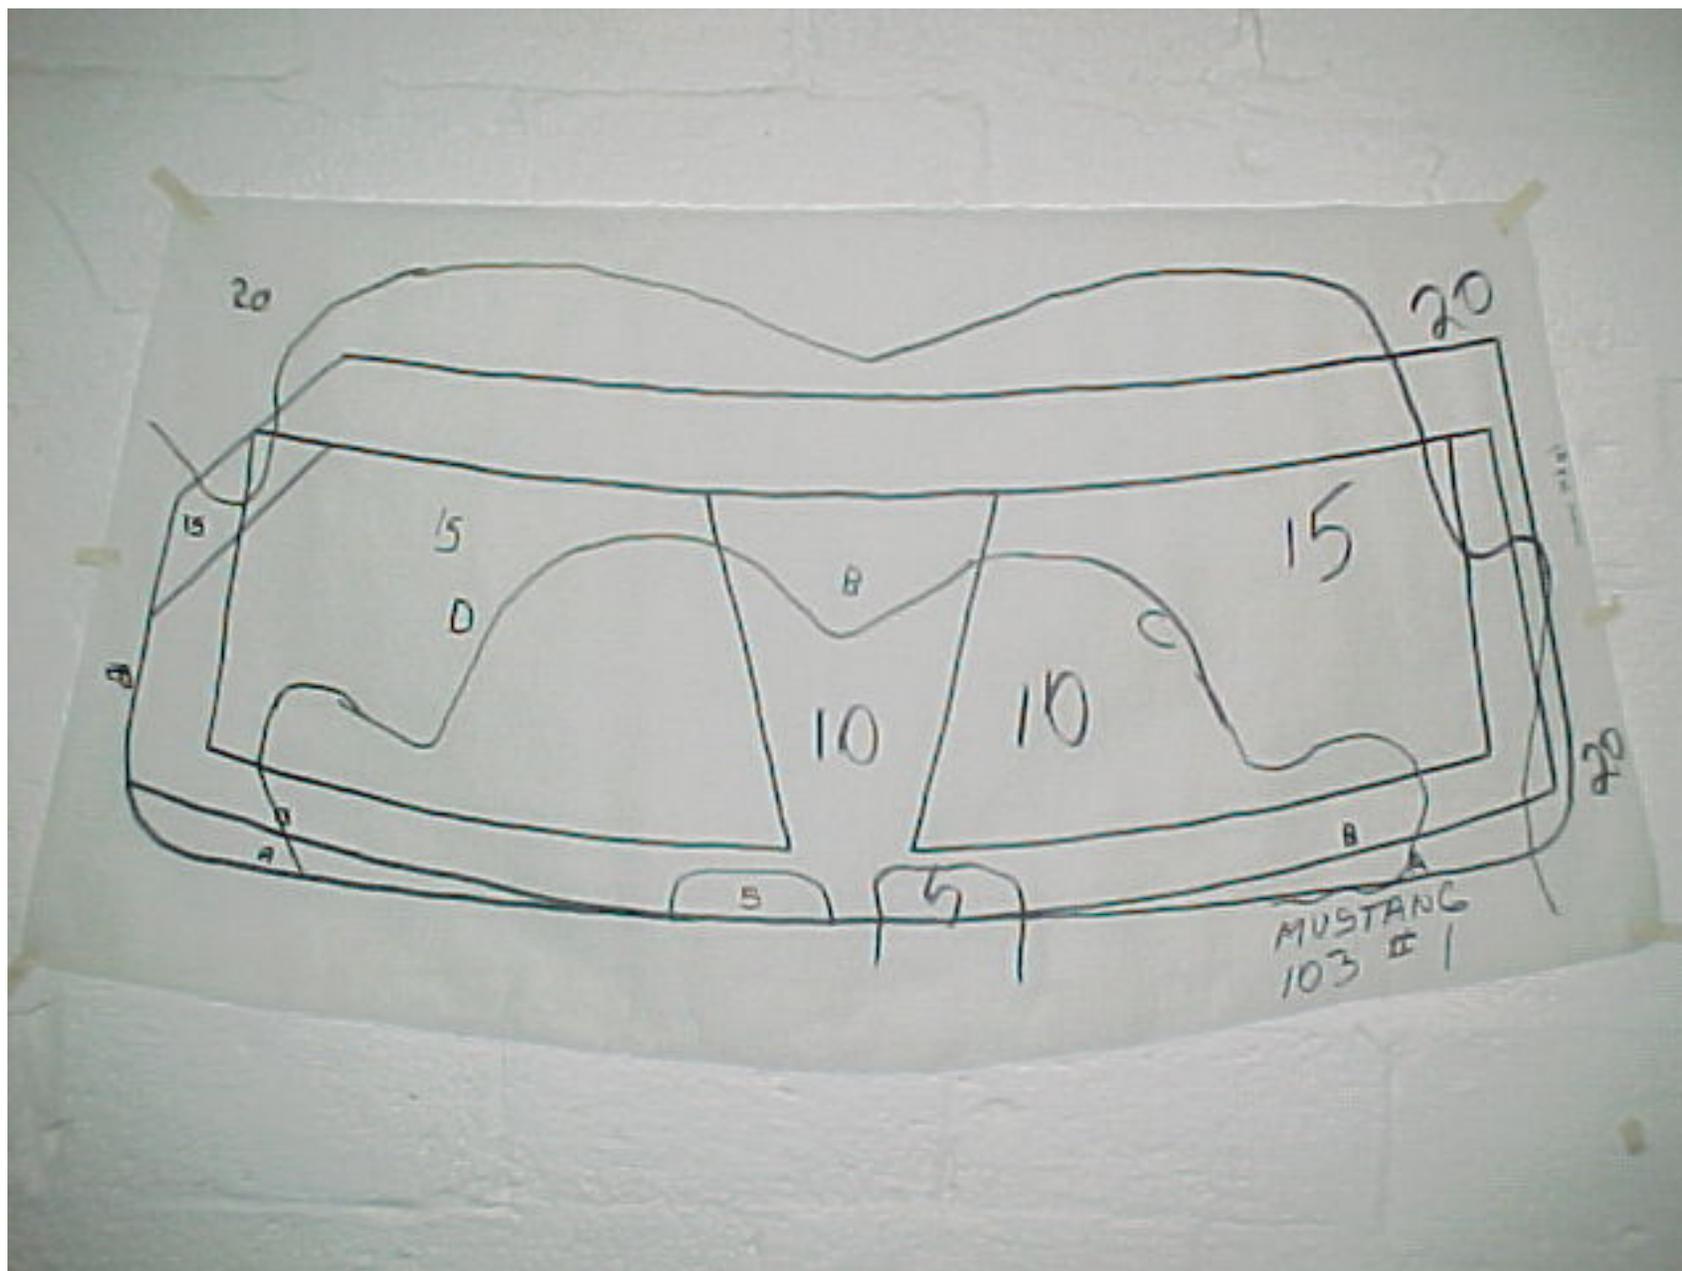
FIGURE 5.11
 WINDSHIELD VELLUM PATTERN, TEST #1

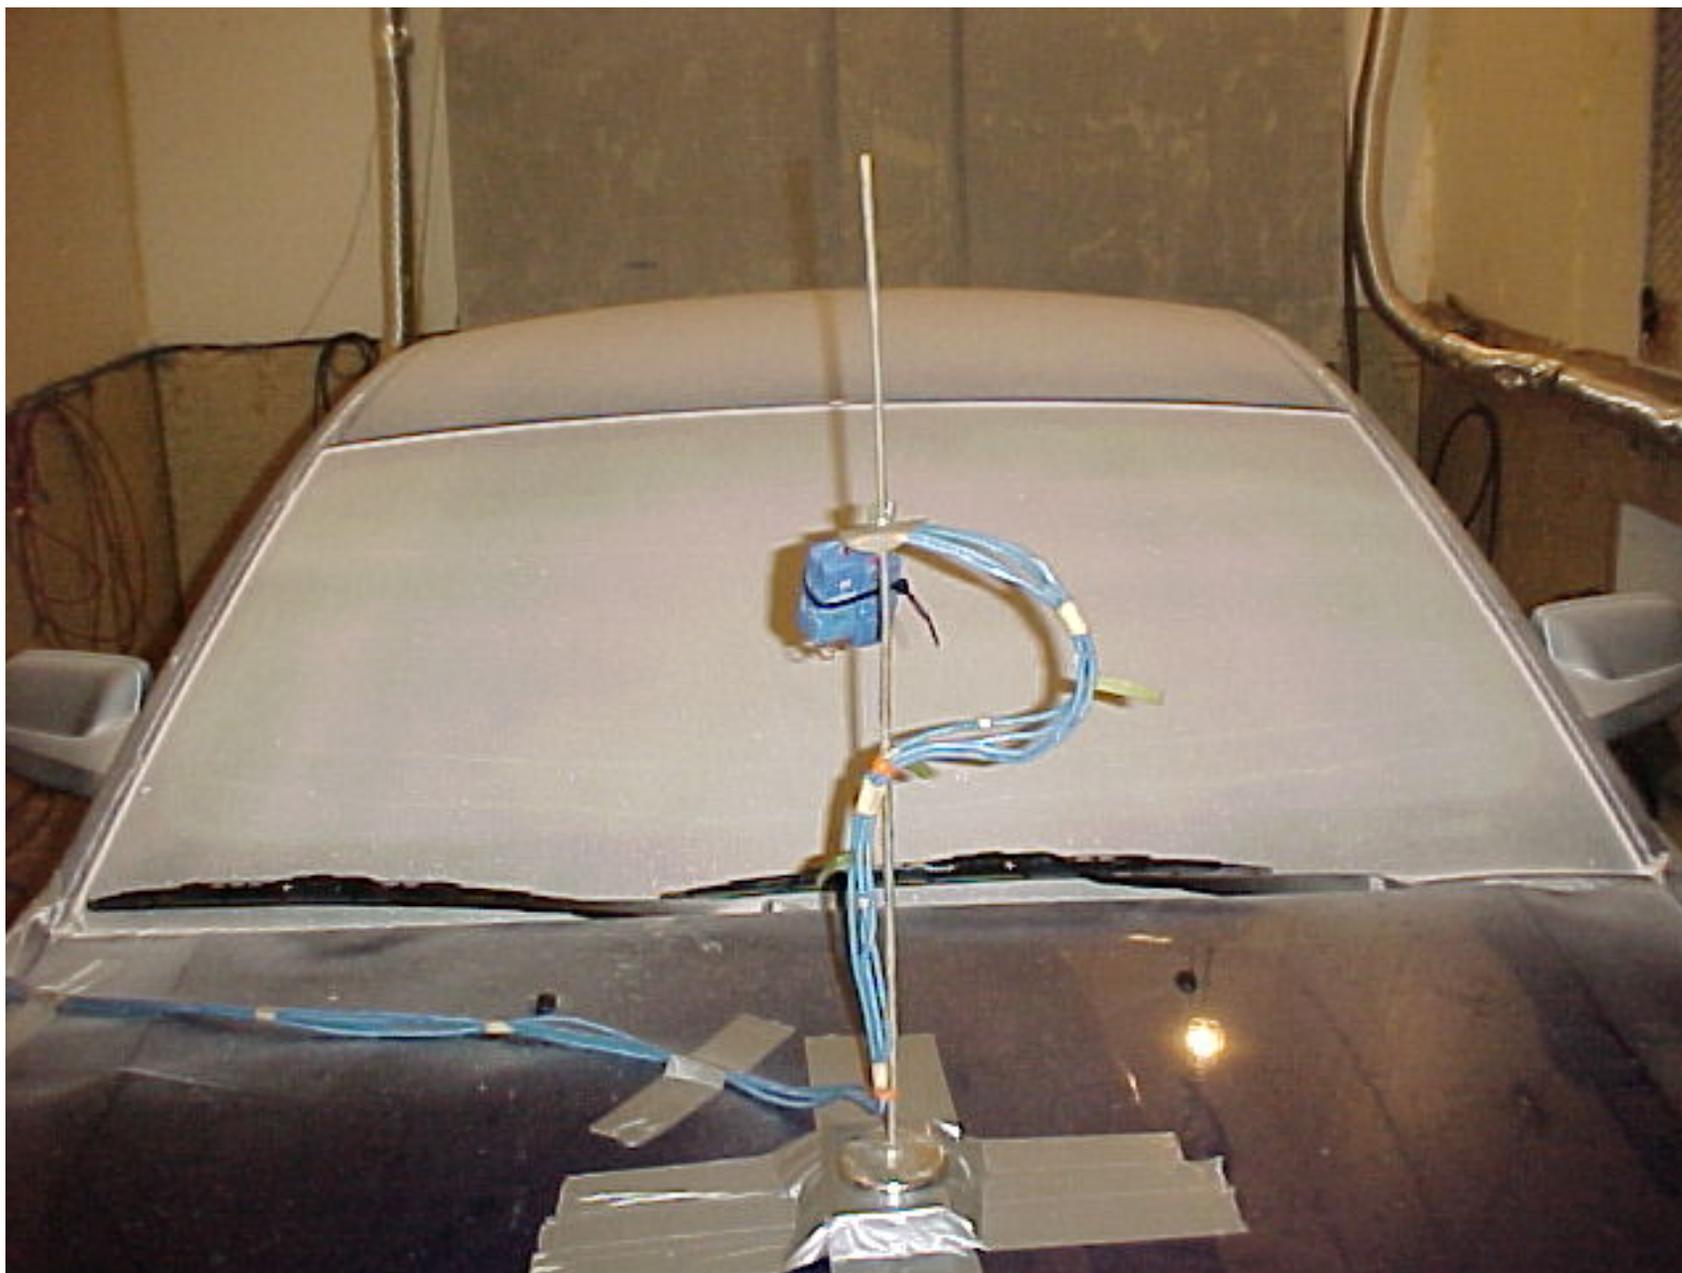
FIGURE 5.12
WINDSHIELD PRE-TEST FROSTED STATE
TEST #2

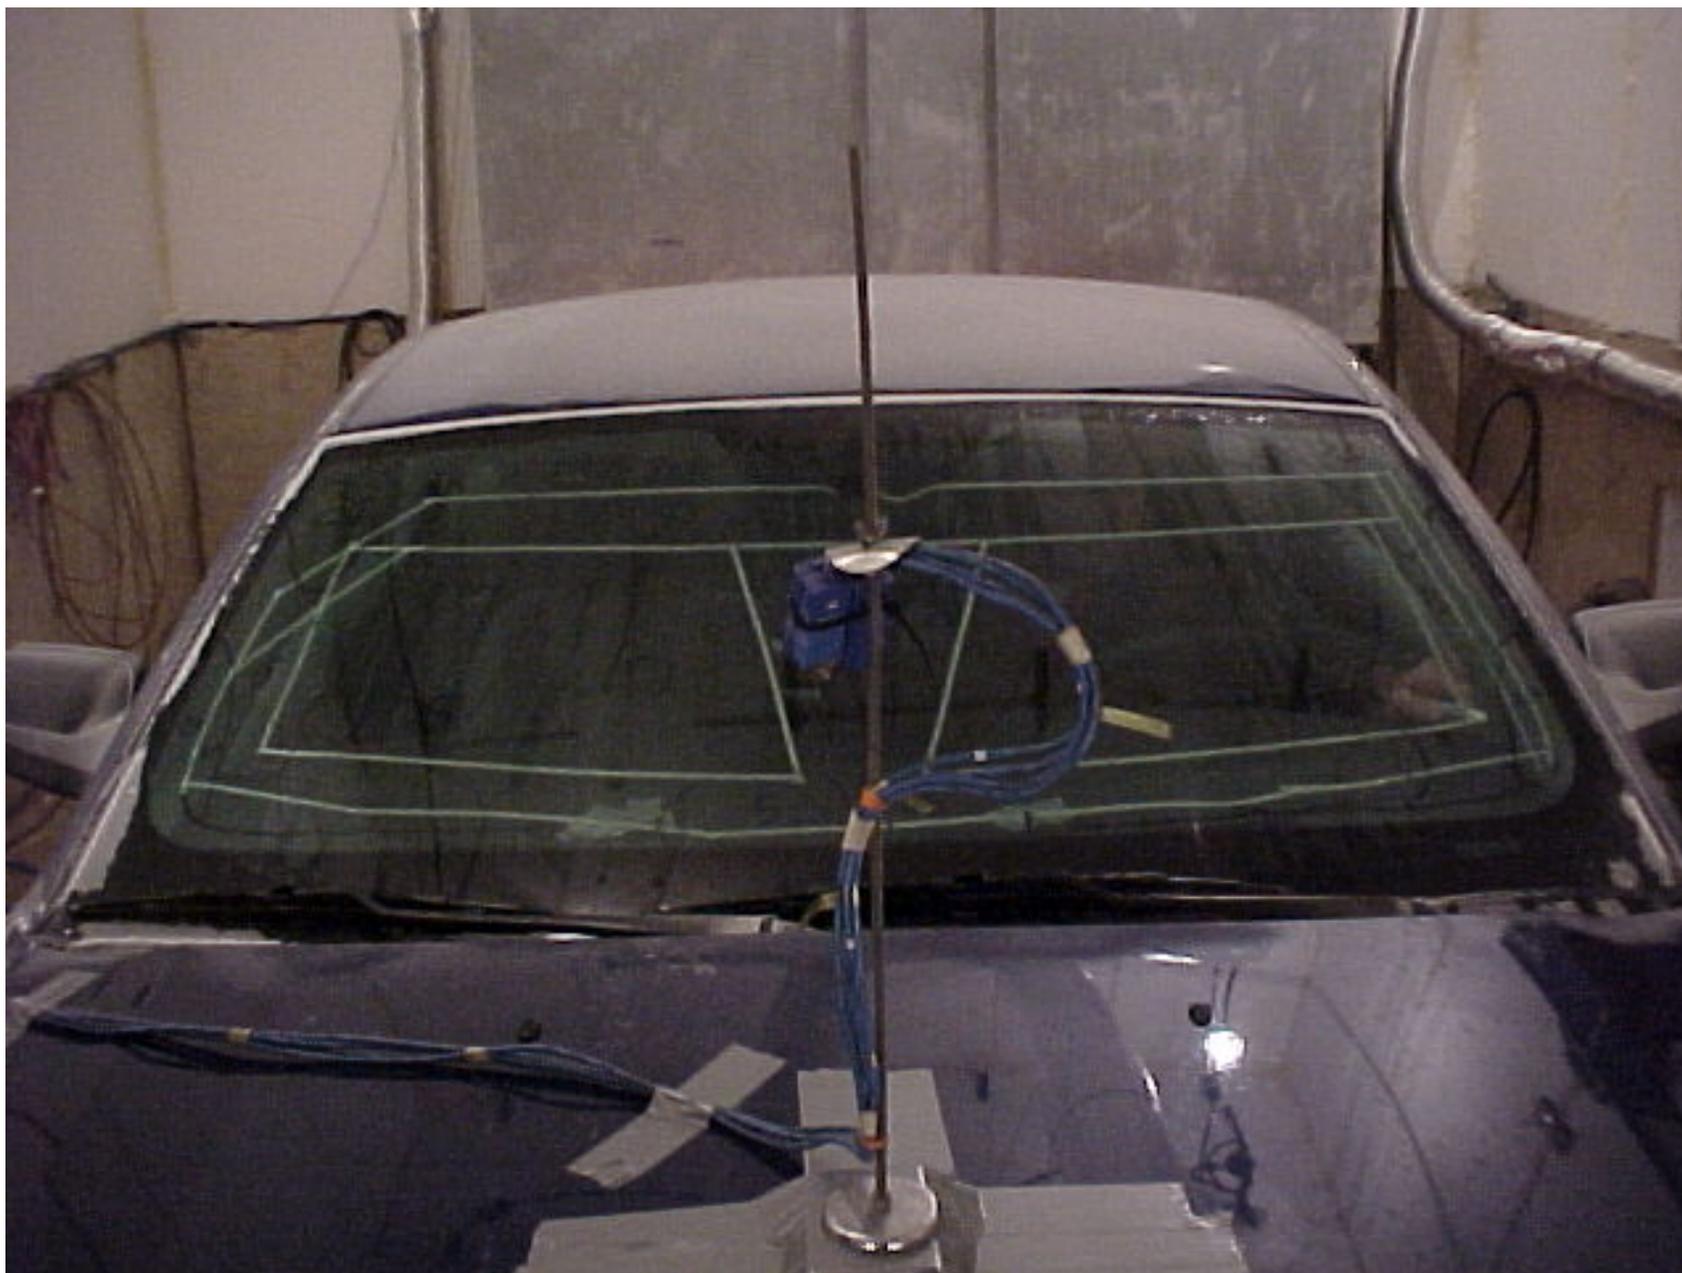
FIGURE 5.13
DEFROSTED AREA AT 20 MINUTES TEST #2

TIME FROM START (minutes)	MOTOR VOLTAGE (volts)	TEMPERATURE, °F					DEFROSTED AREA, %		
		TEST ROOM	ENGINE WATER	HEATER WATER IN	DEFROSTER AIR		A	C	D
					DRVR	PSGR			
0	13.4	-4.0	-4.0	-4.0	-4.0	-4.0	0%	0%	0%
5	14.9	-4.0	-3.6	94.2	63.2	63.2	2.8%	0%	0%
10	14.9	-3.0	-0.7	131.8	95.9	98.7	48.5%	50.1%	58.6%
15	14.9	-1.9	2.2	156.1	118.7	122.1	96.7%	100%	100%
20	14.9	0	3.5	171.4	134.0	137.9	100%	100%	100%

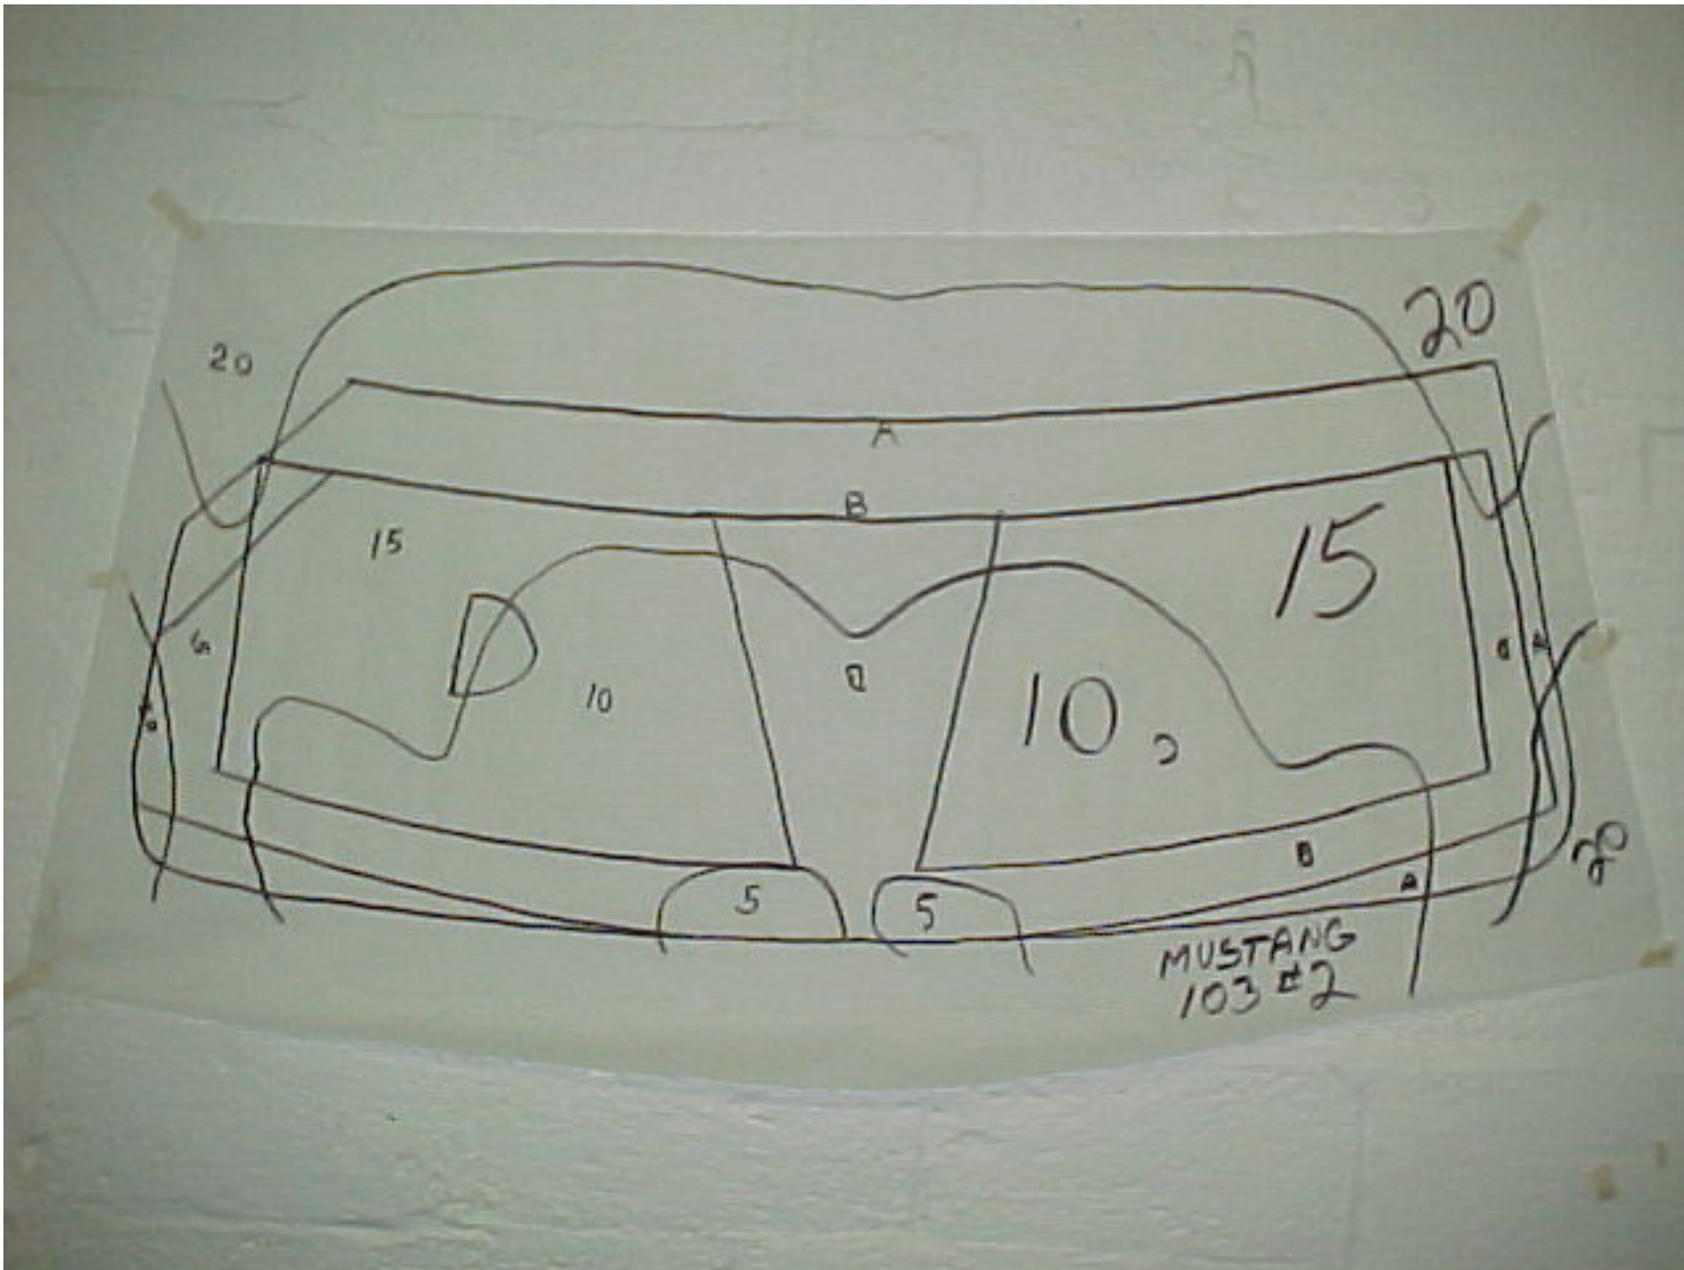
FIGURE 5.14
WINDSHIELD VELLUM PATTERN, POST TEST #2

After the traces were obtained, the windshield was again thoroughly cleaned and the vehicle engine coolant and lubricant stabilization period at $0^{\circ} \pm 5^{\circ}$ F temperature commenced for a repeat of the procedure discussed. The windshield patterns for both tests were used subsequently to determine the cleared area percentages.

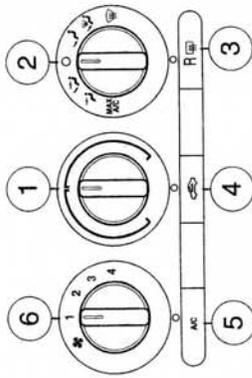
- Temperature selection:** Controls the temperature of the airflow in the vehicle.
- Mode selections:** Controls the location of the airflow in the vehicle. See the following for a brief description of each selection.

: Distributes air through the windshield defroster vents. Can be used to clear the windshield of fog and thin ice.
