REPORT NUMBER: 201U-CAL-06-02

**SAFETY COMPLIANCE TESTING FOR FMVSS 201  
OCCUPANT PROTECTION IN INTERIOR IMPACT  
UPPER INTERIOR HEAD IMPACT PROTECTION**

**GENERAL MOTORS OF CANADA LTD.  
2005 BUICK LACROSSE CX**

NHTSA NUMBER: C50115

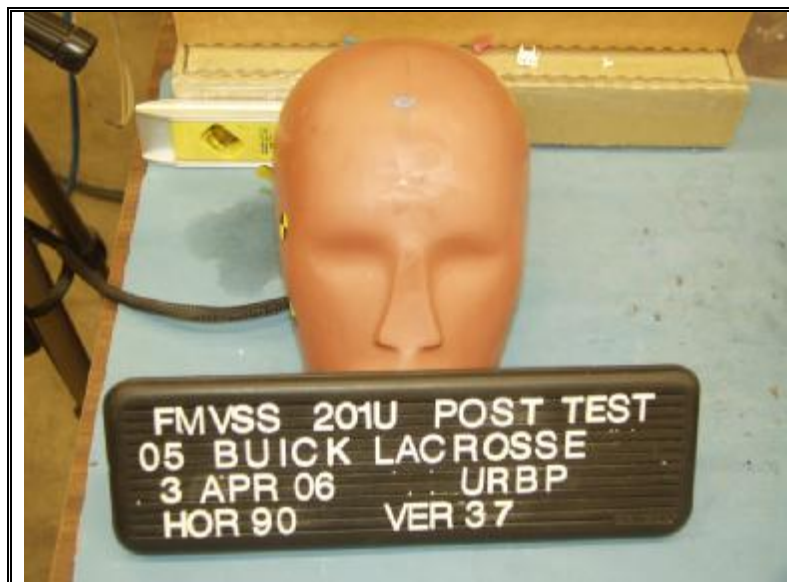
POST-IMPACT URBP PASSENGER HEADFORM

Free Motion HIC	792.2
HIC(d)	764.1
Impact Velocity (kph)	23.44
HIC T1 (msec)	4.1
HIC T2 (msec)	10.2

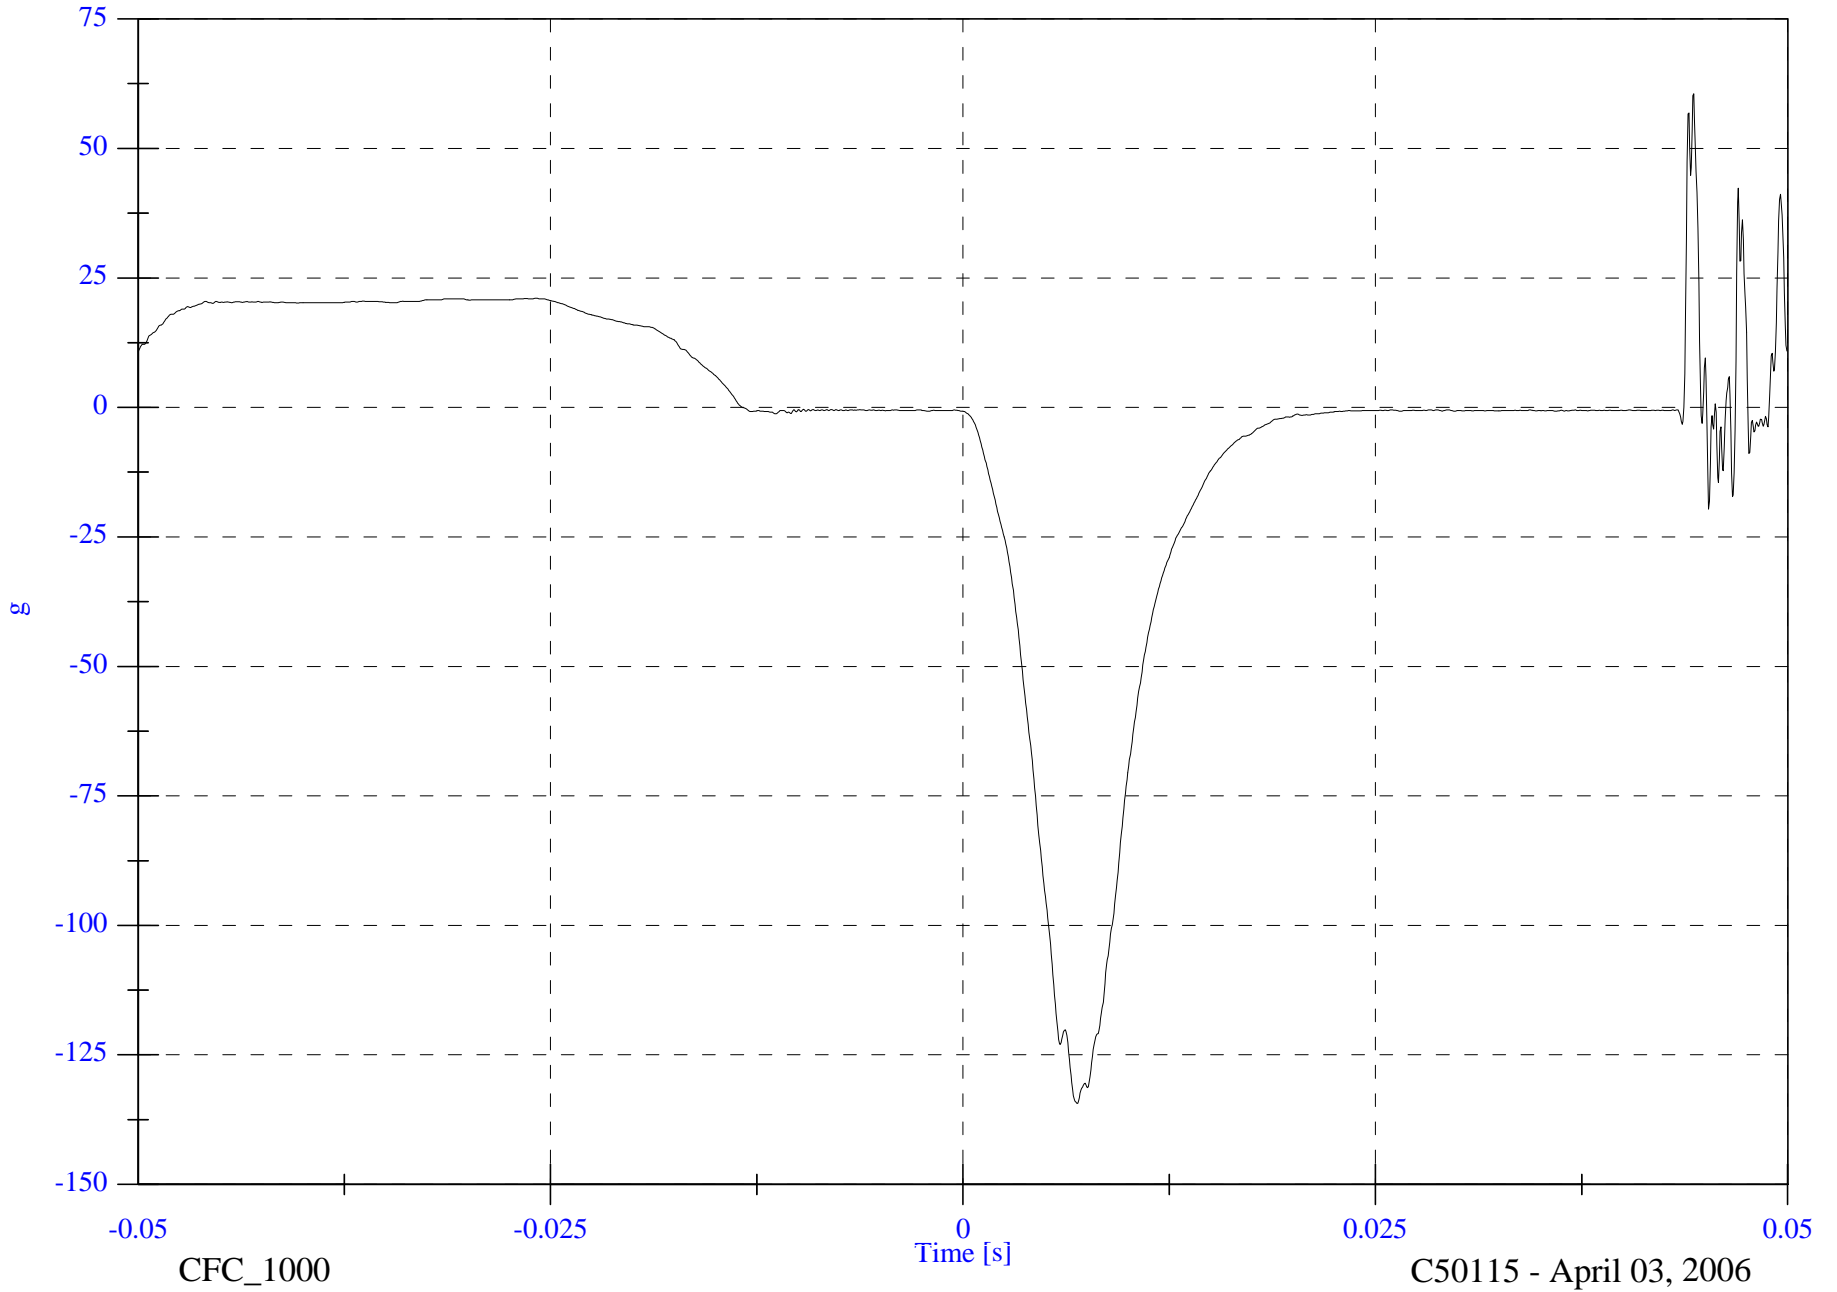
C50115 PASSENGER SIDE URBP IMPACT PLOT #1

FMVSS 201U IMPACT TEST - 2005 Buick LaCrosse

Headform X Acceleration

Max: 60.6 [g] at 0.044 [s]

Min: -134.4 [g] at 0.007 [s]

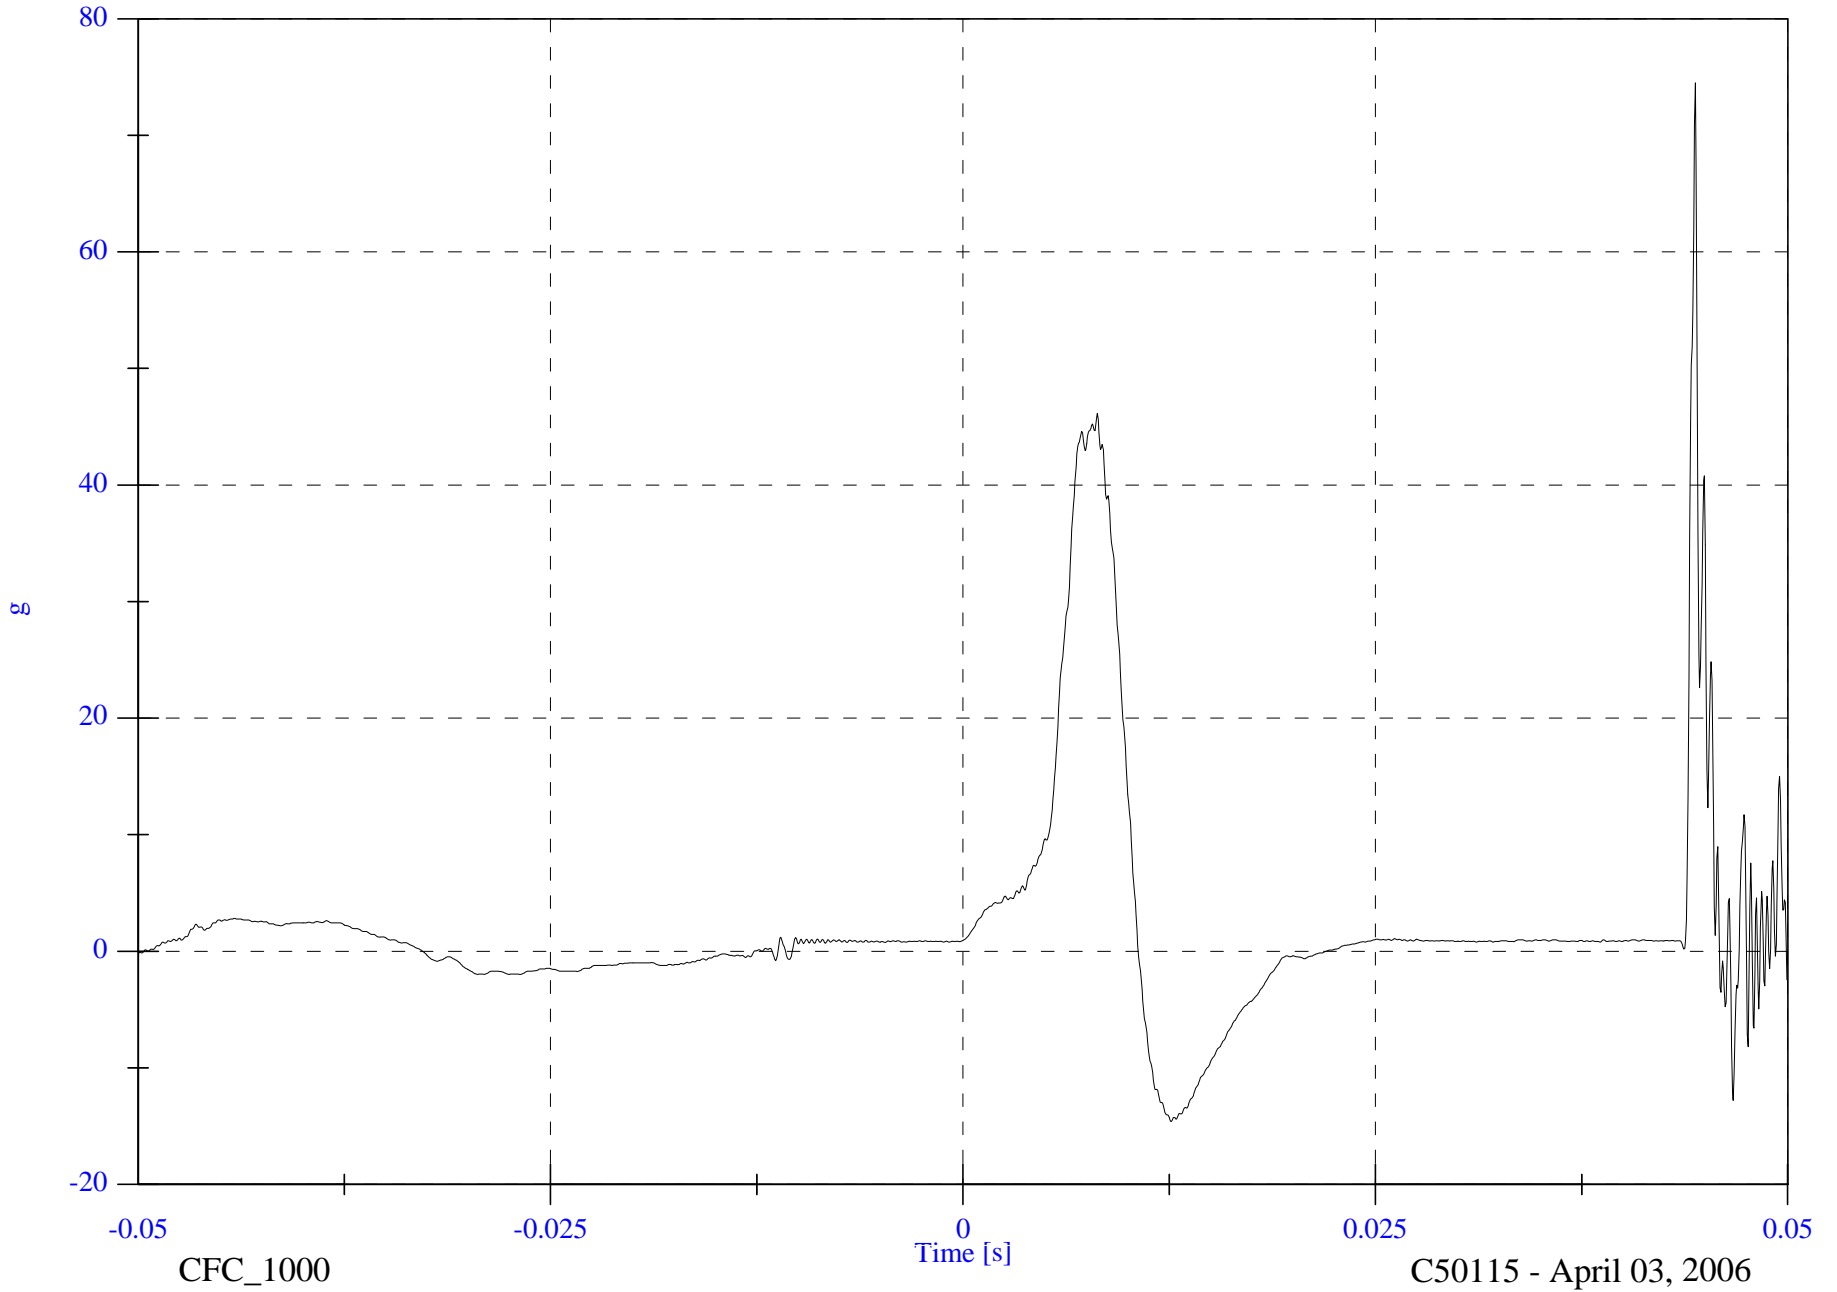
C50115 PASSENGER SIDE URBP IMPACT PLOT #3

FMVSS 201U IMPACT TEST - 2005 Buick LaCrosse

Headform Z Acceleration

Max: 74.5 [g] at 0.044 [s]

Min: -14.6 [g] at 0.013 [s]

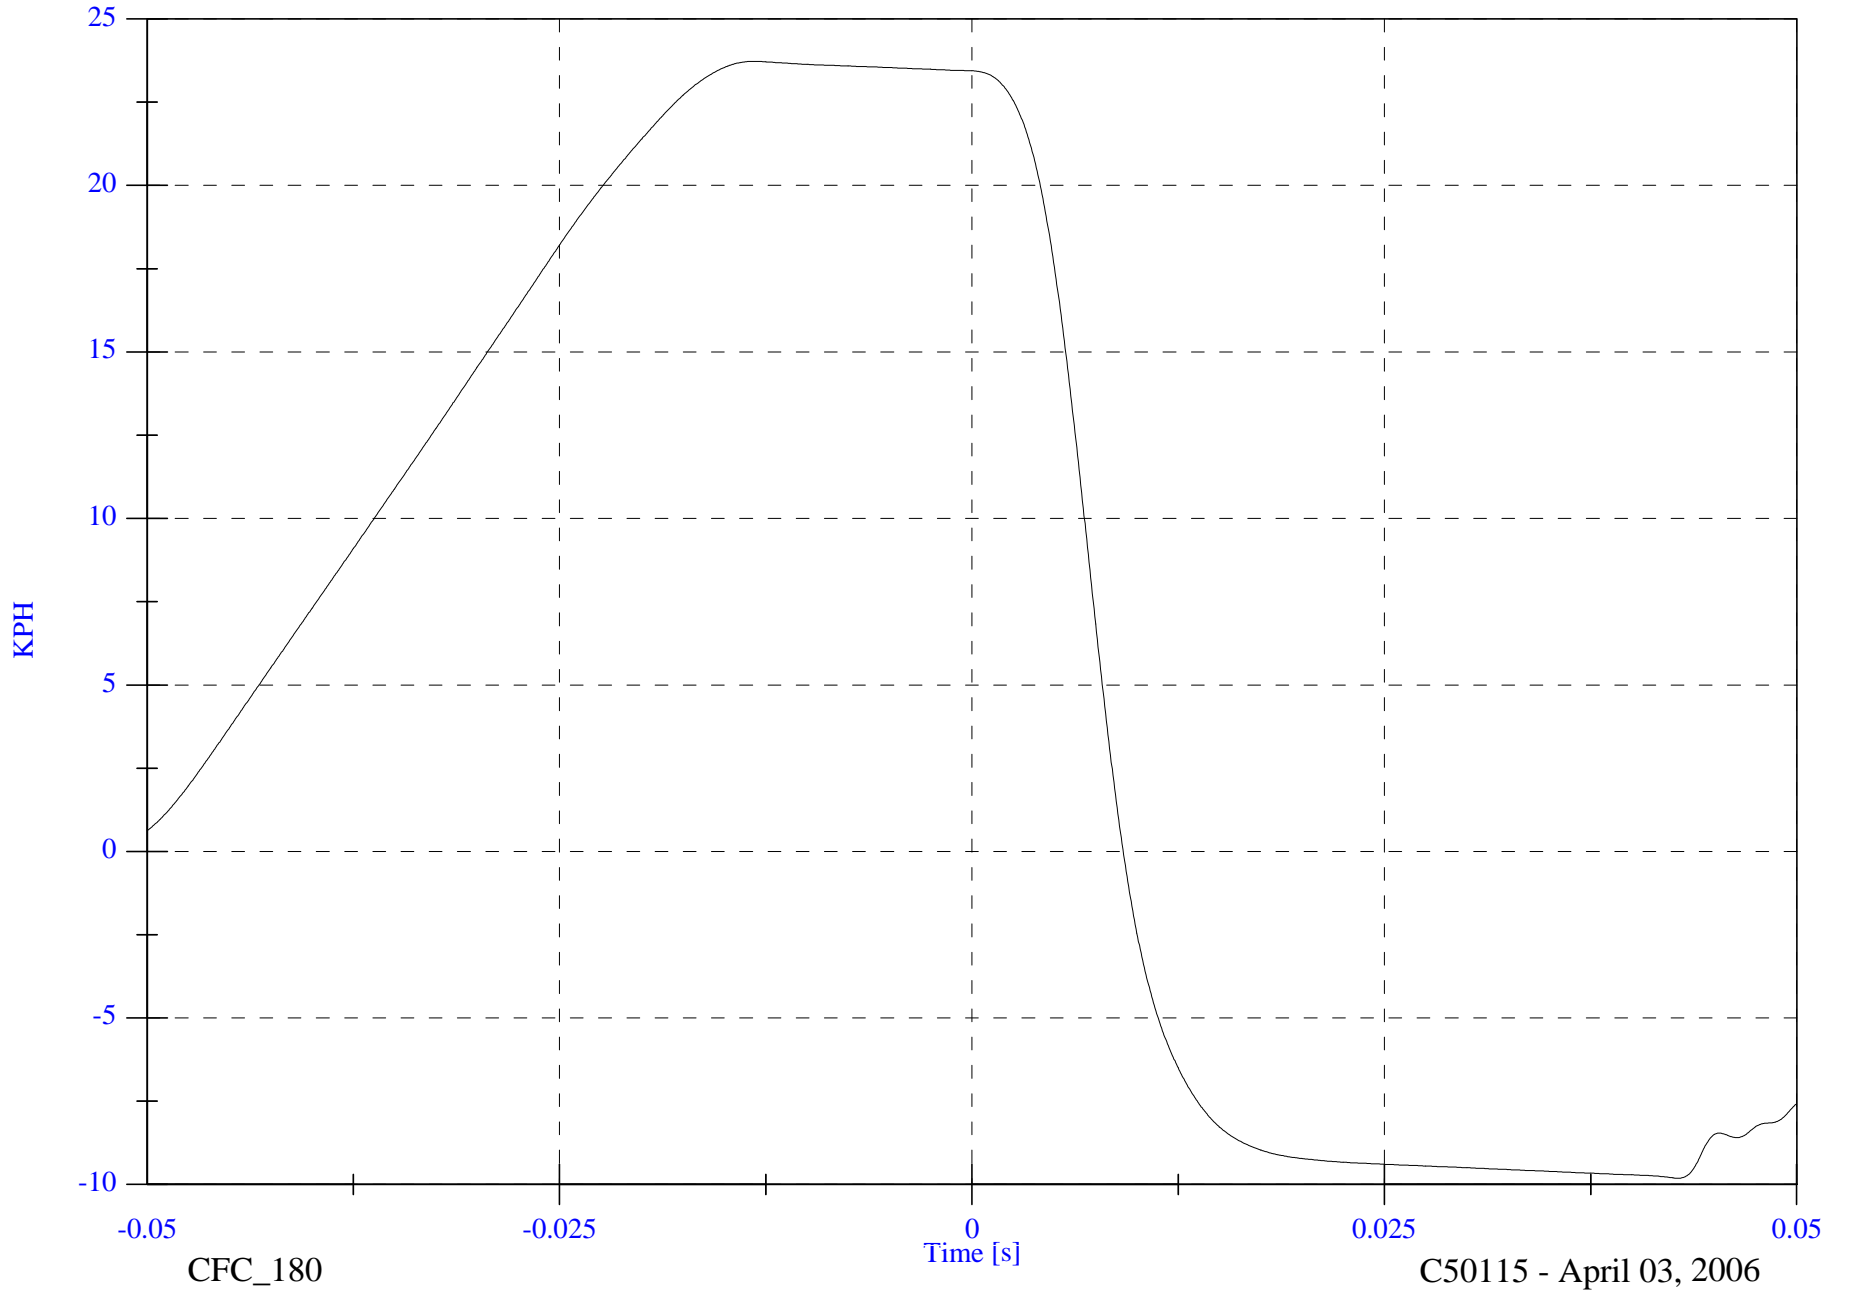
C50115 PASSENGER SIDE URBP IMPACT PLOT #5

FMVSS 201U IMPACT TEST - 2005 Buick LaCrosse

Headform Velocity

Max: 23.7 [KPH] at -0.013 [s]

Min: -9.8 [KPH] at 0.043 [s]

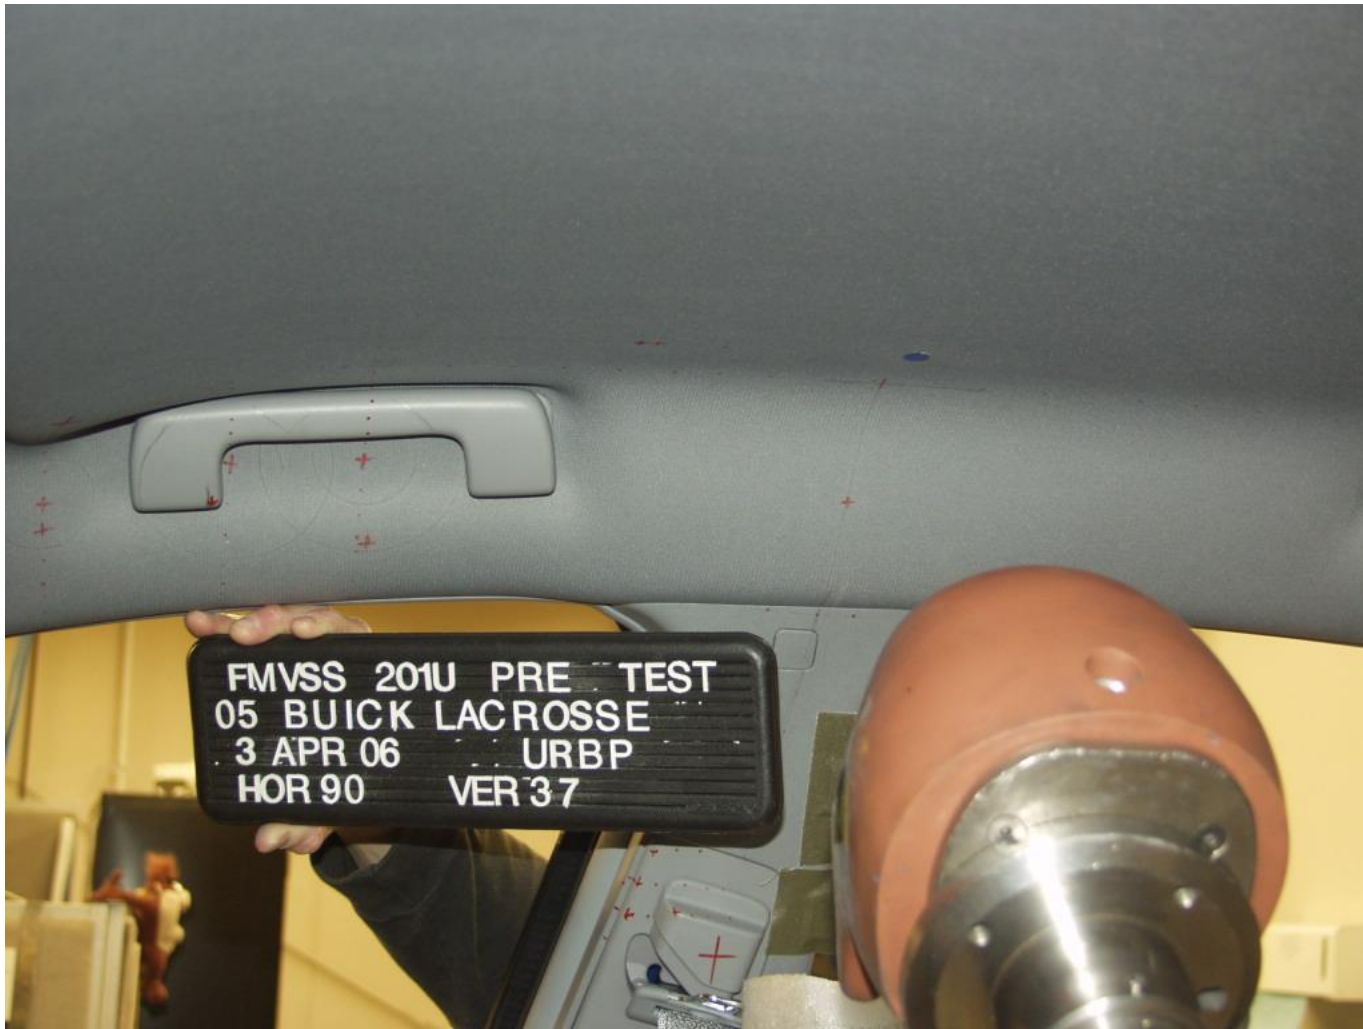
PRE-IMPACT URBP PASSENGER

Test Number:	01
Test Date:	04/03/06
Target Location:	UPPER ROOF
Target Code:	URBP PASSENGER
Horizontal Impact Angle:	90 °
Vertical Impact Angle:	37 °
Ambient Temperature:	22.0 C°
Relative Humidity:	41.9
Time of Impact:	10:38
Headform Number:	355

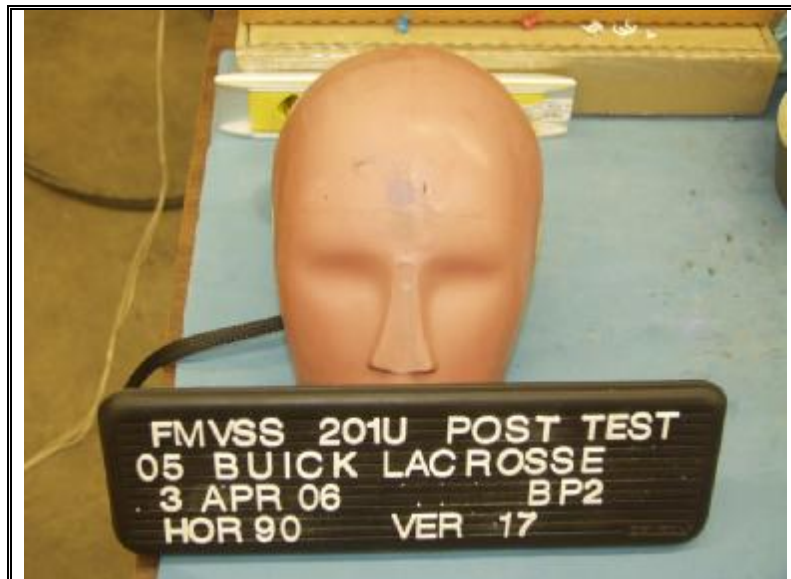
POST-IMPACT BP2 HEADFORM

Free Motion HIC	<b>939.7</b>
HIC(d)	<b>875.3</b>
Impact Velocity (kph)	<b>23.45</b>
HIC T1 (msec)	<b>2.1</b>
HIC T2 (msec)	<b>7.8</b>

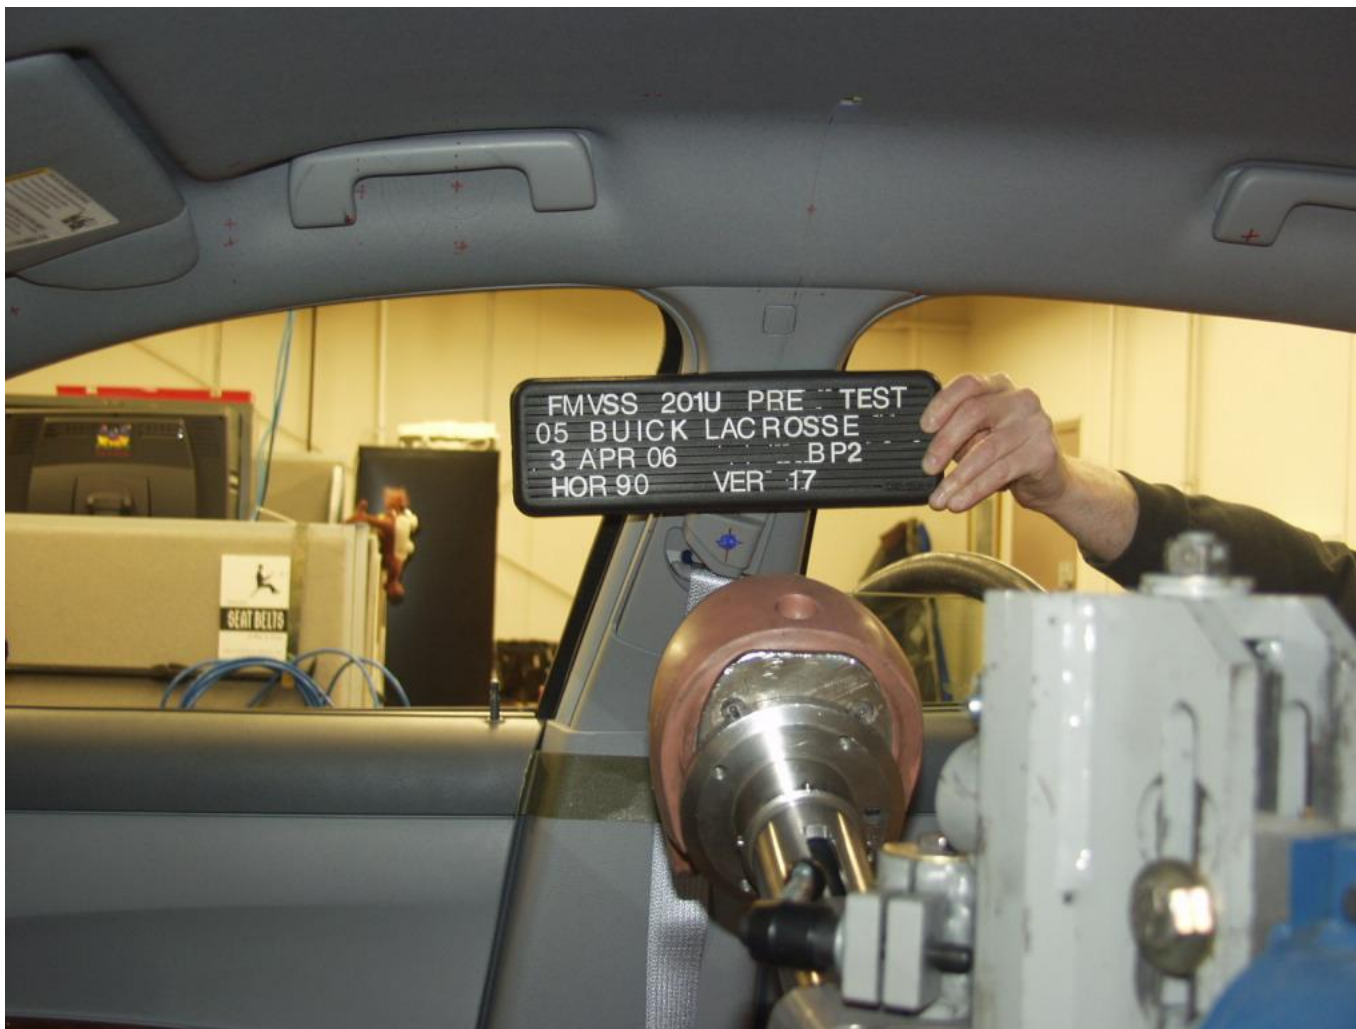
PRE-IMPACT BP2

Test Number:	02
Test Date:	<b>04/03/06</b>
Target Location:	B-PILLAR
Target Code:	BP2
Horizontal Impact Angle:	<b>90 °</b>
Vertical Impact Angle:	<b>17 °</b>
Ambient Temperature:	<b>23.1 C°</b>
Relative Humidity:	<b>38</b>
Time of Impact:	<b>11:35</b>
Headform Number:	<b>805</b>

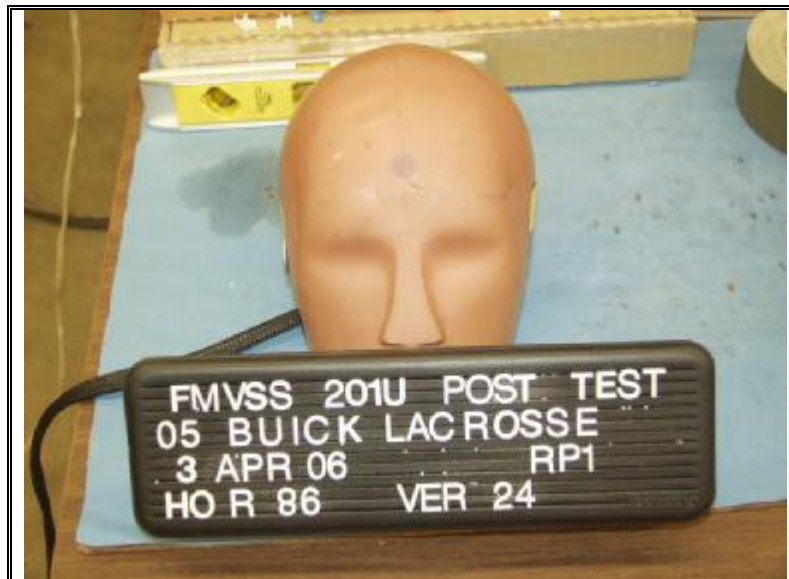
POST-IMPACT RP1 HEADFORM

Free Motion HIC	<b>635.8</b>
HIC(d)	<b>646.1</b>
Impact Velocity (kph)	<b>23.79</b>
HIC T1 (msec)	<b>2.6</b>
HIC T2 (msec)	<b>11.8</b>

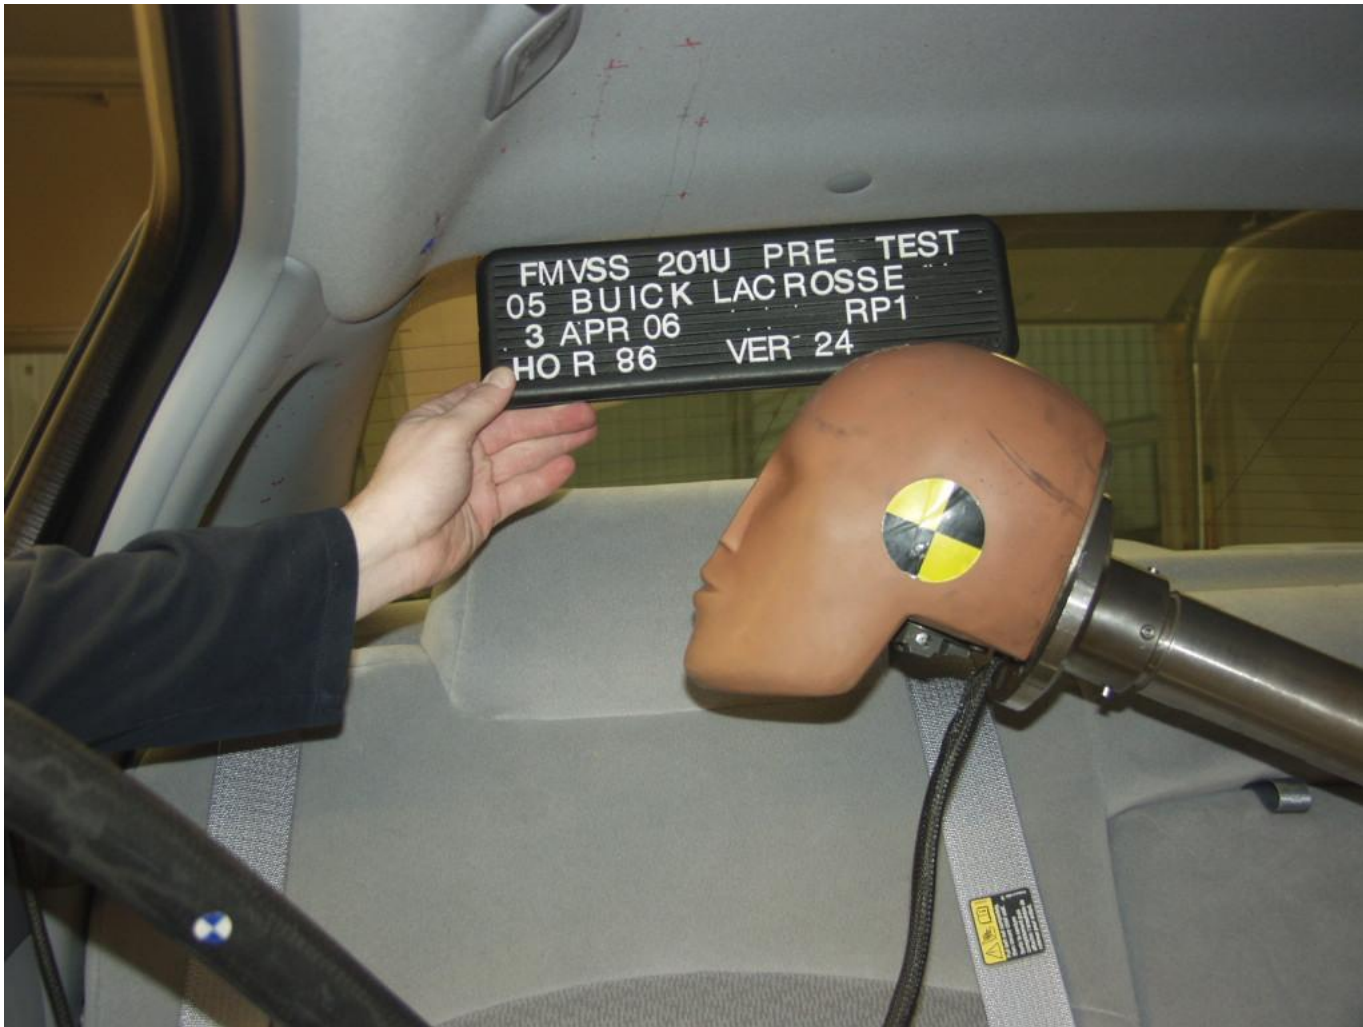
PRE-IMPACT RP1

Test Number:	03
Test Date:	<b>04/03/06</b>
Target Location:	REAR PILLAR
Target Code:	RP1
Horizontal Impact Angle:	<b>86 °</b>
Vertical Impact Angle:	<b>24 °</b>
Ambient Temperature:	<b>22.5 C°</b>
Relative Humidity:	<b>38.9</b>
Time of Impact:	<b>12:30</b>
Headform Number:	<b>642</b>

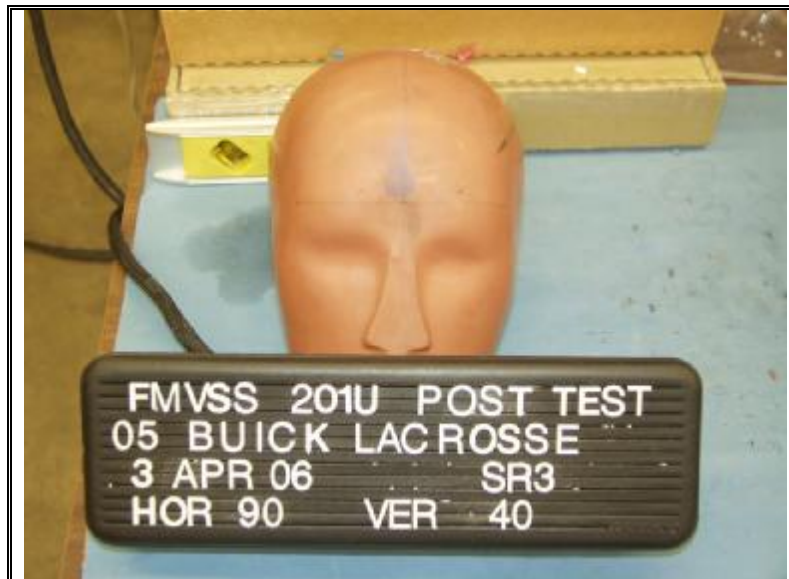
POST-IMPACT SR3R HEADFORM

Free Motion HIC	<b>887.7</b>
HIC(d)	<b>956.1</b>
Impact Velocity (kph)	<b>23.44</b>
HIC T1 (msec)	<b>3.5</b>
HIC T2 (msec)	<b>9.2</b>

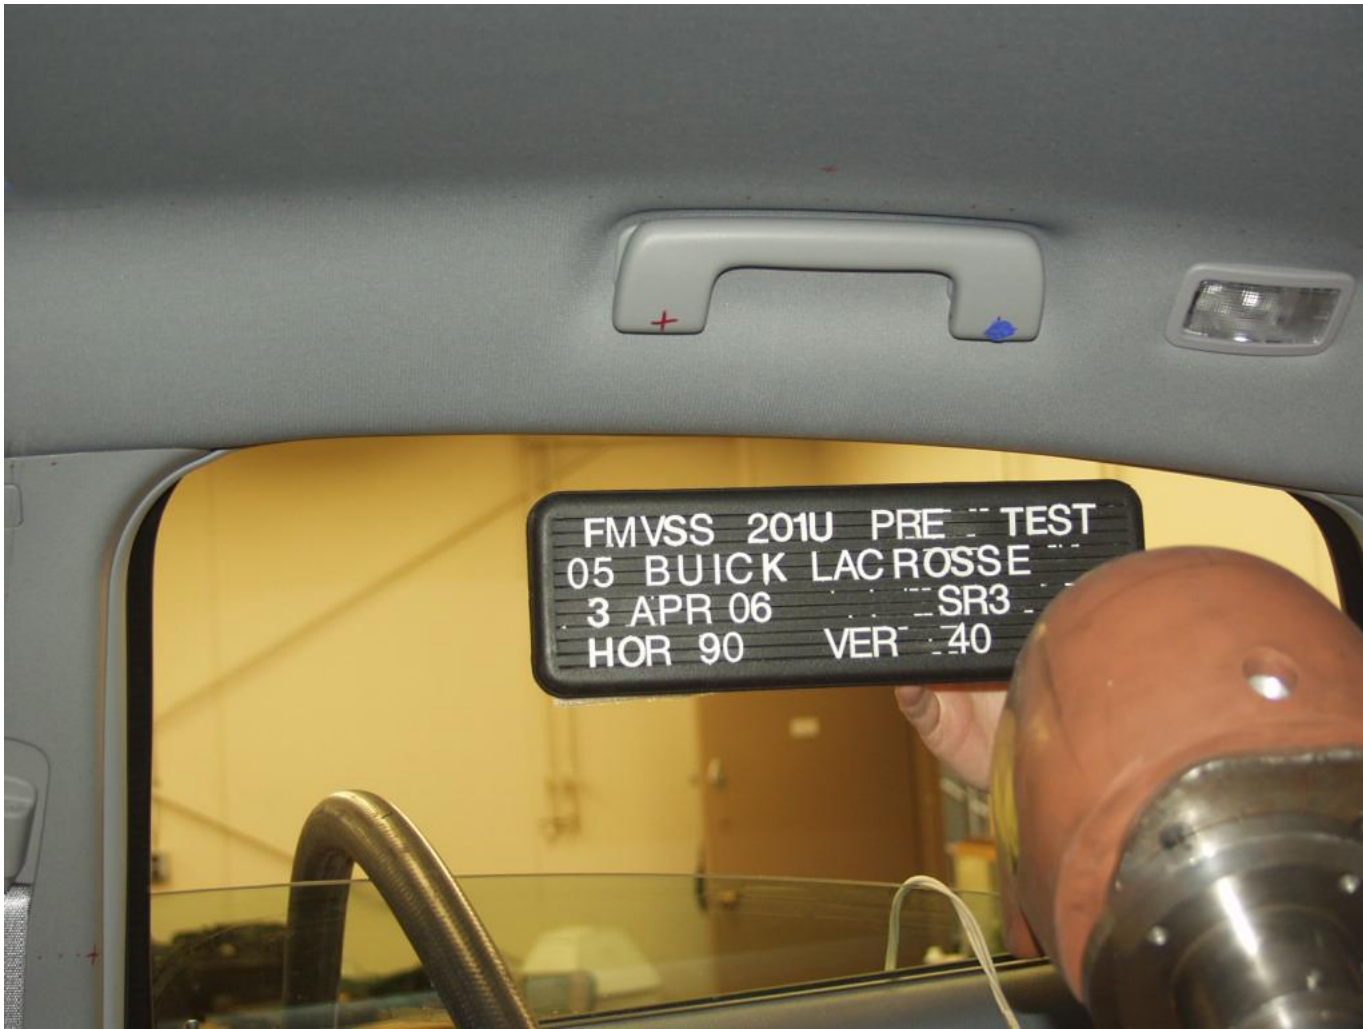
PRE-IMPACT SR3R

Test Number:	04
Test Date:	<b>04/03/06</b>
Target Location:	SIDE RAIL
Target Code:	SR3R
Horizontal Impact Angle:	<b>90 °</b>
Vertical Impact Angle:	<b>40 °</b>
Ambient Temperature:	<b>22.8 C°</b>
Relative Humidity:	<b>37.5</b>
Time of Impact:	<b>14:15</b>
Headform Number:	<b>62</b>

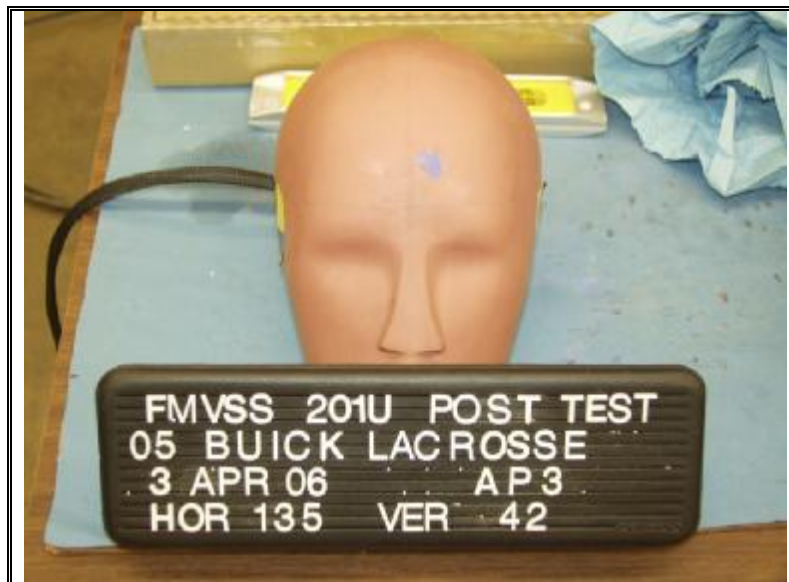
POST-IMPACT AP3 HEADFORM

Free Motion HIC	660.5
HIC(d)	664.7
Impact Velocity (kph)	23.46
HIC T1 (msec)	1.9
HIC T2 (msec)	10.6

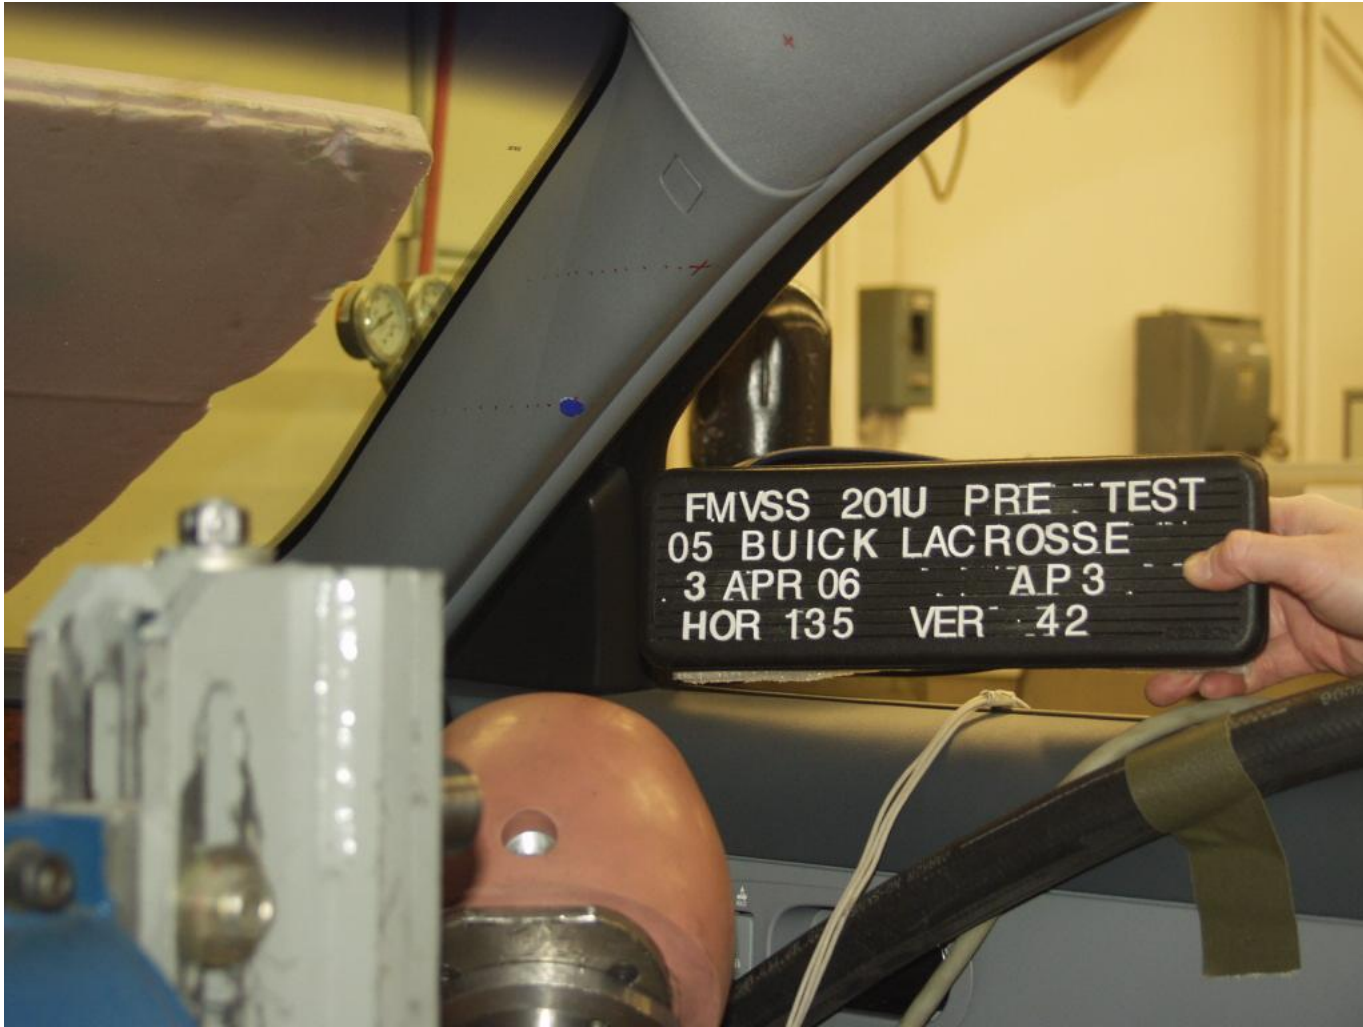
PRE-IMPACT AP3

Test Number:	05
Test Date:	04/03/06
Target Location:	A-PILLAR
Target Code:	AP3
Horizontal Impact Angle:	135 °
Vertical Impact Angle:	42 °
Ambient Temperature:	22.8 C°
Relative Humidity:	39.7
Time of Impact:	15:09
Headform Number:	1255

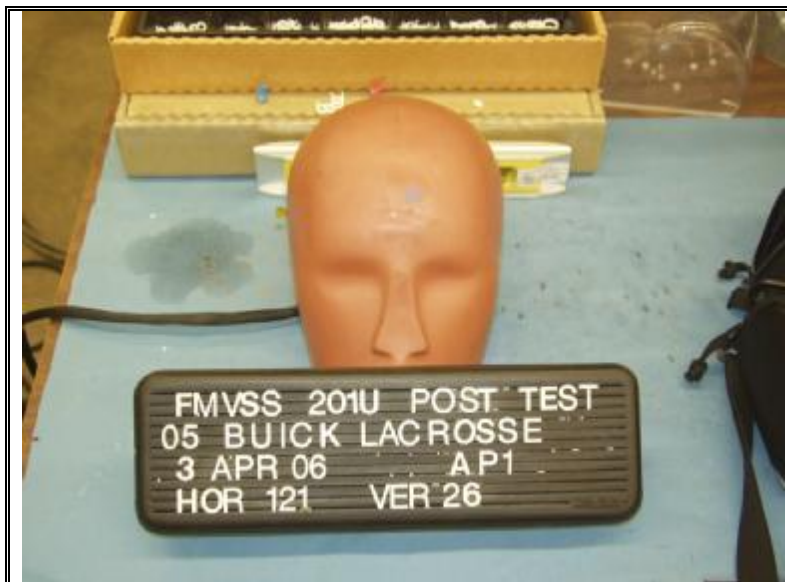
POST-IMPACT AP1 HEADFORM

Free Motion HIC	544.8
HIC(d)	577.5
Impact Velocity (kph)	23.34
HIC T1 (msec)	2.5
HIC T2 (msec)	7.5

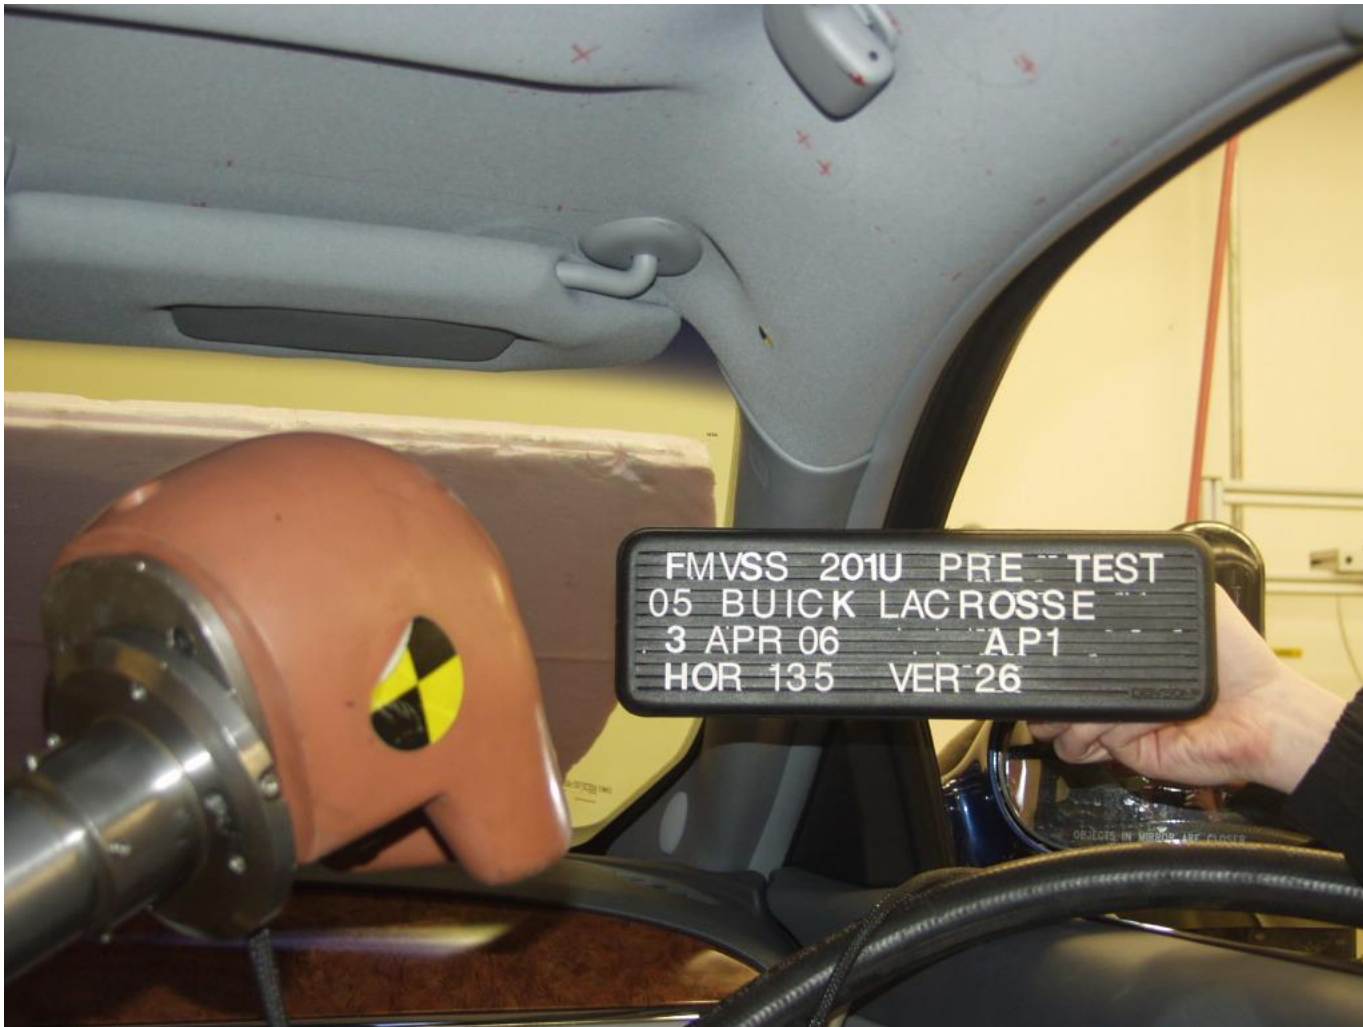
Test Number:	06
Test Date:	04/03/06
Target Location:	A-PILLAR
Target Code:	AP1
Horizontal Impact Angle:	121 °
Vertical Impact Angle:	26 °
Ambient Temperature:	21.8 C°
Relative Humidity:	45.2
Time of Impact:	16:06
Headform Number:	355

PRE-IMPACT AP1 (PLACARD MISLABELED - HOR 121)

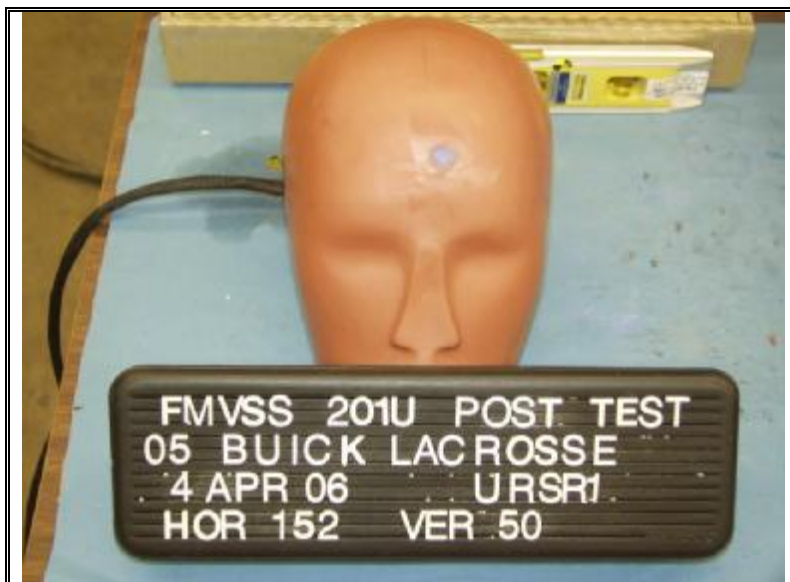
POST-IMPACT URSR1 HEADFORM

Free Motion HIC	323
HIC(d)	410.1
Impact Velocity (kph)	23.59
HIC T1 (msec)	2.4
HIC T2 (msec)	18.2

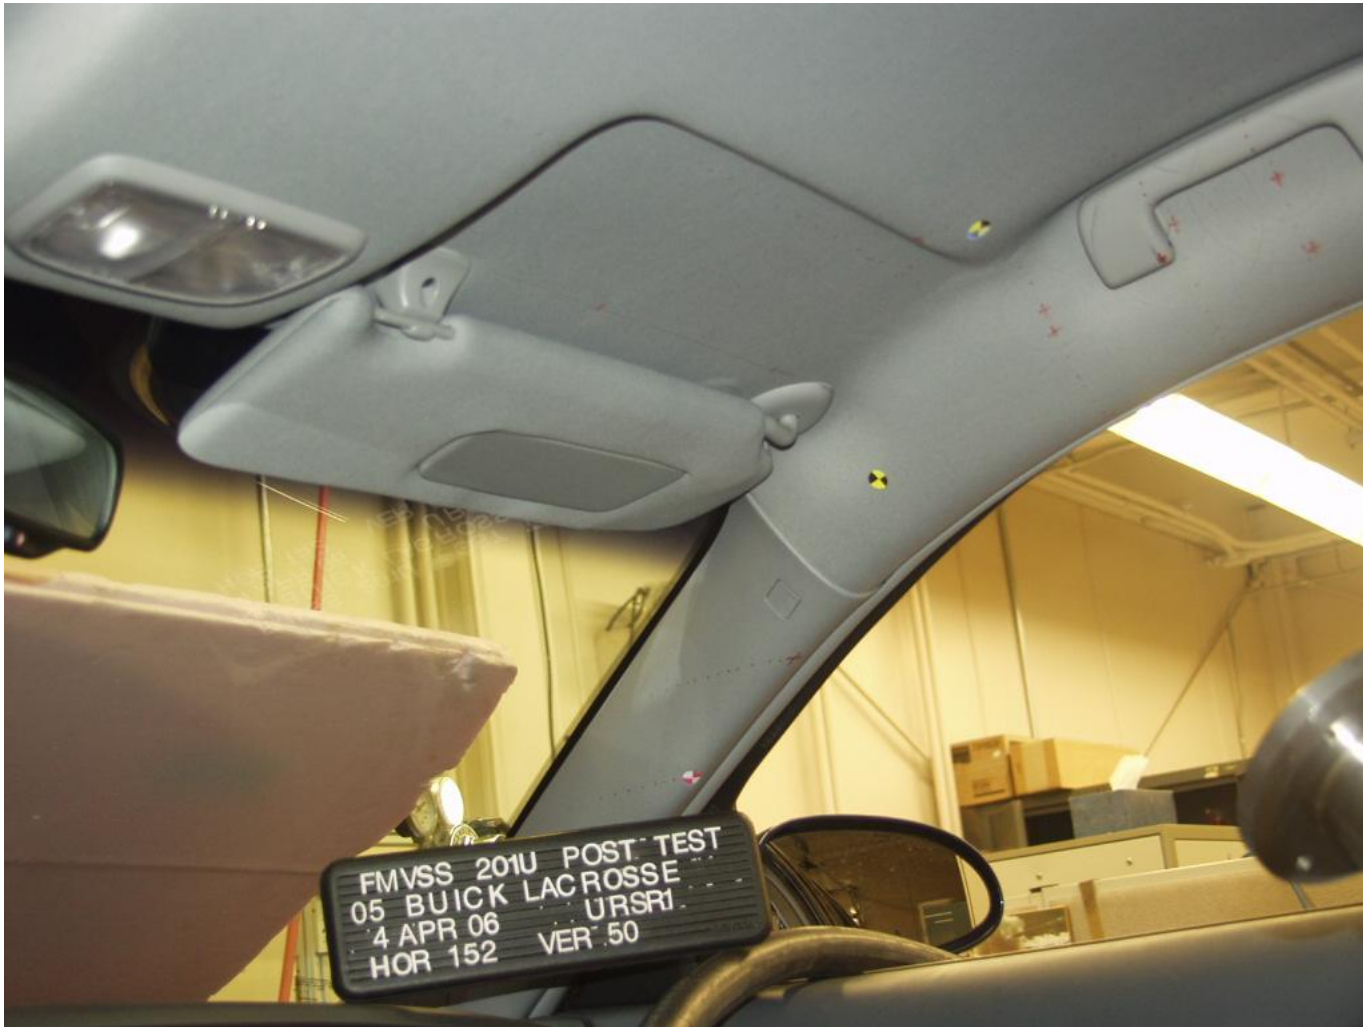
POST-IMPACT URSRI

Test Number:	07
Test Date:	04/04/06
Target Location:	UPPER ROOF
Target Code:	URSR1
Horizontal Impact Angle:	152 °
Vertical Impact Angle:	50 °
Ambient Temperature:	21.1 C°
Relative Humidity:	24.2
Time of Impact:	9:05
Headform Number:	355

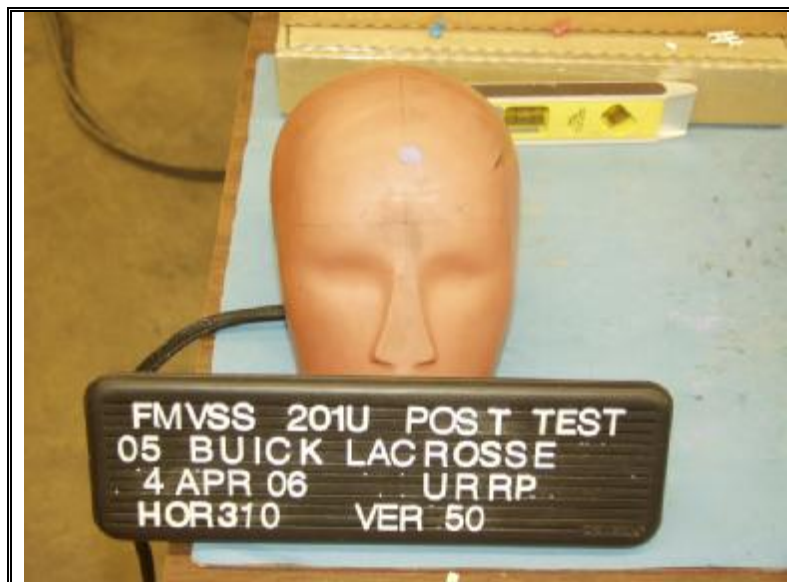
POST-IMPACT URRP HEADFORM

Free Motion HIC	994.4
HIC(d)	916.6
Impact Velocity (kph)	23.71
HIC T1 (msec)	2.5
HIC T2 (msec)	9.3

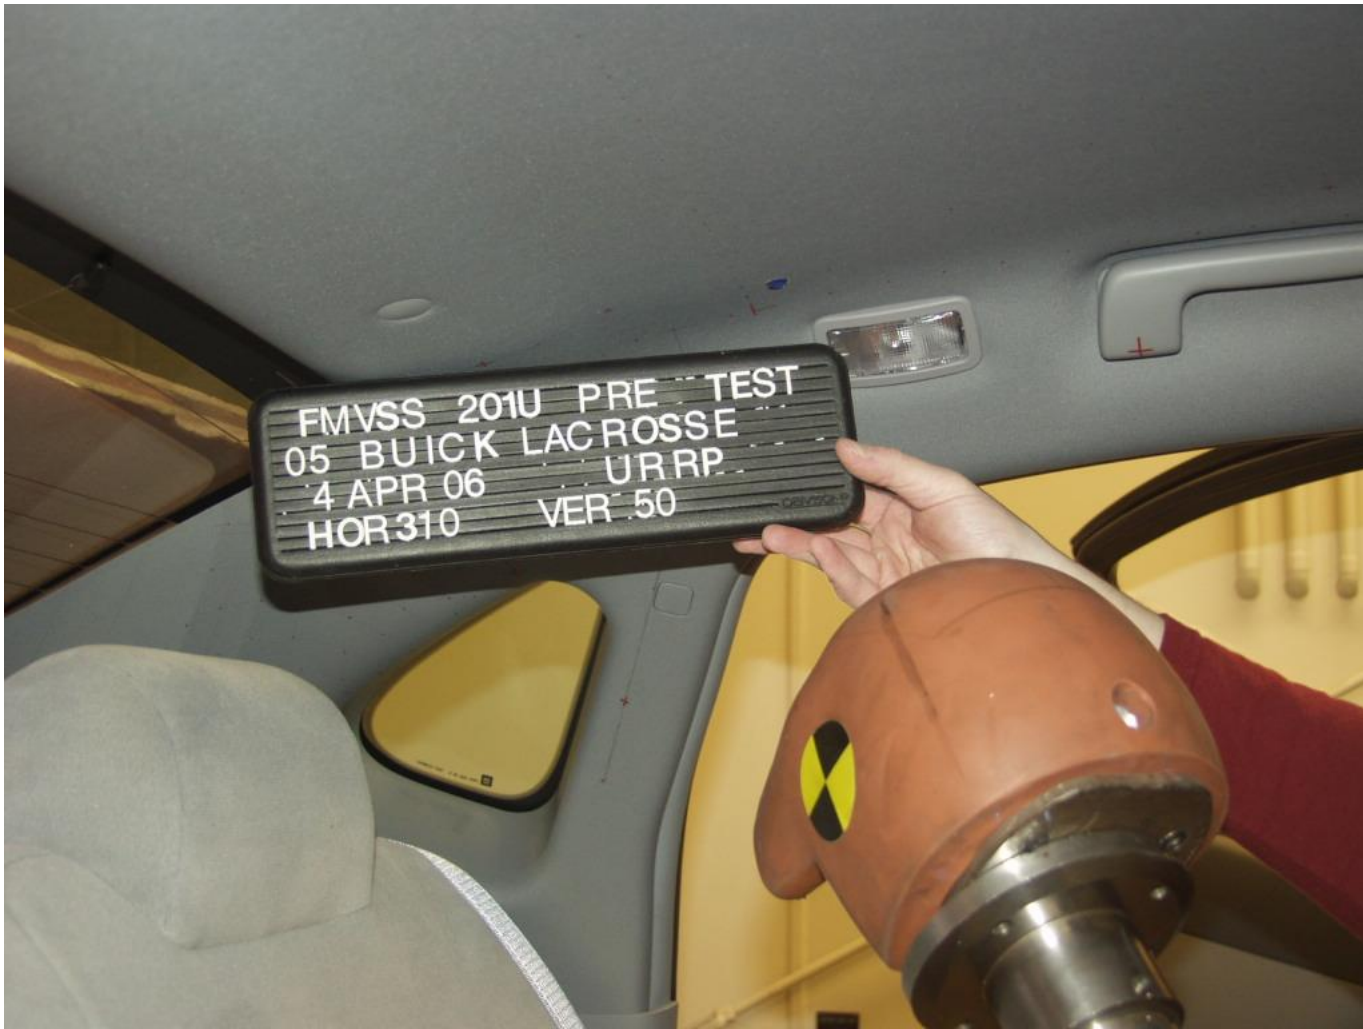
**PRE-IMPACT URRP**

Test Number:	08
Test Date:	04/04/06
Target Location:	UPPER ROOF
Target Code:	URRP
Horizontal Impact Angle:	310 °
Vertical Impact Angle:	50 °
Ambient Temperature:	21.3 C°
Relative Humidity:	24.2
Time of Impact:	10:16
Headform Number:	0062
