REPORT NUMBER: 201U-CAL-06-02

**SAFETY COMPLIANCE TESTING FOR FMVSS 201  
OCCUPANT PROTECTION IN INTERIOR IMPACT  
UPPER INTERIOR HEAD IMPACT PROTECTION**

**GENERAL MOTORS OF CANADA LTD.  
2005 BUICK LACROSSE CX**

NHTSA NUMBER: C50115

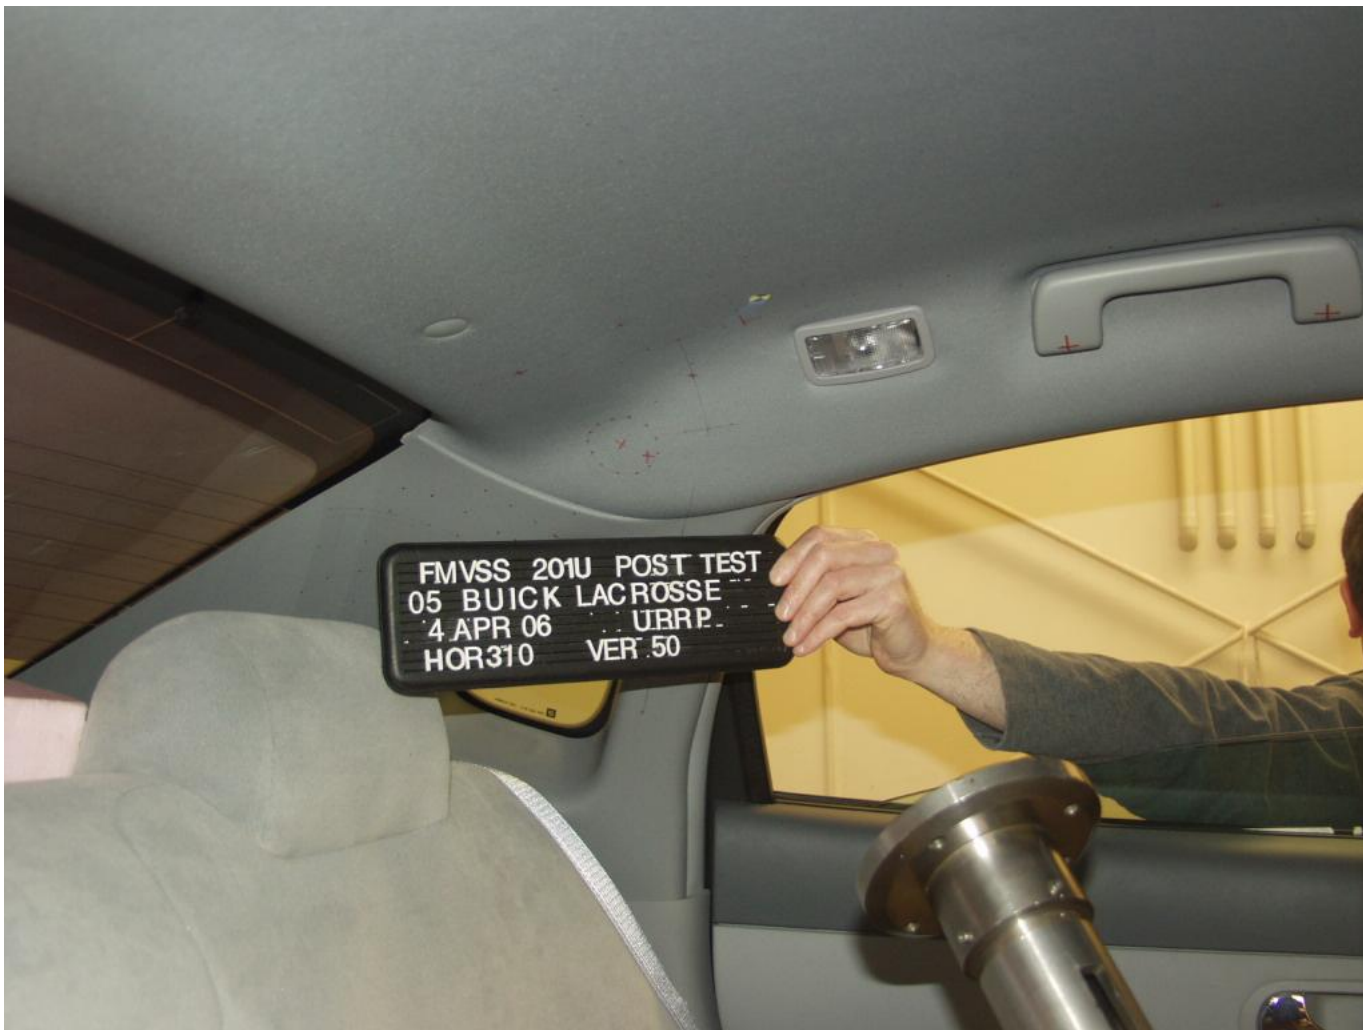
POST-IMPACT URRP

Test Number:	08
Test Date:	04/04/06
Target Location:	UPPER ROOF
Target Code:	URRP
Horizontal Impact Angle:	310 °
Vertical Impact Angle:	50 °
Ambient Temperature:	21.3 C°
Relative Humidity:	24.2
Time of Impact:	10:16
Headform Number:	0062

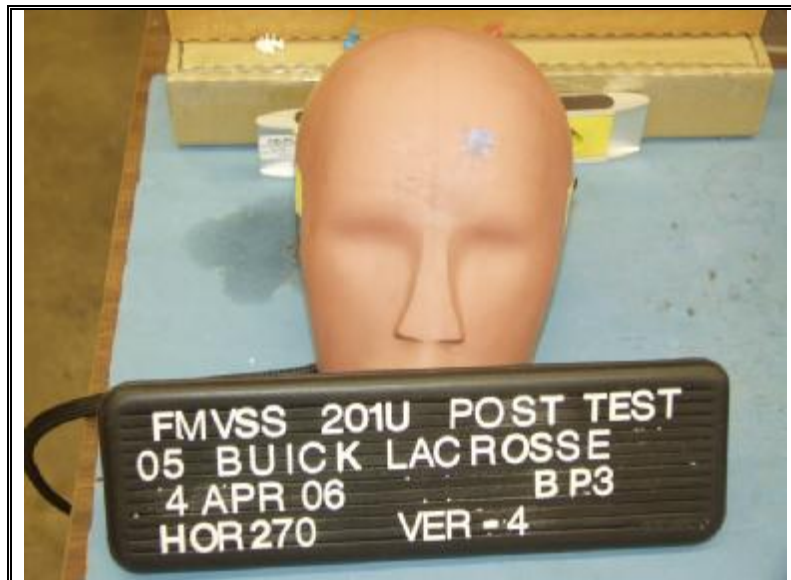
POST-IMPACT BP3 HEADFORM

Free Motion HIC	593.4
HIC(d)	614.1
Impact Velocity (kph)	23.78
HIC T1 (msec)	3.3
HIC T2 (msec)	10.8

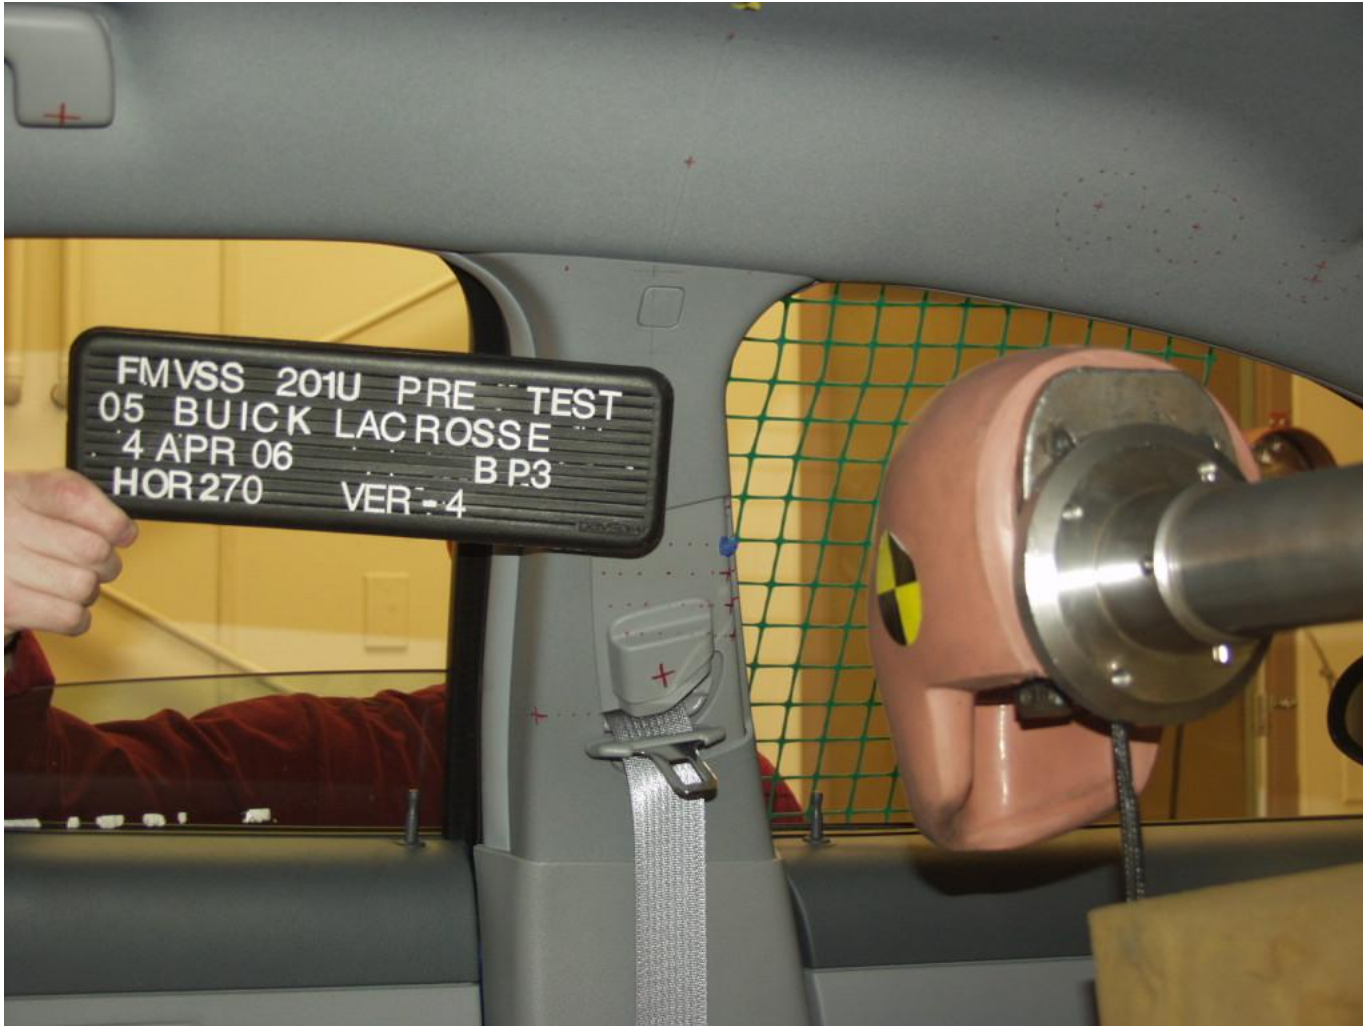
PRE-IMPACT BP3

Test Number:	09
Test Date:	04/04/06
Target Location:	B-PILLAR
Target Code:	BP3
Horizontal Impact Angle:	270 °
Vertical Impact Angle:	- 4 °
Ambient Temperature:	21.1C°
Relative Humidity:	23.2
Time of Impact:	11:05
Headform Number:	1255

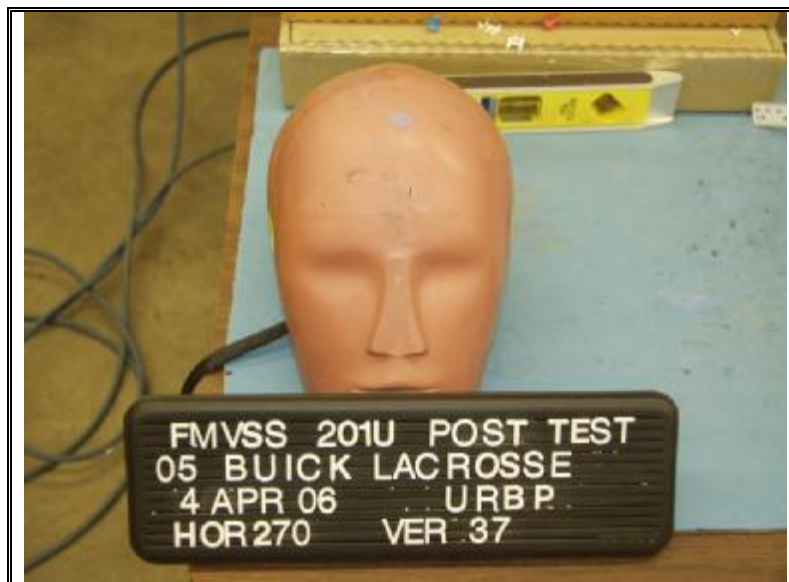
POST-IMPACT URBP DRIVER HEADFORM

Free Motion HIC	878.2
HIC(d)	829.0
Impact Velocity (kph)	23.35
HIC T1 (msec)	3.0
HIC T2 (msec)	8.9

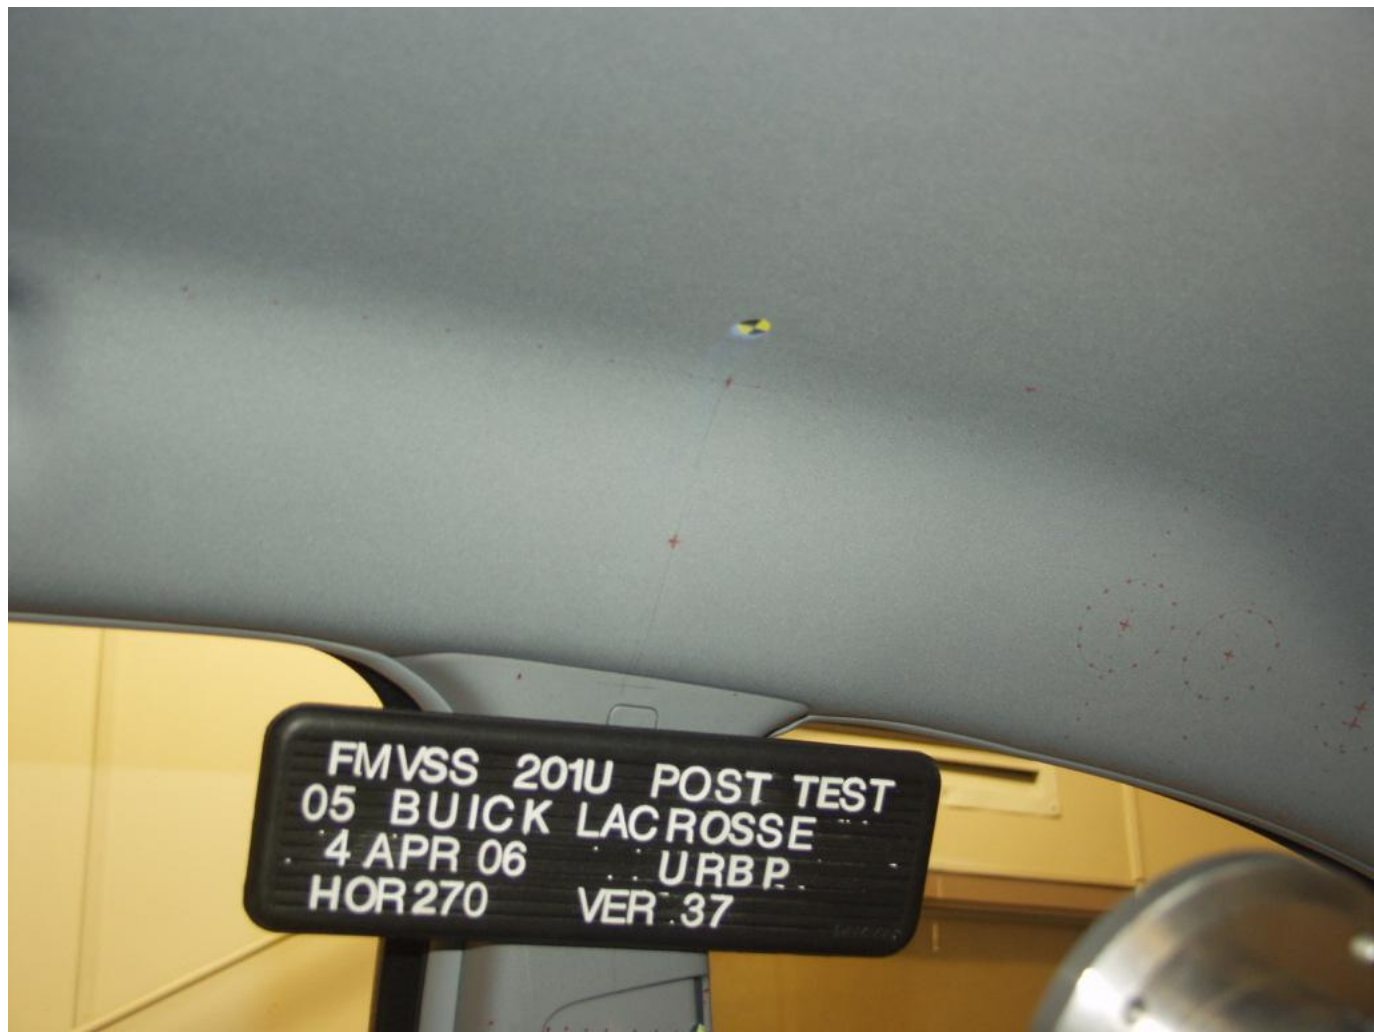
POST-IMPACT D URB.P

Test Number:	10
Test Date:	04/04/06
Target Location:	UPPER ROOF
Target Code:	URBP DRIVER
Horizontal Impact Angle:	270 °
Vertical Impact Angle:	37 °
Ambient Temperature:	21.7C°
Relative Humidity:	22.8
Time of Impact:	11:35
Headform Number:	805

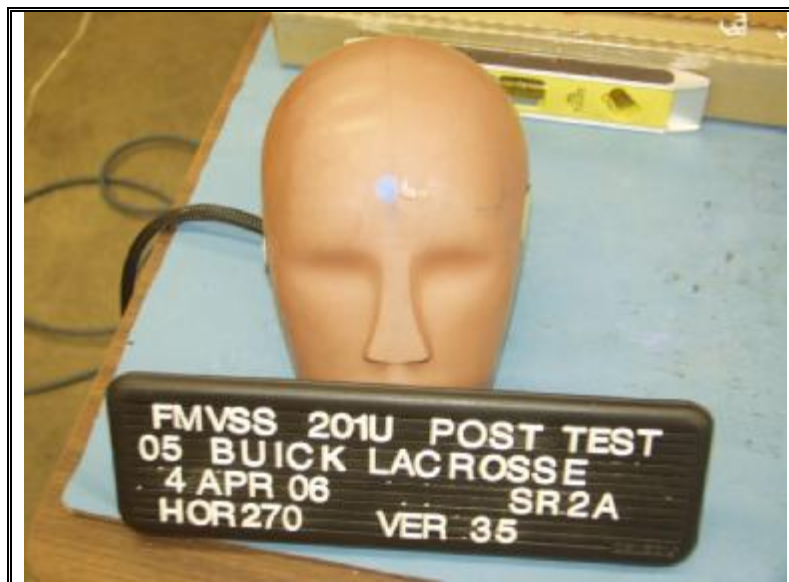
POST-IMPACT SR2A HEADFORM

Free Motion HIC	931.0
HIC(d)	868.8
Impact Velocity (kph)	23.51
HIC T1 (msec)	2.5
HIC T2 (msec)	8.1

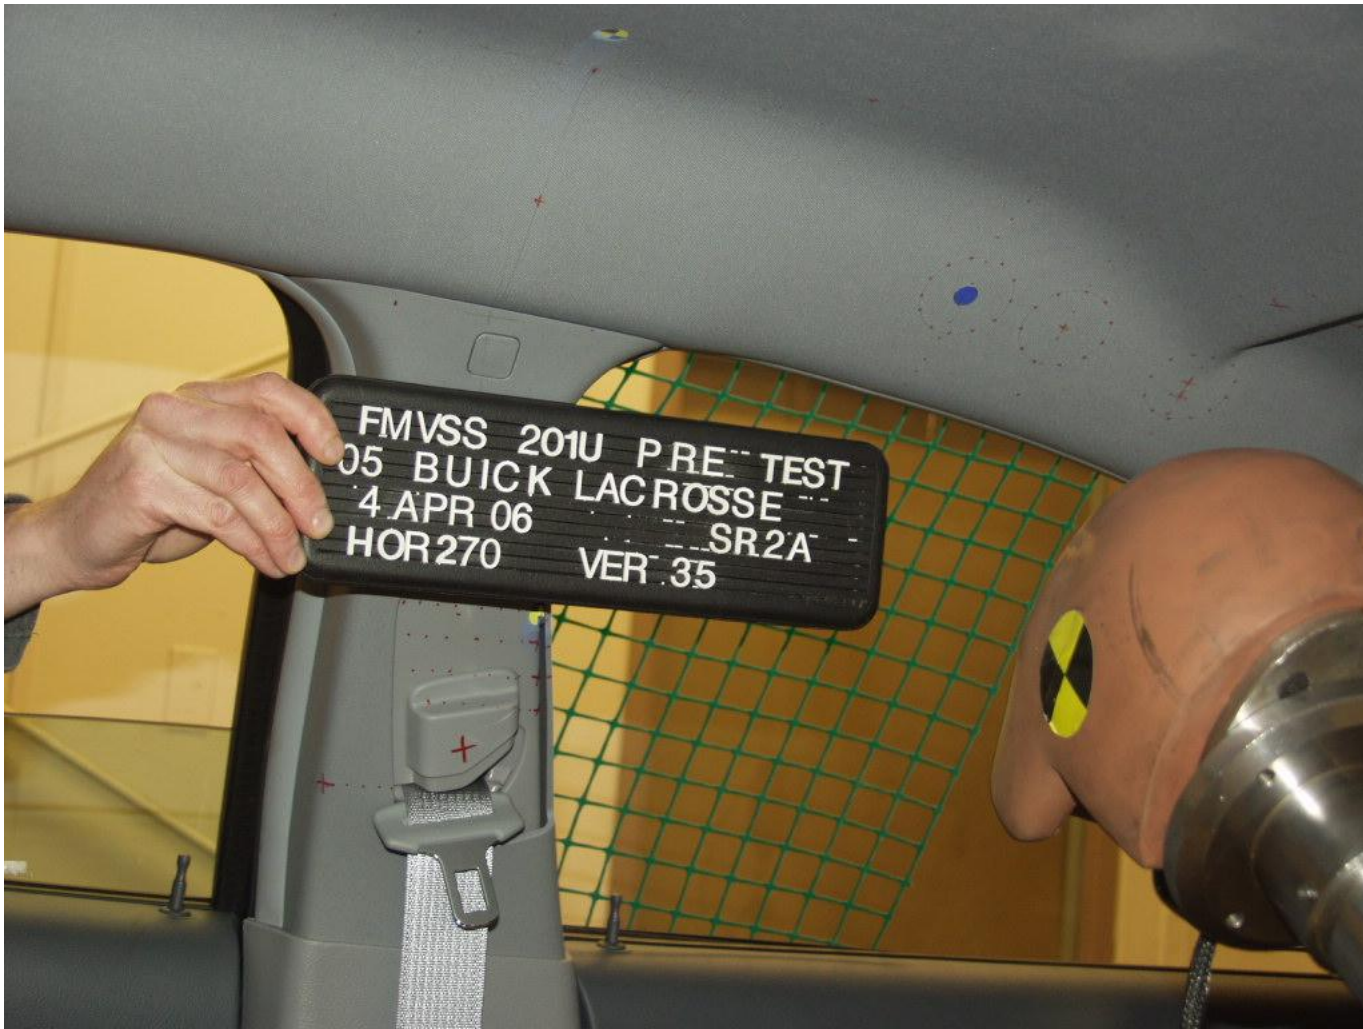
PRE-IMPACT SR2A

Test Number:	11
Test Date:	04/04/06
Target Location:	SIDE RAIL
Target Code:	SR2A
Horizontal Impact Angle:	270 °
Vertical Impact Angle:	35 °
Ambient Temperature:	21.7C°
Relative Humidity:	23.2
Time of Impact:	13:15
Headform Number:	642

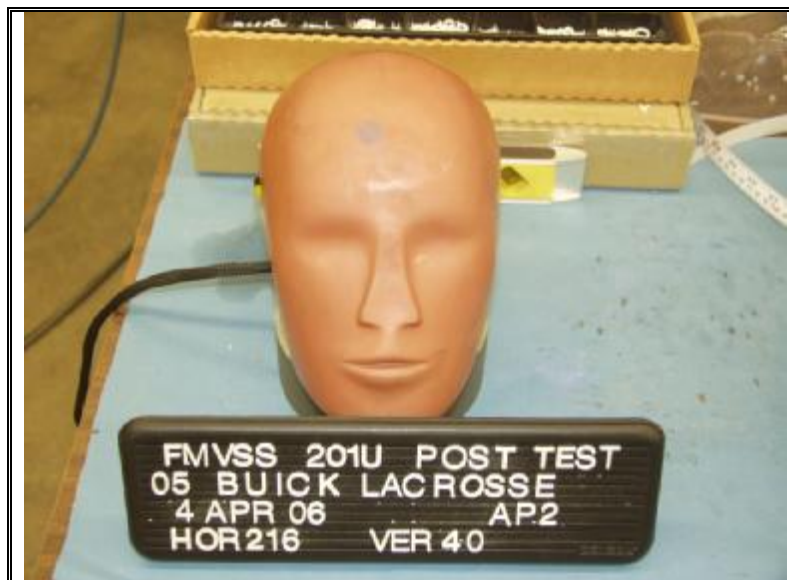
POST-IMPACT AP2 HEADFORM

Free Motion HIC	342
HIC(d)	424.4
Impact Velocity (kph)	23.48
HIC T1 (msec)	1.8
HIC T2 (msec)	11.3

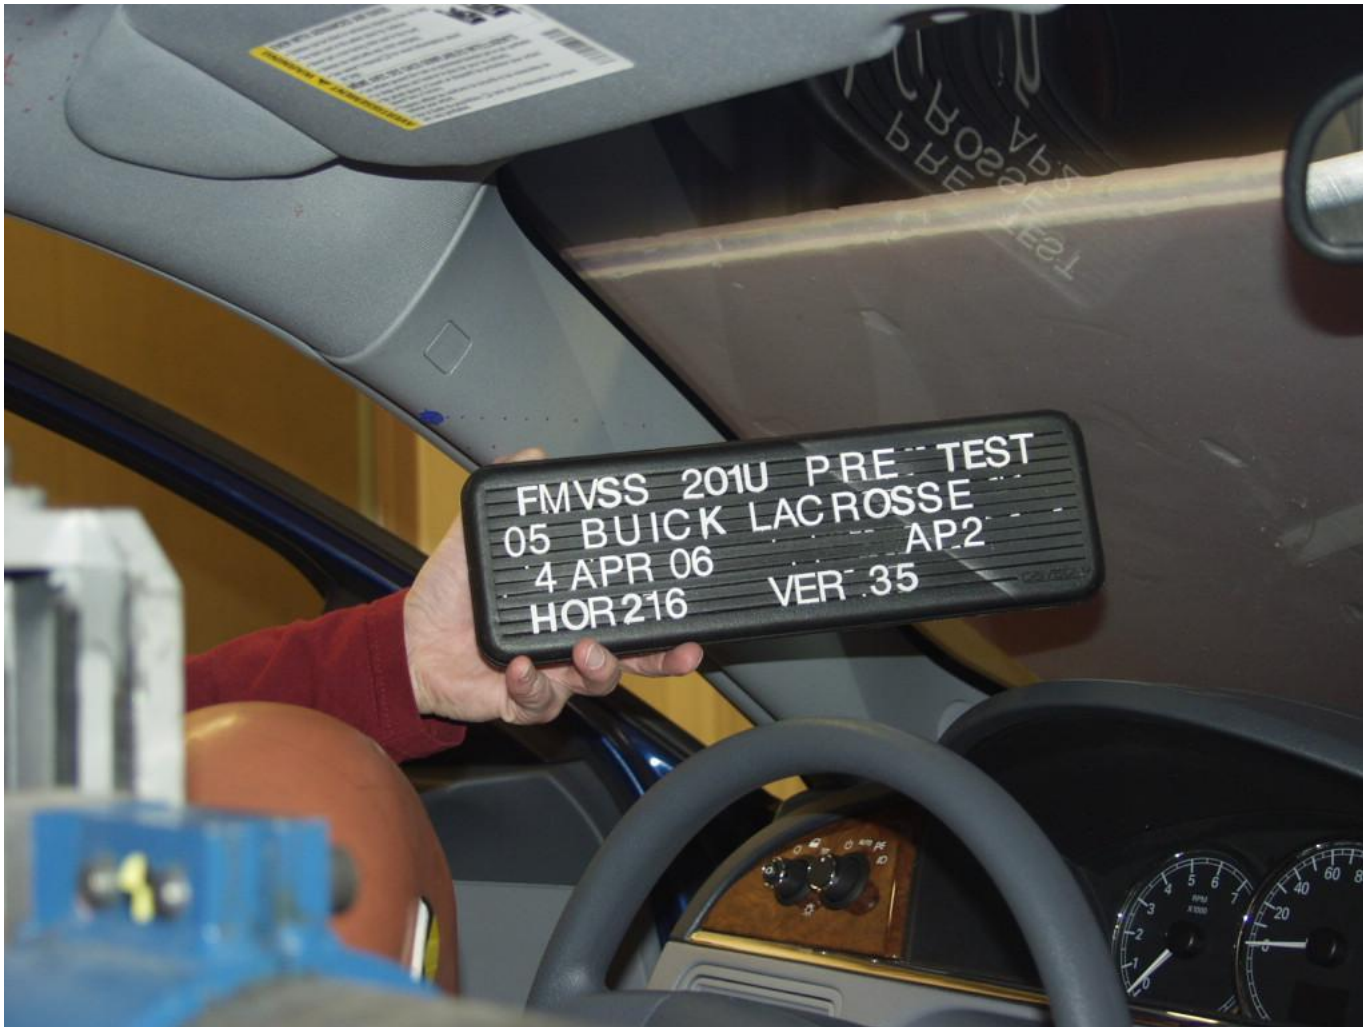
Test Number:	12
Test Date:	04/04/06
Target Location:	A-PILLAR
Target Code:	AP2
Horizontal Impact Angle:	216 °
Vertical Impact Angle:	40 °
Ambient Temperature:	21.7C°
Relative Humidity:	23.1
Time of Impact:	13:50
Headform Number:	355

**PRE-IMPACT AP2 (PLACARD MISLABELED – VER 40)**

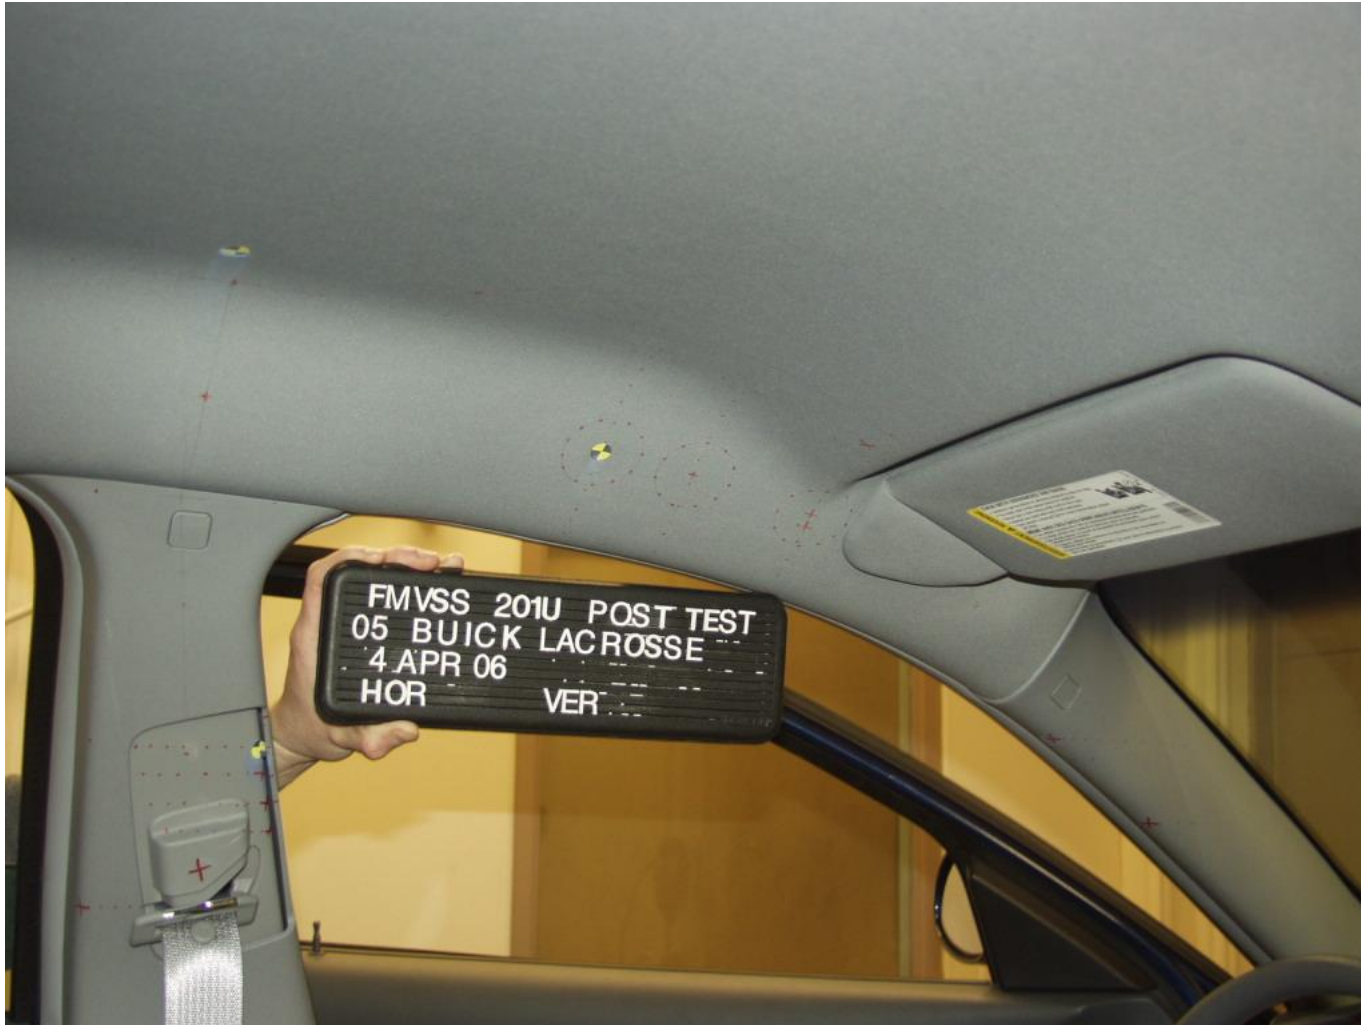
Figure A-20 : POST-TEST DRIVER SIDE FRONT HEADER

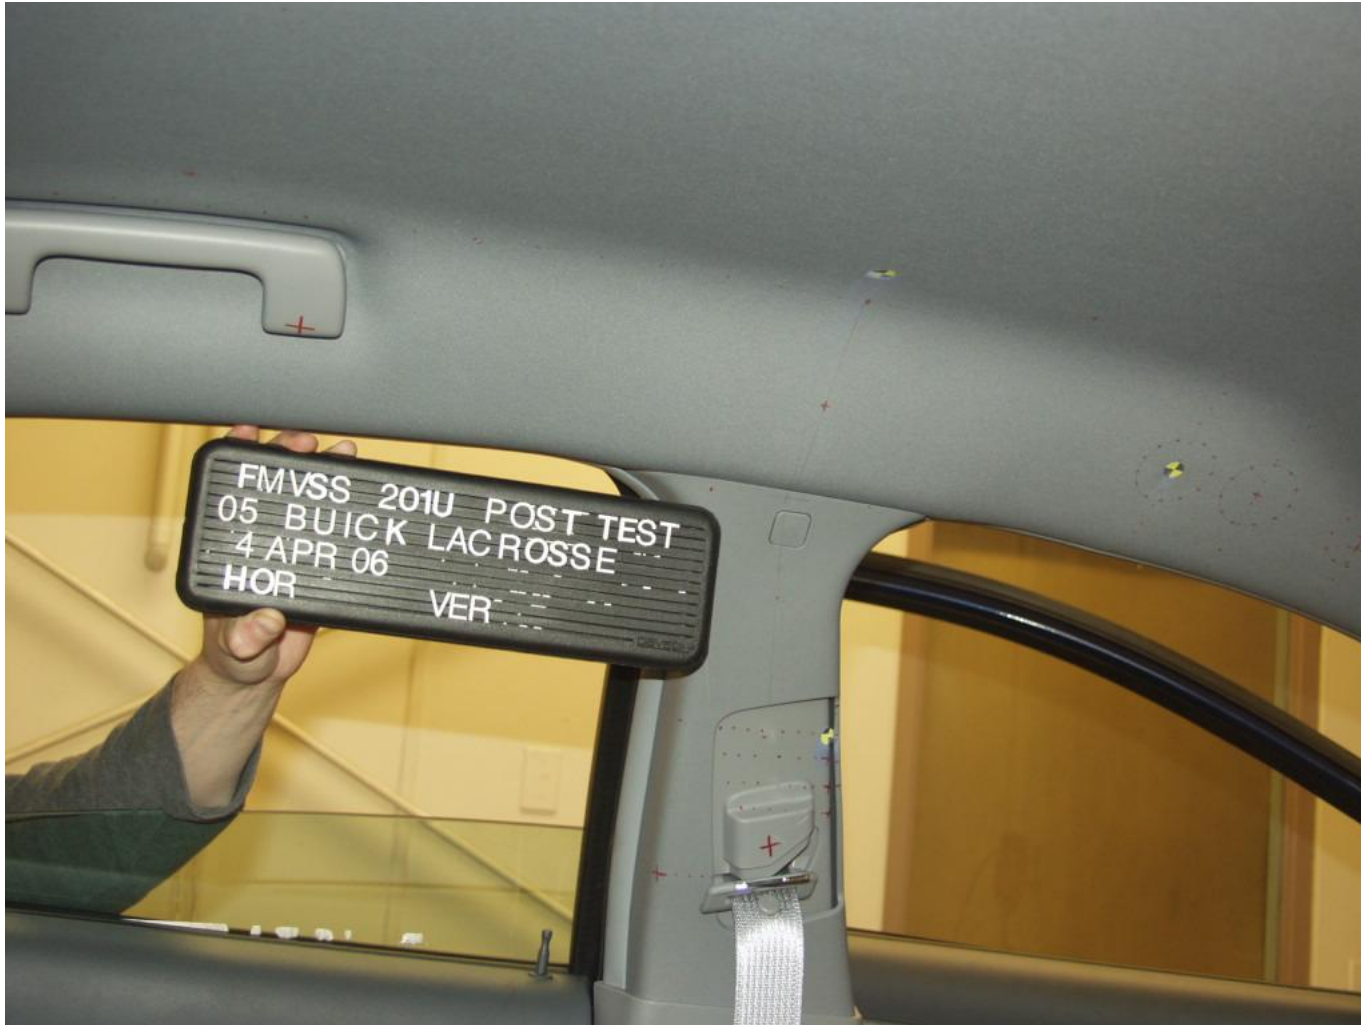
Figure A-21 : POST-TEST DRIVER SIDE SIDE RAIL

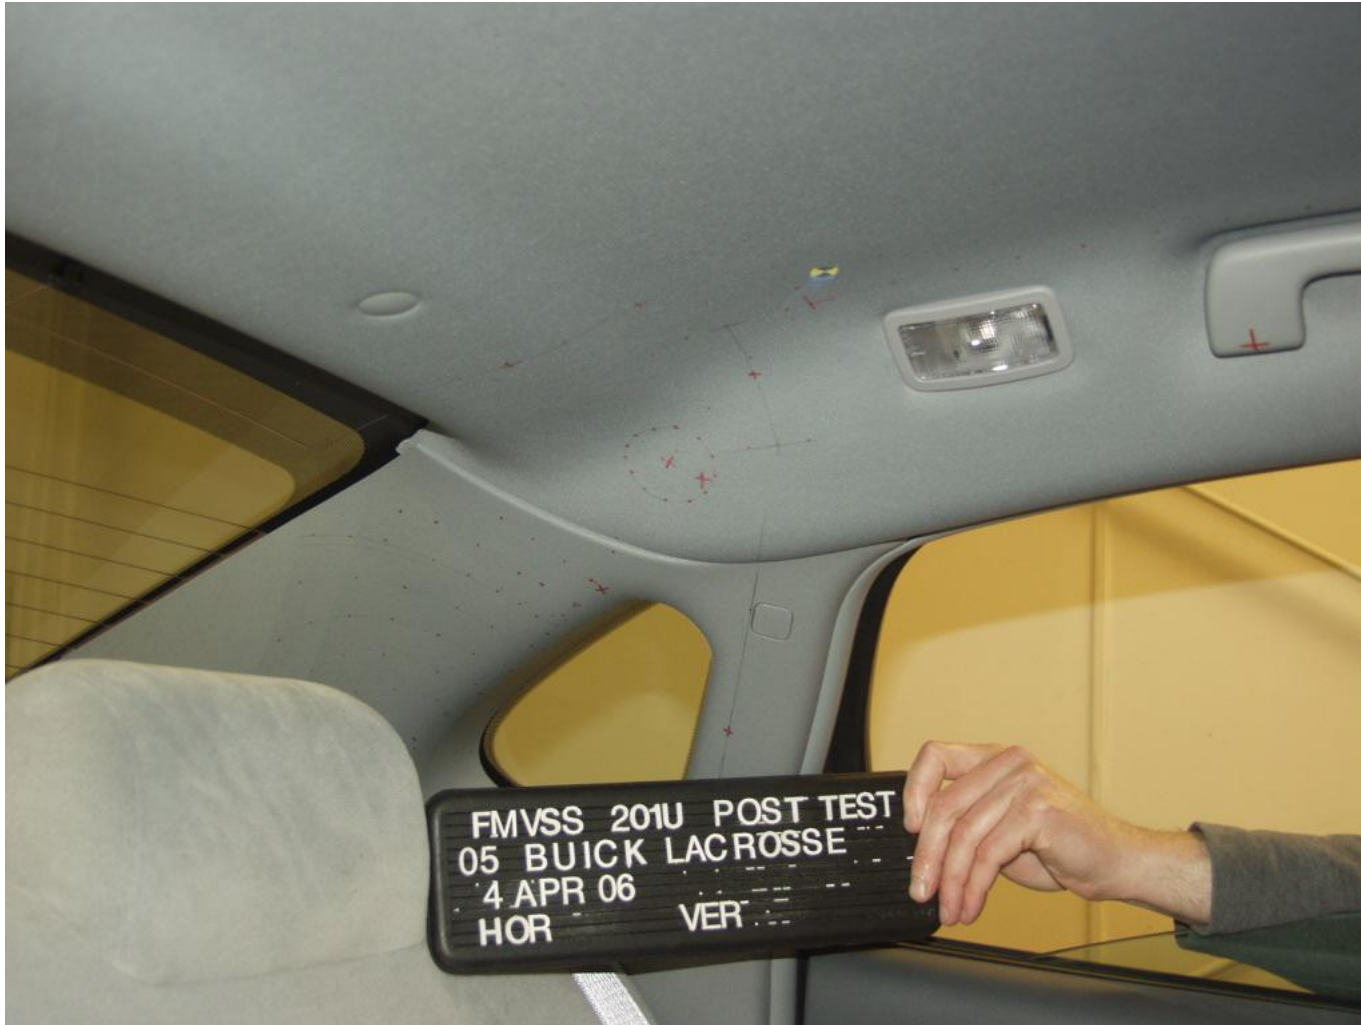
Figure A-23 : POST-TEST DRIVER SIDE REAR SIDE RAIL

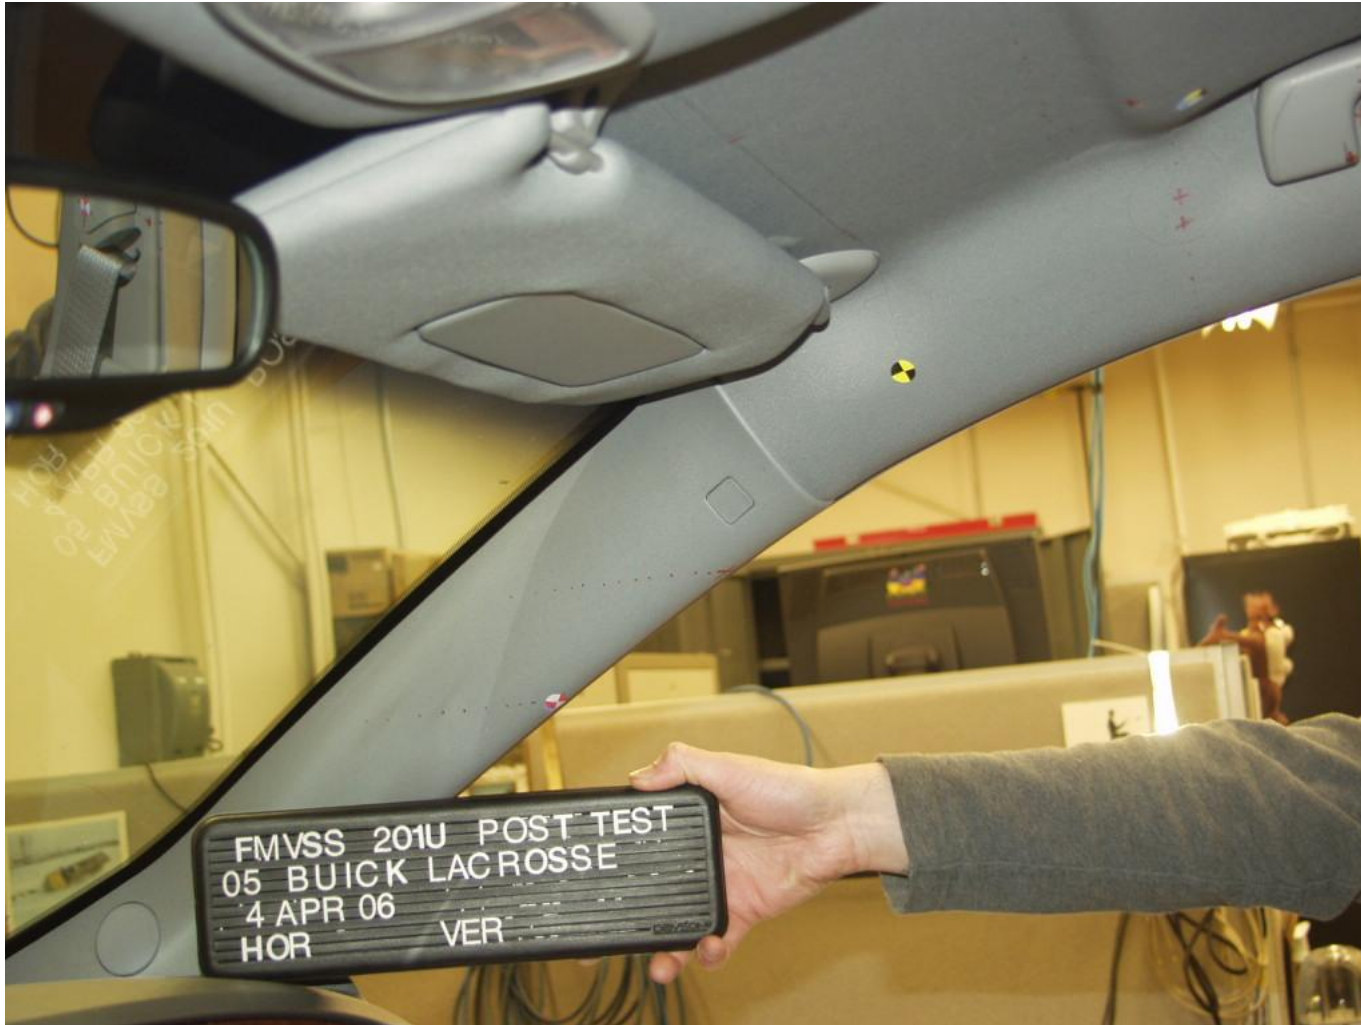
Figure A-24 : POST-TEST DRIVER SIDE REAR PILLAR

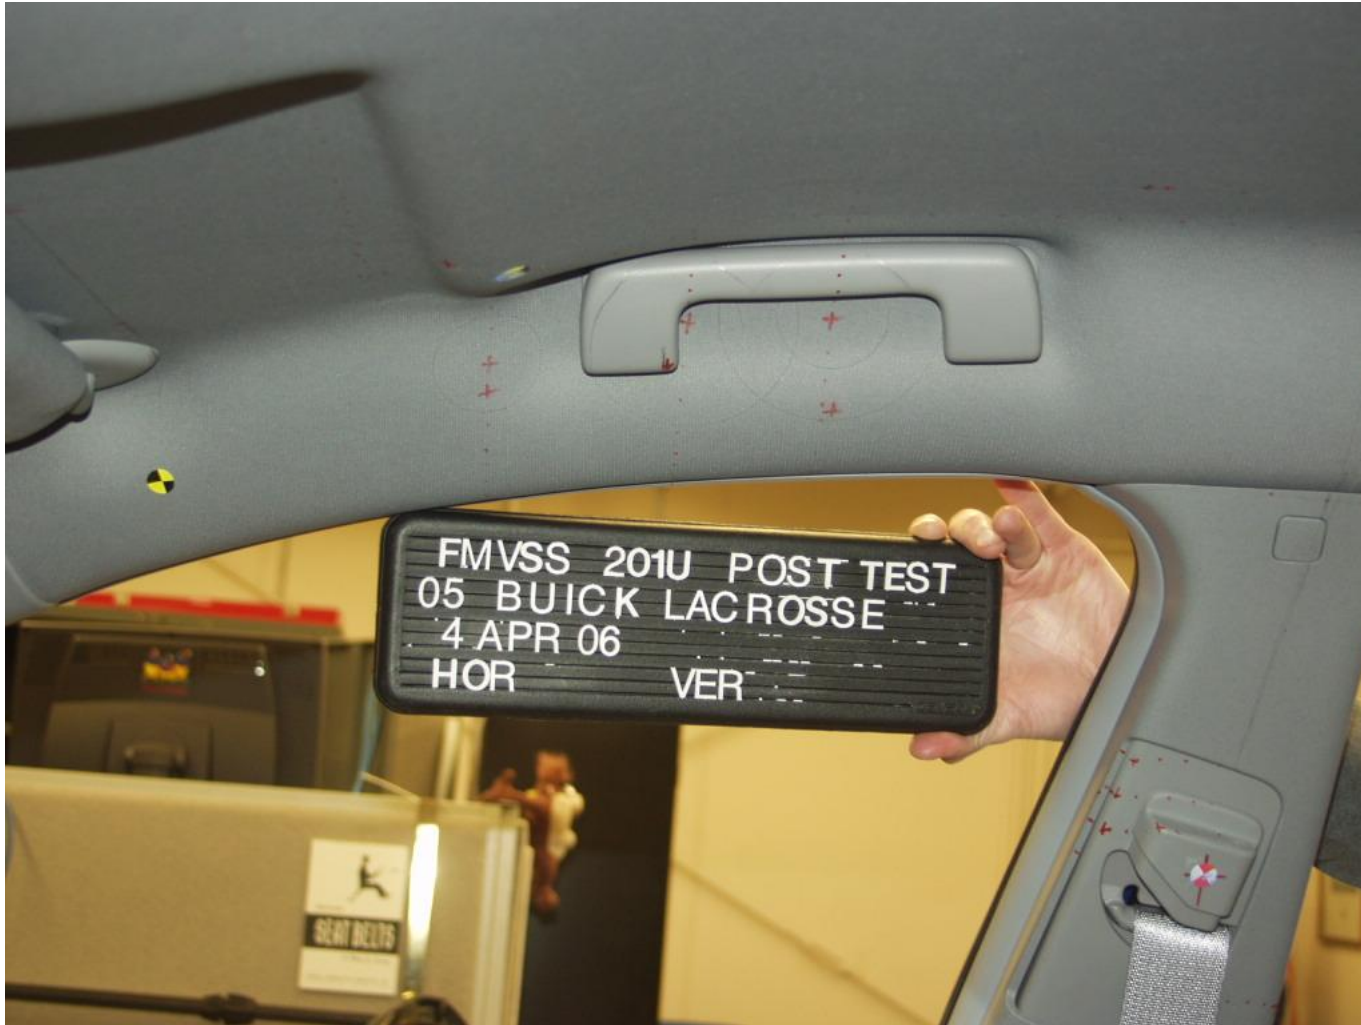
Figure A-25 : POST-TEST PASSENGER SIDE A-PILLAR

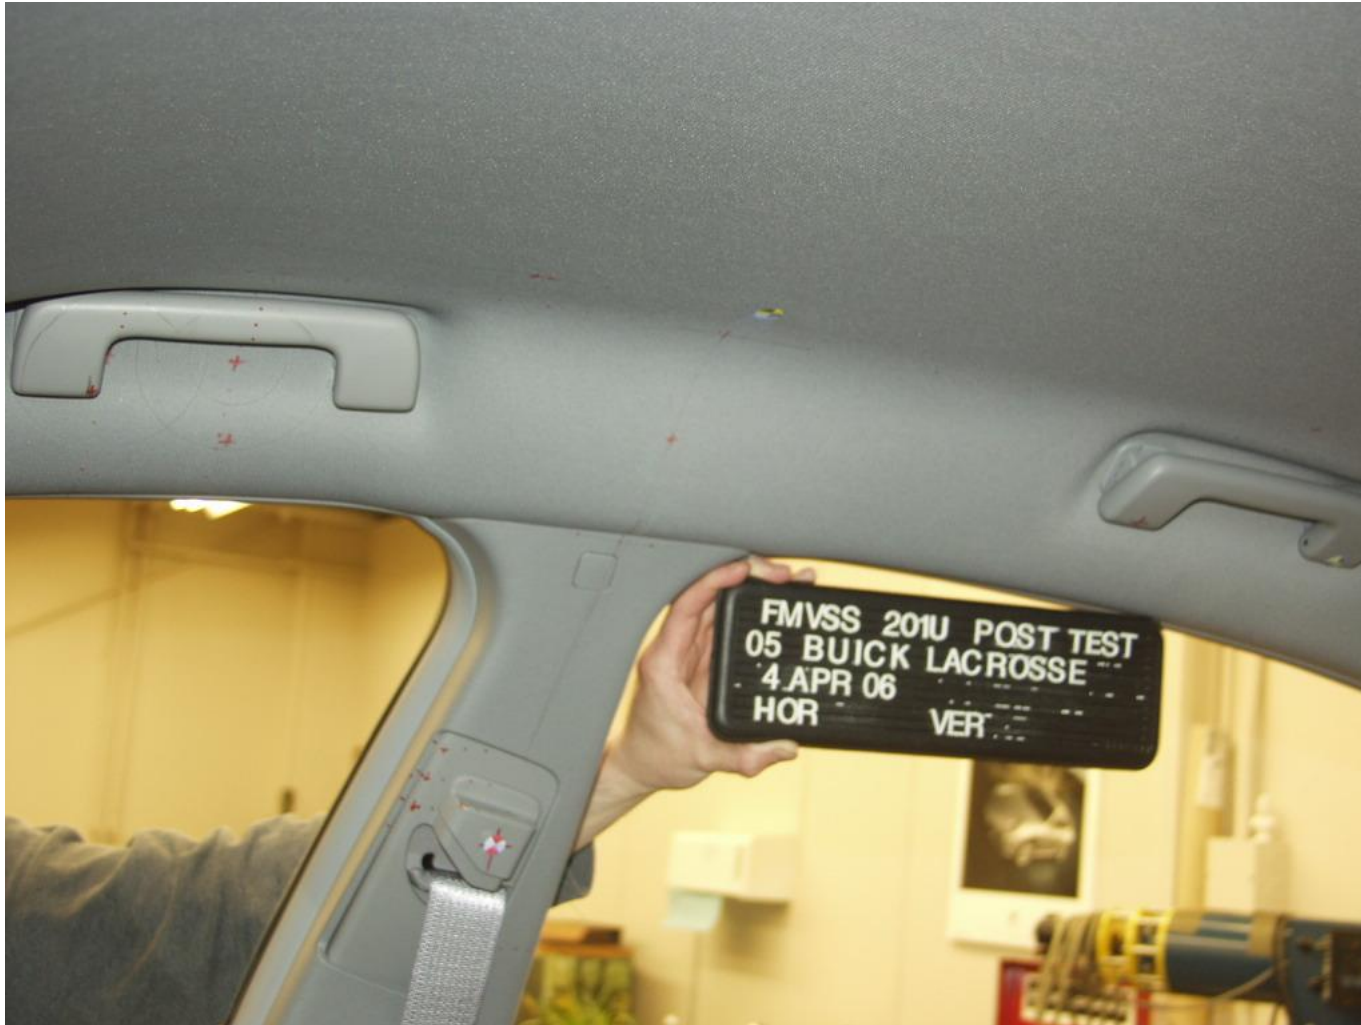
Figure A-27 : POST-TEST PASSENGER SIDE SIDE RAIL

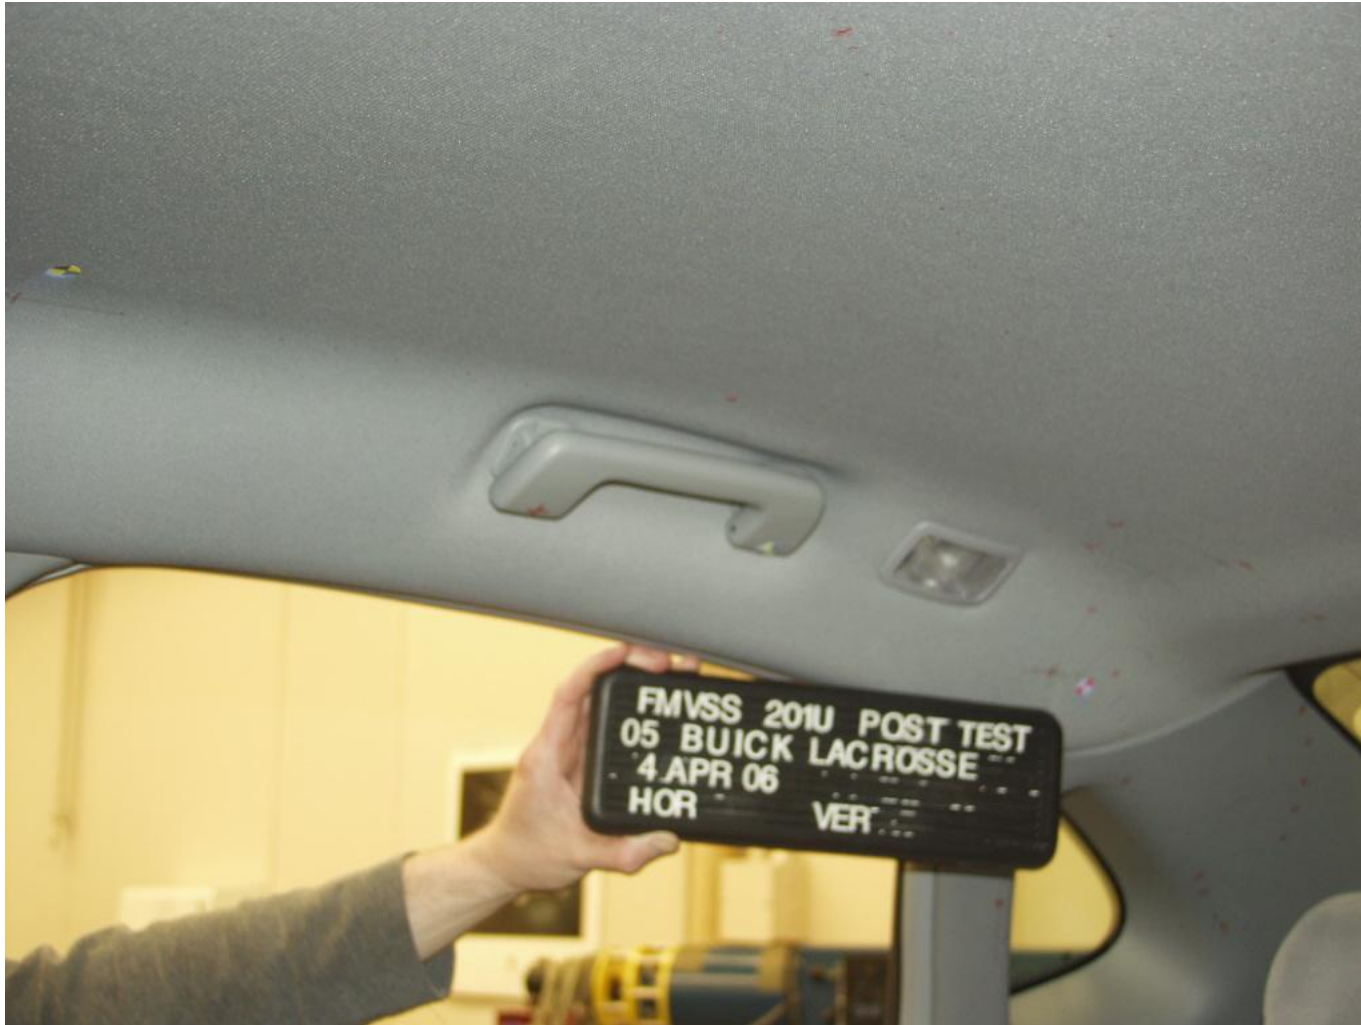
Figure A-28 : POST-TEST PASSENGER SIDE B-PILLAR

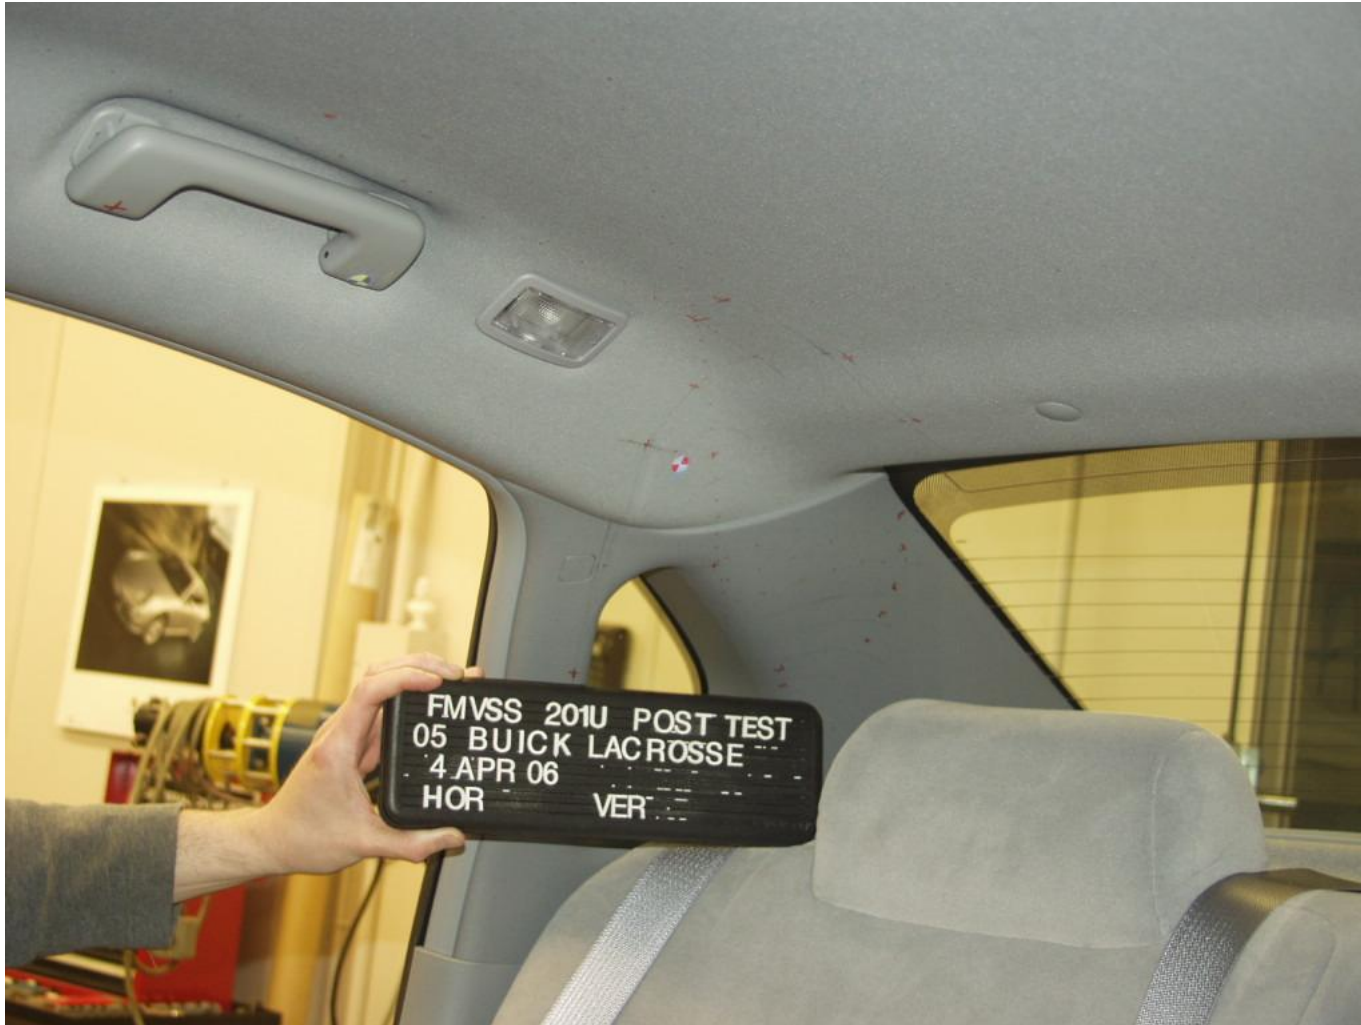
Figure A-29 : POST-TEST PASSENGER SIDE REAR SIDE RAIL

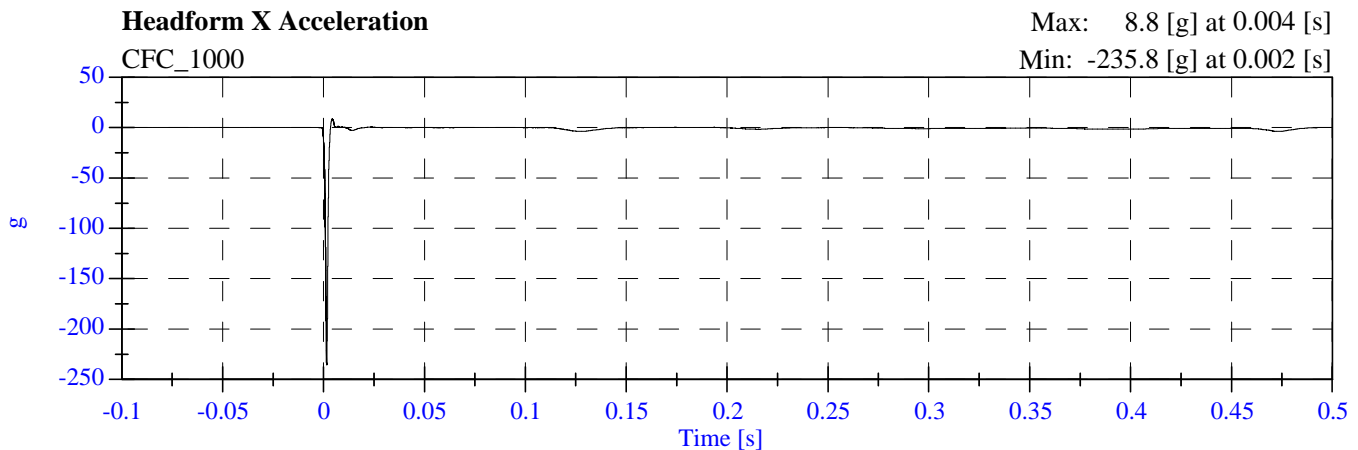
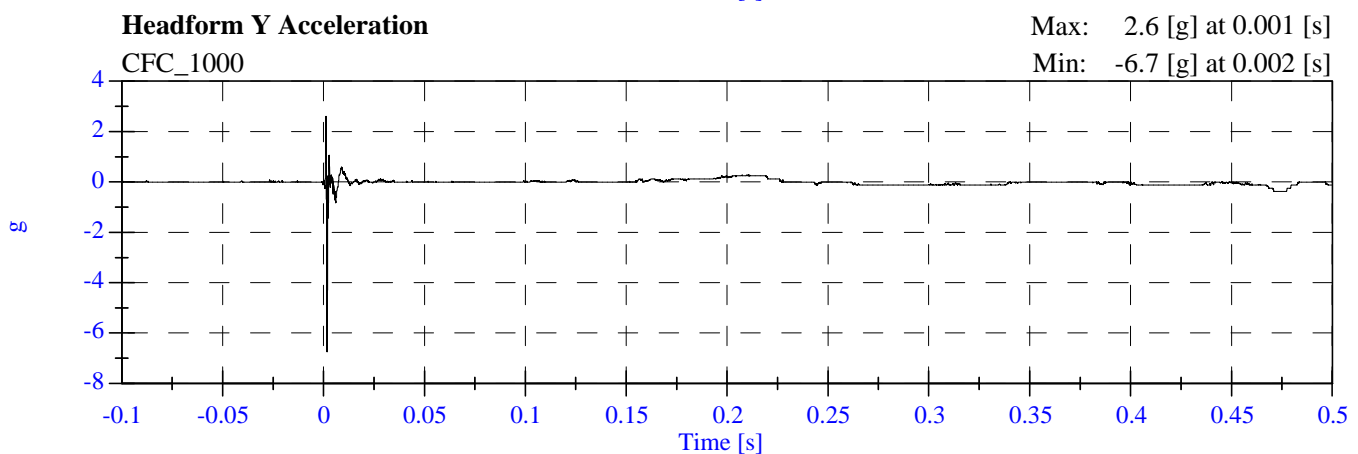
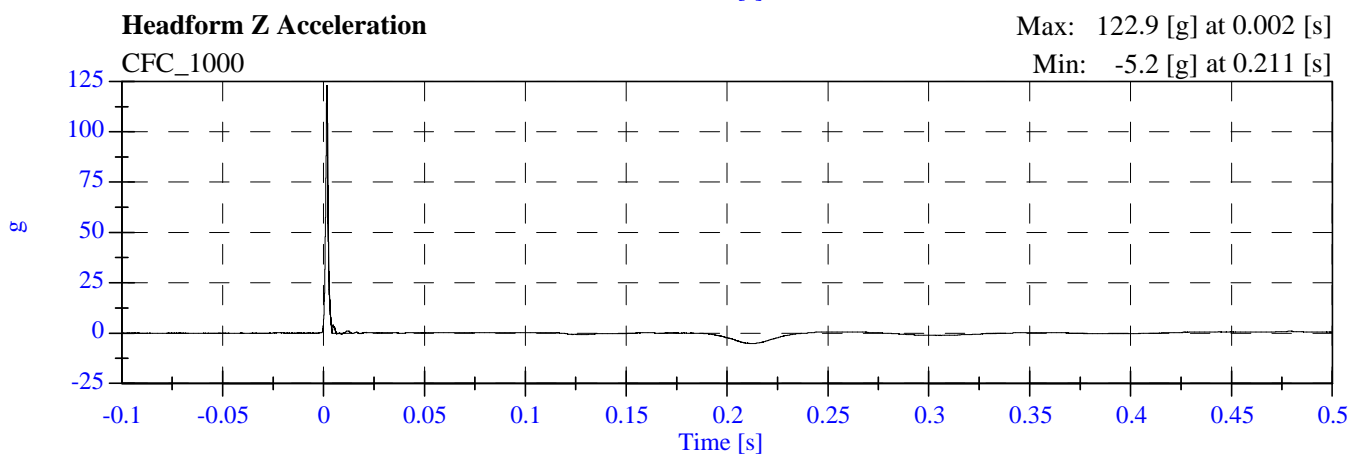
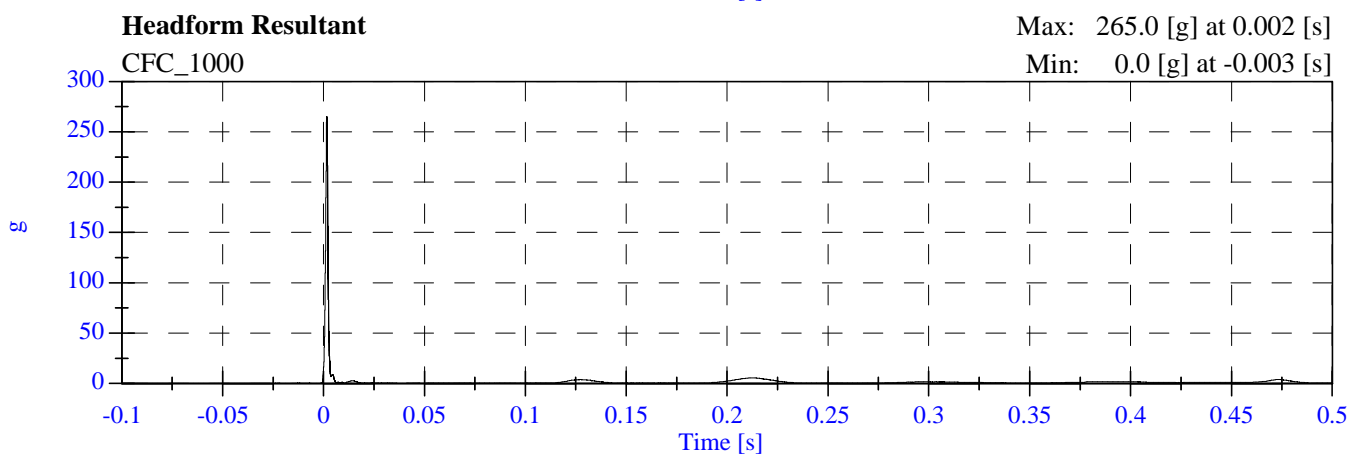
## FMH 1255 - April 06, 2006

# FMVSS 201U - Headform Calibration Drops
