REPORT NUMBER: 201U-CAL-06-05

**SAFETY COMPLIANCE TESTING FOR FMVSS 201
OCCUPANT PROTECTION IN INTERIOR IMPACT
UPPER INTERIOR HEAD IMPACT PROTECTION**

**MAZDA MOTOR CORPORATION
2006 MAZDA 5 SPORT**

NHTSA NUMBER: C65401

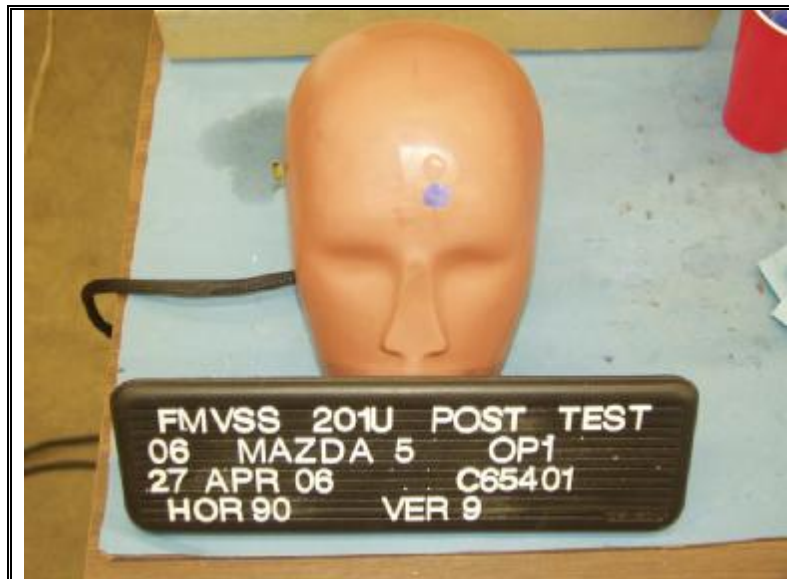
POST-IMPACT OP1 HEADFORM

Impact Point Description (from lower midpoint on midsagittal line)			
On Centerline	10	mm right	x mm left
On Centerline	12	mm up

Free Motion HIC	388.4
HIC(d)	459.4
Impact Velocity (kph)	23.6
HIC T1 (msec)	2.1
HIC T2 (msec)	10.1

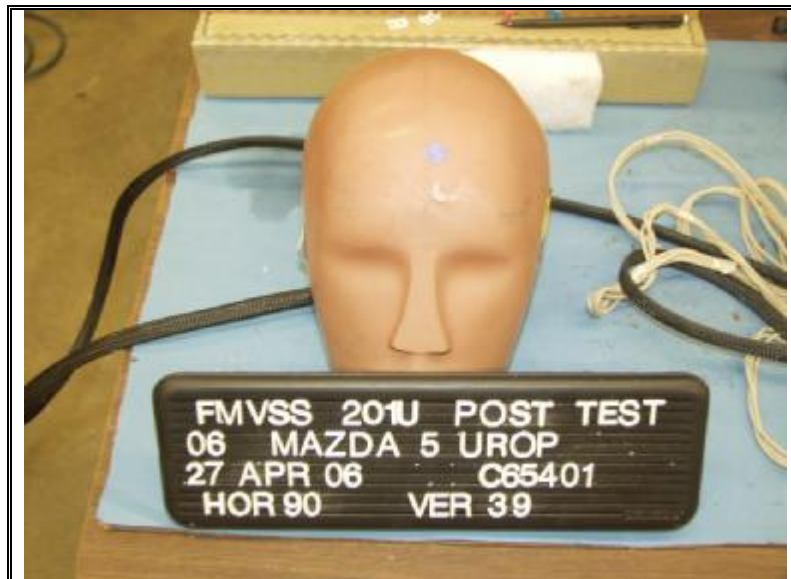
POST-IMPACT UROP HEADFORM

Impact Point Description (from lower midpoint on midsagittal line)			
On Centerline	5	mm right	x mm left
On Centerline	31	mm up

Free Motion HIC	541.9
HIC(d)	575.3
Impact Velocity (kph)	23.69
HIC T1 (msec)	4.1
HIC T2 (msec)	13.3

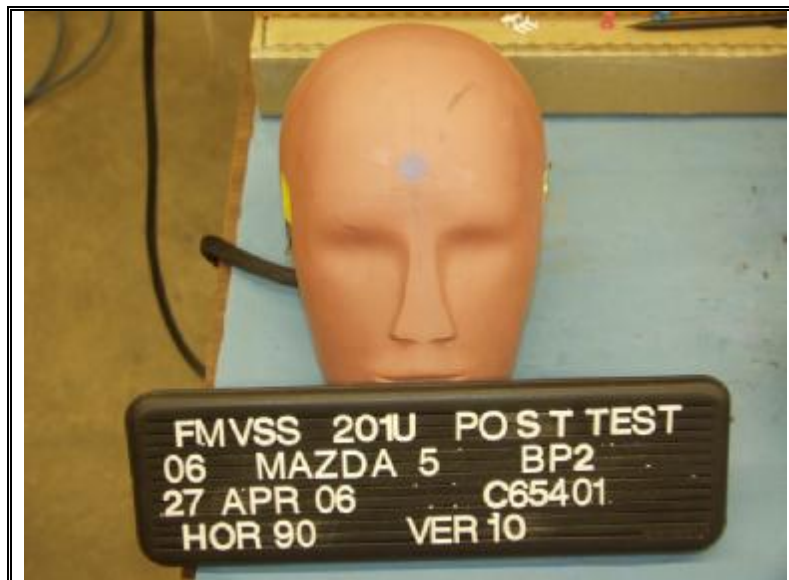
POST-IMPACT BP2 HEADFORM

Impact Point Description (from lower midpoint on midsagittal line)			
On Centerline	0	<input type="checkbox"/>	mm right <input type="checkbox"/> mm left
On Centerline	12		mm up

Free Motion HIC	640.9
HIC(d)	650.0
Impact Velocity (kph)	23.80
HIC T1 (msec)	1.5
HIC T2 (msec)	10.9

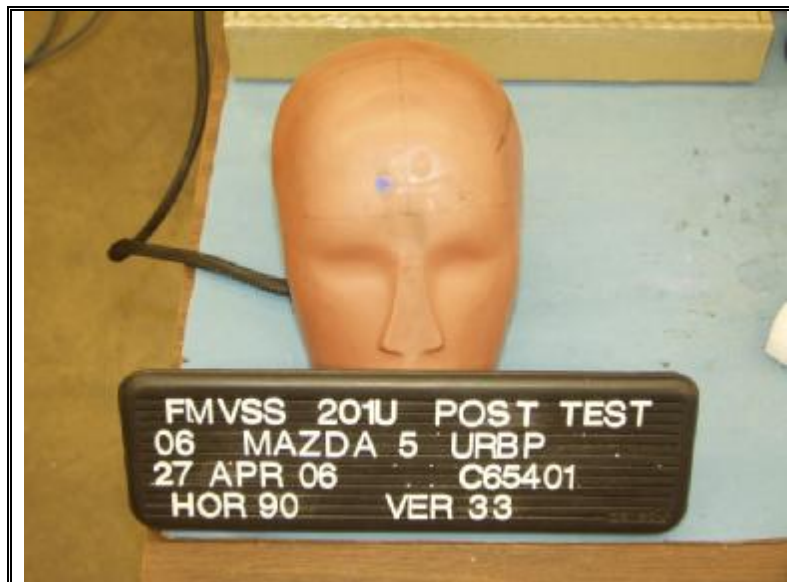
POST-IMPACT URBP HEADFORM

Impact Point Description (from lower midpoint on midsagittal line)					
On Centerline	10	x	mm right		mm left
On Centerline	16				mm up

Free Motion HIC	455.9
HIC(d)	510.4
Impact Velocity (kph)	23.55
HIC T1 (msec)	3.8
HIC T2 (msec)	12.3

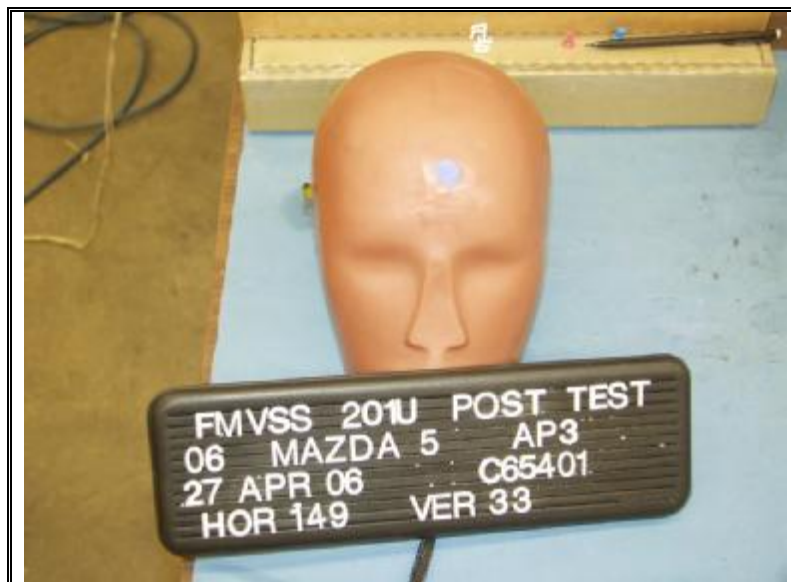
POST-IMPACT AP3 HEADFORM

Impact Point Description (from lower midpoint on midsagittal line)			
On Centerline	4	mm right	x mm left
On Centerline	26	mm up

Free Motion HIC	430.7
HIC(d)	491.4
Impact Velocity (kph)	18.43
HIC T1 (msec)	2.3
HIC T2 (msec)	7.1

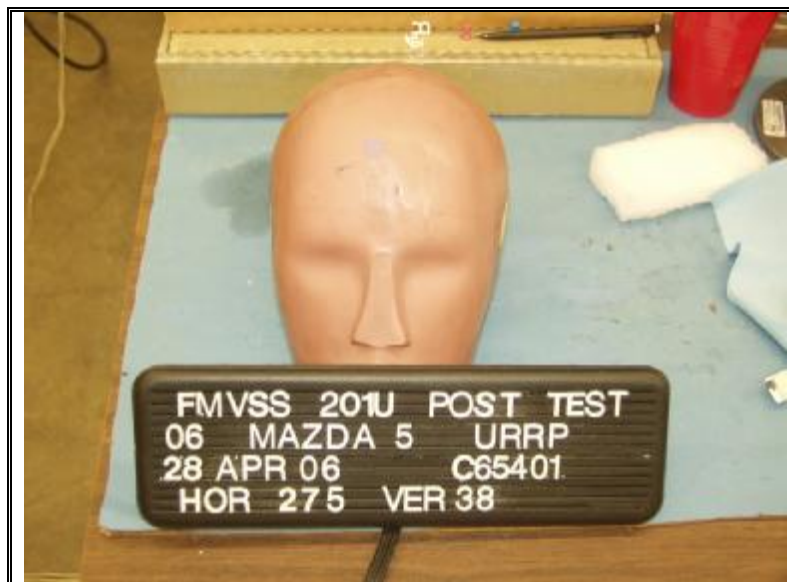
POST-IMPACT URRP HEADFORM

Impact Point Description (from lower midpoint on midsagittal line)				
On Centerline	5	x	mm right	mm left
On Centerline	36		mm up

Free Motion HIC	405.6
HIC(d)	472.5
Impact Velocity (kph)	23.51
HIC T1 (msec)	5.5
HIC T2 (msec)	13.1

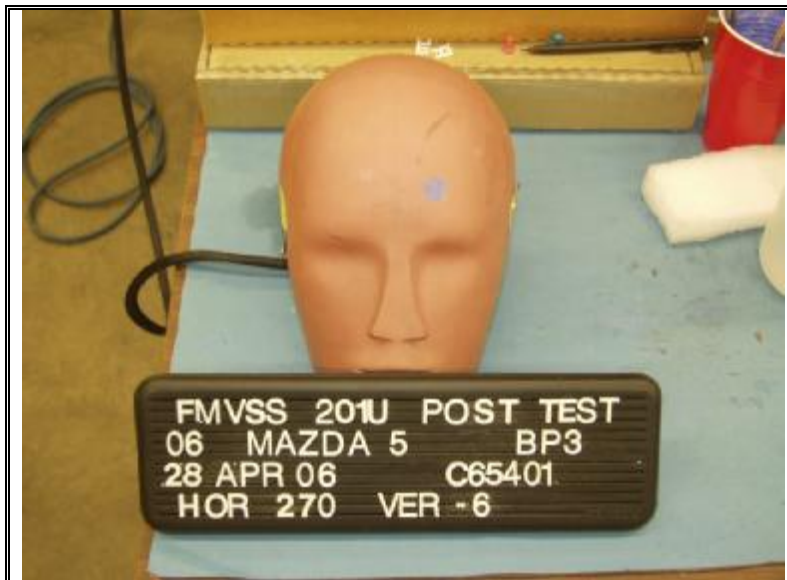
POST-IMPACT BP3 HEADFORM

Impact Point Description (from lower midpoint on midsagittal line)					
On Centerline	24	<input type="checkbox"/>	mm right	<input checked="" type="checkbox"/>	mm left
On Centerline	10				mm up

Free Motion HIC	503.5
HIC(d)	546.3
Impact Velocity (kph)	23.53
HIC T1 (msec)	2.4
HIC T2 (msec)	12.2

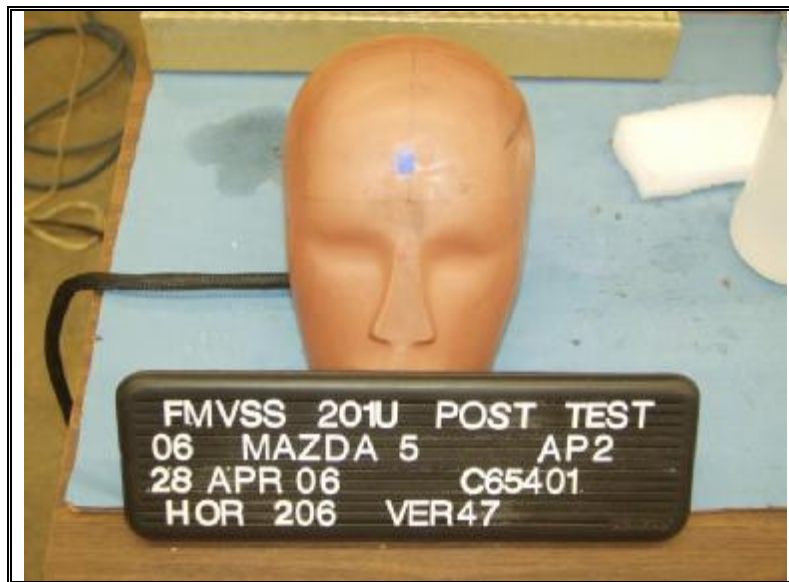
POST-IMPACT AP2 HEADFORM

Impact Point Description (from lower midpoint on midsagittal line)					
On Centerline	1	x	mm right		mm left
On Centerline	20				mm up

Free Motion HIC	358.6
HIC(d)	437
Impact Velocity (kph)	18.81
HIC T1 (msec)	1.7
HIC T2 (msec)	7.7
