REPORT NO. 207-KAR-06-005A

**INDICANT TESTING
FOR FMVSS 210**

SEAT BELT ANCHORAGES FOR SIDE FACING SEATS

2006 FORD RANGER
2-DOOR EXTRA CAB TRUCK

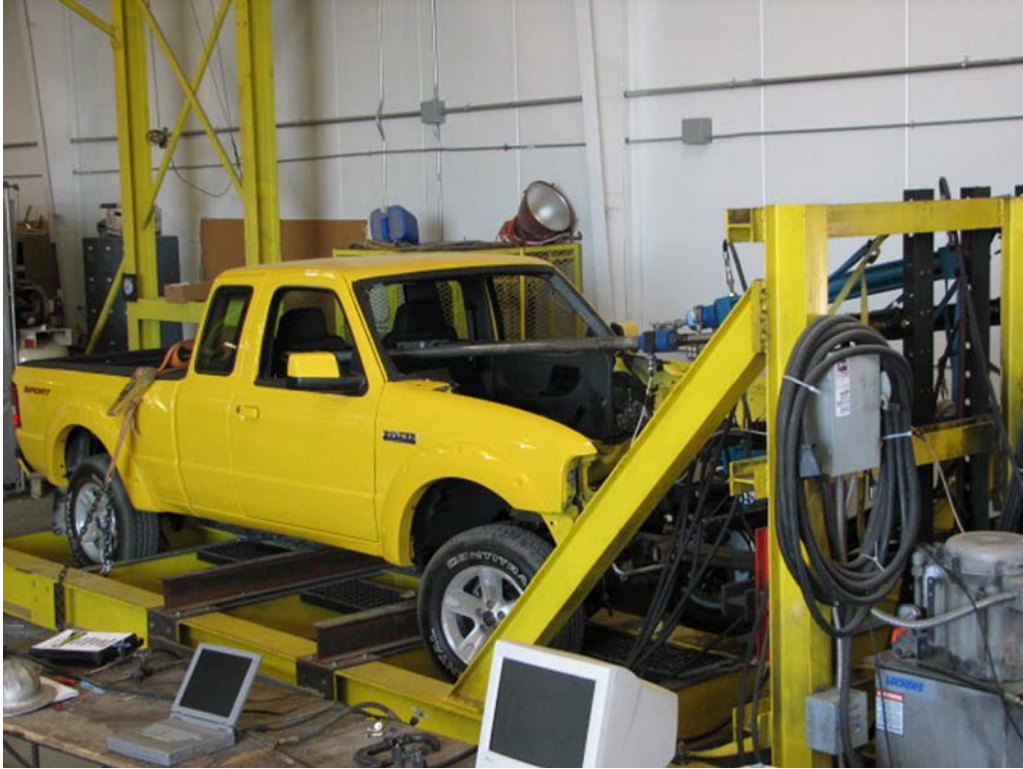
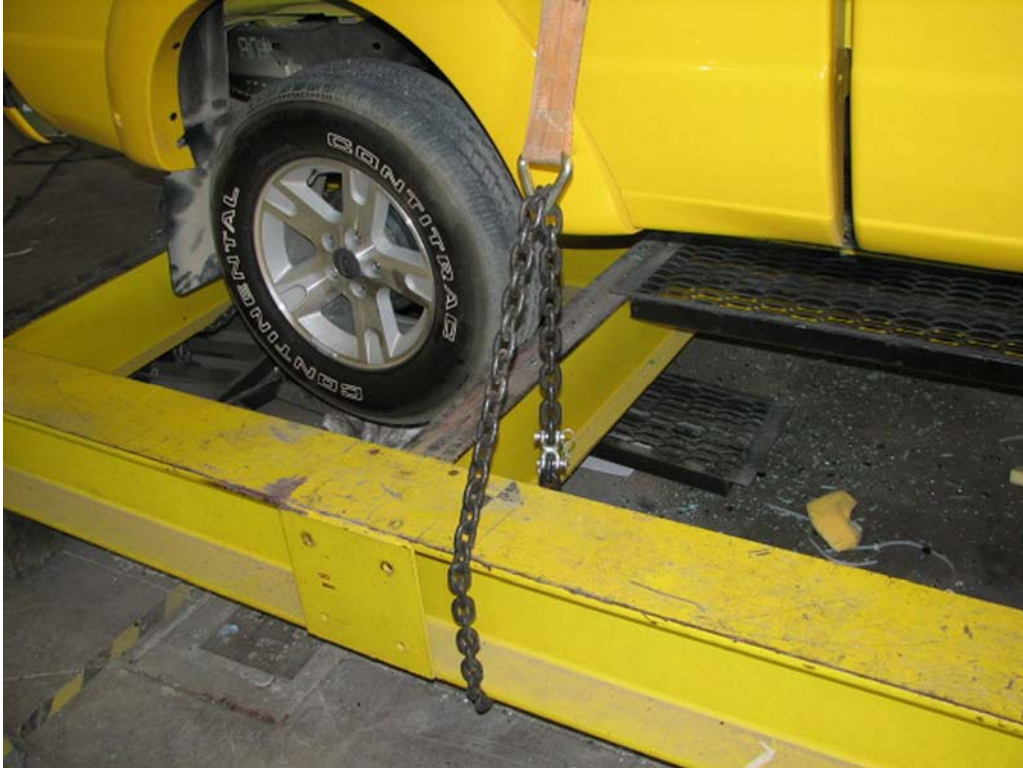
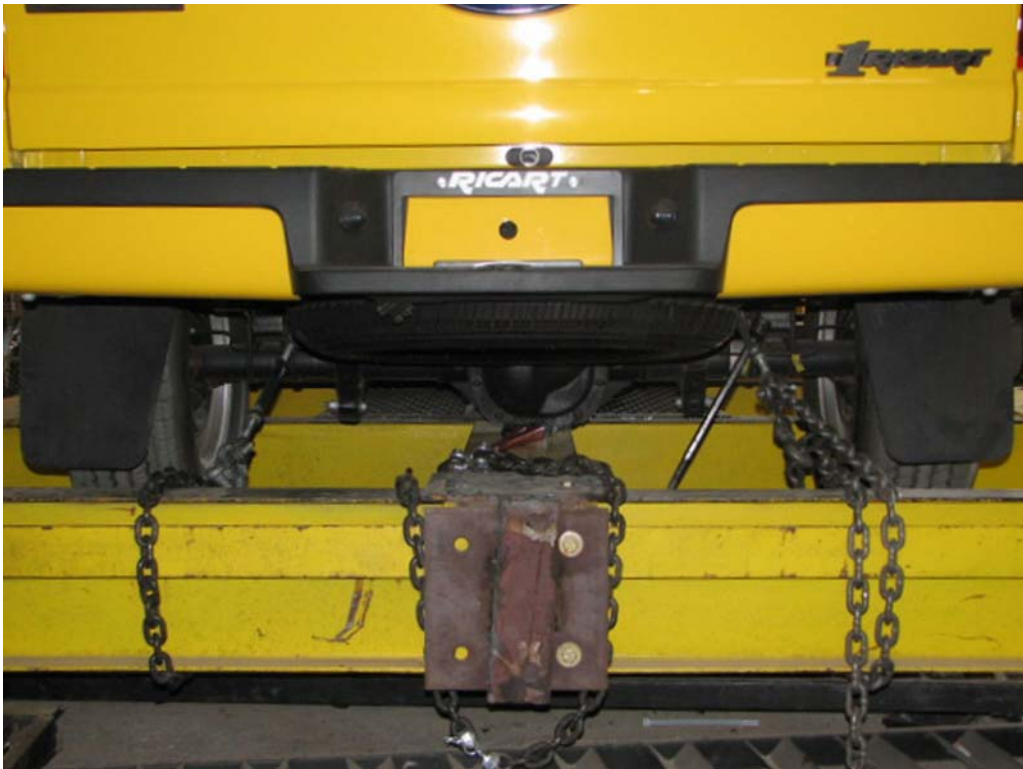
FIGURE 7. Vehicle Mounted in Test Fixture

2.2 Test Vehicle Preparation and Pre-test Measurements. The test vehicle was securely mounted perpendicular to the test fixture and connected to the appropriate number of hydraulic actuators.

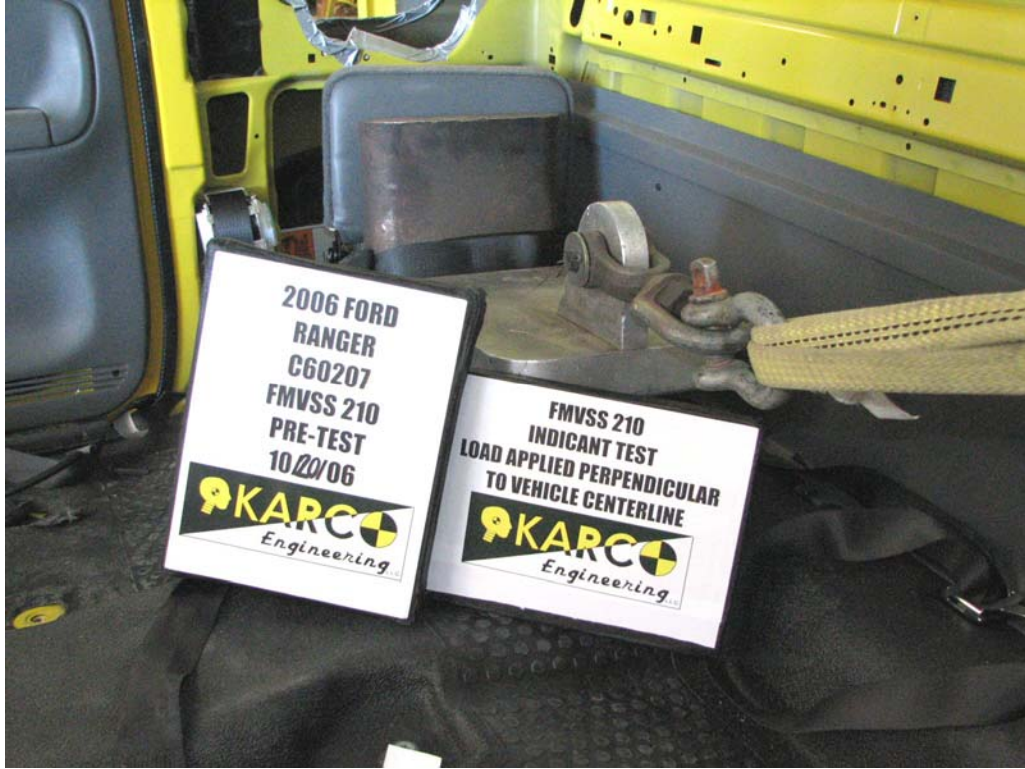
FIGURE 11. Load Applied Perpendicular, P3, Pre-Test

All tests were conducted by pulling seat belt anchorages perpendicular to vehicle's centerline. The load was applied using the standard FMVSS 210 pelvic block. The tests were conducted at KARCO Engineering, LLC. Detailed procedures for receiving, inspecting, testing and reporting of test results are described in the test procedures and are not repeated in this report.

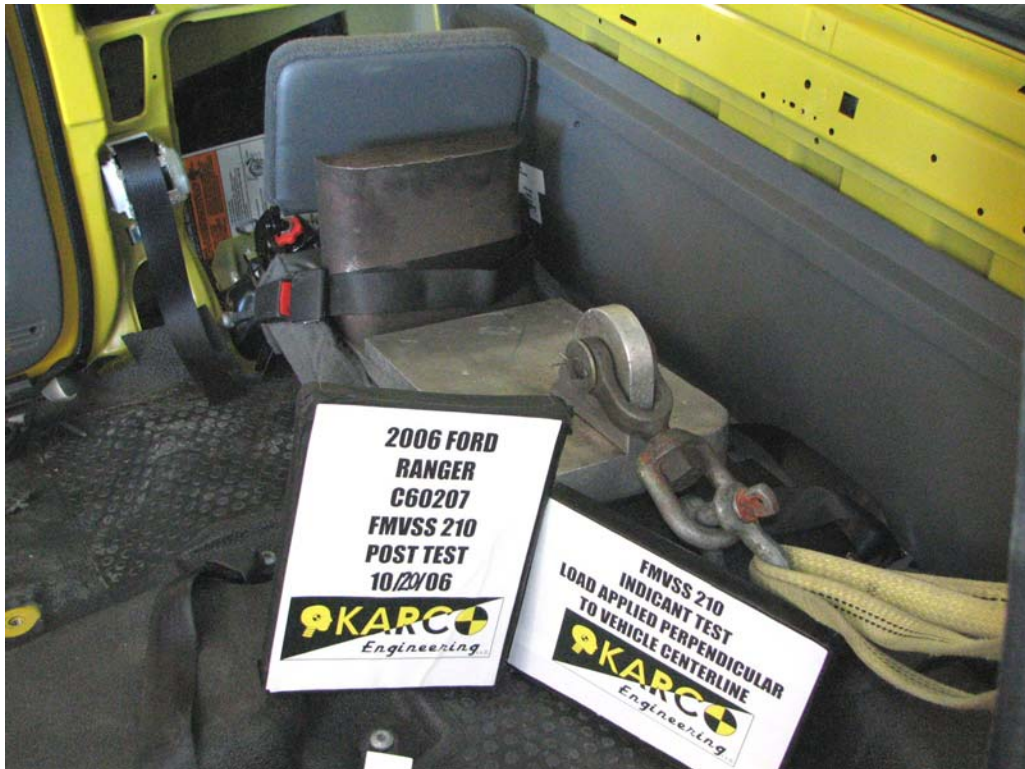
FIGURE 12. Load Applied Perpendicular, P3, Post-Test

LOAD DIRECTION	REQUIRED LOAD (lbs)	ACTUAL LOAD (lbs)	ATTACHMENT (PASS/FAIL)
Right Rear Side Facing Seat	Forward	5000	4997.0	PASS
Left Rear Side Facing Seat	Forward	5000	4908.0	PASS
