**FINAL REPORT NUMBER 225-MGA-06-006**

**SAFETY COMPLIANCE TESTING FOR FMVSS 225**  
*“Child Restraint Anchorage Systems”*

**LANDROVER IN THE UK**  
**2006 LAND ROVER LR3**  
**NHTSA No. C60600**

**MGA RESEARCH CORPORATION**  
**446 Executive Drive**  
**Troy, Michigan 48083**

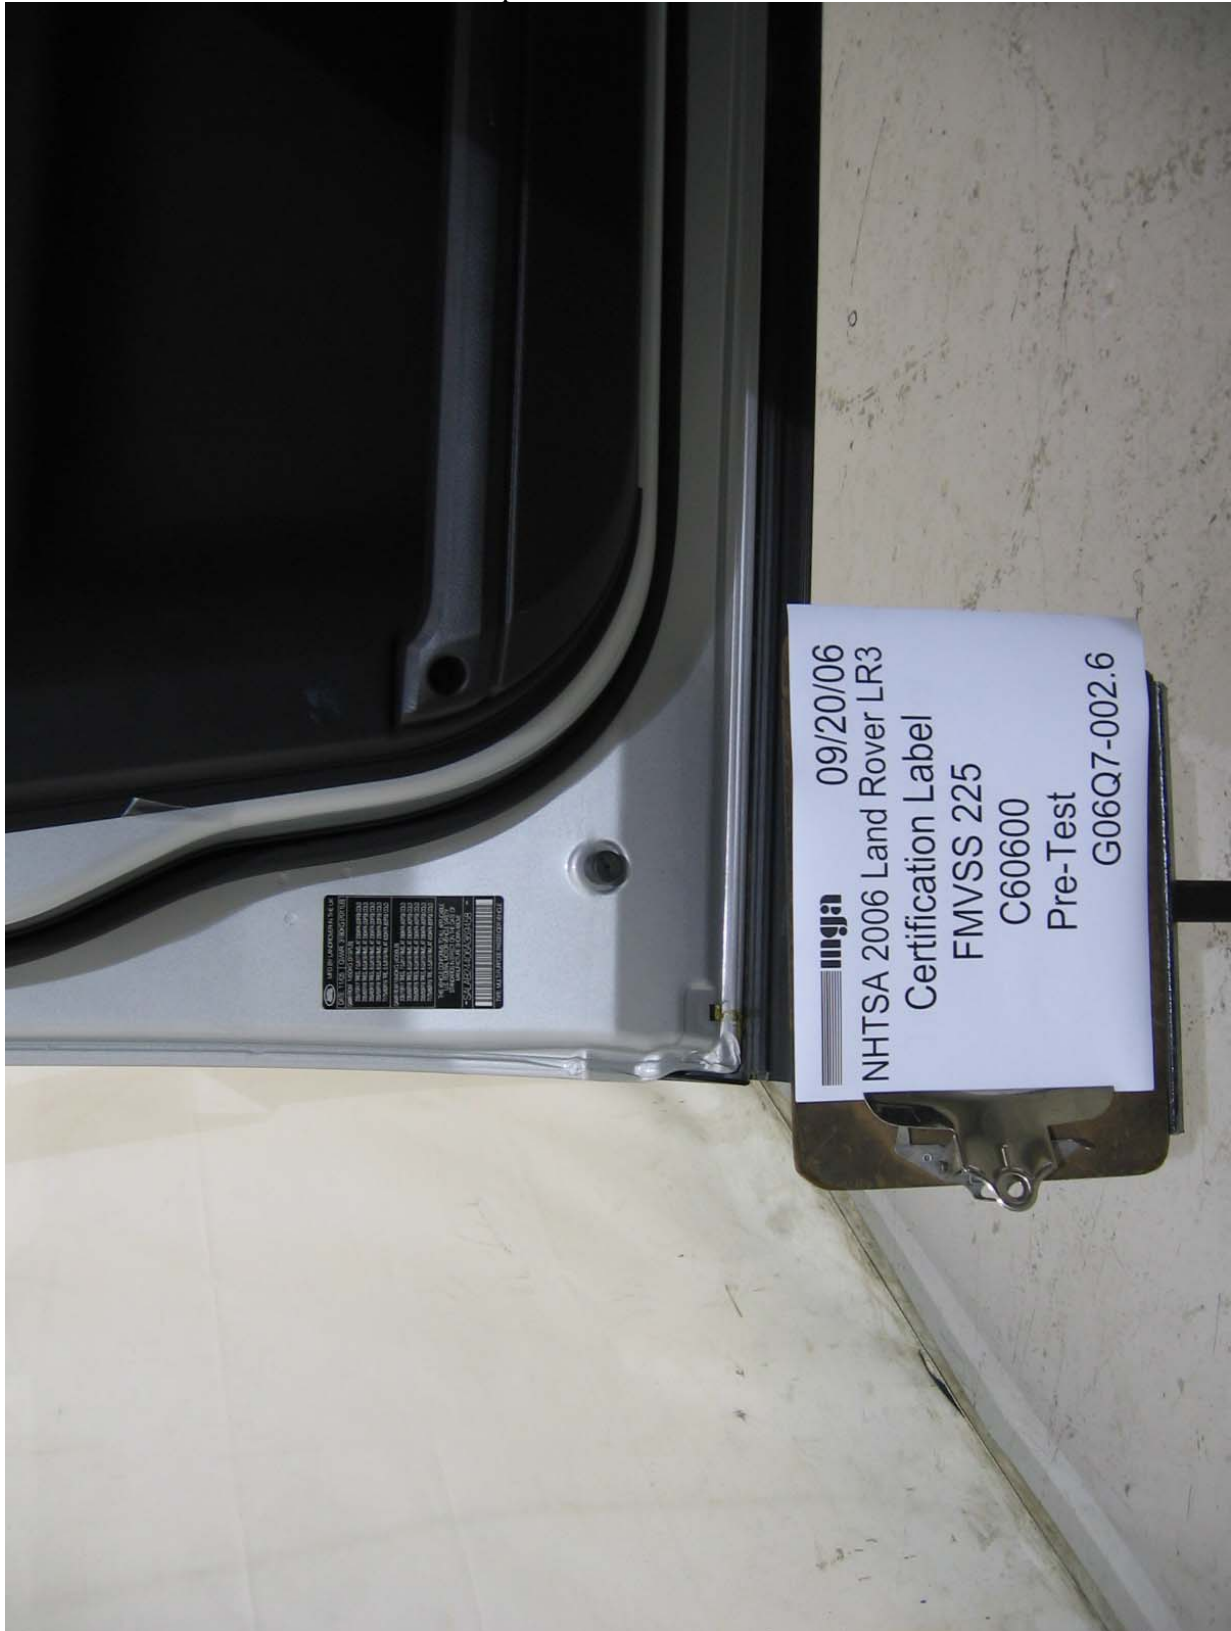
- 6.5 Test vehicle's certification label
- 6.5.1 Certification label photo #1

DATA FROM VEHICLE’S CERTIFICATION LABEL:

Vehicle Manufactured By: LandRover in the UK

Date of Manufacture: 11/05; VIN: SALAB24406A369458

GVWR: 7011 lbs; GAWR FRONT: 3197 lbs

GAWR REAR: 4056 lbs

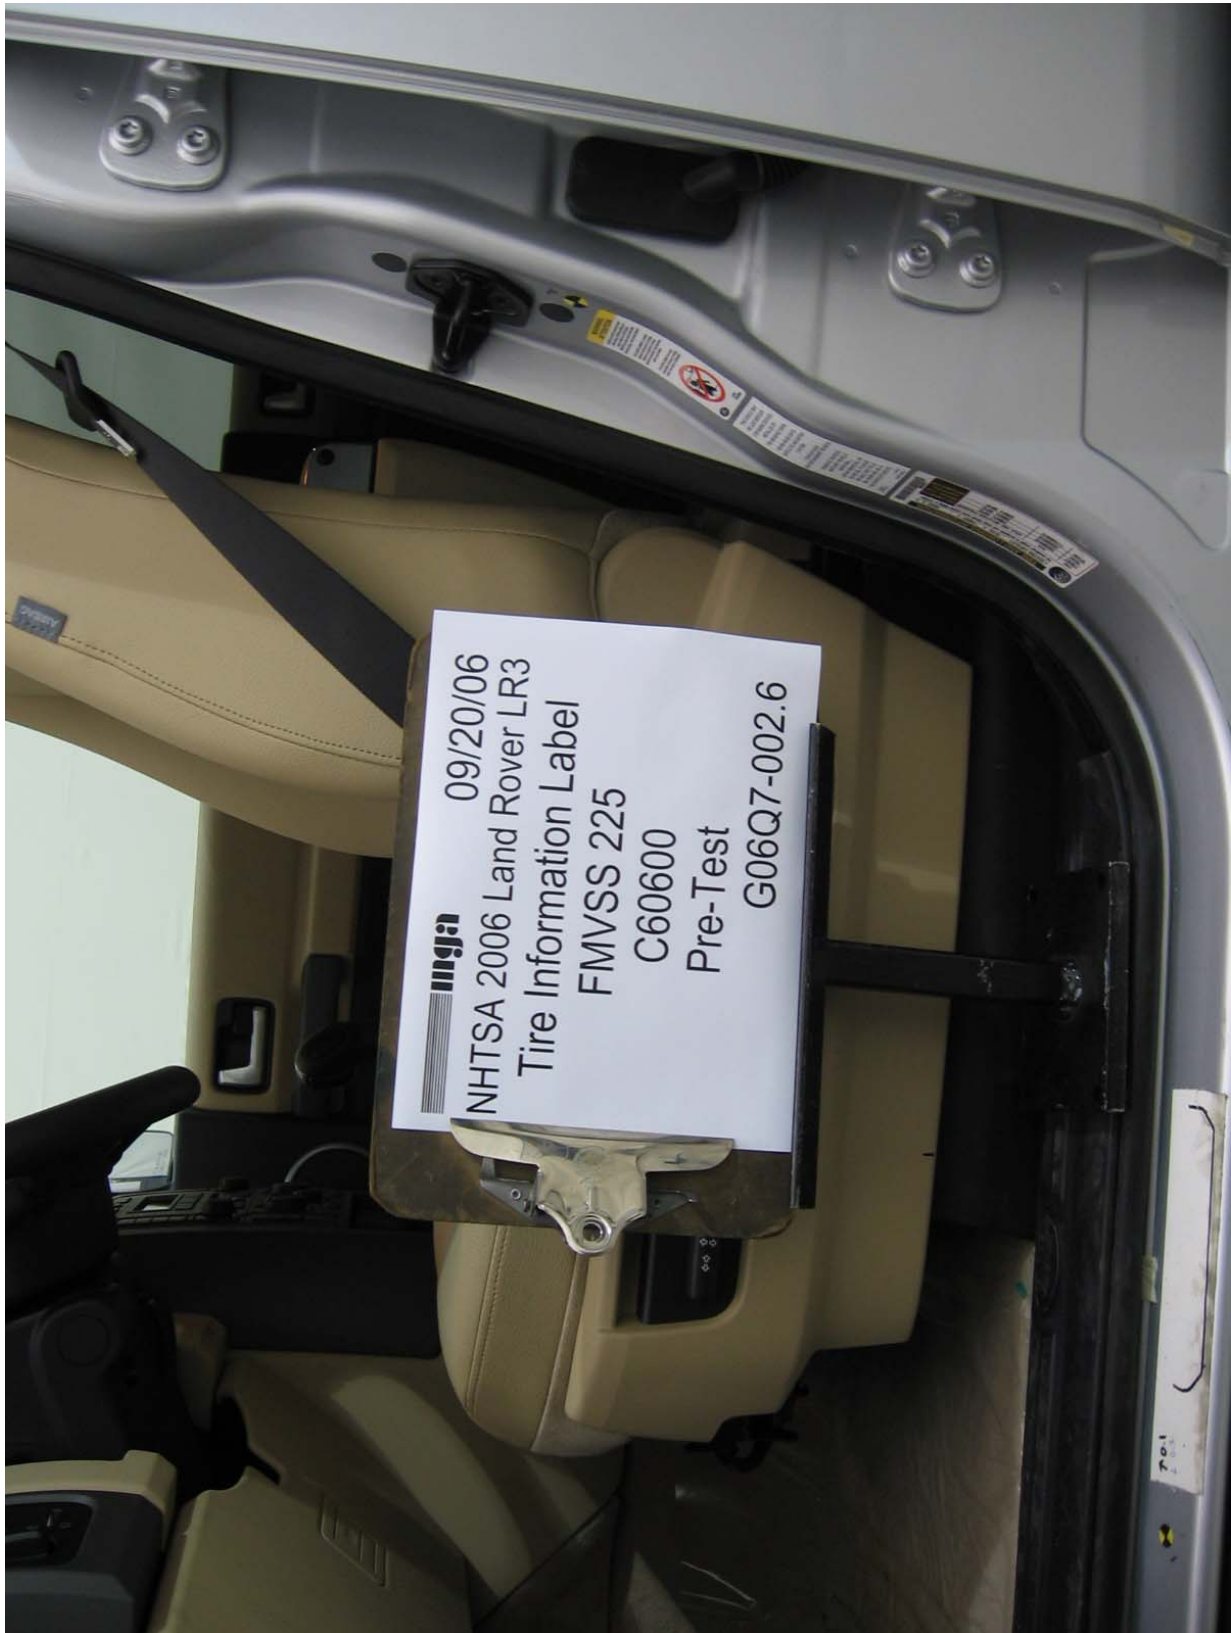
6.5.3 Tire information label photo #1

DATA FROM TIRE PLACARD:

Tire Pressure with Maximum Capacity Vehicle Load:

FRONT: 33 psi REAR: 42 psi

Recommended Tire Size: P225/60R18

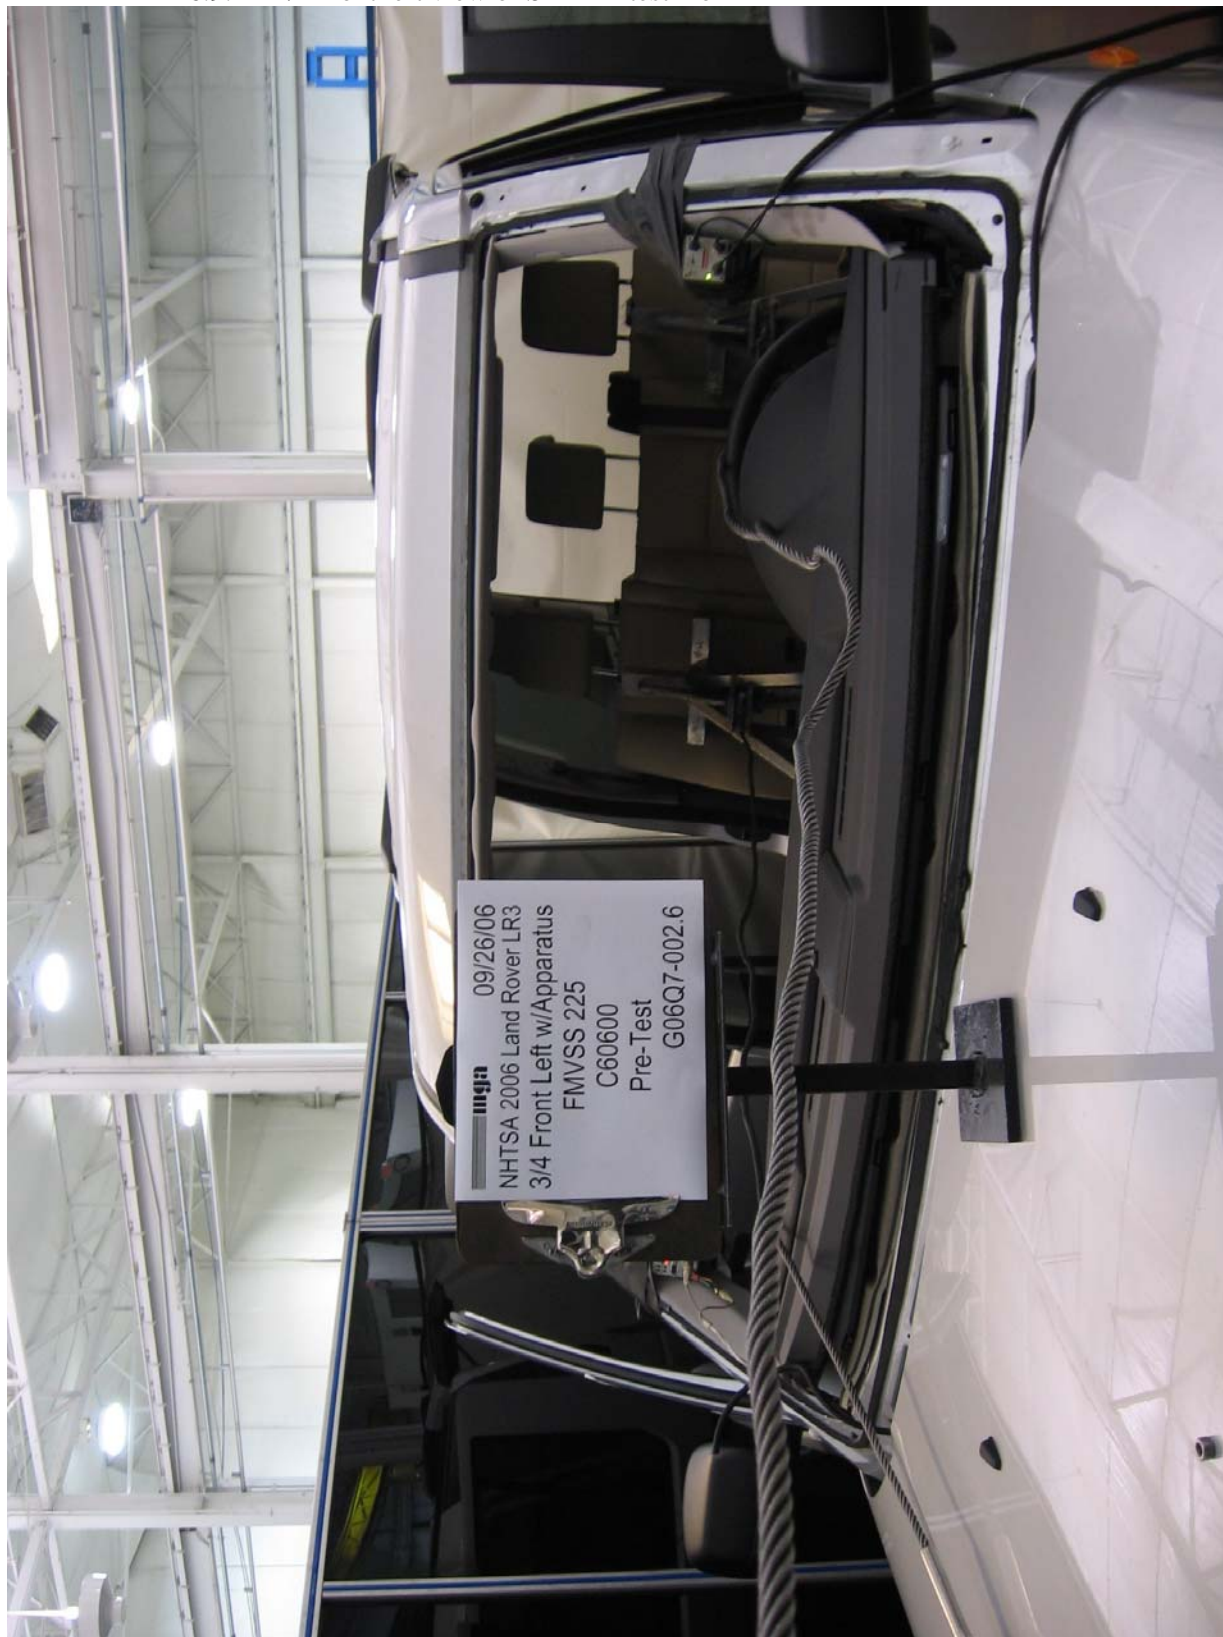
- 6.9 3/4 Front view of test vehicle with test apparatus in place
- 6.9.1 3/4 Front left view of SFADII test 1 of 2

The SFADII at the 2<sup>nd</sup> row left seating position sustained a maximum force of 15,244 N and held the required load for 3 seconds. The SFADII at the 2<sup>nd</sup> row right seating position sustained a maximum force of 11,209 N and held the required load for 3 seconds. The total displacement from point “X” on the SFADII for the 2<sup>nd</sup> row right seating position was 77 mm. The SFADI at the 2<sup>nd</sup> row center seating position sustained a maximum force of 15,171 N and held the required load for 3 seconds.
