REPORT NUMBER: 201UI-CAL-07-01

**SAFETY COMPLIANCE TESTING FOR FMVSS 201  
OCCUPANT PROTECTION IN INTERIOR IMPACT  
UPPER INTERIOR HEAD IMPACT PROTECTION**

**TOYOTA MOTOR CORPORATION  
2007 TOYOTA CAMRY, 4-DOOR SEDAN**

FINAL REPORT

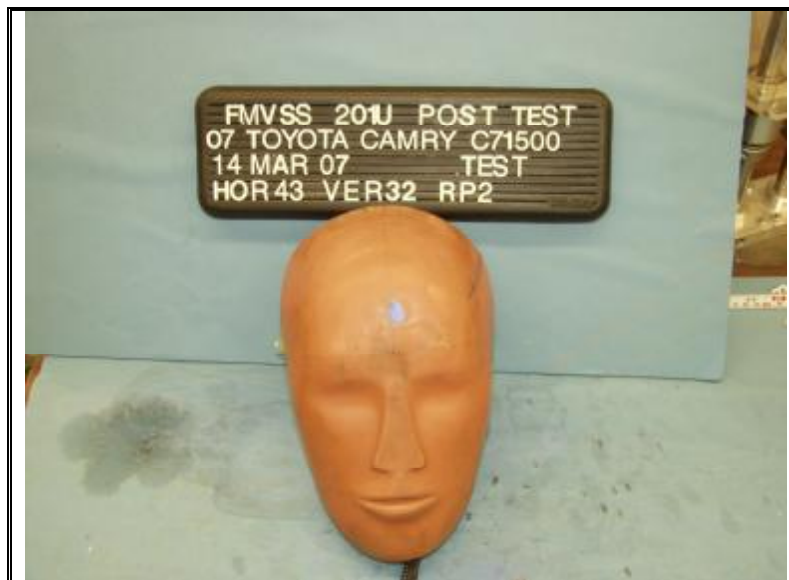
POST-IMPACT RP2 HEADFORM

Test Number:	01
Test Date:	03/14/07
Target Location:	REAR PILLAR
Target Code:	RP2
Horizontal Impact Angle:	43°
Vertical Impact Angle:	32°
Ambient Temperature:	22°C
Relative Humidity:	40.3
Time of Impact:	11:20
Headform Number:	0062

Impact Point Description (from lower midpoint on midsagittal line)					
On Centerline	3	<input checked="" type="checkbox"/>	mm right	<input type="checkbox"/>	mm left
On Centerline	24				mm up

Free Motion HIC	873.1
HIC(d)	825.1
Impact Velocity (kph)	23.42
HIC T1 (msec)	4.1
HIC T2 (msec)	9.7

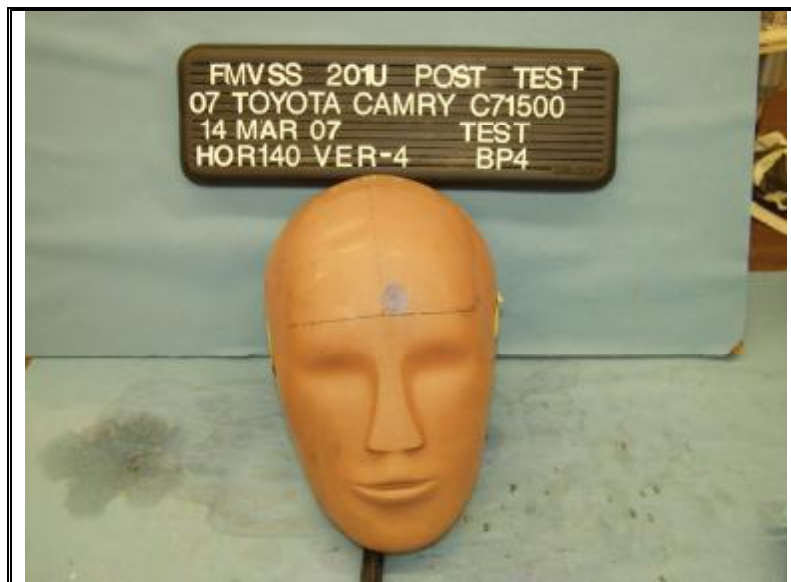
POST-IMPACT BP4 HEADFORM

Test Number:	02
Test Date:	03/14/07
Target Location:	B-PILLAR
Target Code:	BP4
Horizontal Impact Angle:	140°
Vertical Impact Angle:	-4°
Ambient Temperature:	21.2°C
Relative Humidity:	55.2
Time of Impact:	13:30
Headform Number:	0642

Impact Point Description (from lower midpoint on midsagittal line)			
On Centerline	9	mm right	x mm left
On Centerline	10	mm up

Free Motion HIC	561.7
HIC(d)	590.2
Impact Velocity (kph)	23.5
HIC T1 (msec)	6.9
HIC T2 (msec)	11.8

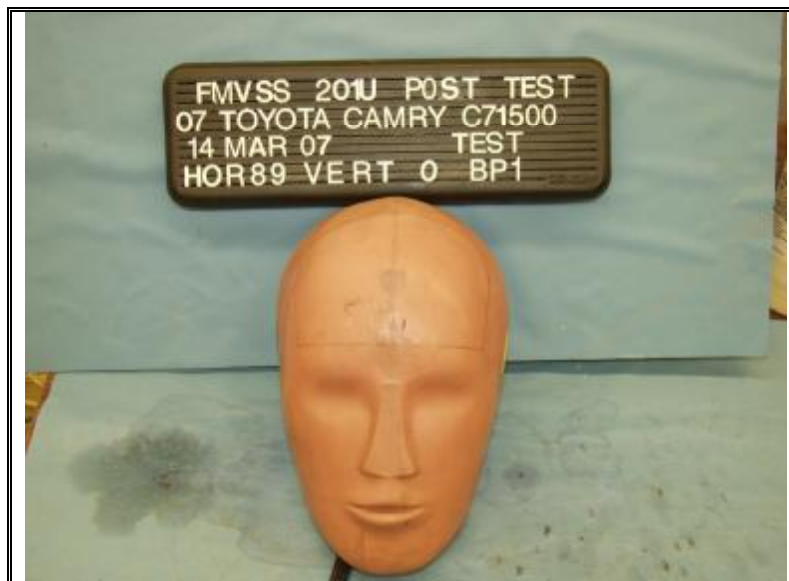
POST-IMPACT BP1 HEADFORM

Test Number:	03
Test Date:	03/14/07
Target Location:	B-PILLAR
Target Code:	BP1
Horizontal Impact Angle:	89°
Vertical Impact Angle:	10°
Ambient Temperature:	20.7°C
Relative Humidity:	58.1
Time of Impact:	14:35
Headform Number:	0805

Impact Point Description (from lower midpoint on midsagittal line)					
On Centerline	0	<input type="checkbox"/>	mm right	<input type="checkbox"/>	mm left
On Centerline	35				mm up

Free Motion HIC	406.1
HIC(d)	472.8
Impact Velocity (kph)	23.29**
HIC T1 (msec)	4.1
HIC T2 (msec)	13.9

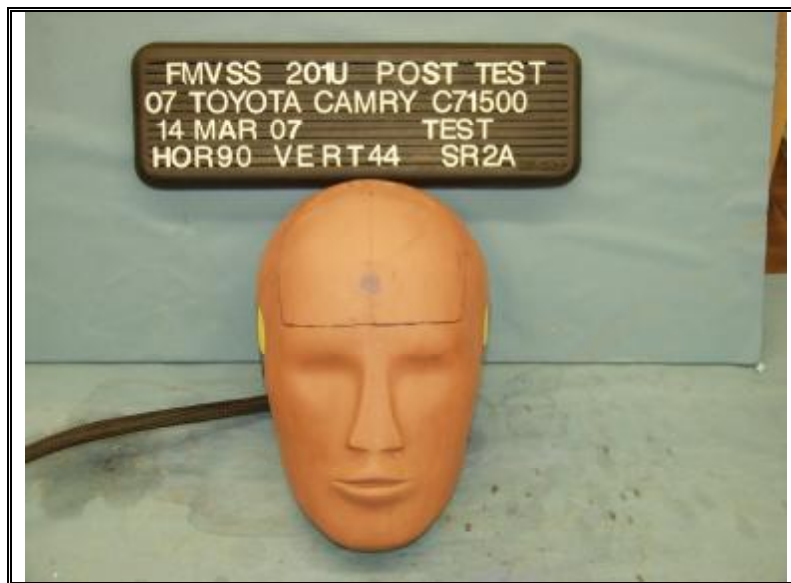
POST-IMPACT SR2A HEADFORM

Test Number:	04
Test Date:	03/14/07
Target Location:	SIDE RAIL
Target Code:	SR2A
Horizontal Impact Angle:	90°
Vertical Impact Angle:	44°
Ambient Temperature:	20.0°C
Relative Humidity:	54.8
Time of Impact:	15:57
Headform Number:	1255

Impact Point Description (from lower midpoint on midsagittal line)					
On Centerline	0	<input type="checkbox"/>	mm right	<input type="checkbox"/>	mm left
On Centerline	25				mm up

Free Motion HIC	343.7
HIC(d)	425.7
Impact Velocity (kph)	18.50
HIC T1 (msec)	3.7
HIC T2 (msec)	12.9

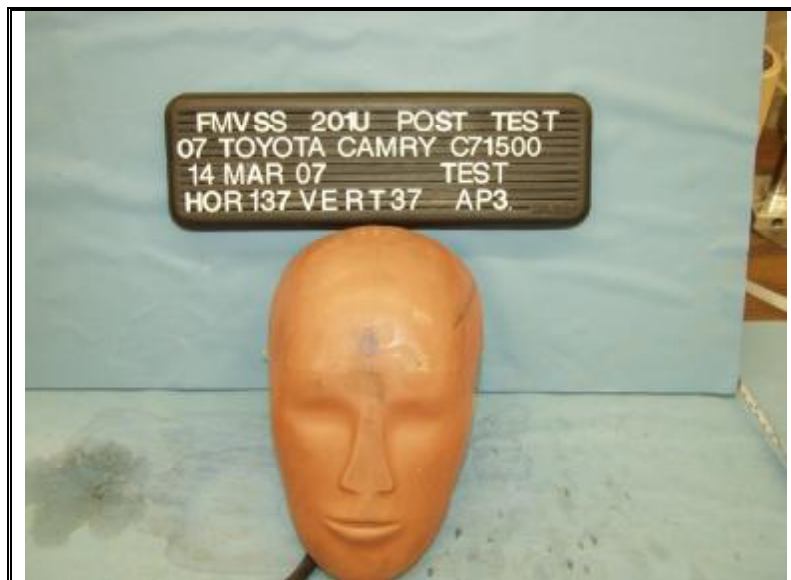
POST-IMPACT AP3 HEADFORM

Test Number:	05
Test Date:	03/14/07
Target Location:	A-PILLAR
Target Code:	AP3
Horizontal Impact Angle:	137°
Vertical Impact Angle:	37°
Ambient Temperature:	20.2°C
Relative Humidity:	56.5
Time of Impact:	16:43
Headform Number:	0062

Impact Point Description (from lower midpoint on midsagittal line)			
On Centerline	3	<input checked="" type="checkbox"/>	mm right <input type="checkbox"/> mm left
On Centerline	17		mm up

Free Motion HIC	170.2
HIC(d)	294.8
Impact Velocity (kph)	18.9
HIC T1 (msec)	9.5
HIC T2 (msec)	15.4

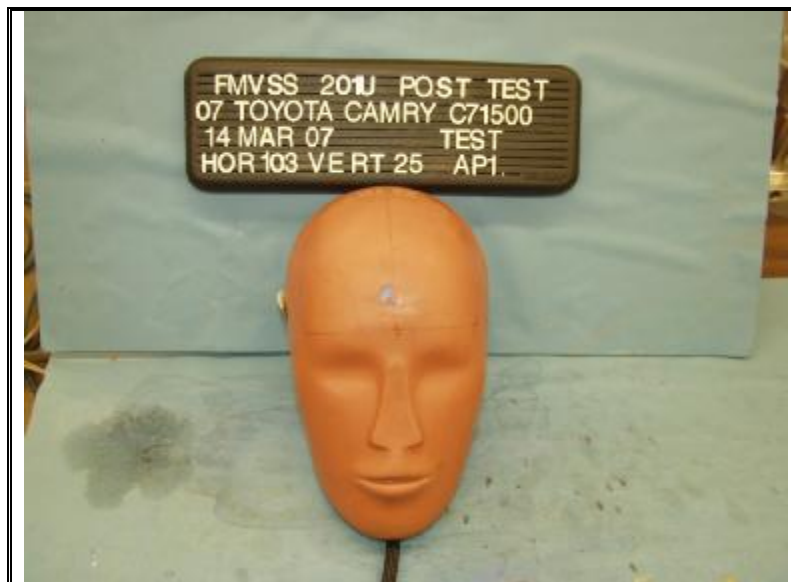
POST-IMPACT AP1 HEADFORM

Test Number:	06
Test Date:	03/14/07
Target Location:	A-PILLAR
Target Code:	AP1
Horizontal Impact Angle:	103°
Vertical Impact Angle:	25°
Ambient Temperature:	20.2°C
Relative Humidity:	56.6
Time of Impact:	17:12
Headform Number:	0355

Impact Point Description (from lower midpoint on midsagittal line)					
On Centerline	3	<input checked="" type="checkbox"/>	mm right	<input type="checkbox"/>	mm left
On Centerline	21				mm up

Free Motion HIC	398.1
HIC(d)	466.8
Impact Velocity (kph)	18.36
HIC T1 (msec)	6.5
HIC T2 (msec)	12.1

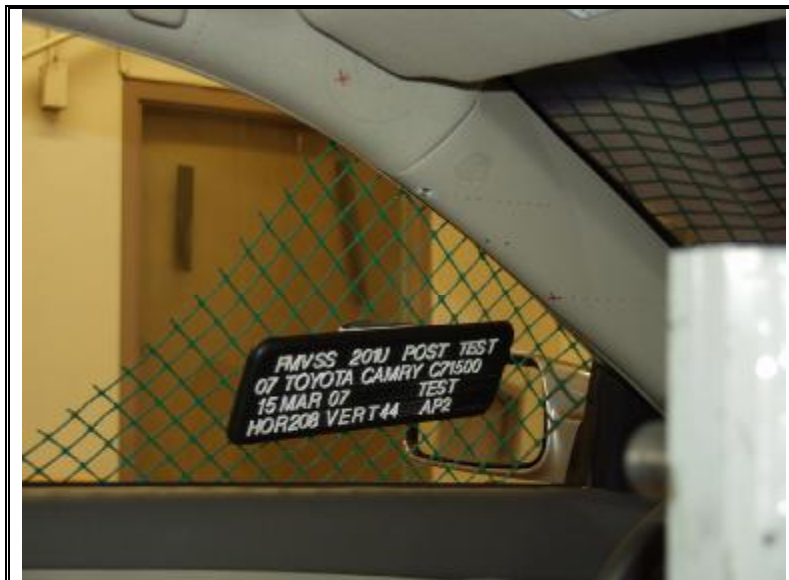
POST-IMPACT AP2 HEADFORM

Test Number:	07
Test Date:	03/15/07
Target Location:	A-PILLAR
Target Code:	AP2
Horizontal Impact Angle:	208°
Vertical Impact Angle:	44°
Ambient Temperature:	21.7°C
Relative Humidity:	28
Time of Impact:	10:18
Headform Number:	0355

Impact Point Description (from lower midpoint on midsagittal line)			
On Centerline	5	<input checked="" type="checkbox"/>	mm right <input type="checkbox"/> mm left
On Centerline	15		mm up

Free Motion HIC	189
HIC(d)	309
Impact Velocity (kph)	18.58
HIC T1 (msec)	7.2
HIC T2 (msec)	13.3

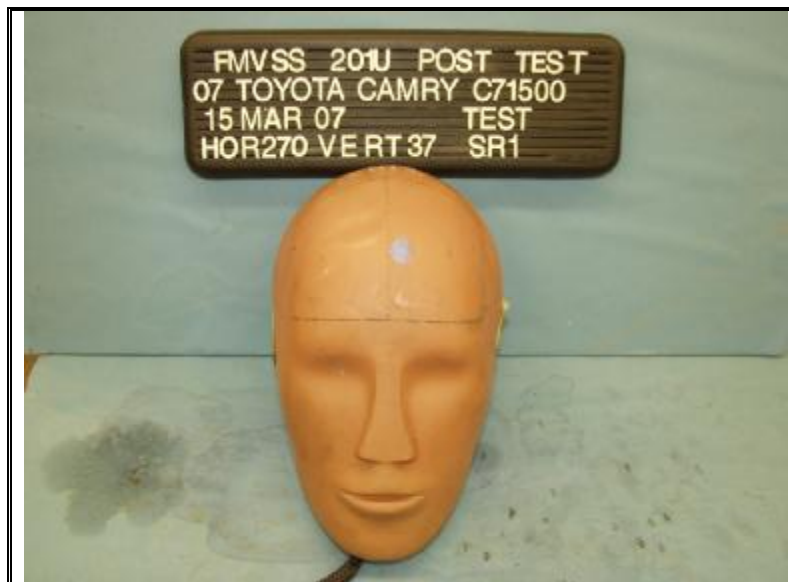
POST-IMPACT SR1 HEADFORM

Test Number:	08
Test Date:	03/15/07
Target Location:	SIDE RAIL
Target Code:	SR1
Horizontal Impact Angle:	270°
Vertical Impact Angle:	37°
Ambient Temperature:	21.8°C
Relative Humidity:	26.8
Time of Impact:	10:54
Headform Number:	0642

Impact Point Description (from lower midpoint on midsagittal line)			
On Centerline	3	mm right	x mm left
On Centerline	39	mm up

Free Motion HIC	317.4
HIC(d)	405.8
Impact Velocity (kph)	18.37
HIC T1 (msec)	3.7
HIC T2 (msec)	11.3

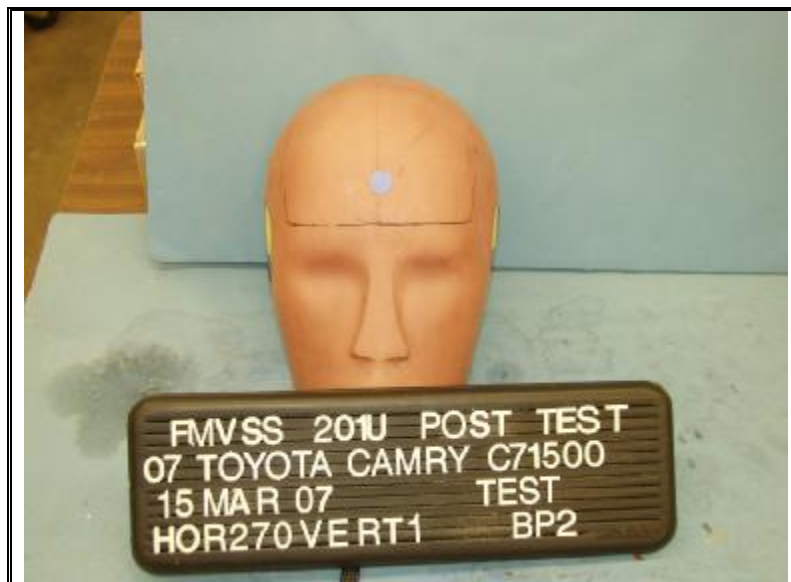
POST-IMPACT BP2 HEADFORM

Test Number:	09
Test Date:	03/15/07
Target Location:	B-PILLAR
Target Code:	BP2
Horizontal Impact Angle:	270°
Vertical Impact Angle:	1°
Ambient Temperature:	21.8°C
Relative Humidity:	24.7
Time of Impact:	12:02
Headform Number:	1255

Impact Point Description (from lower midpoint on midsagittal line)			
On Centerline	3	mm right	x mm left
On Centerline	24	mm up

Free Motion HIC	495.1
HIC(d)	539.9
Impact Velocity (kph)	23.32
HIC T1 (msec)	2.9
HIC T2 (msec)	10.8

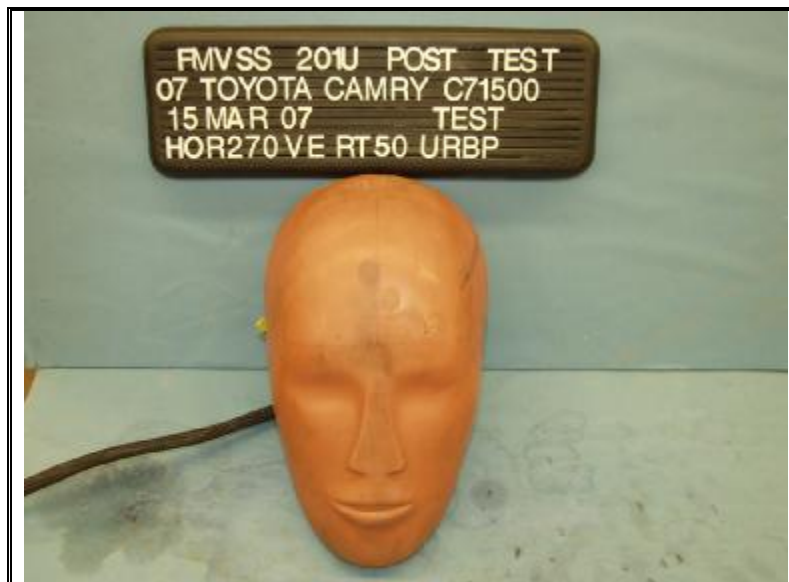
POST-IMPACT URBP HEADFORM

Test Number:	10
Test Date:	03/15/07
Target Location:	UPPER ROOF
Target Code:	URBP
Horizontal Impact Angle:	270°
Vertical Impact Angle:	50°
Ambient Temperature:	21.8°C
Relative Humidity:	25.3
Time of Impact:	12:42
Headform Number:	0062

Impact Point Description (from lower midpoint on midsagittal line)					
On Centerline	4	<input checked="" type="checkbox"/>	mm right	<input type="checkbox"/>	mm left
On Centerline	40				mm up

Free Motion HIC	598.4
HIC(d)	617.8
Impact Velocity (kph)	23.46
HIC T1 (msec)	3.1
HIC T2 (msec)	12.9

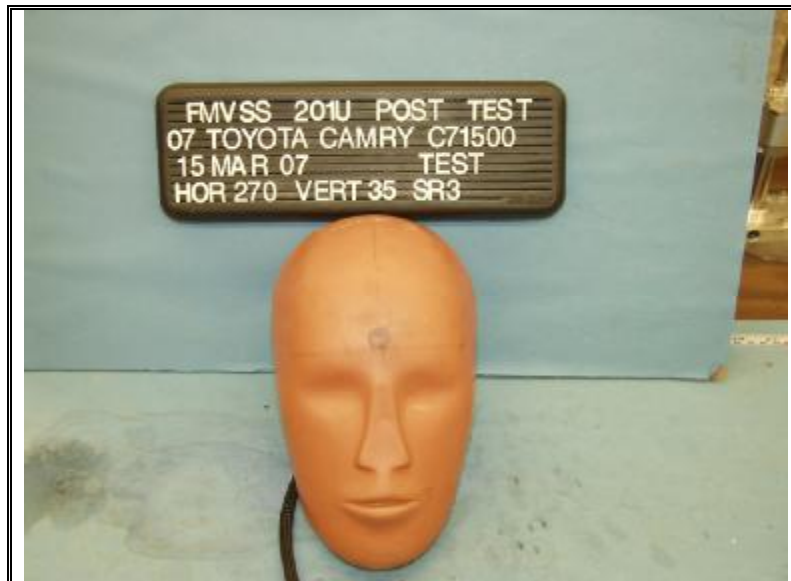
POST-IMPACT SR3 HEADFORM

Test Number:	11
Test Date:	03/15/07
Target Location:	SIDE RAIL
Target Code:	SR3
Horizontal Impact Angle:	270°
Vertical Impact Angle:	35°
Ambient Temperature:	21.8°C
Relative Humidity:	23.2
Time of Impact:	2:30
Headform Number:	0355

Impact Point Description (from lower midpoint on midsagittal line)			
On Centerline	0	<input type="checkbox"/>	mm right <input type="checkbox"/> mm left
On Centerline	6		mm up

Free Motion HIC	210.4
HIC(d)	325.2
Impact Velocity (kph)	18.53
HIC T1 (msec)	1.9
HIC T2 (msec)	11.7

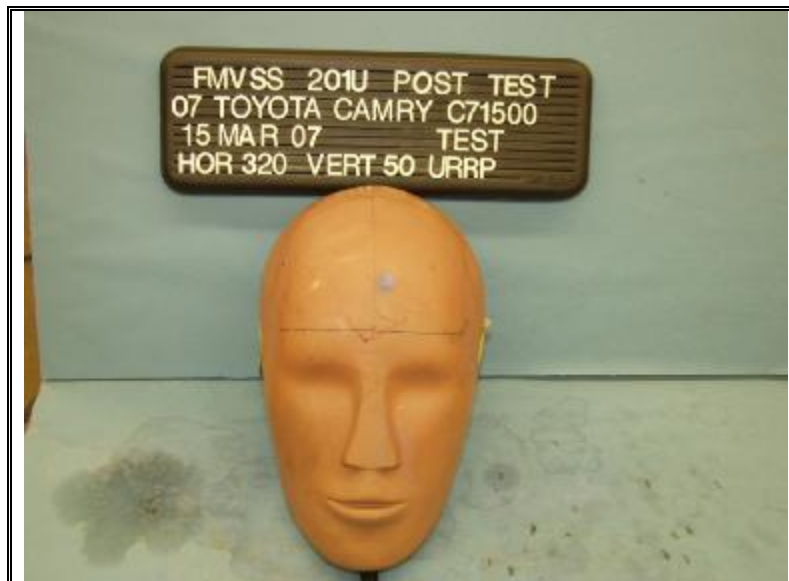
POST-IMPACT URRP HEADFORM

Test Number:	12
Test Date:	03/15/07
Target Location:	UPPER ROOF
Target Code:	URRP
Horizontal Impact Angle:	320E
Vertical Impact Angle:	50E
Ambient Temperature:	21.7EC
Relative Humidity:	22.6
Time of Impact:	14:24
Headform Number:	0642

Impact Point Description (from lower midpoint on midsagittal line)			
On Centerline	6	mm right	x mm left
On Centerline	28	mm up

Free Motion HIC	444.3
HIC(d)	501.6
Impact Velocity (kph)	23.3
HIC T1 (msec)	4.1
HIC T2 (msec)	15.6
