REPORT NUMBER: 201UI-CAL-07-02

**SAFETY COMPLIANCE TESTING FOR FMVSS 201
OCCUPANT PROTECTION IN INTERIOR IMPACT
UPPER INTERIOR HEAD IMPACT PROTECTION**

**KIA MOTOR CORPORATION FOR HYUNDAI MOTOR COMPANY
2007 HYUNDAI ENTOURAGE GLS**

FINAL REPORT

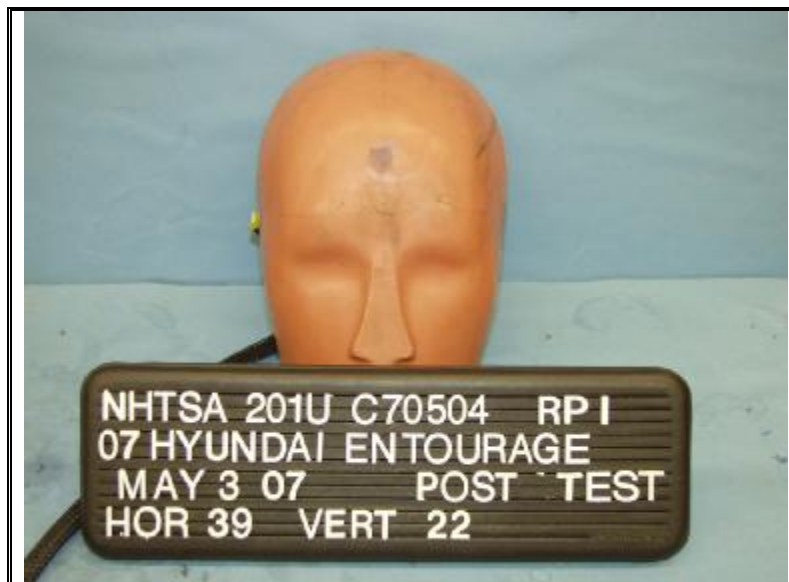
POST-IMPACT RP1 HEADFORM

Impact Point Description (from lower midpoint on midsagittal line)			
On Centerline	0	mm right	mm left
On Centerline	30	mm up

Free Motion HIC	236.1
HIC(d)	344.5
Impact Velocity (kph)	23.59
HIC T1 (msec)	3.9
HIC T2 (msec)	21.9

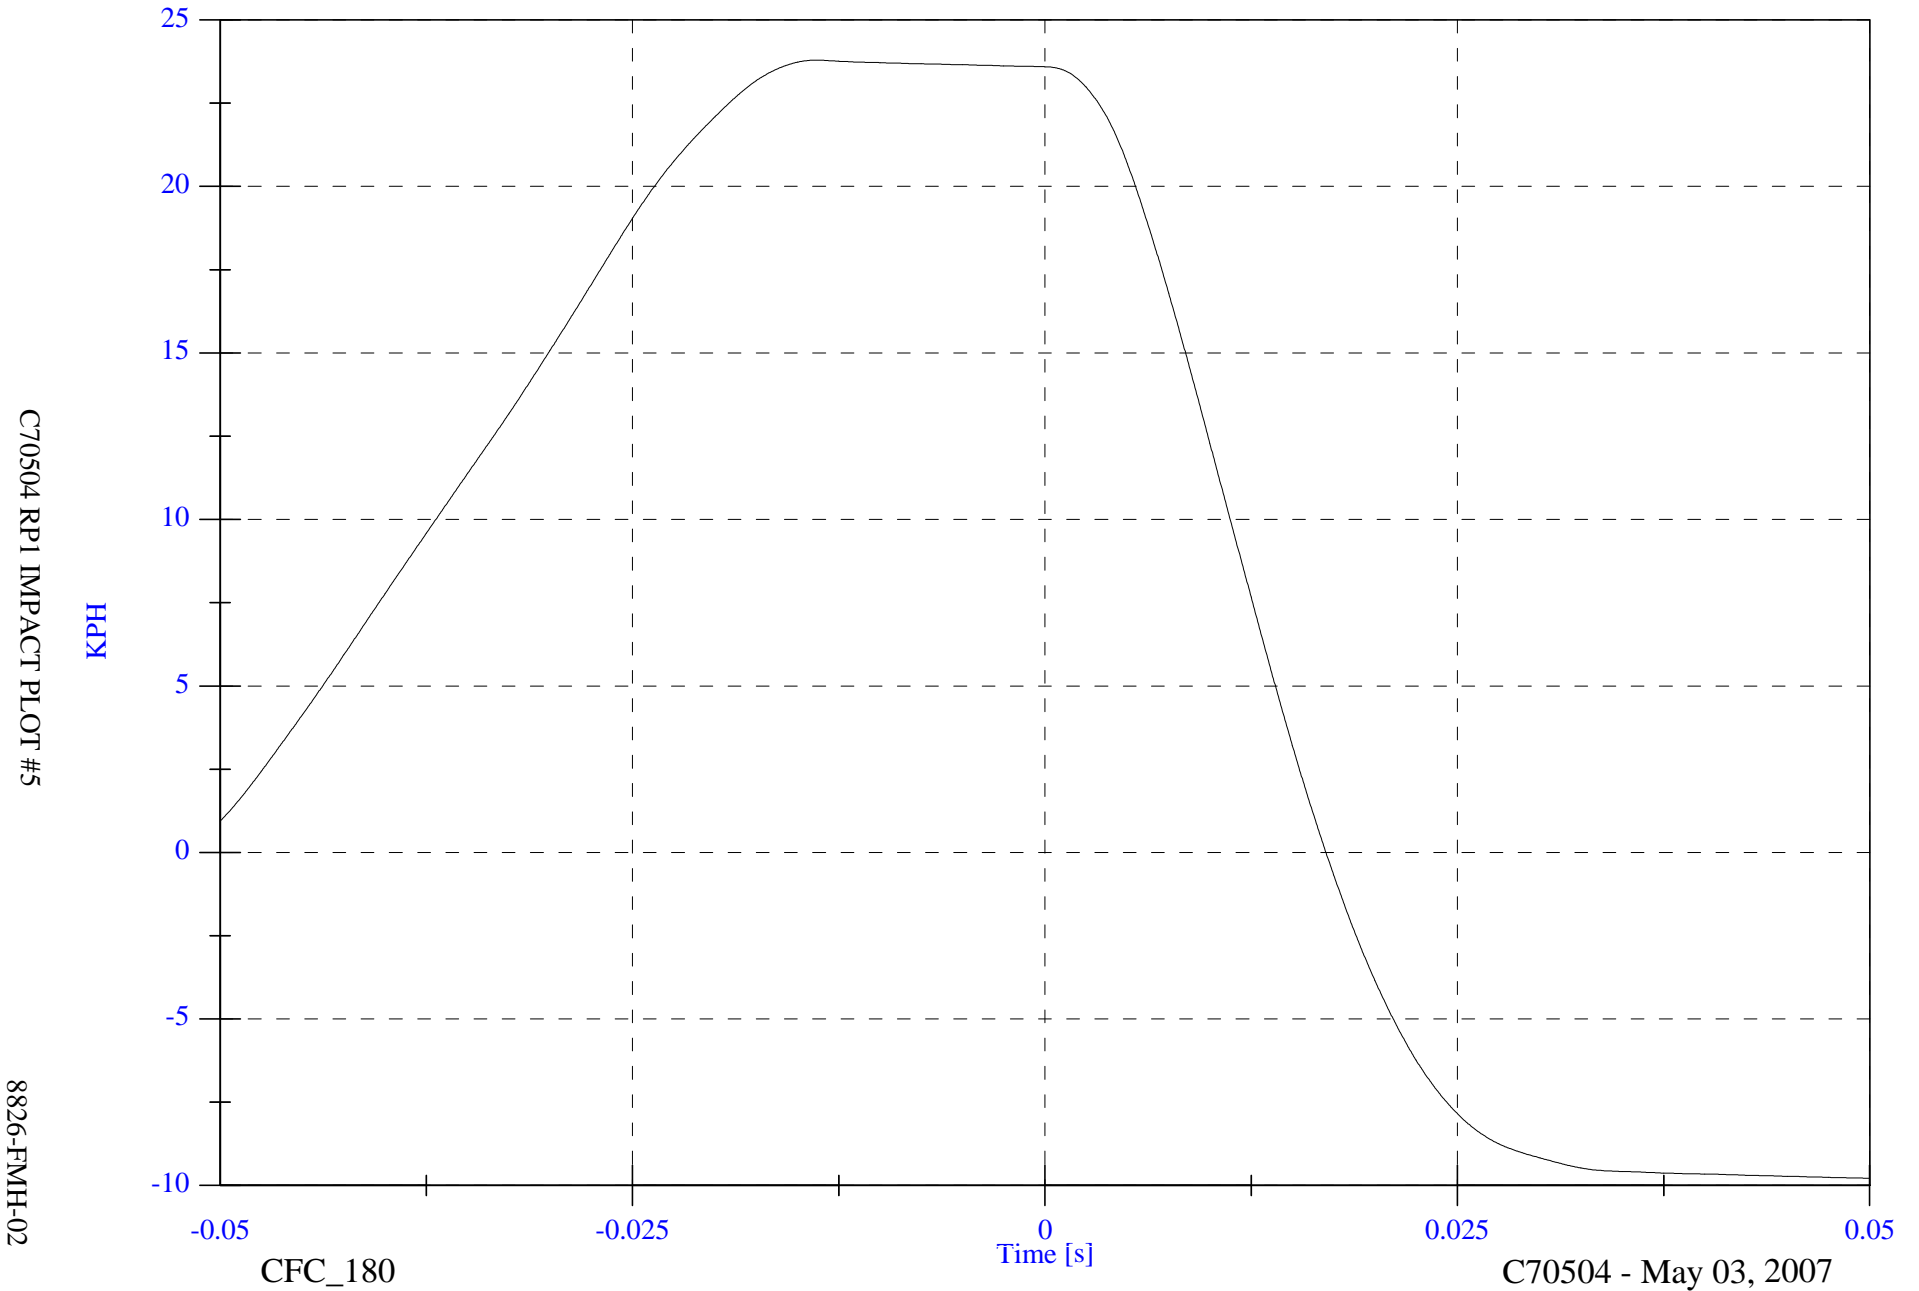
C70504 RP1 IMPACT PLOT #5

Max: 23.8 [KPH] at -0.014 [s]

Min: -9.8 [KPH] at 0.050 [s]

Headform Velocity

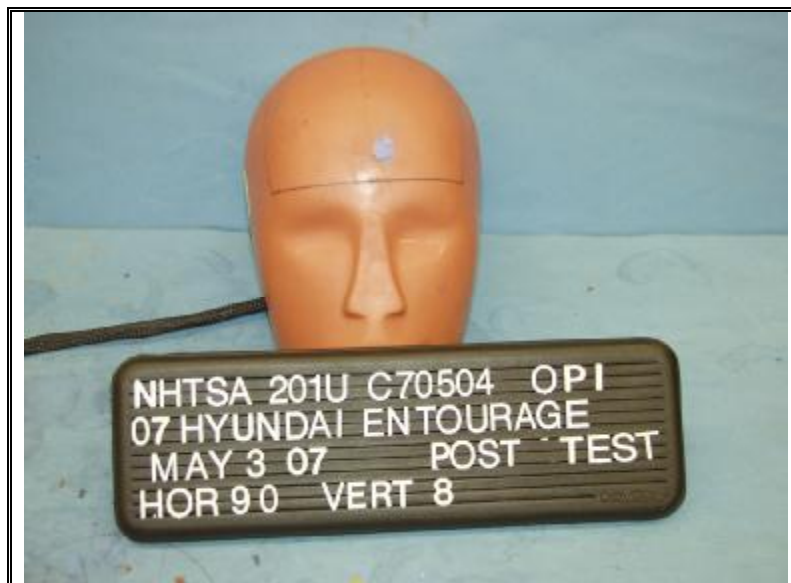
POST-IMPACT OP1 HEADFORM

Impact Point Description (from lower midpoint on midsagittal line)			
On Centerline	10	<input type="checkbox"/>	mm right <input checked="" type="checkbox"/> mm left
On Centerline	18		mm up

Free Motion HIC	534.8
HIC(d)	569.9
Impact Velocity (kph)	23.45
HIC T1 (msec)	5.2
HIC T2 (msec)	14.3

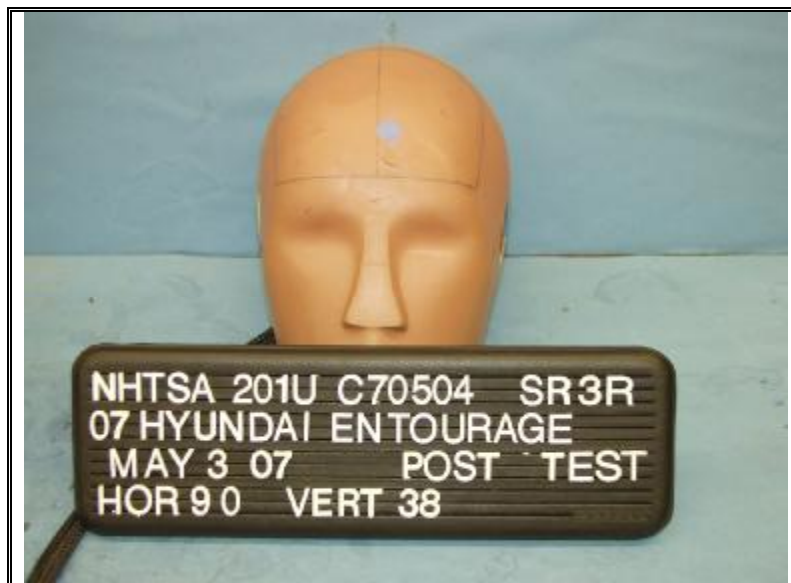
POST-IMPACT SR3R HEADFORM

Impact Point Description (from lower midpoint on midsagittal line)			
On Centerline	6	<input type="checkbox"/>	mm right <input checked="" type="checkbox"/> mm left
On Centerline	25		mm up

Free Motion HIC	444.6
HIC(d)	501.8
Impact Velocity (kph)	23.64
HIC T1 (msec)	2.3
HIC T2 (msec)	11.9

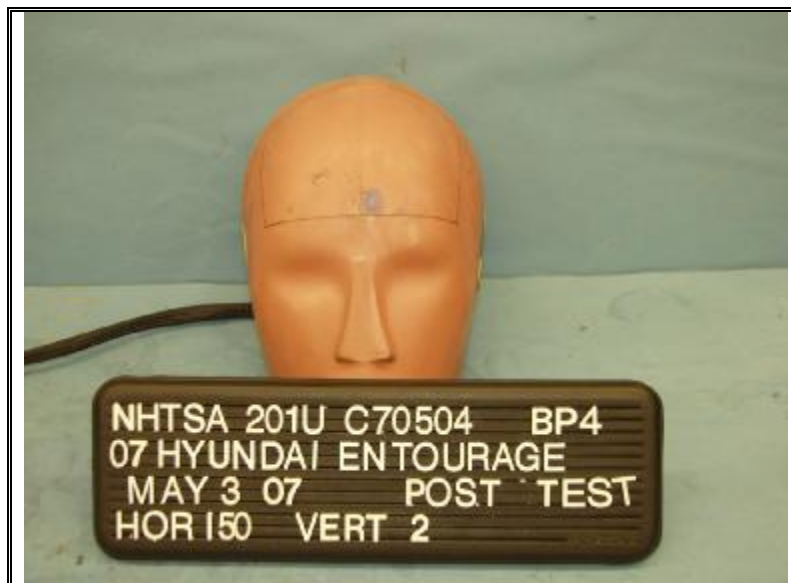
POST-IMPACT BP4 HEADFORM

Impact Point Description (from lower midpoint on midsagittal line)			
On Centerline	7	<input type="checkbox"/>	mm right <input checked="" type="checkbox"/> mm left
On Centerline	7		mm up

Free Motion HIC	452.8
HIC(d)	508.1
Impact Velocity (kph)	23.53
HIC T1 (msec)	2.5
HIC T2 (msec)	12.1

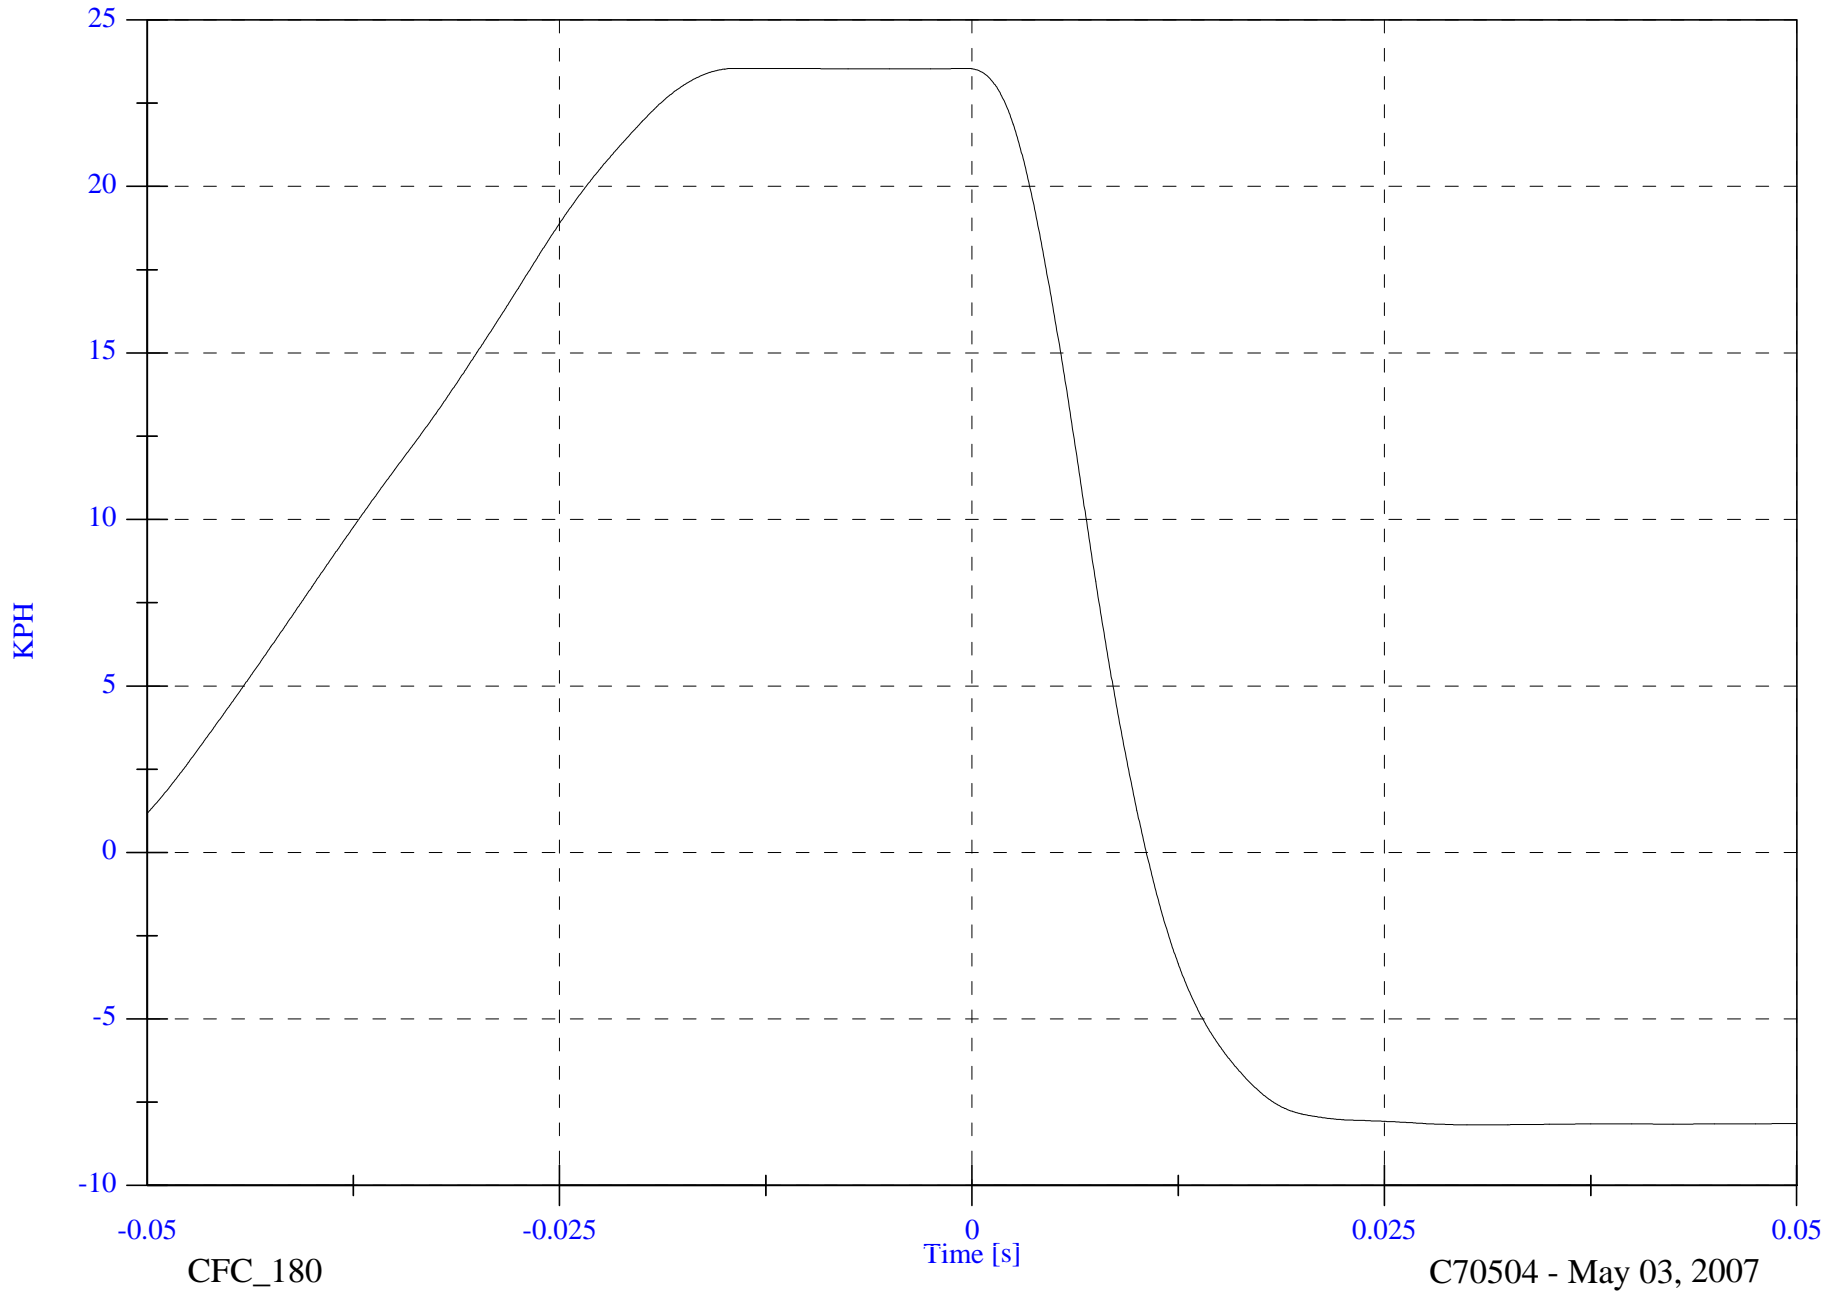
C70504 BP4 IMPACT PLOT #5

Min: -8.2 [KPH] at 0.030 [s]

Headform Velocity

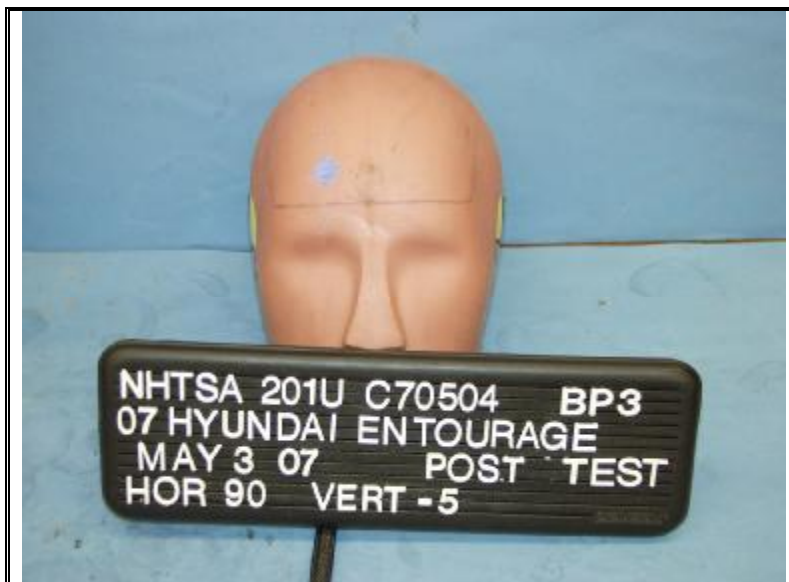
POST-IMPACT BP3 HEADFORM

Impact Point Description (from lower midpoint on midsagittal line)					
On Centerline	23	<input checked="" type="checkbox"/>	mm right	<input type="checkbox"/>	mm left
On Centerline	17			<input type="checkbox"/>	mm up

Free Motion HIC	480.4
HIC(d)	528.9
Impact Velocity (kph)	23.49
HIC T1 (msec)	4.0
HIC T2 (msec)	12.2

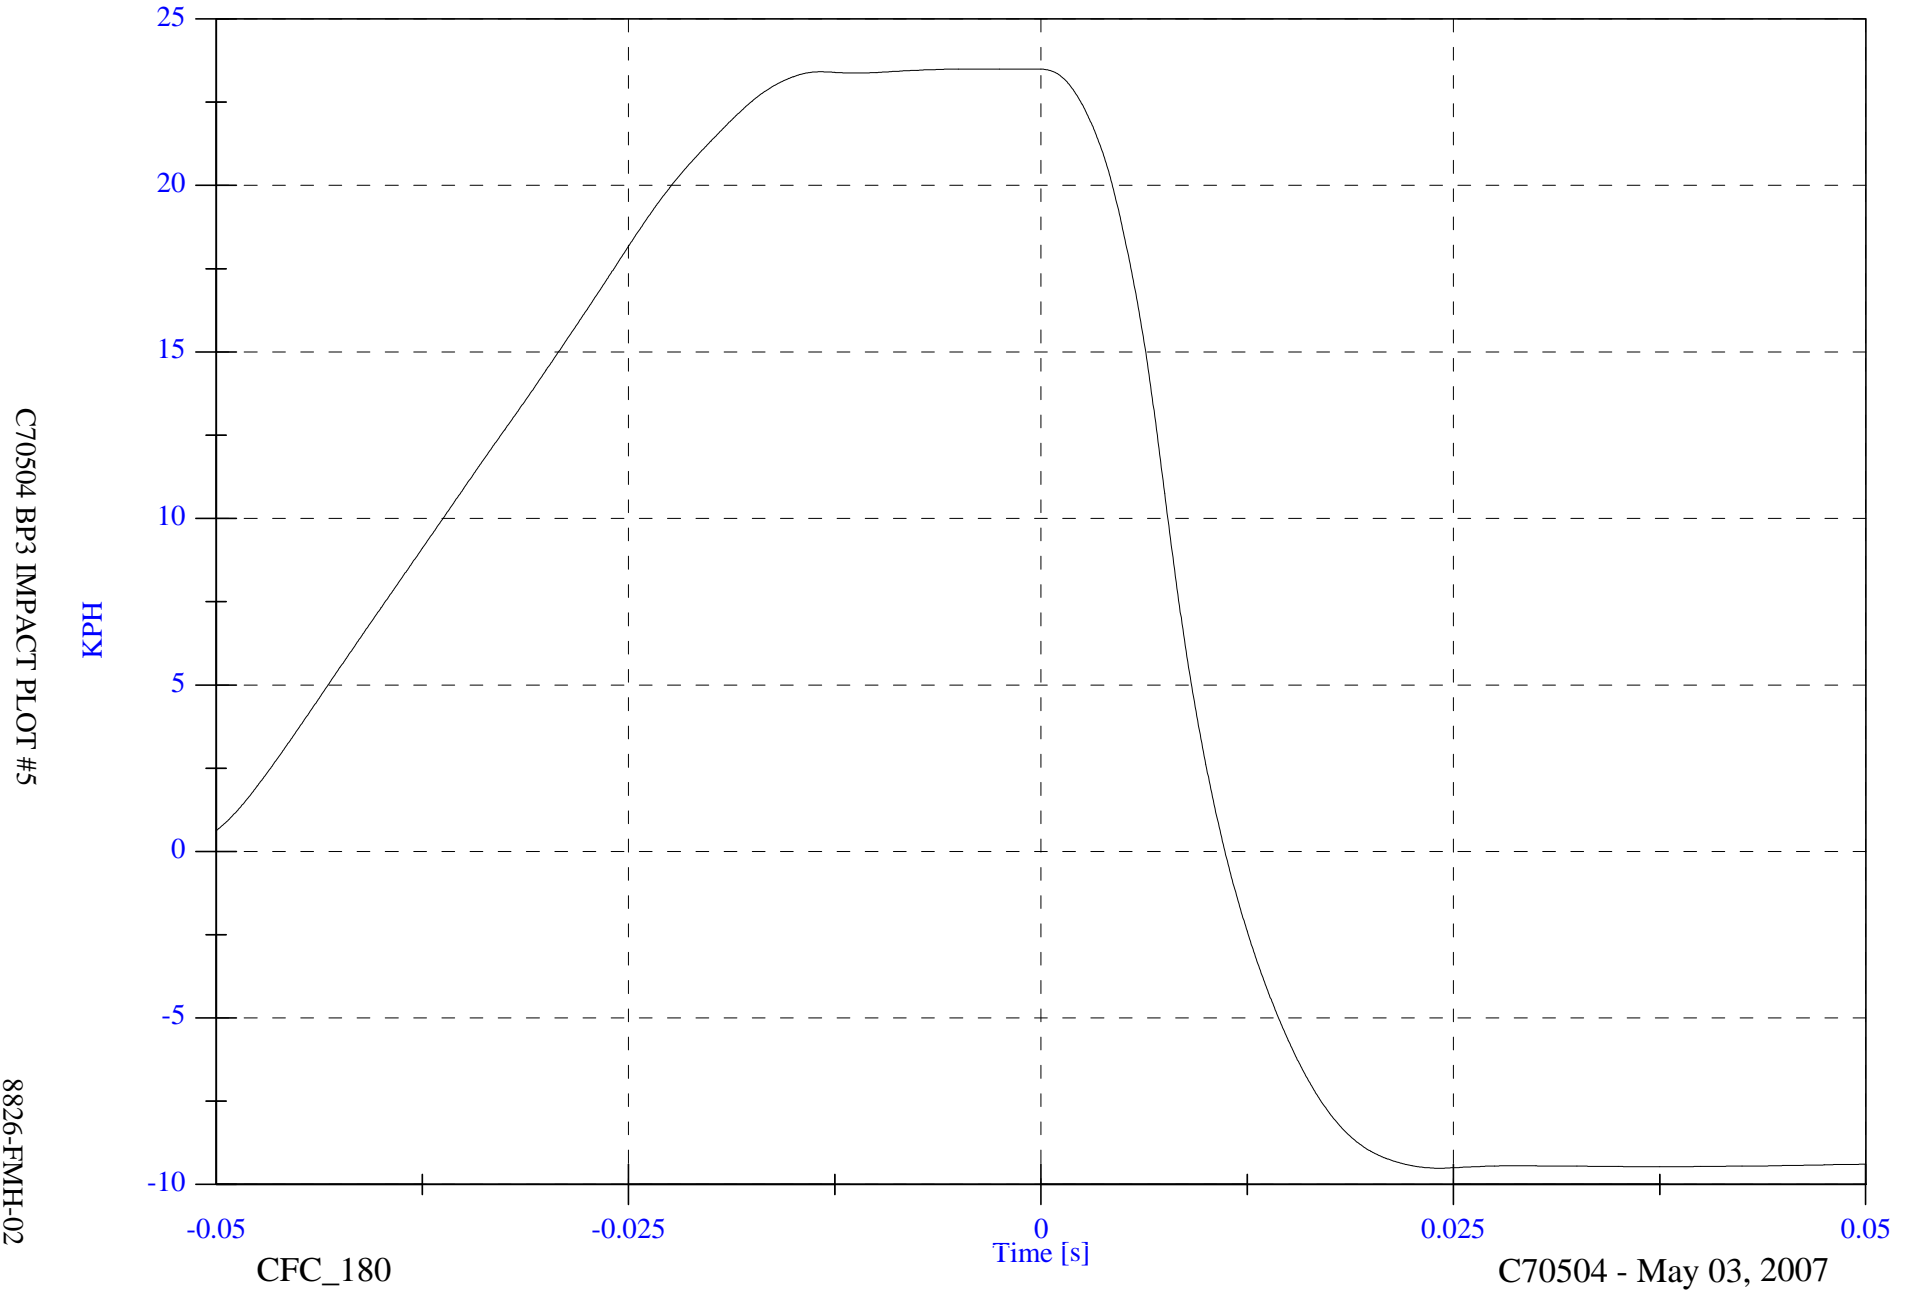
C70504 BP3 IMPACT PLOT #5

Min: -9.5 [KPH] at 0.024 [s]

Headform Velocity

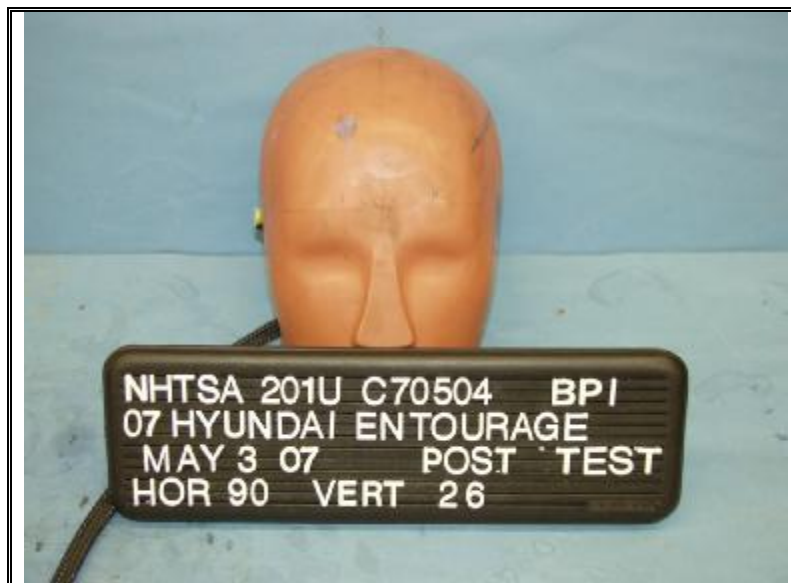
POST-IMPACT BP1 HEADFORM

Impact Point Description (from lower midpoint on midsagittal line)					
On Centerline	20	<input checked="" type="checkbox"/>	mm right	<input type="checkbox"/>	mm left
On Centerline	44				mm up

Free Motion HIC	508.5
HIC(d)	550.0
Impact Velocity (kph)	18.55
HIC T1 (msec)	7.6
HIC T2 (msec)	12.7

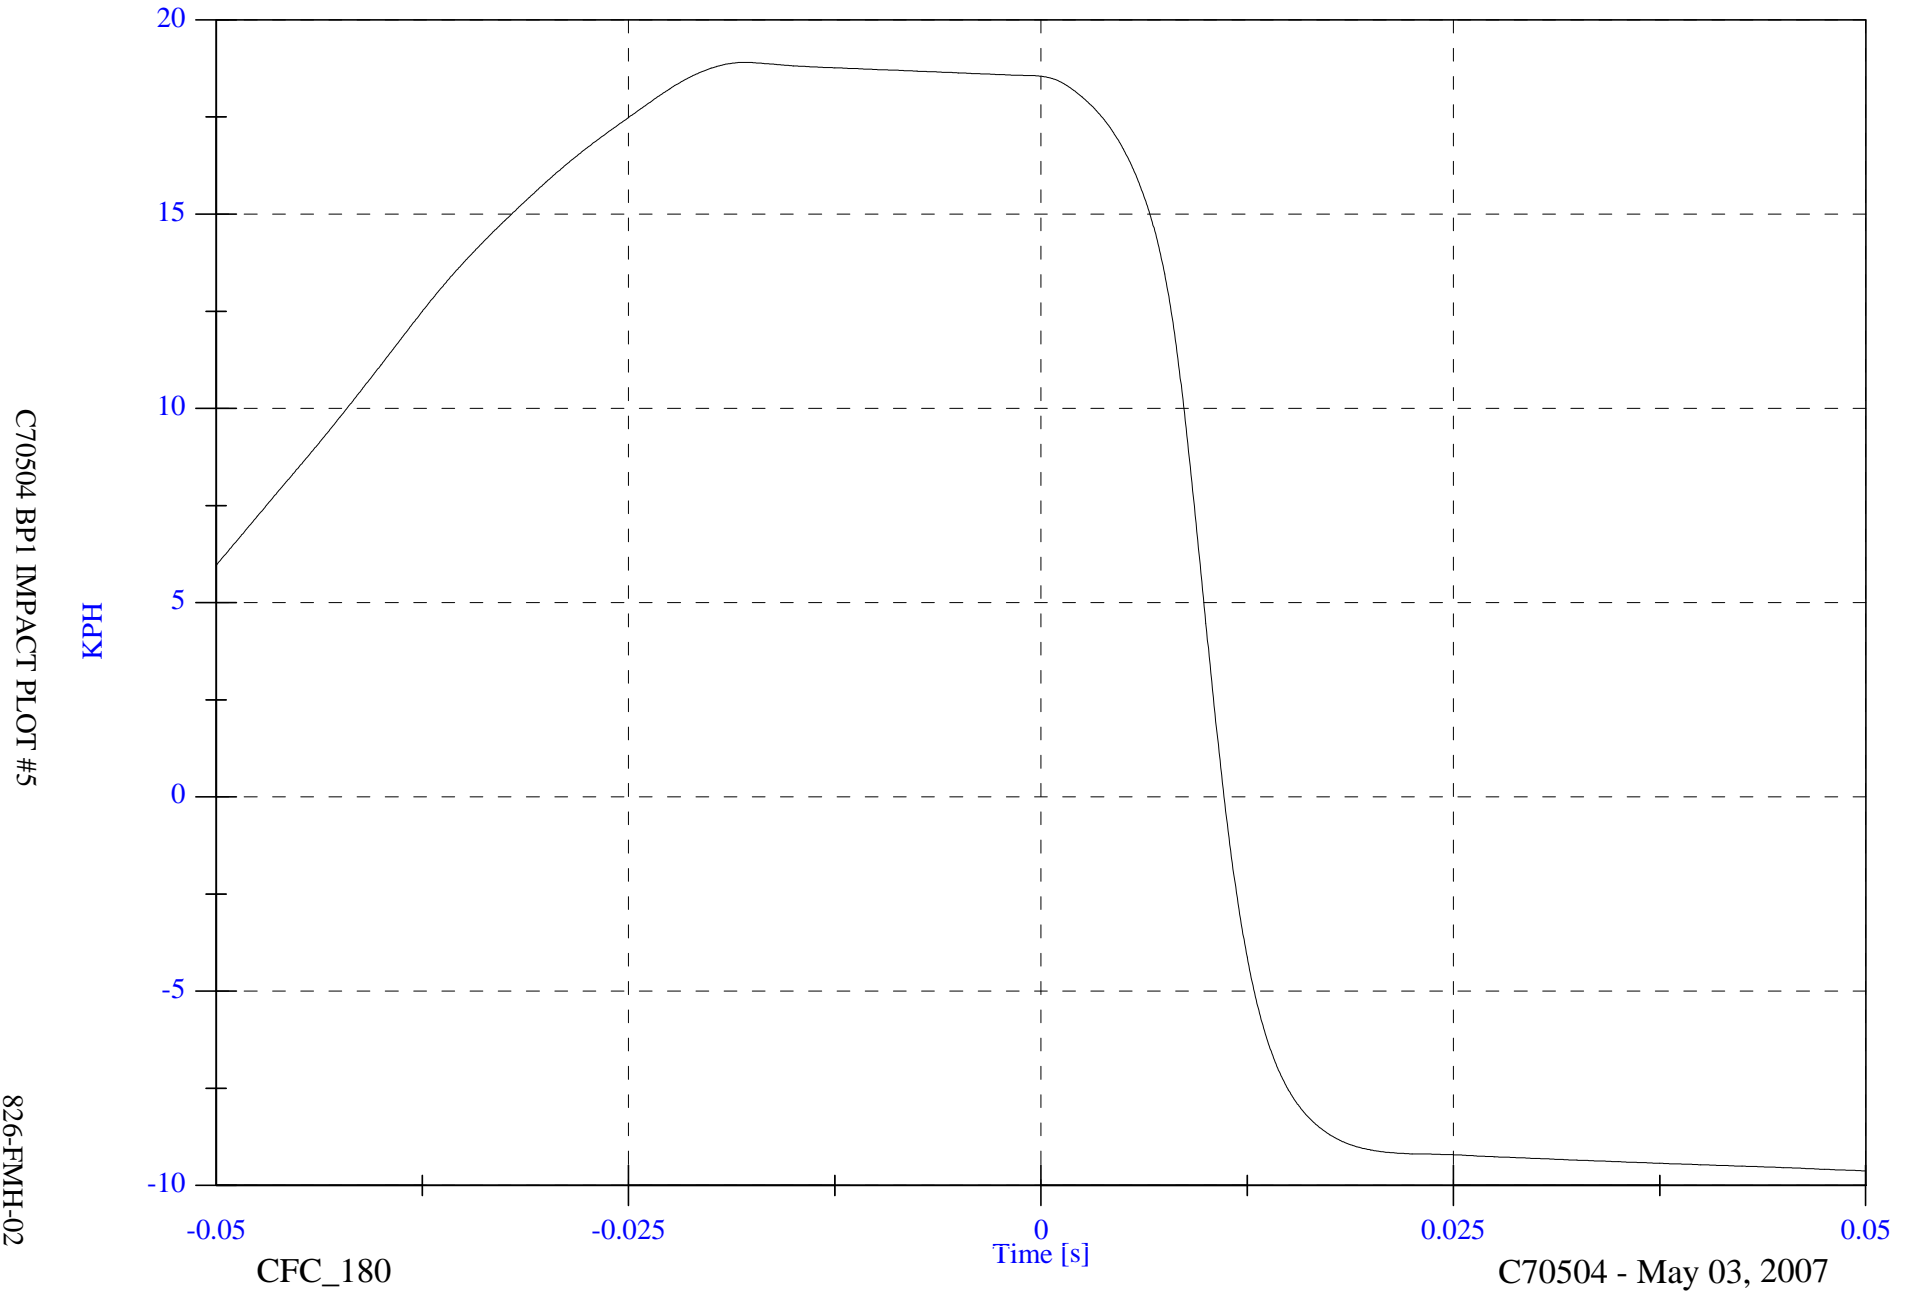
C70504 BP1 IMPACT PLOT #5

Max: 18.9 [KPH] at -0.018 [s]
Min: -9.6 [KPH] at 0.050 [s]

Headform Velocity

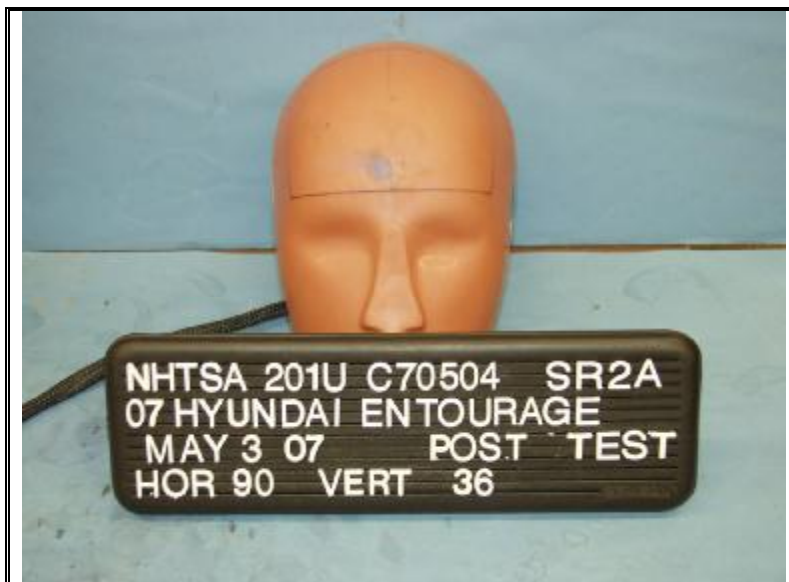
POST-IMPACT SR2A HEADFORM

Impact Point Description (from lower midpoint on midsagittal line)					
On Centerline	6	<input checked="" type="checkbox"/>	mm right	<input type="checkbox"/>	mm left
On Centerline	12				mm up

Free Motion HIC	430.4
HIC(d)	491.1
Impact Velocity (kph)	18.55
HIC T1 (msec)	7.7
HIC T2 (msec)	12.9

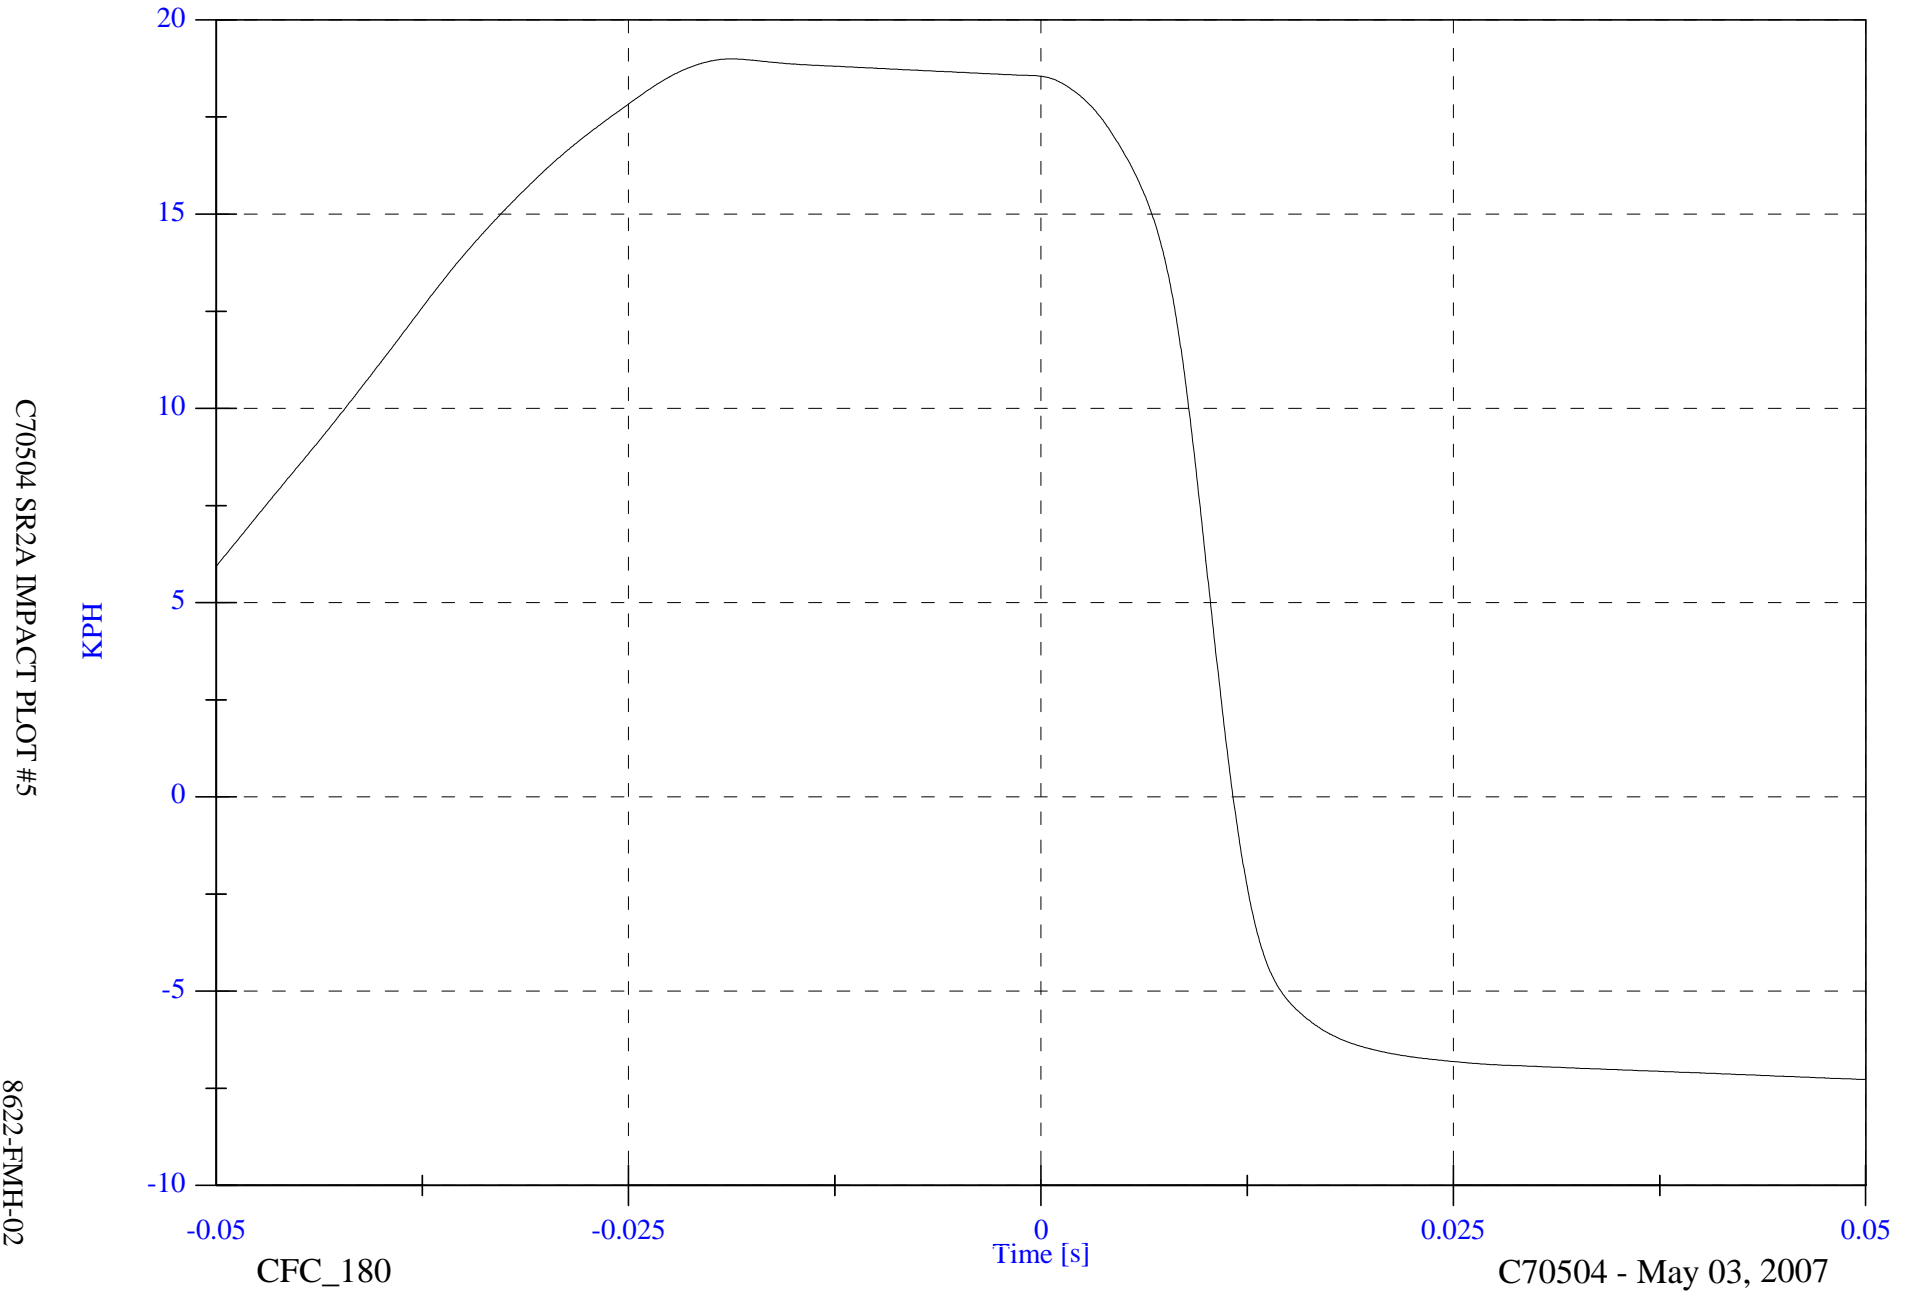
C70504 SR2A IMPACT PLOT #5

Min: -7.3 [KPH] at 0.050 [s]

Headform Velocity

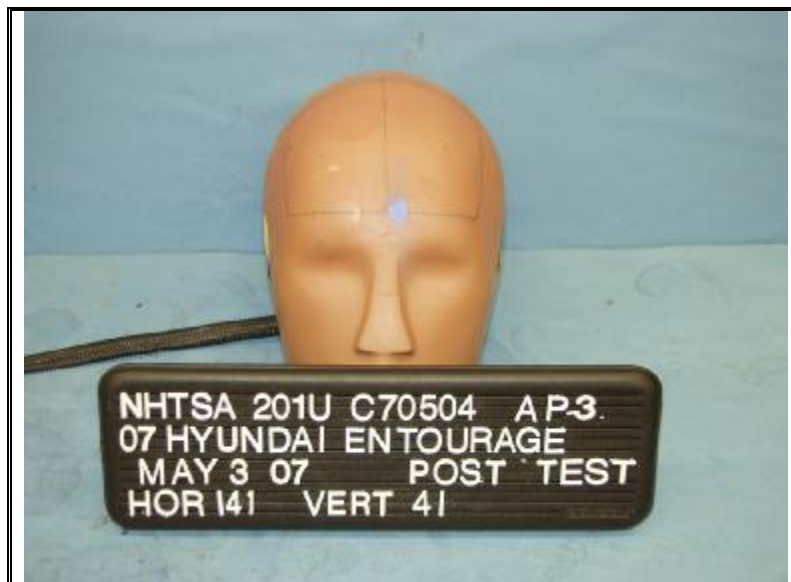
POST-IMPACT AP3 HEADFORM

Impact Point Description (from lower midpoint on midsagittal line)			
On Centerline	7	mm right	x mm left
On Centerline	1		mm up

Free Motion HIC	304.5
HIC(d)	396.1
Impact Velocity (kph)	18.78
HIC T1 (msec)	2.0
HIC T2 (msec)	13.4

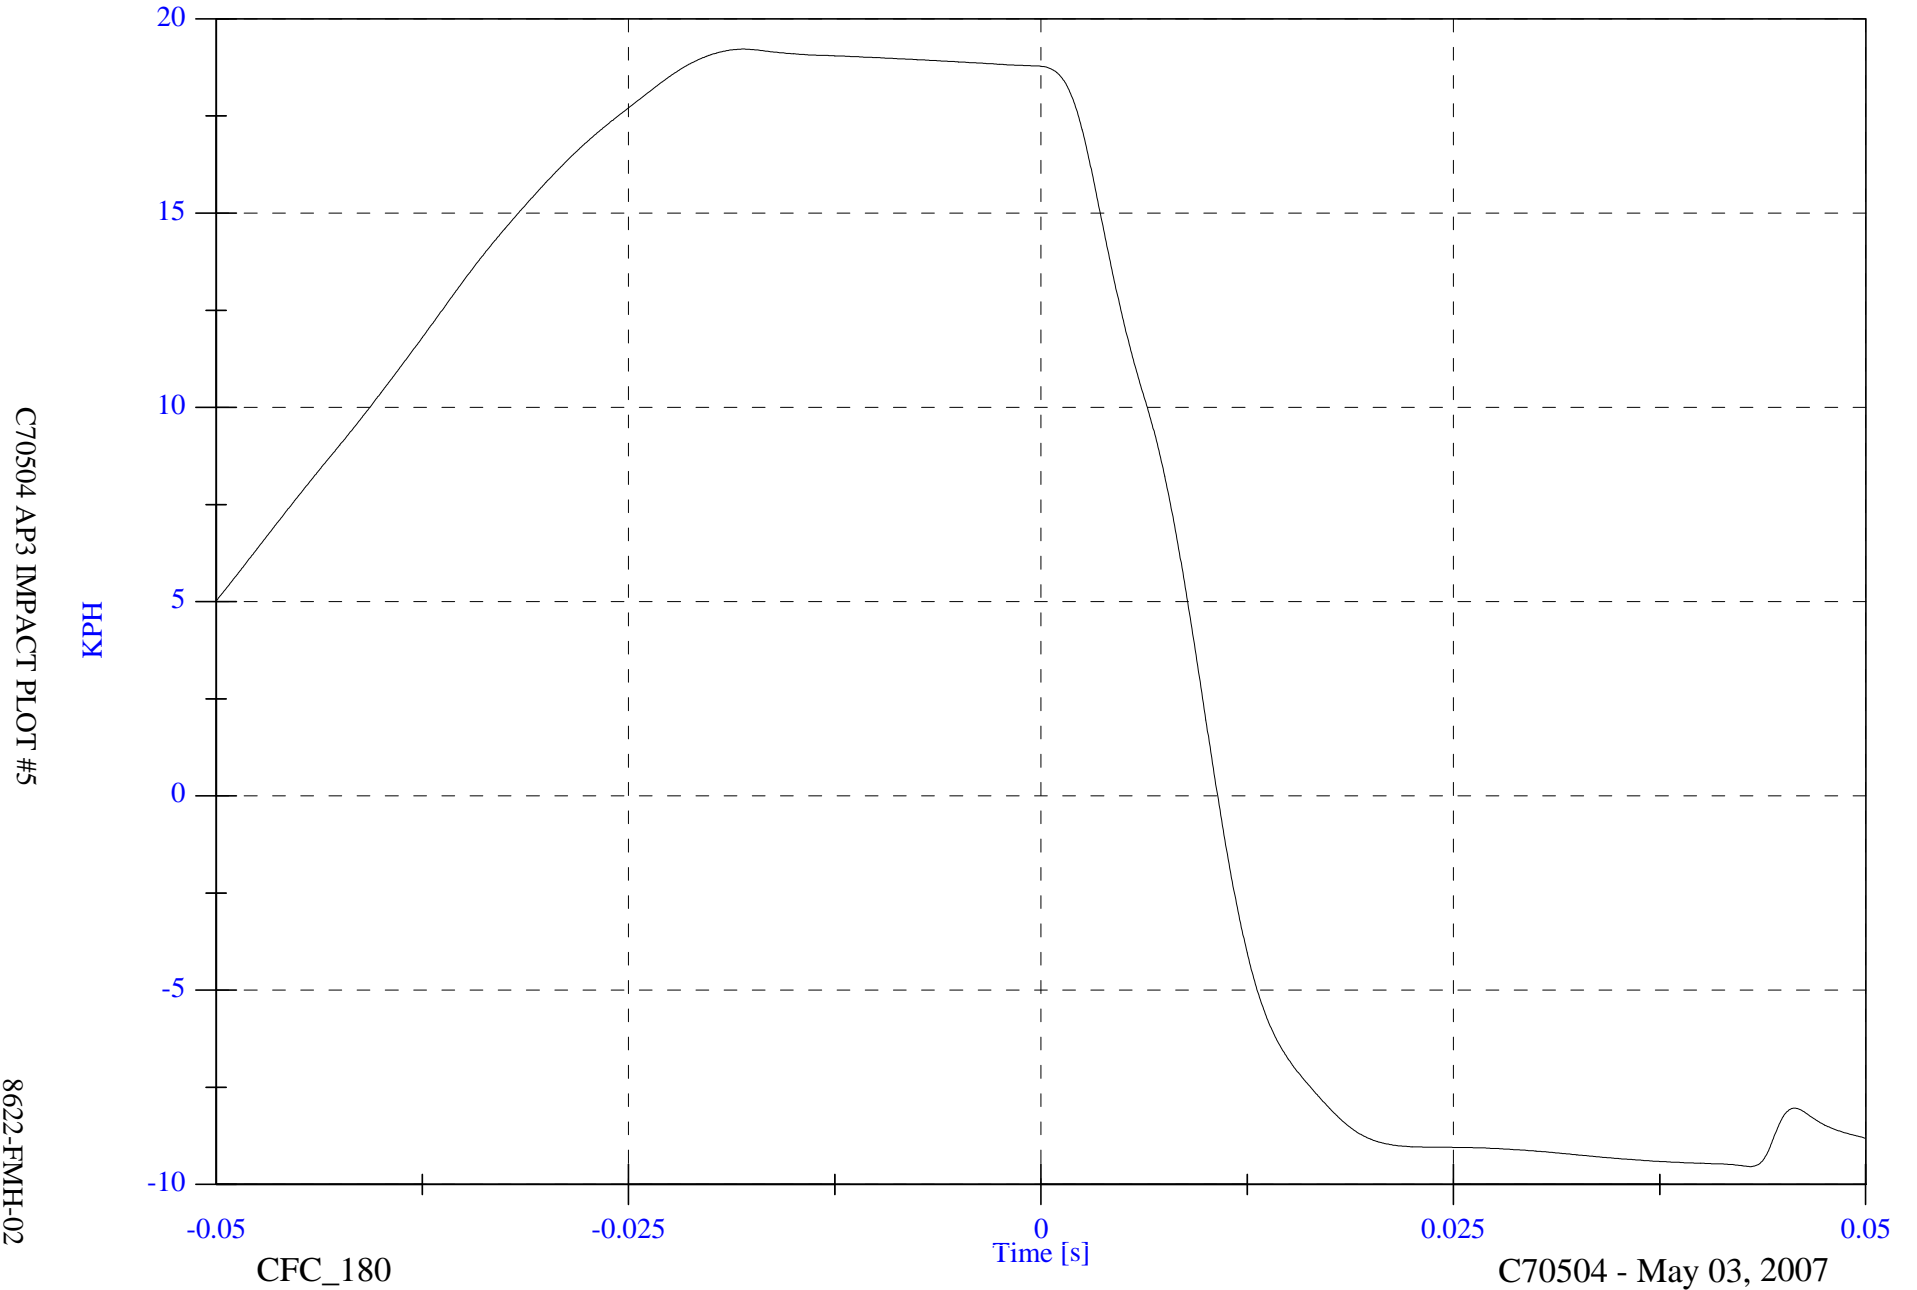
C70504 AP3 IMPACT PLOT #5

Min: -9.5 [KPH] at 0.043 [s]

Headform Velocity

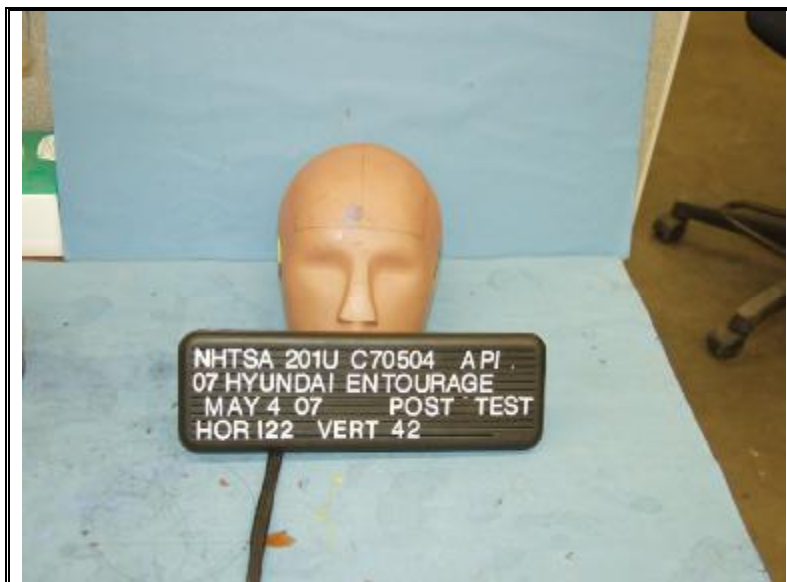
POST-IMPACT AP1 HEADFORM

Impact Point Description (from lower midpoint on midsagittal line)					
On Centerline	5	<input checked="" type="checkbox"/>	mm right	<input type="checkbox"/>	mm left
On Centerline	9				mm up

Free Motion HIC	491.4
HIC(d)	537.2
Impact Velocity (kph)	18.76
HIC T1 (msec)	6.8
HIC T2 (msec)	12.1

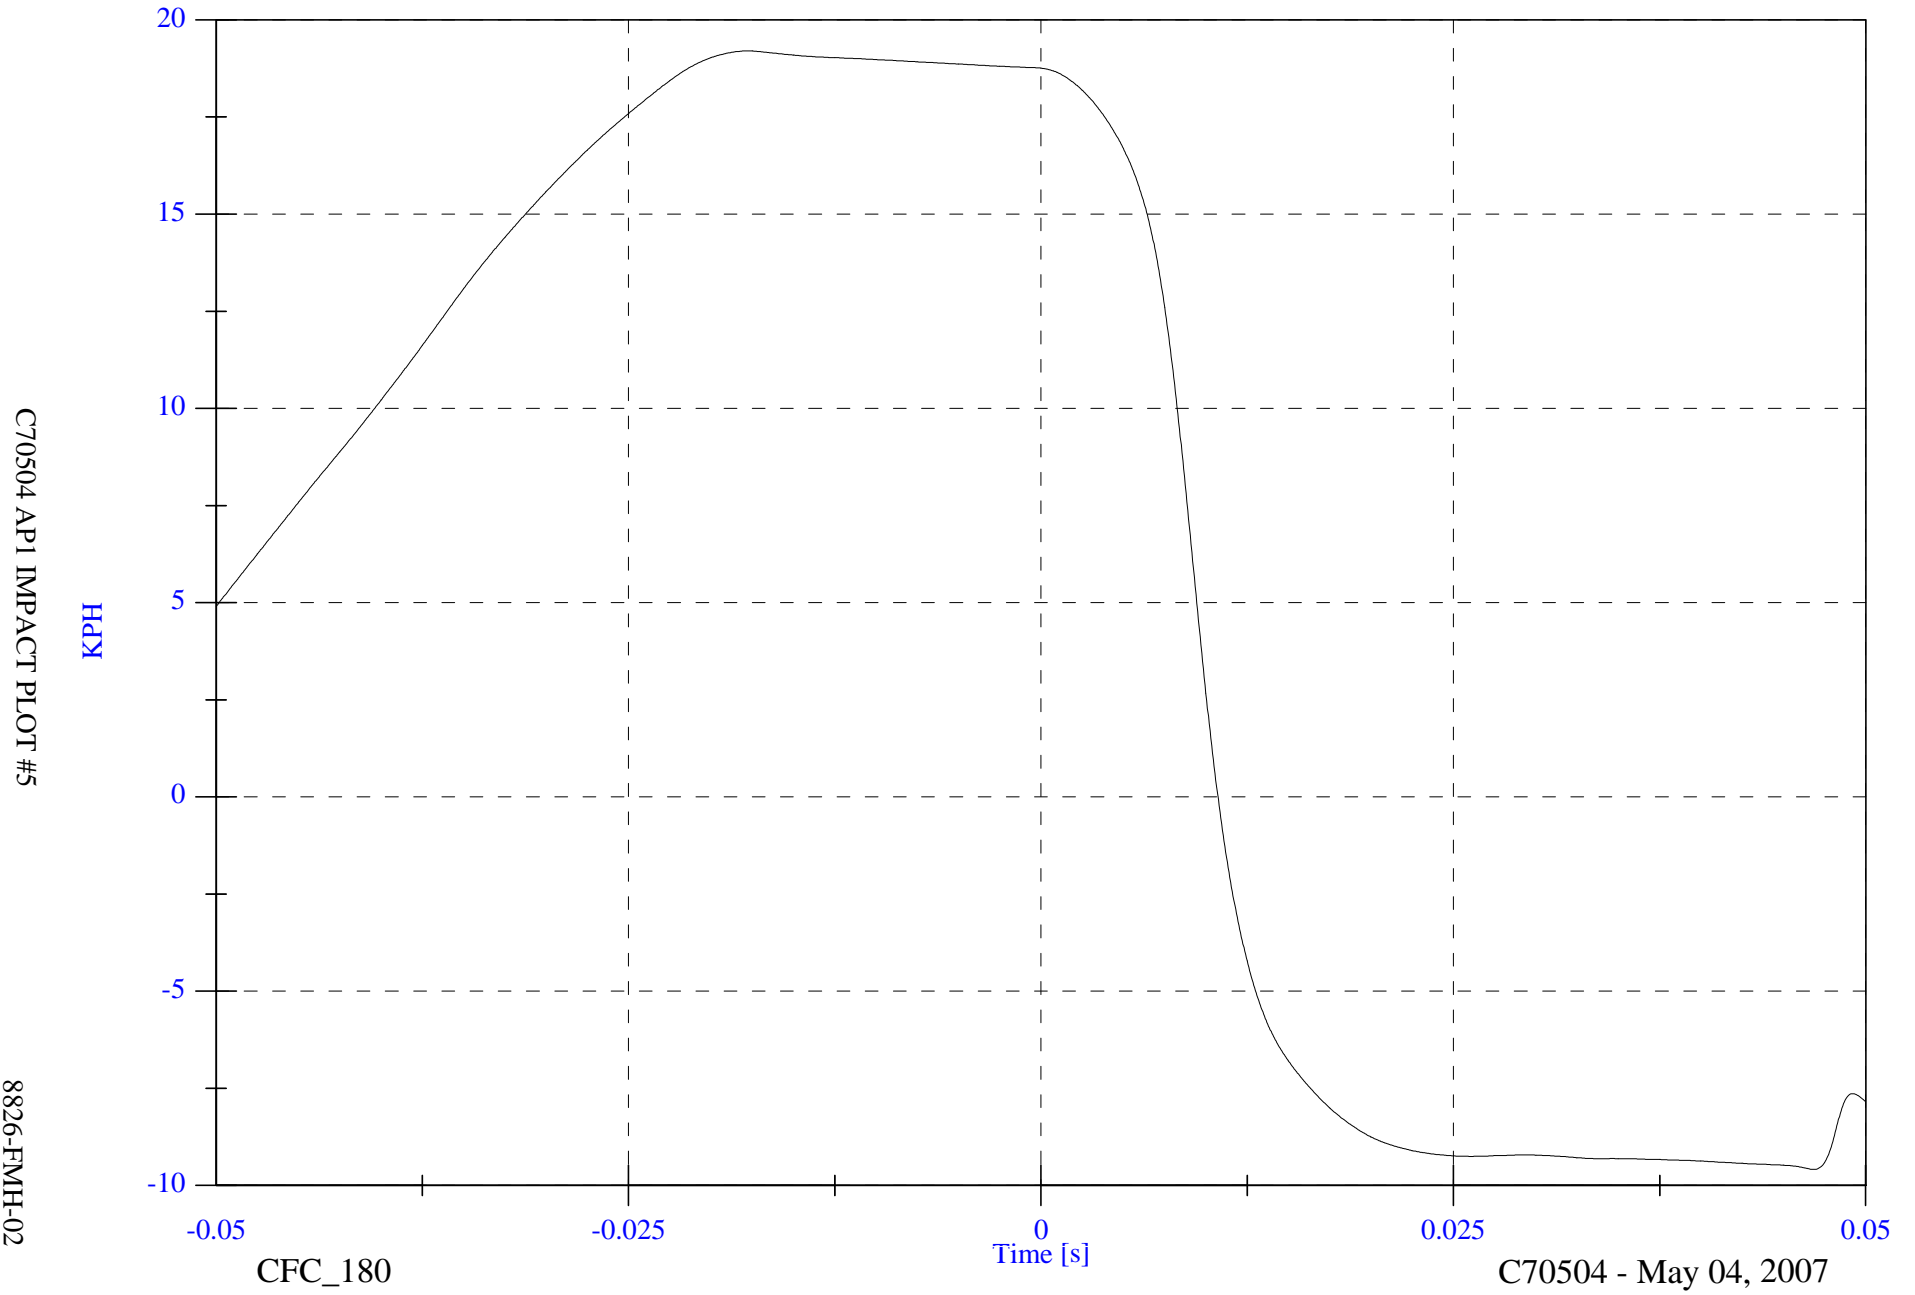
C70504 AP1 IMPACT PLOT #5

Min: -9.6 [KPH] at 0.047 [s]

Headform Velocity

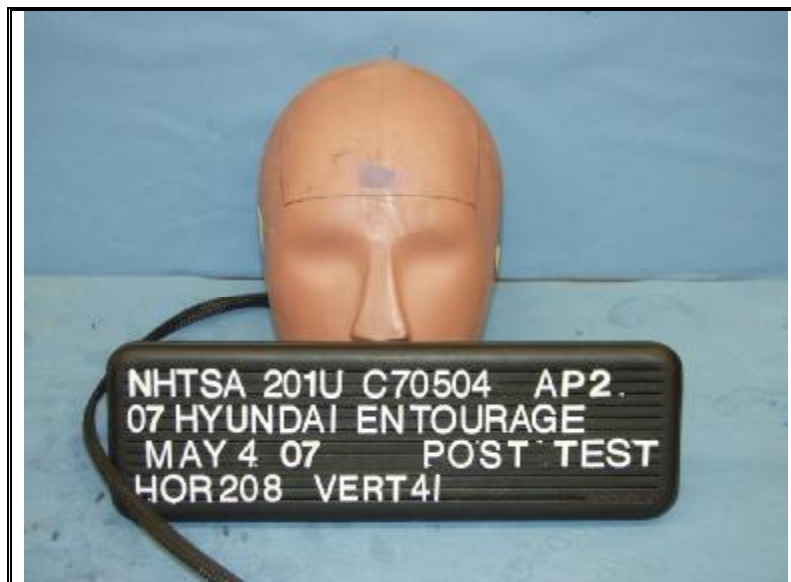
POST-IMPACT AP2 HEADFORM

Impact Point Description (from lower midpoint on midsagittal line)			
On Centerline	0	mm right	mm left
On Centerline	10	mm up

Free Motion HIC	363.0
HIC(d)	440.0
Impact Velocity (kph)	18.73
HIC T1 (msec)	6.3
HIC T2 (msec)	11.1
