REPORT NUMBER: 201UI-CAL-07-02

**SAFETY COMPLIANCE TESTING FOR FMVSS 201
OCCUPANT PROTECTION IN INTERIOR IMPACT
UPPER INTERIOR HEAD IMPACT PROTECTION**

**KIA MOTOR CORPORATION FOR HYUNDAI MOTOR COMPANY
2007 HYUNDAI ENTOURAGE GLS**

FINAL REPORT

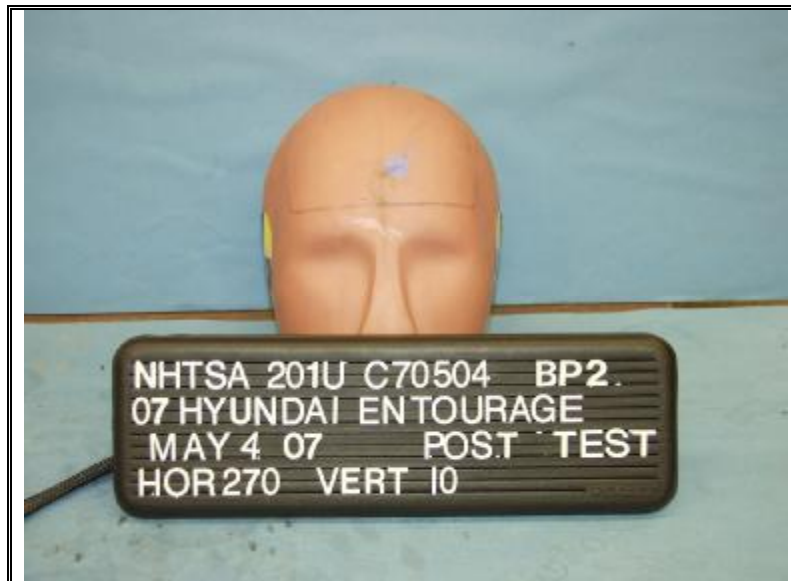
POST-IMPACT BP2HEADFORM

Impact Point Description (from lower midpoint on midsagittal line)			
On Centerline	9	<input type="checkbox"/>	mm right <input checked="" type="checkbox"/> mm left
On Centerline	21		mm up

Free Motion HIC	650.6
HIC(d)	657.2
Impact Velocity (kph)	23.59
HIC T1 (msec)	4.0
HIC T2 (msec)	11.8

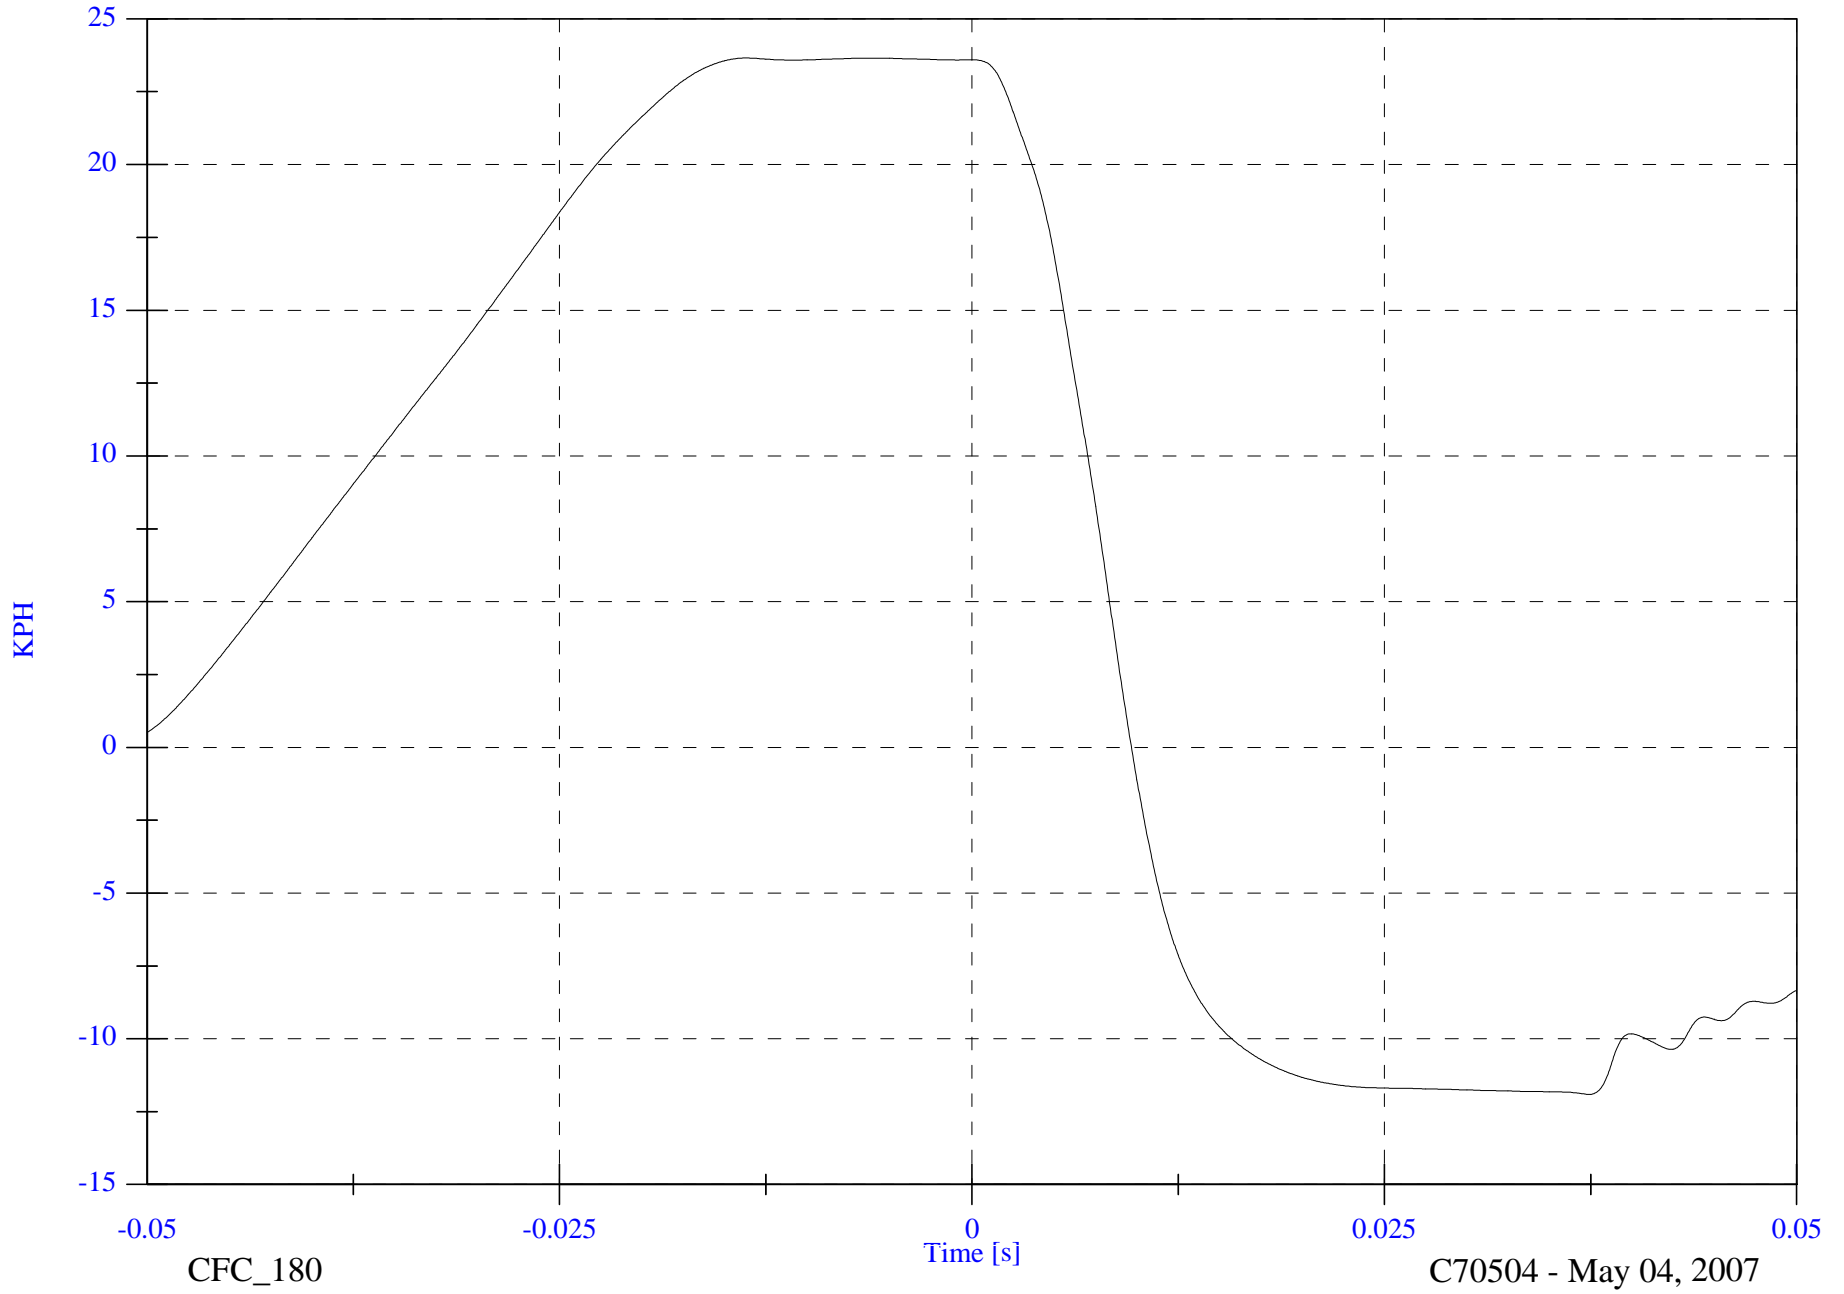
C70504 BP2 IMPACT PLOT #5

Min: -11.9 [KPH] at 0.037 [s]

Headform Velocity

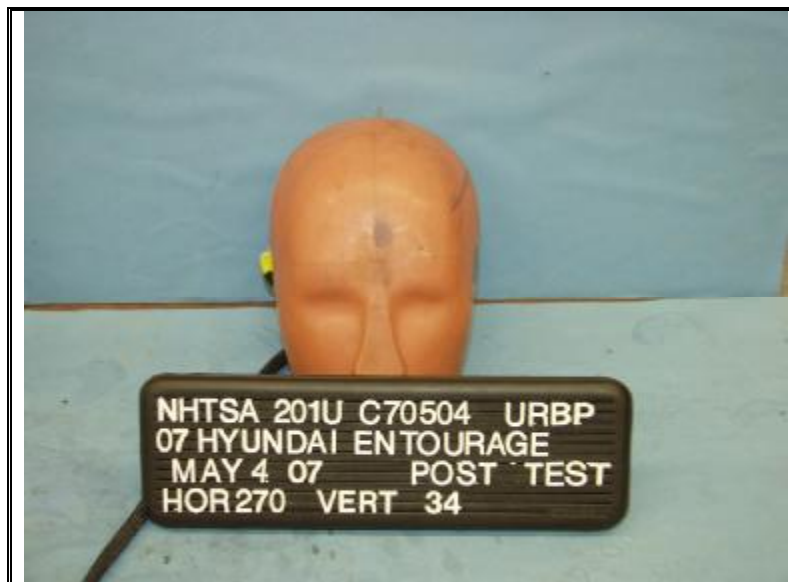
POST-IMPACT URBP HEADFORM

Impact Point Description (from lower midpoint on midsagittal line)					
On Centerline	5	<input type="checkbox"/>	mm right	<input checked="" type="checkbox"/>	mm left
On Centerline	15				mm up

Free Motion HIC	555.4
HIC(d)	585.4
Impact Velocity (kph)	23.63
HIC T1 (msec)	6.3
HIC T2 (msec)	10.4

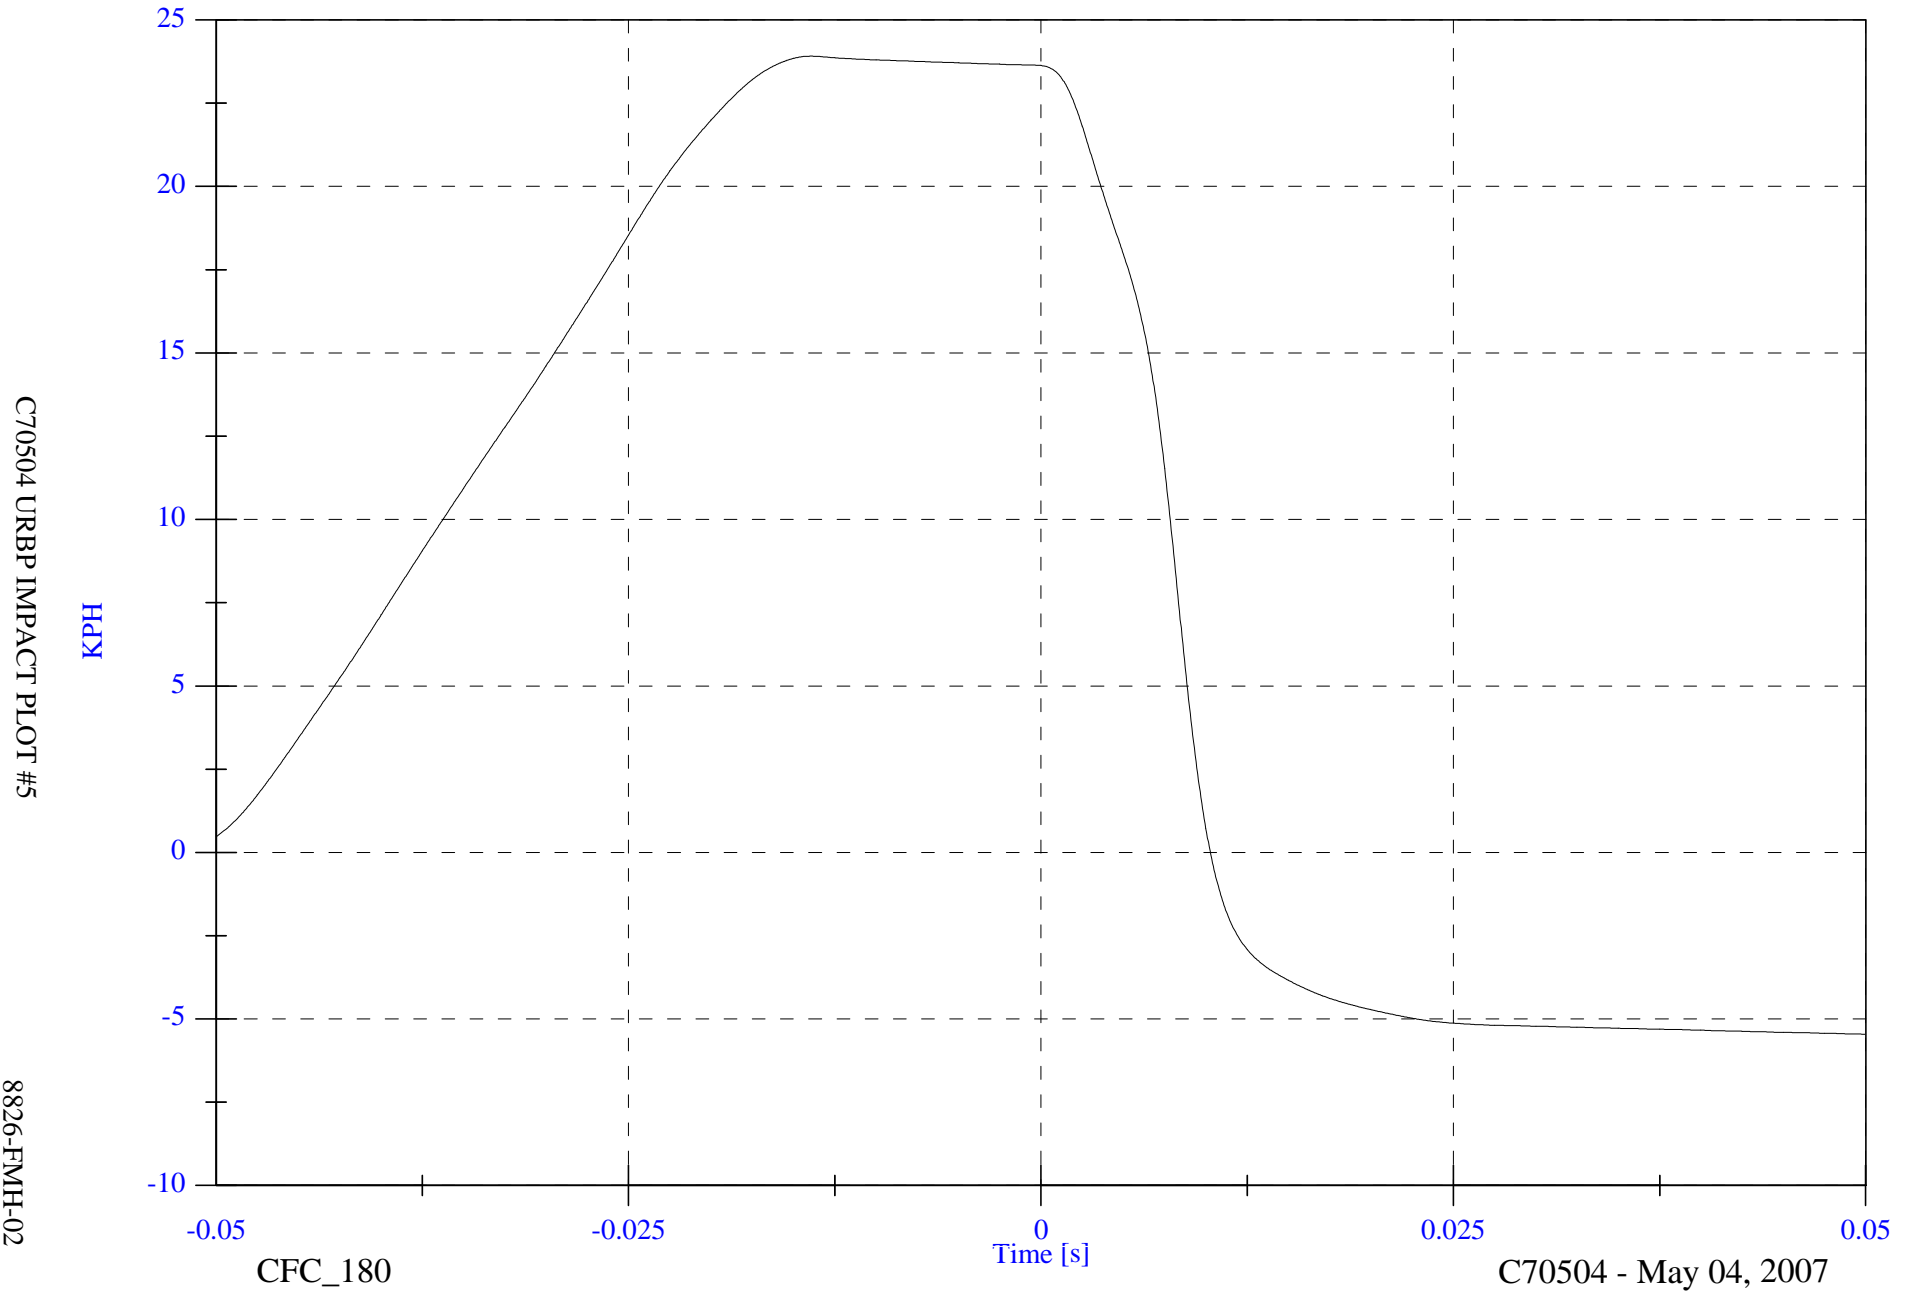
C70504 URBP IMPACT PLOT #5

Max: 23.9 [KPH] at -0.014 [s]

Headform Velocity
