**REPORT NUMBER: 201-MGA-2007-002**

**SAFETY COMPLIANCE TESTING FOR FMVSS 201  
RIGID POLE SIDE IMPACT TEST**

**GENERAL MOTORS OF CANADA LTD.  
2007 BUICK LACROSSE CX  
NHTSA NUMBER: C70116**

**FINAL REPORT**

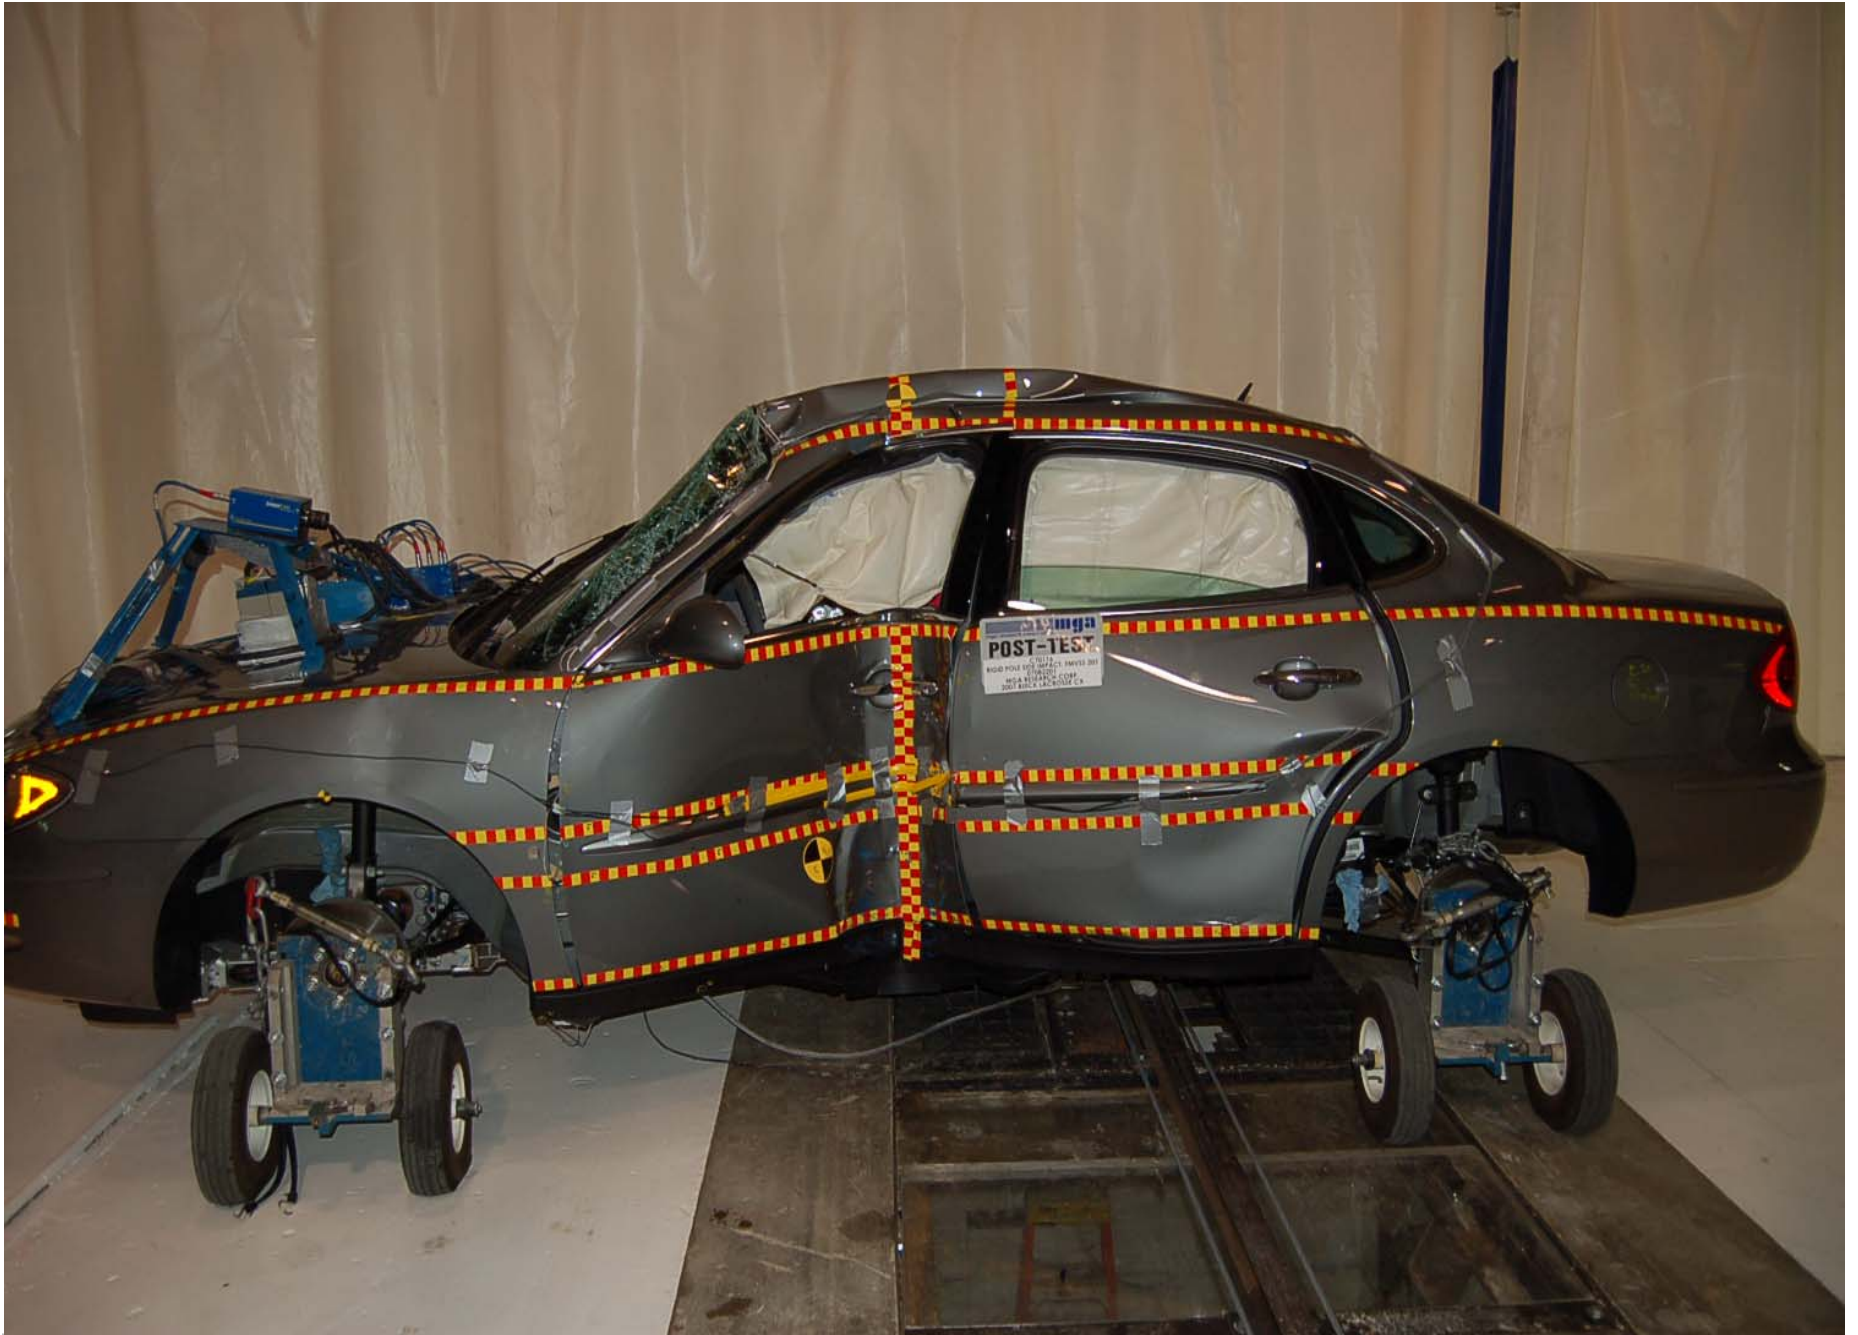
A-6.

Post-Test Left Side View of Test Vehicle

The test vehicle sustained a maximum static crush of 397 mm at level 3, at the vertical impact line. The driver SID/HIII, Serial No. 036, was calibrated just prior to this test. The SID/HIII's injury criteria are summarized as follows:

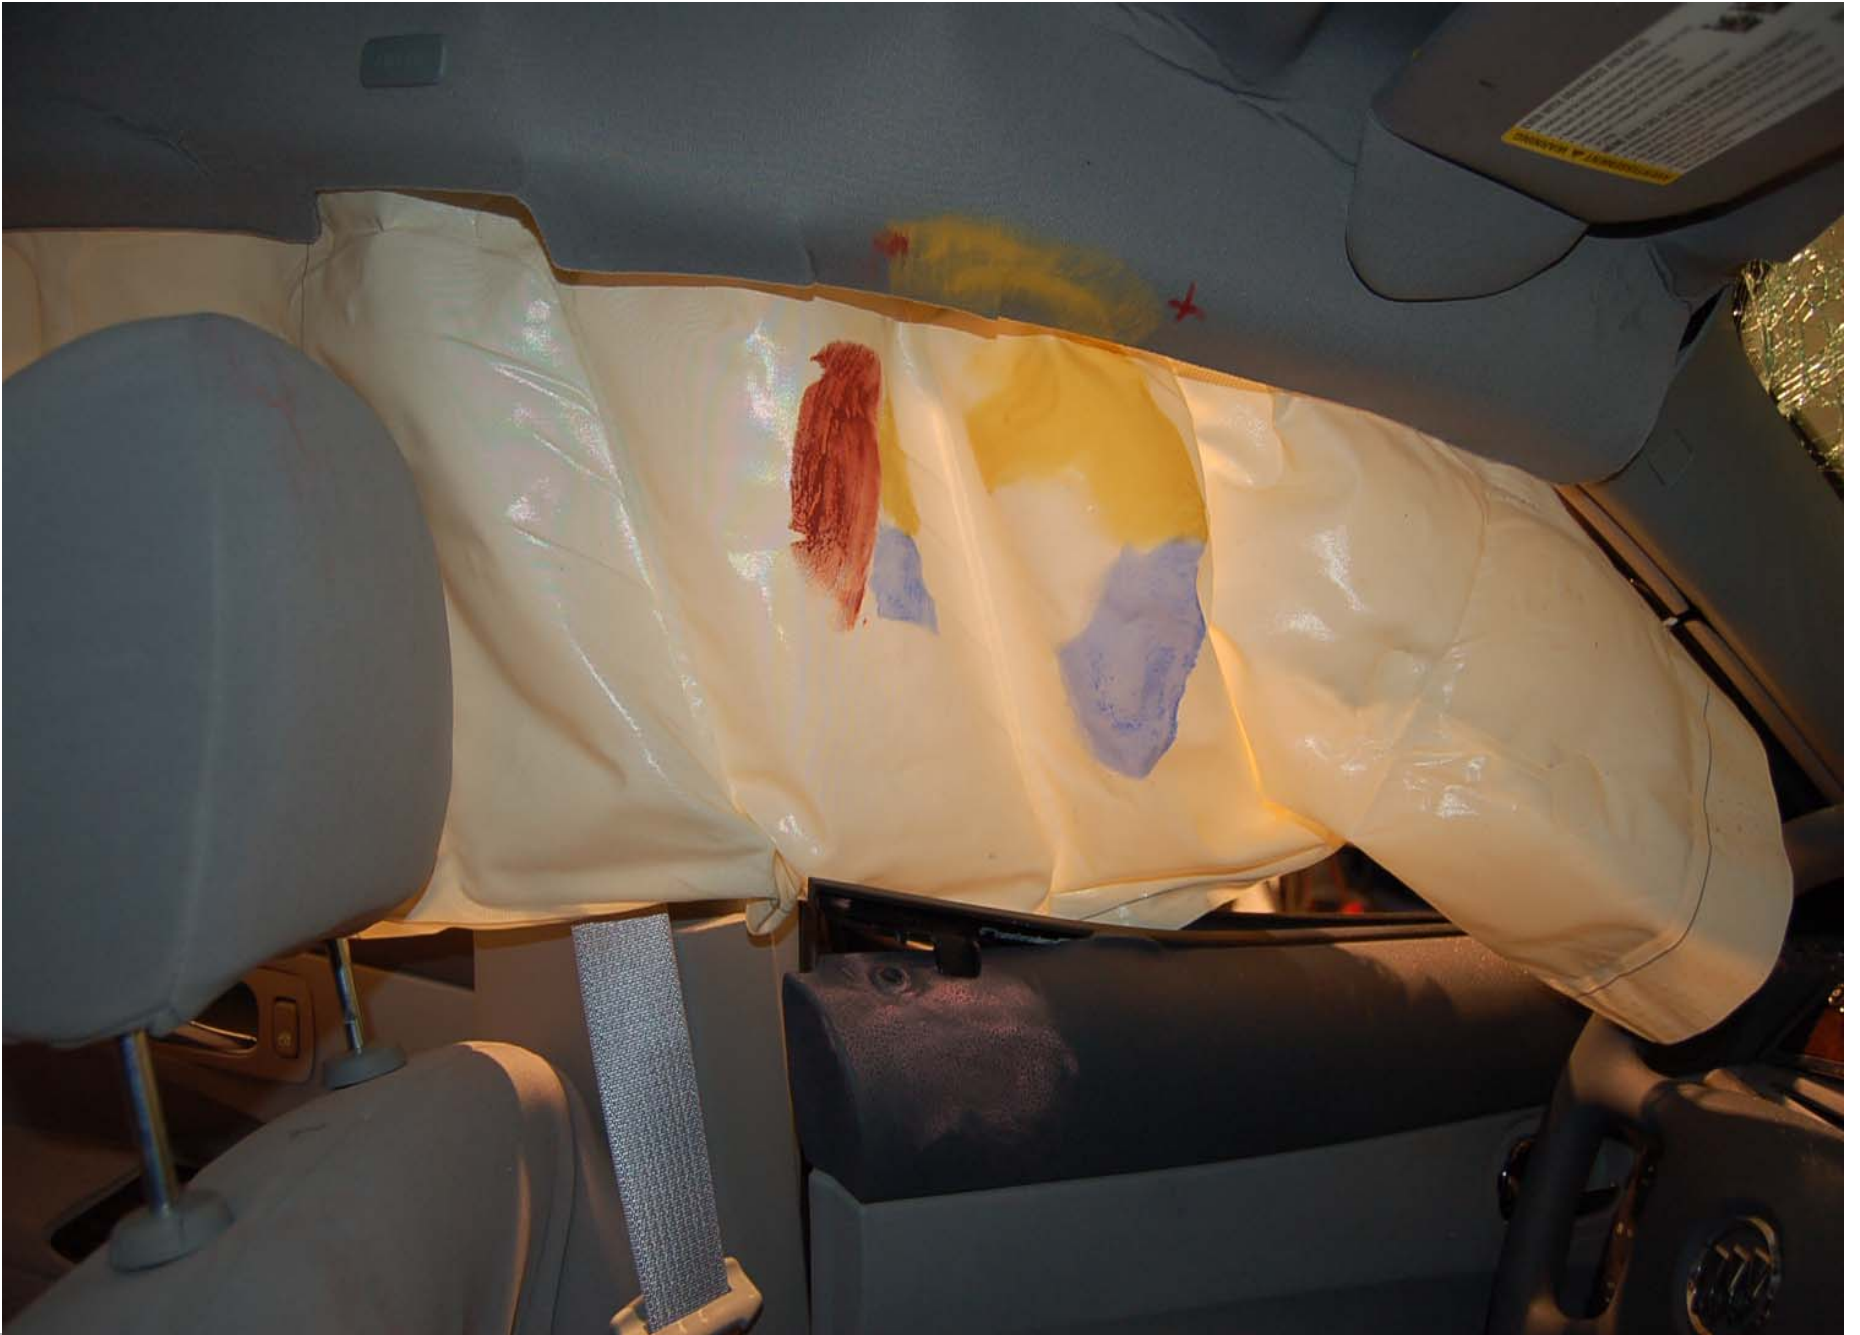
A-28.

Post-Test Driver Dummy Head Contact (headliner, CAB)

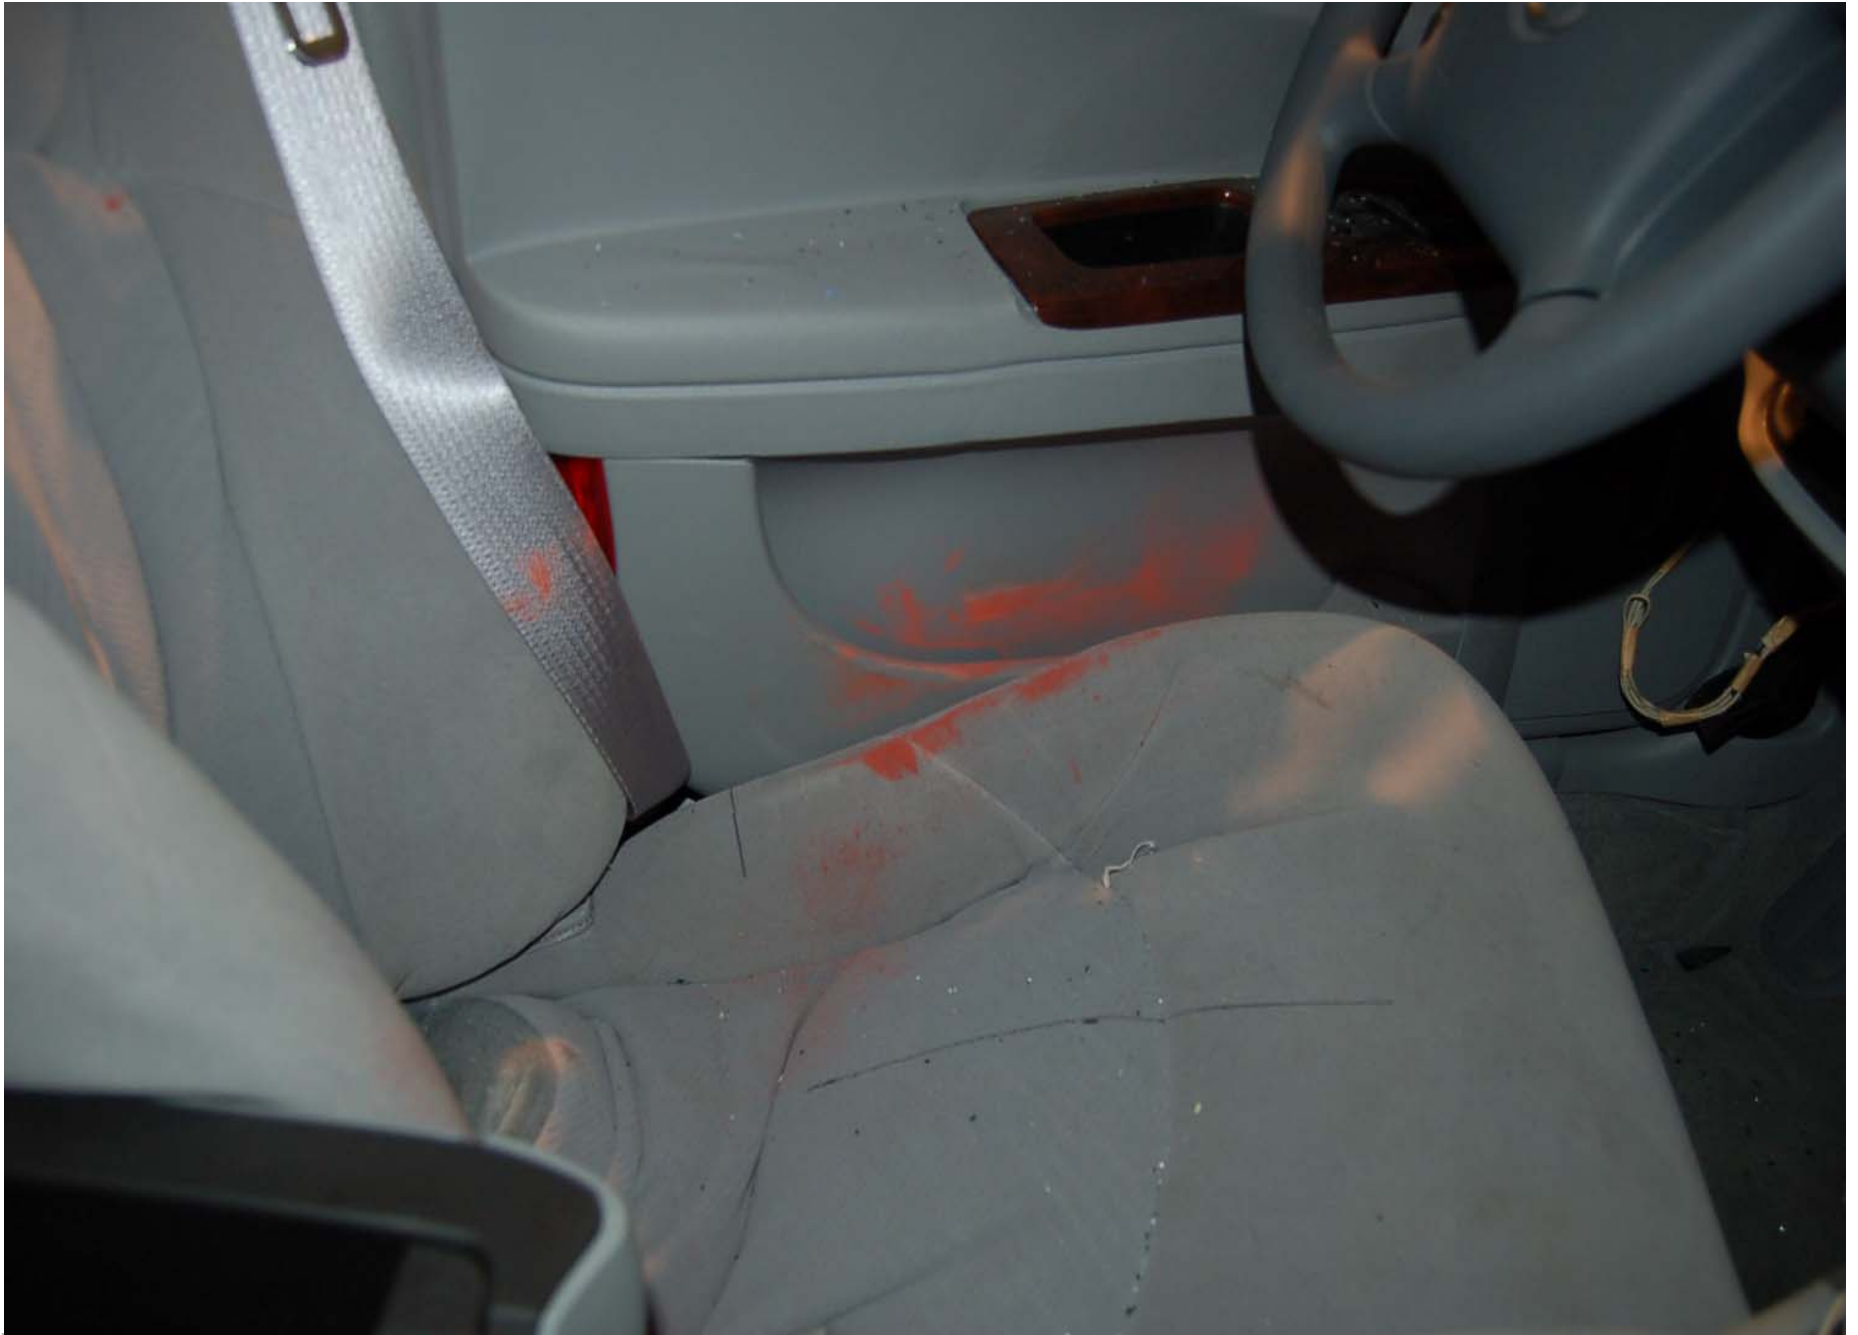
A-29.

Post-Test Driver Dummy Thorax Contact

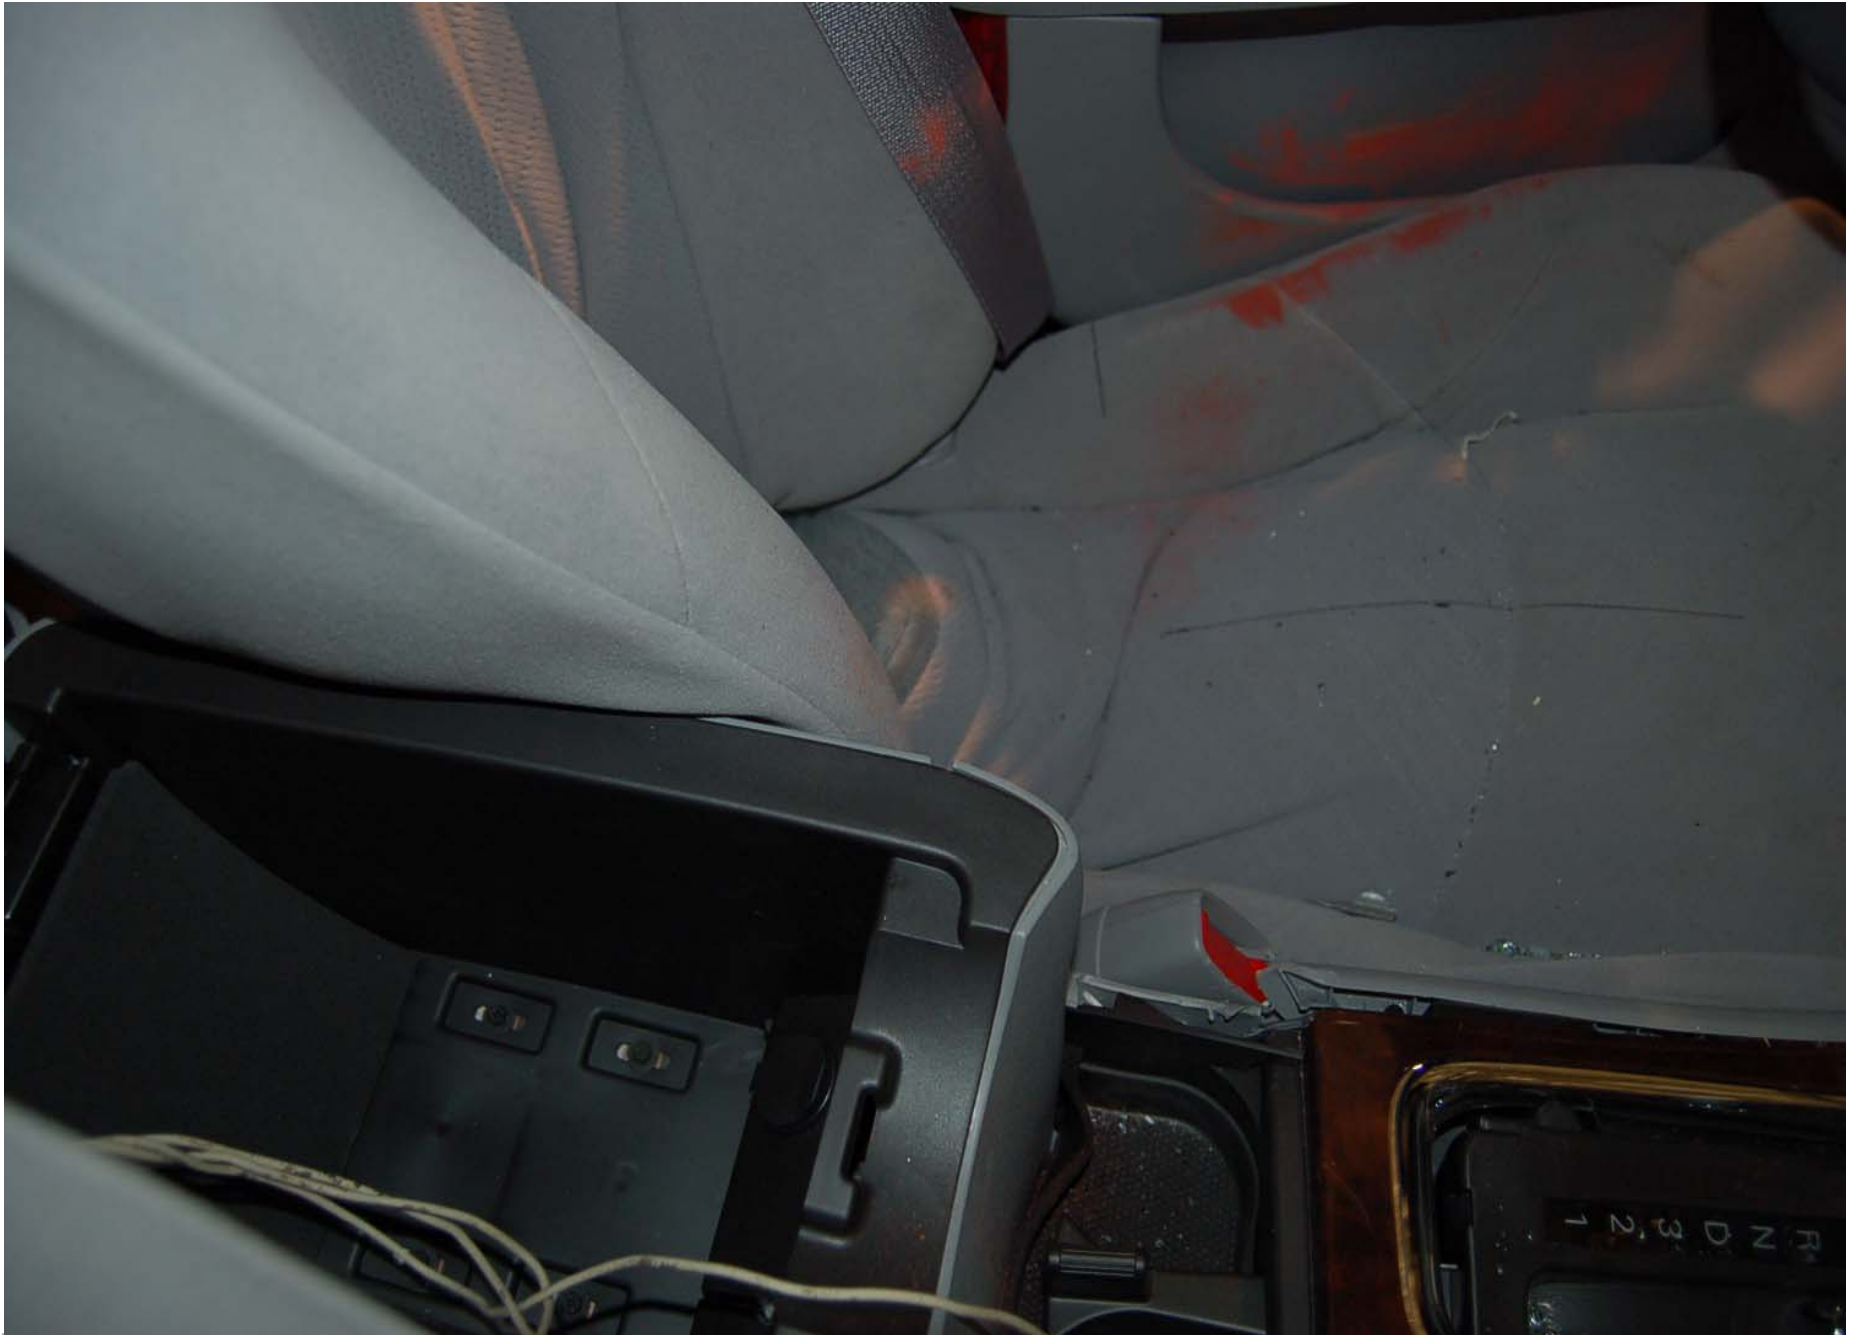
A-30.

Post-Test Driver Dummy Thorax Contact

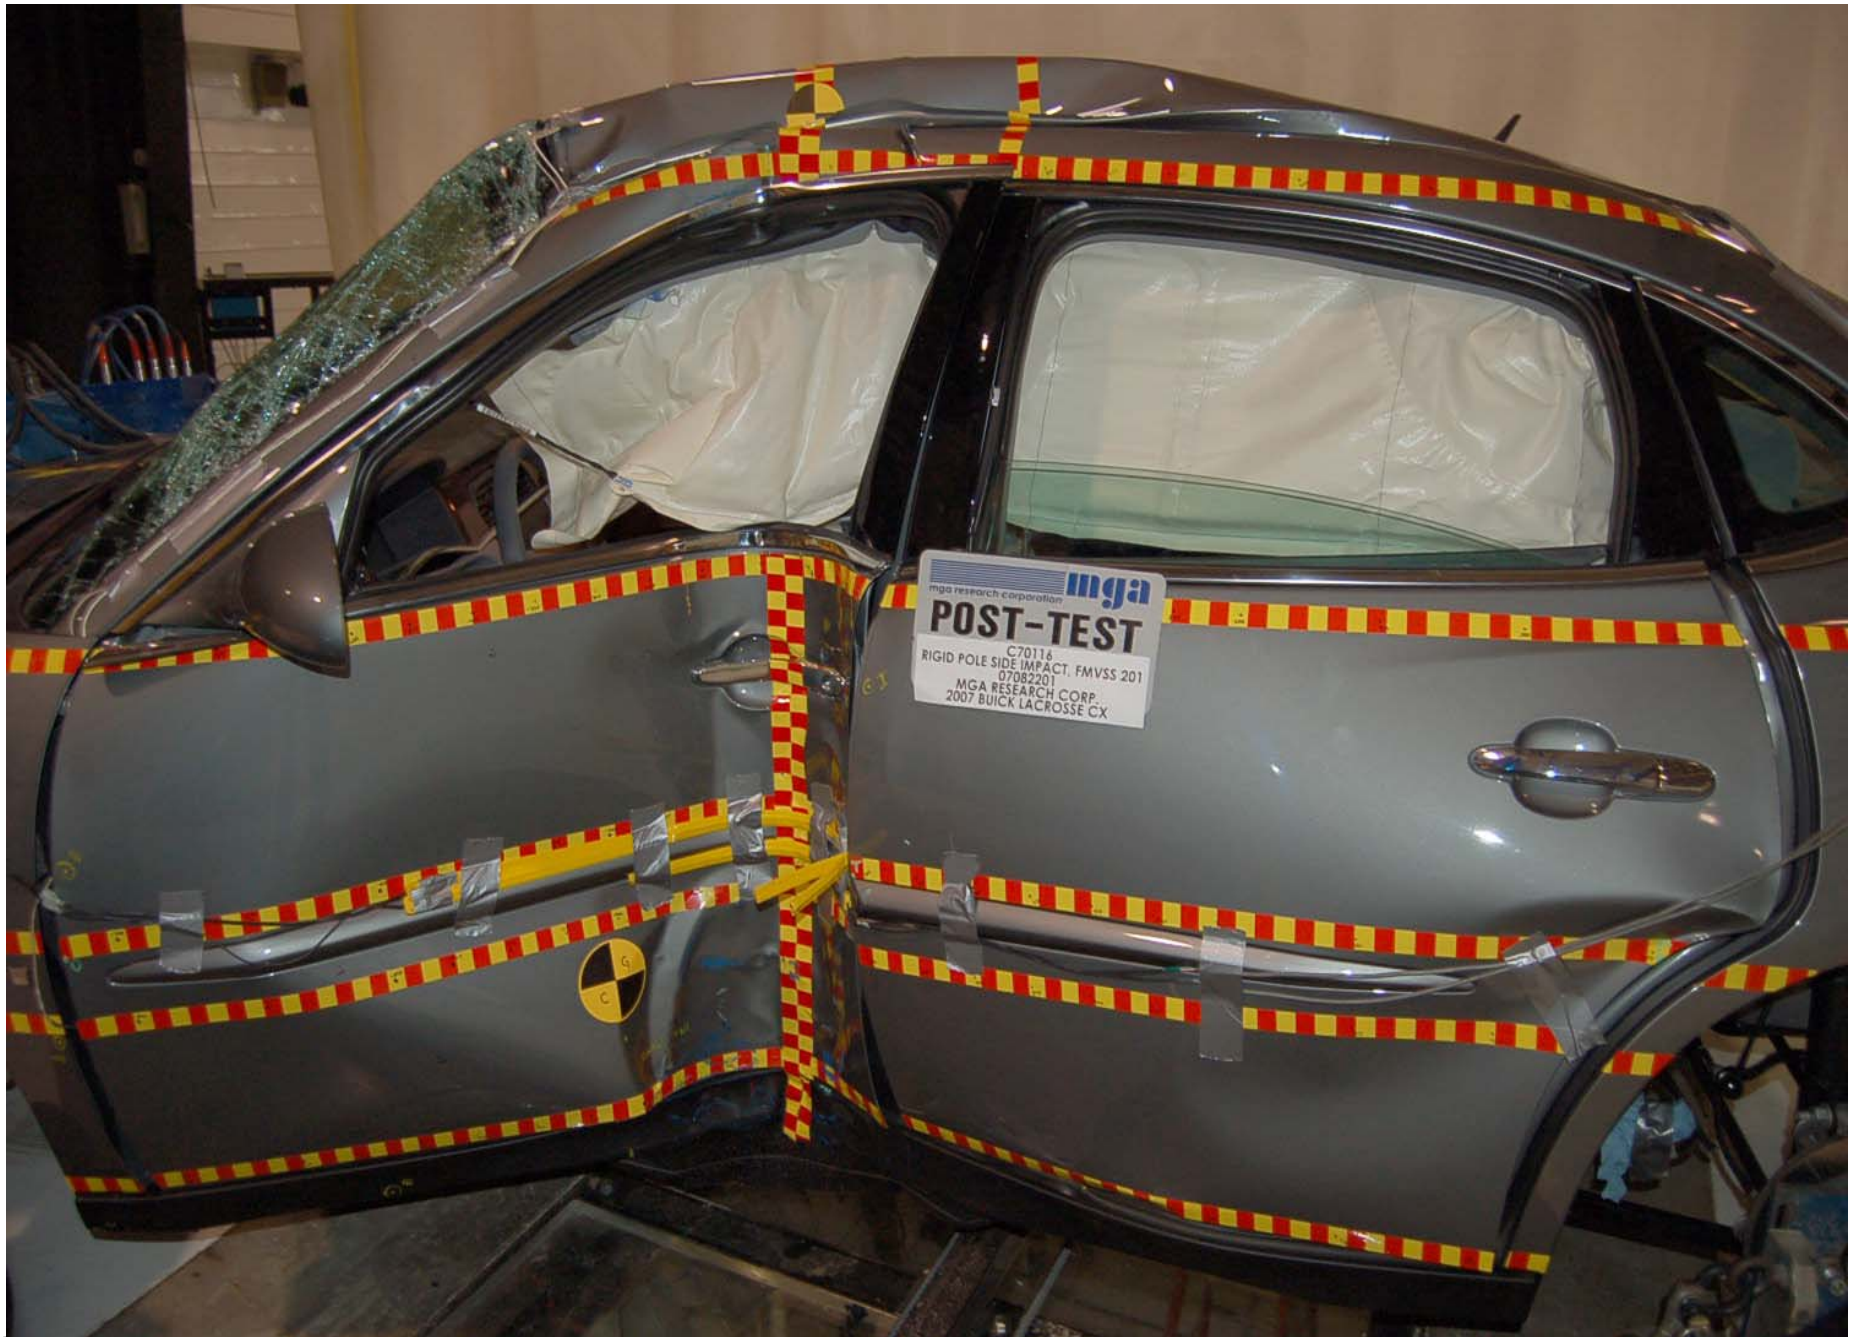
Post-Test Impact Zone Close-up View

Level	Measured Parameter	Units	Maximum Crush	Above Ground
Level 1	Sill Top Height	mm	327	309
Level 2	Occupant H-Point	mm	390	548
Level 3	Mid Door	mm	397	660
Level 4	Window Sill	mm	340	964
Level 5	Window Top	mm	152	1405
N/A	Maximum Penetration	mm	397	660
