REPORT NUMBER 124-GTL-07-004

SAFETY COMPLIANCE TESTING FOR FMVSS 124 ACCELERATOR CONTROL SYSTEMS

HONDA MOTOR CO.,
2007 HONDA FIT,
4-DOOR PASSENGER CAR
NHTSA NO. C75300

FINAL REPORT

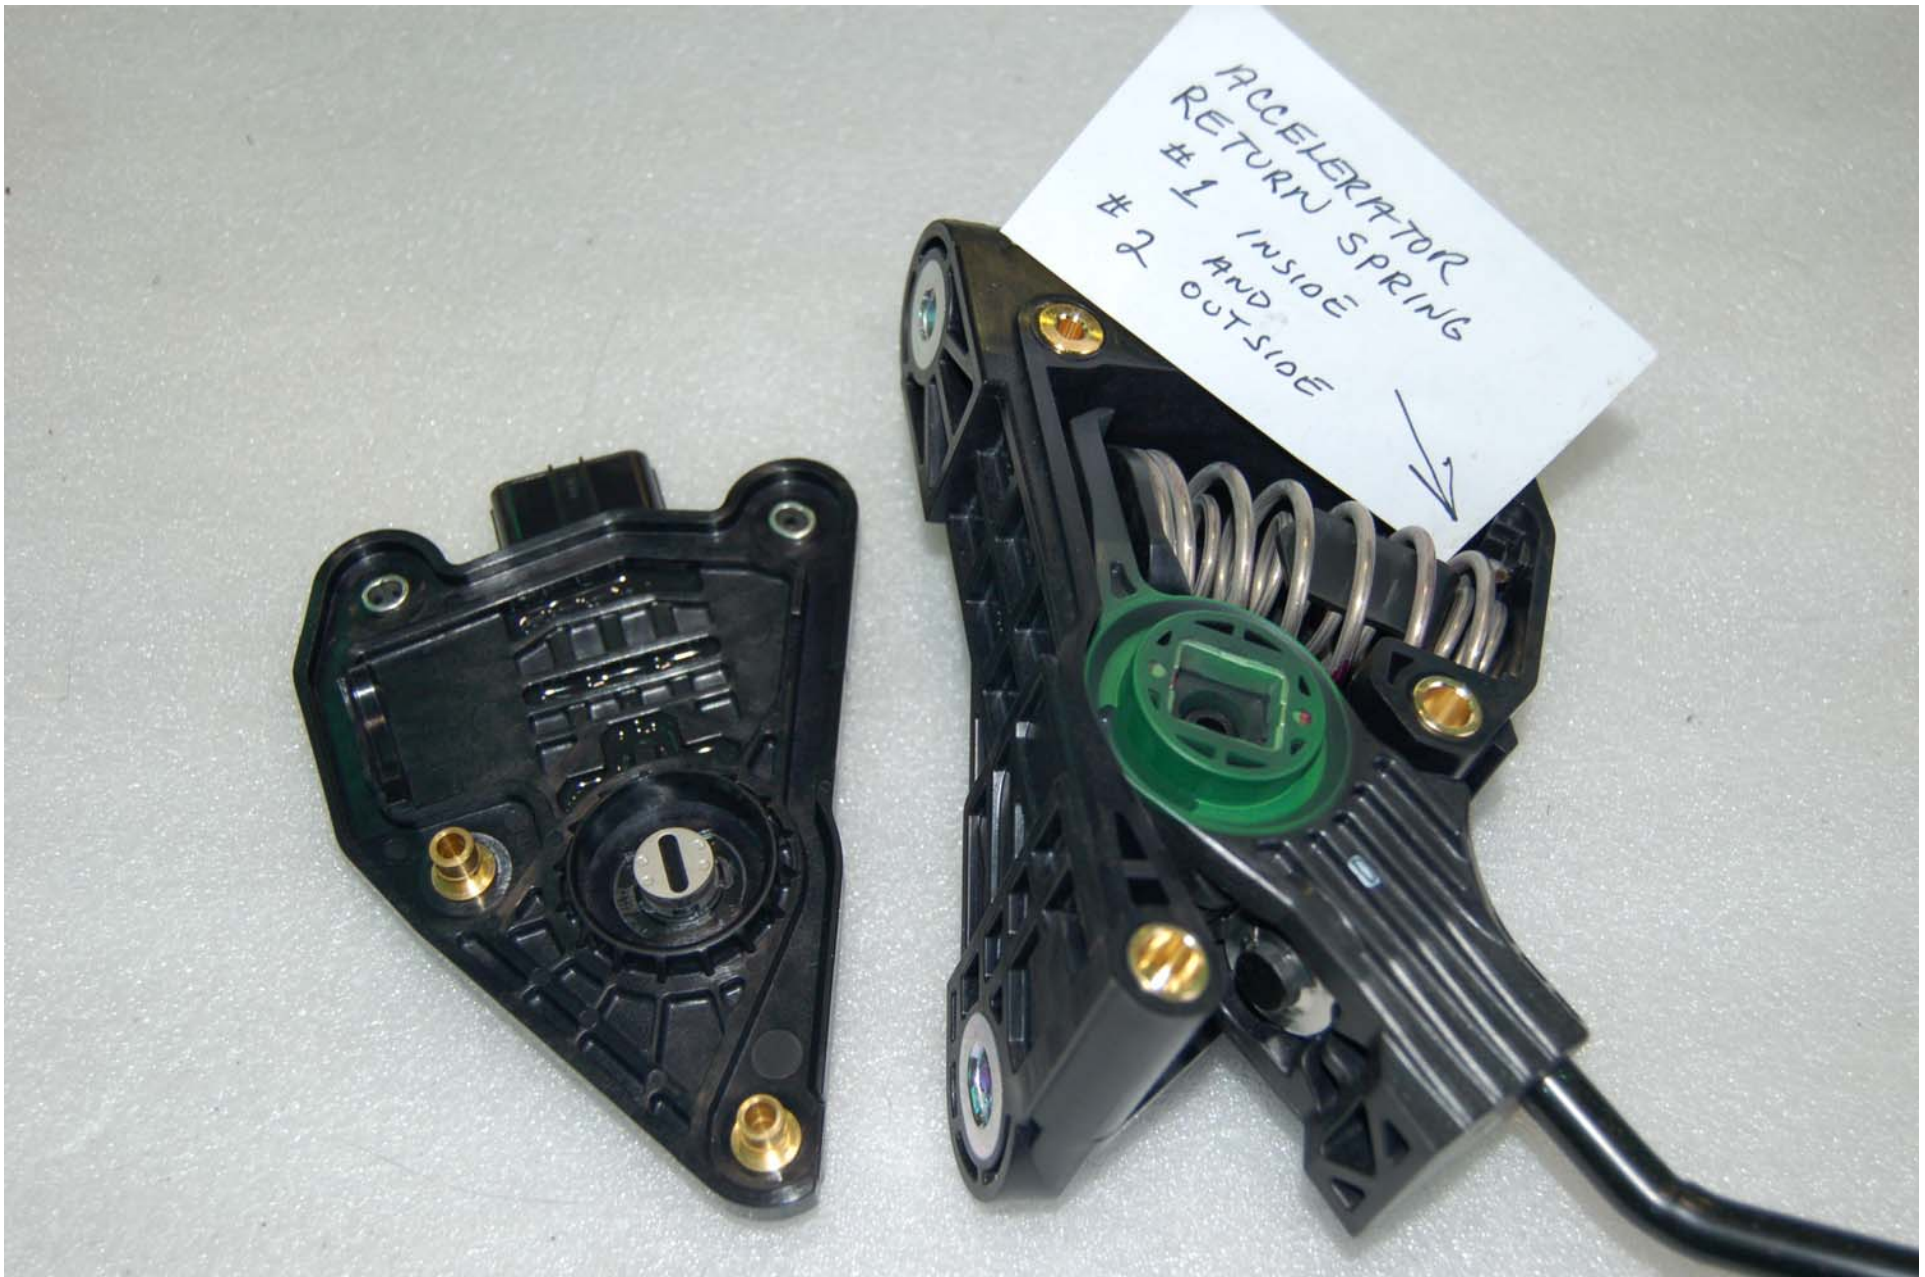
FIGURE 5.11
APS SPRINGS #1 AND #2

SYSTEM CONDITION: #1 SPRING DISCONNECTED APS INSIDE SPRING REMOVED

SYSTEM CONDITION: #2 SPRING DISCONNECTED
APS OUTSIDE SPRING REMOVED

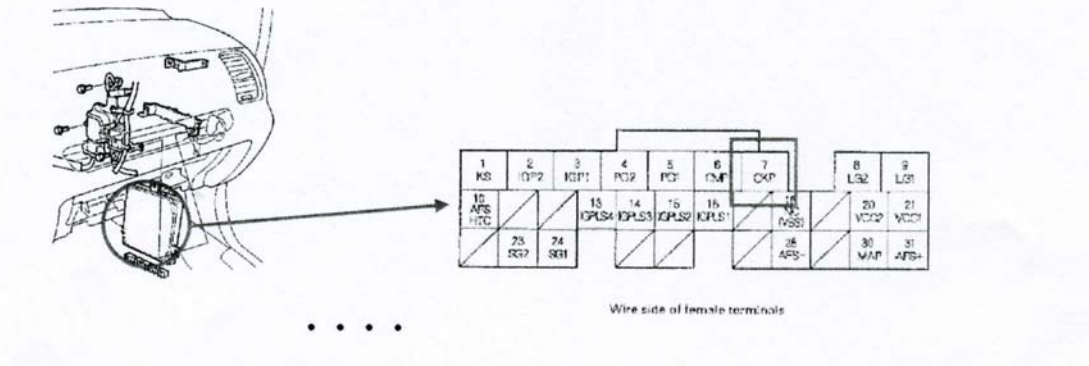
Fig.6 ECM connector (31pin)

Fig.6 shows ECM connector (31pin). The information from the pin No.7 of this connector is the signal from CKP(Crankshaft position sensor). The frequency is expressed by the conversion rate, $100[\text{rpm}] = 1.67[\text{Hz}]$, when a cycle is 13pulse.
