REPORT NUMBER 104-GTL-07-004

# SAFETY COMPLIANCE TESTING FOR FMVSS NO. 104 WINDSHIELD WIPING AND WASHING SYSTEMS

VOLKSWAGEN AG GERMANY  
2007 VOLKSWAGEN RABBIT, PASSENGER CAR  
NHTSA NO. C75800

**FINAL REPORT**

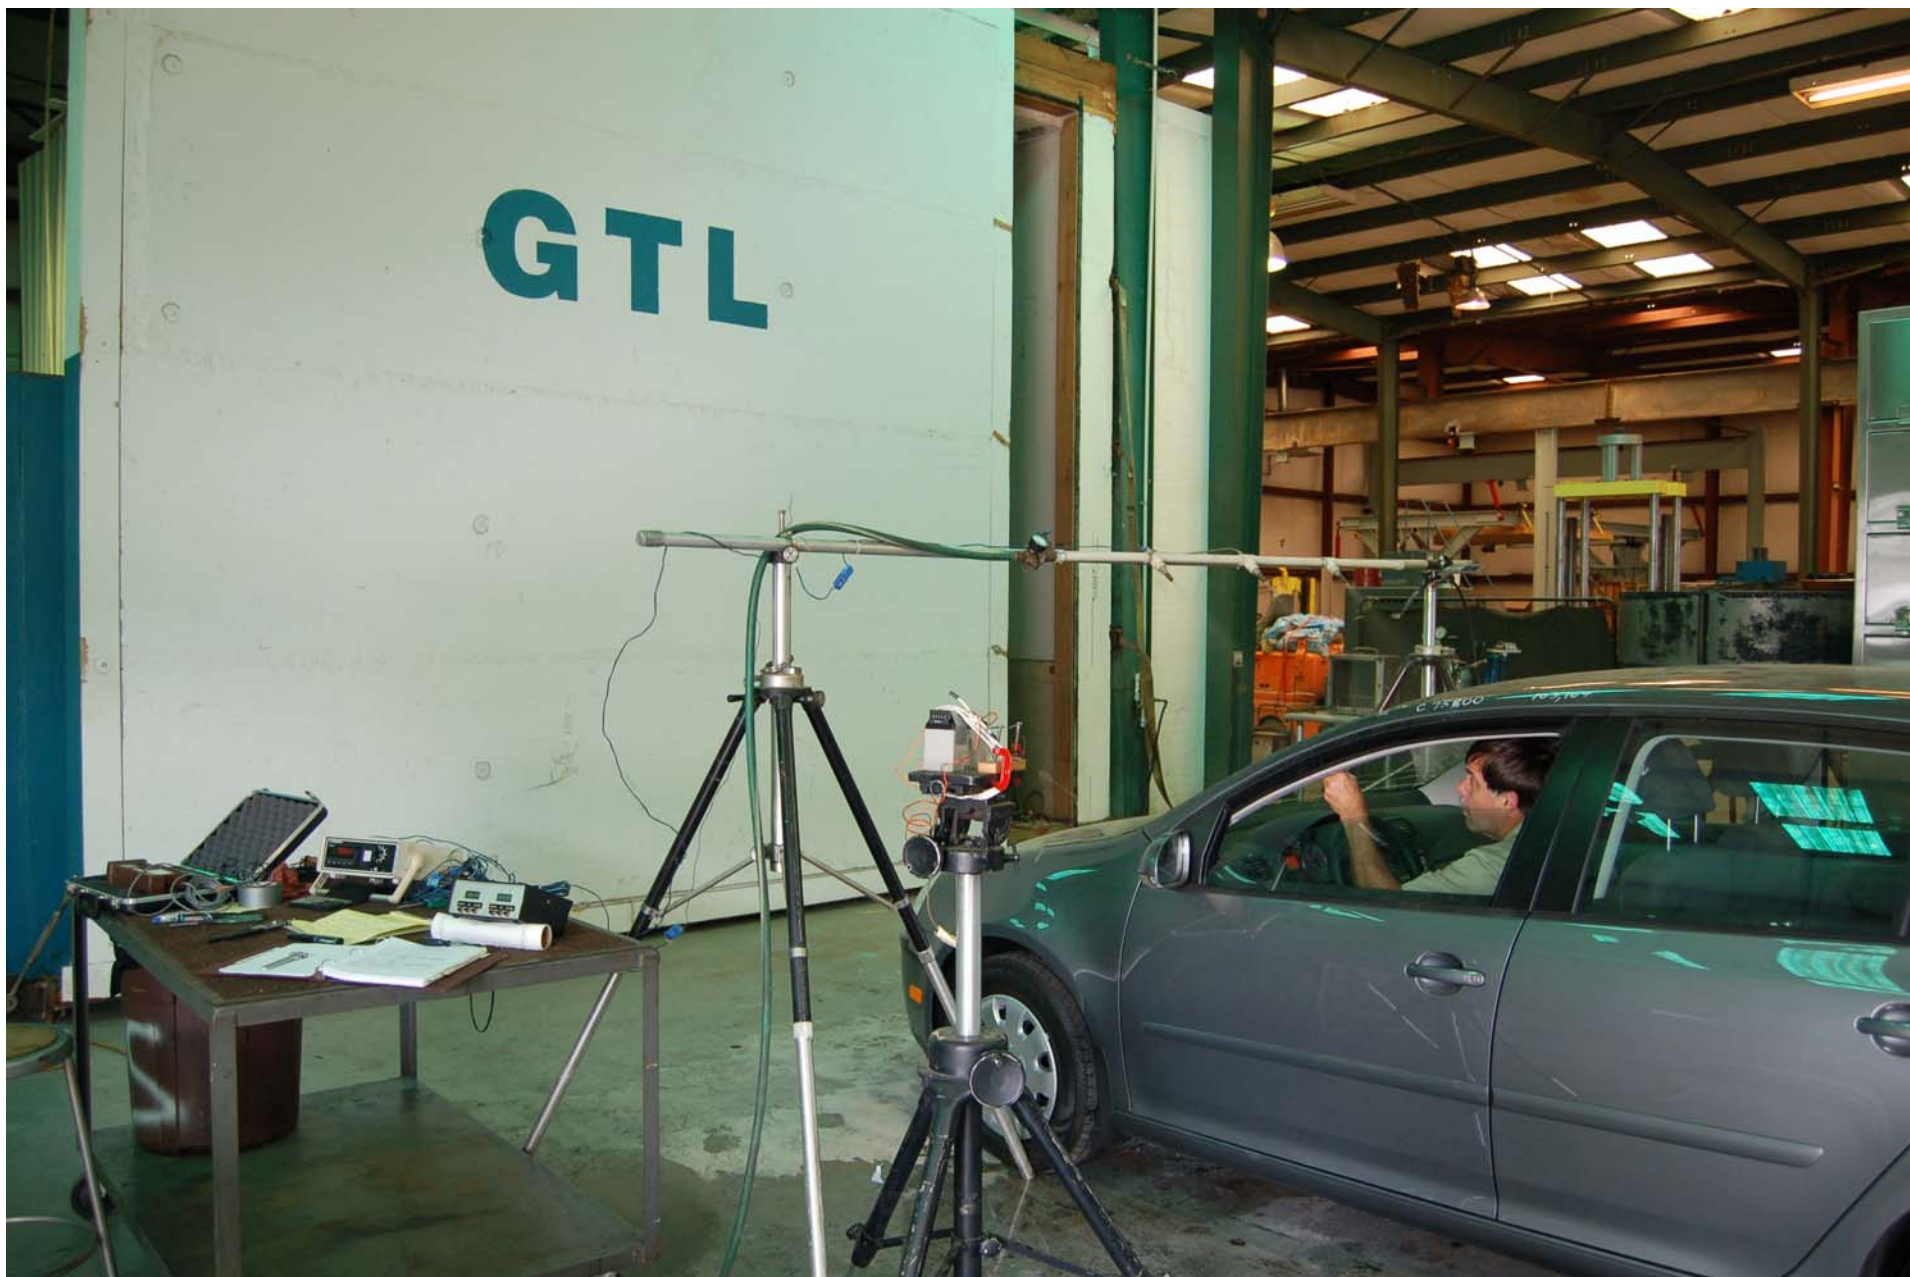
FIGURE 5.7  
INSTRUMENTATION AND EQUIPMENT SET-UP

The 2007 Volkswagen Rabbit passenger car, NHTSA No. C75800 was subjected to FMVSS No. 104 tests on October 9, 2007. The selected portions of FMVSS No. 104 tests used were as amplified in the following subparagraphs. The test vehicle was positioned in the test system with three water spray nozzles suspended in line with the center of the longitudinal axis of the windshield and horizontal left/right center of the windshield to provide an even distribution of spray to the entire windshield. The height of the nozzles was approximately 22 inches above the glazing surface.

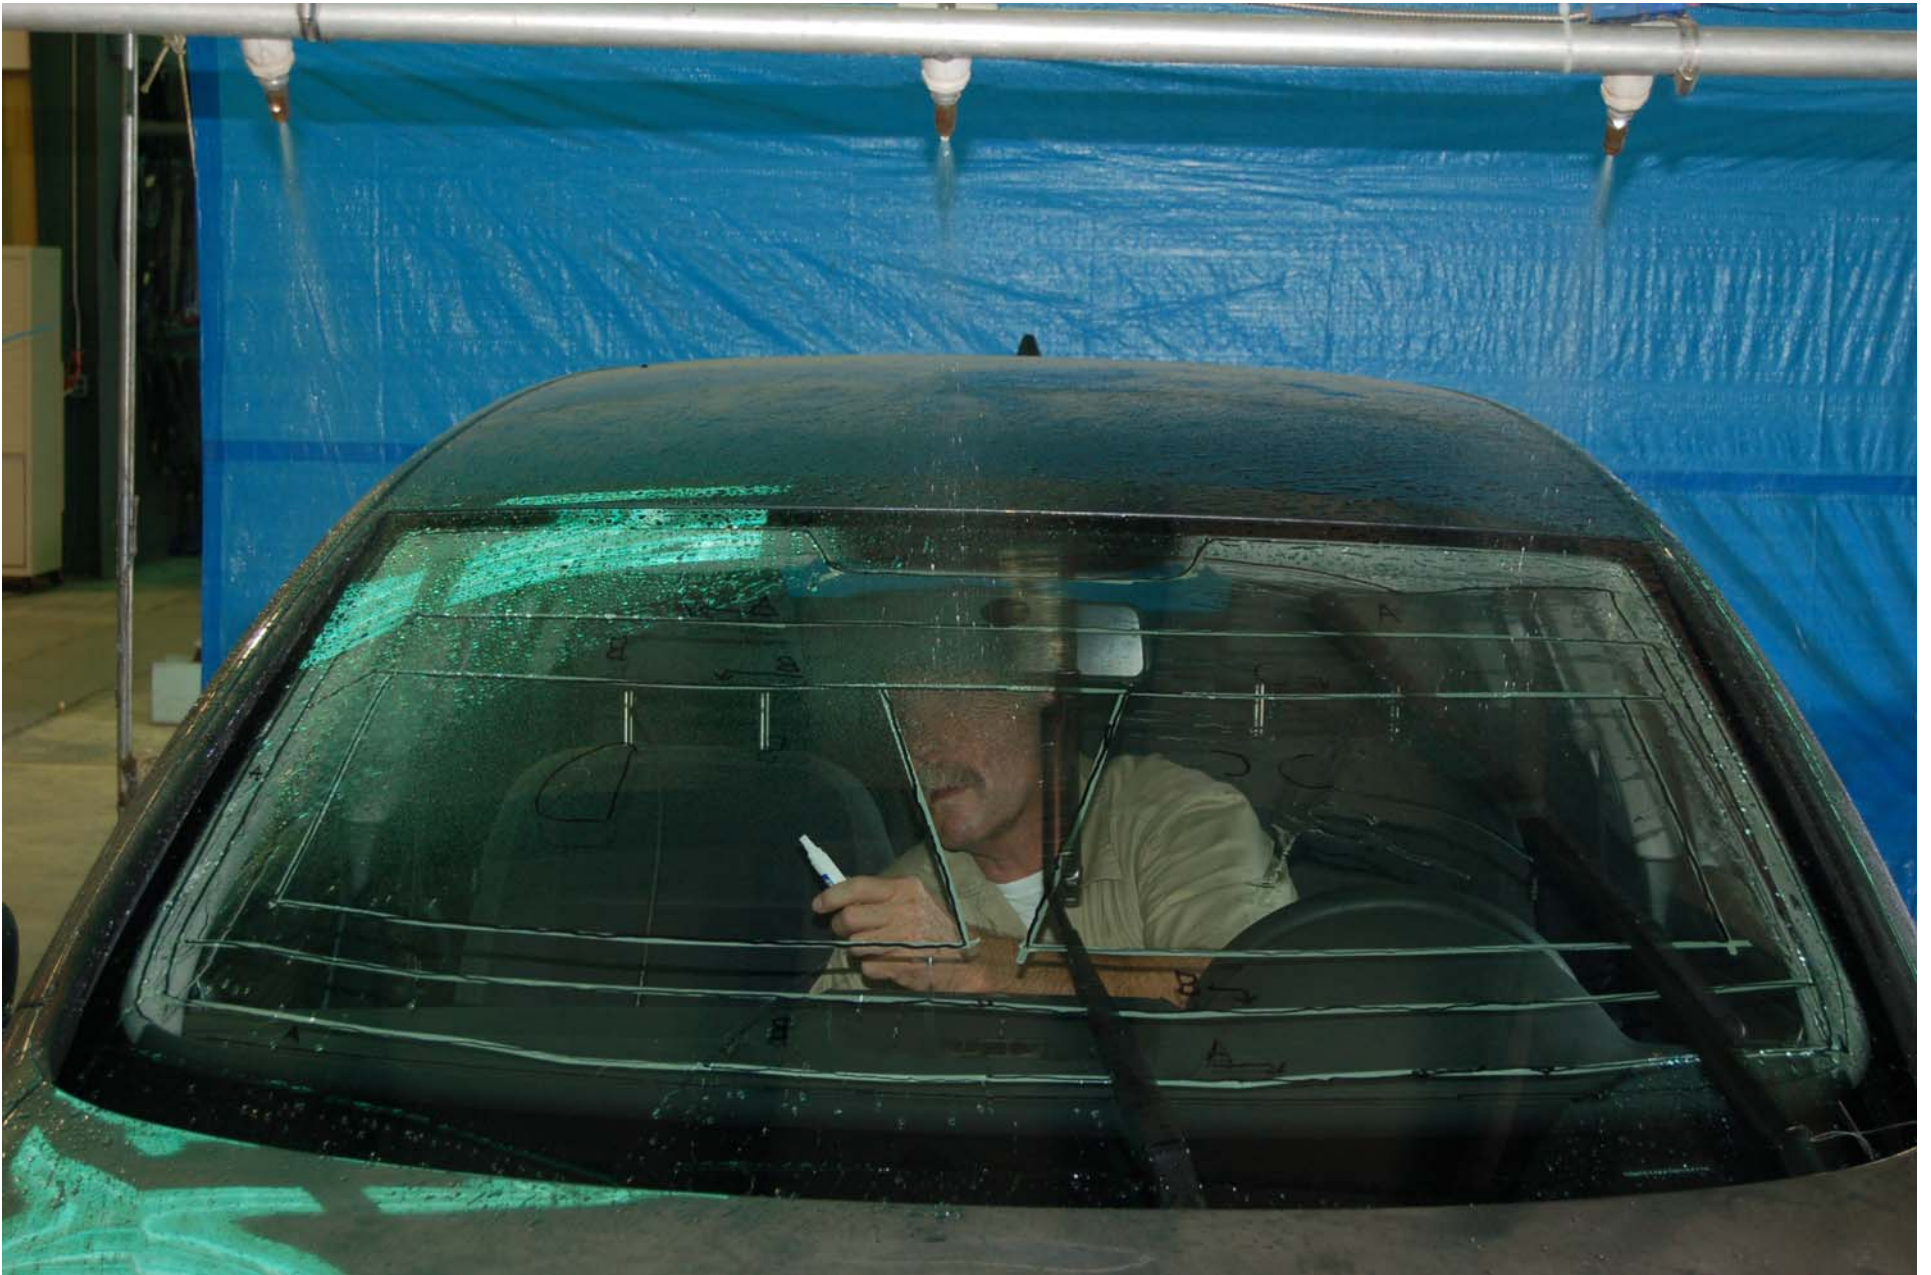
FIGURE 5.8  
WIPED AREA TEST IN PROCESS

The test was conducted with the windshield wiper system operating at the high speed setting, engine at idle RPM and the spray nozzles spraying water at a minimum of 50 cubic inches per minute. The wiper blade wipe pattern was outlined on the glazing surface and then transferred to a windshield pattern. The wiped area was determined for areas A, B and C from the windshield pattern.

PERCENT WIPED				
WINDSHIELD AREA	ACTUAL	REQUIRED	PASS	FAIL
A	93.0%	80%	X	
B	94.1%	94%	X	
C	100%	99%	X

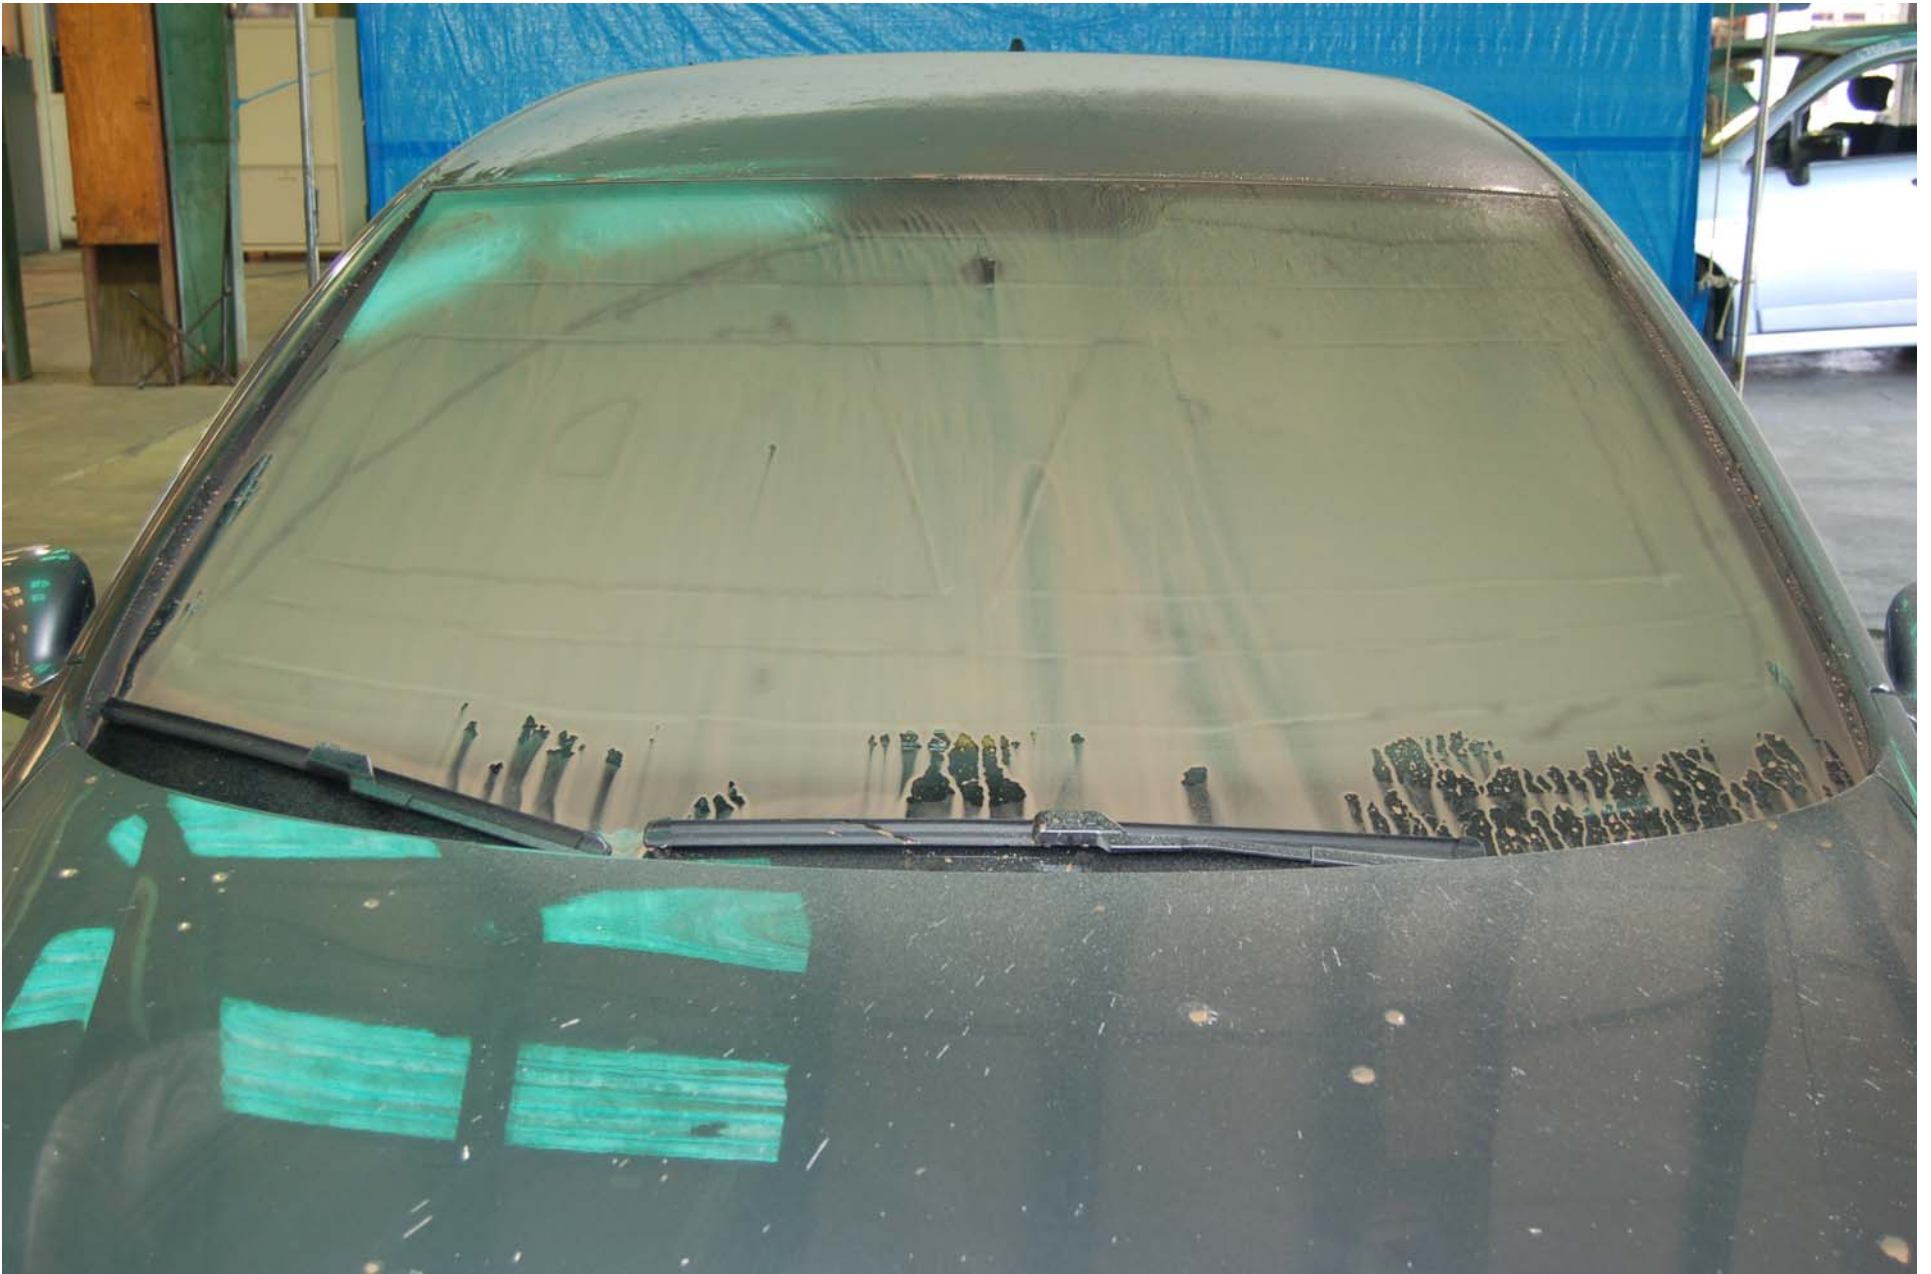
FIGURE 5.10  
CAPABILITY TEST #1 PRE-COATED WINDSHIELD

The windshield glazing surface was coated with a mixture of water and fine grade test dust. Within 15 seconds following application of the water-dust mixture, the windshield wiper and washing system was activated in the high speed mode for ten complete cycles. The vehicle's engine was operating at idle RPM. The cleared areas of the windshield were marked on the inside windshield surface. After ten complete cycles the system was deactivated and the wiped area transferred to a windshield pattern.

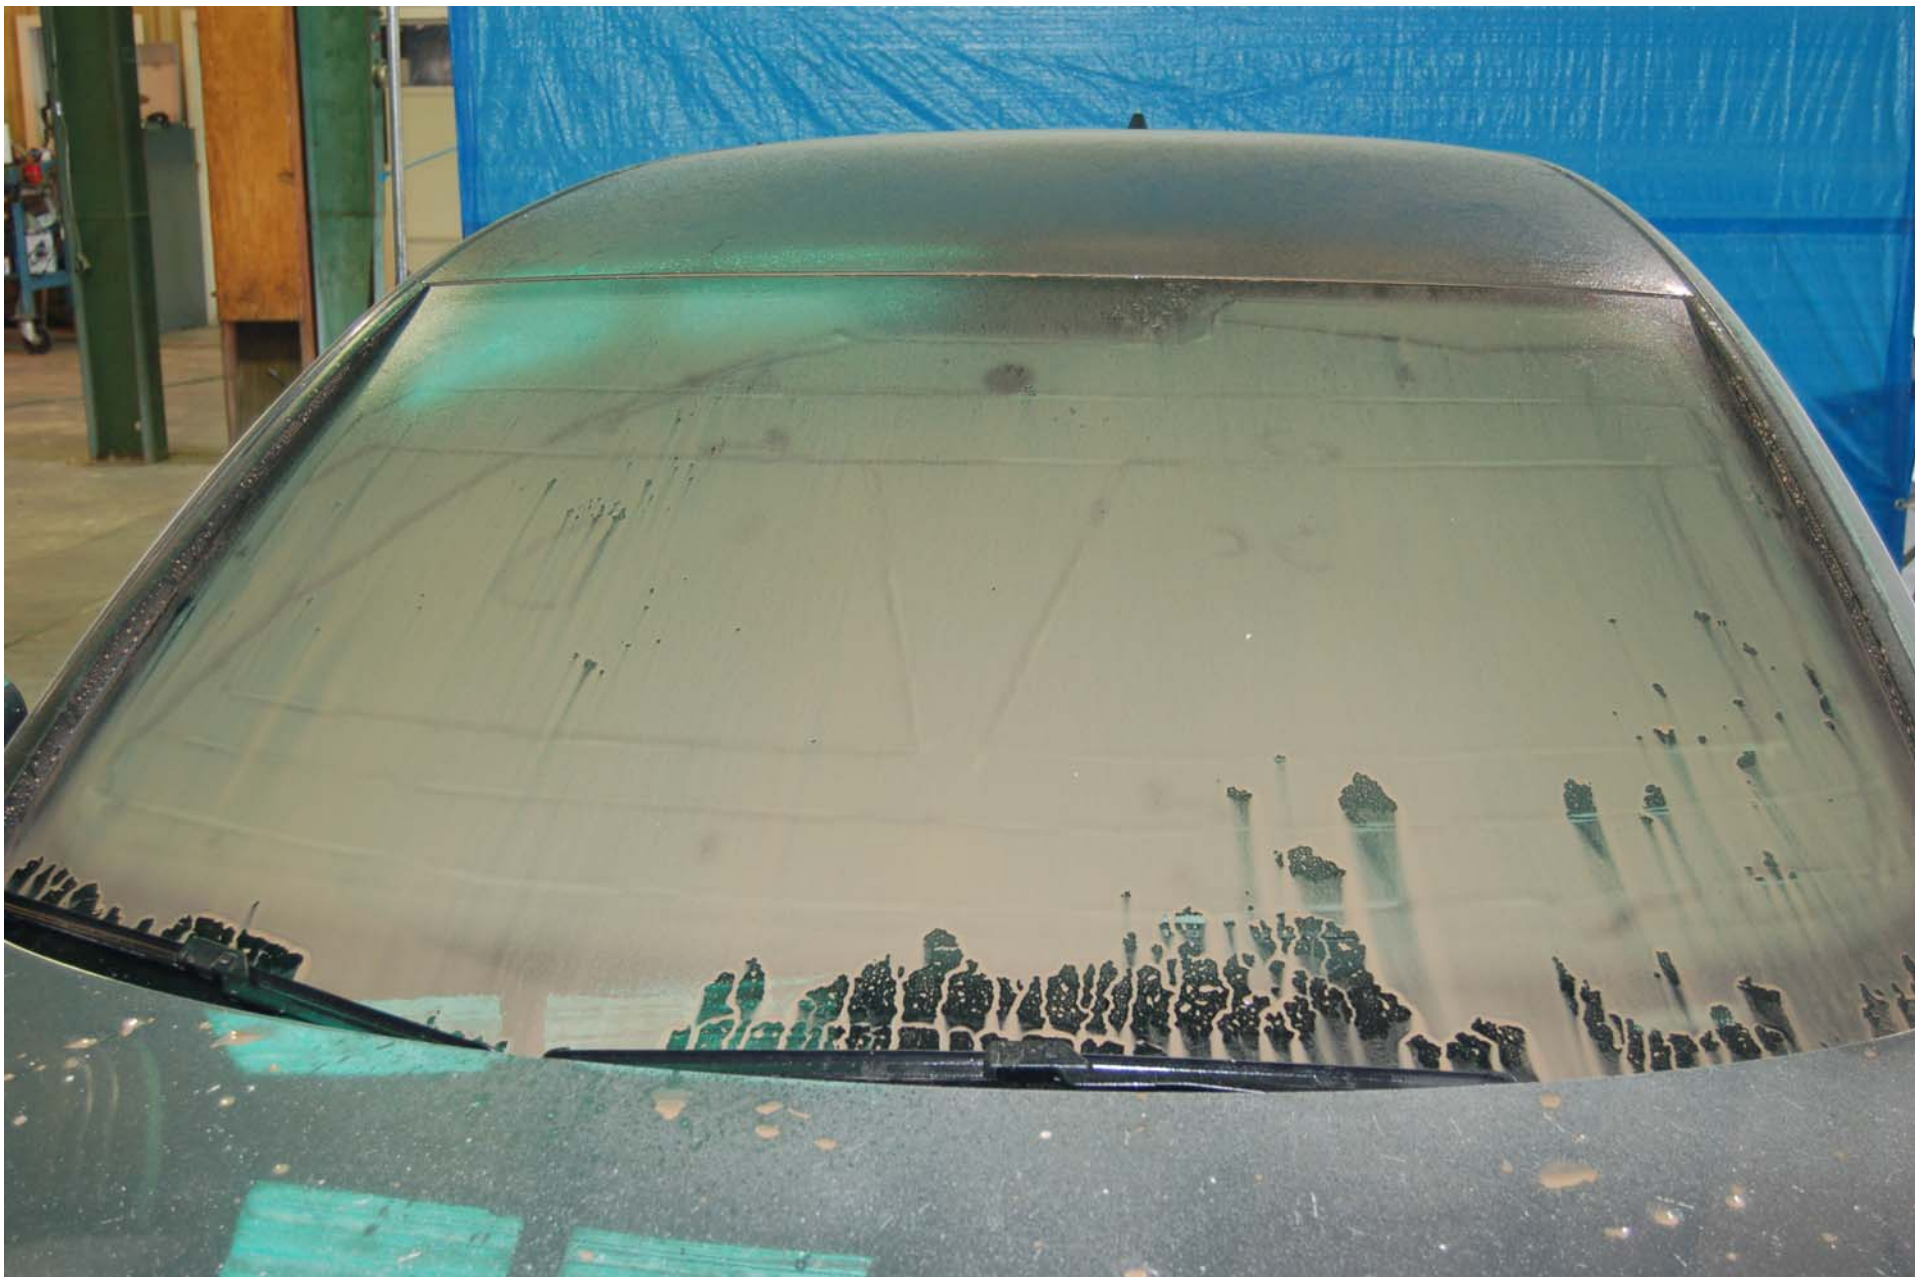
FIGURE 5.12  
CAPABILITY TEST #2 PRE-COATED WINDSHIELD

The glazing surface was cleaned and dried. The water dust mixture was re-applied and the test repeated.
