126-TRC-07-004

SAFETY COMPLIANCE TESTING FOR FMVSS 126 (Indicant) Electronic Stability Control Systems

Toyota Motor Company
2008 Toyota Highlander
NHTSA No. C85104

FINAL REPORT

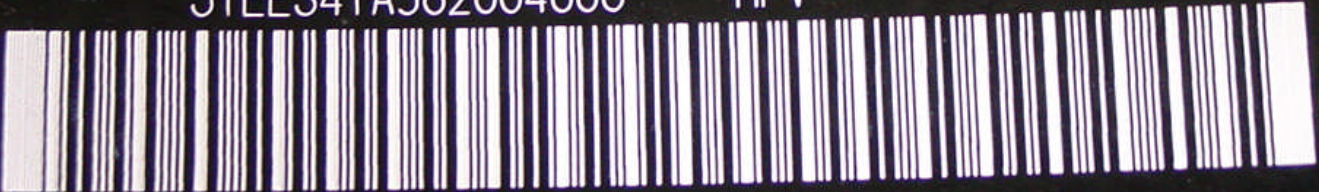
5.2 VEHICLE CERTIFICATION LABEL

MFD. BY: TOYOTA MOTOR CORPORATION
GVWR: 2720KG (6000LB)
GAWR: FRT. 1340KG (2955LB) WITH P245/65R17 TIRES.
17X7 1/2J RIMS, AT 210KPA (30PSI) COLD.
RR. 1585KG (3505LB) WITH P245/65R17 TIRES.
17X7 1/2J RIMS, AT 210KPA (30PSI) COLD.
THIS VEHICLE CONFORMS TO ALL APPLICABLE FEDERAL MOTOR
VEHICLE SAFETY AND THEFT PREVENTION STANDARDS IN EFFECT ON
THE DATE OF MANUFACTURE SHOWN ABOVE.
JTEES41A582004636 MPV

C/TR: 202/FC40 GSU45L-BRANKA
A/TM: -01B/U151F MADE IN JAPAN 538

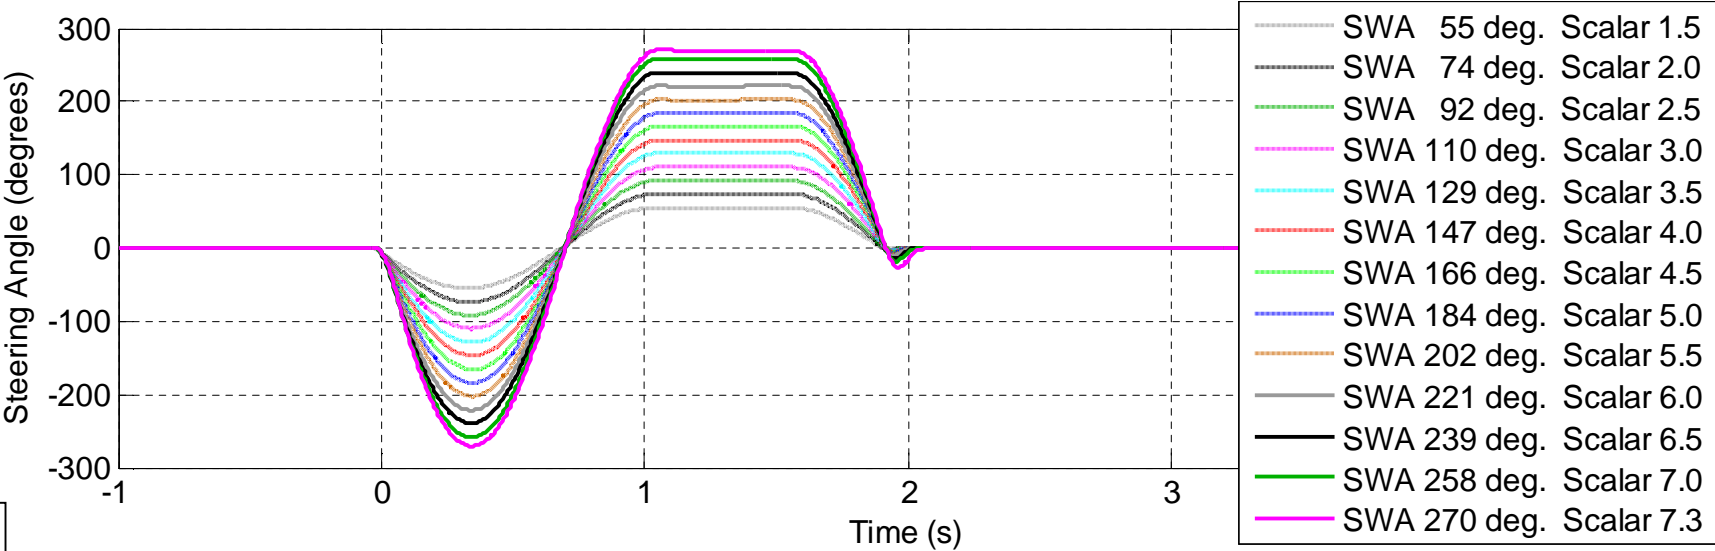
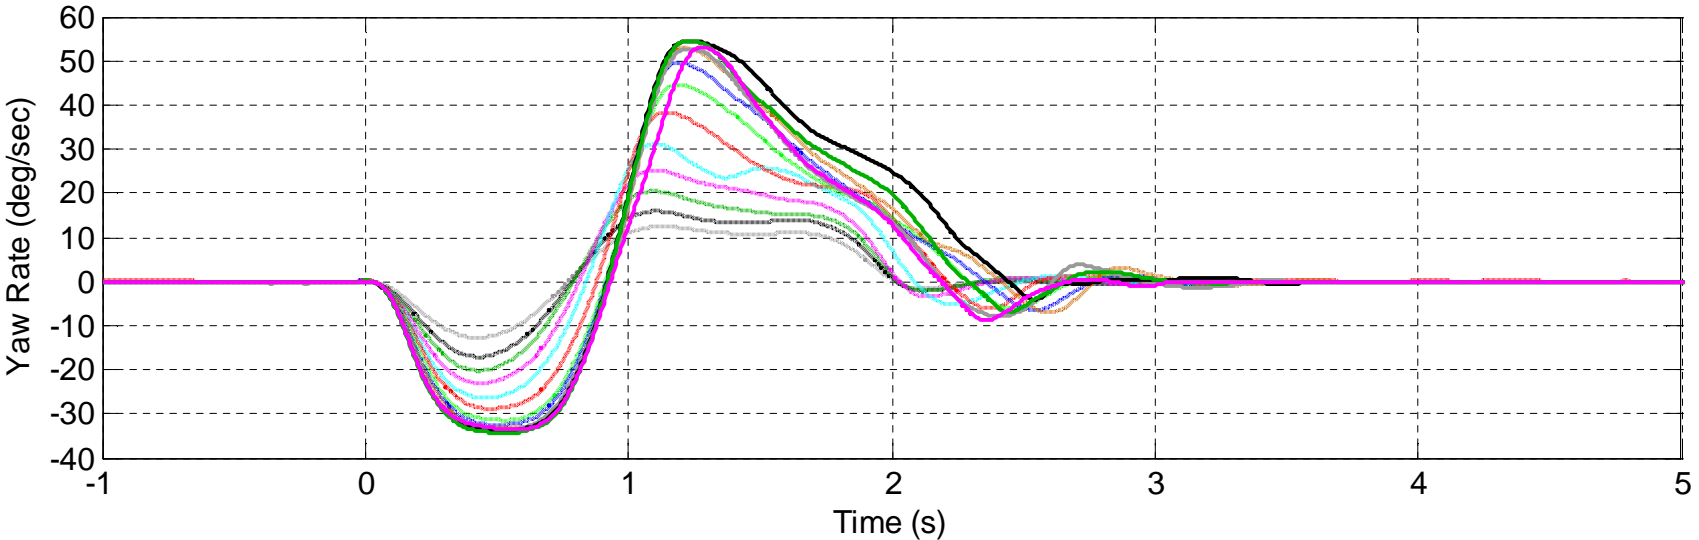
Figure 1. Steering Angle and Yaw Rate Time History, Counter-Clockwise Initial Steer Tests

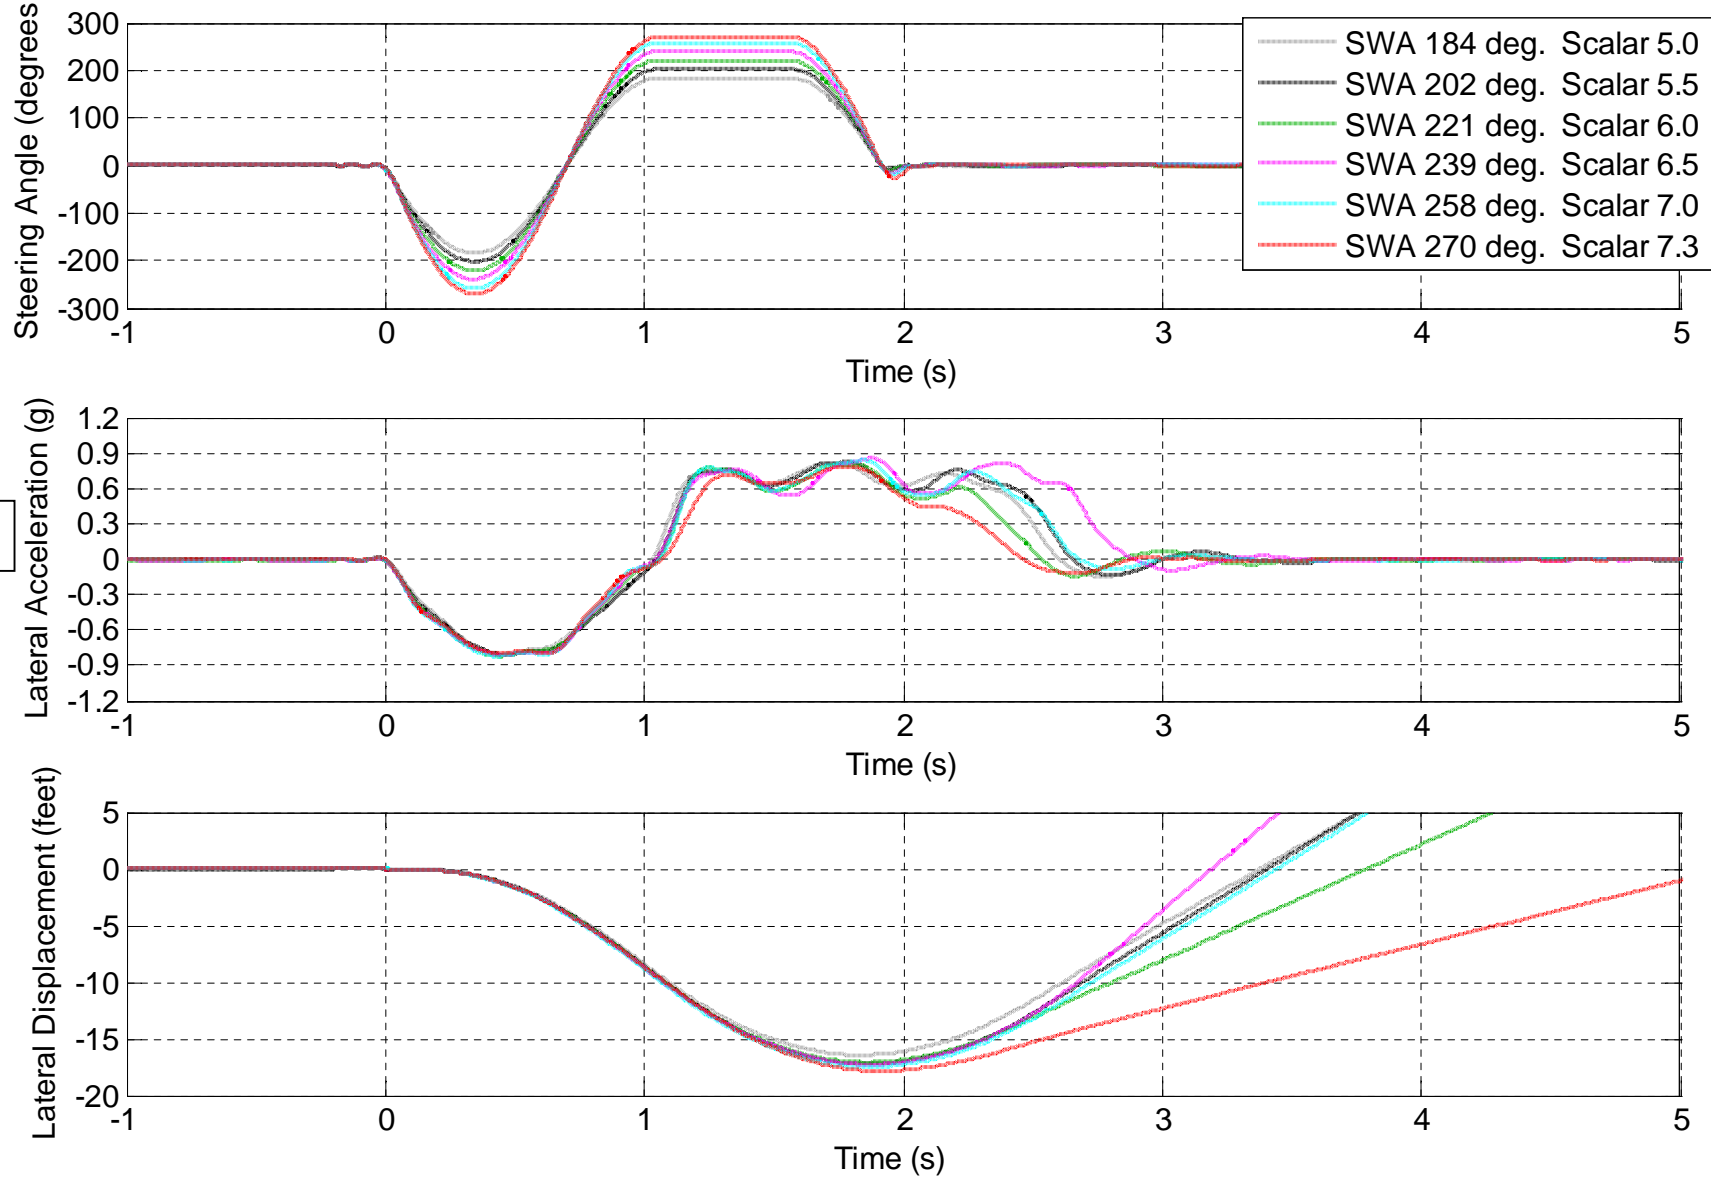
Figure 2. Steering Angle, Lateral Acceleration, and Lateral Displacement Time History, Counter-Clockwise Initial Steer Tests

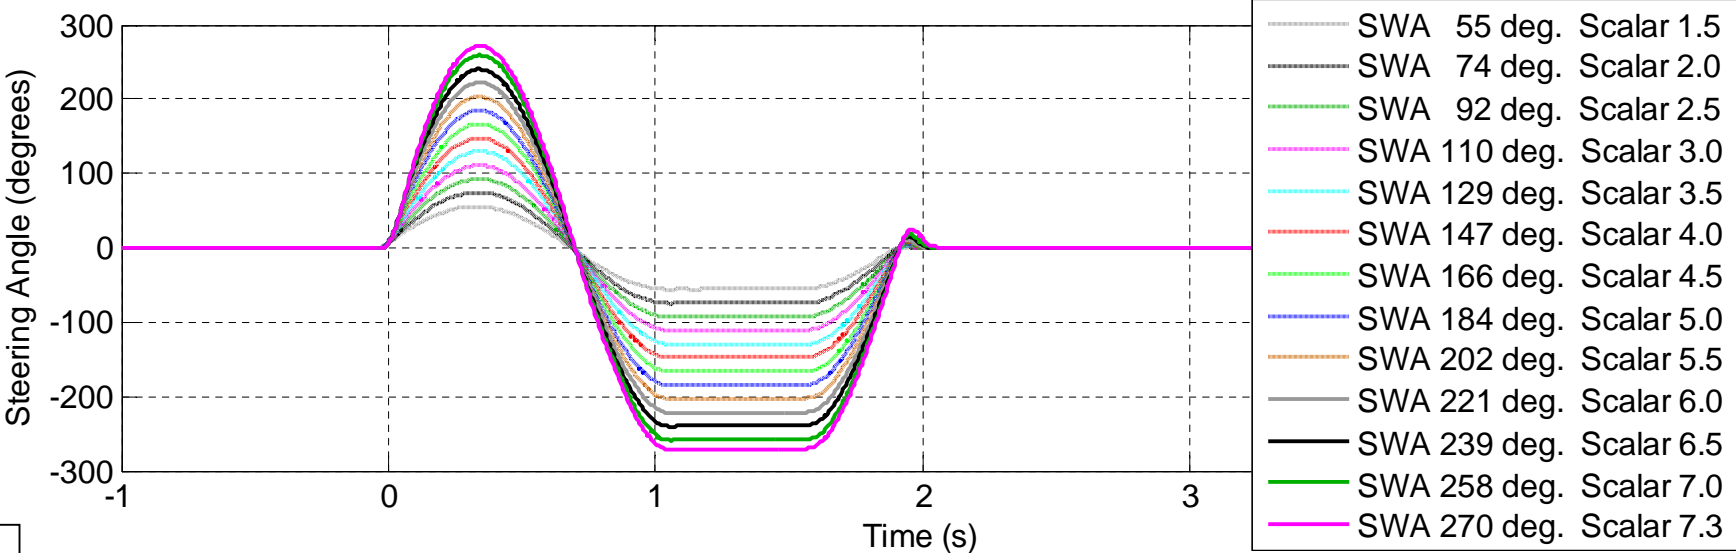
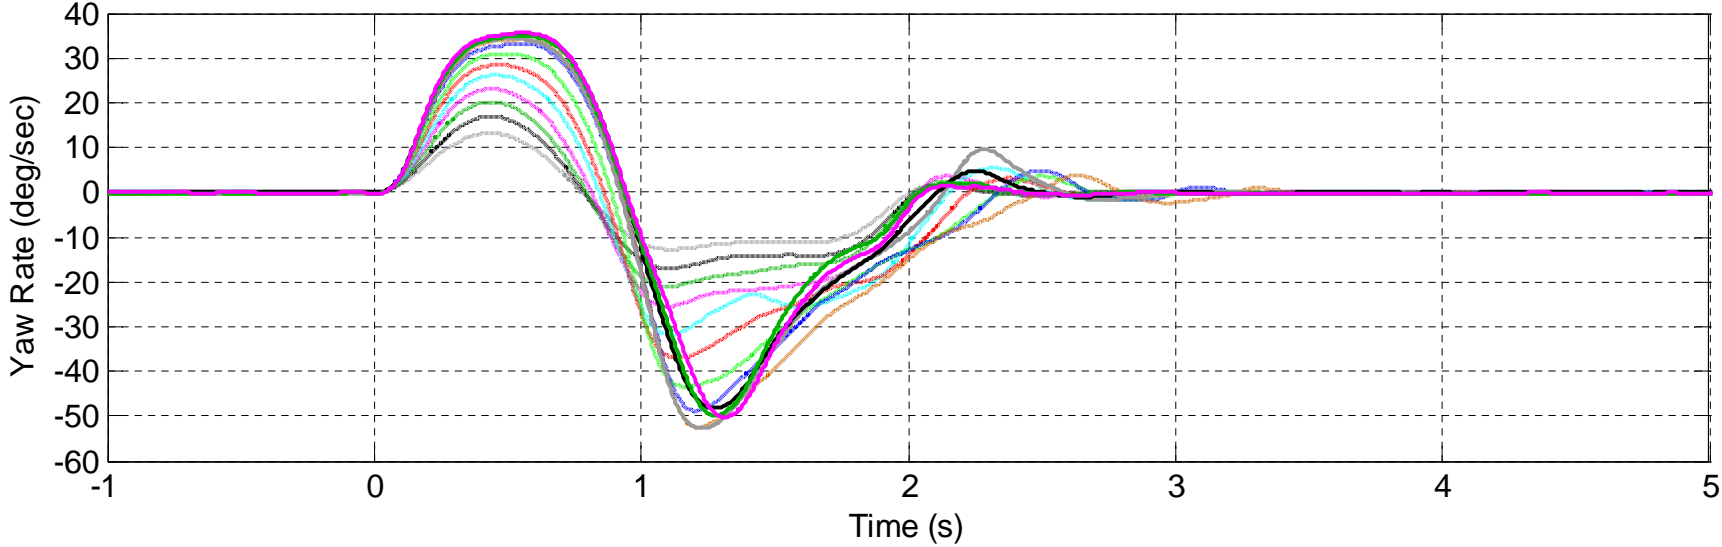
Figure 3. Steering Angle and Yaw Rate Time History, Clockwise Initial Steer Tests

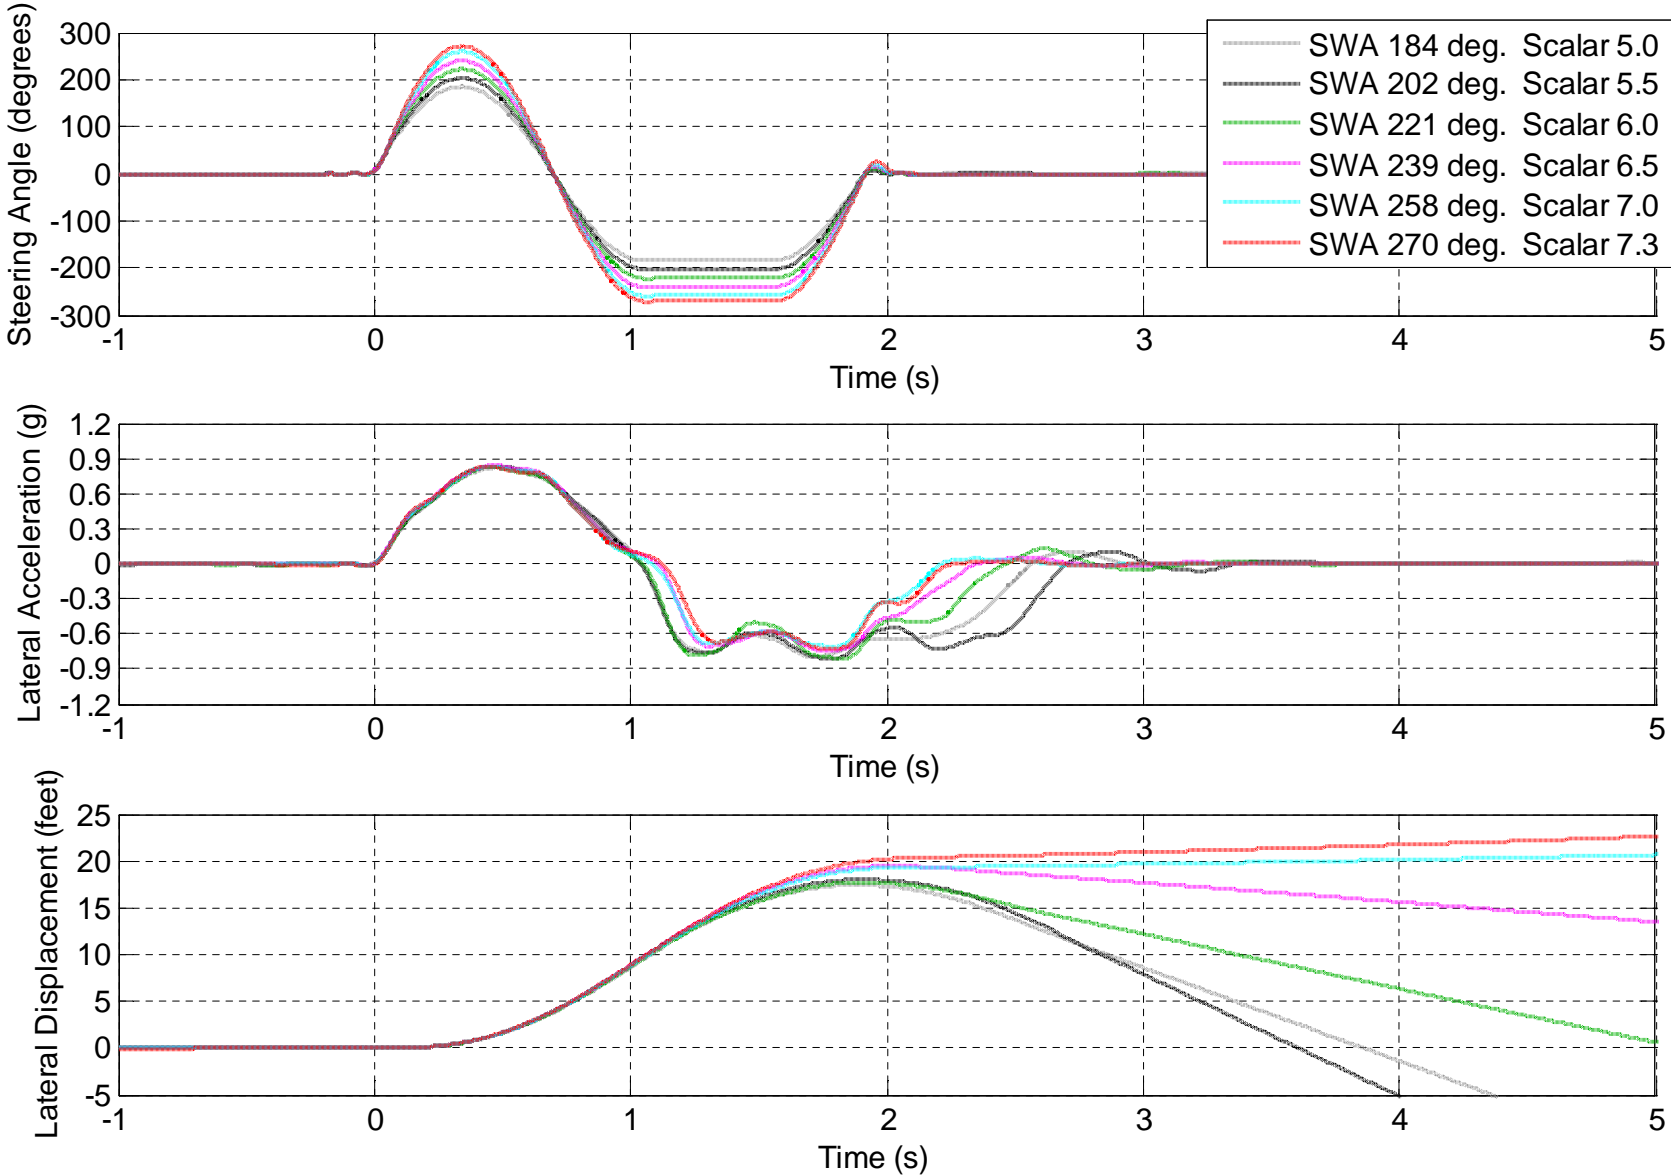
Figure 4. Steering Angle, Lateral Acceleration, and Lateral Displacement Time History, Clockwise Initial Steer Tests

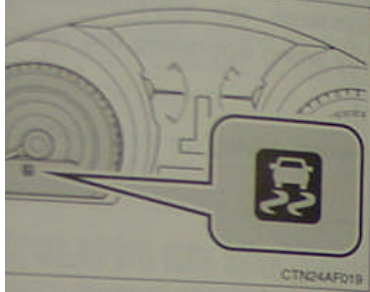
the VSC/TRAC/hill-start assist control systems are open

If the vehicle is in danger of slipping, rolling backwards starting on an incline, or the wheels (2WD models) or wheels (4WD models) the indicator flashes to indicate the VSC/TRAC/hill-start assist control systems have engaged.

A buzzer (intermittent) will indicate that VSC is open. The stop lights and high beam stoplight turn on when the hill-start assist control system is operating.

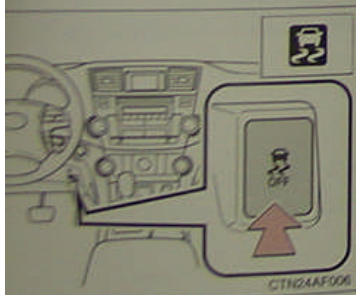
Quickly push and release the button to turn off TRAC and VSC. The slip indicator light and VSC OFF indicator light will come on. Push the button again to turn the system back on.

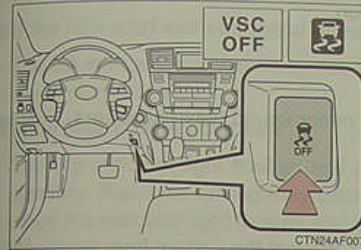
Turning off TRAC and VSC

Push and hold the button while the vehicle is stopped to turn off TRAC and VSC.

The slip indicator light and VSC OFF indicator light should come on.
