REPORT NUMBER 103-GTL-07-001

**SAFETY COMPLIANCE TESTING FOR
FMVSS NO. 103
WINDSHIELD DEFROSTING AND
DEFOGGING SYSTEMS**

**HYUNDAI MOTOR COMPANY
2007 HYUNDAI ELANTRA, PASSENGER CAR
NHTSA NO. C70502**

**GENERAL TESTING LABORATORIES, INC.
1623 LEEDSTOWN ROAD
COLONIAL BEACH, VIRGINIA 22443**

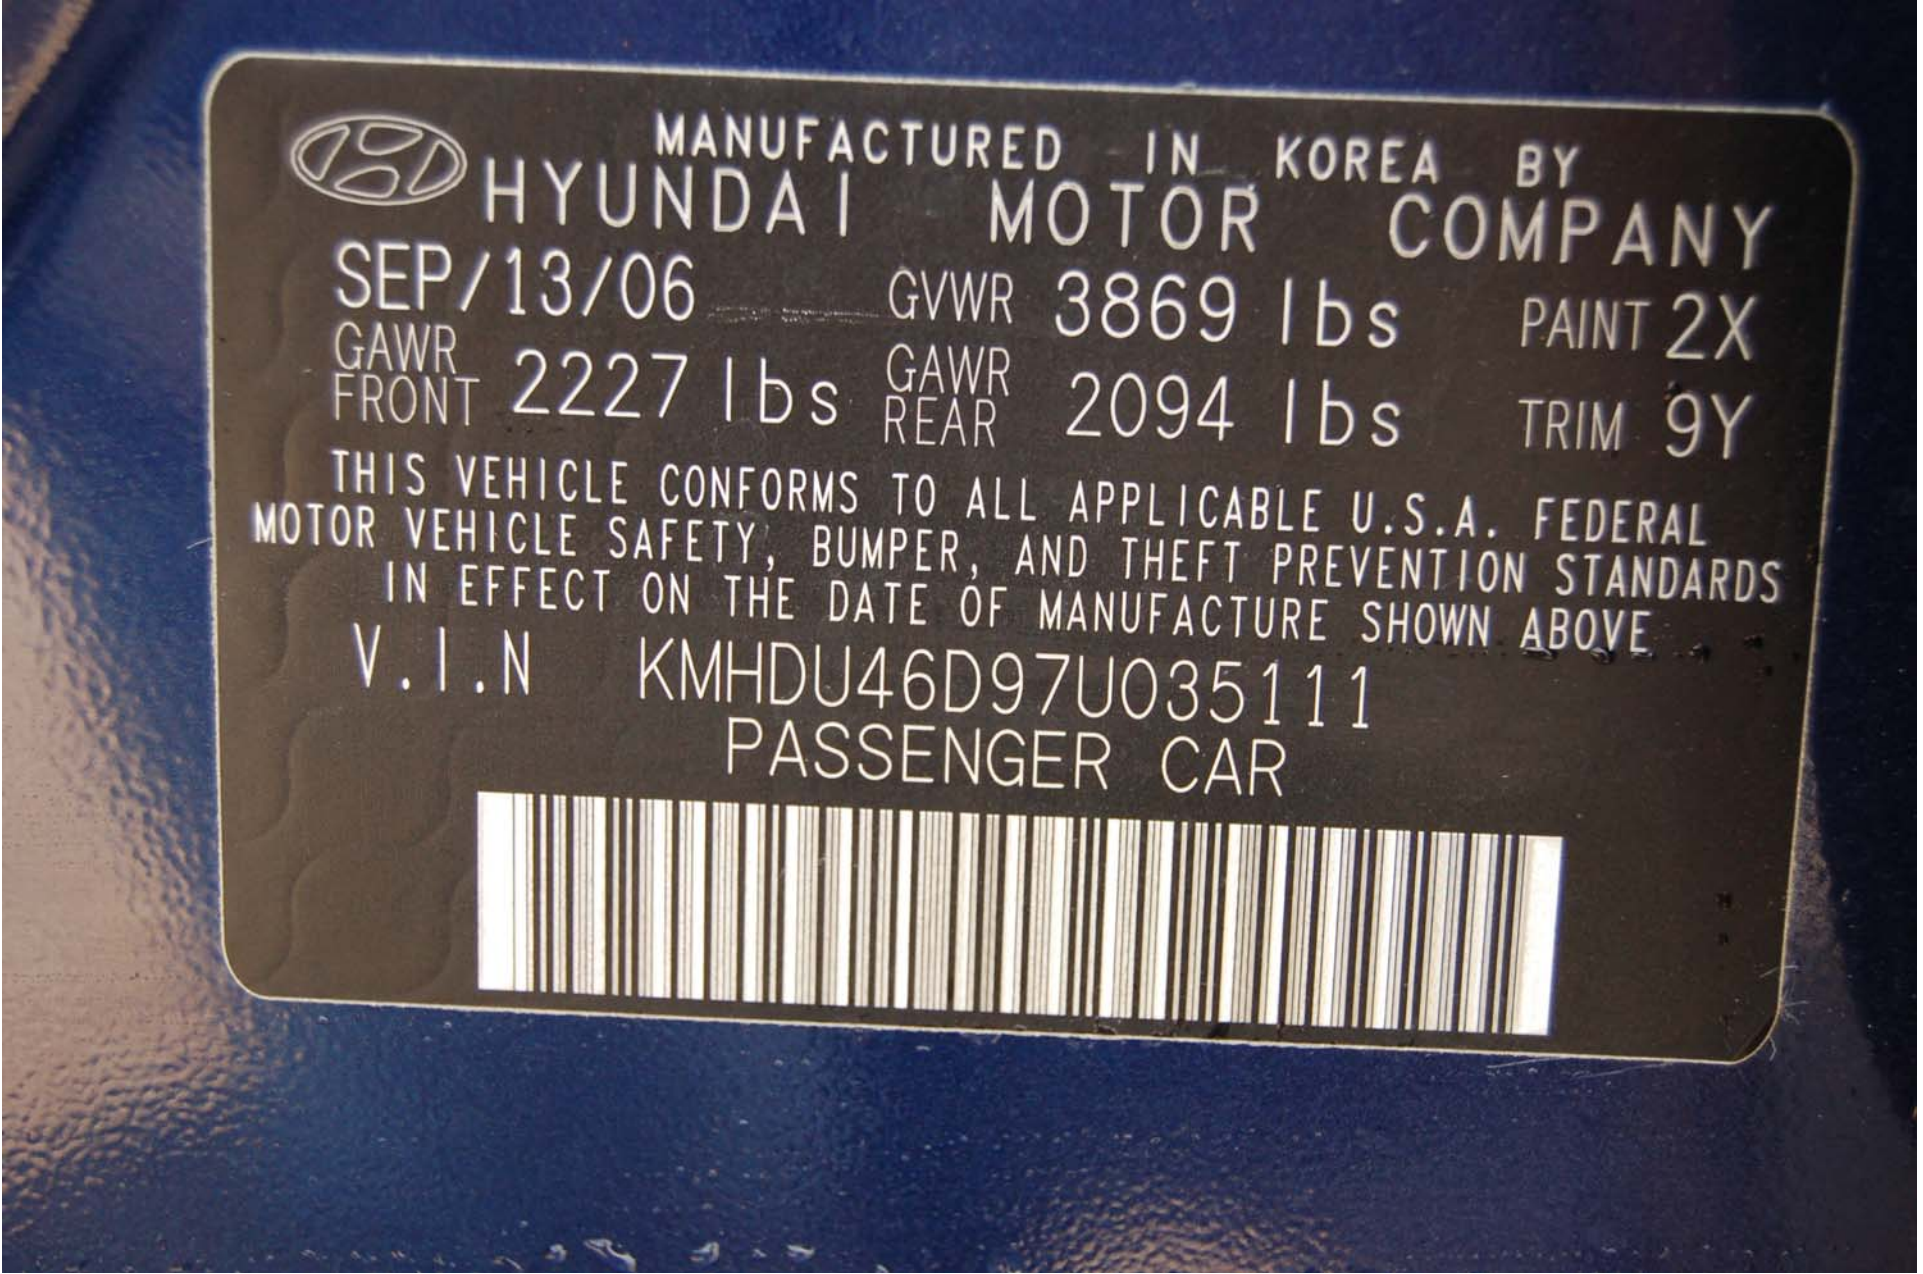
FIGURE 5.5
 VEHICLE CERTIFICATION LABEL

SEP/13/06 GVWR 3869 lbs PAINT 2X
 GAWR FRONT 2227 lbs GAWR REAR 2094 lbs TRIM 9Y

THIS VEHICLE CONFORMS TO ALL APPLICABLE U.S.A. FEDERAL
 MOTOR VEHICLE SAFETY, BUMPER, AND THEFT PREVENTION STANDARDS
 IN EFFECT ON THE DATE OF MANUFACTURE SHOWN ABOVE

V.I.N KMHDU46D97U035111
 PASSENGER CAR

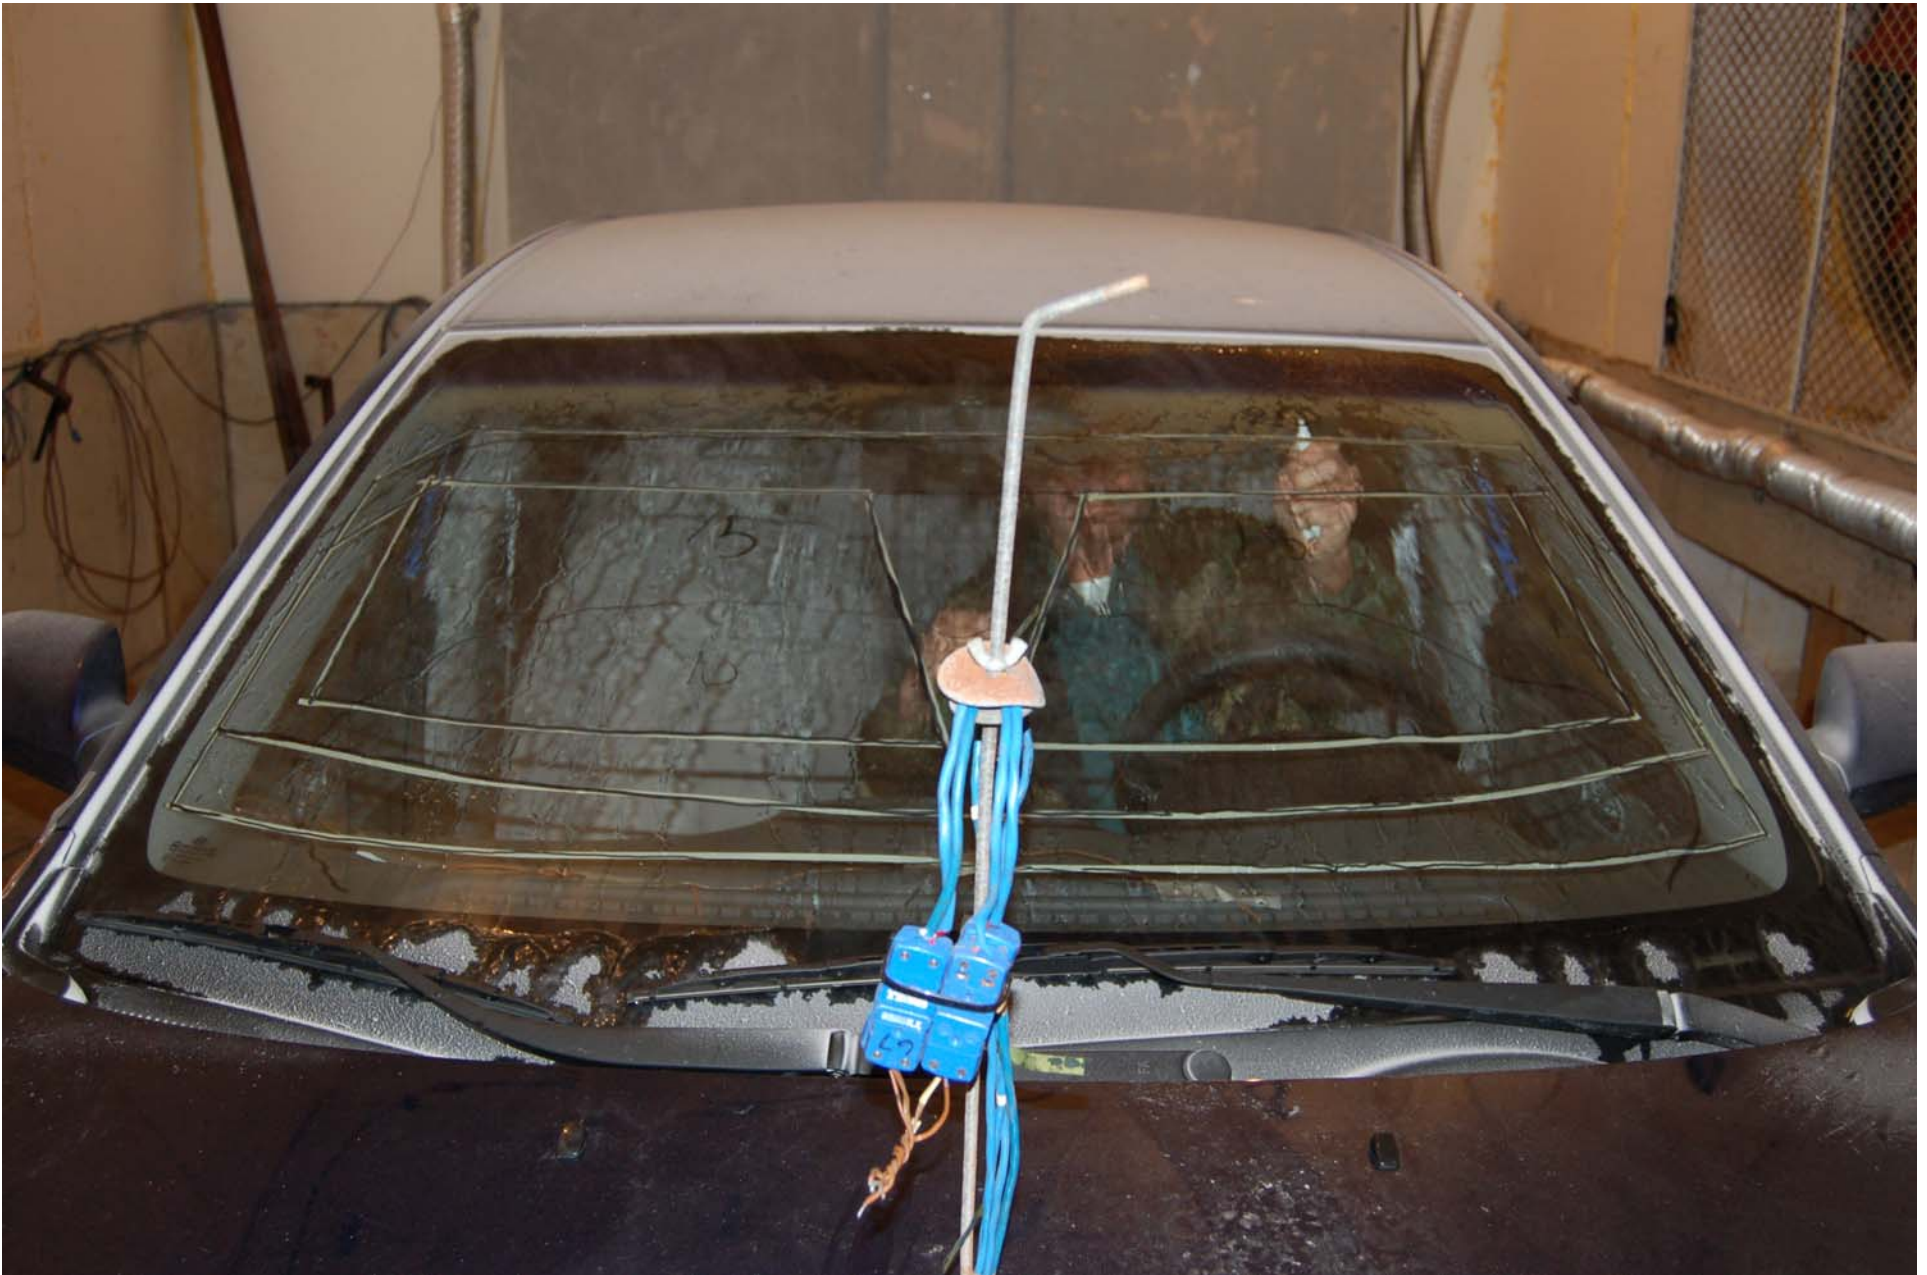
FIGURE 5.10
DEFROSTED AREA AT 20 MINUTES TEST #1

TIME FROM START (minutes)	MOTOR VOLTAGE (volts)	TEMPERATURE, °F					DEFROSTED AREA, %		
		TEST ROOM	ENGINE WATER	HEATER WATER IN	DEFROSTER AIR		A	C	D
					DRVR	PSGR			
0	13.5	-1.6	.3	-1.0*	1.3	1.7	0%	0%	0%
5	14.6	0	23.4	49.0*	57.6	56.9	0%	0%	0%
10	14.6	.2	71.5	89.5*	84.7	82.6	43.7%	42.0%	38.0%
15	14.6	1.7	94.8	103.4*	96.7	94.2	94.7%	100%	100%
20	14.5	2.0	104.9	109.0*	101.0	98.8	100%	100%	100%

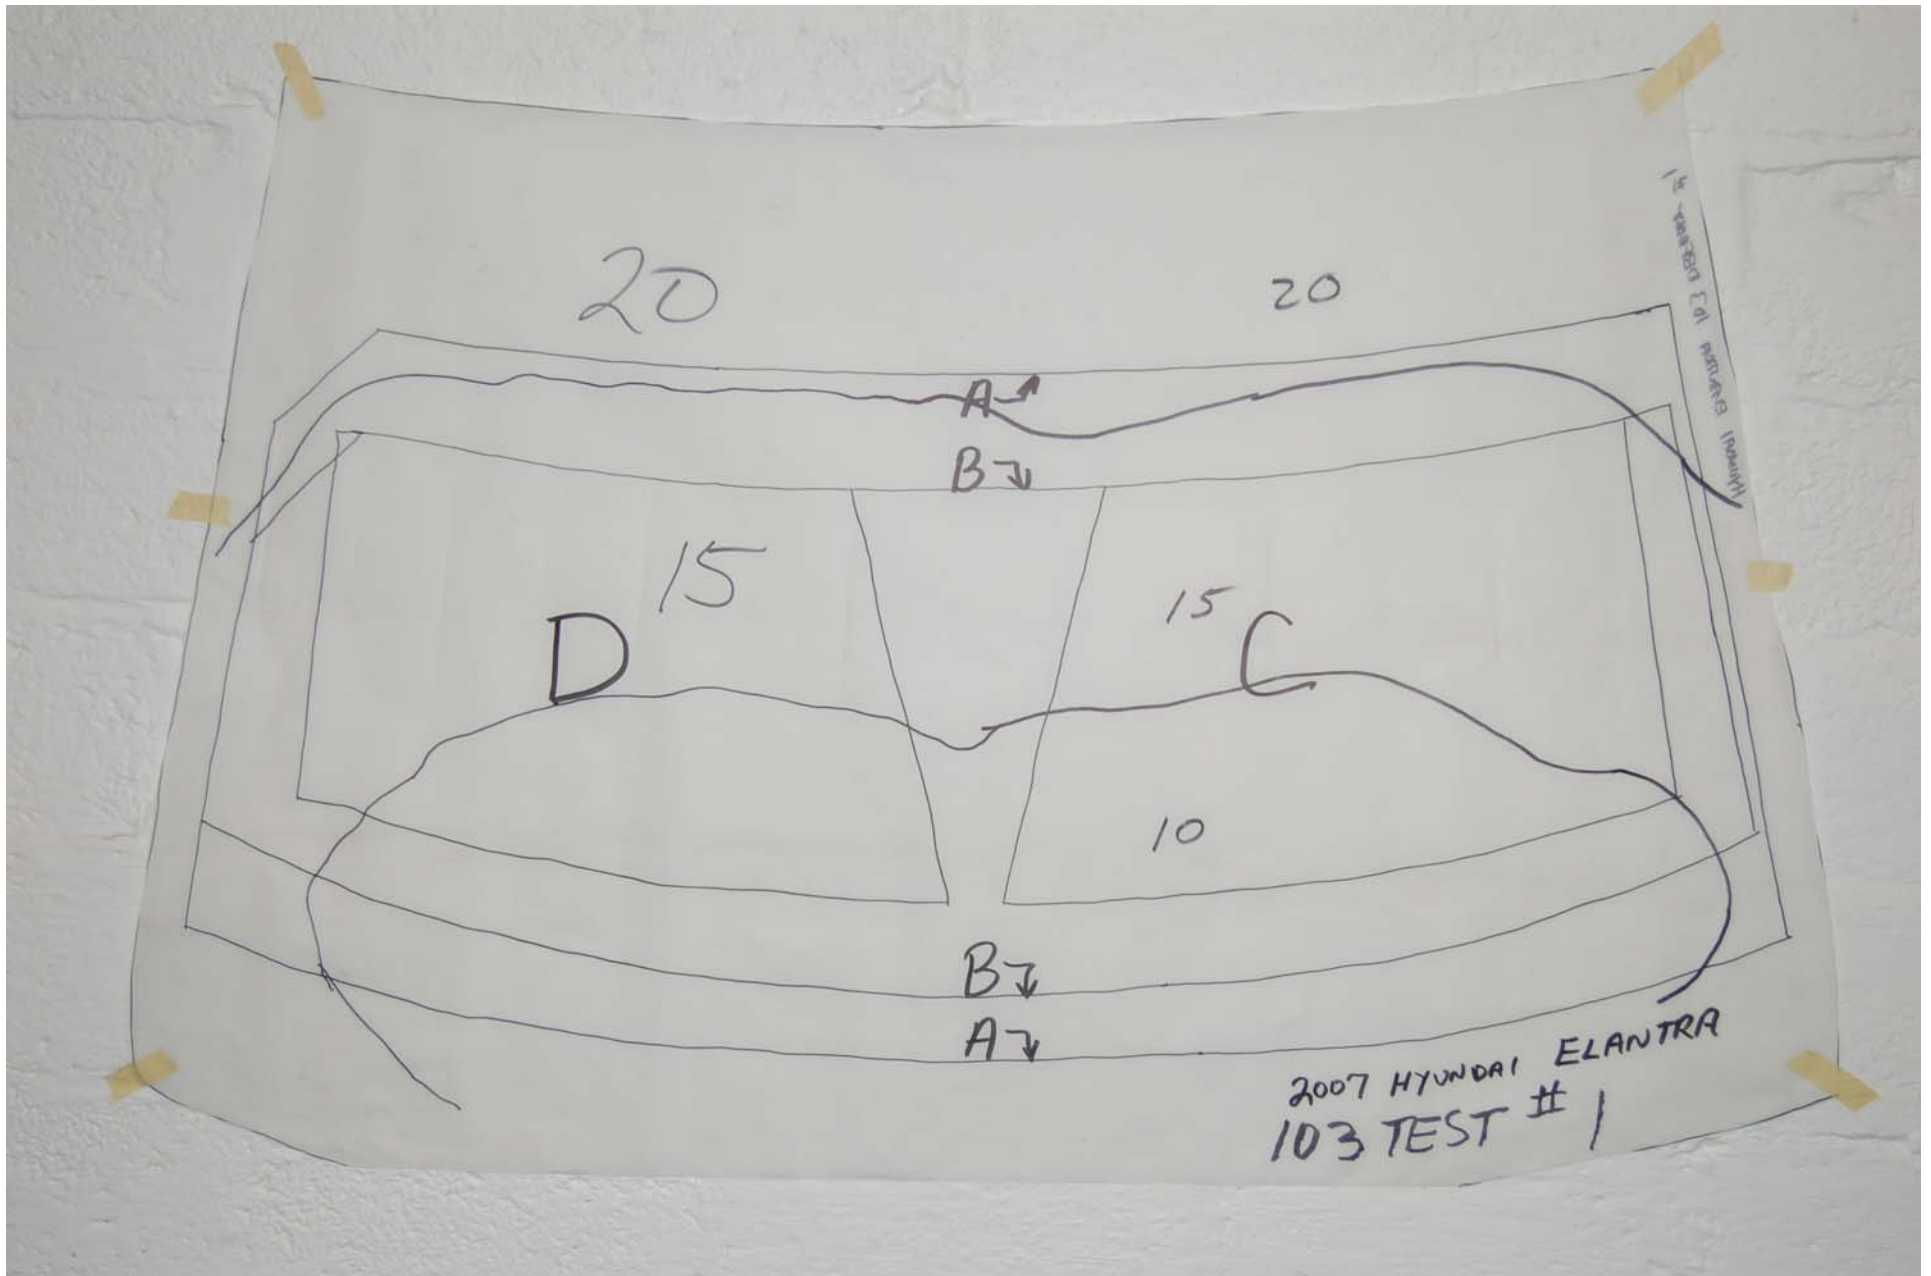
FIGURE 5.11
WINDSHIELD VELLUM PATTERN POST TEST #1

DESIGNATION	AREA PERCENT DEFROSTED					
	TEST 1	TEST 2	AVG	REQ'D	PASS	FAIL
CRITICAL AREA C AT 20 MINUTES	100%	100%	100%	80% MINIMUM	PASS	
PASSENGER AREA D AT 25 MINUTES	100%	100%	100%	80% MINIMUM	PASS	
TOTAL AREA A AT 40 MINUTES	100%	100%	100%	95% MINIMUM	PASS

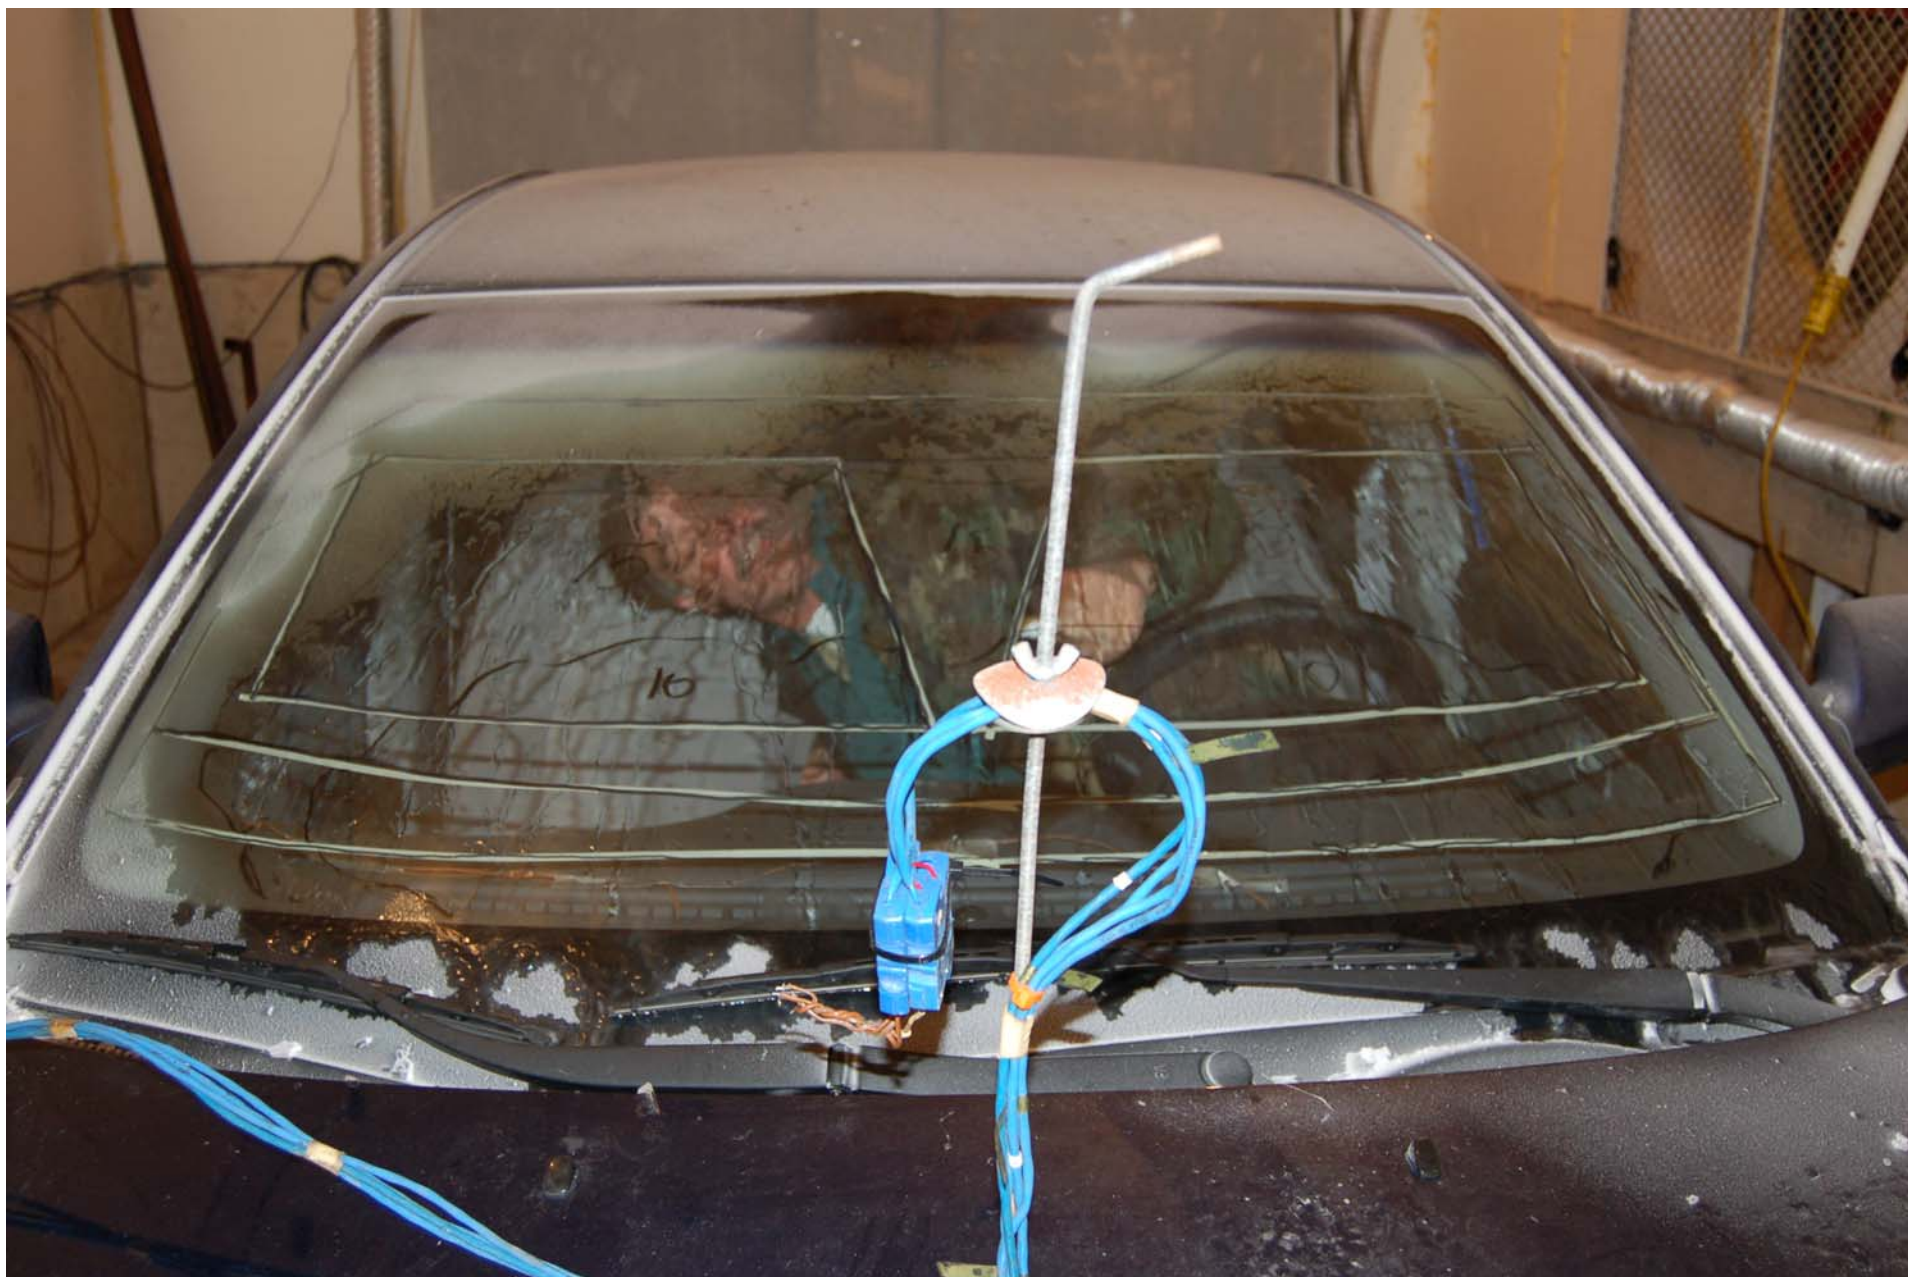
FIGURE 5.13
DEFROSTED AREA AT 20 MINUTES TEST #2

TIME FROM START (minutes)	MOTOR VOLTAGE (volts)	TEMPERATURE, °F					DEFROSTED AREA, %		
		TEST ROOM	ENGINE WATER	HEATER WATER IN	DEFROSTER AIR		A	C	D
					DRVR	PSGR			
0	13.5	.4	-.1	-.1*	.6	.8	0%	0%	0%
5	14.6	.1	30.1	56.9*	64.3	63.4	0%	0%	0%
10	14.6	-1.0	69.8	85.8*	81.9	80.0	34.1%	30.3%	19.2%
15	14.5	.2	92.0	98.1*	92.3	90.1	74.1%	93.0%	78.3%
20	14.4	0	104.8	105.4*	99.4	96.9	99.4%	100%	100%
25	14.4	1.1	114.9	111.8*	106.0	103.2	100%	100%	100%

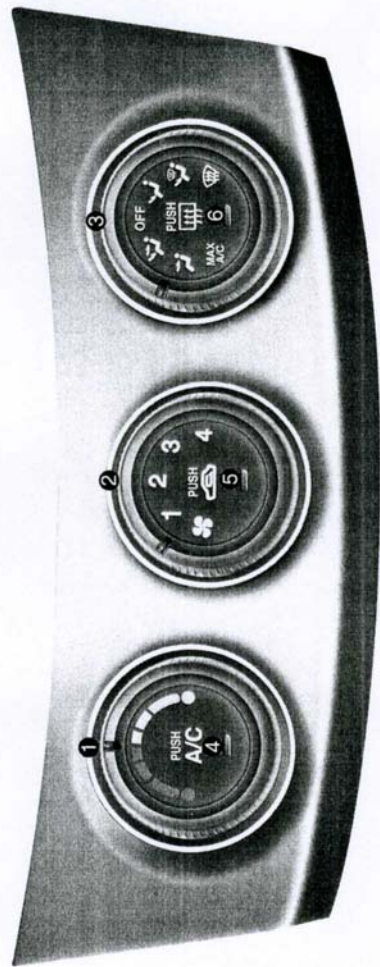
- 1. Temperature control knob
- 2. Fan speed control knob
- 3. Mode selection knob

- 4. Air conditioning button (if equipped)
- 5. Air intake control button
- 6. Rear window defroster button
