REPORT NUMBER: 201UI-CAL-08-02

**SAFETY COMPLIANCE TESTING FOR FMVSS 201  
OCCUPANT PROTECTION IN INTERIOR IMPACT  
UPPER INTERIOR HEAD IMPACT PROTECTION**

**GENERAL MOTORS OF CANADA LTD.  
2008 CHEVROLET IMPALA LS 4-DOOR SEDAN**

NHTSA NUMBER: C80102

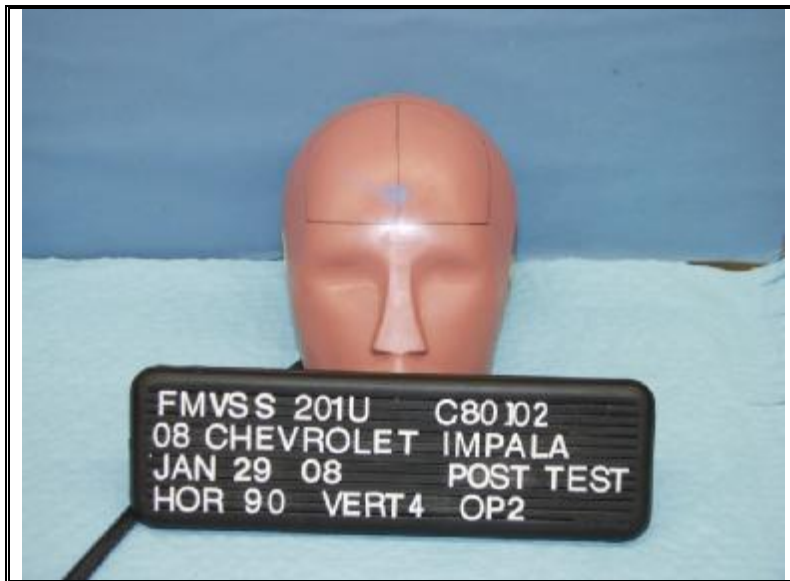
POST-IMPACT OP2 HEADFORM

Test Number:	01
Test Date:	01/29/08
Target Location:	OTHER PILLAR
Target Code:	OP2
Horizontal Impact Angle:	90°
Vertical Impact Angle:	4°
Ambient Temperature:	23.4 C°
Relative Humidity:	24.5%
Time of Impact:	11:15
Headform Number:	1140

Impact Point Description (from lower midpoint on midsagittal line)			
On Centerline	0	mm right	mm left
On Centerline	18	mm up

Free Motion HIC	833.2
HIC(d)	795.0
Impact Velocity (kph)	23.47
HIC T1 (msec)	1.9
HIC T2 (msec)	7.4

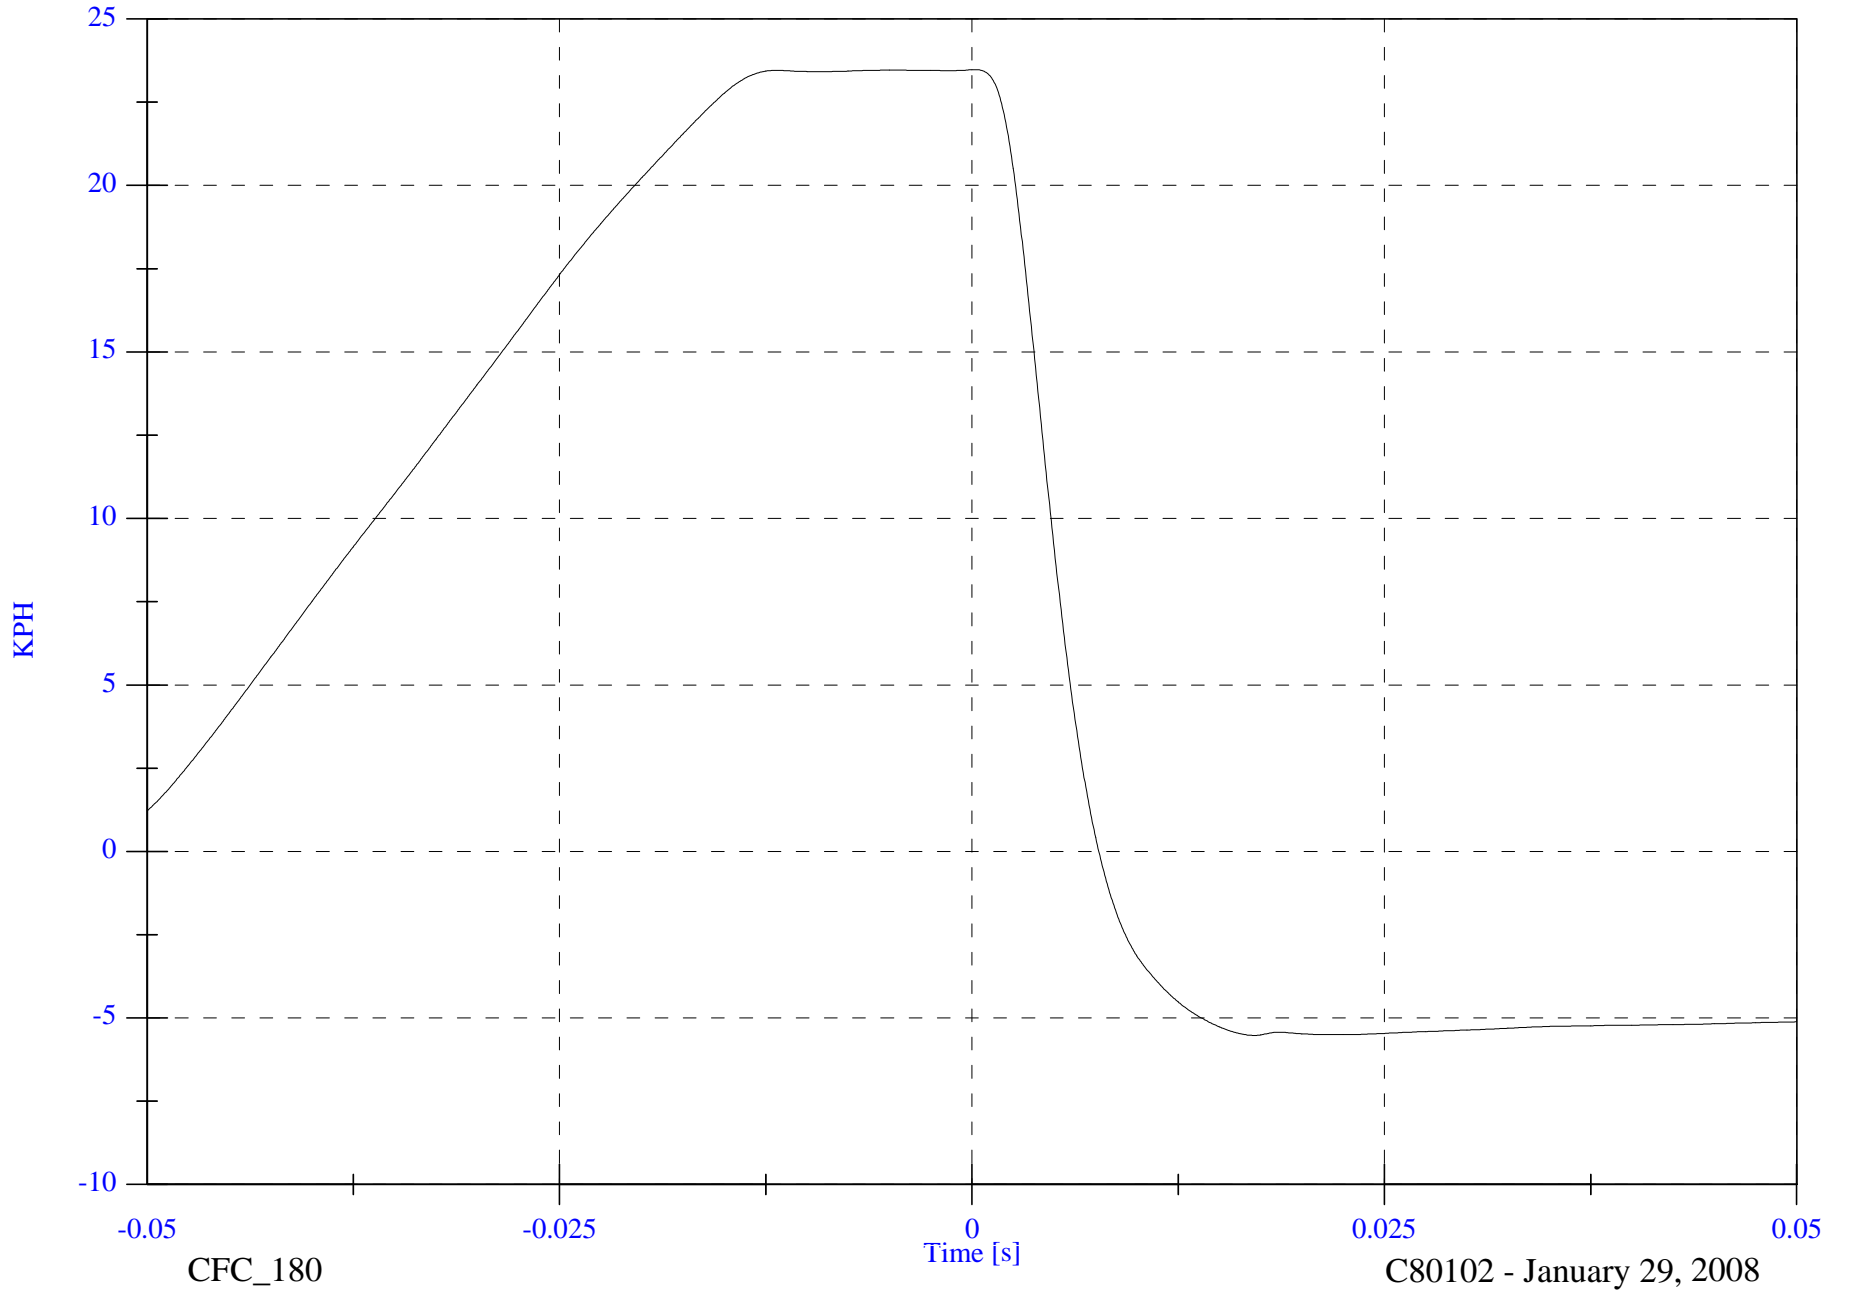
C80102 PASSENGER SIDE OP2 IMPACT PLOT #5

Max: 23.5 [KPH] at 0.000 [s]

Min: -5.5 [KPH] at 0.017 [s]

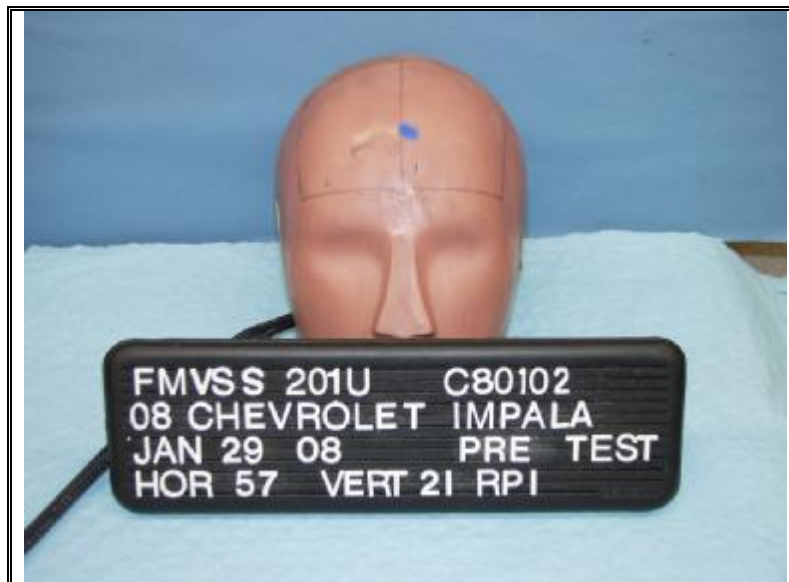
POST-IMPACT RP1 HEADFORM

Test Number:	02
Test Date:	01/29/08
Target Location:	REAR PILLAR
Target Code:	RP1
Horizontal Impact Angle:	57°
Vertical Impact Angle:	21°
Ambient Temperature:	23.7 C°
Relative Humidity:	24.2%
Time of Impact:	11:50
Headform Number:	805

Impact Point Description (from lower midpoint on midsagittal line)					
On Centerline	5	<input type="checkbox"/>	mm right	<input checked="" type="checkbox"/>	mm left
On Centerline	34				mm up

Free Motion HIC	291.3
HIC(d)	386.2
Impact Velocity (kph)	18.65
HIC T1 (msec)	4.7
HIC T2 (msec)	12.4

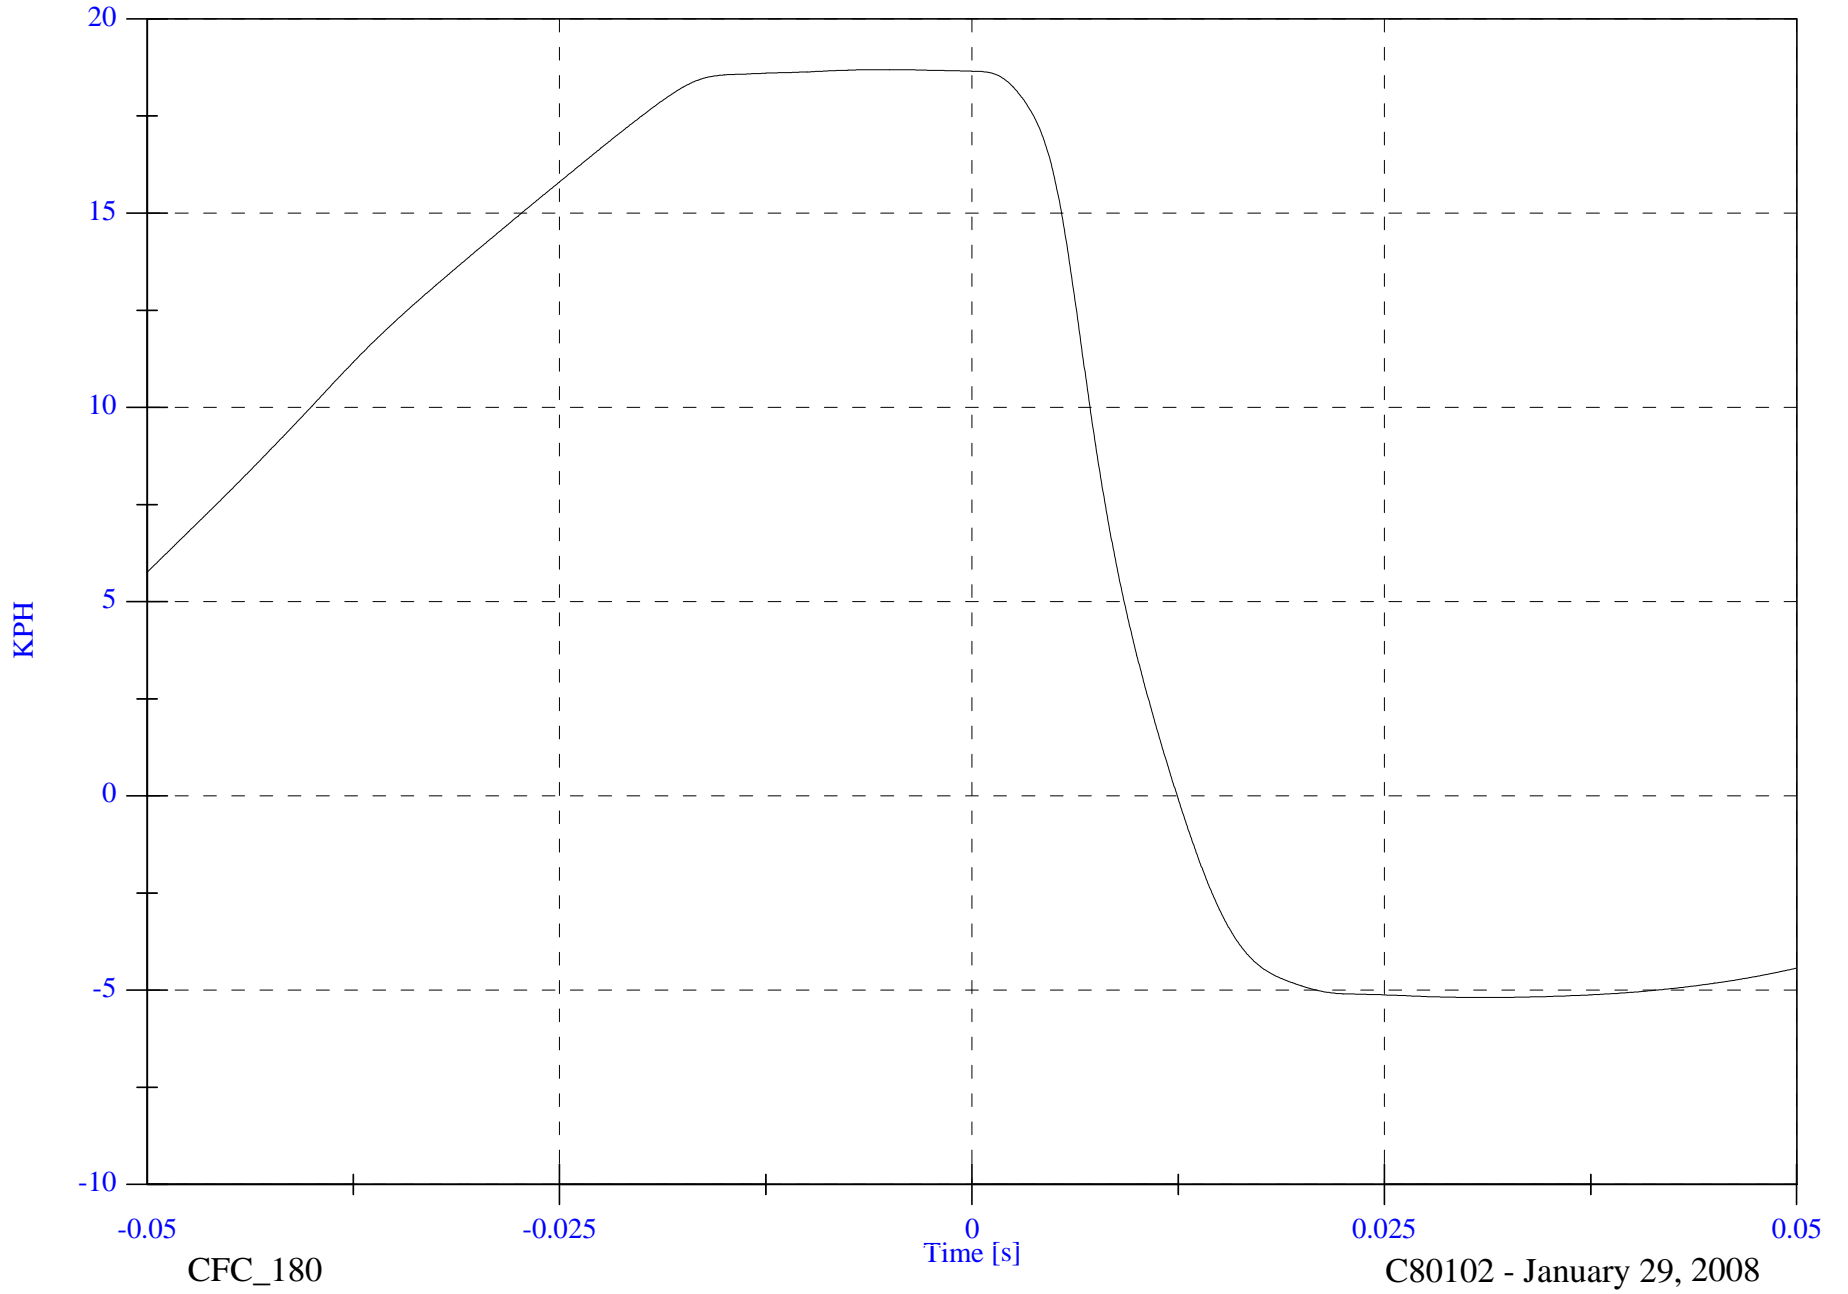
C80102 PASSENGER SIDE RP1 IMPACT PLOT #5

Min: -5.2 [KPH] at 0.032 [s]

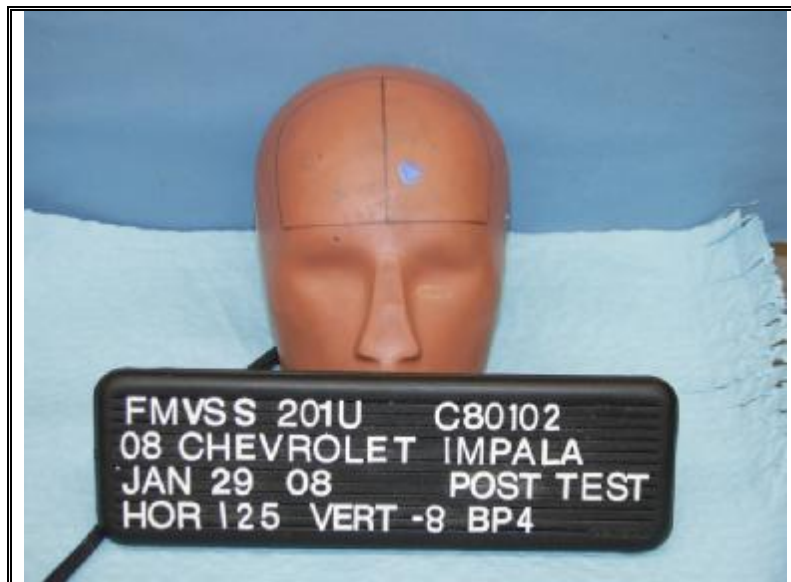
POST-IMPACT BP4 HEADFORM

Test Number:	03
Test Date:	01/29/08
Target Location:	B-PILLAR
Target Code:	BP4
Horizontal Impact Angle:	125°
Vertical Impact Angle:	-8°
Ambient Temperature:	23.8 C°
Relative Humidity:	24.3%
Time of Impact:	13:10
Headform Number:	355

Impact Point Description (from lower midpoint on midsagittal line)					
On Centerline	13	<input type="checkbox"/>	mm right	<input checked="" type="checkbox"/>	mm left
On Centerline	25				mm up

Free Motion HIC	670.8
HIC(d)	672.5
Impact Velocity (kph)	23.54
HIC T1 (msec)	1.5
HIC T2 (msec)	10.3

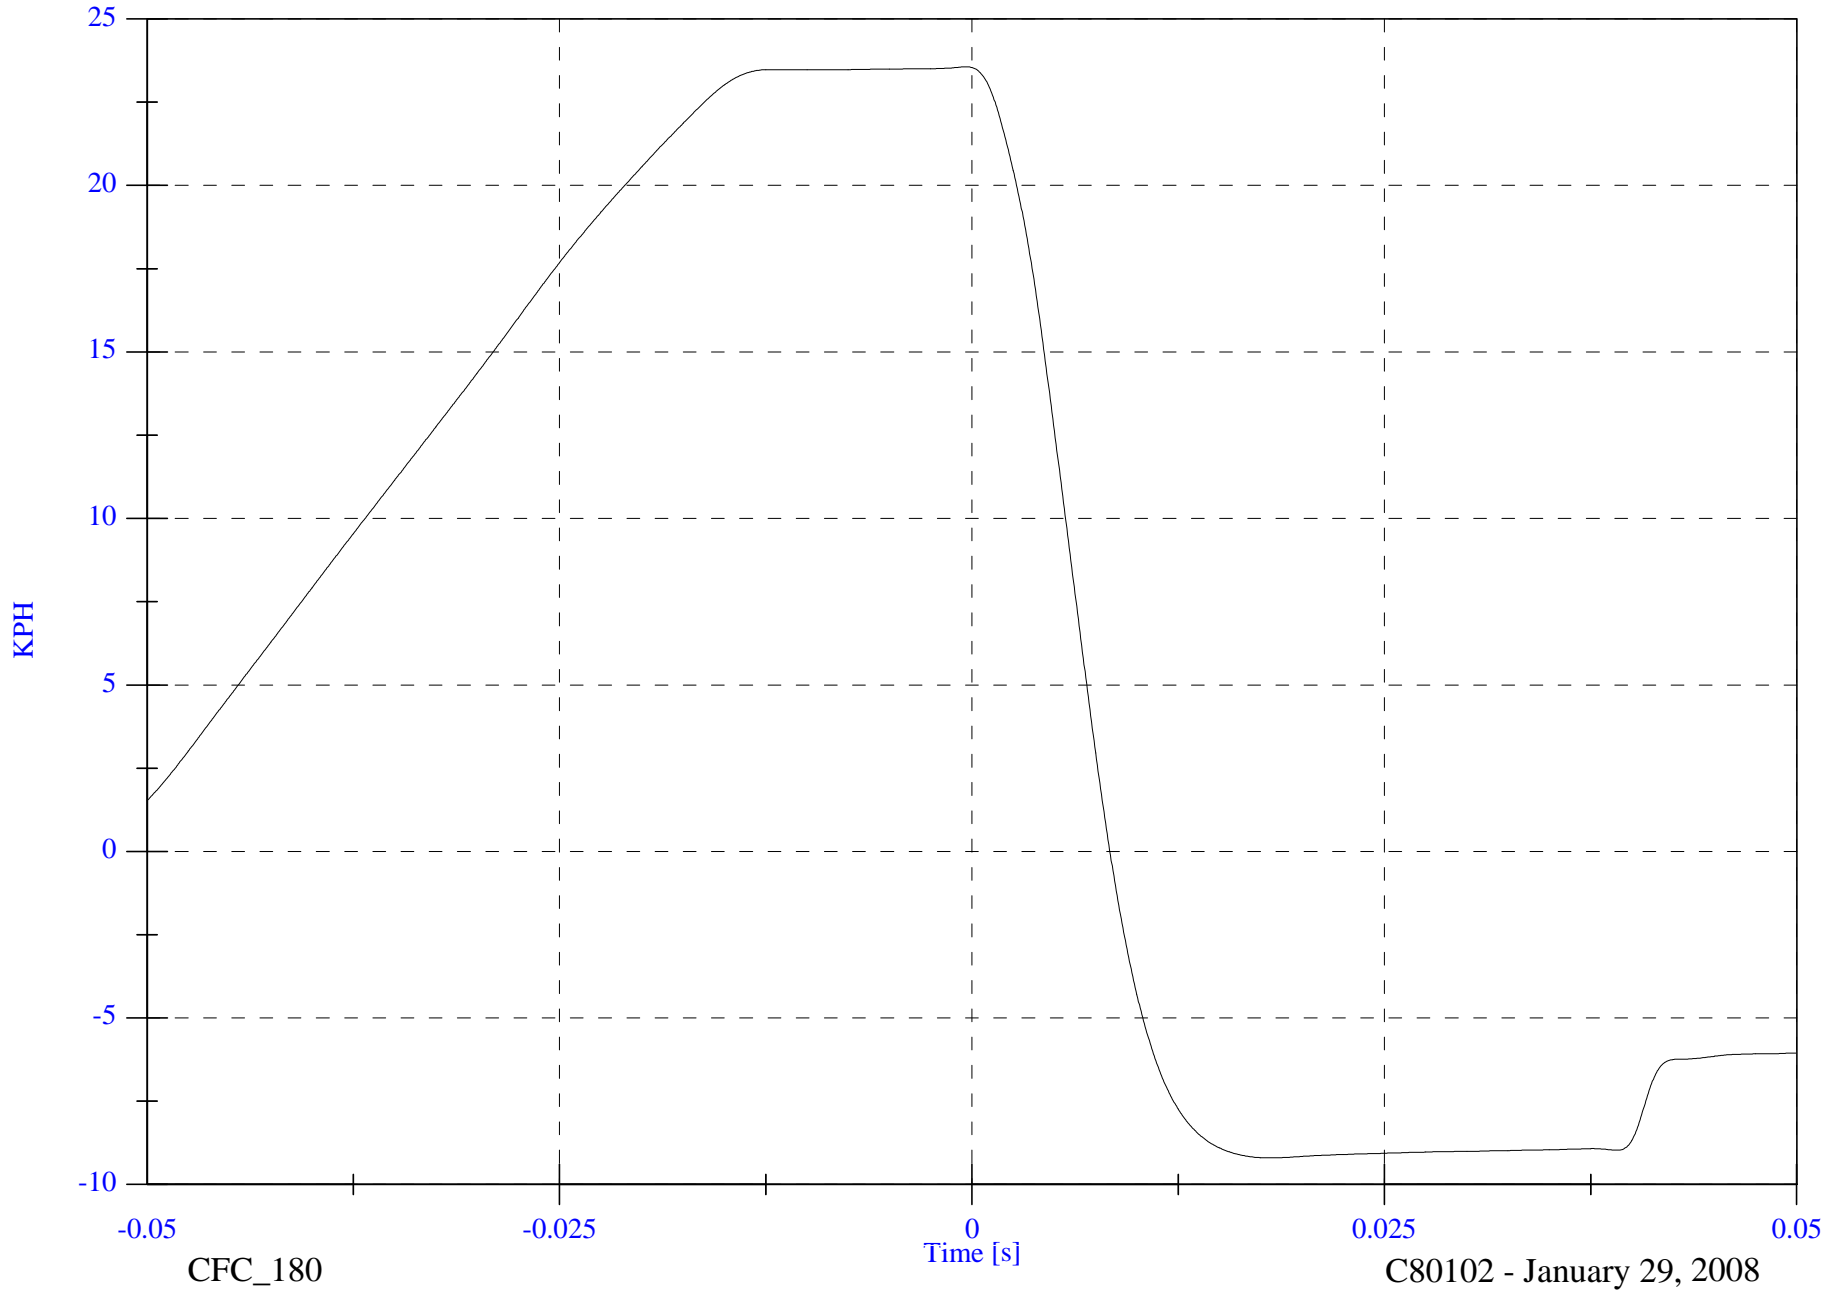
C80102 PASSENGER SIDE BP4 IMPACT PLOT #5

Min: -9.2 [KPH] at 0.018 [s]

### Headform Velocity

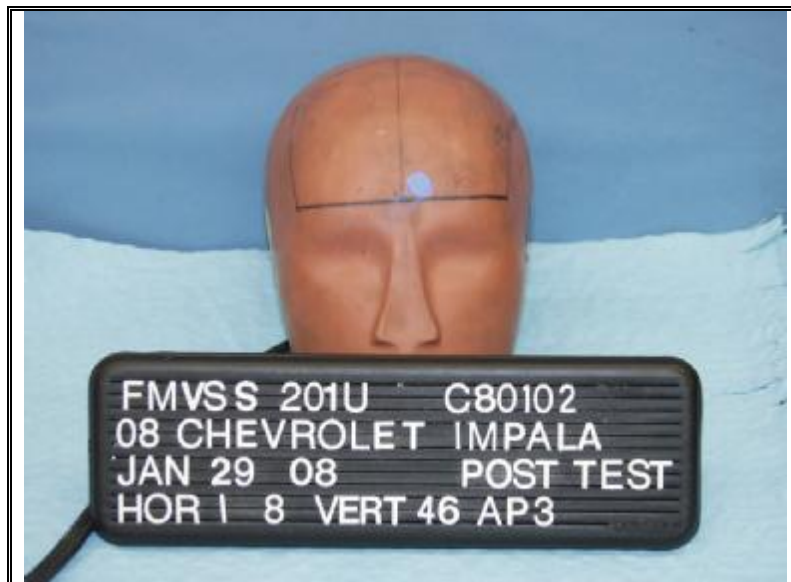
POST-IMPACT AP3 HEADFORM

Test Number:	04
Test Date:	01/29/08
Target Location:	A-PILLAR
Target Code:	AP3
Horizontal Impact Angle:	138°
Vertical Impact Angle:	46°
Ambient Temperature:	24.0 C°
Relative Humidity:	24.9%
Time of Impact:	13:50
Headform Number:	62

Impact Point Description (from lower midpoint on midsagittal line)					
On Centerline	10	<input type="checkbox"/>	mm right	<input checked="" type="checkbox"/>	mm left
On Centerline	7				mm up

Free Motion HIC	215.7
HIC(d)	329.1
Impact Velocity (kph)	18.75
HIC T1 (msec)	2.1
HIC T2 (msec)	13.3

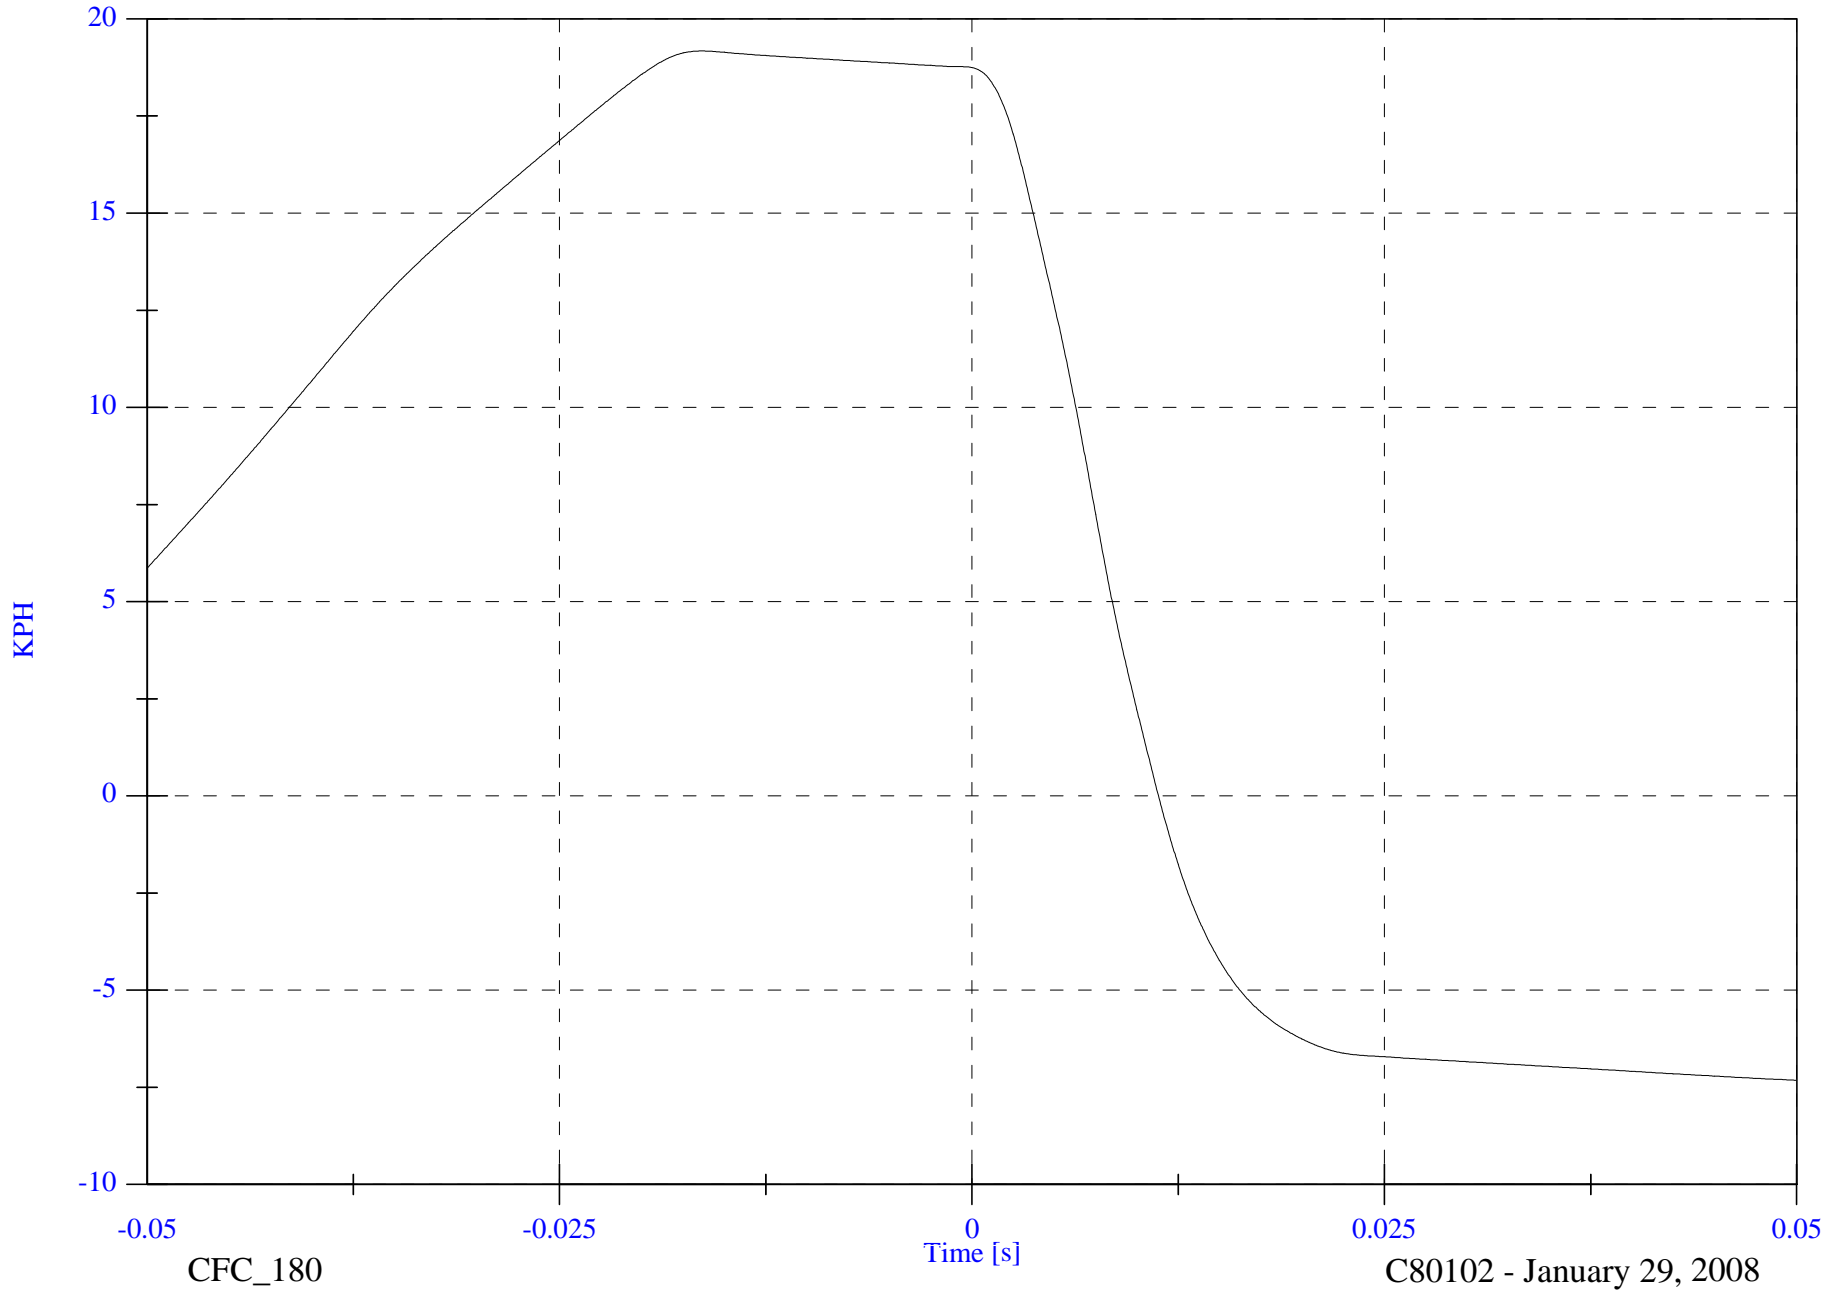
C80102 PASSENGER SIDE AP3 IMPACT PLOT # 5

Max: 19.2 [KPH] at -0.016 [s]

Min: -7.3 [KPH] at 0.050 [s]

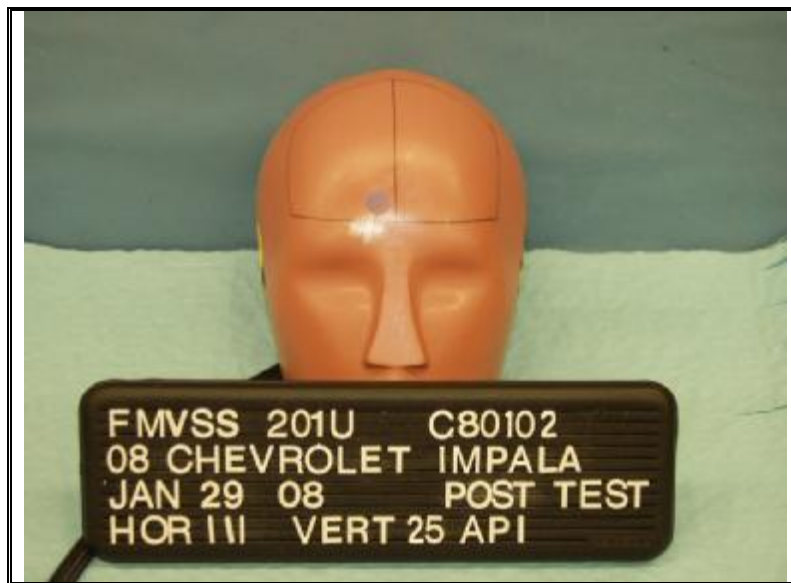
POST-IMPACT AP1 HEADFORM

Test Number:	05
Test Date:	01/29/08
Target Location:	A-PILLAR
Target Code:	AP1
Horizontal Impact Angle:	111°
Vertical Impact Angle:	25°
Ambient Temperature:	24.0 C°
Relative Humidity:	25.2%
Time of Impact:	14:50
Headform Number:	1142

Impact Point Description (from lower midpoint on midsagittal line)					
On Centerline	9	<input checked="" type="checkbox"/>	mm right	<input type="checkbox"/>	mm left
On Centerline	7				mm up

Free Motion HIC	746.8
HIC(d)	729.8
Impact Velocity (kph)	18.45
HIC T1 (msec)	5.8
HIC T2 (msec)	8.9

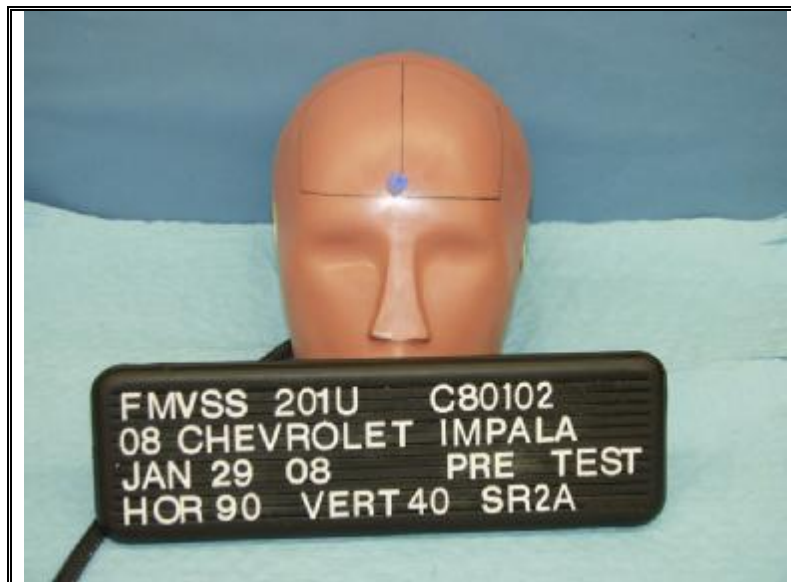
POST-IMPACT SR2A HEADFORM

Test Number:	06
Test Date:	01/29/08
Target Location:	SIDE RAIL
Target Code:	SR2A
Horizontal Impact Angle:	90°
Vertical Impact Angle:	40°
Ambient Temperature:	24.3 C°
Relative Humidity:	25.9%
Time of Impact:	15:40
Headform Number:	1140

Impact Point Description (from lower midpoint on midsagittal line)					
On Centerline	2	<input checked="" type="checkbox"/>	mm right	<input type="checkbox"/>	mm left
On Centerline	6				mm up

Free Motion HIC	219.0
HIC(d)	331.6
Impact Velocity (kph)	18.33
HIC T1 (msec)	3.1
HIC T2 (msec)	13.6

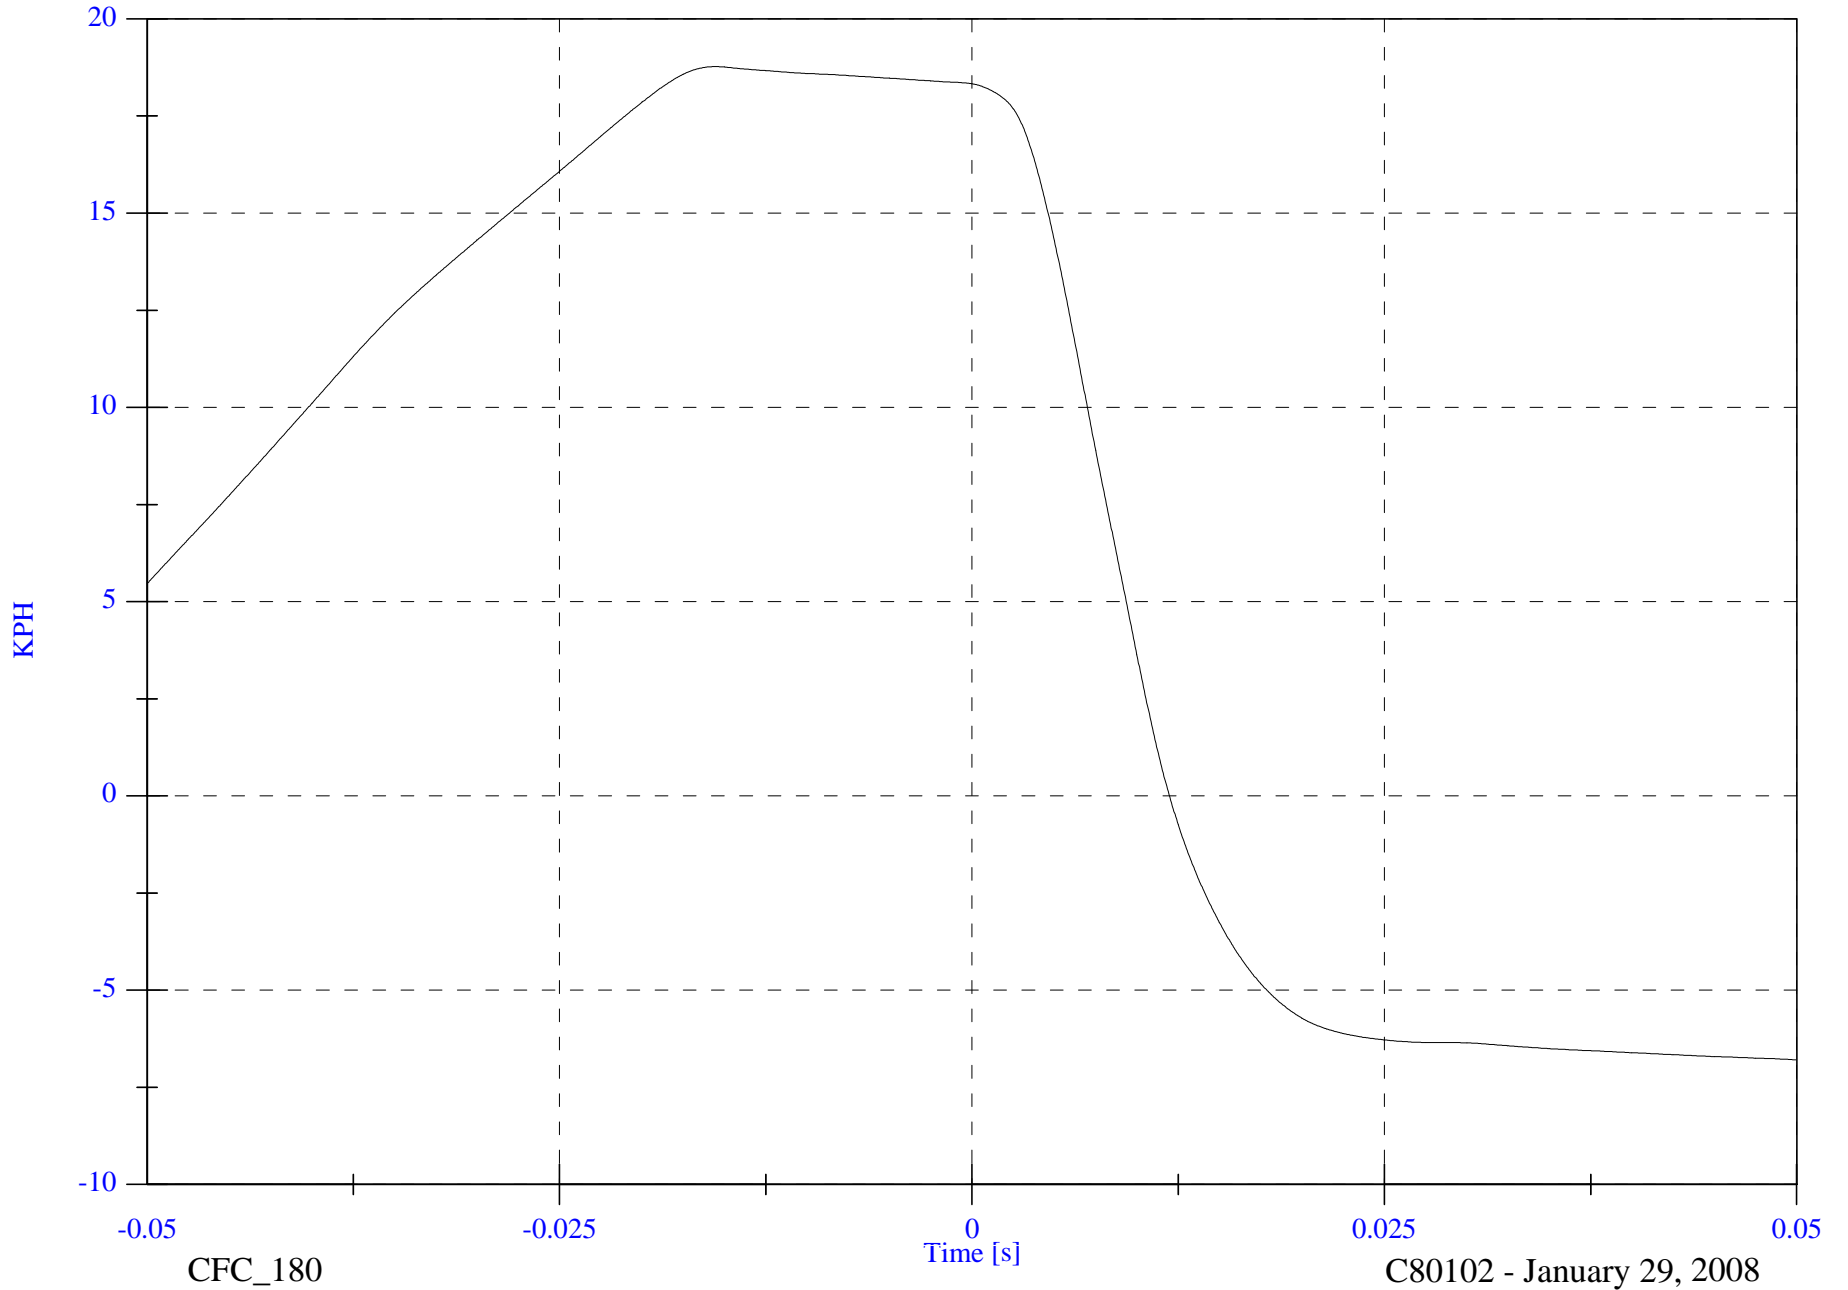
C80102 PASSENGER SIDE SR2A IMPACT PLOT #5

Min: -6.8 [KPH] at 0.050 [s]

### Headform Velocity

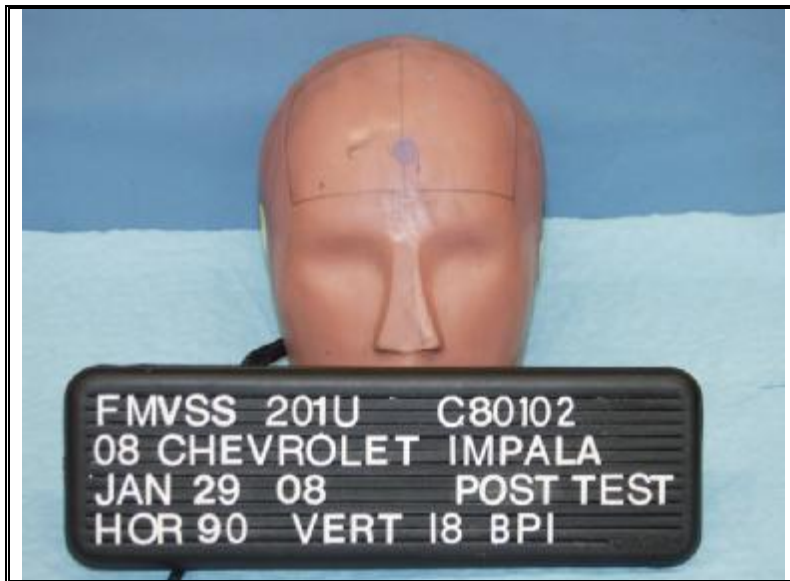
POST-IMPACT BP1 HEADFORM

Test Number:	07
Test Date:	01/29/08
Target Location:	B-PILLAR
Target Code:	BP1
Horizontal Impact Angle:	90°
Vertical Impact Angle:	18°
Ambient Temperature:	24.3 C°
Relative Humidity:	25.9%
Time of Impact:	16:25
Headform Number:	805

Impact Point Description (from lower midpoint on midsagittal line)					
On Centerline	3	<input type="checkbox"/>	mm right	<input checked="" type="checkbox"/>	mm left
On Centerline	21				mm up

Free Motion HIC	385.2
HIC(d)	457.0
Impact Velocity (kph)	18.51
HIC T1 (msec)	4.7
HIC T2 (msec)	13.6

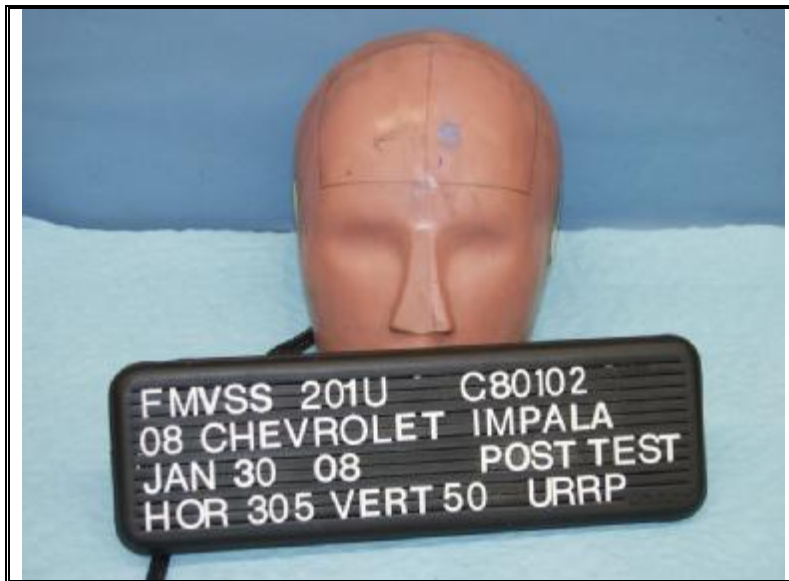
POST-IMPACT URRP HEADFORM

Test Number:	08
Test Date:	01/30/08
Target Location:	UPPER ROOF
Target Code:	URRP
Horizontal Impact Angle:	305°
Vertical Impact Angle:	50°
Ambient Temperature:	21.1 C°
Relative Humidity:	17.3%
Time of Impact:	9:45
Headform Number:	805

Impact Point Description (from lower midpoint on midsagittal line)					
On Centerline	12	<input type="checkbox"/>	mm right	<input checked="" type="checkbox"/>	mm left
On Centerline	29				mm up

Free Motion HIC	943.8
HIC(d)	878.4
Impact Velocity (kph)	23.86
HIC T1 (msec)	5.4
HIC T2 (msec)	10.3

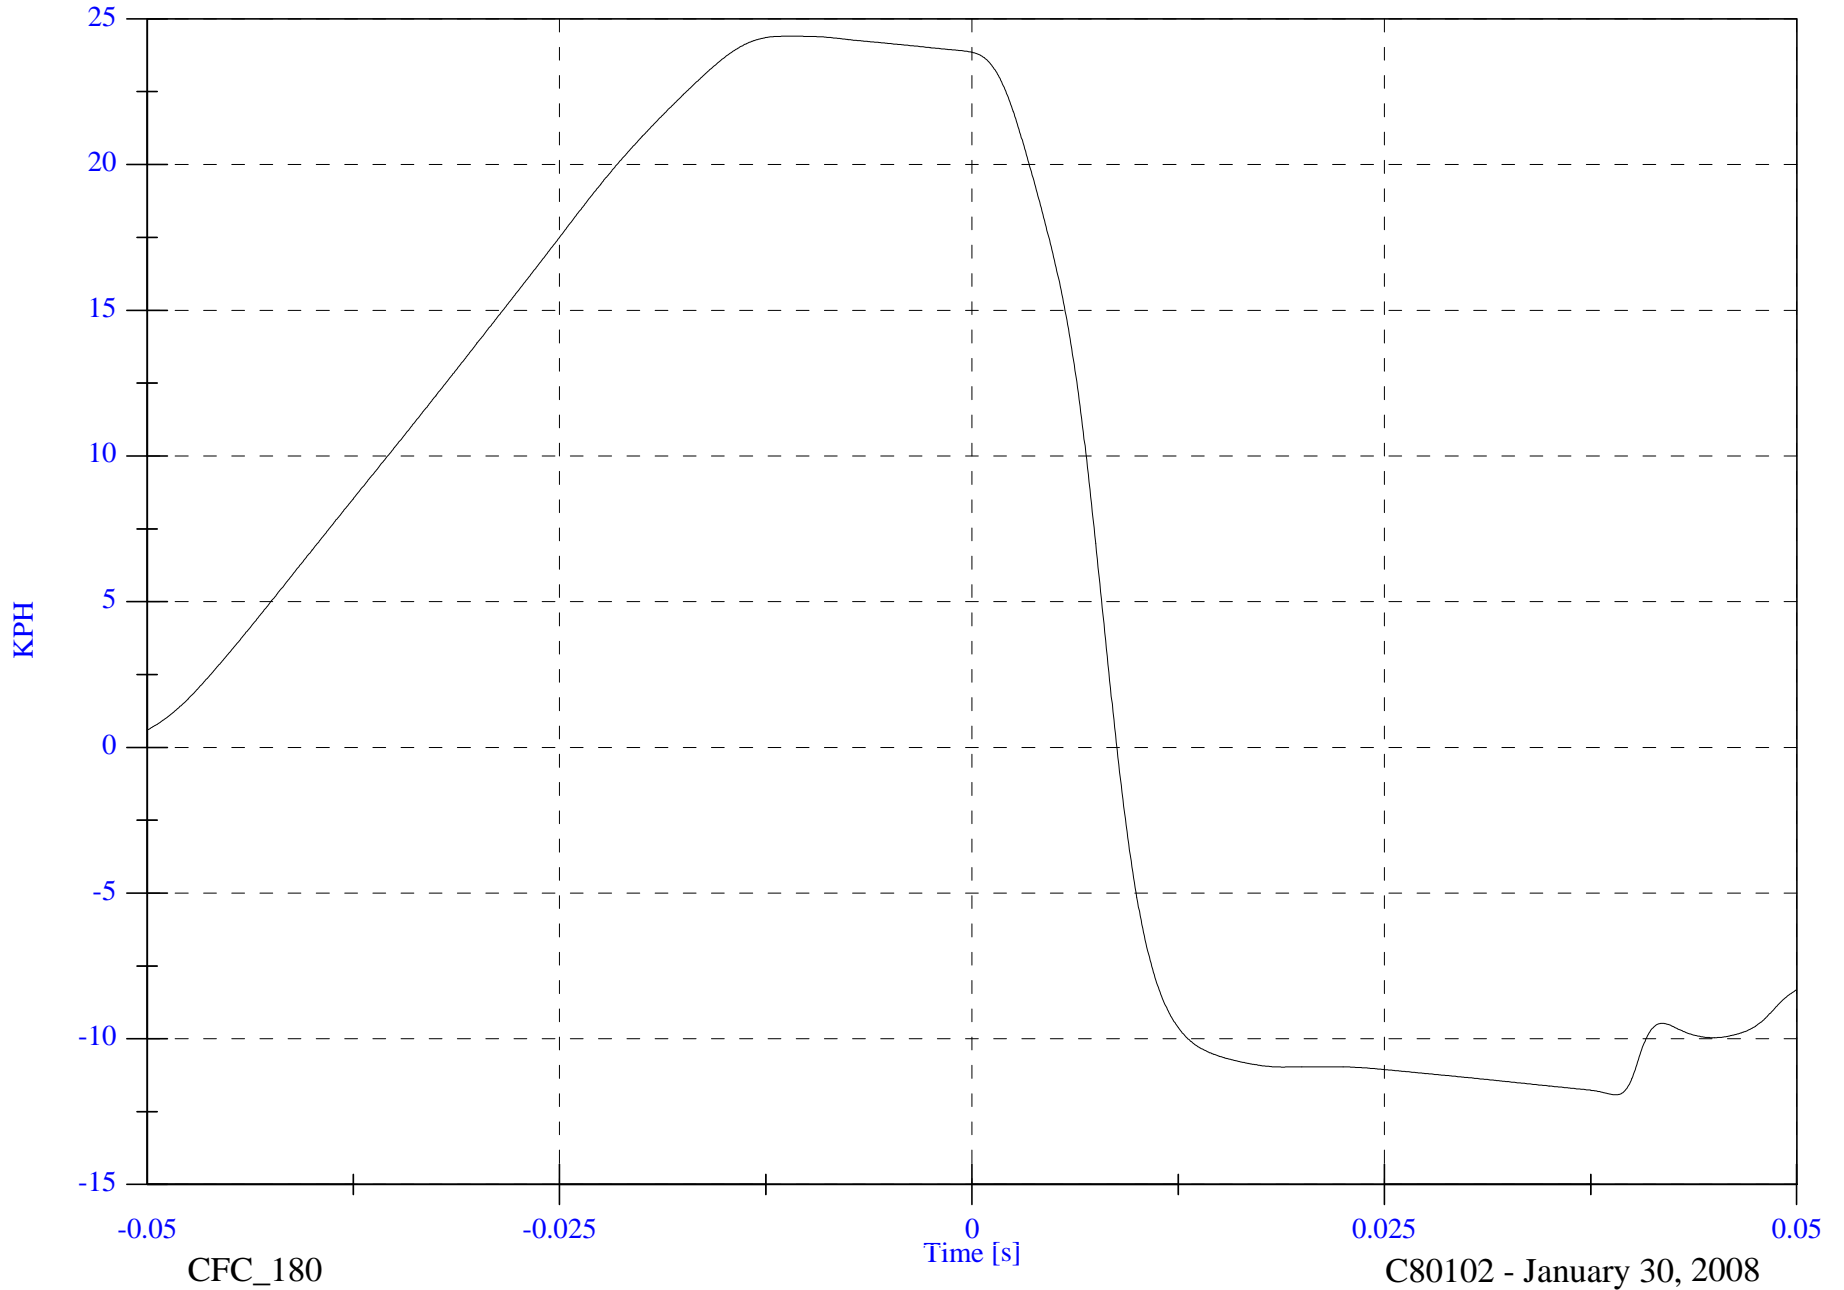
C80102 DRIVER SIDE URRP IMPACT PLOT #5

Max: 24.4 [KPH] at -0.011 [s]

Min: -11.9 [KPH] at 0.039 [s]

### Headform Velocity

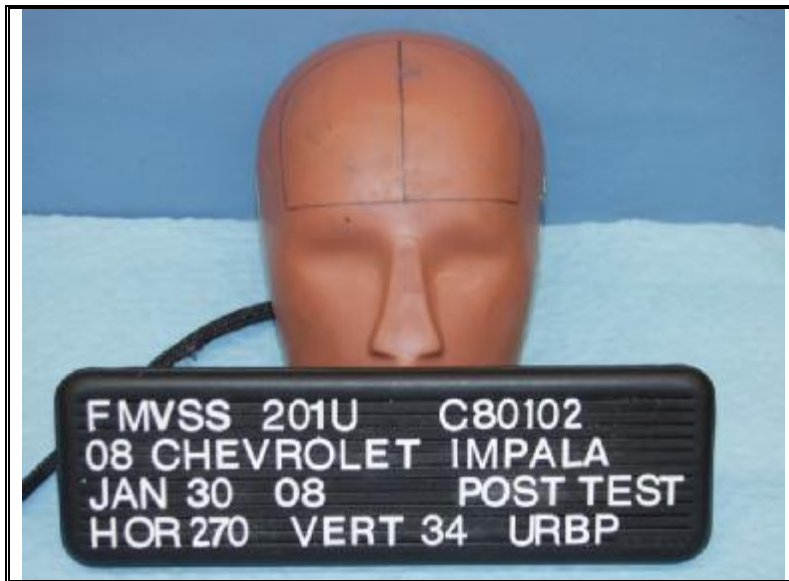
POST-IMPACT URBP HEADFORM

Test Number:	09
Test Date:	01/30/08
Target Location:	UPPER ROOF
Target Code:	URBP
Horizontal Impact Angle:	270°
Vertical Impact Angle:	34°
Ambient Temperature:	20.9 C°
Relative Humidity:	16.0%
Time of Impact:	11:00
Headform Number:	355

Impact Point Description (from lower midpoint on midsagittal line)					
On Centerline	5	<input type="checkbox"/>	mm right	<input checked="" type="checkbox"/>	mm left
On Centerline	68				mm up

Free Motion HIC	583.6
HIC(d)	606.7
Impact Velocity (kph)	23.48
HIC T1 (msec)	6.4
HIC T2 (msec)	13.9

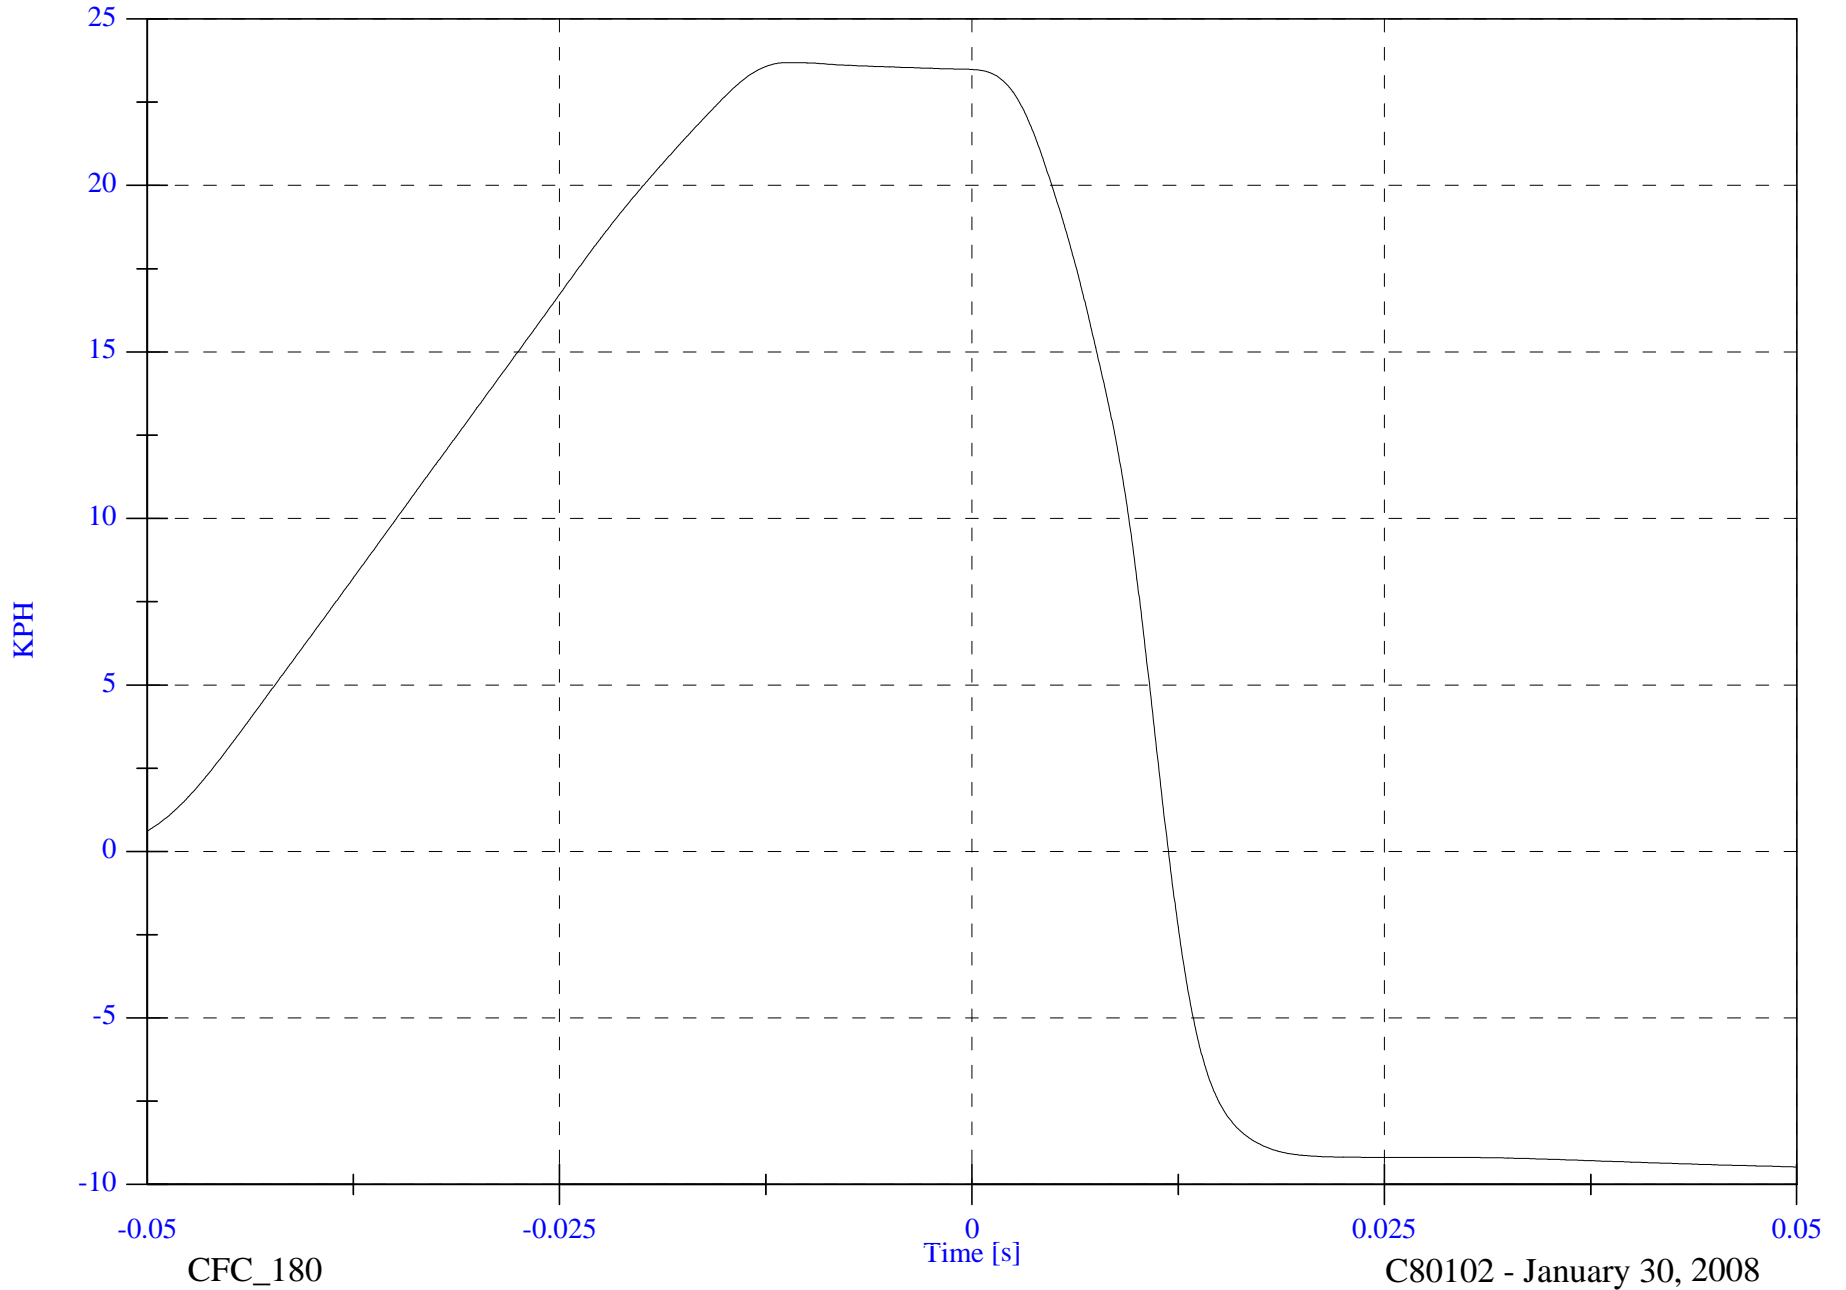
C80102 DRIVER SIDE URBP IMPACT PLOT #5

Min: -9.5 [KPH] at 0.050 [s]

### Headform Velocity

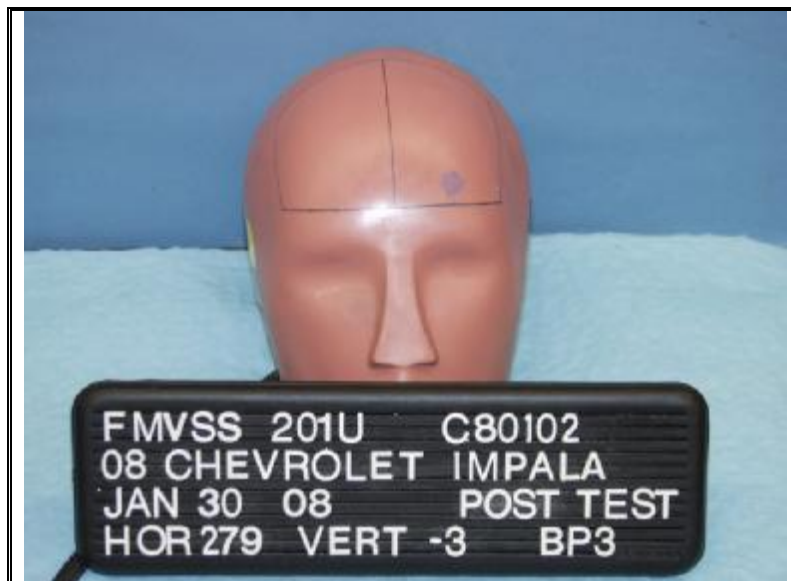
POST-IMPACT BP3 HEADFORM

Test Number:	10
Test Date:	01/30/08
Target Location:	B-PILLAR
Target Code:	BP3
Horizontal Impact Angle:	279°
Vertical Impact Angle:	-3°
Ambient Temperature:	20.8 C°
Relative Humidity:	15.4%
Time of Impact:	11:40
Headform Number:	1140

Impact Point Description (from lower midpoint on midsagittal line)					
On Centerline	30	<input type="checkbox"/>	mm right	<input checked="" type="checkbox"/>	mm left
On Centerline	11				mm up

Free Motion HIC	686.8
HIC(d)	684.6
Impact Velocity (kph)	23.56
HIC T1 (msec)	2.1
HIC T2 (msec)	9.8
