REPORT NUMBER: 201UI-CAL-08-02

**SAFETY COMPLIANCE TESTING FOR FMVSS 201  
OCCUPANT PROTECTION IN INTERIOR IMPACT  
UPPER INTERIOR HEAD IMPACT PROTECTION**

**GENERAL MOTORS OF CANADA LTD.  
2008 CHEVROLET IMPALA LS 4-DOOR SEDAN**

NHTSA NUMBER: C80102

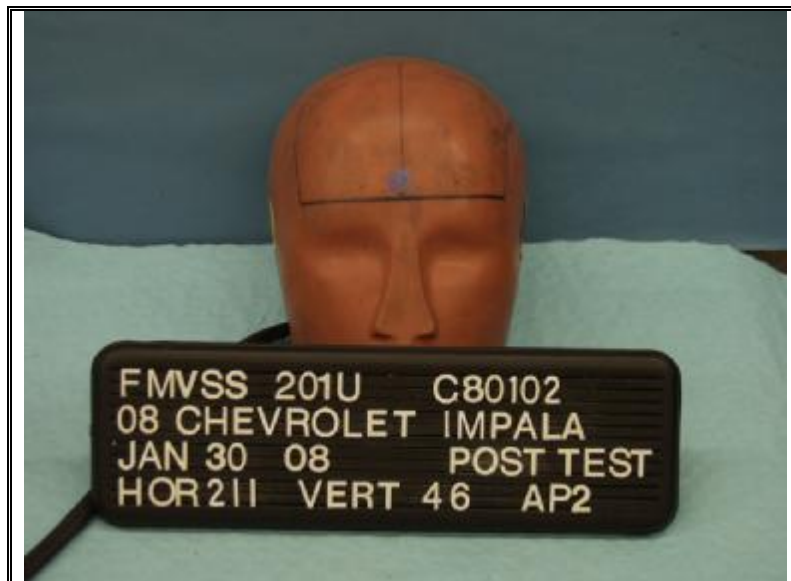
POST-IMPACT AP2HEADFORM

Test Number:	11
Test Date:	01/30/08
Target Location:	A-PILLAR
Target Code:	AP2
Horizontal Impact Angle:	211°
Vertical Impact Angle:	46°
Ambient Temperature:	20.5 C°
Relative Humidity:	15.7%
Time of Impact:	13:25
Headform Number:	62

Impact Point Description (from lower midpoint on midsagittal line)					
On Centerline	2	<input checked="" type="checkbox"/>	mm right	<input type="checkbox"/>	mm left
On Centerline	7				mm up

Free Motion HIC	203.3
HIC(d)	319.8
Impact Velocity (kph)	18.62
HIC T1 (msec)	2.0
HIC T2 (msec)	11.2

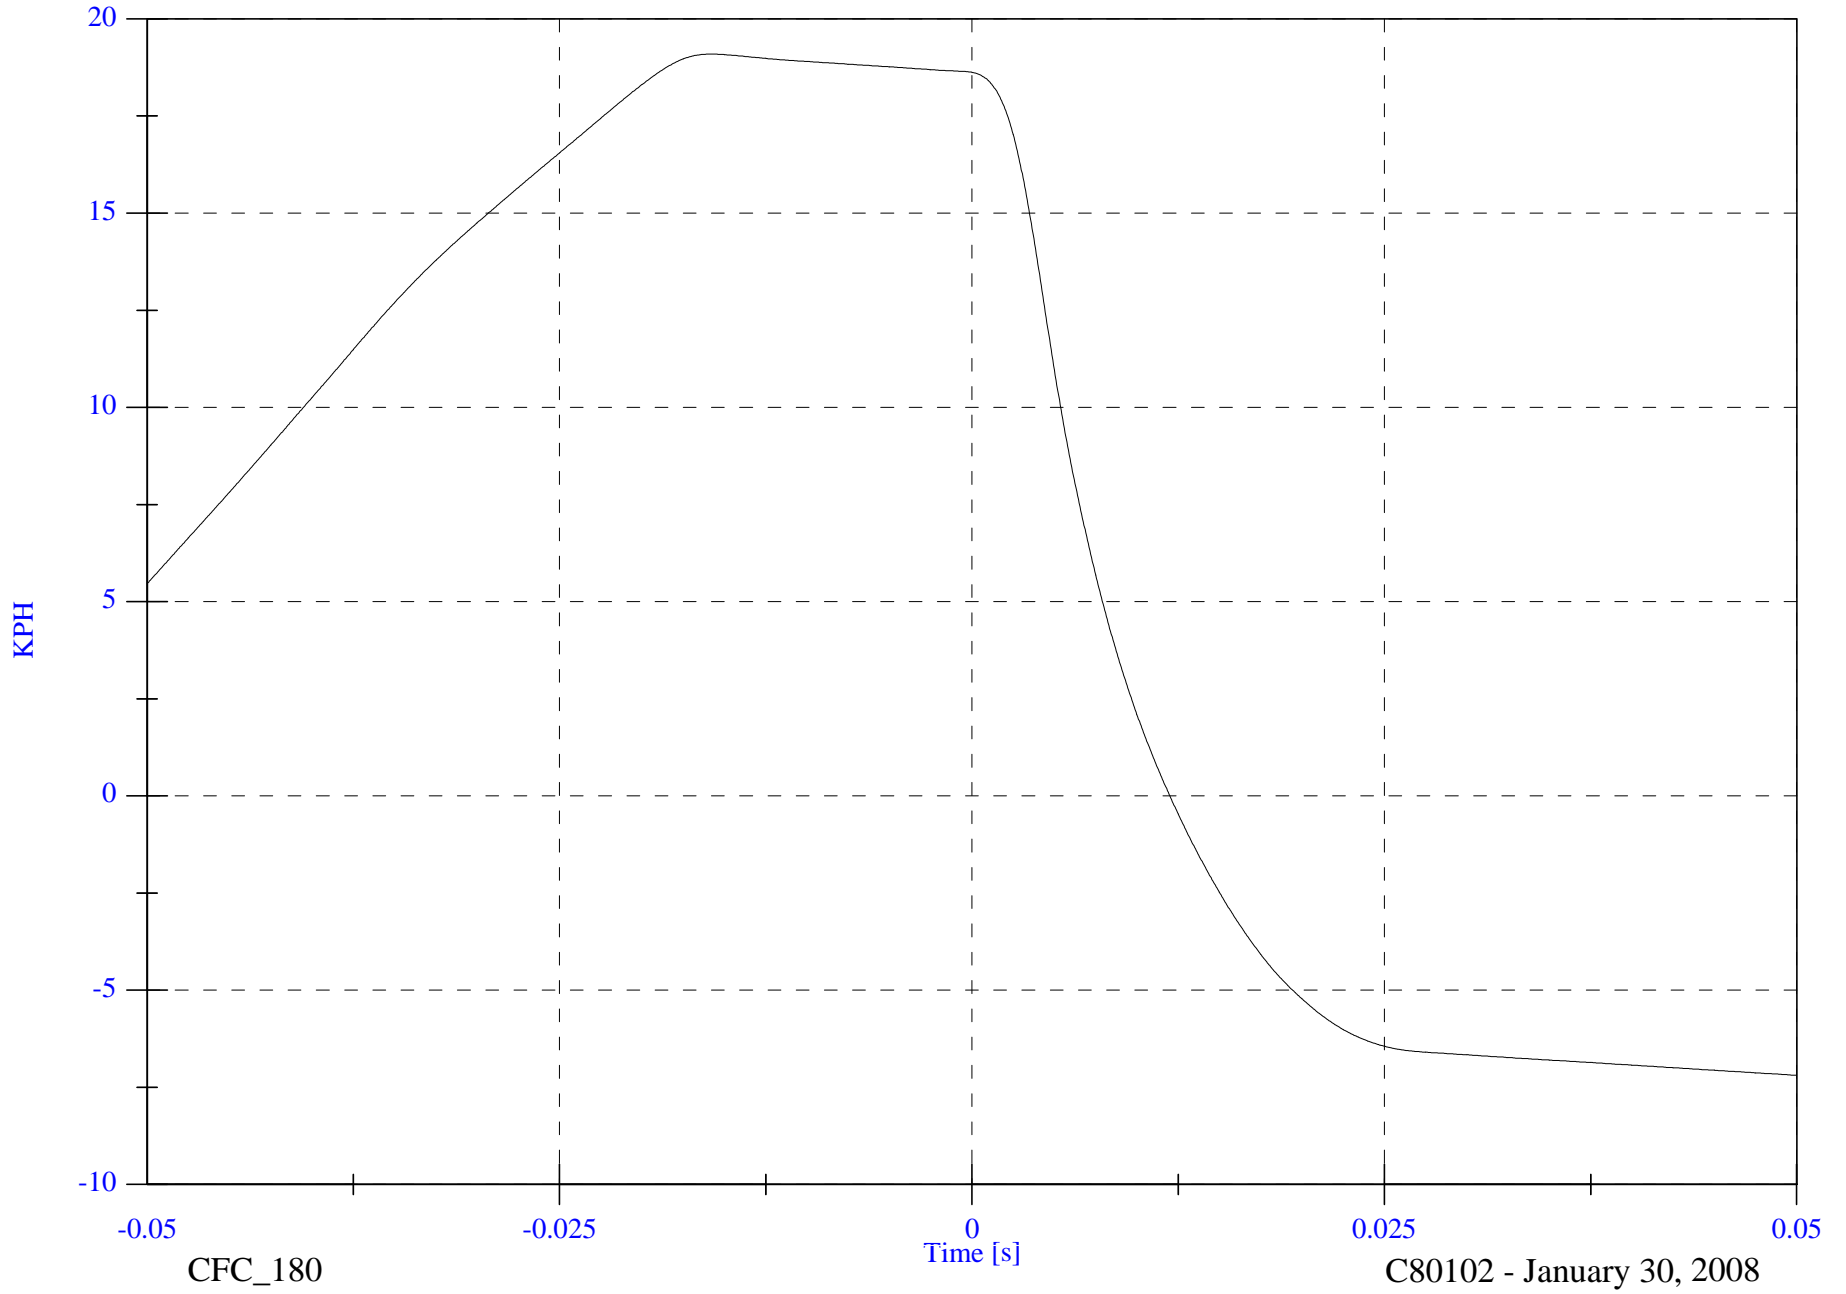
C80102 DRIVER SIDE AP2 IMPACT PLOT #5

Headform Velocity

Min: -7.2 [KPH] at 0.050 [s]

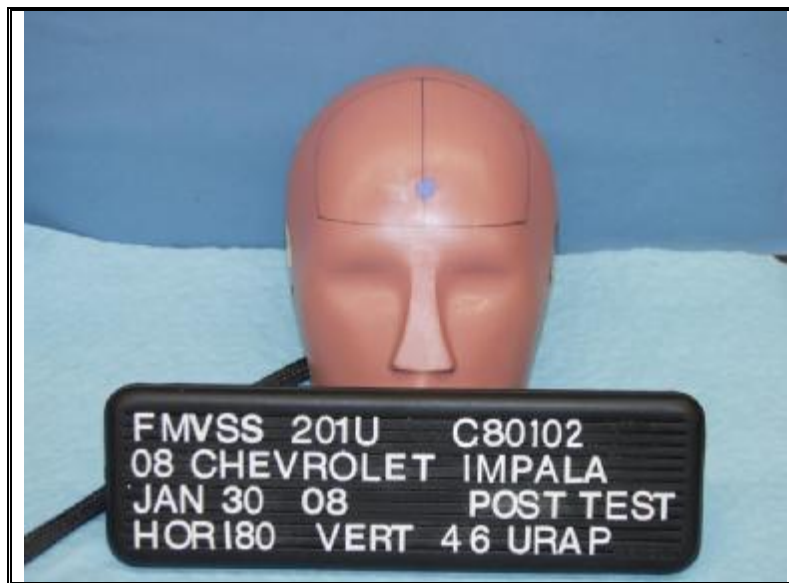
POST-IMPACT URAP HEADFORM

Test Number:	12
Test Date:	01/30/08
Target Location:	UPPER ROOF
Target Code:	URAP
Horizontal Impact Angle:	180°
Vertical Impact Angle:	46°
Ambient Temperature:	20.5 C°
Relative Humidity:	15.7%
Time of Impact:	13:55
Headform Number:	1142

Impact Point Description (from lower midpoint on midsagittal line)					
On Centerline	2	<input type="checkbox"/>	mm right	<input checked="" type="checkbox"/>	mm left
On Centerline	19				mm up

Free Motion HIC	708.4
HIC(d)	700.8
Impact Velocity (kph)	23.48
HIC T1 (msec)	3.1
HIC T2 (msec)	9.5
