REPORT NUMBER: 201UI-CAL-08-05

**SAFETY COMPLIANCE TESTING FOR FMVSS 201
OCCUPANT PROTECTION IN INTERIOR IMPACT
UPPER INTERIOR HEAD IMPACT PROTECTION**

**GENERAL MOTORS DE MEXICO
2008 SATURN VUE XE**

NHTSA NUMBER: C80113

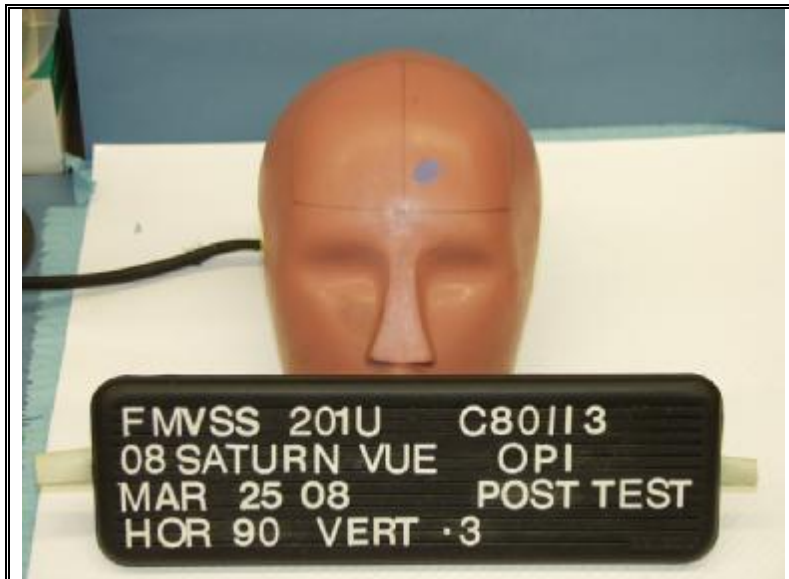
POST-IMPACT OP1 HEADFORM

Free Motion HIC	587.4
HIC(d)	609.5
Impact Velocity (kph)	23.68
HIC T1 (msec)	2.6
HIC T2 (msec)	10.9

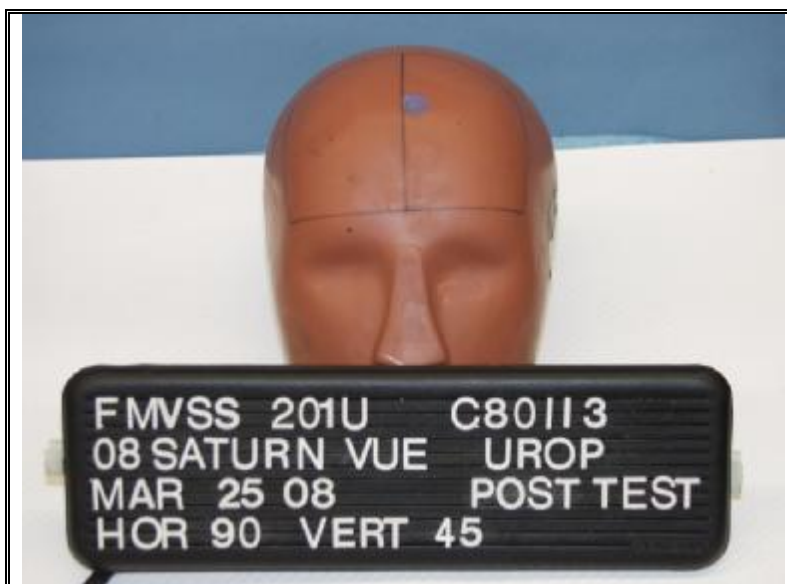
POST-IMPACT UROP HEADFORM

Free Motion HIC	741.2
HIC(d)	725.6
Impact Velocity (kph)	23.63
HIC T1 (msec)	3.3
HIC T2 (msec)	11.1

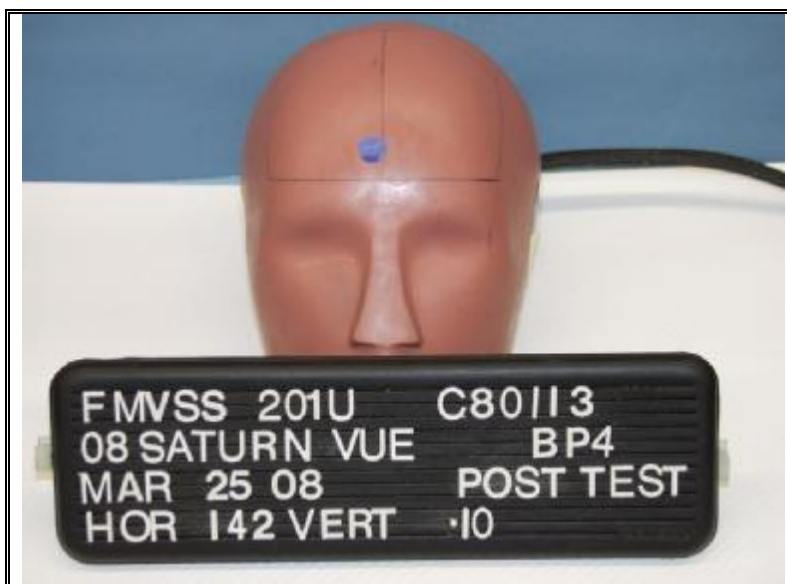
POST-IMPACT BP4 HEADFORM

Free Motion HIC	684.4
HIC(d)	682.7
Impact Velocity (kph)	23.36
HIC T1 (msec)	1.7
HIC T2 (msec)	10.4

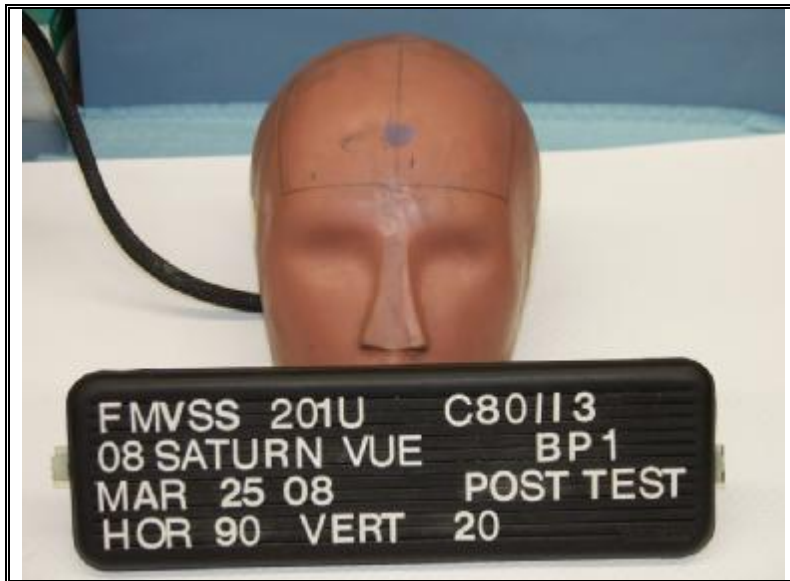
POST-IMPACT BP1 HEADFORM

Free Motion HIC	404.4
HIC(d)	471.5
Impact Velocity (kph)	18.5
HIC T1 (msec)	5.4
HIC T2 (msec)	11.9

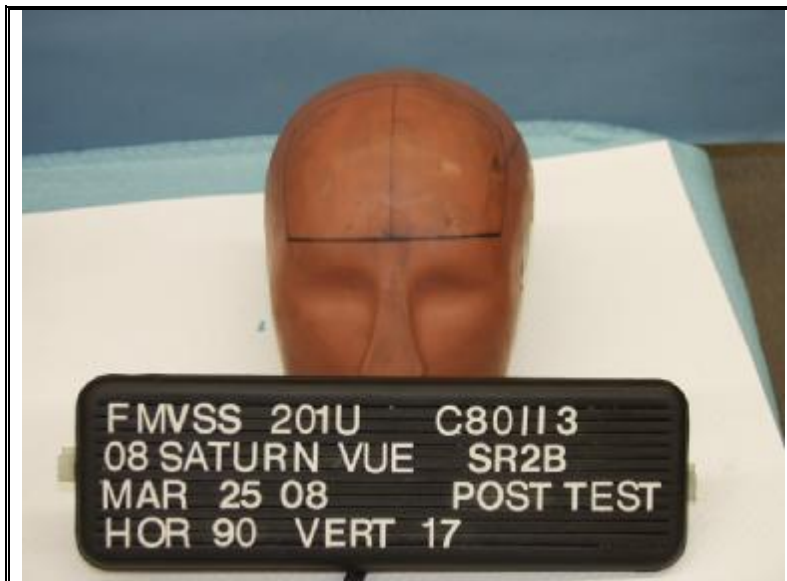
POST-IMPACT SR2B HEADFORM

Free Motion HIC	221.8
HIC(d)	333.7
Impact Velocity (kph)	18.66
HIC T1 (msec)	5.5
HIC T2 (msec)	12.4

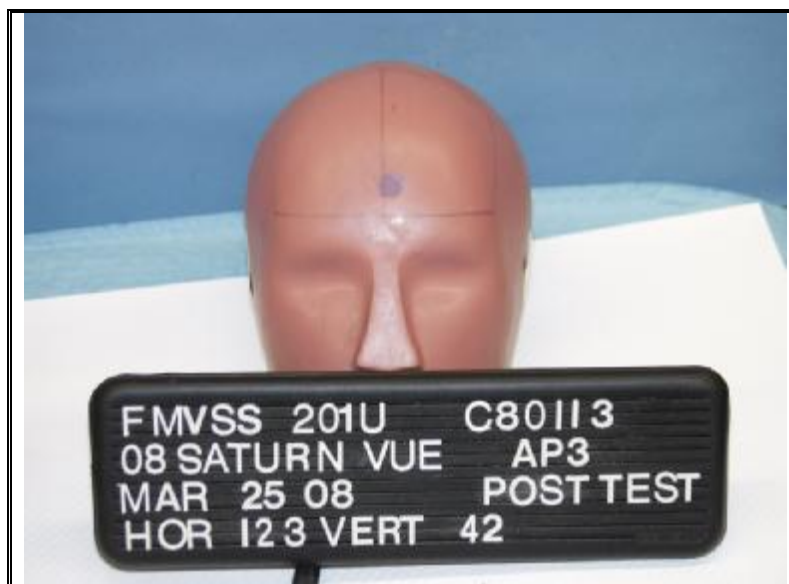
POST-IMPACT AP3 HEADFORM

Free Motion HIC	234.6
HIC(d)	343.4
Impact Velocity (kph)	18.78
HIC T1 (msec)	2.6
HIC T2 (msec)	8.7

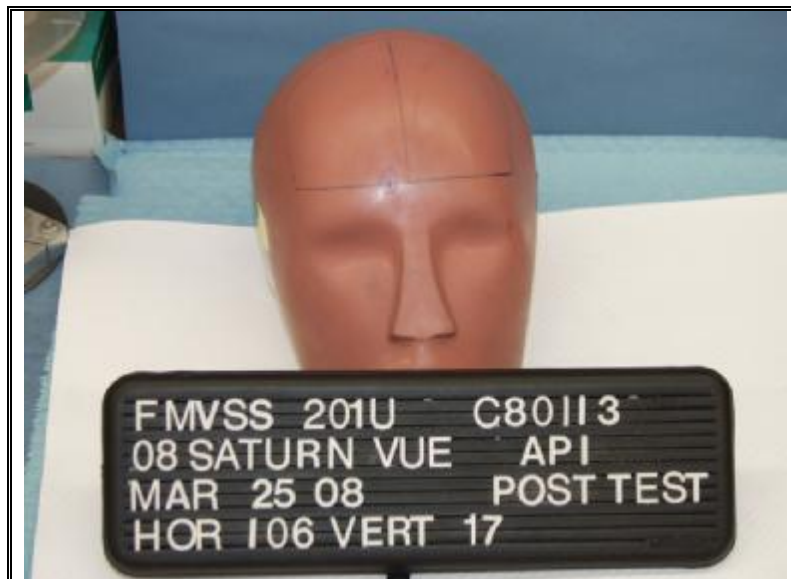
POST-IMPACT AP1 HEADFORM

Free Motion HIC	317.4
HIC(d)	405.8
Impact Velocity (kph)	18.48
HIC T1 (msec)	5.3
HIC T2 (msec)	9.6

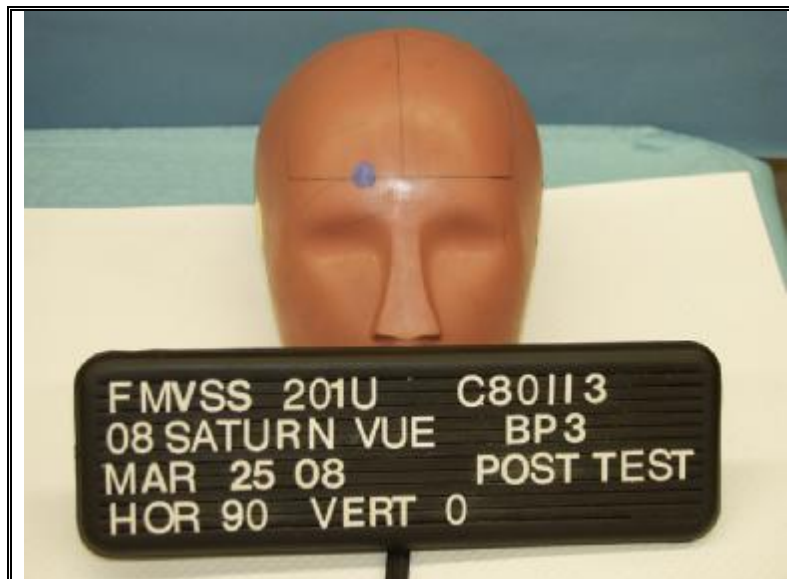
POST-IMPACT BP3 HEADFORM (TEST PLACARD DATE SHOULD BE MAR. 26, 2008)

Free Motion HIC	768.1
HIC(d)	745.9
Impact Velocity (kph)	23.63
HIC T1 (msec)	1.3
HIC T2 (msec)	8.3

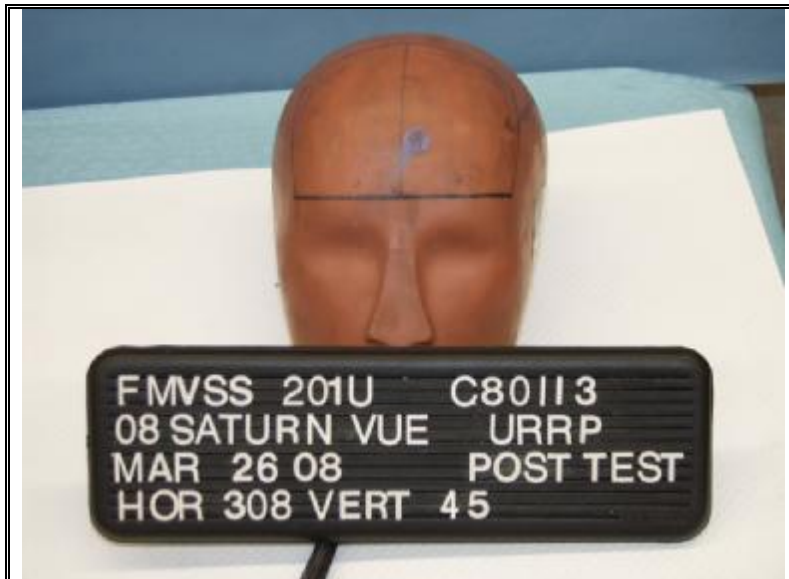
POST-IMPACT URRP HEADFORM

Free Motion HIC	468.9
HIC(d)	520.2
Impact Velocity (kph)	23.66
HIC T1 (msec)	6.2
HIC T2 (msec)	15.1

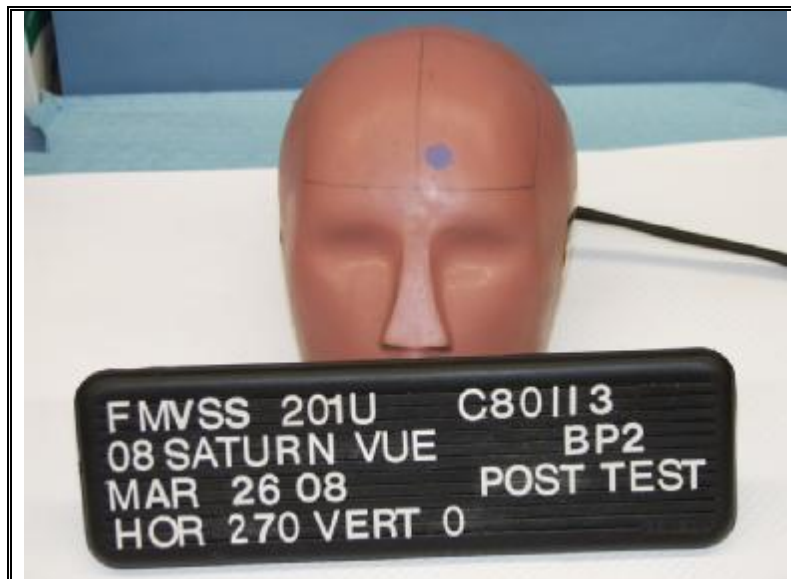
POST-IMPACT BP2 HEADFORM

Free Motion HIC	564.6
HIC(d)	592.3
Impact Velocity (kph)	23.65
HIC T1 (msec)	1.1
HIC T2 (msec)	9.8

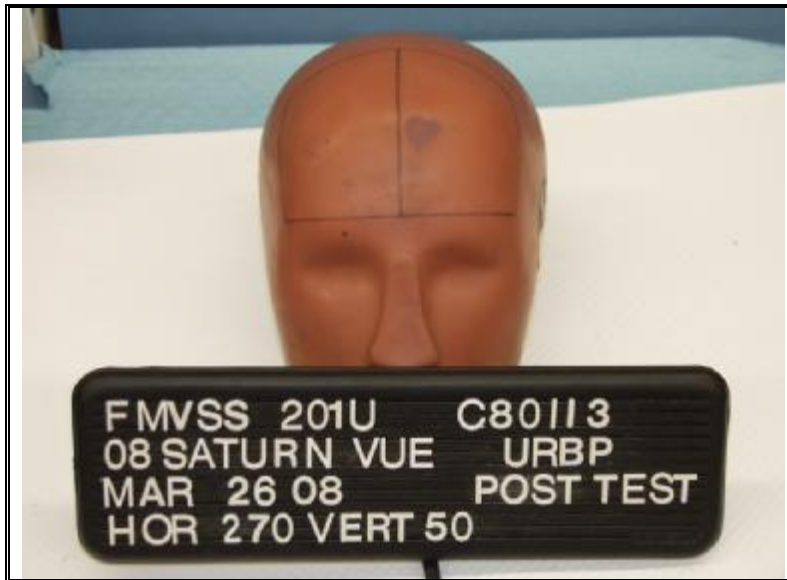
POST-IMPACT URBP HEADFORM

Free Motion HIC	632.9
HIC(d)	643.9
Impact Velocity (kph)	23.73
HIC T1 (msec)	3.8
HIC T2 (msec)	10.9

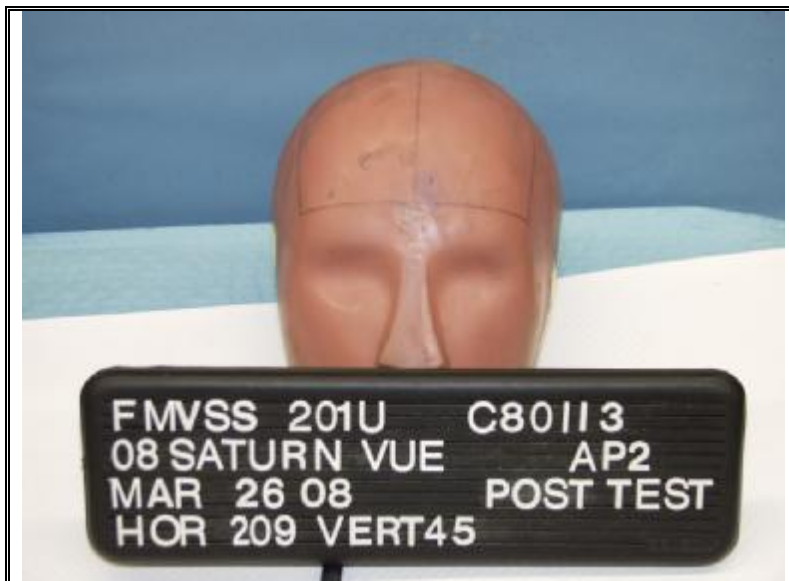
POST-IMPACT AP2 HEADFORM

Free Motion HIC	247.9
HIC(d)	353.4
Impact Velocity (kph)	18.71
HIC T1 (msec)	3.6
HIC T2 (msec)	11.8
