REPORT NUMBER 138-STF-08-006

SAFETY COMPLIANCE TESTING FOR FMVSS NO. 138 TIRE PRESSURE MONITORING SYSTEMS

FUJI HEAVY INDUSTRIES
2008 SUBARU IMPREZA
FOUR-DOOR PASSENGER CAR
NHTSA NO. C85502

FINAL REPORT

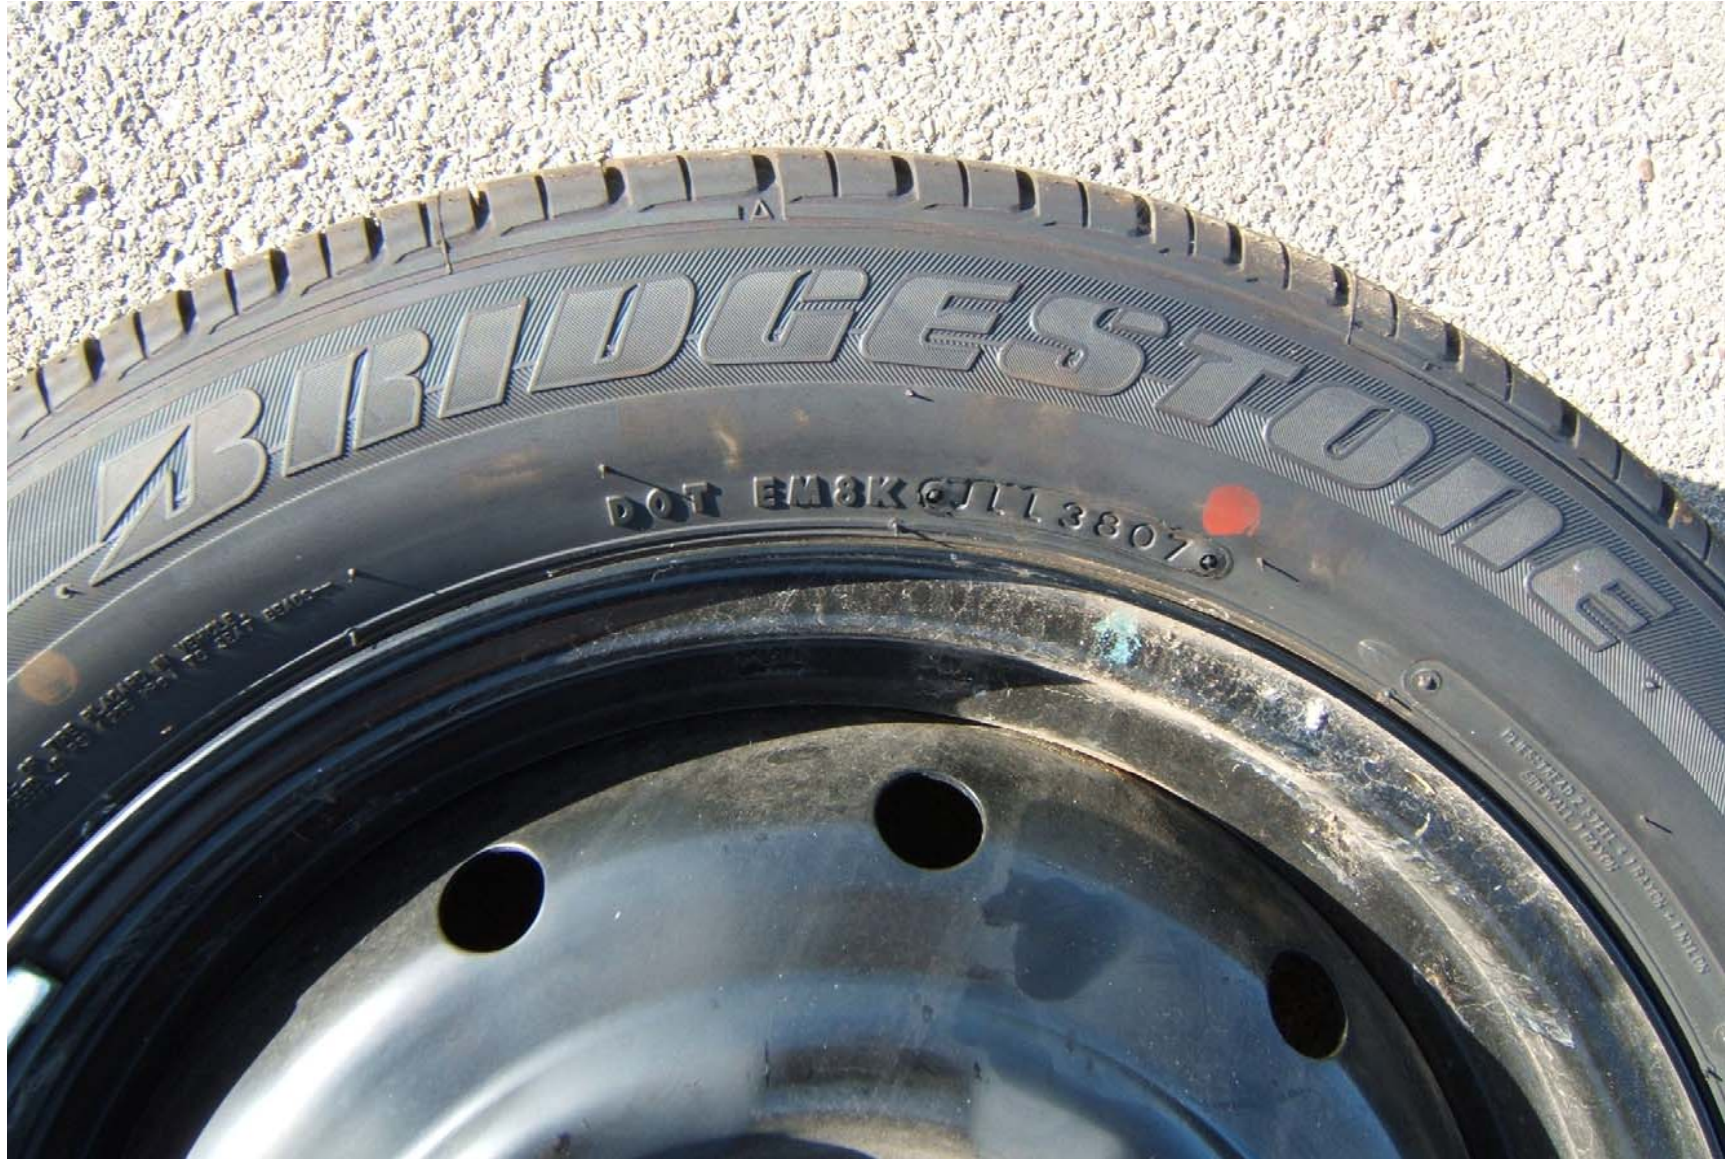
FIGURE 5.4
TIRE SHOWING BRAND

Manufacturer/Tire Name: Bridgestone Potenza RE92A

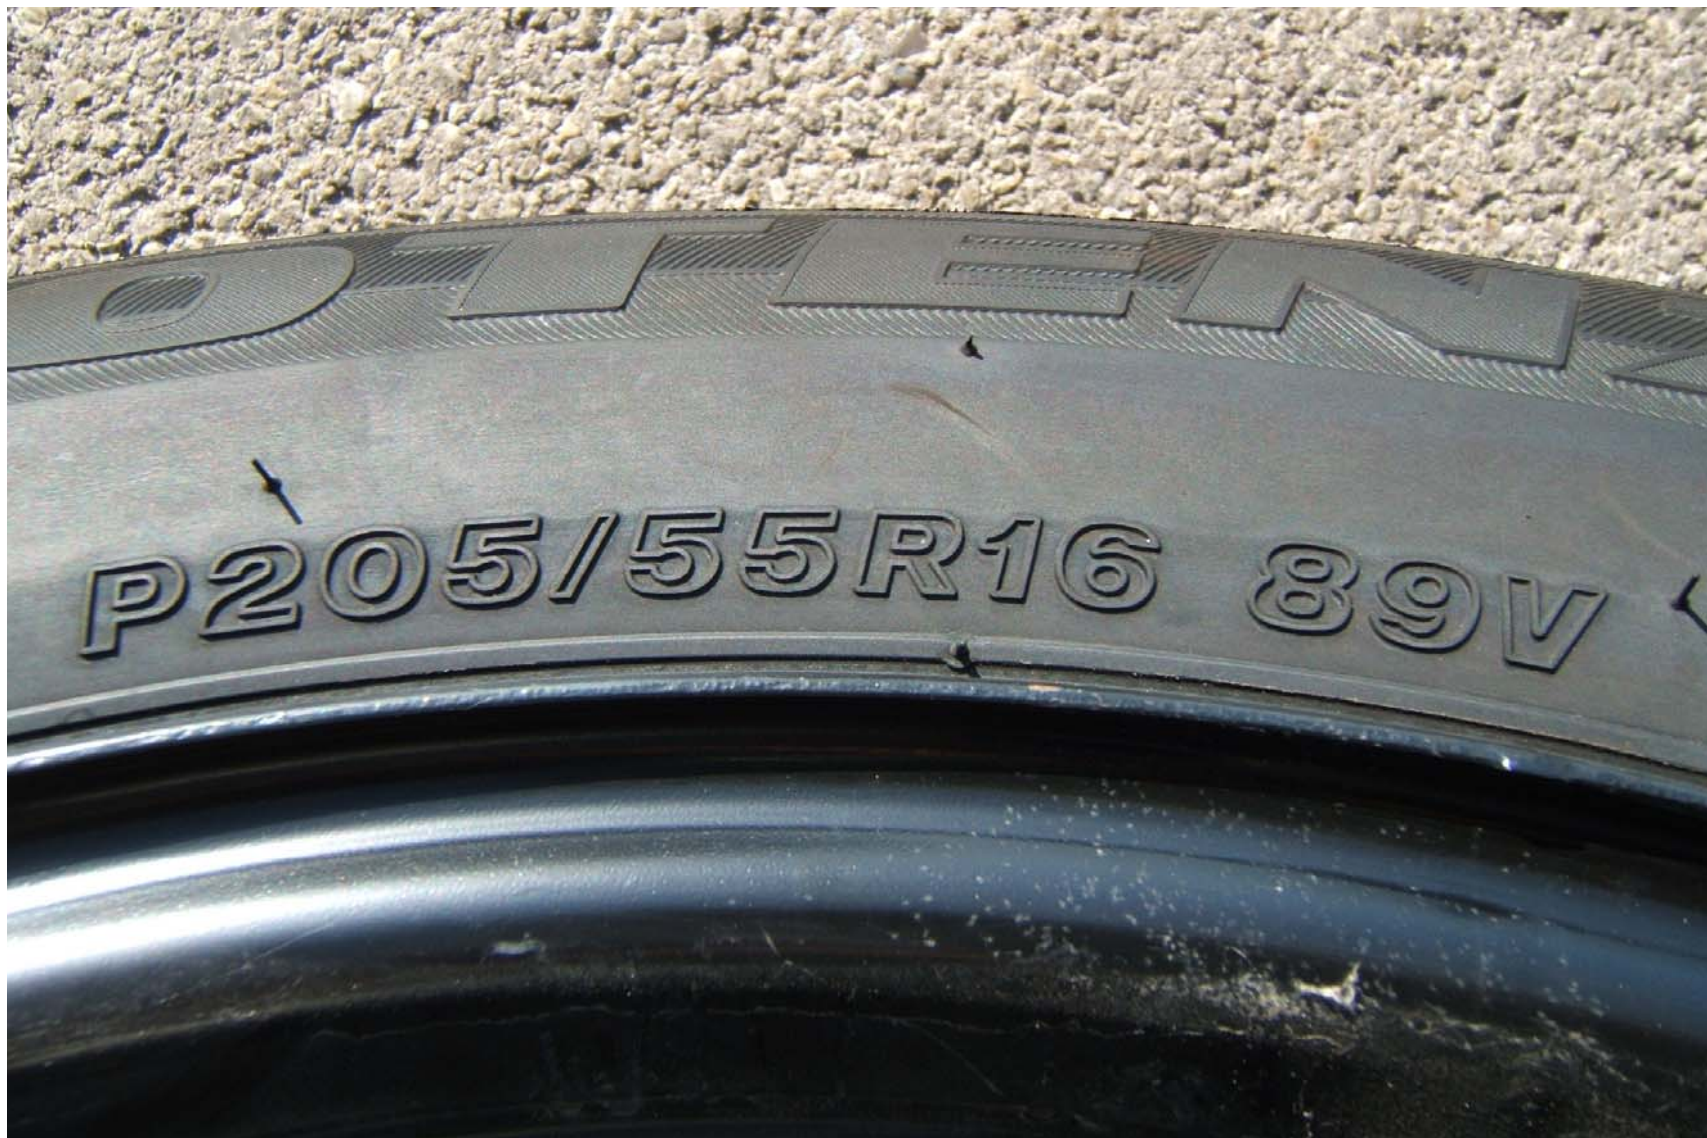
FIGURE 5.6
TIRE SHOWING SIZE AND LOAD INDEX / SPEED RATING

Tire Size and Load Index / Speed Rating: P205/55R16 89V

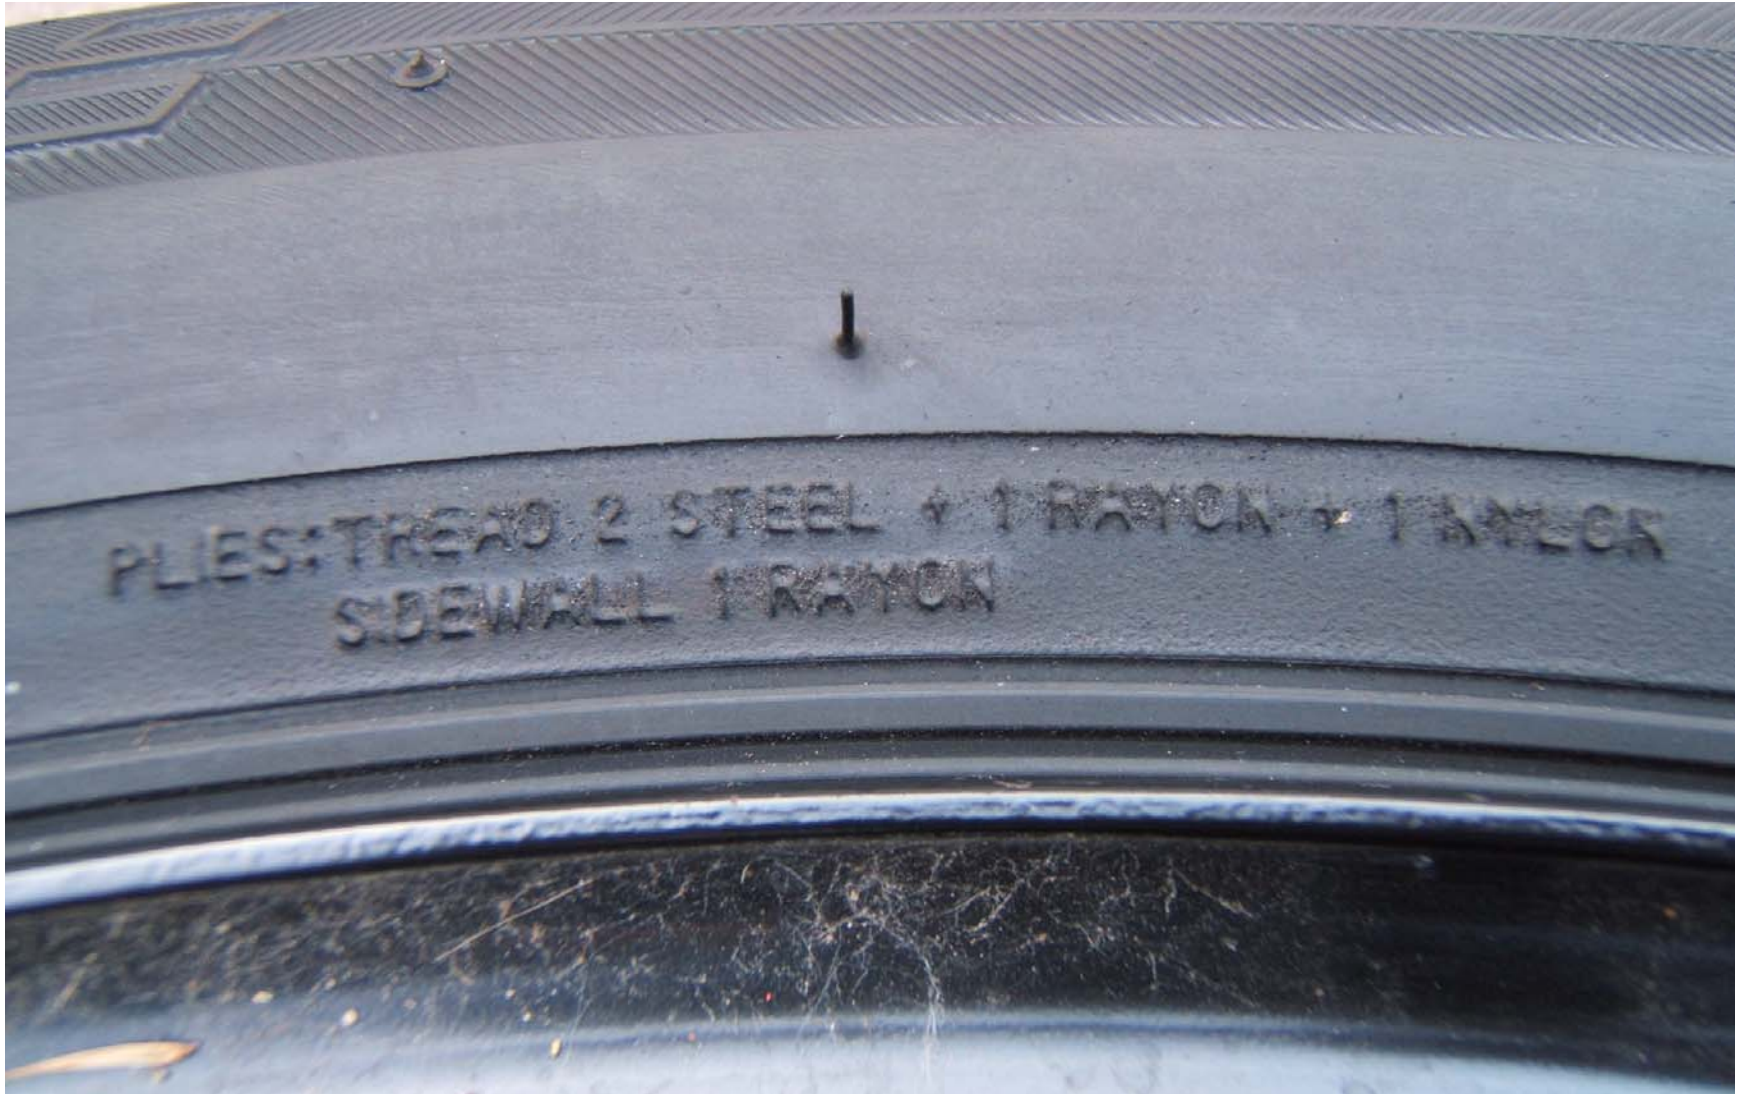
FIGURE 5.9
TIRE SHOWING SIDEWALL / TREAD CONSTRUCTION

Sidewall Construction (number of plies and ply material): 1 rayon

Tread Construction (number of plies and ply material): 2 steel, 1 rayon, 1 nylon

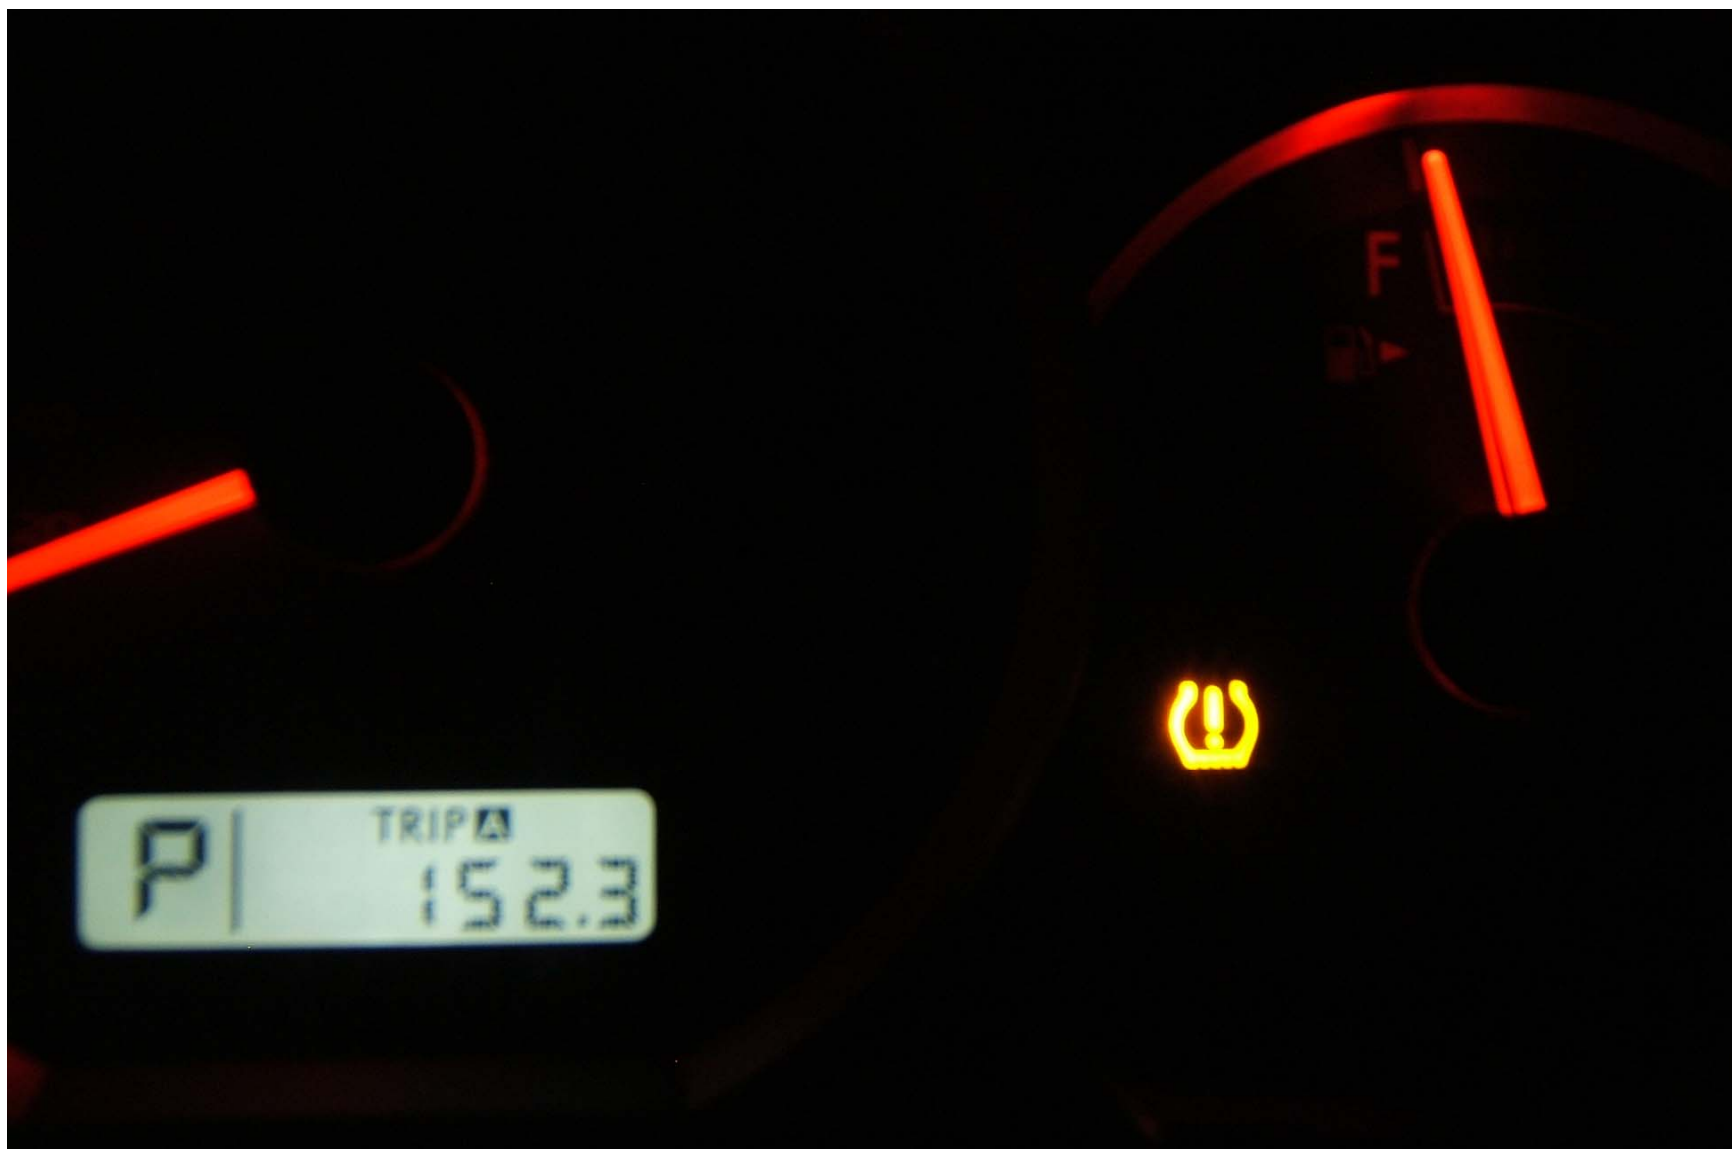
FIGURE 5.11
DISPLAY SHOWING LOW TIRE
PRESSURE / MALFUNCTION TELLTALE

Is the telltale yellow in color? (X)YES ()NO (fail)

Low Tire Pressure / Malfunction Warning Telltale (PASS/FAIL) **PASS**

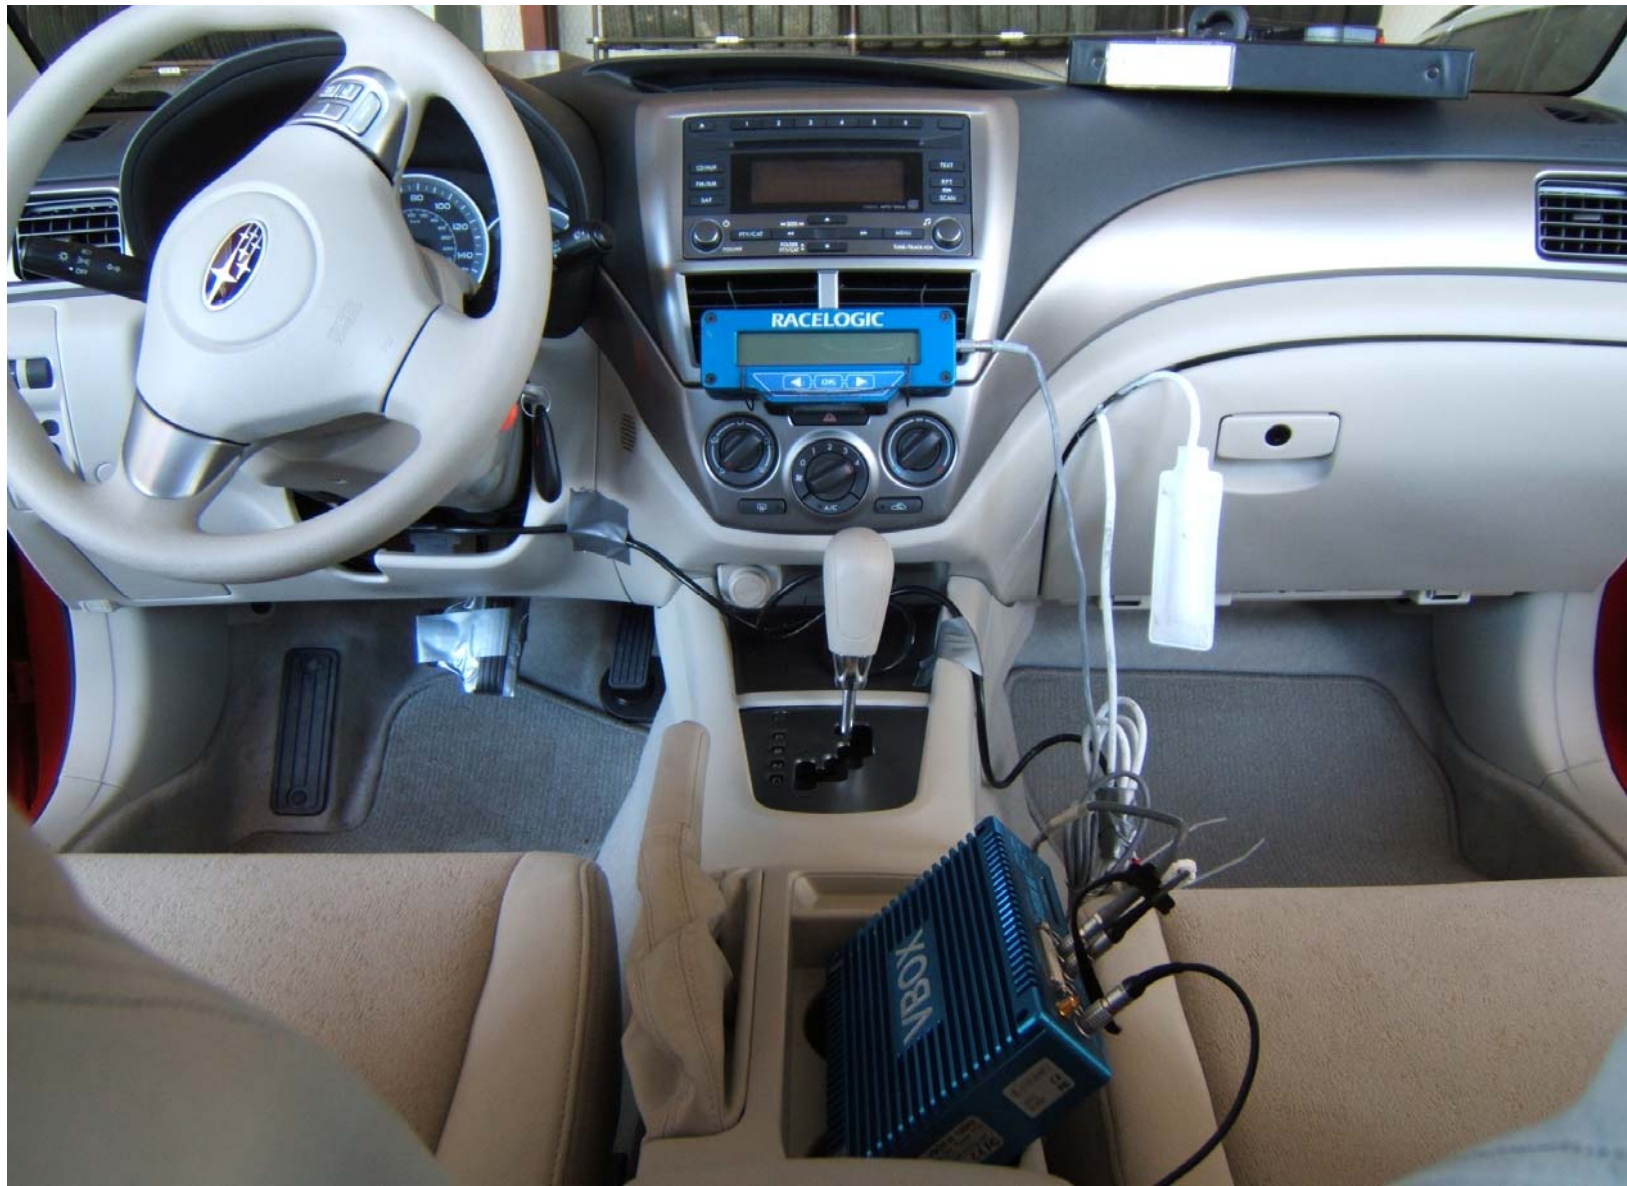
FIGURE 5.12
TEST INSTRUMENTATION ON VEHICLE

The vehicle was instrumented with a Racelogic VBOX III 100 Hz GPS Data Logger and brake pedal trigger. The VBOX uses GPS to measure vehicle speed, time, and distance. Test data were recorded to a compact flash card. During the test, a stopwatch was used to determine the approximate "cumulative driving time" during each test phase. Cumulative driving time does not include time during the brake application or when the vehicle speed was below 50 km/h or above 100 km/h. Upon completion of a tire deflation scenario, graphs were generated by VBOX software showing vehicle speed versus time during the test procedures. The graphs furnish a second-by-second analysis of each calibration phase. The cumulative driving time was calculated by post processing the VBOX graph data and is reported in Section 3 (Test Data) as 'Total Driving Time'. Driving above 50 km/h was not required for the detection phases.

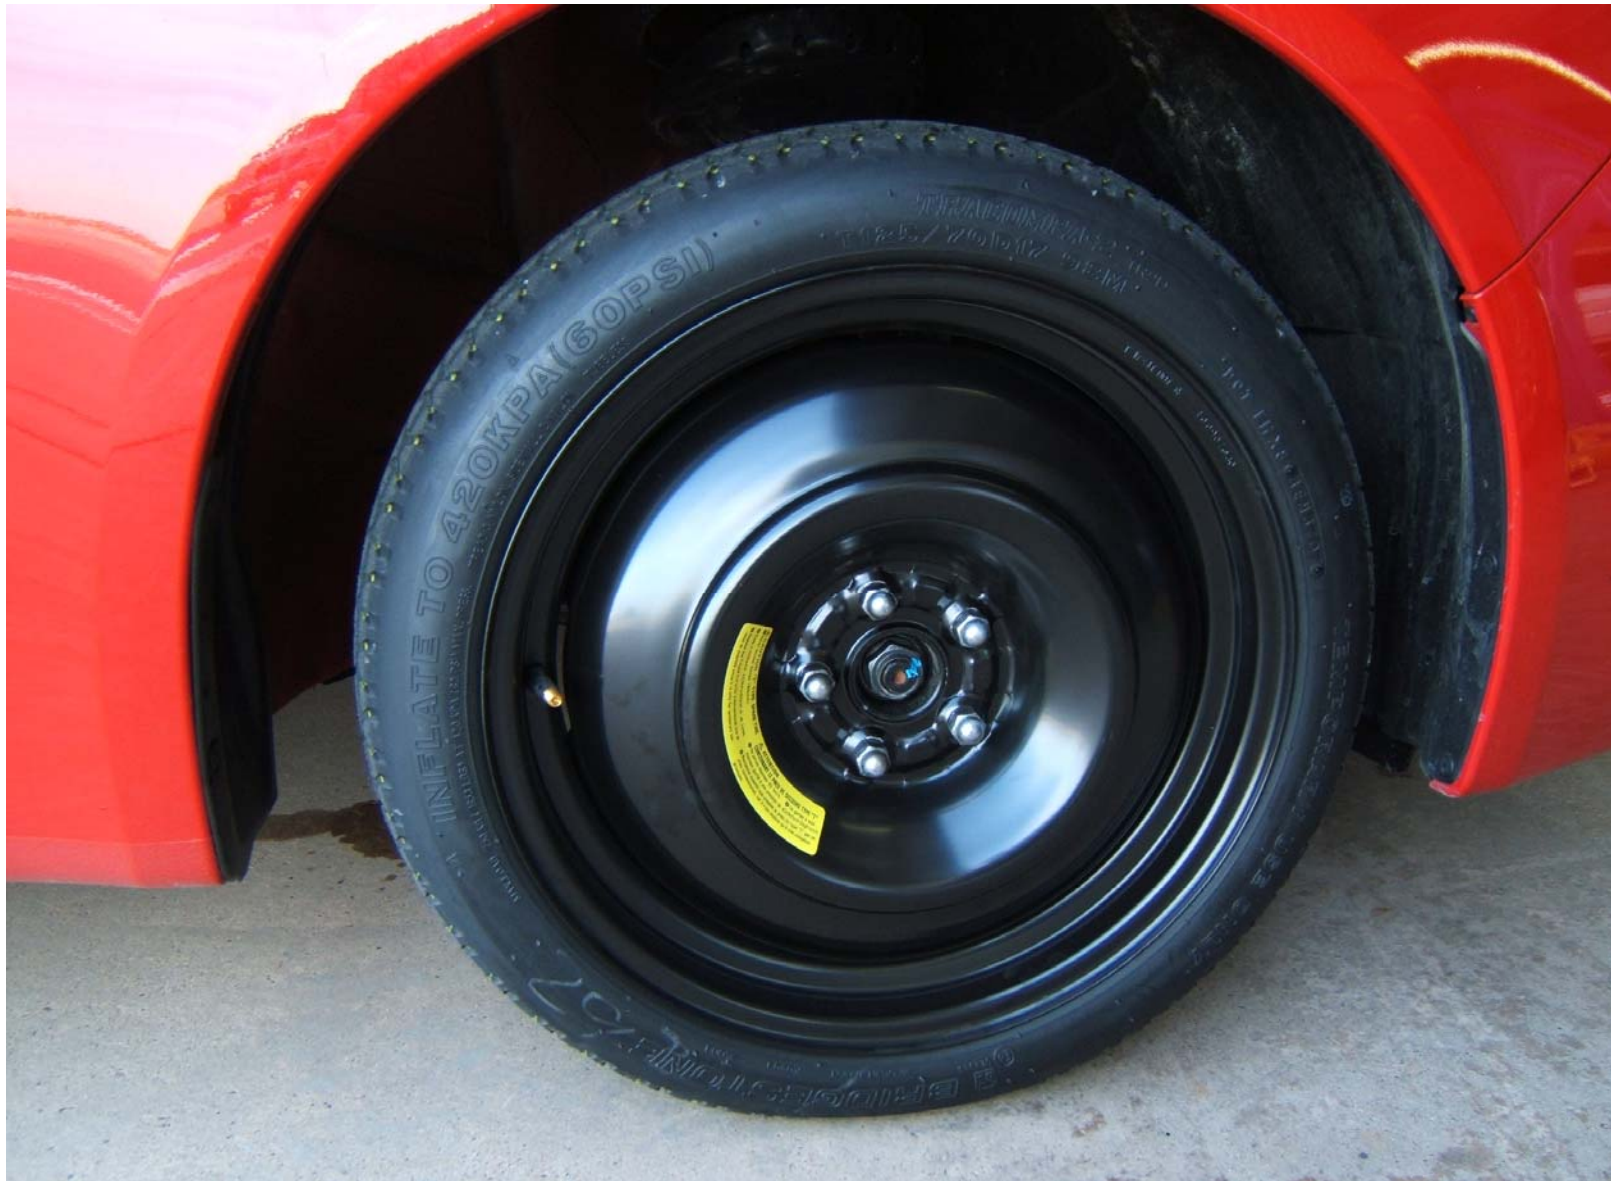
FIGURE 5.16
SPARE INSTALLED ON RIGHT FRONT
FOR MALFUNCTION DETECTION TEST

A malfunction detection scenario was performed with the vehicle loaded to its LLVW. A malfunction was simulated by placing the compact spare tire (with no TPMS sensor) on the right front wheel position. The vehicle was started and driven until telltale illumination.

TPMS MALFUNCTION PERFORMANCE TEST RESULTS (PASS/FAIL) PASS
Spare without TPMS sensor was applied to right front at LLVW.

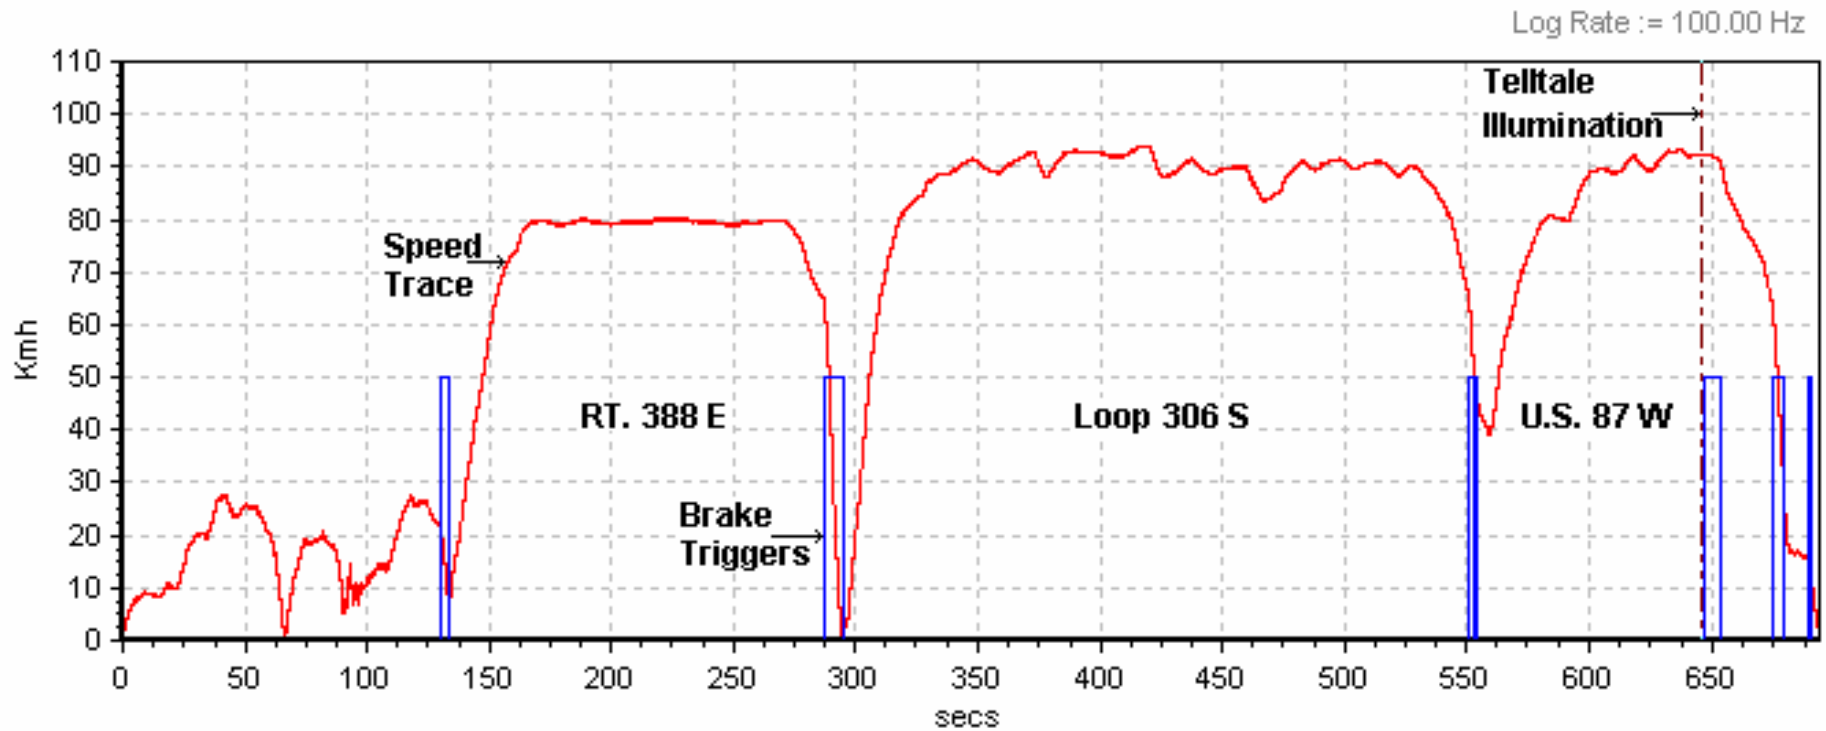
2008 Subaru Impreza (C85502) RF Spare Tire Malfunction Illumination LLVW

Malfunction Illumination: Spare without TPMS sensor was applied to right front at LLVW.
Test Date: 8/12/08
Data File Time: 11:34 minutes
Cumulative Driving Time: 07:49 minutes
Start Point: GAFB North Gate
