REPORT NO. 111-KAR-08-002

**SAFETY COMPLIANCE TESTING
FOR FMVSS 111**

**2008 JEEP LIBERTY
5-DOOR MPV**

NHTSA NO: C80304

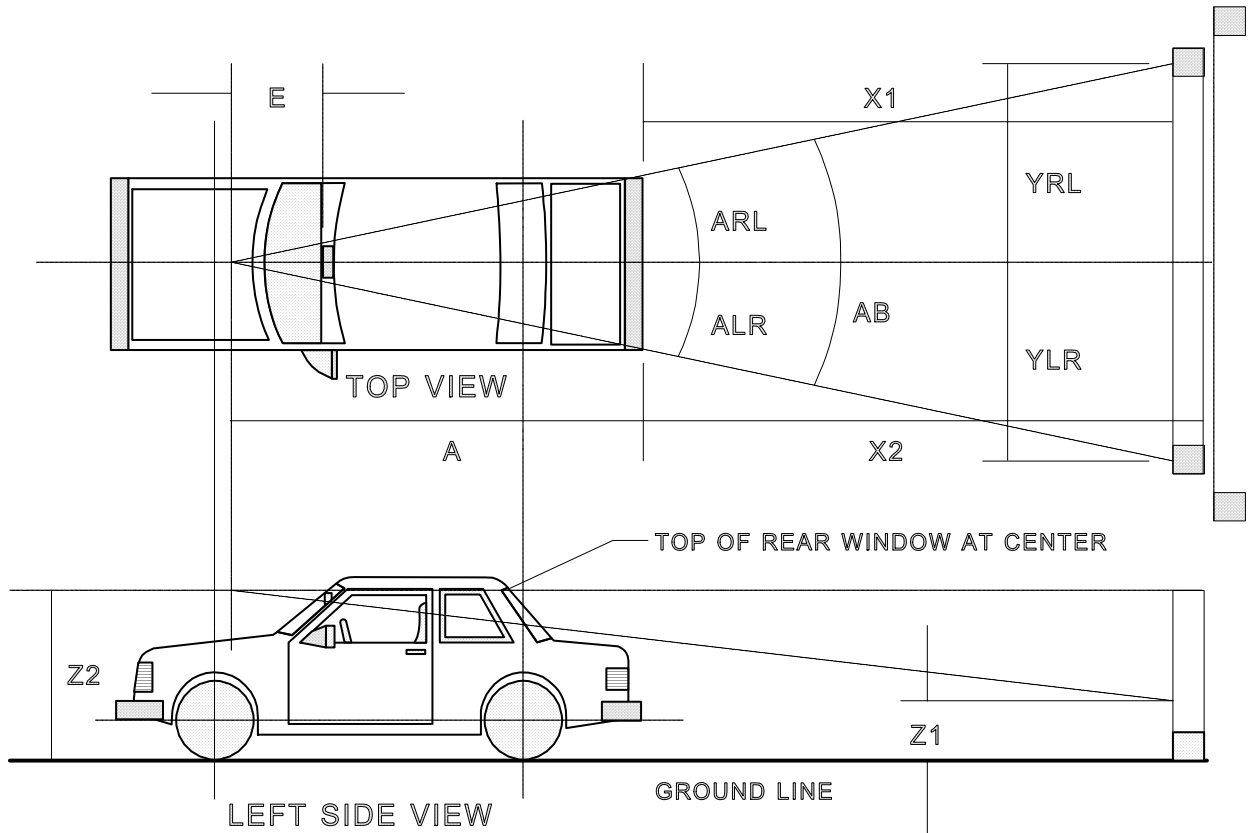
INSIDE REARVIEW MIRROR FIELD OF VIEW
TEST GRID AND MARKER SETUP

- E Distance from center of mirror to projected eye point location = 446.0 mm
- A Distance from rear of vehicle to projected eye point location = 3148.0 mm
- X1 Distance from rear of vehicle to field of view grid = 8126.0 mm
- Z1 Vertical distance to lowest point of field of view at distance X1 = 527.0 mm
- Z2 Height of center of mirror = 1482.0 mm
- X2 Distance from rear of vehicle where the road surface is first visible
 $X2 = [(Z2 \times X1) + (Z1 \times A)] / (Z2 - Z1) =$
(S111 REQUIREMENT = 61m maximum) 14347.4 mm (14.35 m)

ANGLE AB = 20.1° (S111 REQUIREMENT = 20 degrees minimum)

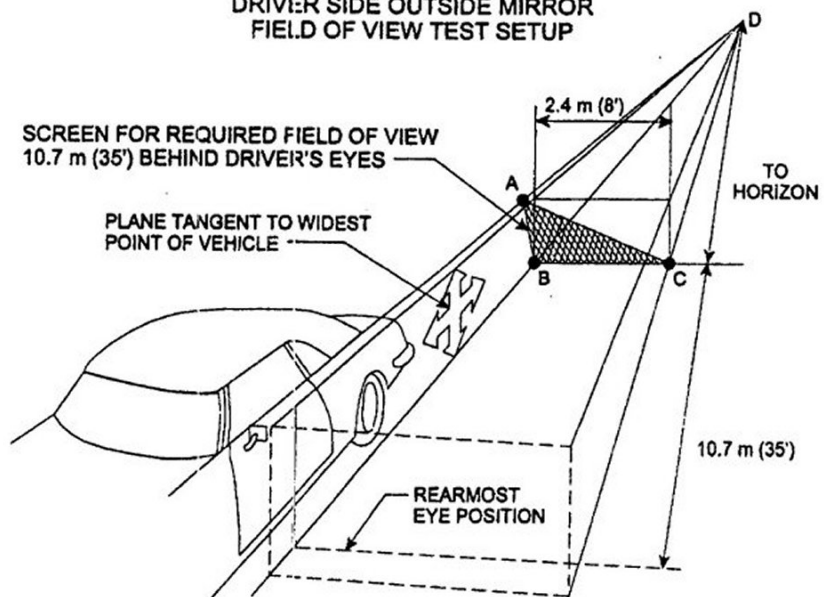
DRIVER SIDE OUTSIDE MIRROR FIELD OF VIEW TEST SETUP

VEHICLE ATTITUDE AND GROUND LEVEL WERE RAISED 4" (101.6) TO PERFORM THE TEST.

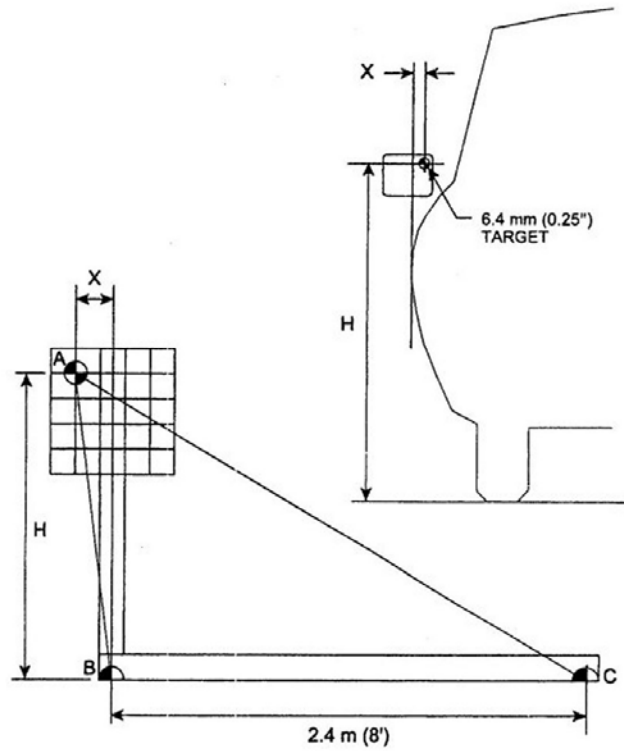
DRIVER SIDE OUTSIDE MIRROR TARGET DISC LOCATION WITH X AND H DIMENSIONS

HEIGHT OF TARGET DISC ON MIRROR _____ **1271 mm**

DISTANCE OF TARGET DISC ON MIRROR FROM VEHICLE TANGENT PLANE _____ **18 mm**

TARGET DISC LOCATION RELATIVE TO VEHICLE TANGENT PLANE _____ **OUTBOARD**
(Inboard or Outboard)

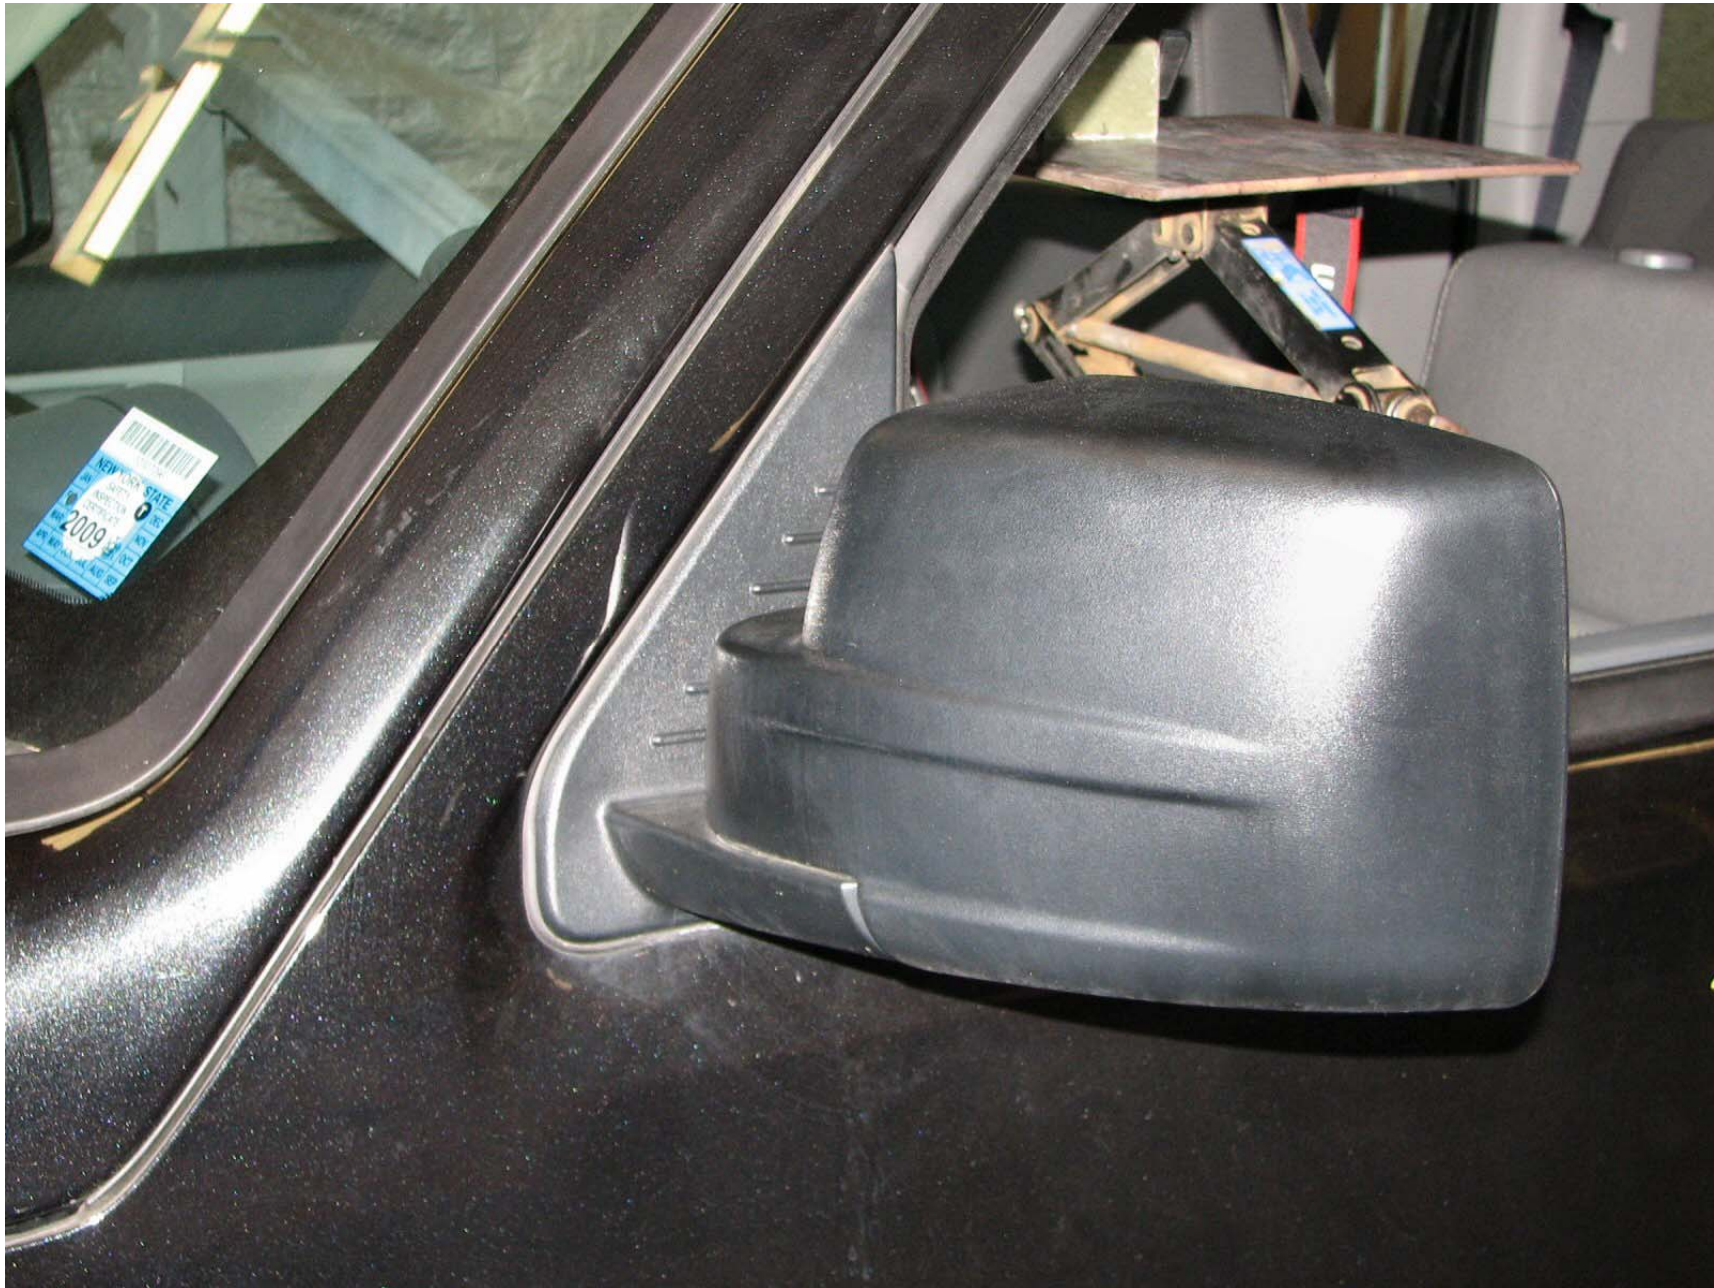
FIGURE 7: DRIVER SIDE REARVIEW MIRROR AND MOUNTING

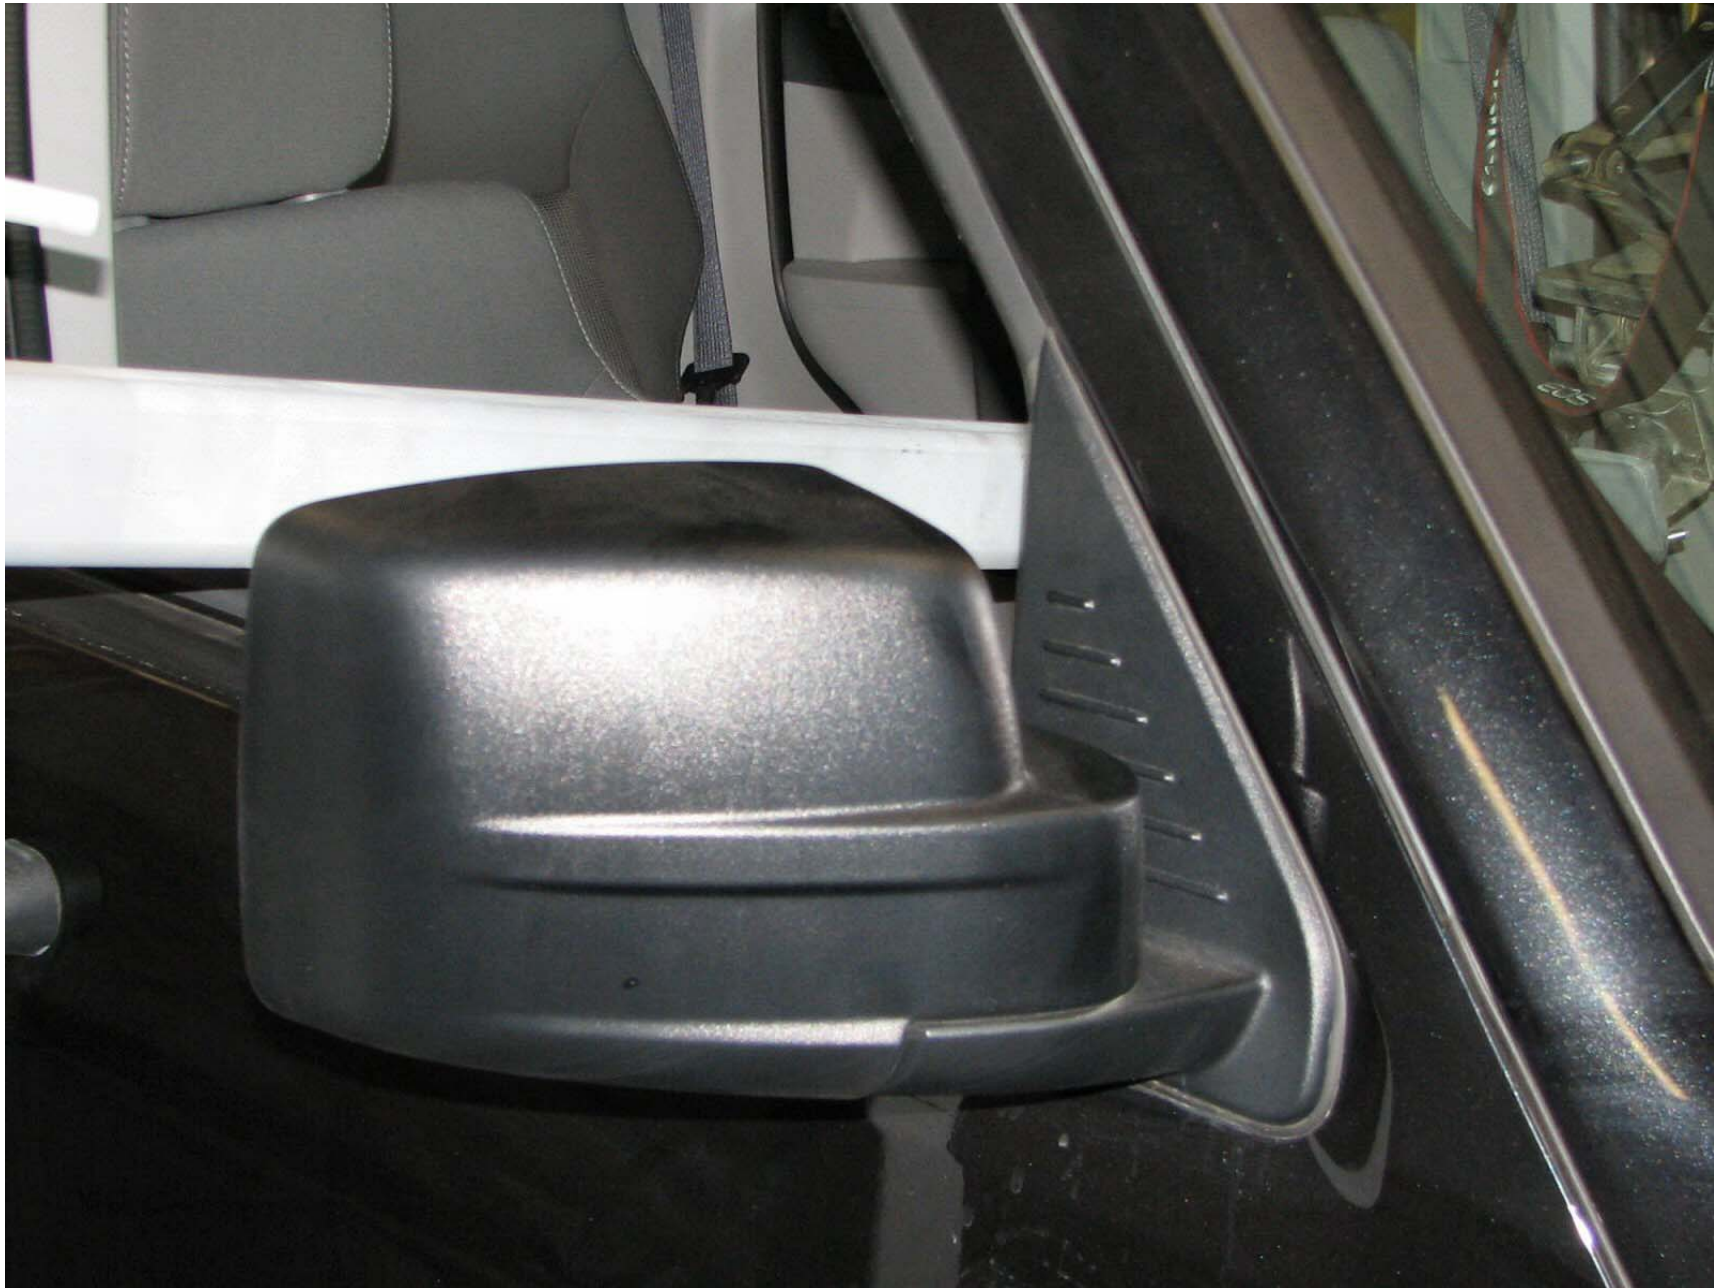
FIGURE 8: PASSENGER SIDE REARVIEW MIRROR AND MOUNTING

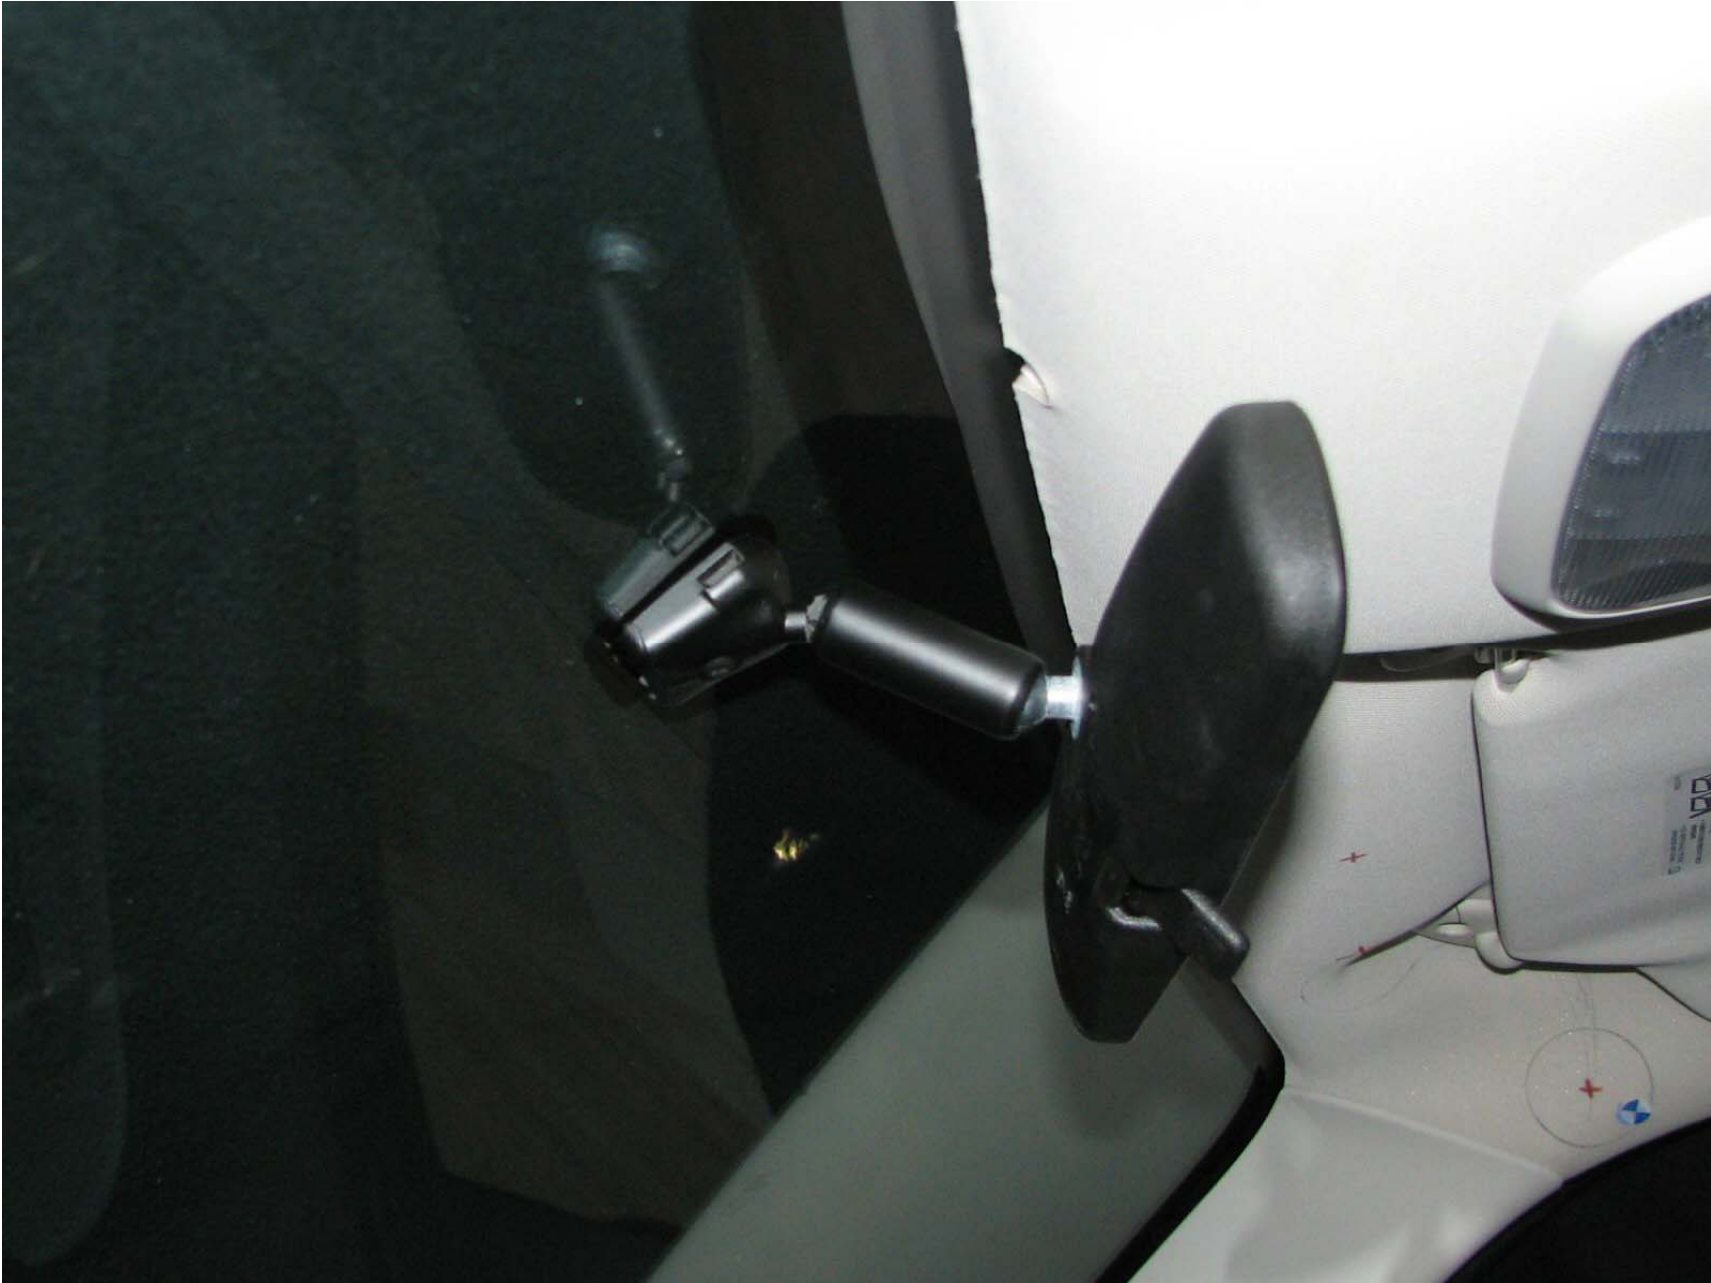
FIGURE 9: INSIDE REARVIEW MIRROR AND MOUNTING

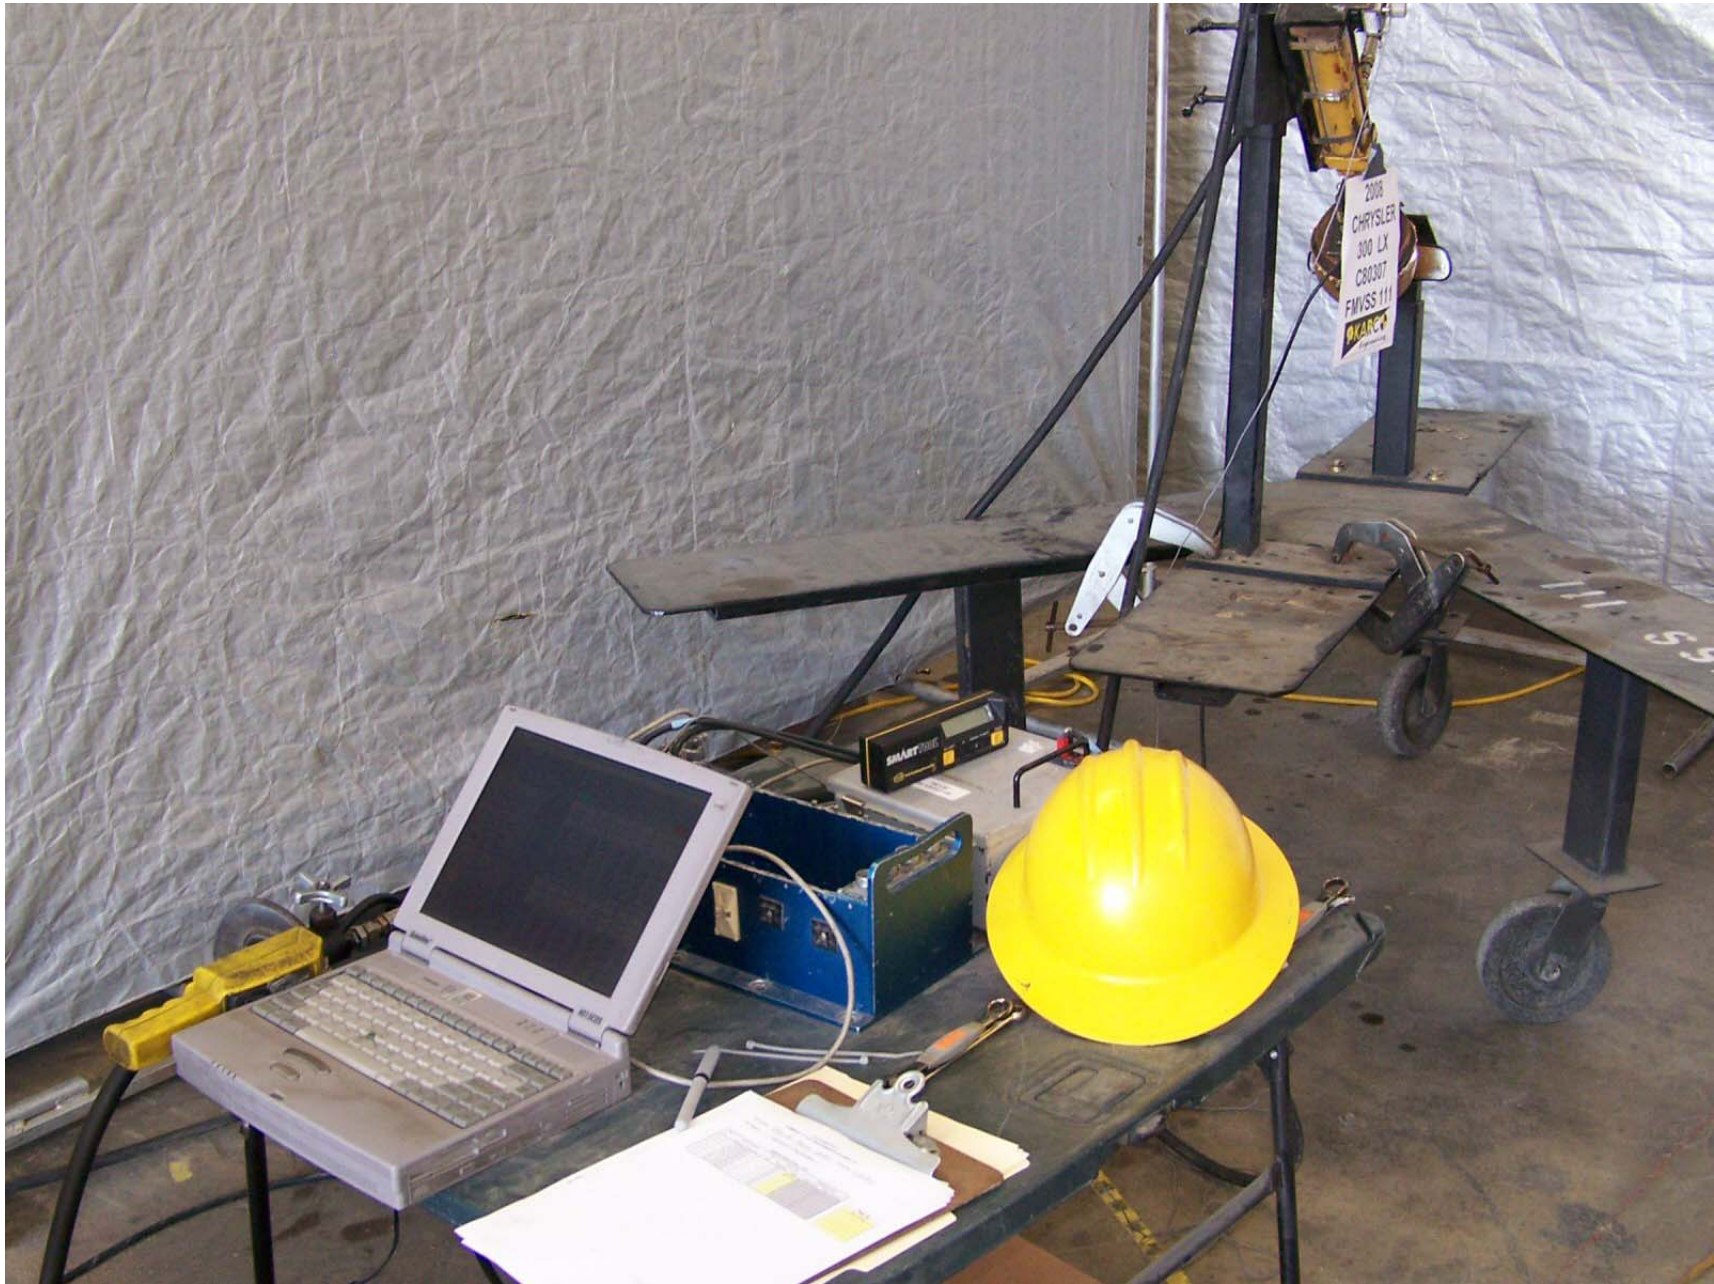
FIGURE 12: OVERALL SET-UP AND INSTRUMENTATION FOR MIRROR BREAK- AWAY TEST

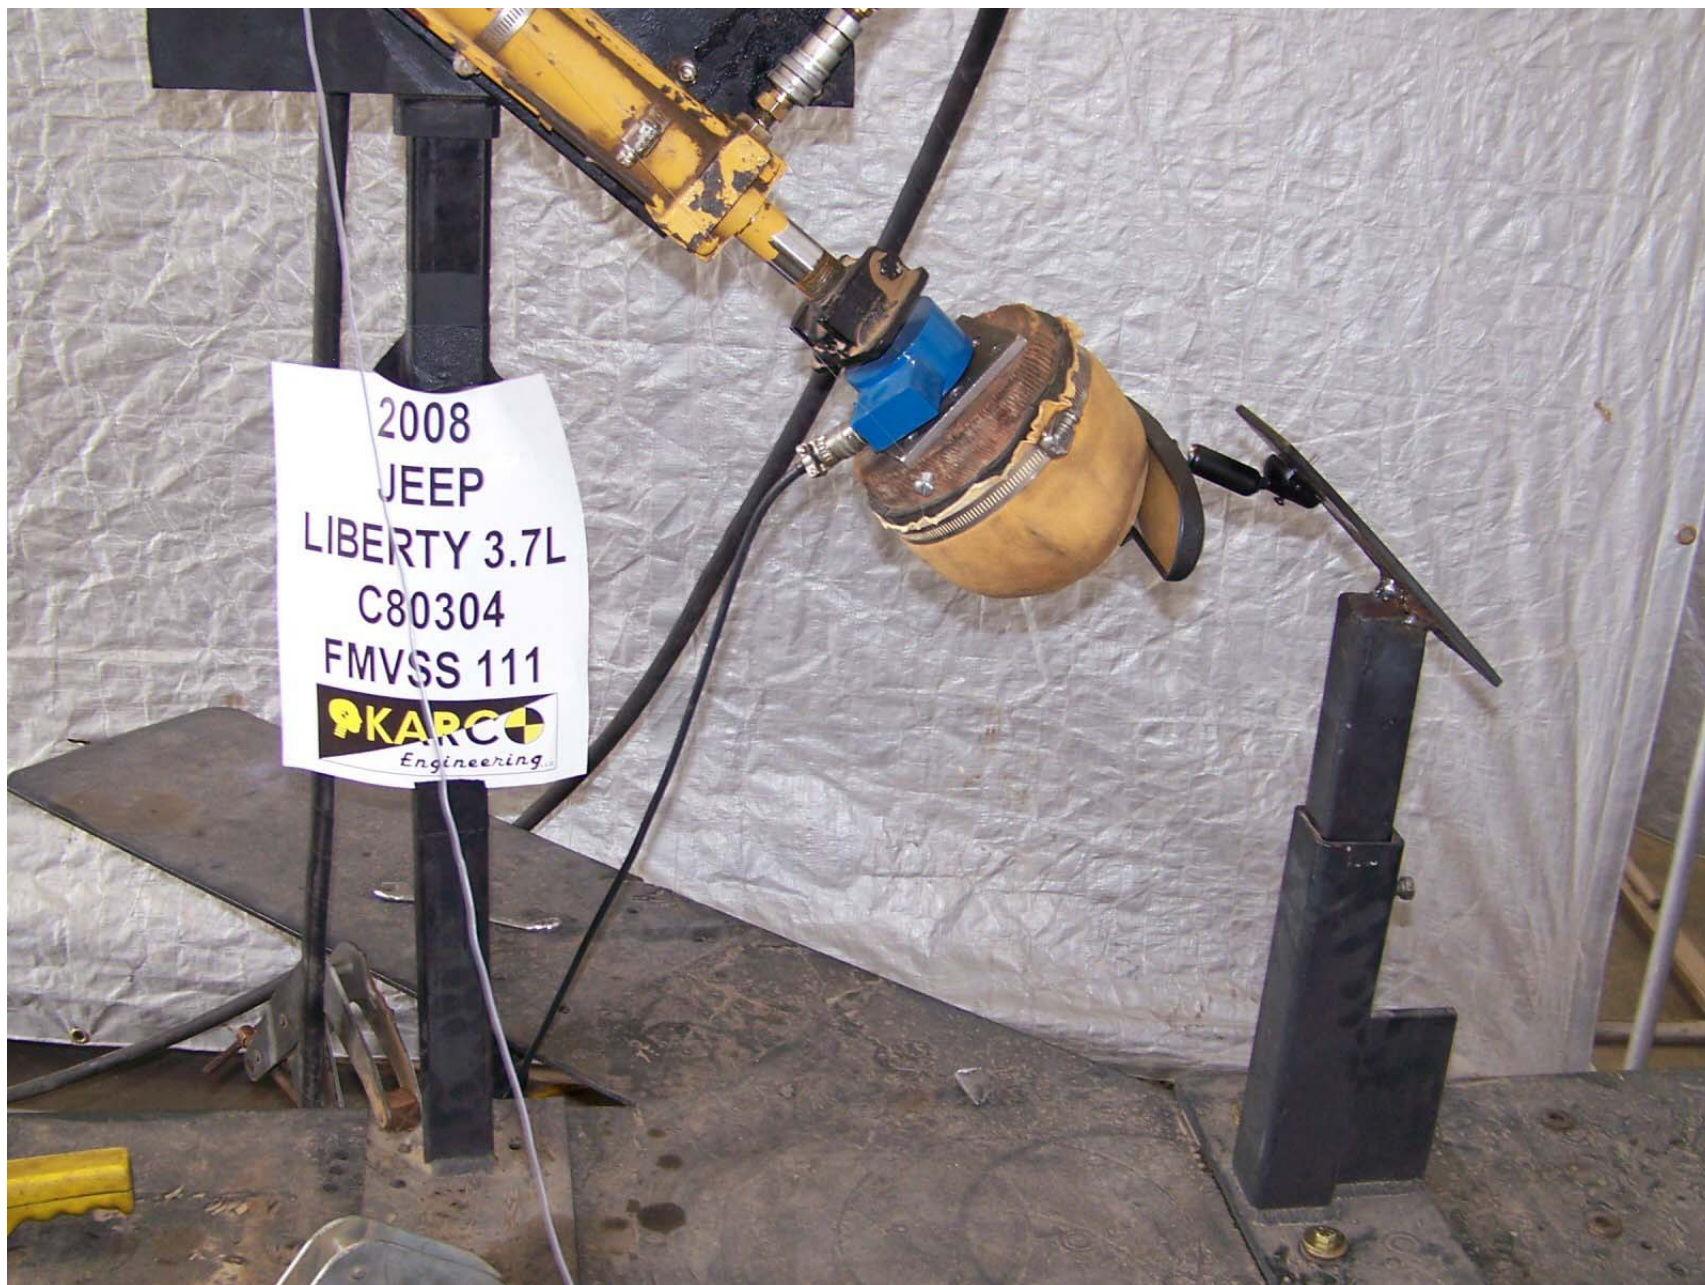
FIGURE 13:CLOSE-UP OF MIRROR BREAK- AWAY TEST

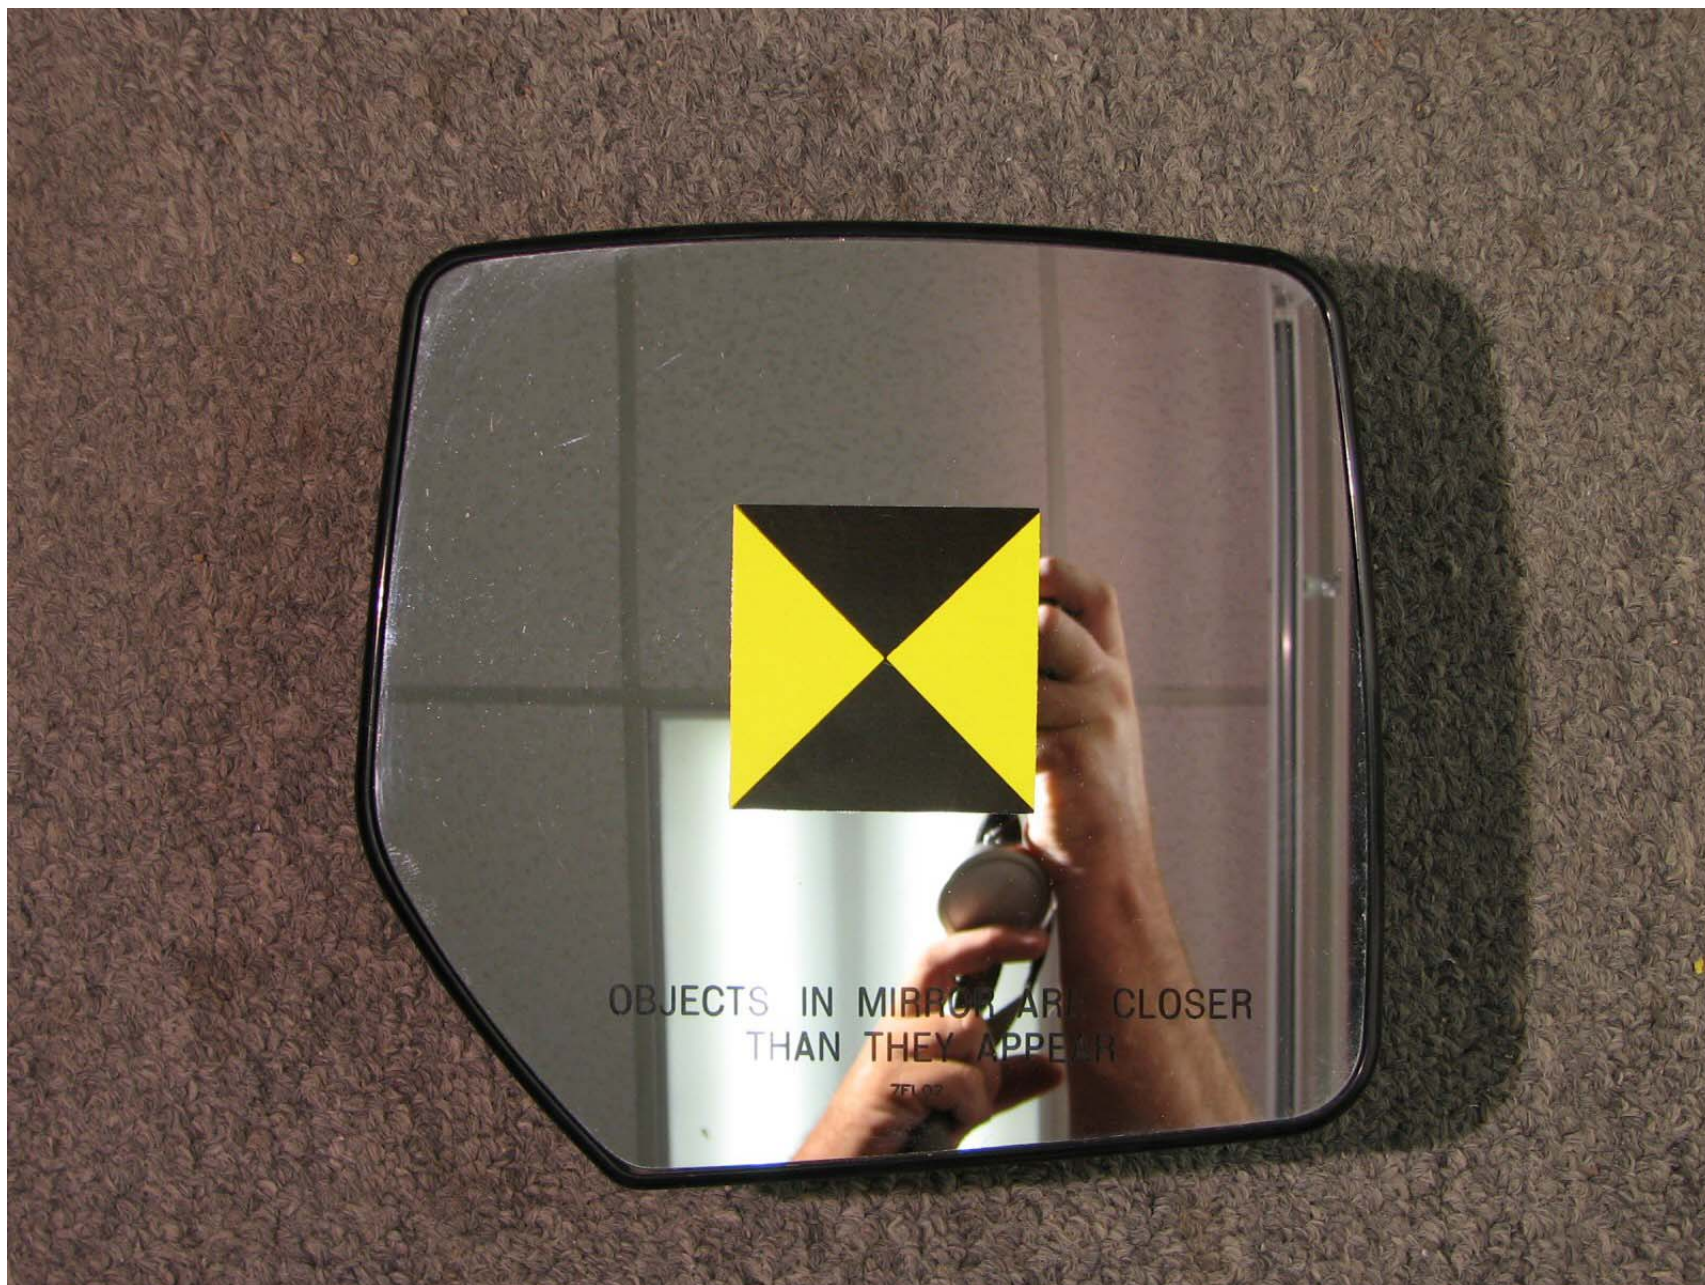
MIRRORS	AREA (cm ²)	REQUIREMENT		RESULTS	
		GVWR ≤ 4536 kg	GVWR ≥ 4536 kg	PASS	FAIL
Outside Driver's Side	228 cm²	126 cm ²	323cm ²	N/A	
Outside Passenger Side	226 cm²	126 cm ²	323 cm ²	N/A

FIGURE 15: MIRROR SET-UP FOR AREA MEASUREMENT

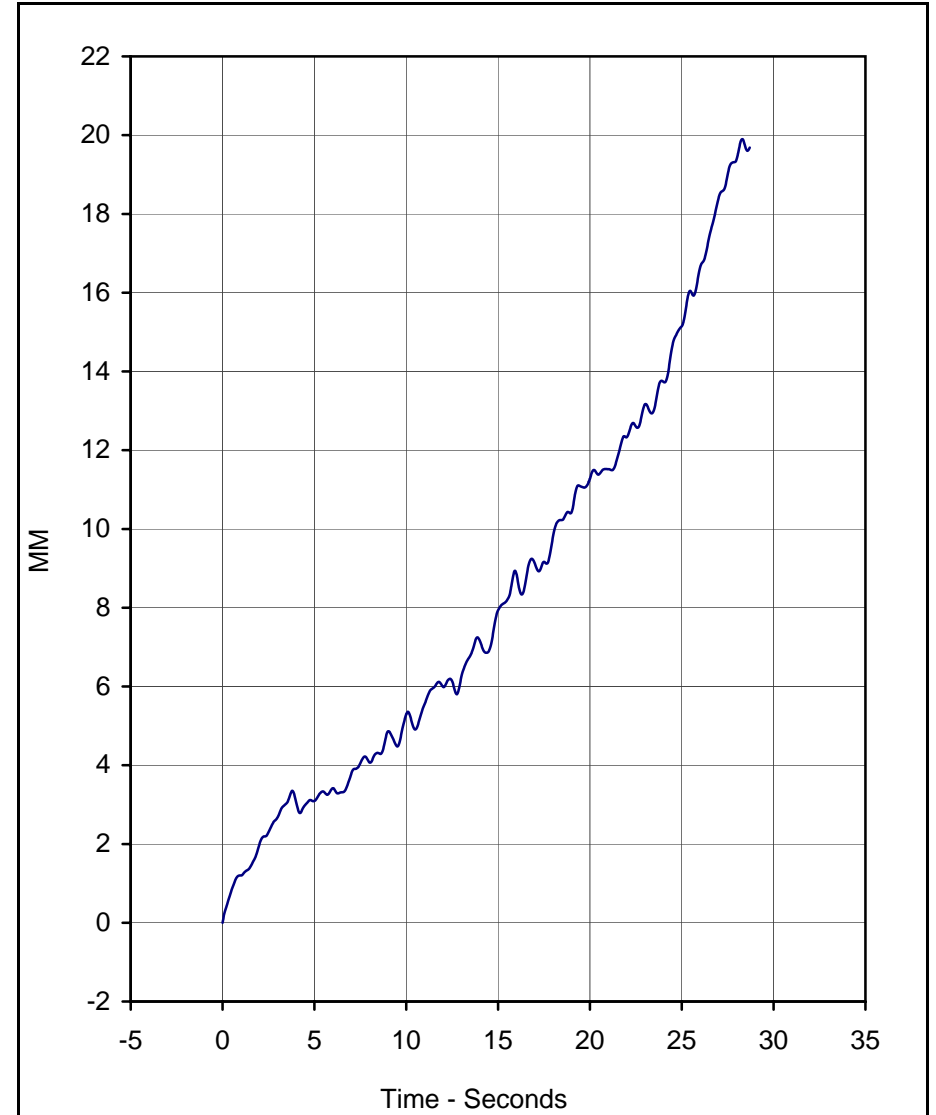
Load Direction: +45 / 90
 Test Date: 8/25/08

Units	Peak Force	Displacement	Filter (Hz)
Newtons	292.7	19.1	1

Units	Max	Time	Displ. Rate (mm/min.)	Filter (Hz)
MM	19.9	28.3	40.3	1
