REPORT NUMBER 401-STF-08-002

SAFETY COMPLIANCE TESTING FOR FMVSS NO. 401 TIRE PRESSURE MONITORING SYSTEMS

MITSUBISHI MOTORS CORPORATION
2008 MITSUBISHI LANCER
FOUR-DOOR PASSENGER CAR
NHTSA NO. C85603

FINAL REPORT

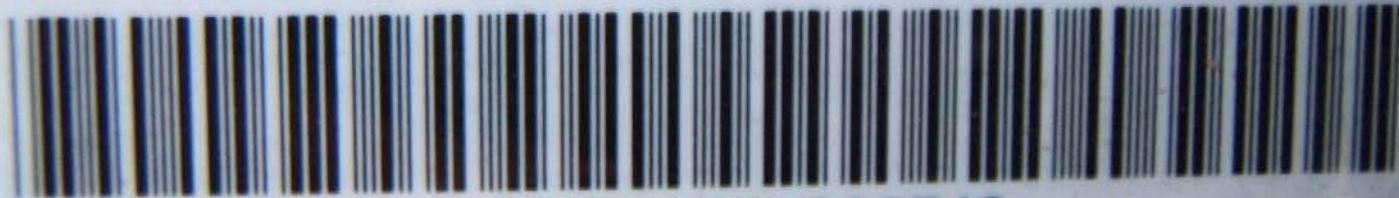
FIGURE 5.6
VEHICLE CERTIFICATION LABEL

MFD. BY MITSUBISHI MOTORS CORPORATION

GVWR 4079LBS/ 1850KG

GAWR FR 2227LBS/1010KG GAWR RR 2007LBS/ 910KG

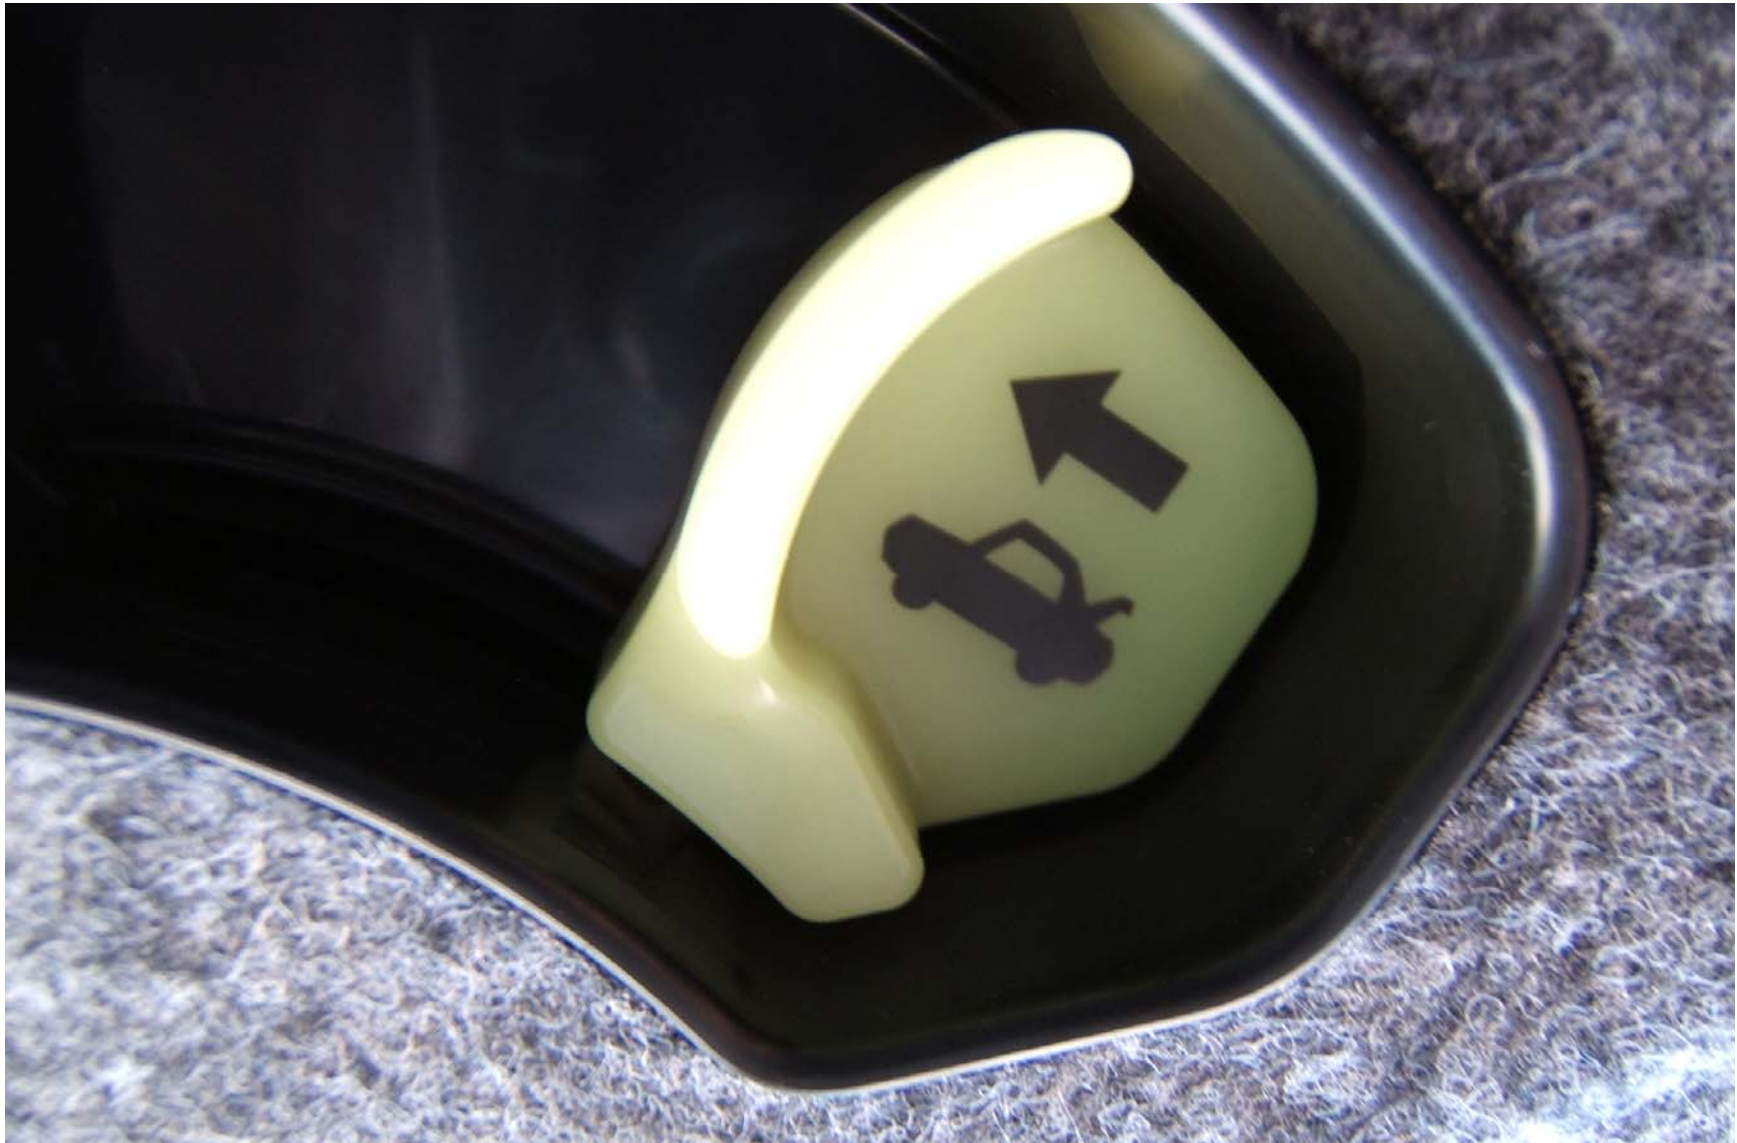
Method used to actuate interior trunk release: Rotating lever

FIGURE 5.8
VEHICLE TRUNK COMPARTMENT MANUAL RELEASE MECHANISM

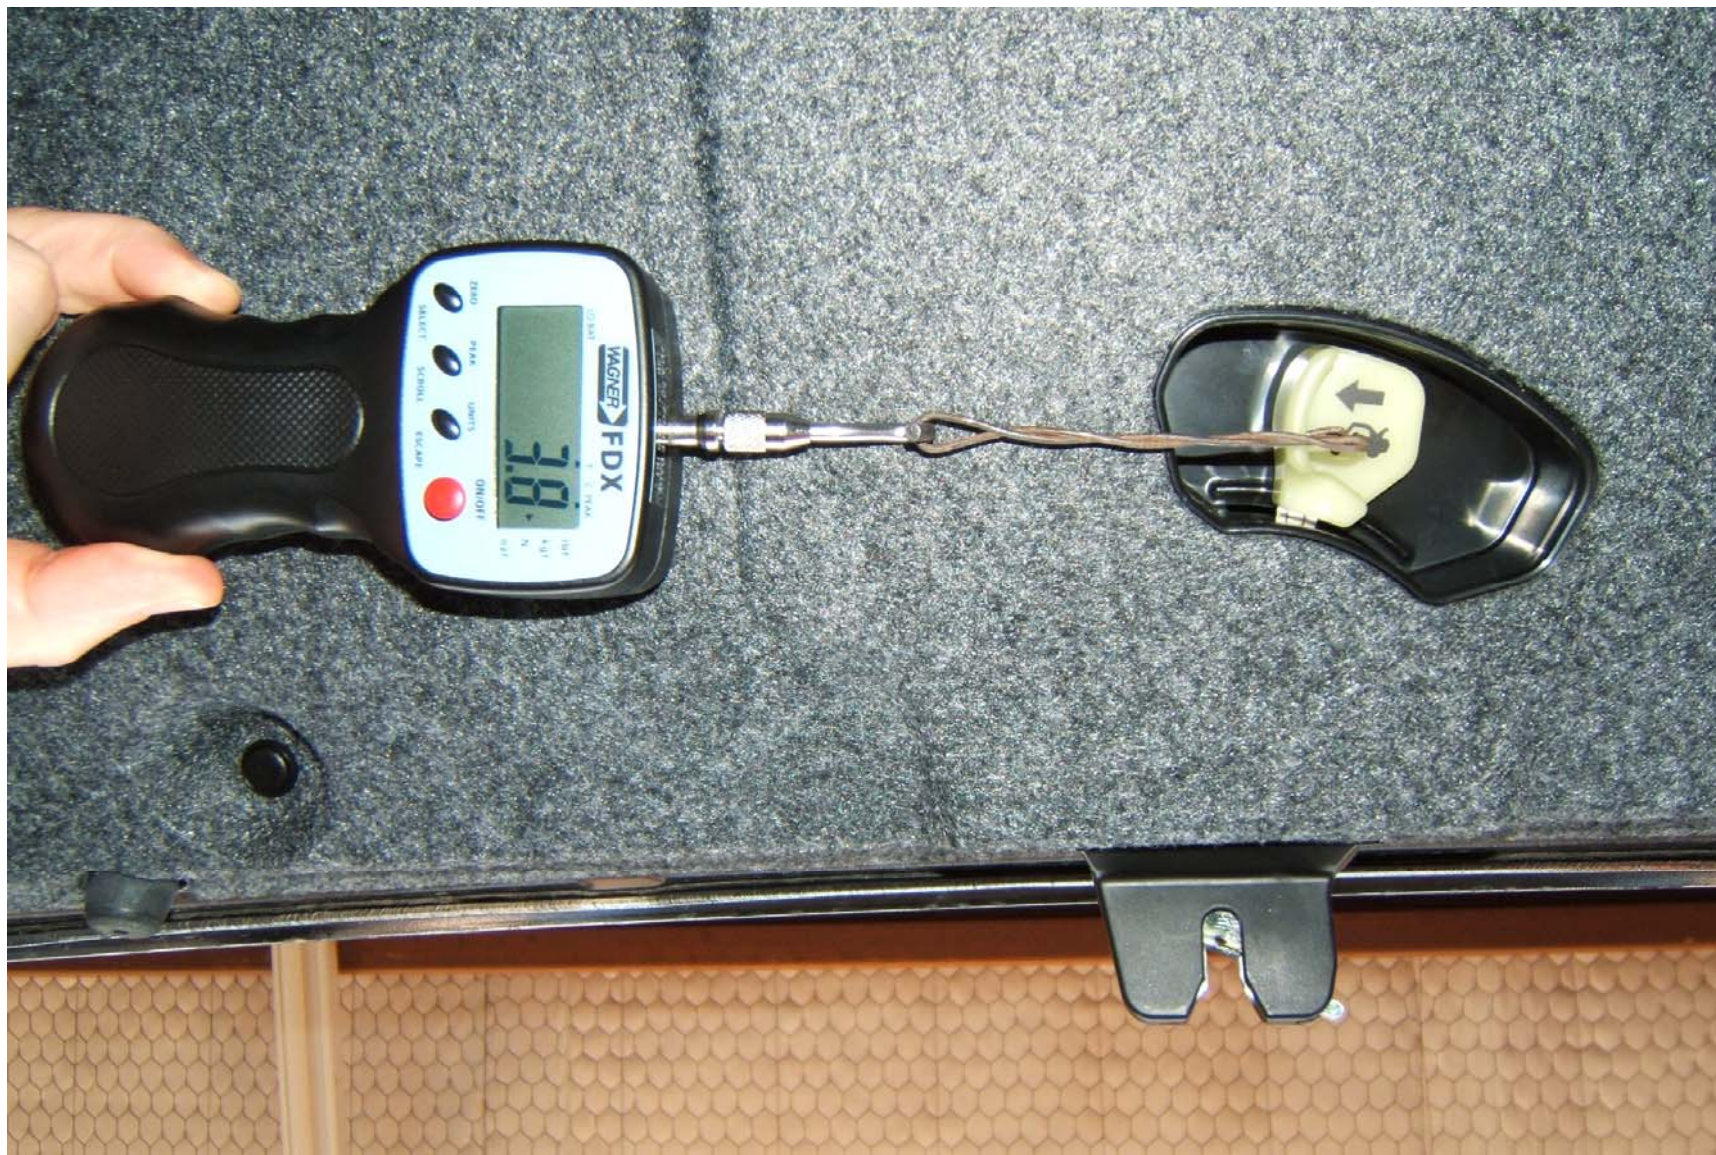
Vehicle Stationary (0 km/h)	Force in Newtons Required to Release Trunk Lid (no requirement)	Trunk Released from All Latching Positions	Pass/Fail
NO KEY IN IGNITION			
Attempt 1	3.6	Yes	Pass
Attempt 2	4.0	Yes	Pass
Attempt 3	4.0	Yes	Pass
Average	3.9		
ENGINE IDLING			
Attempt 1	3.6	Yes	Pass
Attempt 2	3.8	Yes	Pass
Attempt 3	3.4	Yes	Pass
Average	3.6

FIGURE 5.9
RELEASE MECHANISM WITH TEST EQUIPMENT ATTACHED

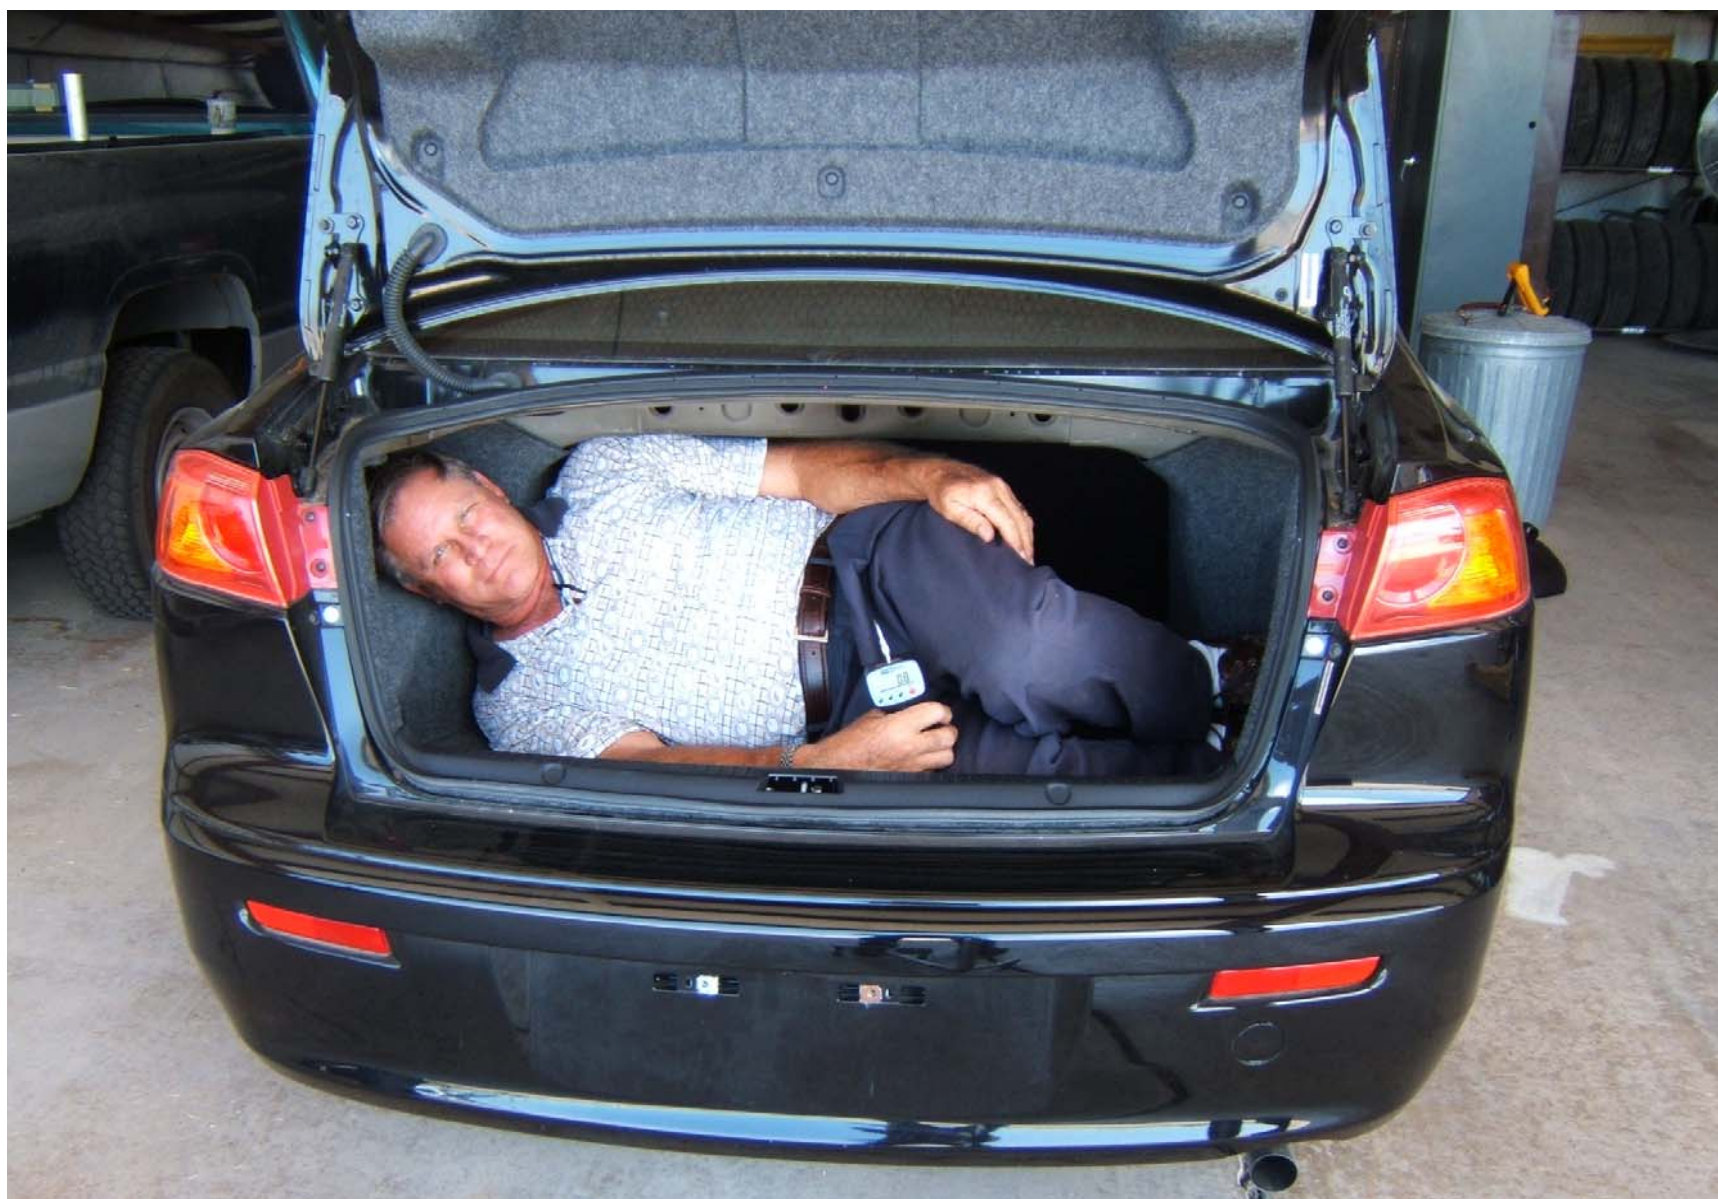
Size of occupant: 5' 10", large frame

FIGURE 5.10
TEST OBSERVER IN TRUNK COMPARTMENT
