**SAFETY COMPLIANCE TESTING FOR FMVSS 201  
Occupant Protection In Interior Impact  
Upper Interior Head Impact Protection**

**MITSUBISHI MOTORS NORTH AMERICA, INC.  
2008 Mitsubishi Galant, 4-Door Sedan  
NHTSA No. C85601**

**FINAL REPORT**

1. Report No. 201UI-MGA-08-05		2. Government Accession No.		3. Recipient's Catalog No.	
4. Title and Subtitle Final Report of FMVSS 201 Compliance Testing of a 2008 Mitsubishi Galant, 4-Door Sedan, NHTSA No. C85601				5. Report Date June 13, 2008

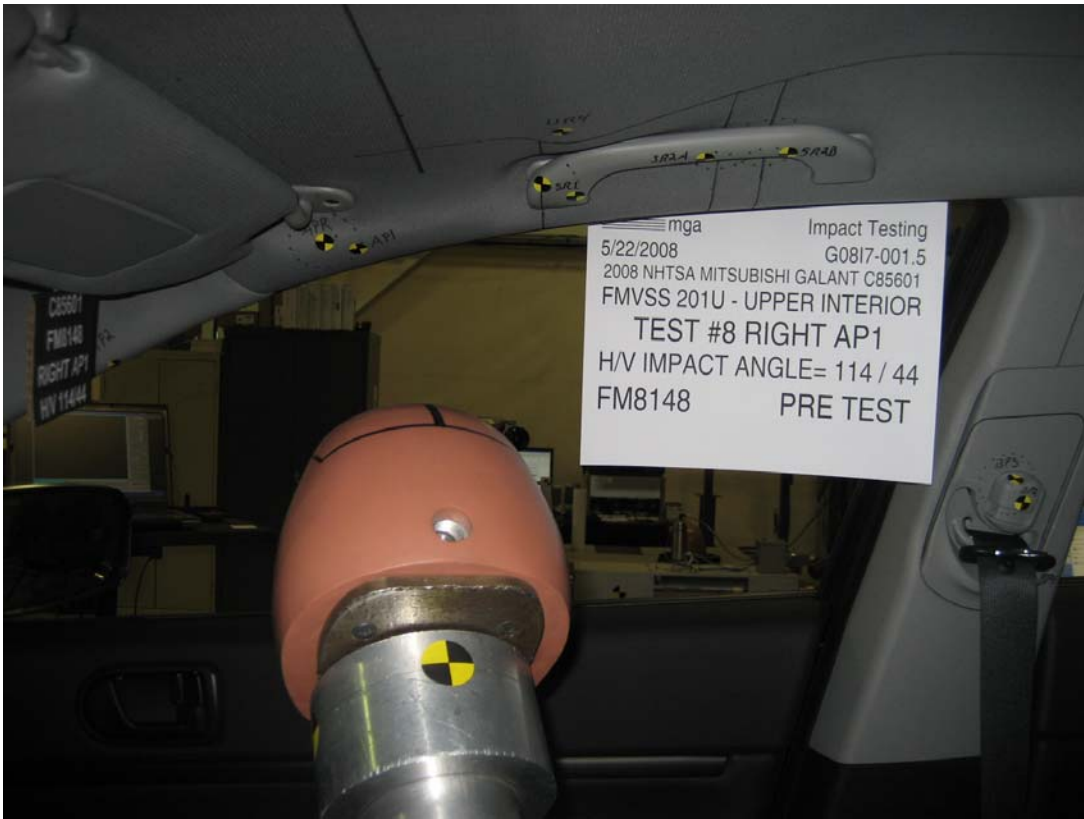
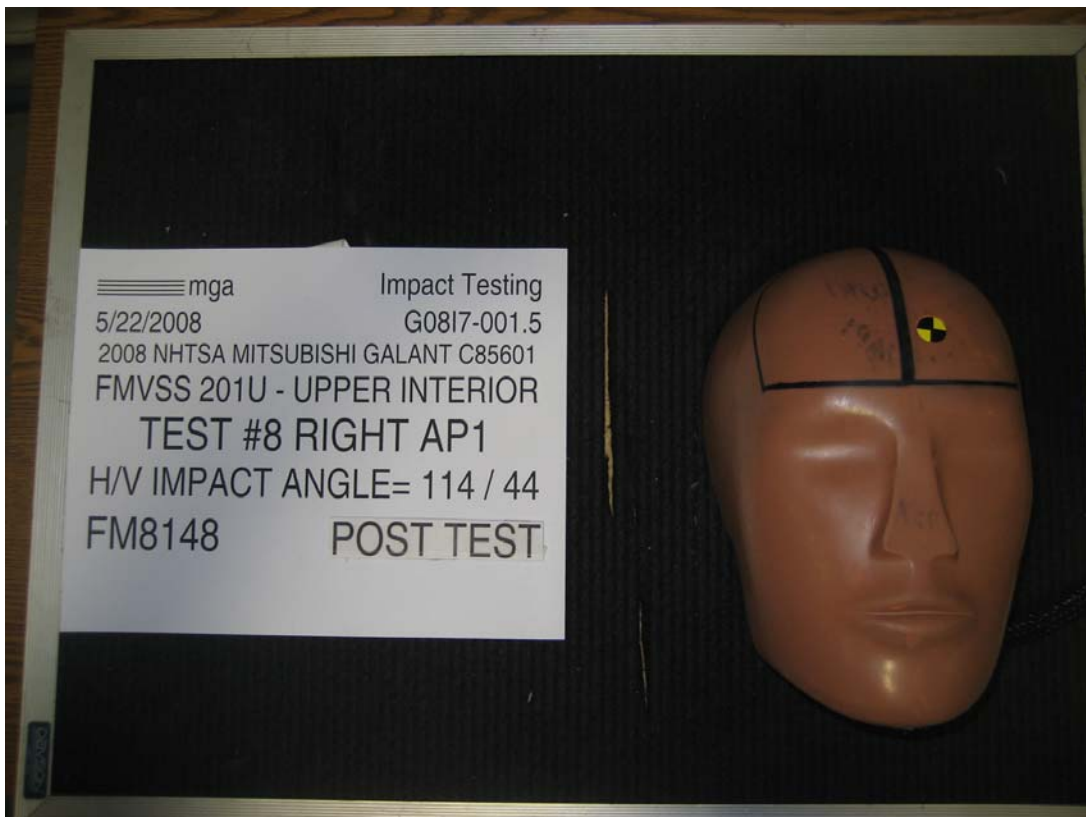
Test Number:#8  
Target (Vehicle Side): AP1Right      Temperature:22C  
MGA Test Reference No.:FM8148      Humidity:38%  
Approach Horizontal Angles:114°      Time of Test:2:05:20 PM  
Approach Vertical Angles:44°      FMH Serial No:[037]  
Additional Description:1 Relocation.

**REMARKS** (Summary of test, damage, non-compliance, invalid test, etc.):

No visible damage.

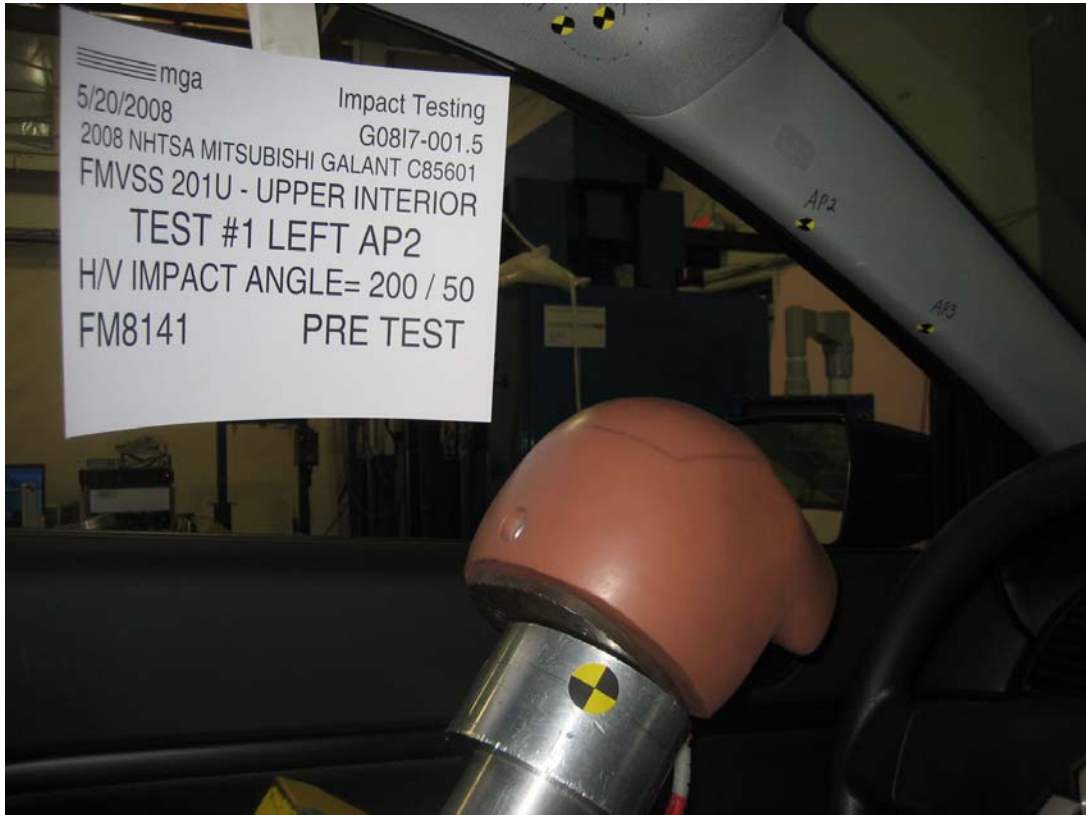
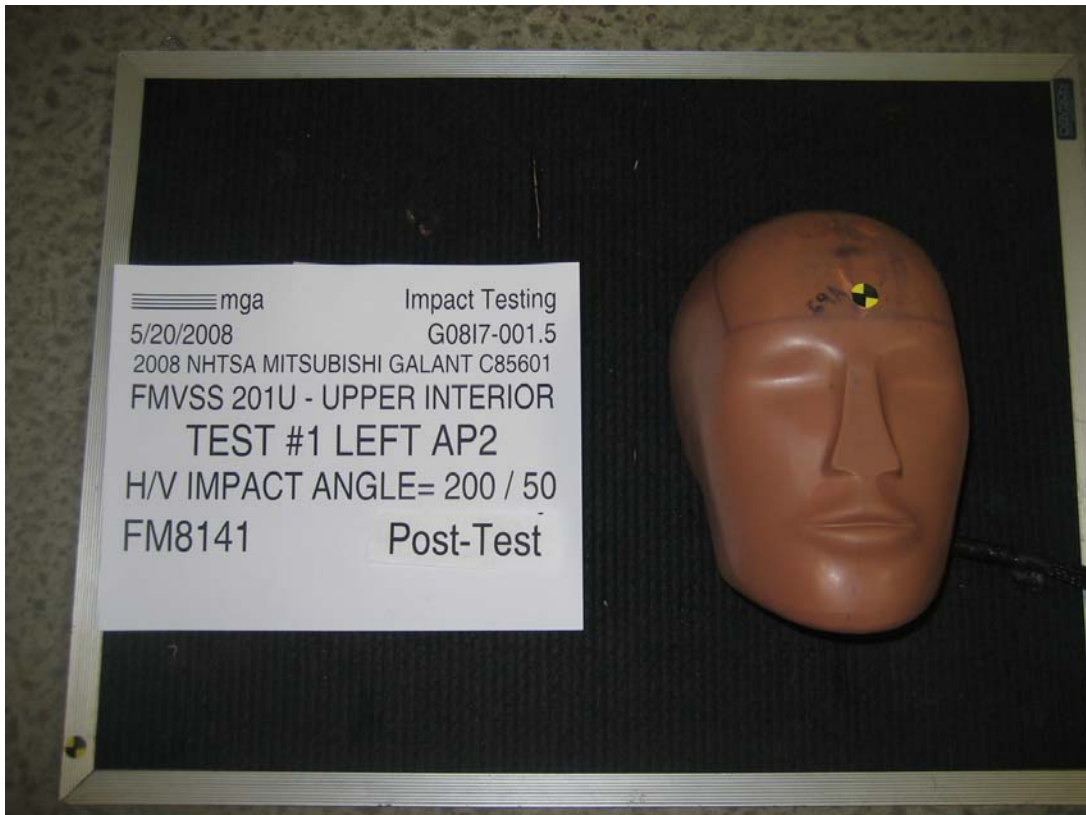
Test Number:#1  
 Target (Vehicle Side): AP2Left      Temperature:22C  
 MGA Test Reference No.:FM8141      Humidity:33%  
 Approach Horizontal Angles:200°      Time of Test:3:31:37 PM  
 Approach Vertical Angles:50°      FMH Serial No:[035]  
 Additional Description:

**REMARKS** (Summary of test, damage, non-compliance, invalid test, etc.):

No visible damage.

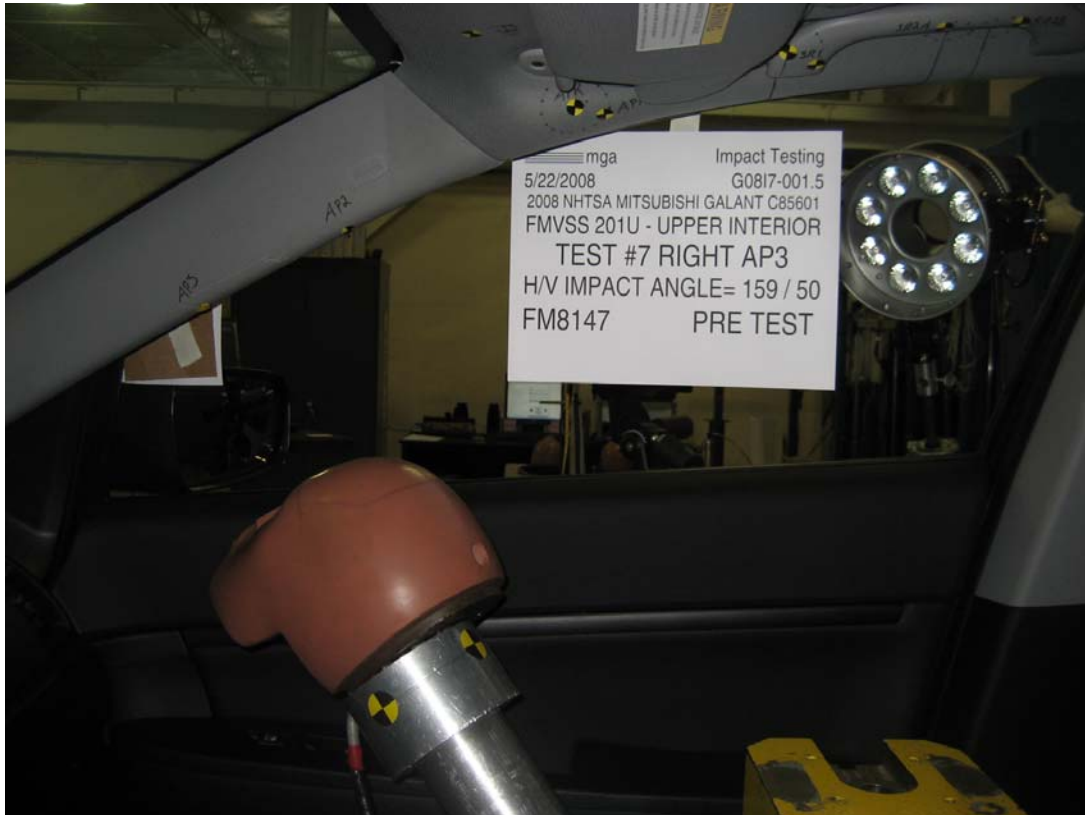
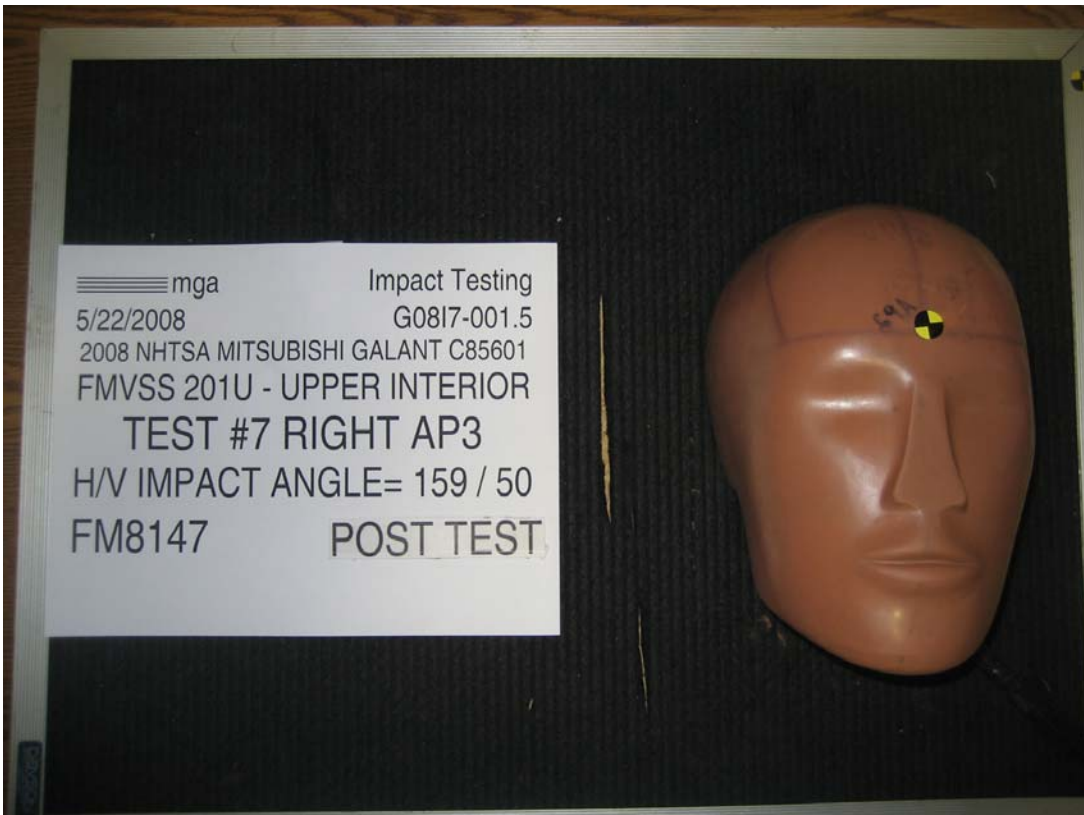
Test Number:#7  
Target (Vehicle Side): AP3Right      Temperature:22C  
MGA Test Reference No.:FM8147      Humidity:36%  
Approach Horizontal Angles:159°      Time of Test:11:14:01 AM  
Approach Vertical Angles:50°      FMH Serial No:[035]  
Additional Description:

**REMARKS** (Summary of test, damage, non-compliance, invalid test, etc.):

No visible damage.

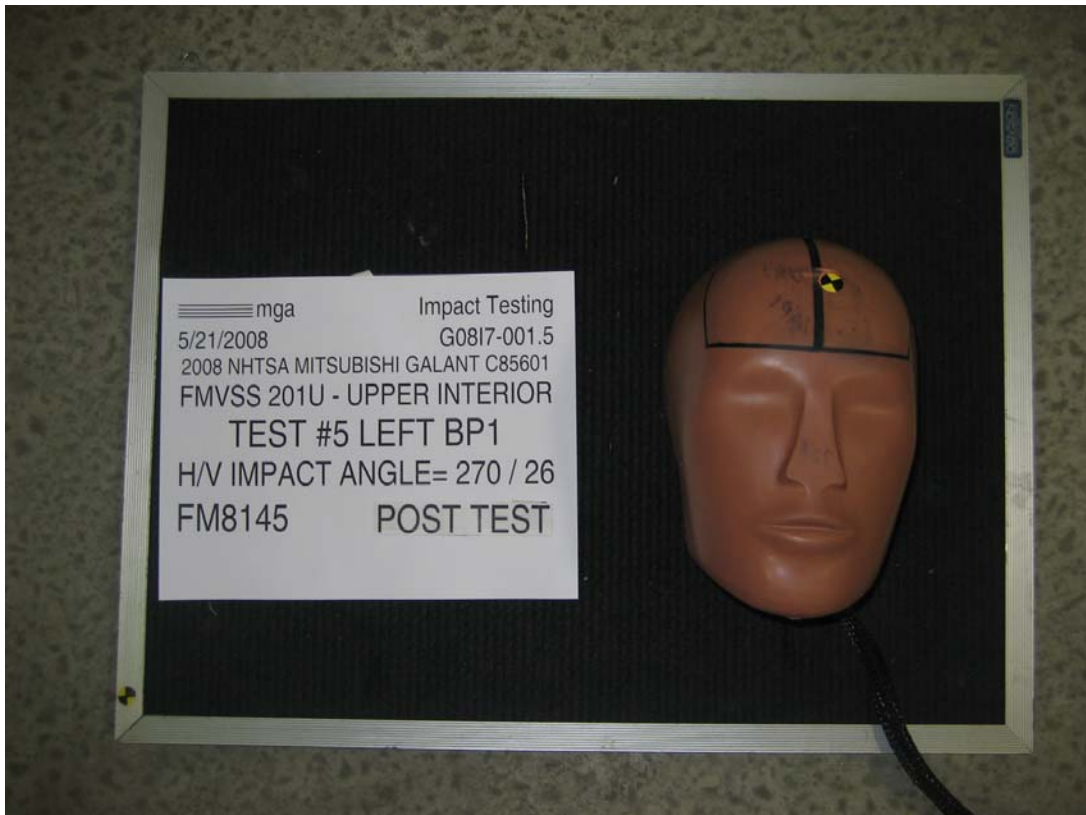
Test Number:#5  
Target (Vehicle Side): BP1Left      Temperature:22C  
MGA Test Reference No.:FM8145      Humidity:32%  
Approach Horizontal Angles:270°      Time of Test:11:31:07 AM  
Approach Vertical Angles:26°      FMH Serial No:[037]  
Additional Description:

**REMARKS** (Summary of test, damage, non-compliance, invalid test, etc.):

No visible damage.

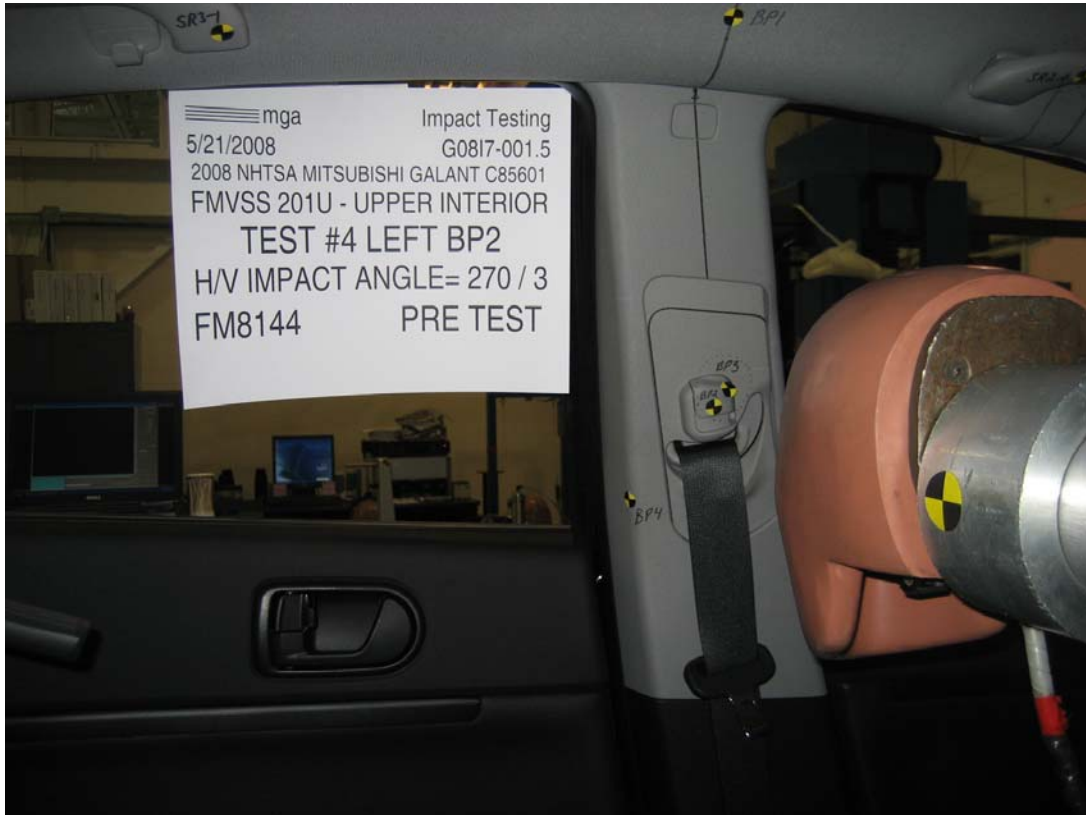
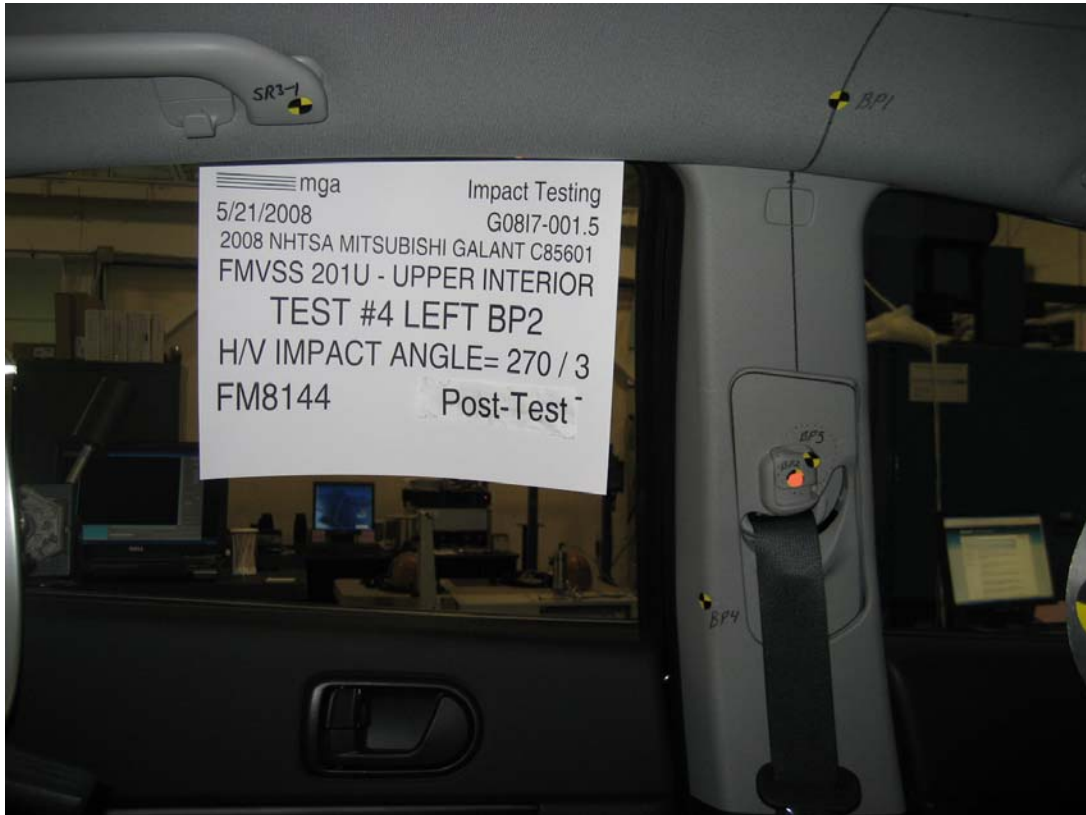
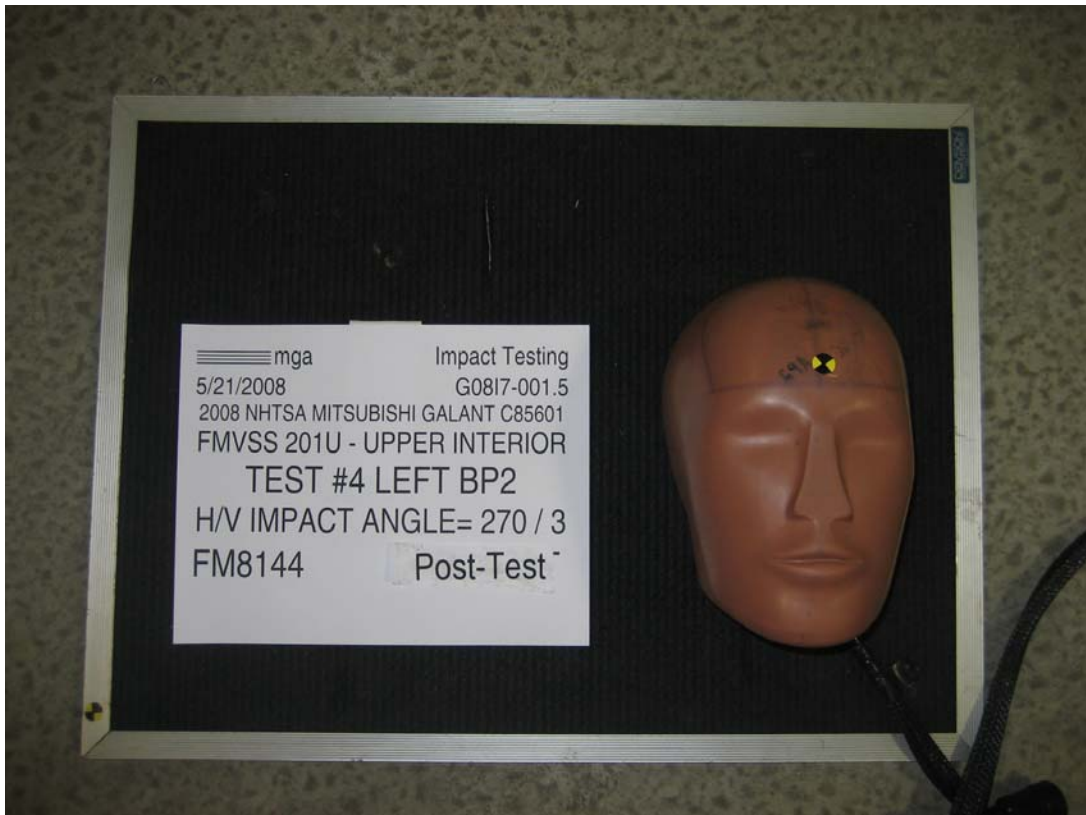
Test Number:#4  
 Target (Vehicle Side): BP2Left      Temperature:23C  
 MGA Test Reference No.:FM8144      Humidity:34%  
 Approach Horizontal Angles:270°      Time of Test:10:05:20 AM  
 Approach Vertical Angles:3°      FMH Serial No:[035]  
 Additional Description:

**REMARKS** (Summary of test, damage, non-compliance, invalid test, etc.):

No visible damage.

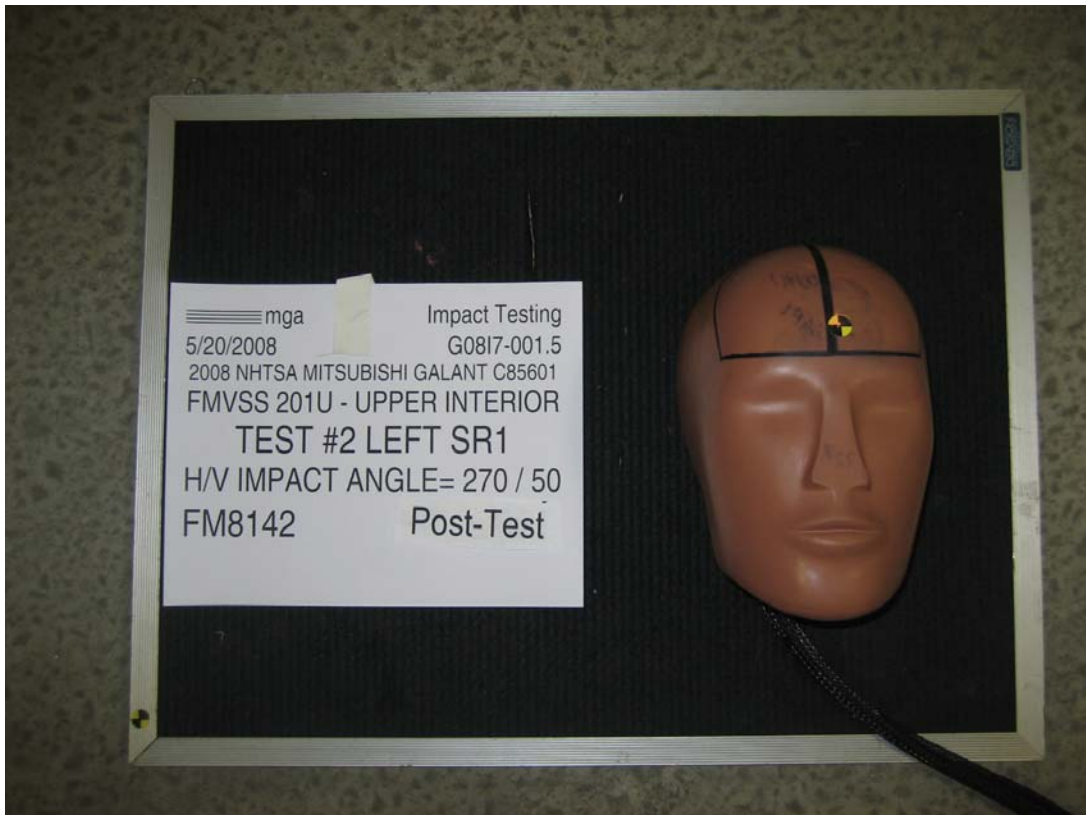
SR1 Left: Headliner deformation.

Test Number:#2  
 Target (Vehicle Side): SR1Left      Temperature:23C  
 MGA Test Reference No.:FM8142      Humidity:34%  
 Approach Horizontal Angles:270°      Time of Test:4:37:32 PM  
 Approach Vertical Angles:50°      FMH Serial No:[037]  
 Additional Description:1 Relocation

**REMARKS** (Summary of test, damage, non-compliance, invalid test, etc.):

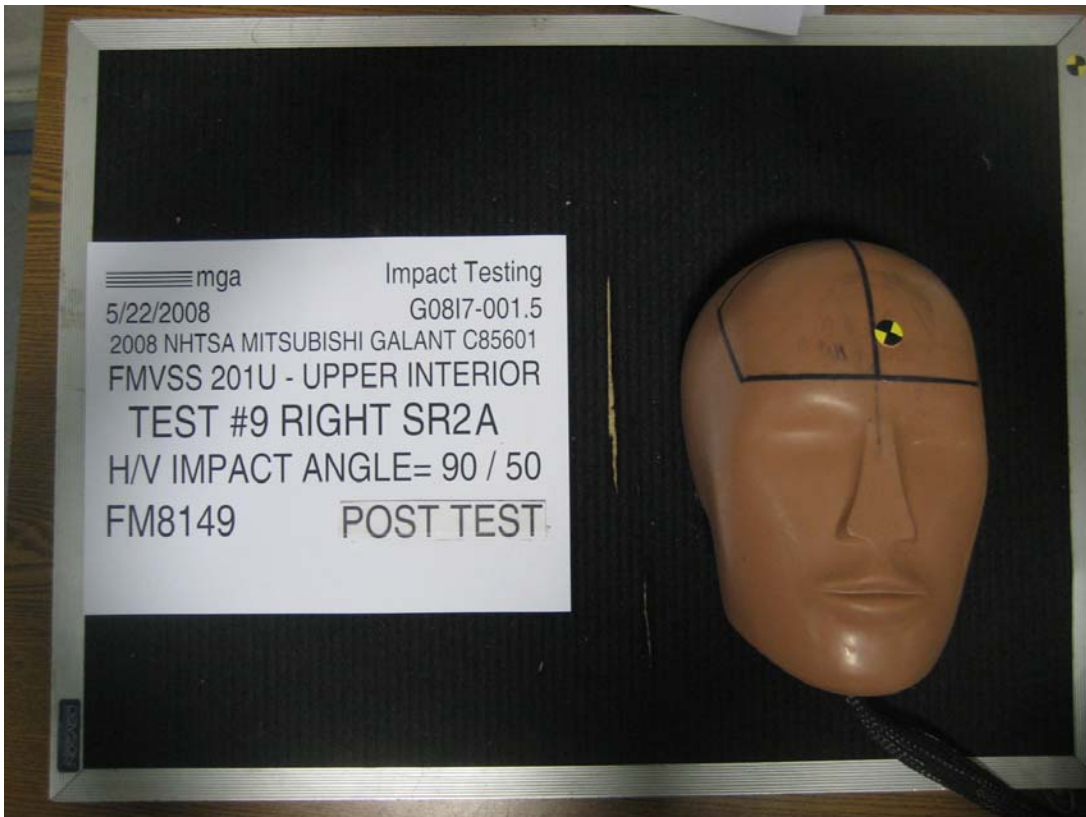
SR2A Right: Grab handle deformation.

Test Number:#9  
Target (Vehicle Side): SR2A Right      Temperature:22C  
MGA Test Reference No.:FM8149      Humidity:38%  
Approach Horizontal Angles:90°      Time of Test:3:11:15 PM  
Approach Vertical Angles:50°      FMH Serial No:[038]  
Additional Description:1 Relocation.

**REMARKS** (Summary of test, damage, non-compliance, invalid test, etc.):

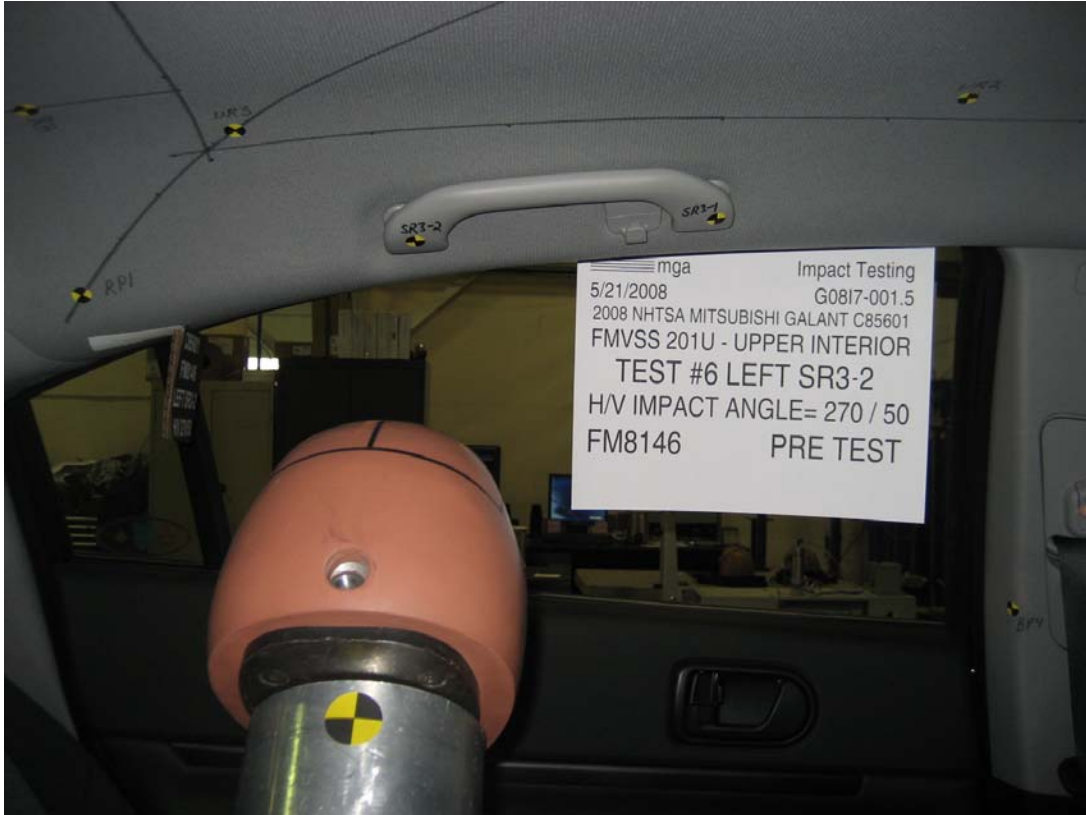
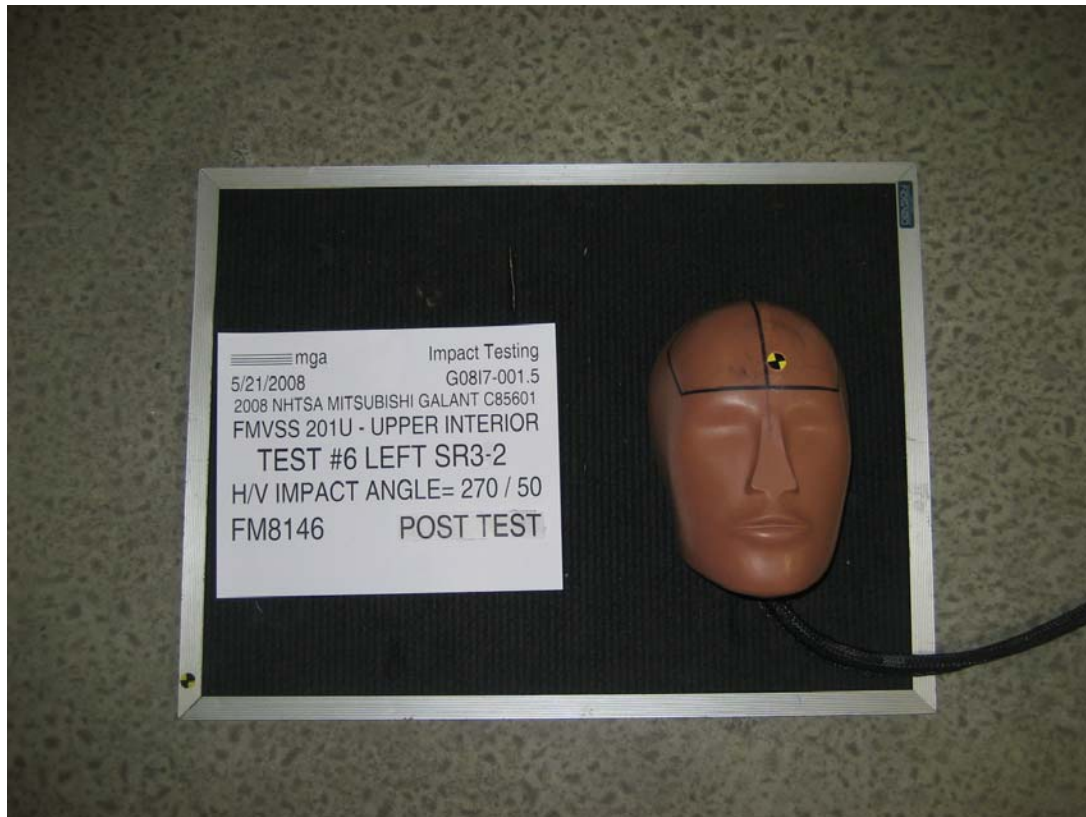
SR3-2 Left: Grab handle displacement.

Test Number:#6  
Target (Vehicle Side): SR3-2 Left      Temperature:23C  
MGA Test Reference No.:FM8146      Humidity:33%  
Approach Horizontal Angles:270°      Time of Test:1:57:49 PM  
Approach Vertical Angles:50°      FMH Serial No:[038]  
Additional Description:

**REMARKS** (Summary of test, damage, non-compliance, invalid test, etc.):

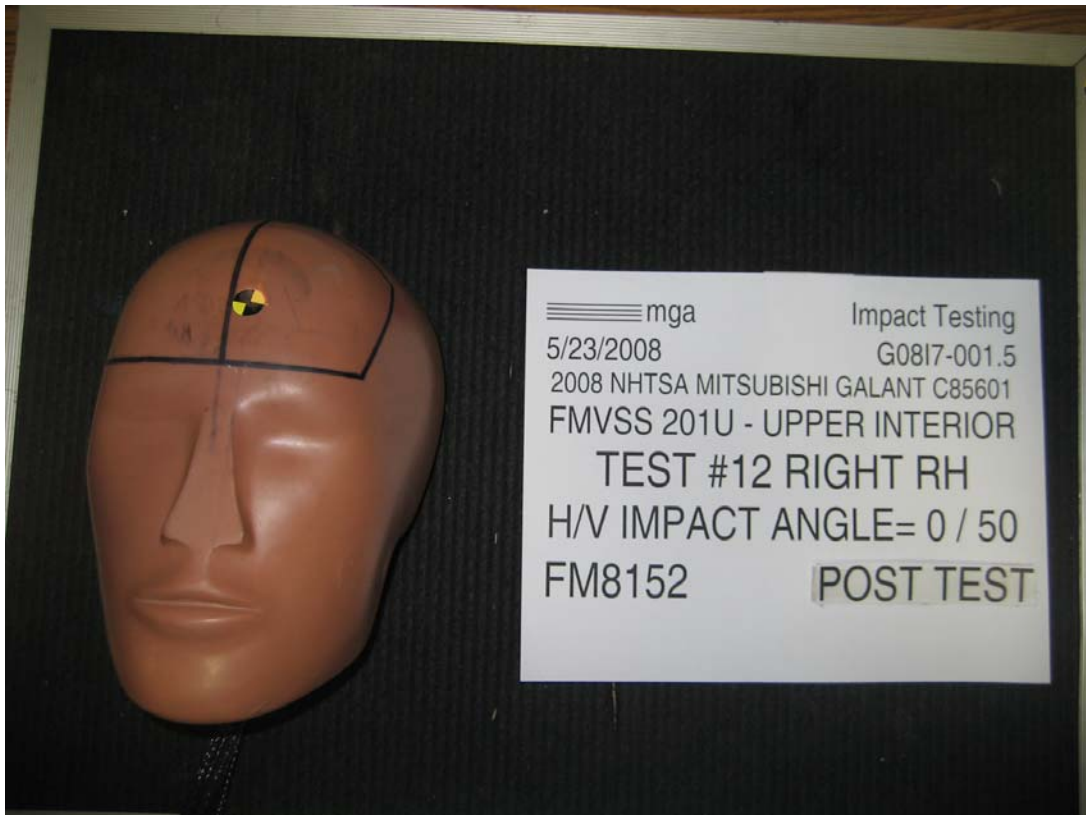
**GENERAL TEST PARAMETERS:**      Test Number:#12  
 Target (Vehicle Side): RH Right      Temperature:22C  
 MGA Test Reference No.:FM8152      Humidity:40%  
 Approach Horizontal Angles: 0°      Time of Test:11:05:58 AM  
 Approach Vertical Angles:50°      FMH Serial No:[038]  
 Additional Description:

**REMARKS** (Summary of test, damage, non-compliance, invalid test, etc.):

No visible damage.

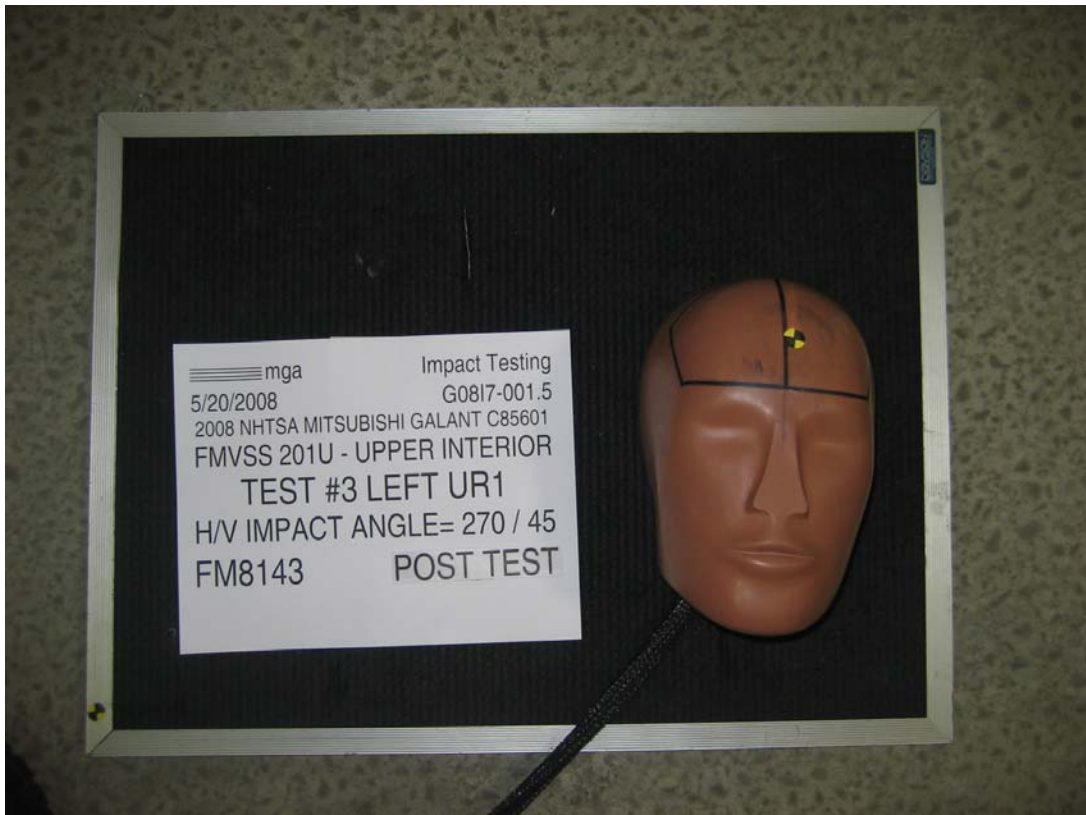
**GENERAL TEST PARAMETERS:**      Test Number:#3  
 Target (Vehicle Side): UR1Left      Temperature:23C  
 MGA Test Reference No.:FM8143      Humidity:34%  
 Approach Horizontal Angles:270°      Time of Test:5:18:40 PM  
 Approach Vertical Angles:45°      FMH Serial No:[038]  
 Additional Description:@ Rear SR2A

**REMARKS** (Summary of test, damage, non-compliance, invalid test, etc.):

No visible damage.

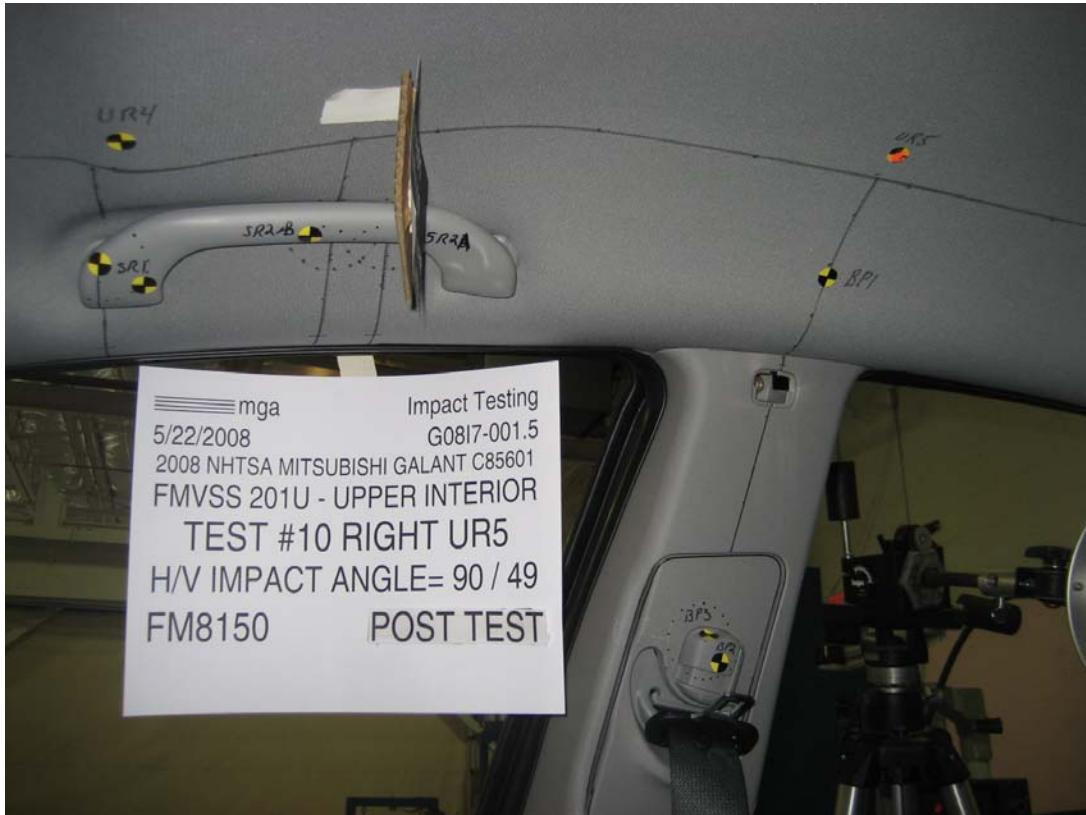
**GENERAL TEST PARAMETERS:**      Test Number:#10  
Target (Vehicle Side): UR5Right      Temperature:22C  
MGA Test Reference No.:FM8150      Humidity:39%  
Approach Horizontal Angles:90°      Time of Test:5:00:44 PM  
Approach Vertical Angles:49°      FMH Serial No:[035]  
Additional Description:@ BPR

**REMARKS** (Summary of test, damage, non-compliance, invalid test, etc.):

No visible damage.

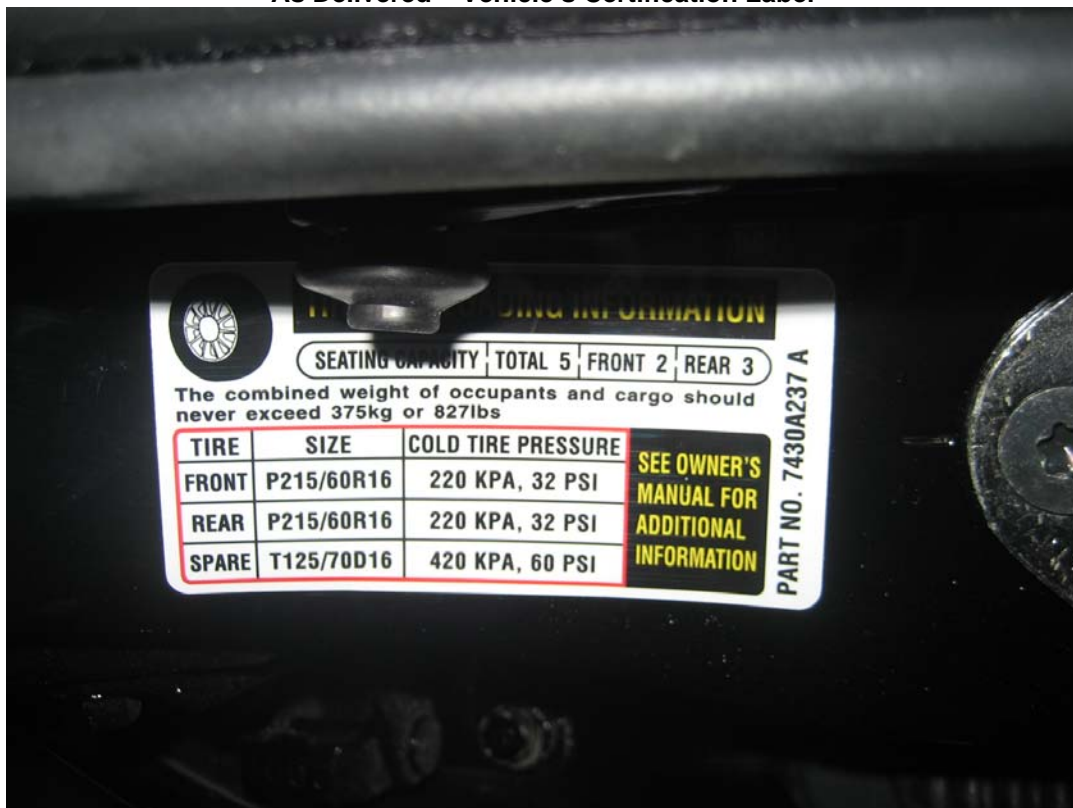
As Delivered – Vehicle’s Tire Information Label

**SEATING CAPACITY** TOTAL 5 FRONT 2 REAR 3

The combined weight of occupants and cargo should never exceed 375kg or 827lbs
