FINAL REPORT NUMBER 201UI-MGA-08-08

**SAFETY COMPLIANCE TESTING FOR FMVSS 201
Occupant Protection In Interior Impact
Upper Interior Head Impact Protection**

**HONDA DE MEXICO SA, DE CV
2008 Honda CRV, 4-Door MPV
NHTSA No. C85307**

**MGA RESEARCH CORPORATION
446 Executive Drive
Troy, Michigan 48083**

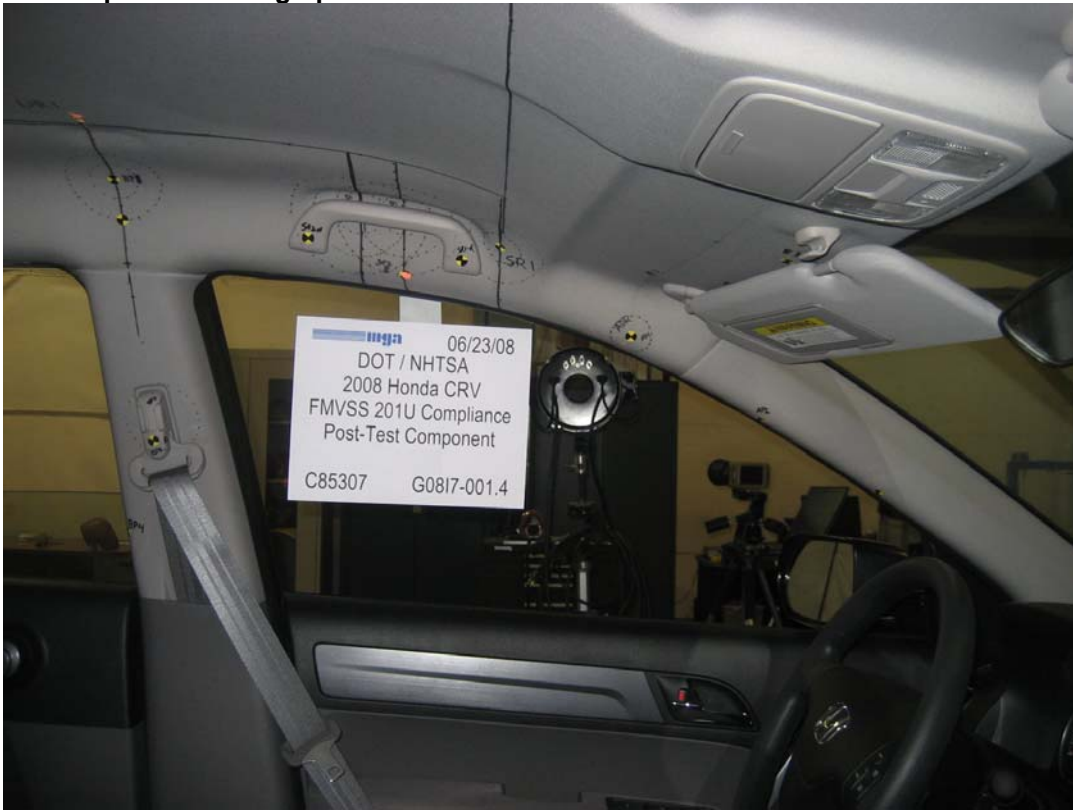
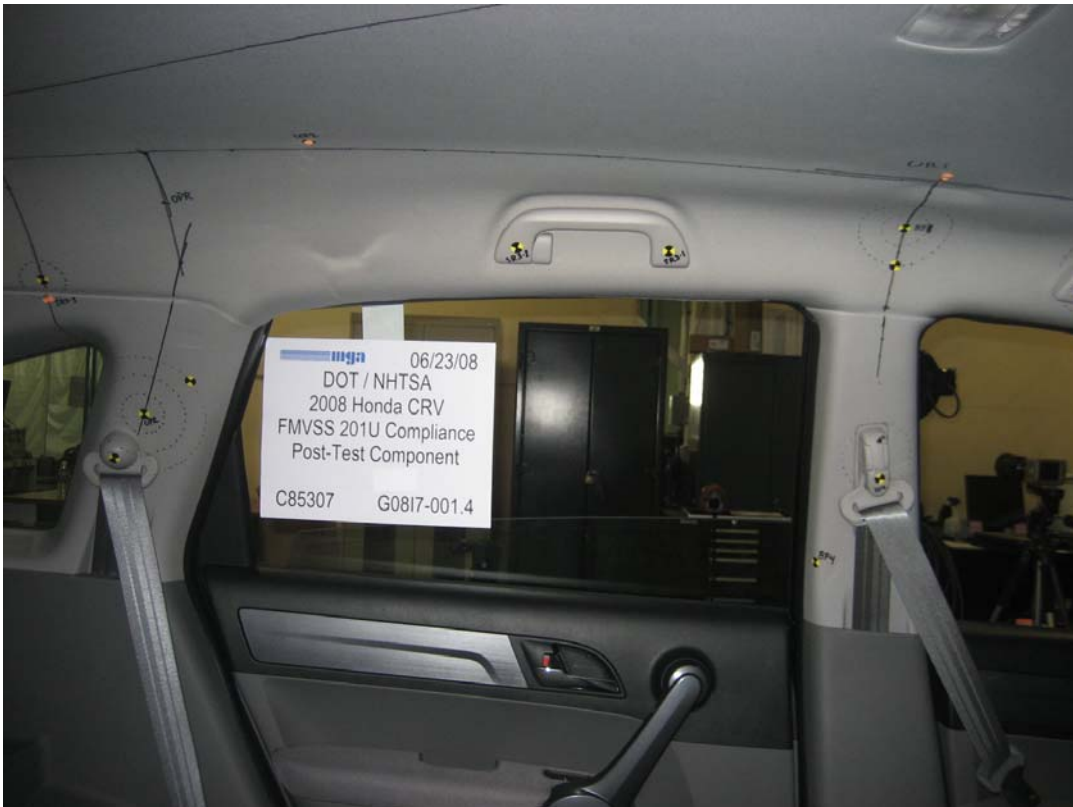
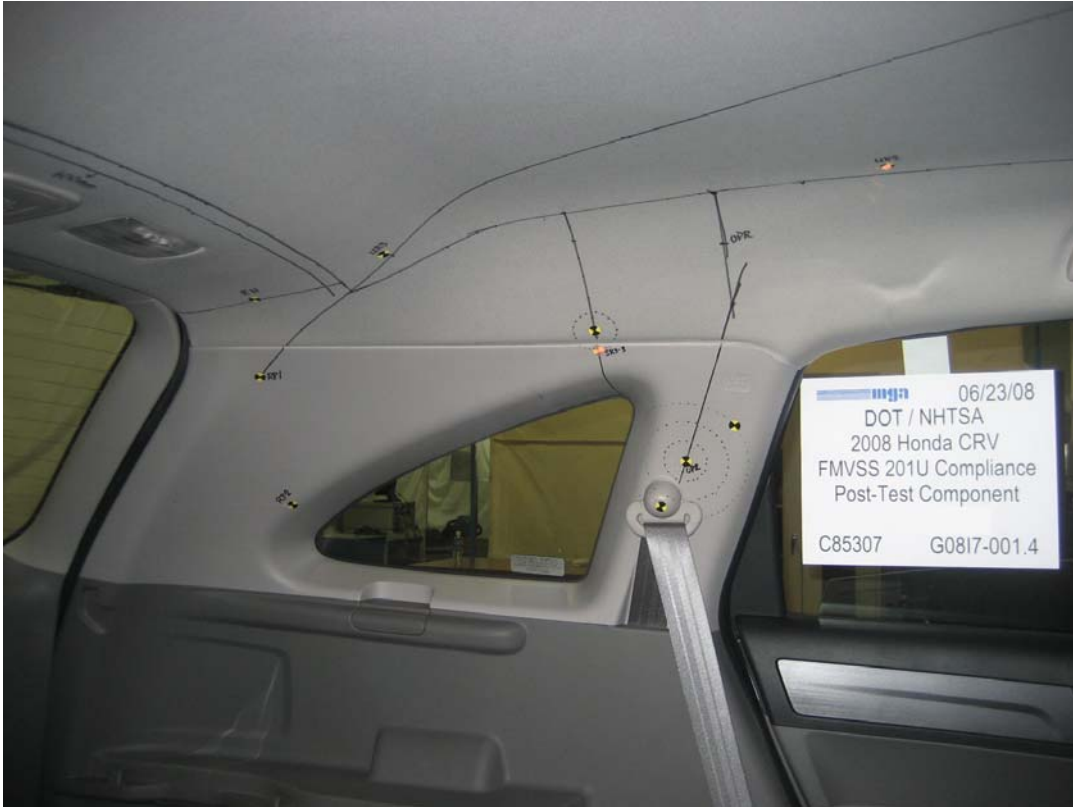
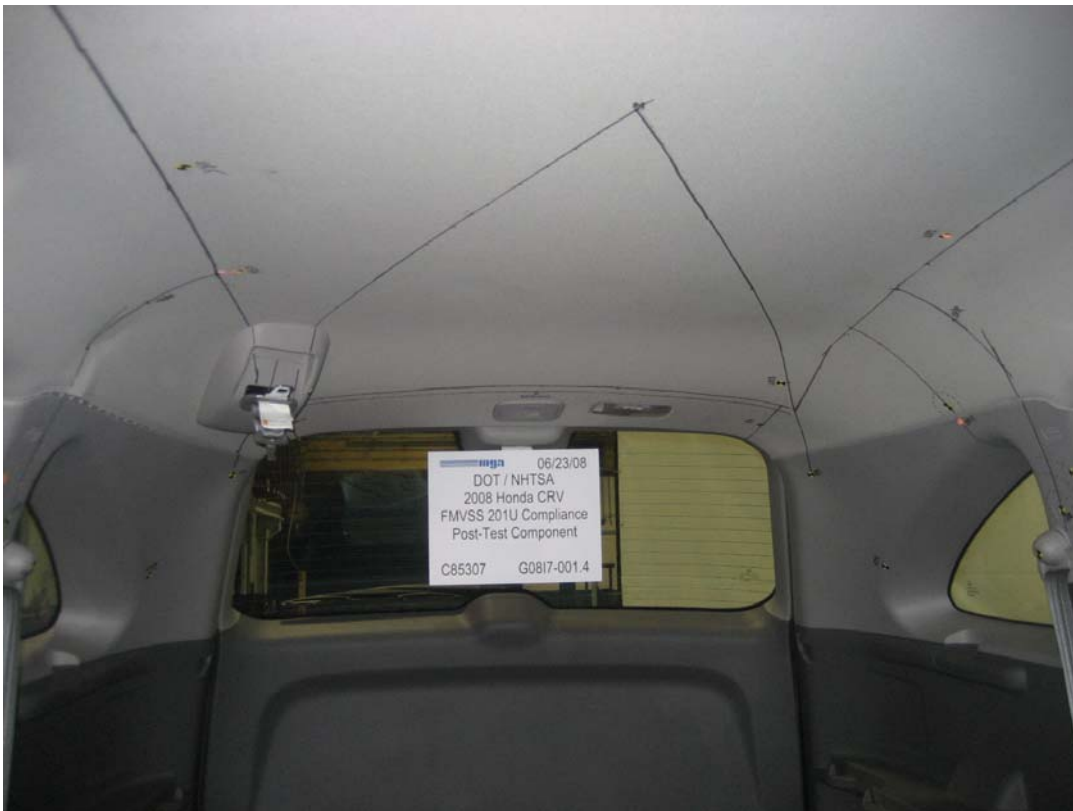
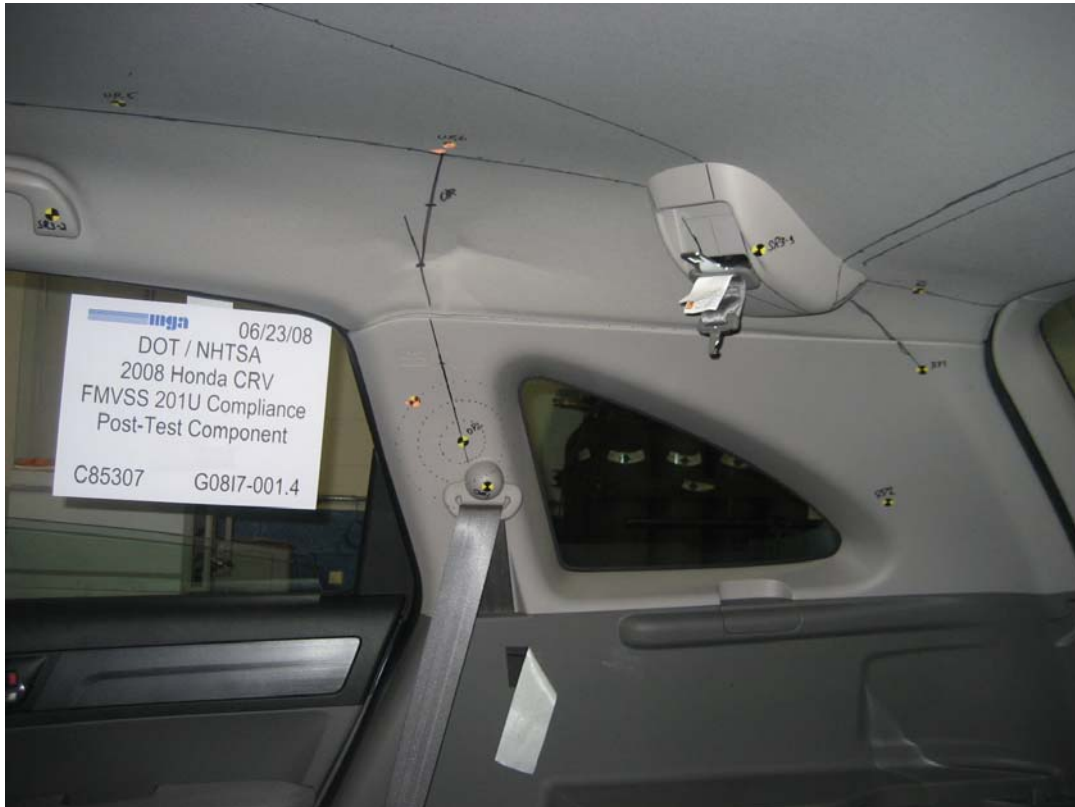
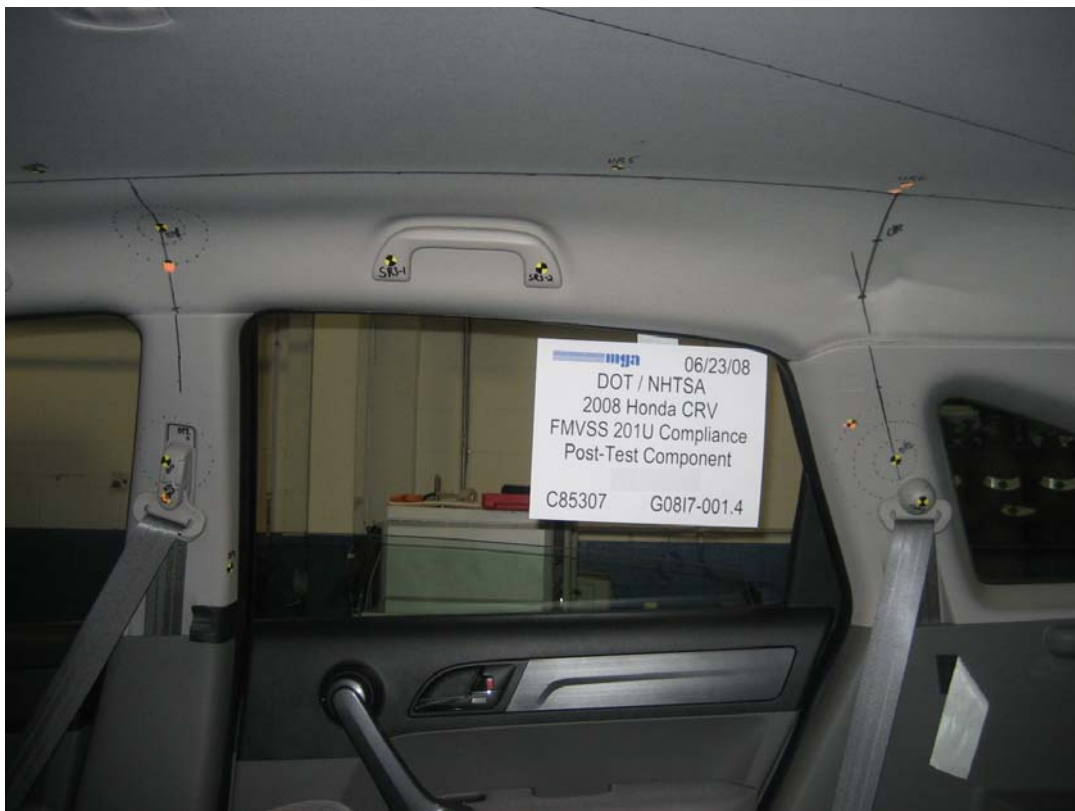
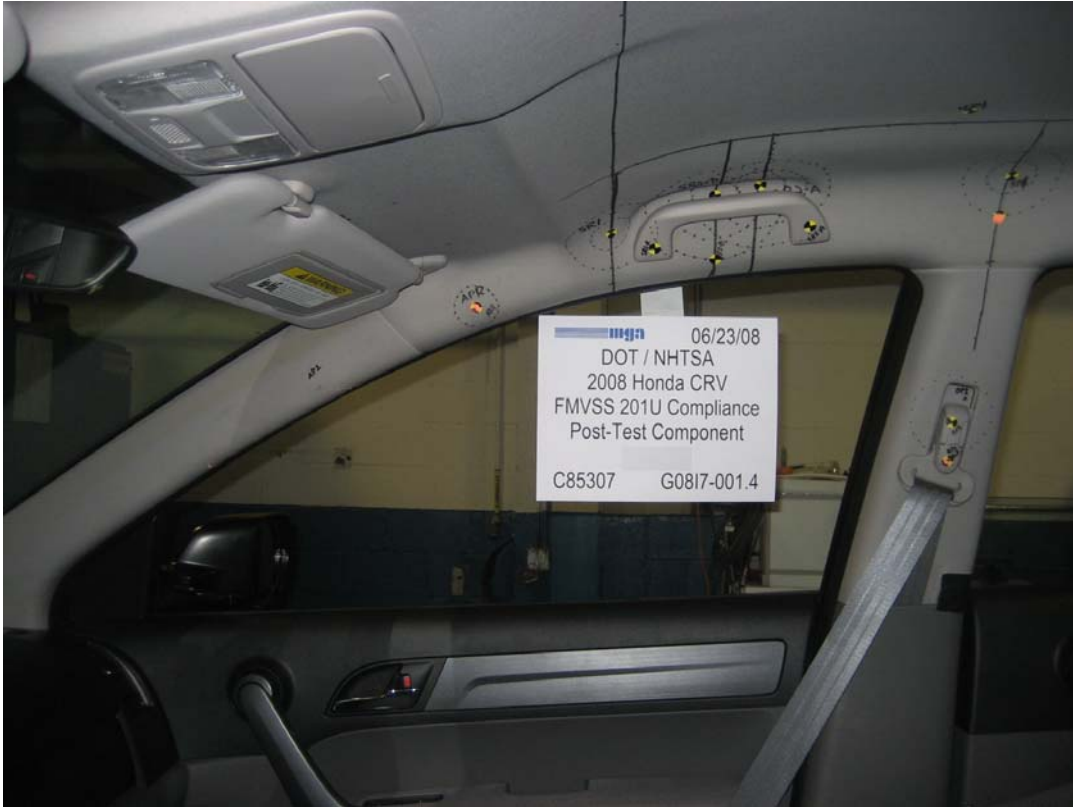
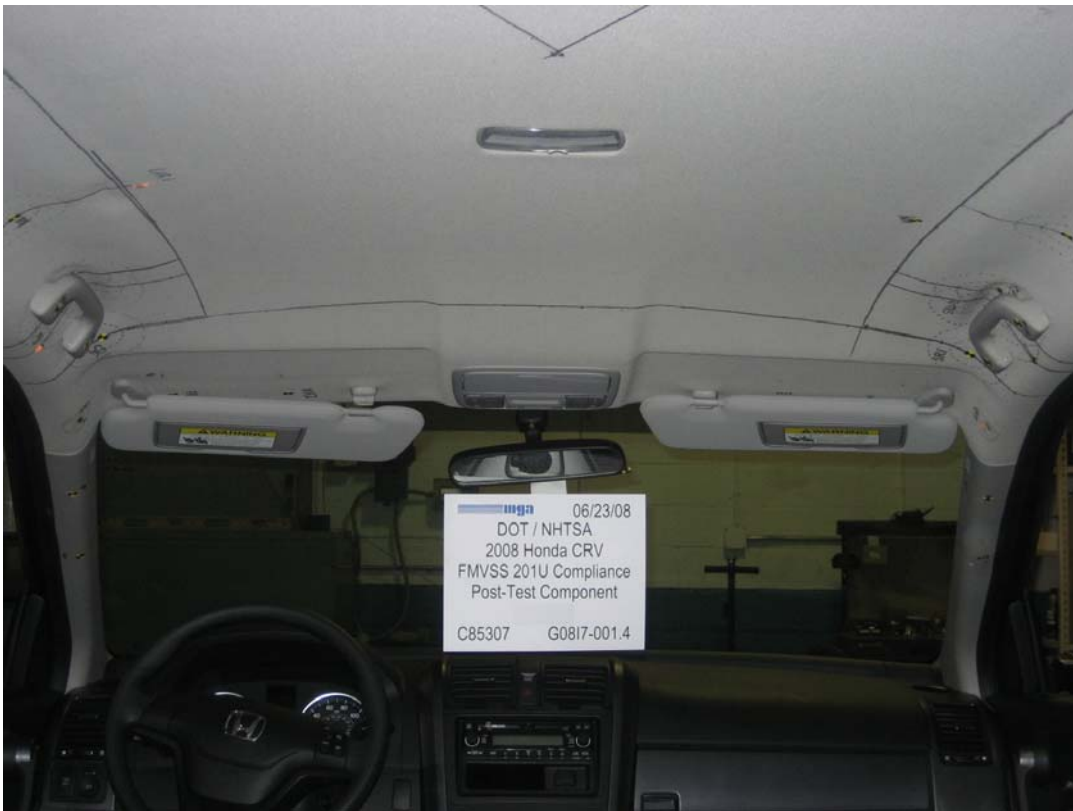
Post-Test Component Photographs

UR1 Left: Headliner deformation. Dent on roof exterior.

UR2 Left: Headliner deformation.

UR6 Right: Headliner deformation.

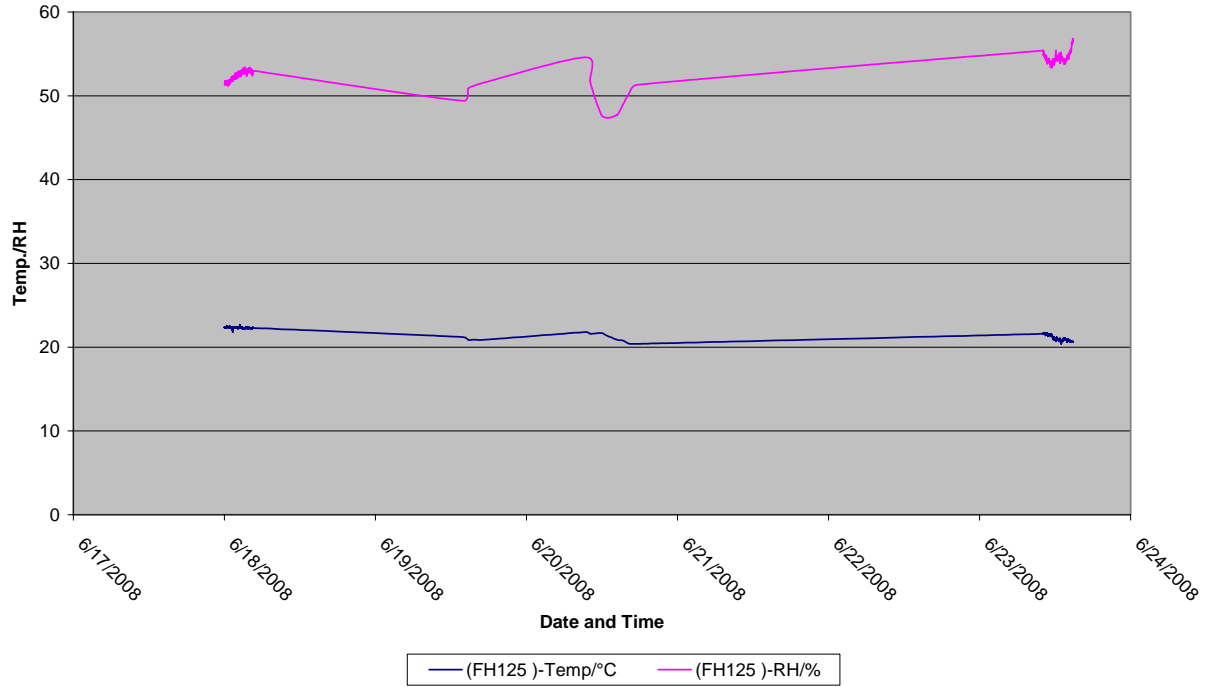
Appendix A – Temperature Trace

Temperature Recording
2008 Honda CR-V, NHTSA No. C85307
June 18, 2008 to June 23, 2008
