REPORT NUMBER: 201UI-CAL-09-04

**SAFETY COMPLIANCE TESTING FOR FMVSS 201  
OCCUPANT PROTECTION IN INTERIOR IMPACT  
UPPER INTERIOR HEAD IMPACT PROTECTION**

**NISSAN MOTOR COMPANY, LTD.  
2009 NISSAN MURANO**

NHTSA NUMBER: C95204

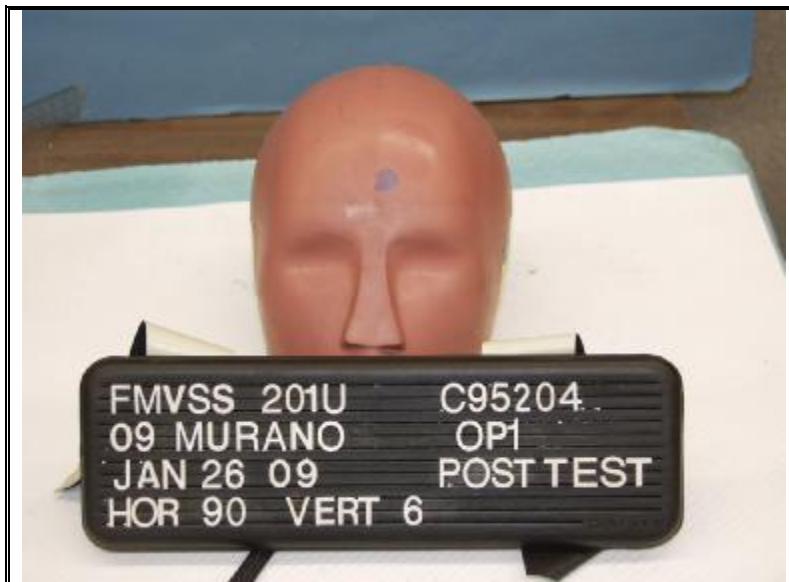
POST-IMPACT OP1 HEADFORM

Test Number:	01
Test Date:	01/26/09
Target Location:	OTHER PILLAR
Target Code:	OP1
Horizontal Impact Angle:	90°
Vertical Impact Angle:	6°
Ambient Temperature:	21°C
Relative Humidity:	13
Time of Impact:	9:00
Headform Number:	1142

Impact Point Description (from lower midpoint on midsagittal line)					
On Centerline	6	<input type="checkbox"/>	mm right	<input checked="" type="checkbox"/>	mm left
On Centerline	10				mm up

Free Motion HIC	514.8
HIC(d)	554.8
Impact Velocity (kph)	23.54
HIC T1 (msec)	1.7
HIC T2 (msec)	11.1

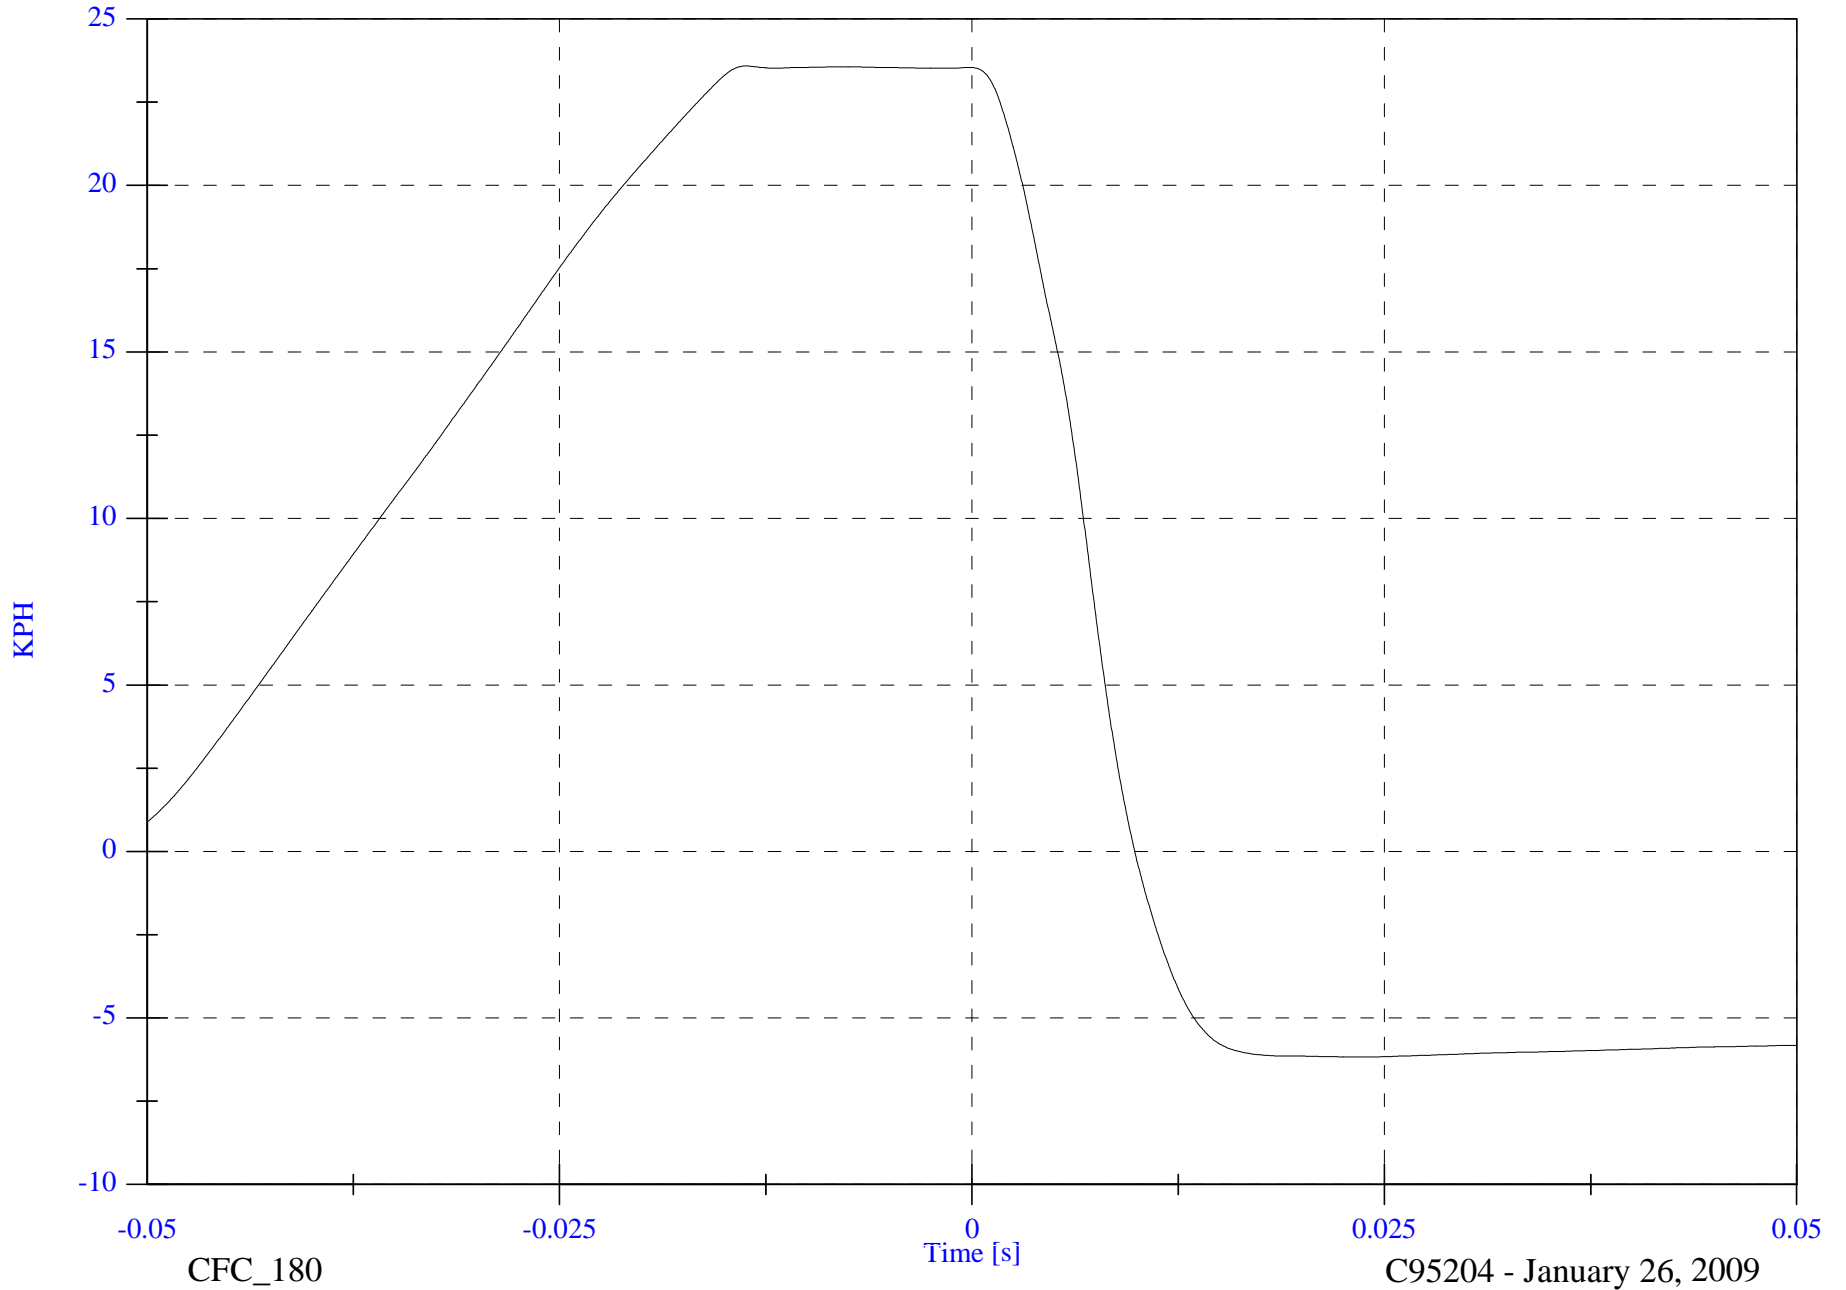
C95204 PASSENGER SIDE OP1 IMPACT PLOT #5

FMVSS 201U 09 Nissan Murano

Max: 23.6 [KPH] at -0.014 [s]

Min: -6.2 [KPH] at 0.024 [s]

### Headform Velocity

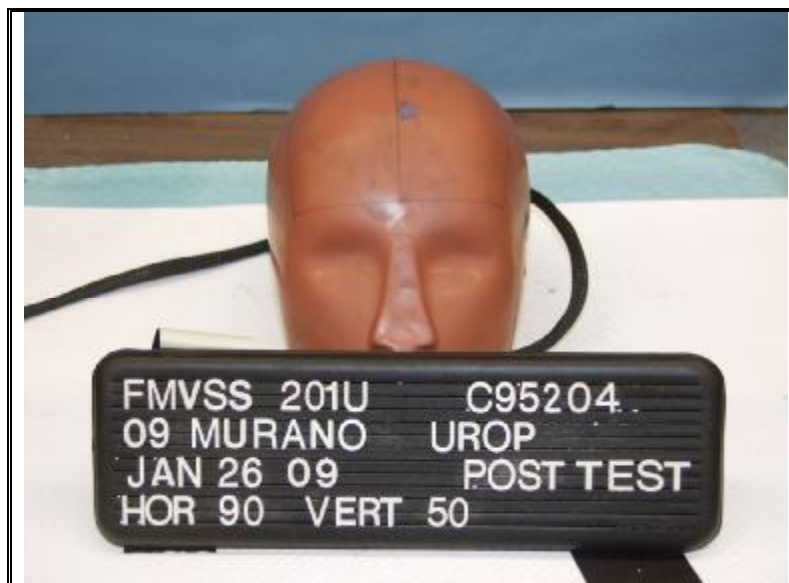
POST-IMPACT UROP HEADFORM

Test Number:	02
Test Date:	01/26/09
Target Location:	UPPER ROOF
Target Code:	UROP
Horizontal Impact Angle:	90°
Vertical Impact Angle:	50°
Ambient Temperature:	21°C
Relative Humidity:	13
Time of Impact:	9:30
Headform Number:	0355

Impact Point Description (from lower midpoint on midsagittal line)			
On Centerline	5	<input type="checkbox"/>	mm right <input checked="" type="checkbox"/> mm left
On Centerline	47		mm up

Free Motion HIC	616.6
HIC(d)	631.6
Impact Velocity (kph)	23.70
HIC T1 (msec)	3.7
HIC T2 (msec)	12.8

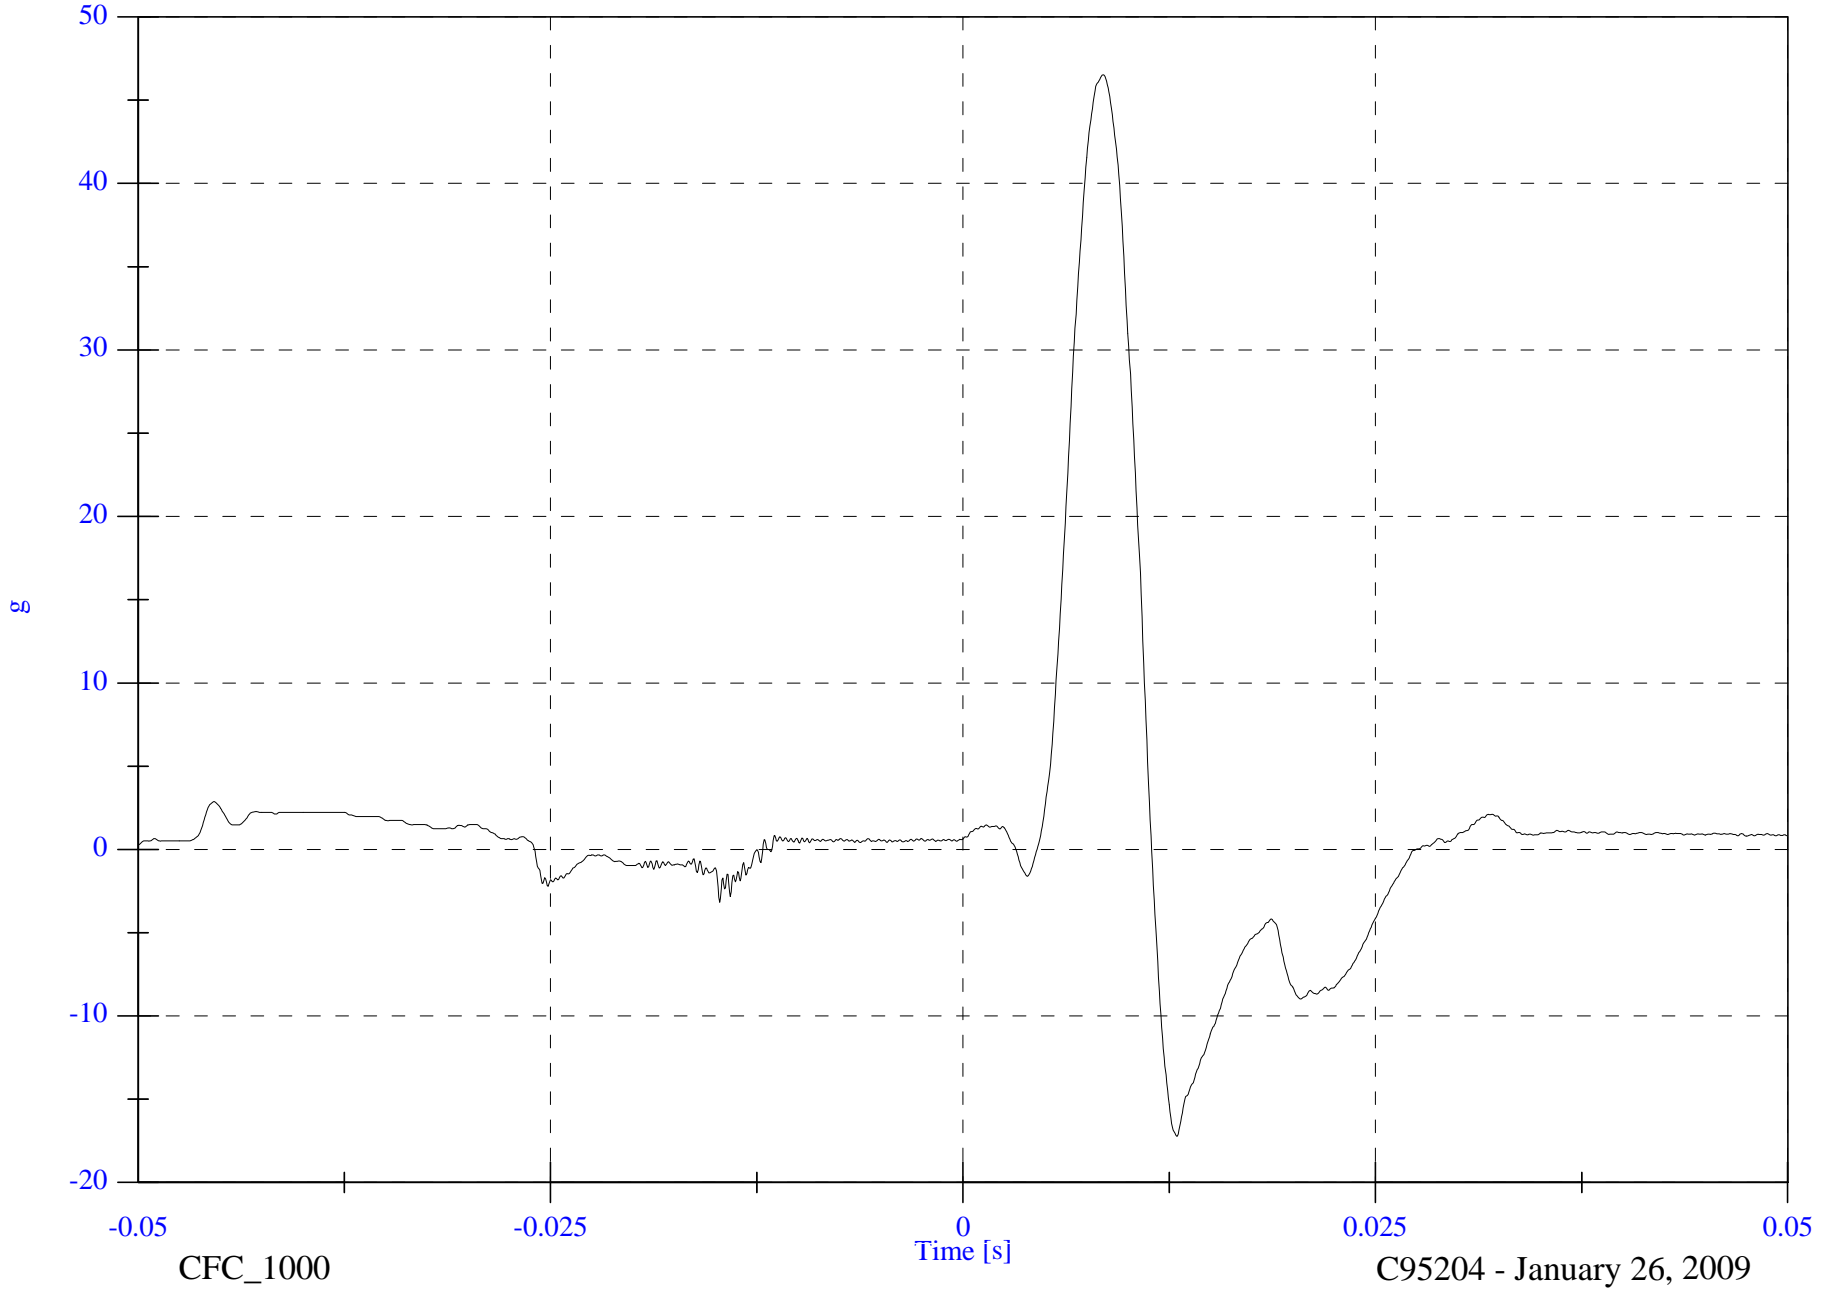
C95204 PASSENGER SIDE UROP IMPACT PLOT #4

Min: 0.5 [g] at -0.013 [s]

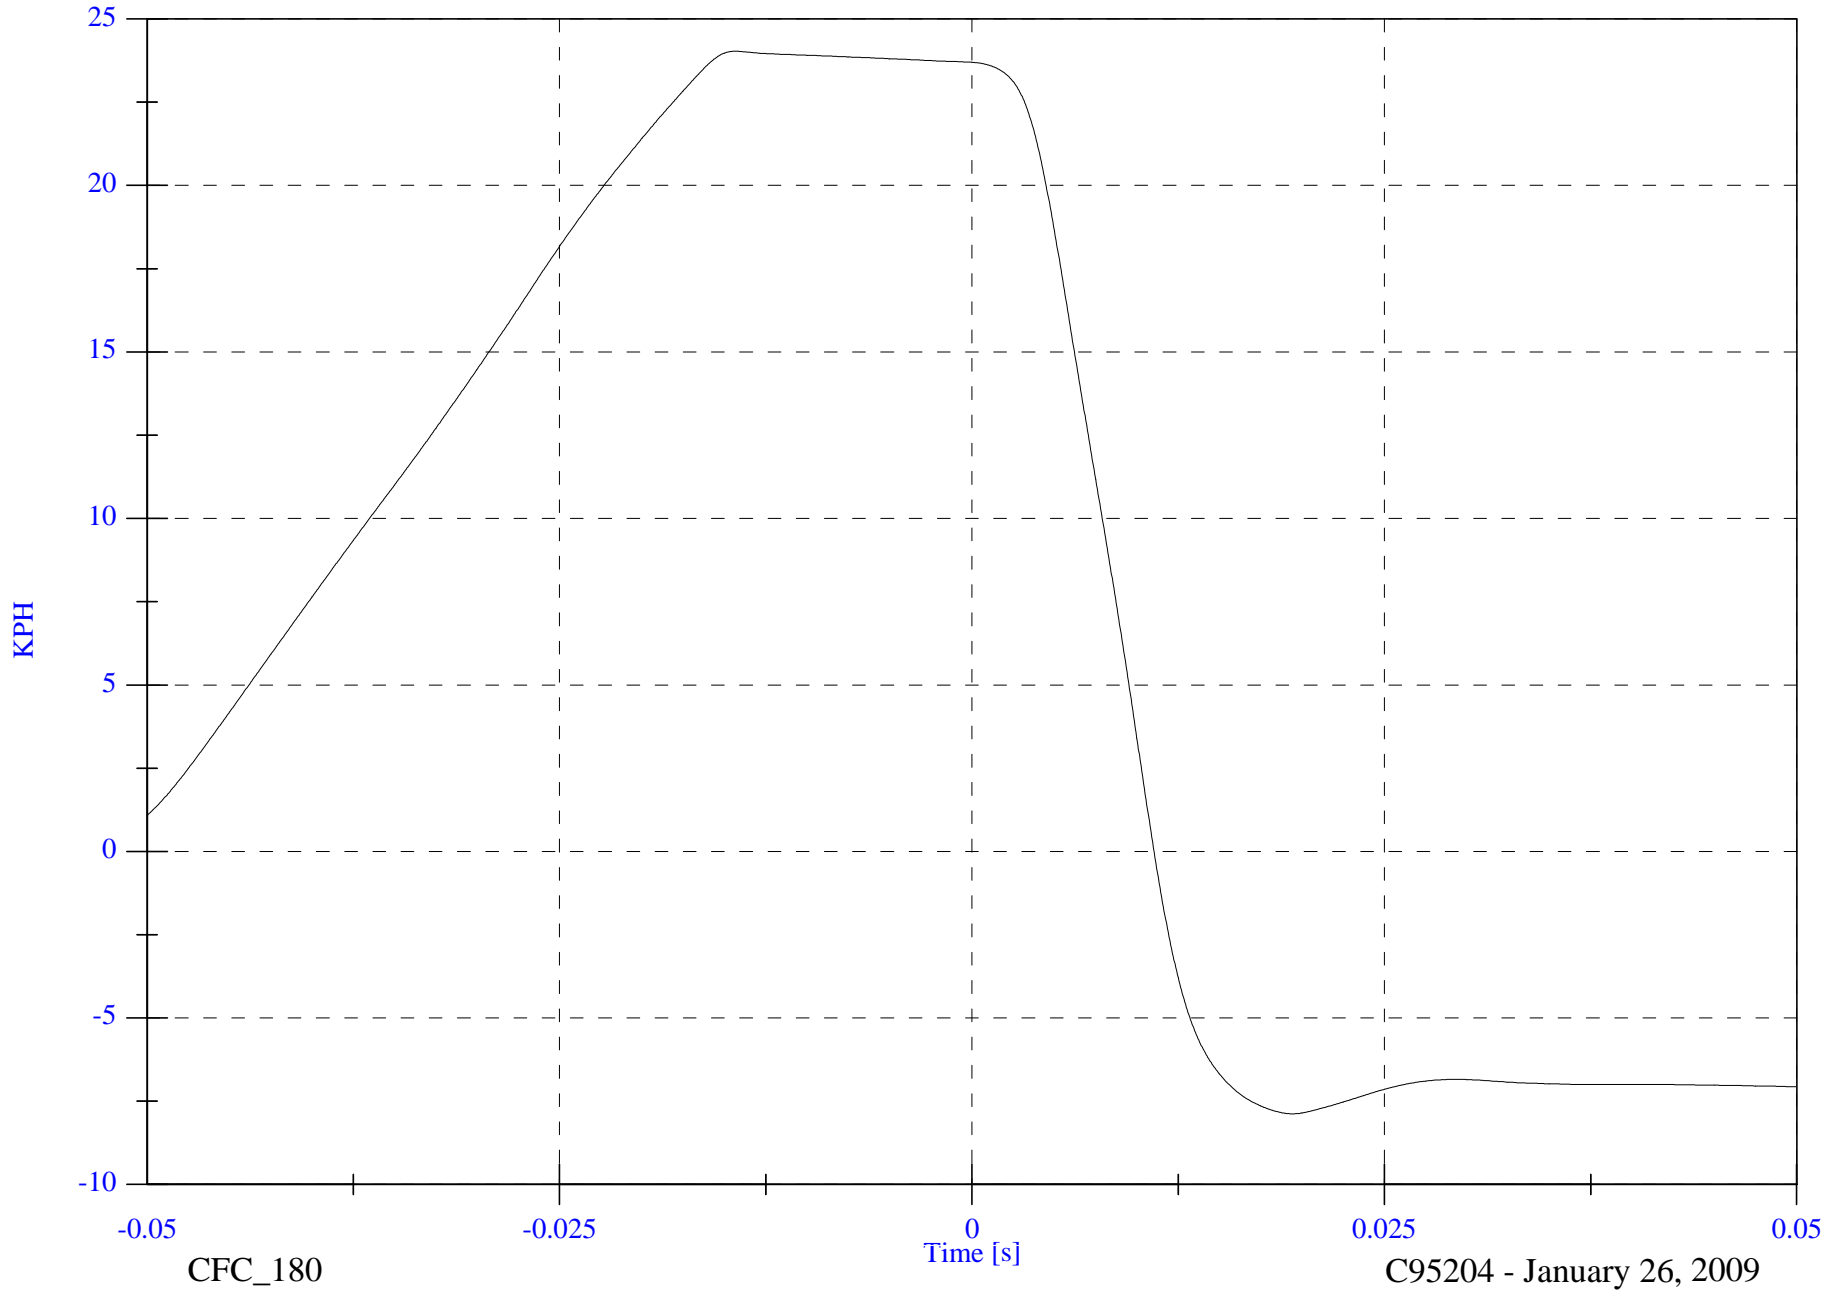
C95204 PASSENGER SIDE UROP IMPACT PLOT #5

Max: 24.0 [KPH] at -0.014 [s]

### Headform Velocity

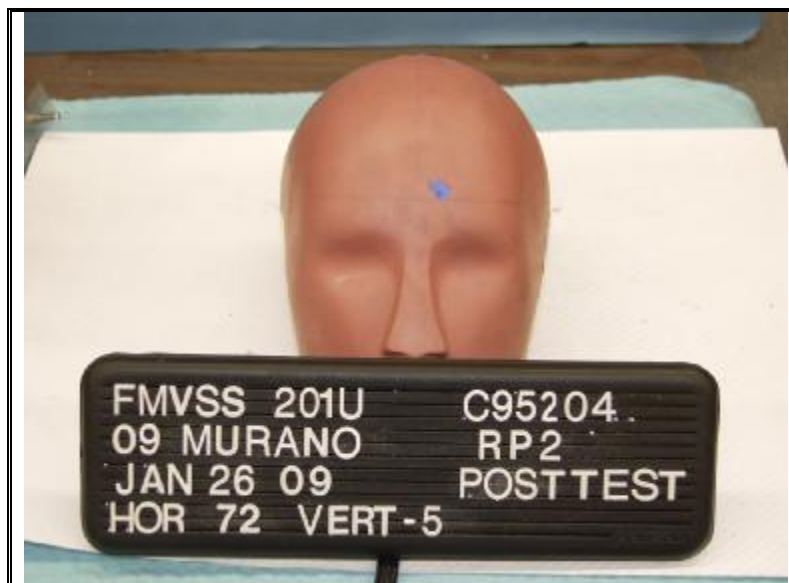
POST-IMPACT RP2 HEADFORM

Test Number:	03
Test Date:	01/26/09
Target Location:	REAR PILLAR
Target Code:	RP2
Horizontal Impact Angle:	72°
Vertical Impact Angle:	-5°
Ambient Temperature:	21°C
Relative Humidity:	13
Time of Impact:	10:00
Headform Number:	1140

Impact Point Description (from lower midpoint on midsagittal line)					
On Centerline	13	<input type="checkbox"/>	mm right	<input checked="" type="checkbox"/>	mm left
On Centerline	4				mm up

Free Motion HIC	301.6
HIC(d)	393.9
Impact Velocity (kph)	23.60
HIC T1 (msec)	1.5
HIC T2 (msec)	17.4

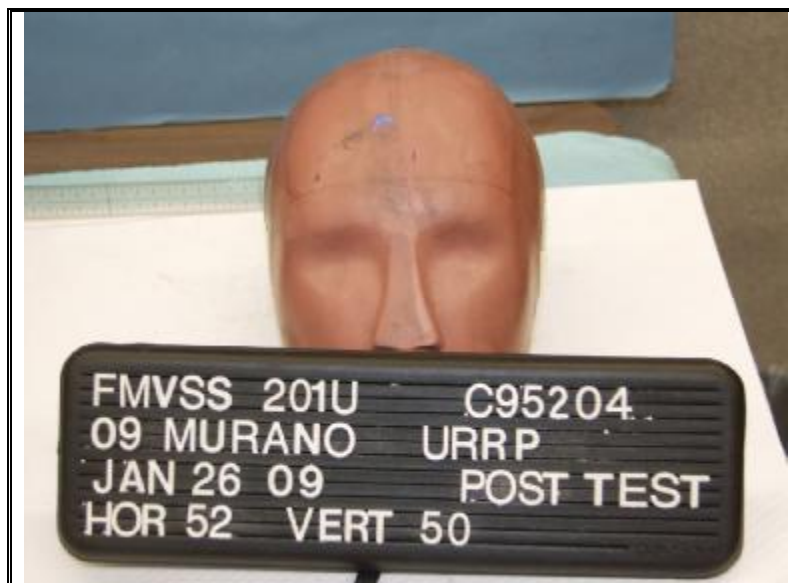
POST-IMPACT URRP HEADFORM

Test Number:	04
Test Date:	01/26/09
Target Location:	UPPER ROOF
Target Code:	URRP
Horizontal Impact Angle:	52°
Vertical Impact Angle:	50°
Ambient Temperature:	21°C
Relative Humidity:	13
Time of Impact:	11:00
Headform Number:	0805

Impact Point Description (from lower midpoint on midsagittal line)					
On Centerline	8	<input checked="" type="checkbox"/>	mm right	<input type="checkbox"/>	mm left
On Centerline	32				mm up

Free Motion HIC	554.4
HIC(d)	584.7
Impact Velocity (kph)	23.59
HIC T1 (msec)	3.8
HIC T2 (msec)	12.5

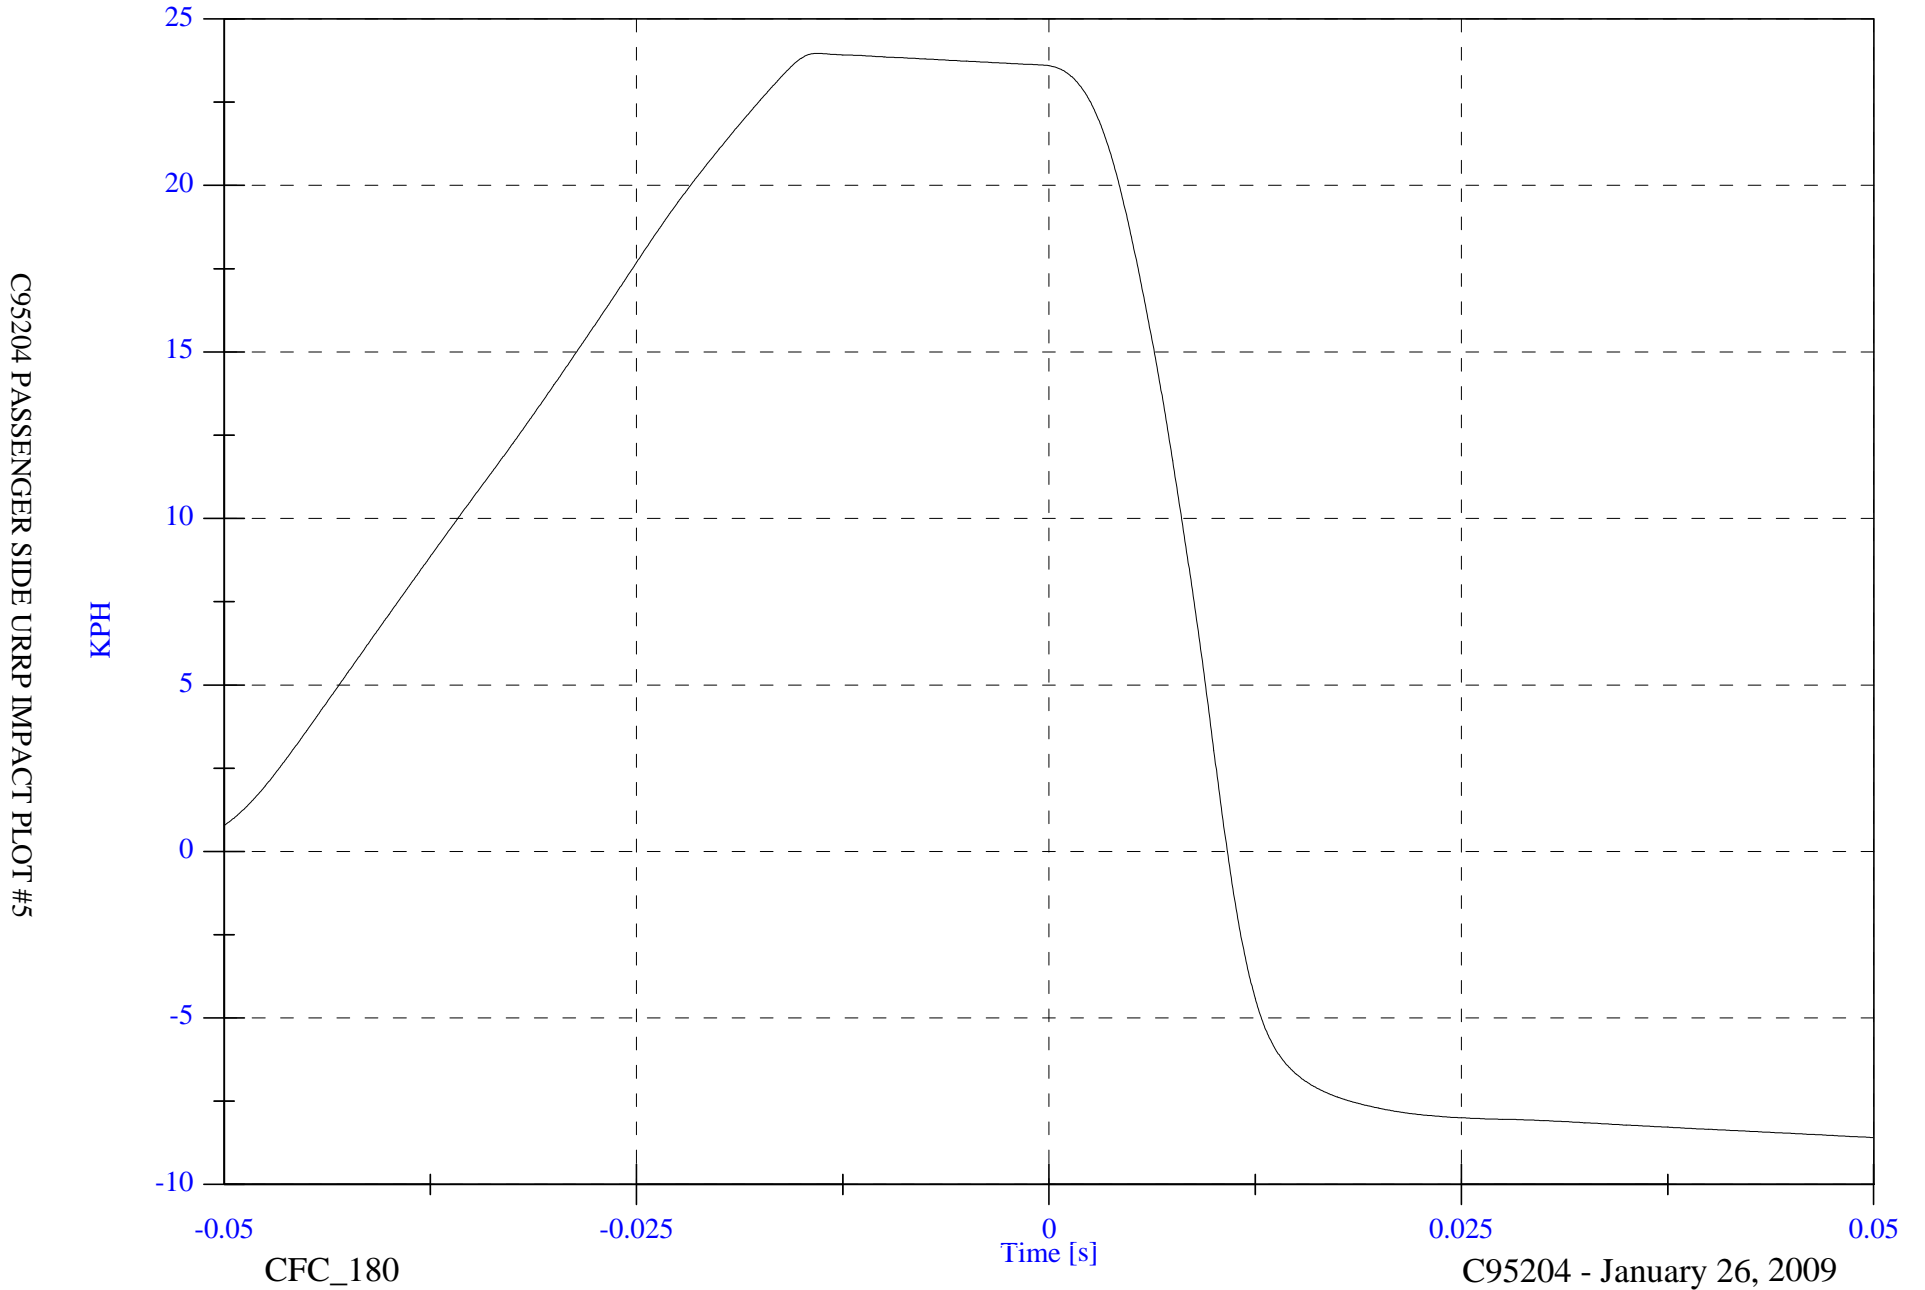
C95204 PASSENGER SIDE URRP IMPACT PLOT #5

Max: 24.0 [KPH] at -0.014 [s]

Min: -8.6 [KPH] at 0.050 [s]

### Headform Velocity

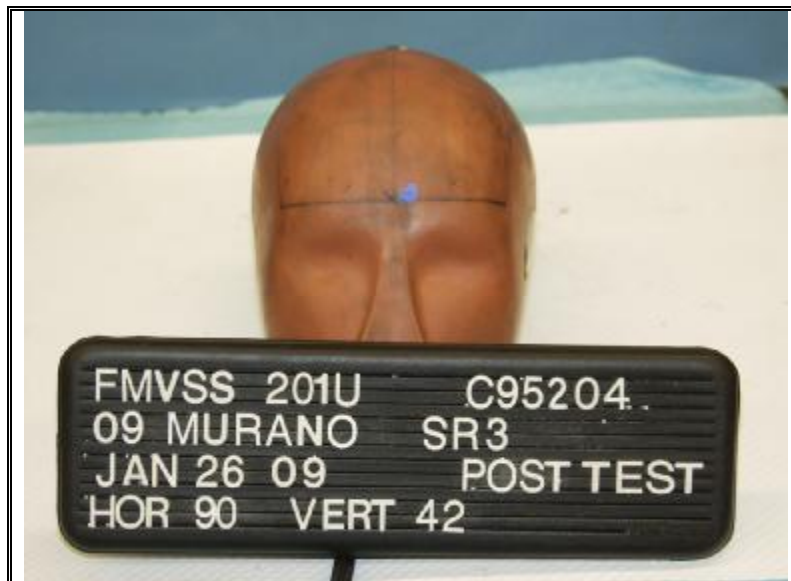
POST-IMPACT SR3 HEADFORM

Test Number:	05
Test Date:	01/26/09
Target Location:	SIDE RAIL
Target Code:	SR3
Horizontal Impact Angle:	90°
Vertical Impact Angle:	42°
Ambient Temperature:	21°C
Relative Humidity:	13
Time of Impact:	11:25
Headform Number:	0062

Impact Point Description (from lower midpoint on midsagittal line)			
On Centerline	6	<input type="checkbox"/>	mm right <input checked="" type="checkbox"/> mm left
On Centerline	2		mm up

Free Motion HIC	266.1
HIC(d)	367.2
Impact Velocity (kph)	18.78
HIC T1 (msec)	1.1
HIC T2 (msec)	9.3

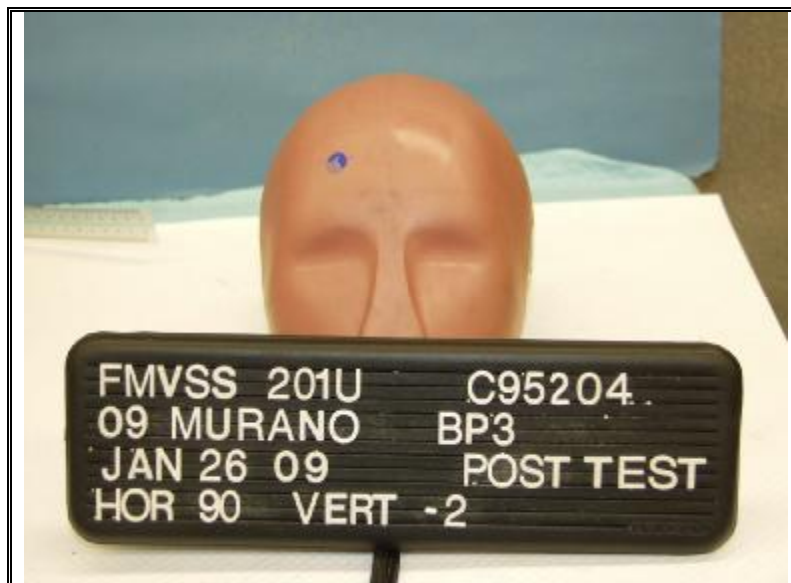
POST-IMPACT BP3 HEADFORM

Test Number:	06
Test Date:	01/26/09
Target Location:	B-PILLAR
Target Code:	BP3
Horizontal Impact Angle:	90°
Vertical Impact Angle:	-2°
Ambient Temperature:	21°C
Relative Humidity:	13
Time of Impact:	13:15
Headform Number:	1142

Impact Point Description (from lower midpoint on midsagittal line)					
On Centerline	26	<input checked="" type="checkbox"/>	mm right	<input type="checkbox"/>	mm left
On Centerline	16				mm up

Free Motion HIC	367.2
HIC(d)	443.5
Impact Velocity (kph)	23.44
HIC T1 (msec)	1.9
HIC T2 (msec)	11.3

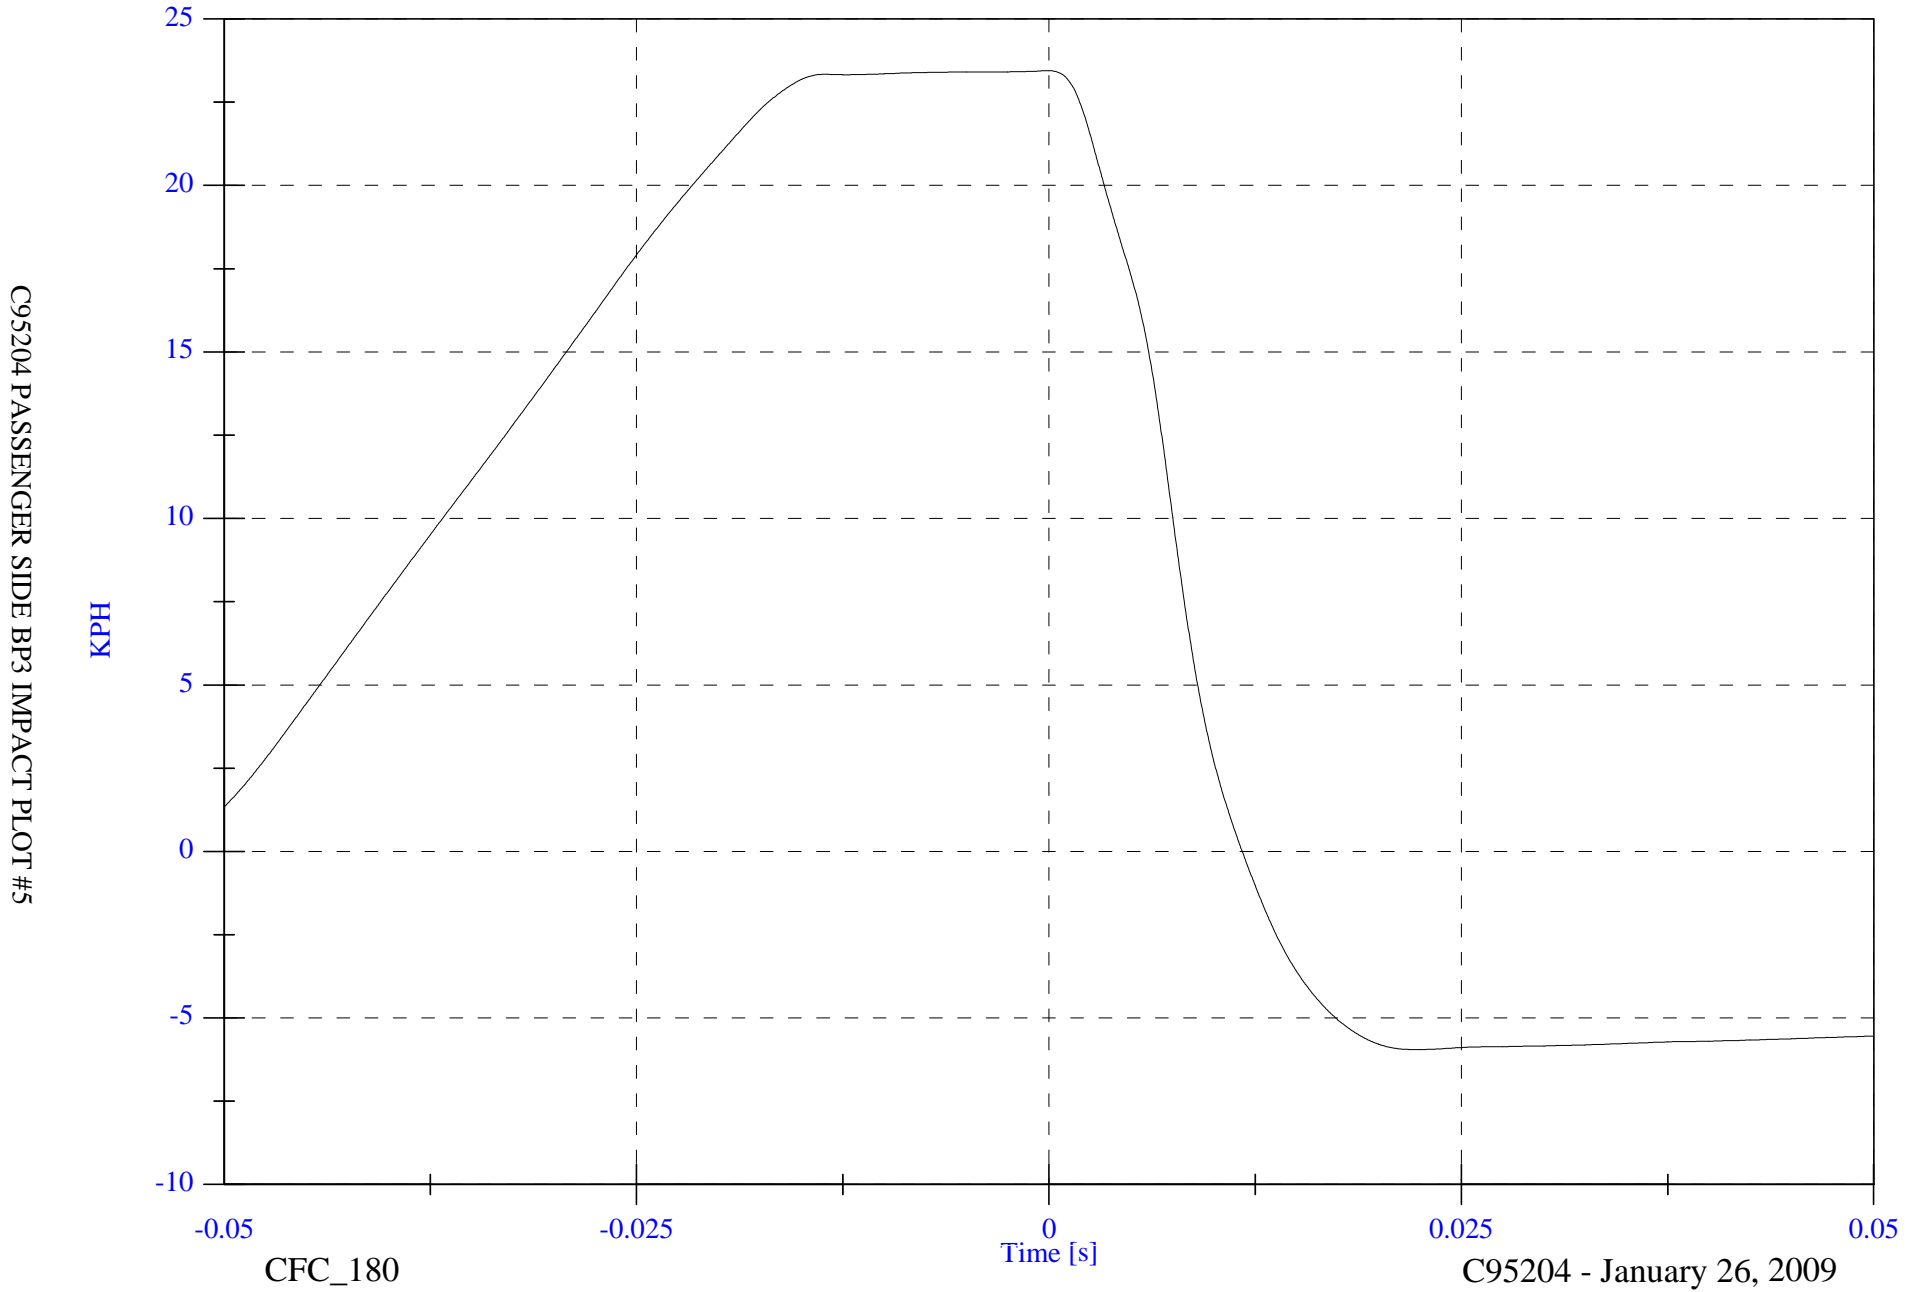
C95204 PASSENGER SIDE BP3 IMPACT PLOT #5

Min: -6.0 [KPH] at 0.022 [s]

### Headform Velocity

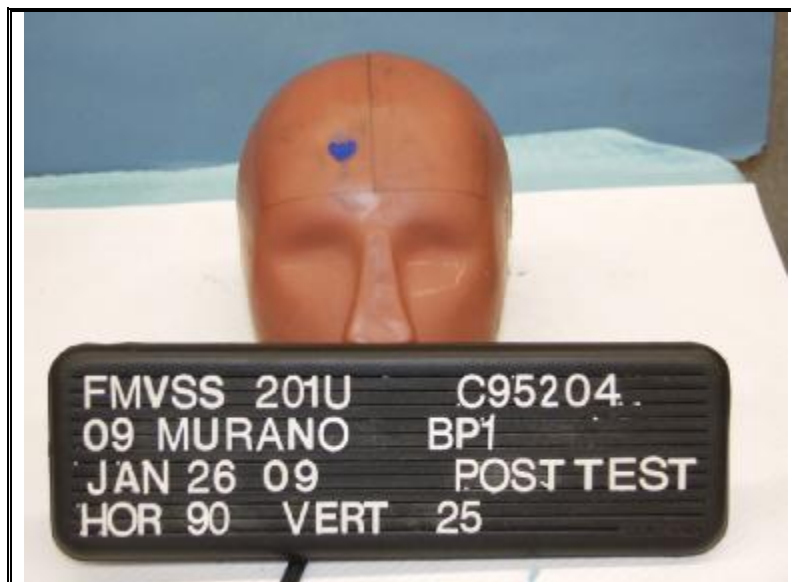
POST-IMPACT BP1 HEADFORM

Test Number:	07
Test Date:	01/26/09
Target Location:	B-PILLAR
Target Code:	BP1
Horizontal Impact Angle:	90°
Vertical Impact Angle:	25°
Ambient Temperature:	21°C
Relative Humidity:	13
Time of Impact:	13:30
Headform Number:	0355

Impact Point Description (from lower midpoint on midsagittal line)					
On Centerline	14	<input checked="" type="checkbox"/>	mm right	<input type="checkbox"/>	mm left
On Centerline	20				mm up

Free Motion HIC	378.4
HIC(d)	451.9
Impact Velocity (kph)	18.51
HIC T1 (msec)	7.0
HIC T2 (msec)	12.5

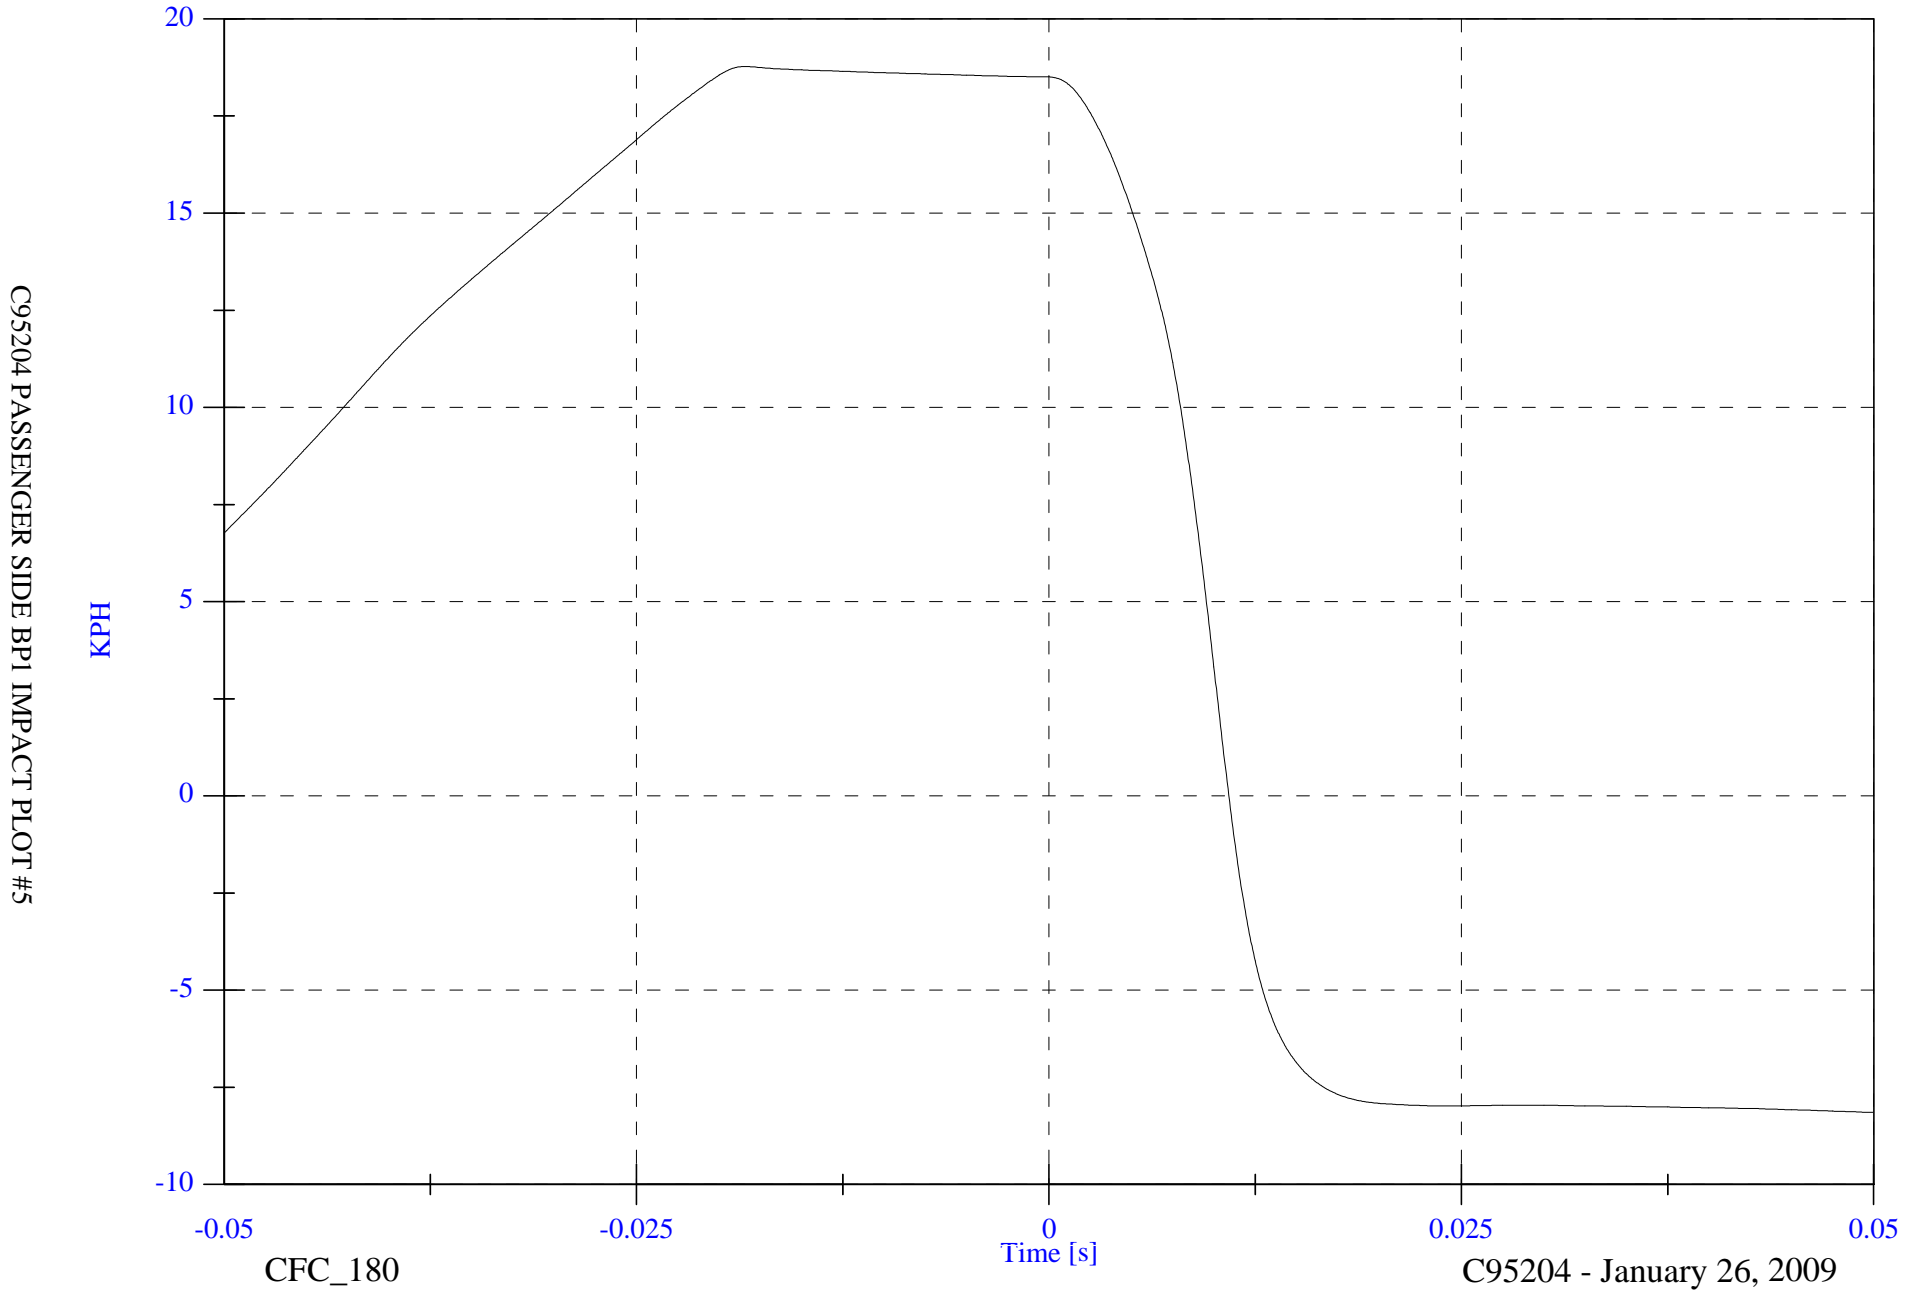
C95204 PASSENGER SIDE BP1 IMPACT PLOT #5

Min: -8.1 [KPH] at 0.050 [s]

### Headform Velocity

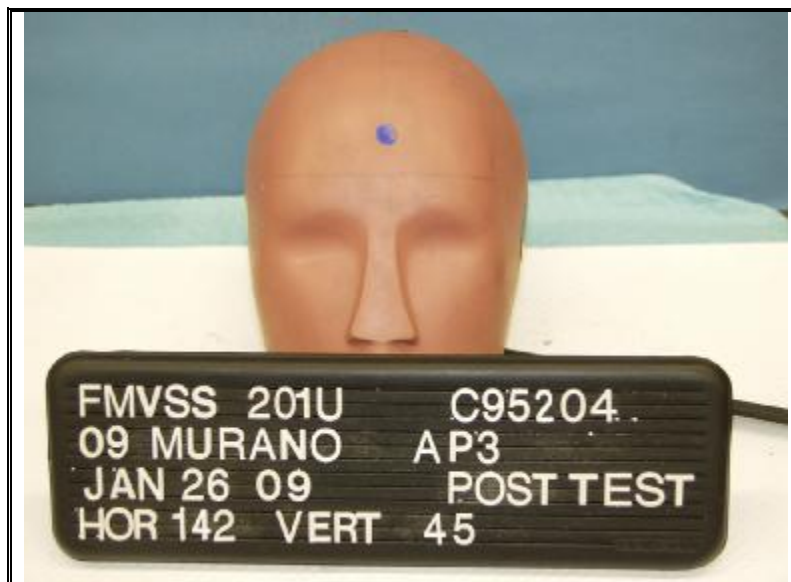
POST-IMPACT AP3 HEADFORM

Test Number:	08
Test Date:	01/26/09
Target Location:	A-PILLAR
Target Code:	AP3
Horizontal Impact Angle:	142°
Vertical Impact Angle:	45°
Ambient Temperature:	21°C
Relative Humidity:	13
Time of Impact:	13:55
Headform Number:	1140

Impact Point Description (from lower midpoint on midsagittal line)			
On Centerline	0	<input type="checkbox"/>	mm right <input type="checkbox"/> mm left
On Centerline	17		mm up

Free Motion HIC	461.4
HIC(d)	514.5
Impact Velocity (kph)	18.44
HIC T1 (msec)	5.8
HIC T2 (msec)	9.8

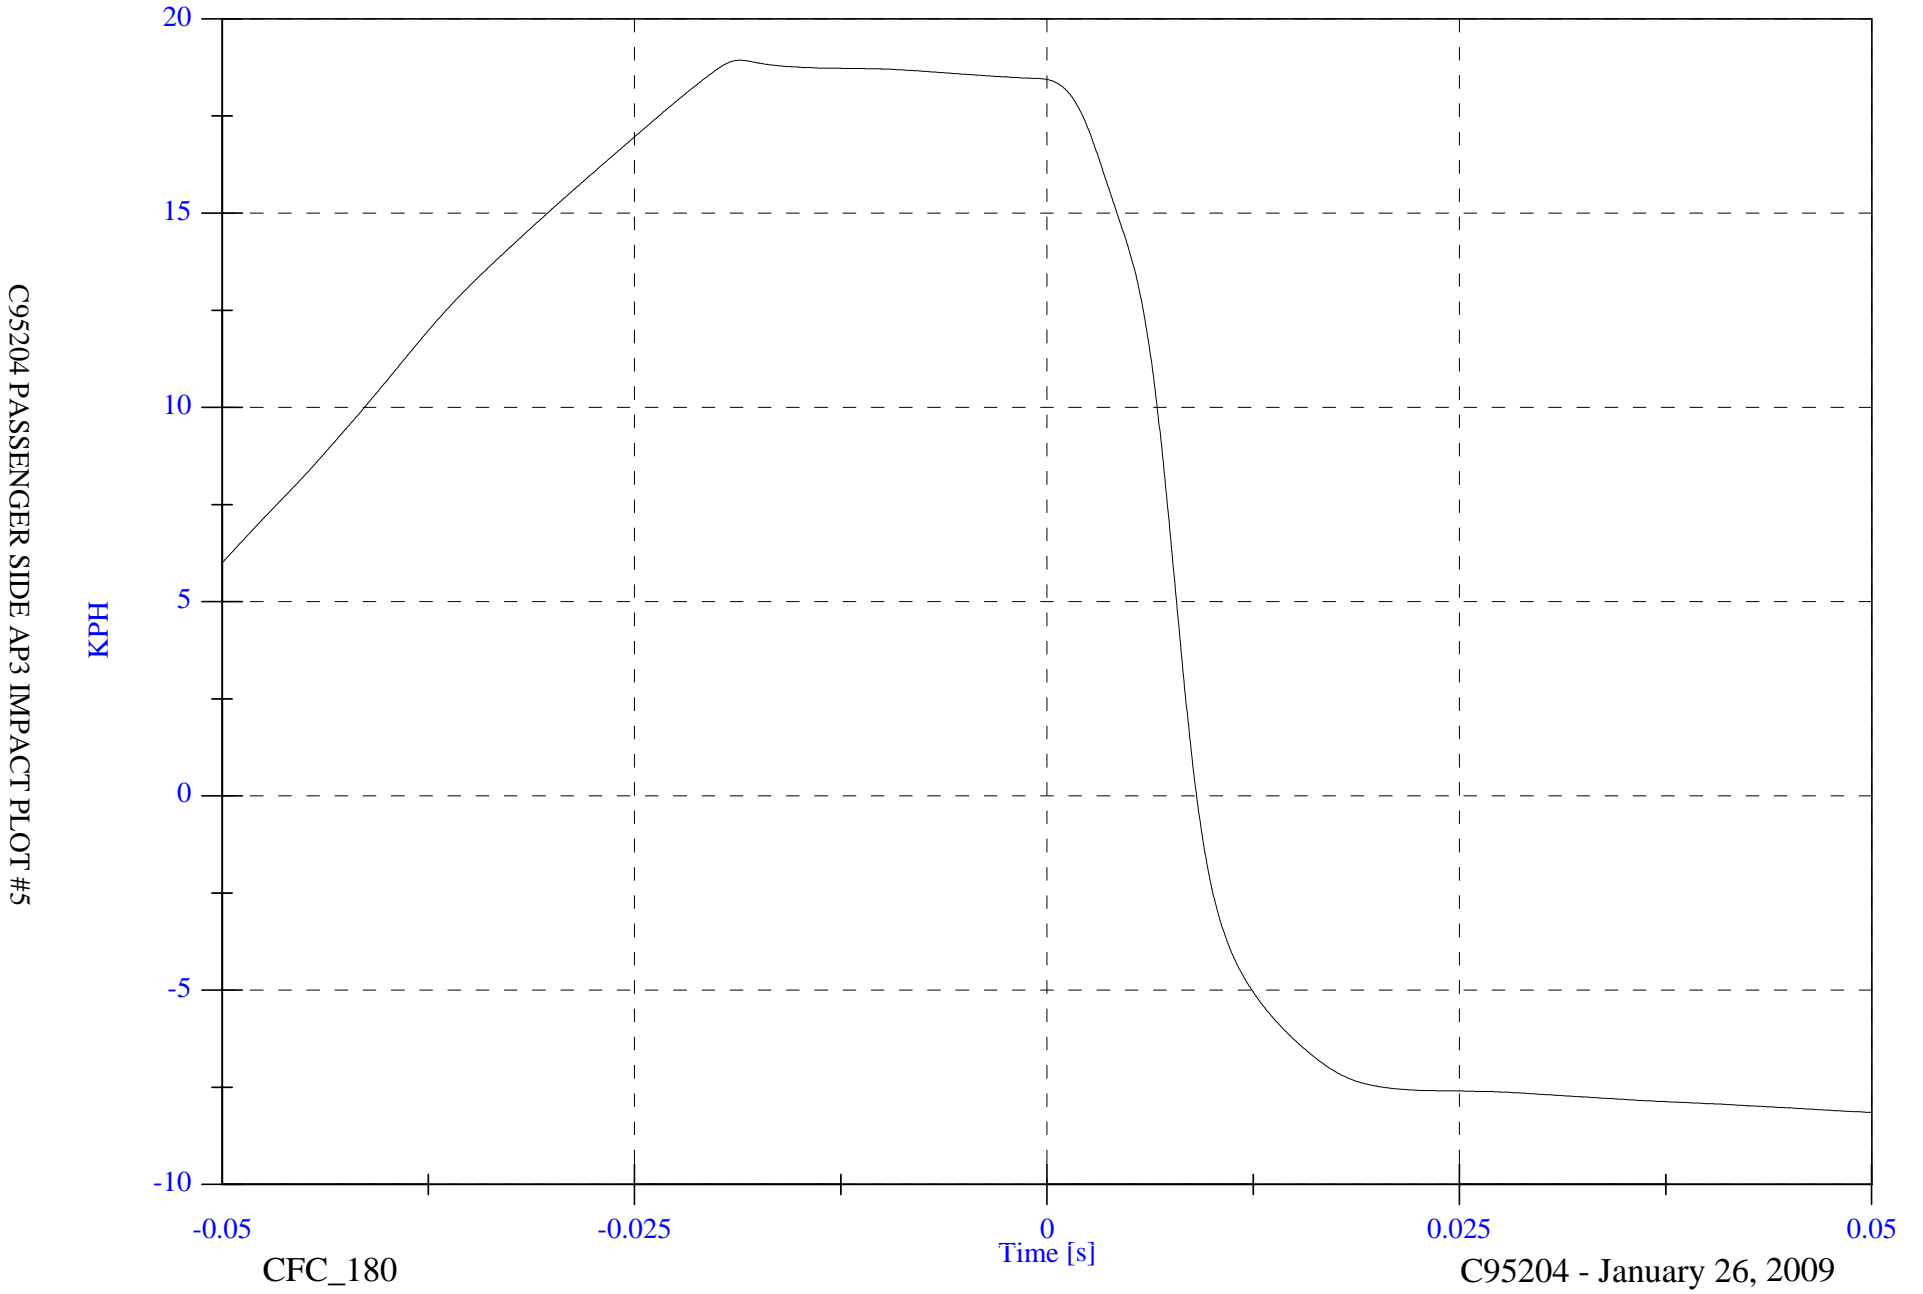
C95204 PASSENGER SIDE AP3 IMPACT PLOT #5

Min: -8.1 [KPH] at 0.050 [s]

### Headform Velocity

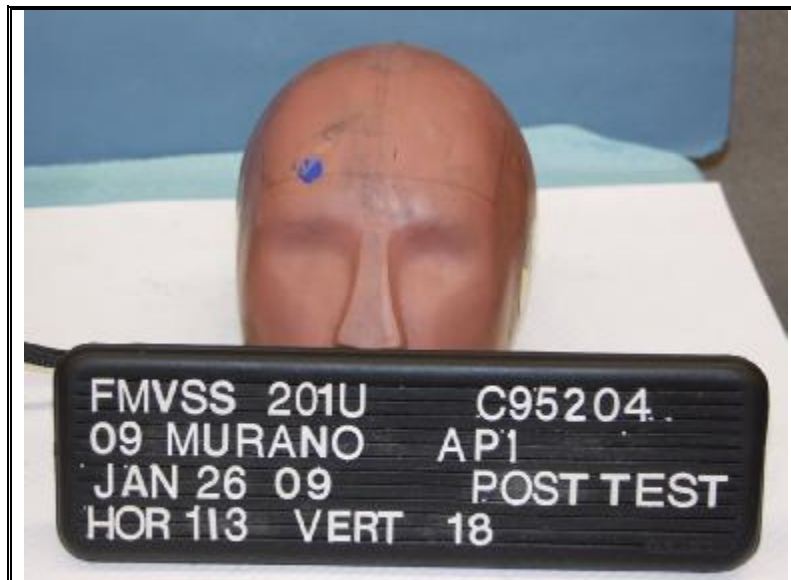
POST-IMPACT AP1 HEADFORM

Test Number:	09
Test Date:	01/26/09
Target Location:	A-PILLAR
Target Code:	AP1
Horizontal Impact Angle:	113°
Vertical Impact Angle:	18°
Ambient Temperature:	21°C
Relative Humidity:	13
Time of Impact:	14:30
Headform Number:	0805

Impact Point Description (from lower midpoint on midsagittal line)					
On Centerline	34	<input checked="" type="checkbox"/>	mm right	<input type="checkbox"/>	mm left
On Centerline	5				mm up

Free Motion HIC	112.9
HIC(d)	251.6
Impact Velocity (kph)	18.32
HIC T1 (msec)	3.0
HIC T2 (msec)	18.4
