REPORT NUMBER: 201UI-CAL-09-04

**SAFETY COMPLIANCE TESTING FOR FMVSS 201  
OCCUPANT PROTECTION IN INTERIOR IMPACT  
UPPER INTERIOR HEAD IMPACT PROTECTION**

**NISSAN MOTOR COMPANY, LTD.  
2009 NISSAN MURANO**

NHTSA NUMBER: C95204

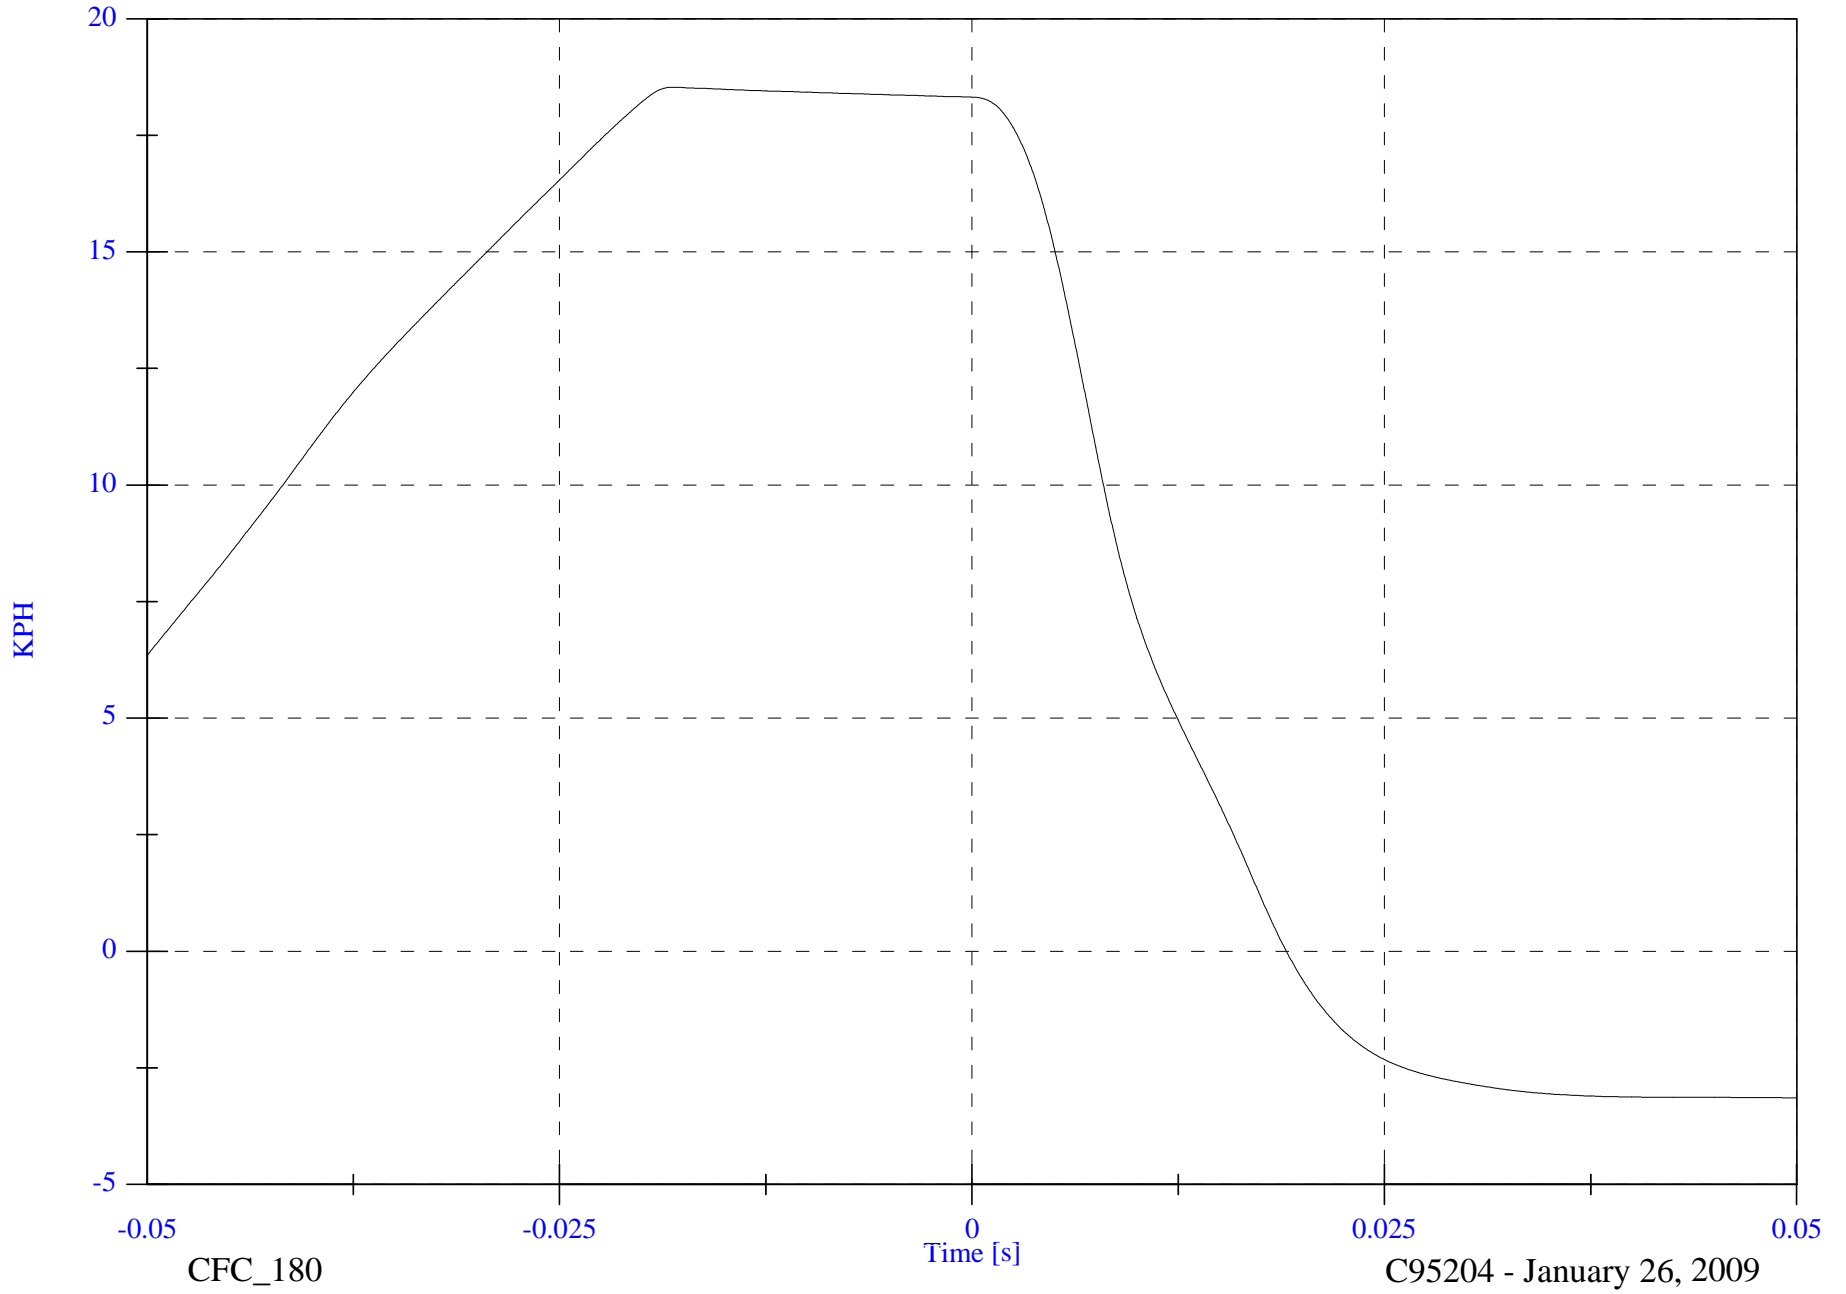
C95204 PASSENGER SIDE AP1 IMPACT PLOT # 5

### Headform Velocity

Min: -3.1 [KPH] at 0.050 [s]

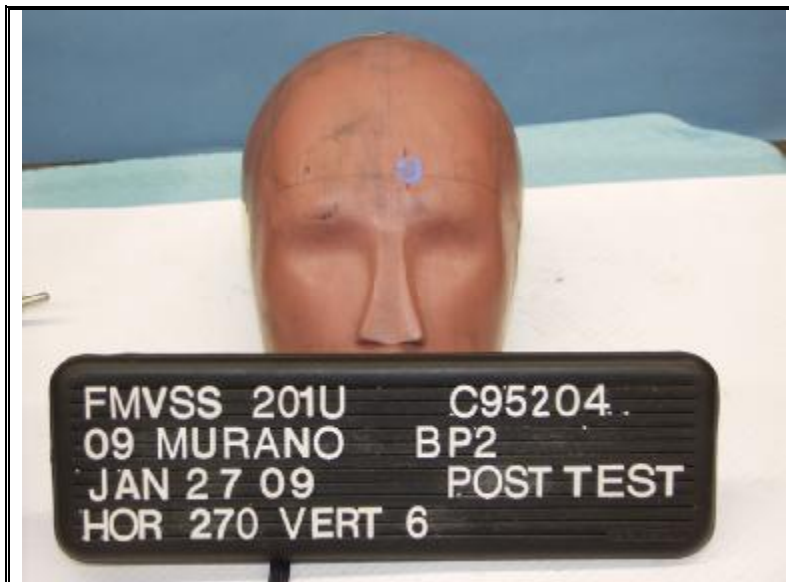
POST-IMPACT BP2 HEADFORM

Test Number:	10
Test Date:	01/27/09
Target Location:	B-PILLAR
Target Code:	BP2
Horizontal Impact Angle:	270°
Vertical Impact Angle:	6°
Ambient Temperature:	21°C
Relative Humidity:	14
Time of Impact:	9:30
Headform Number:	0805

Impact Point Description (from lower midpoint on midsagittal line)			
On Centerline	7	<input type="checkbox"/>	mm right <input checked="" type="checkbox"/> mm left
On Centerline	5		mm up

Free Motion HIC	705.2
HIC(d)	698.5
Impact Velocity (kph)	23.44
HIC T1 (msec)	2.9
HIC T2 (msec)	8.9

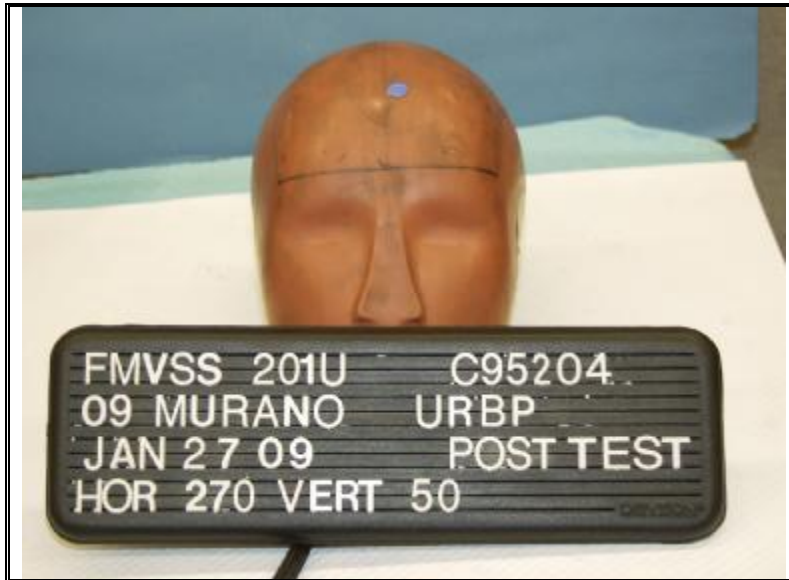
POST-IMPACT URBP HEADFORM

Test Number:	11
Test Date:	01/27/09
Target Location:	UPPER ROOF
Target Code:	URBP
Horizontal Impact Angle:	270°
Vertical Impact Angle:	50°
Ambient Temperature:	21°C
Relative Humidity:	14
Time of Impact:	10:08
Headform Number:	0062

Impact Point Description (from lower midpoint on midsagittal line)					
On Centerline	4	<input type="checkbox"/>	mm right	<input checked="" type="checkbox"/>	mm left
On Centerline	34				mm up

Free Motion HIC	645.0
HIC(d)	653.0
Impact Velocity (kph)	23.83
HIC T1 (msec)	3.1
HIC T2 (msec)	10.3

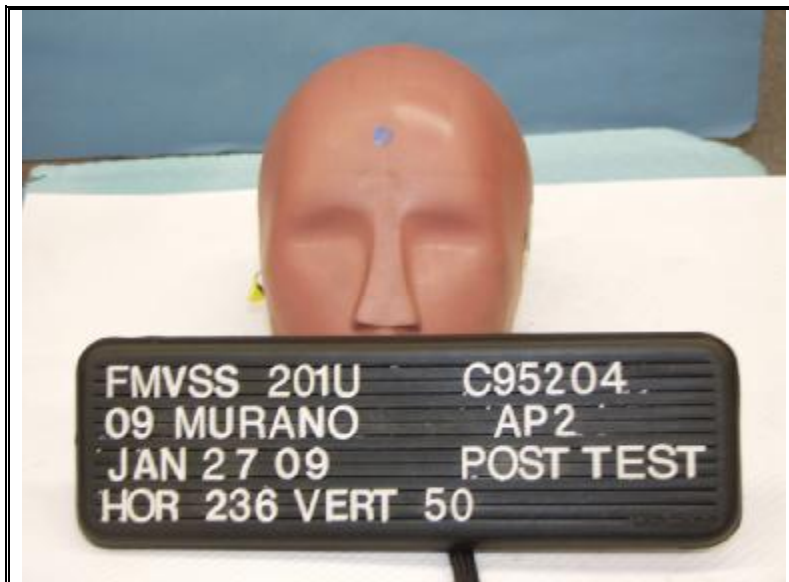
POST-IMPACT AP2 HEADFORM

Test Number:	12
Test Date:	01/27/09
Target Location:	A-PILLAR
Target Code:	AP2
Horizontal Impact Angle:	236°
Vertical Impact Angle:	50°
Ambient Temperature:	21°C
Relative Humidity:	14
Time of Impact:	10:50
Headform Number:	1142

Impact Point Description (from lower midpoint on midsagittal line)			
On Centerline	0	<input type="checkbox"/>	mm right <input type="checkbox"/> mm left
On Centerline	17		mm up

Free Motion HIC	440.5
HIC(d)	498.8
Impact Velocity (kph)	18.76
HIC T1 (msec)	6.1
HIC T2 (msec)	10.3
