REPORT NUMBER: 201UI-CAL-09-03

**SAFETY COMPLIANCE TESTING FOR FMVSS 201  
OCCUPANT PROTECTION IN INTERIOR IMPACT  
UPPER INTERIOR HEAD IMPACT PROTECTION**

**GENERAL MOTORS CORP.  
2009 CHEVROLET TRAILBLAZER**

FINAL REPORT

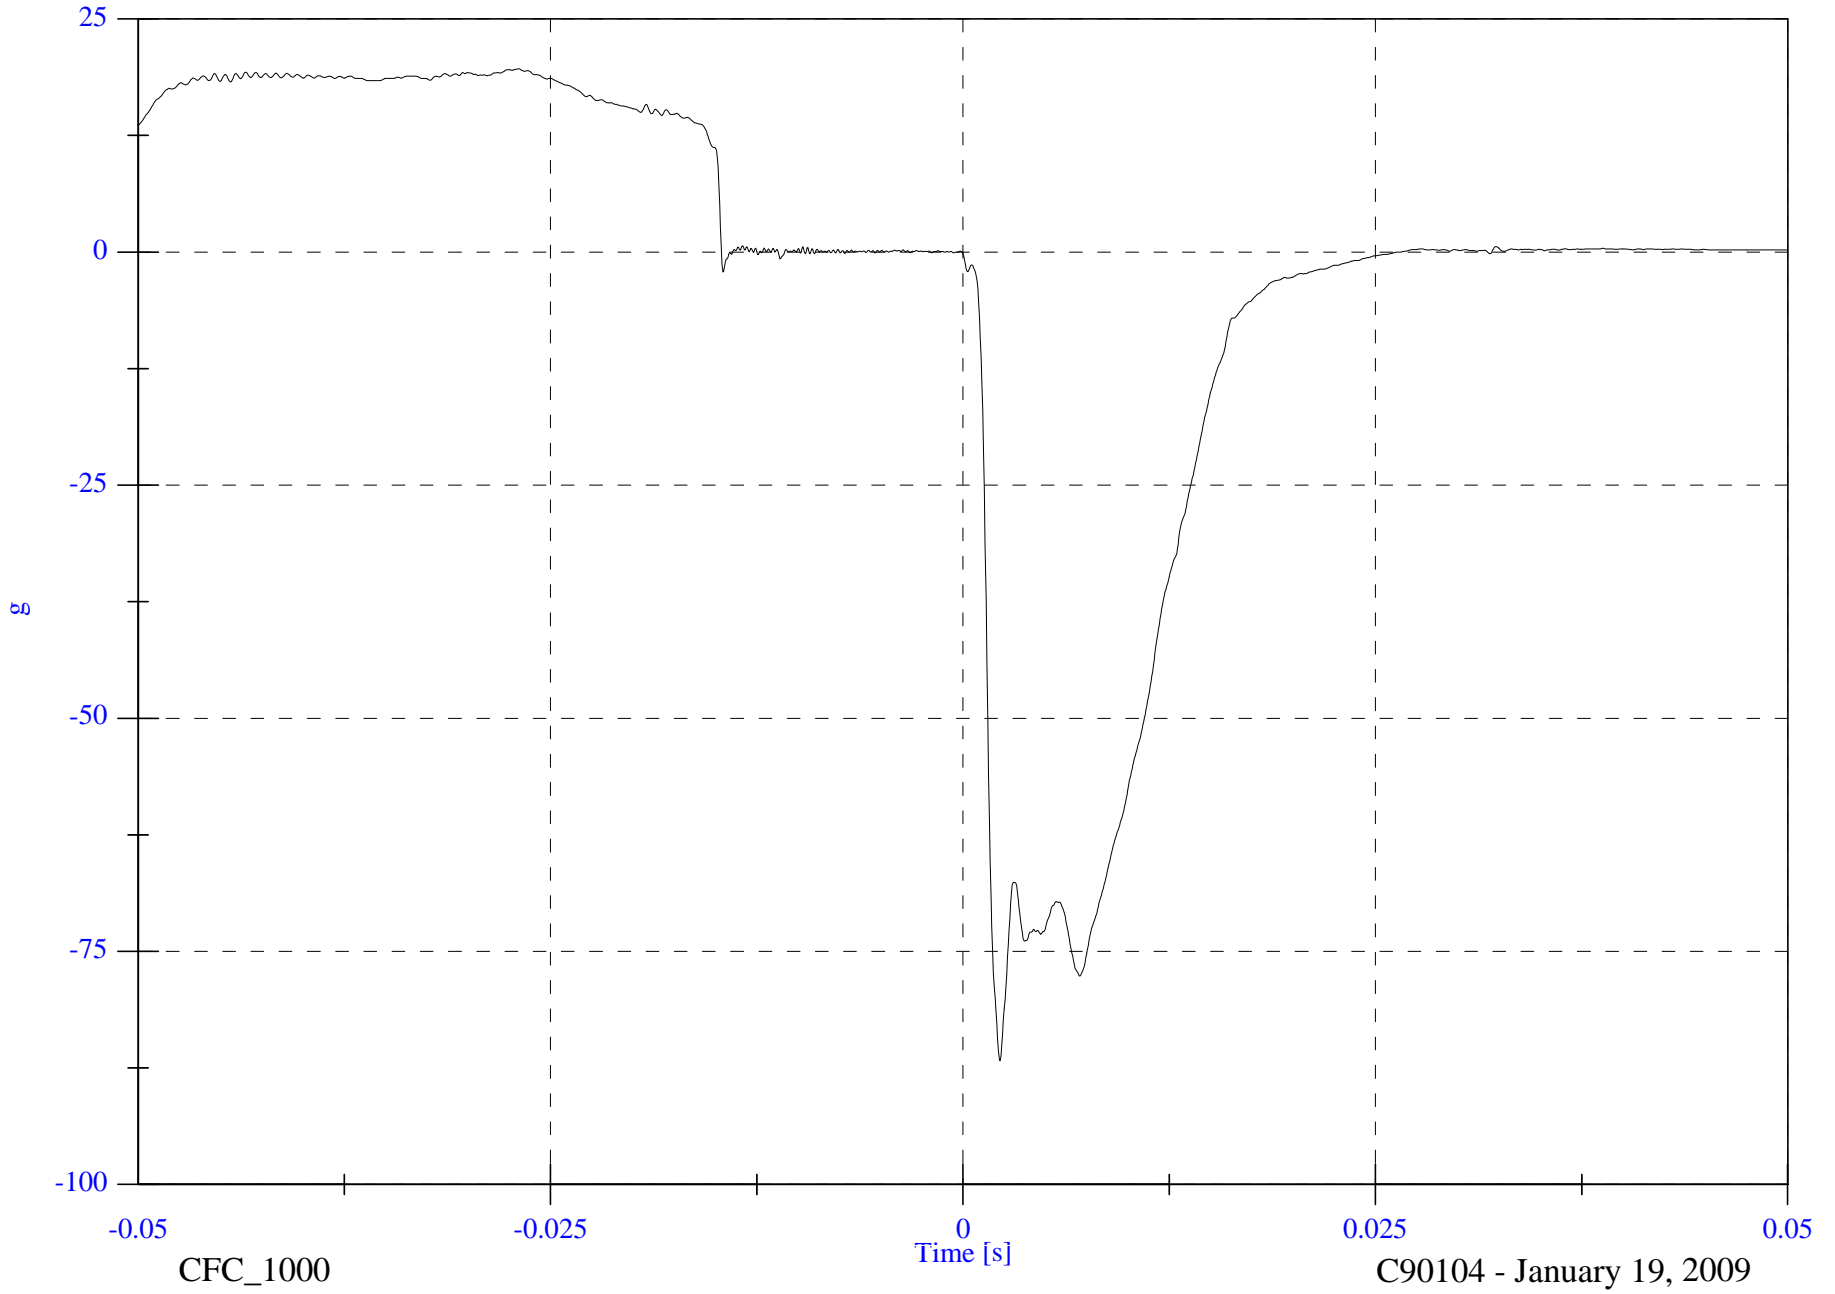
C90104 PASSENGER SIDE OP1 IMPACT PLOT #1

Min: -86.7 [g] at 0.002 [s]

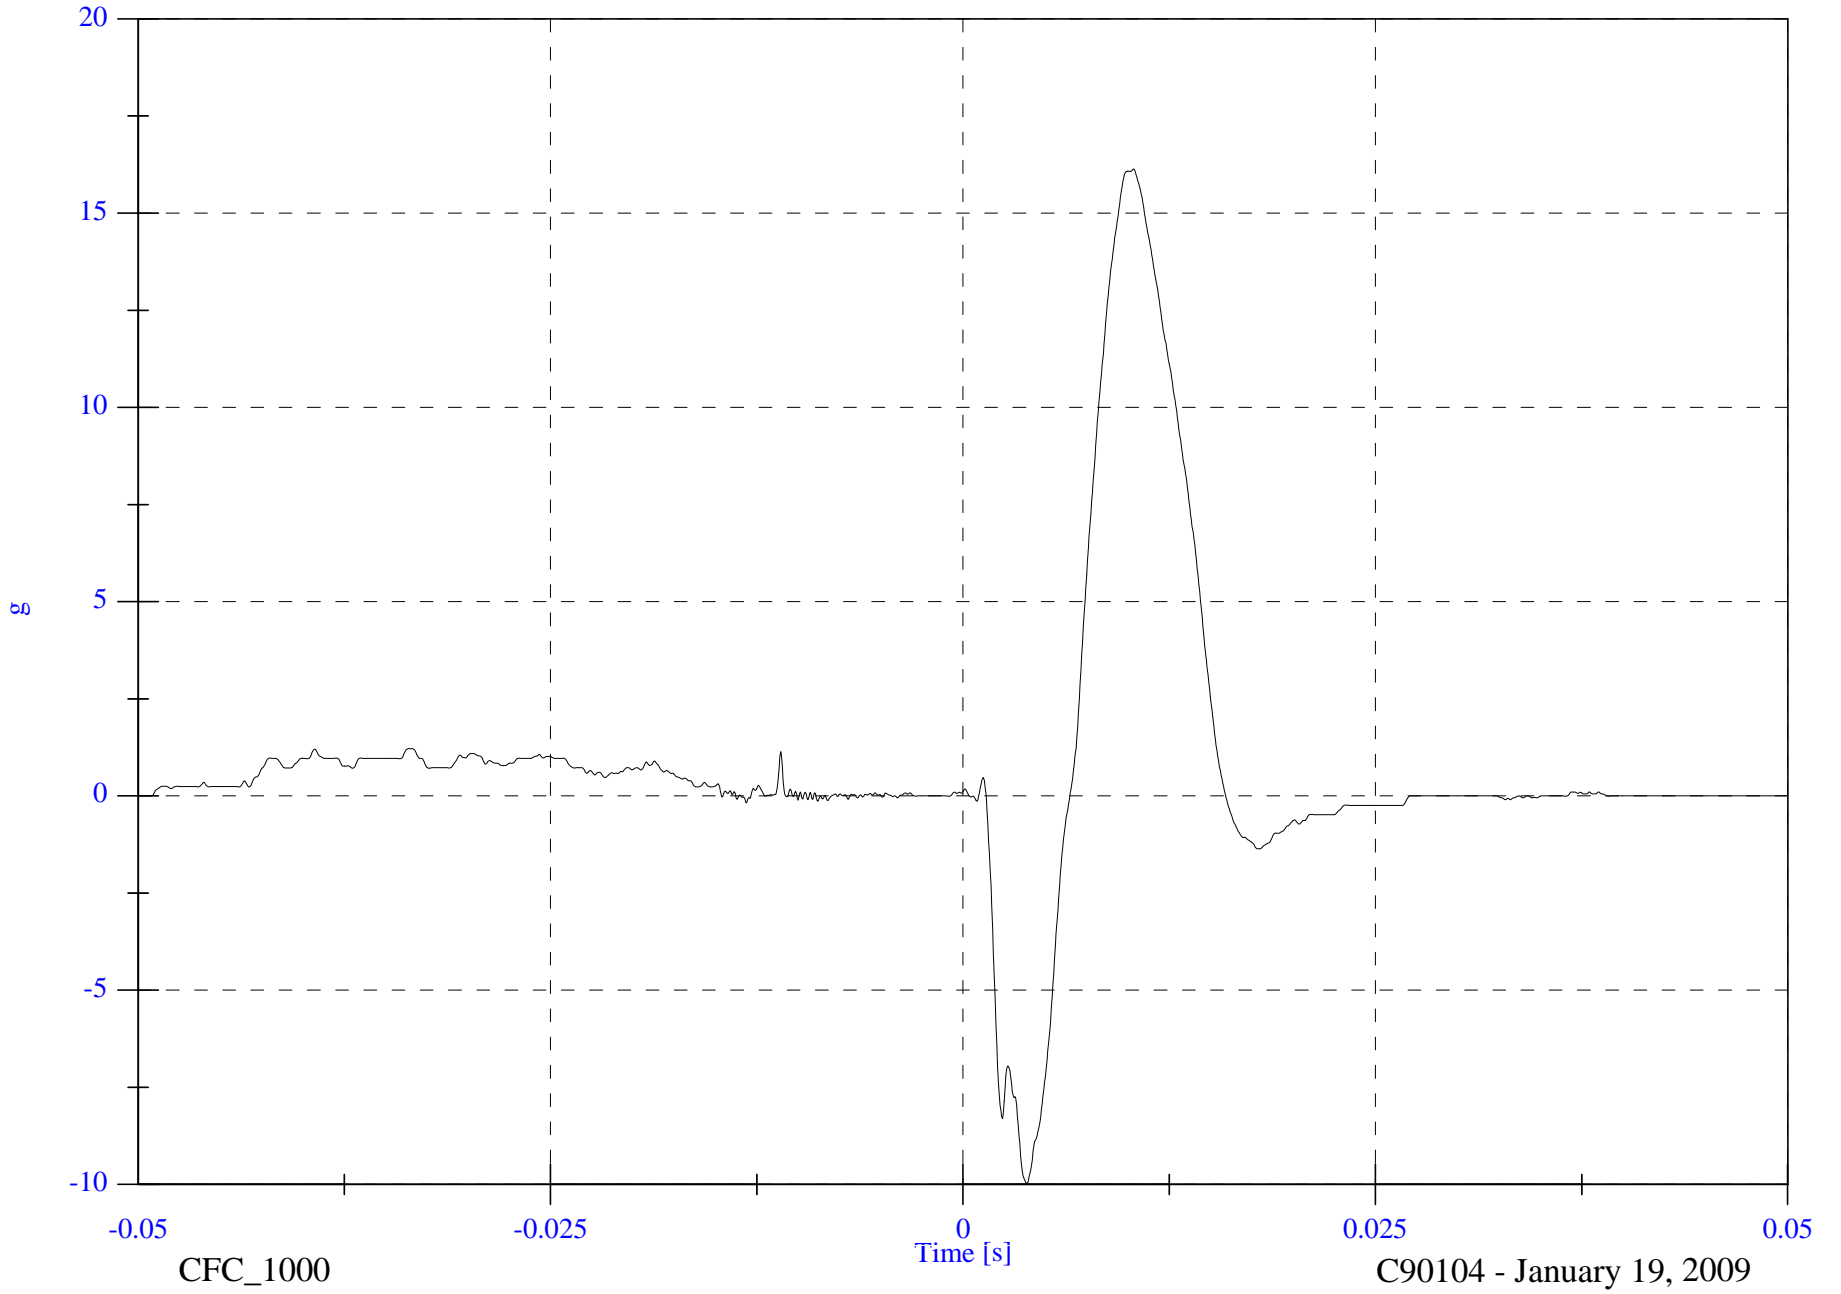
C90104 PASSENGER SIDE OP1 IMPACT PLOT #2

Min: -10.0 [g] at 0.004 [s]

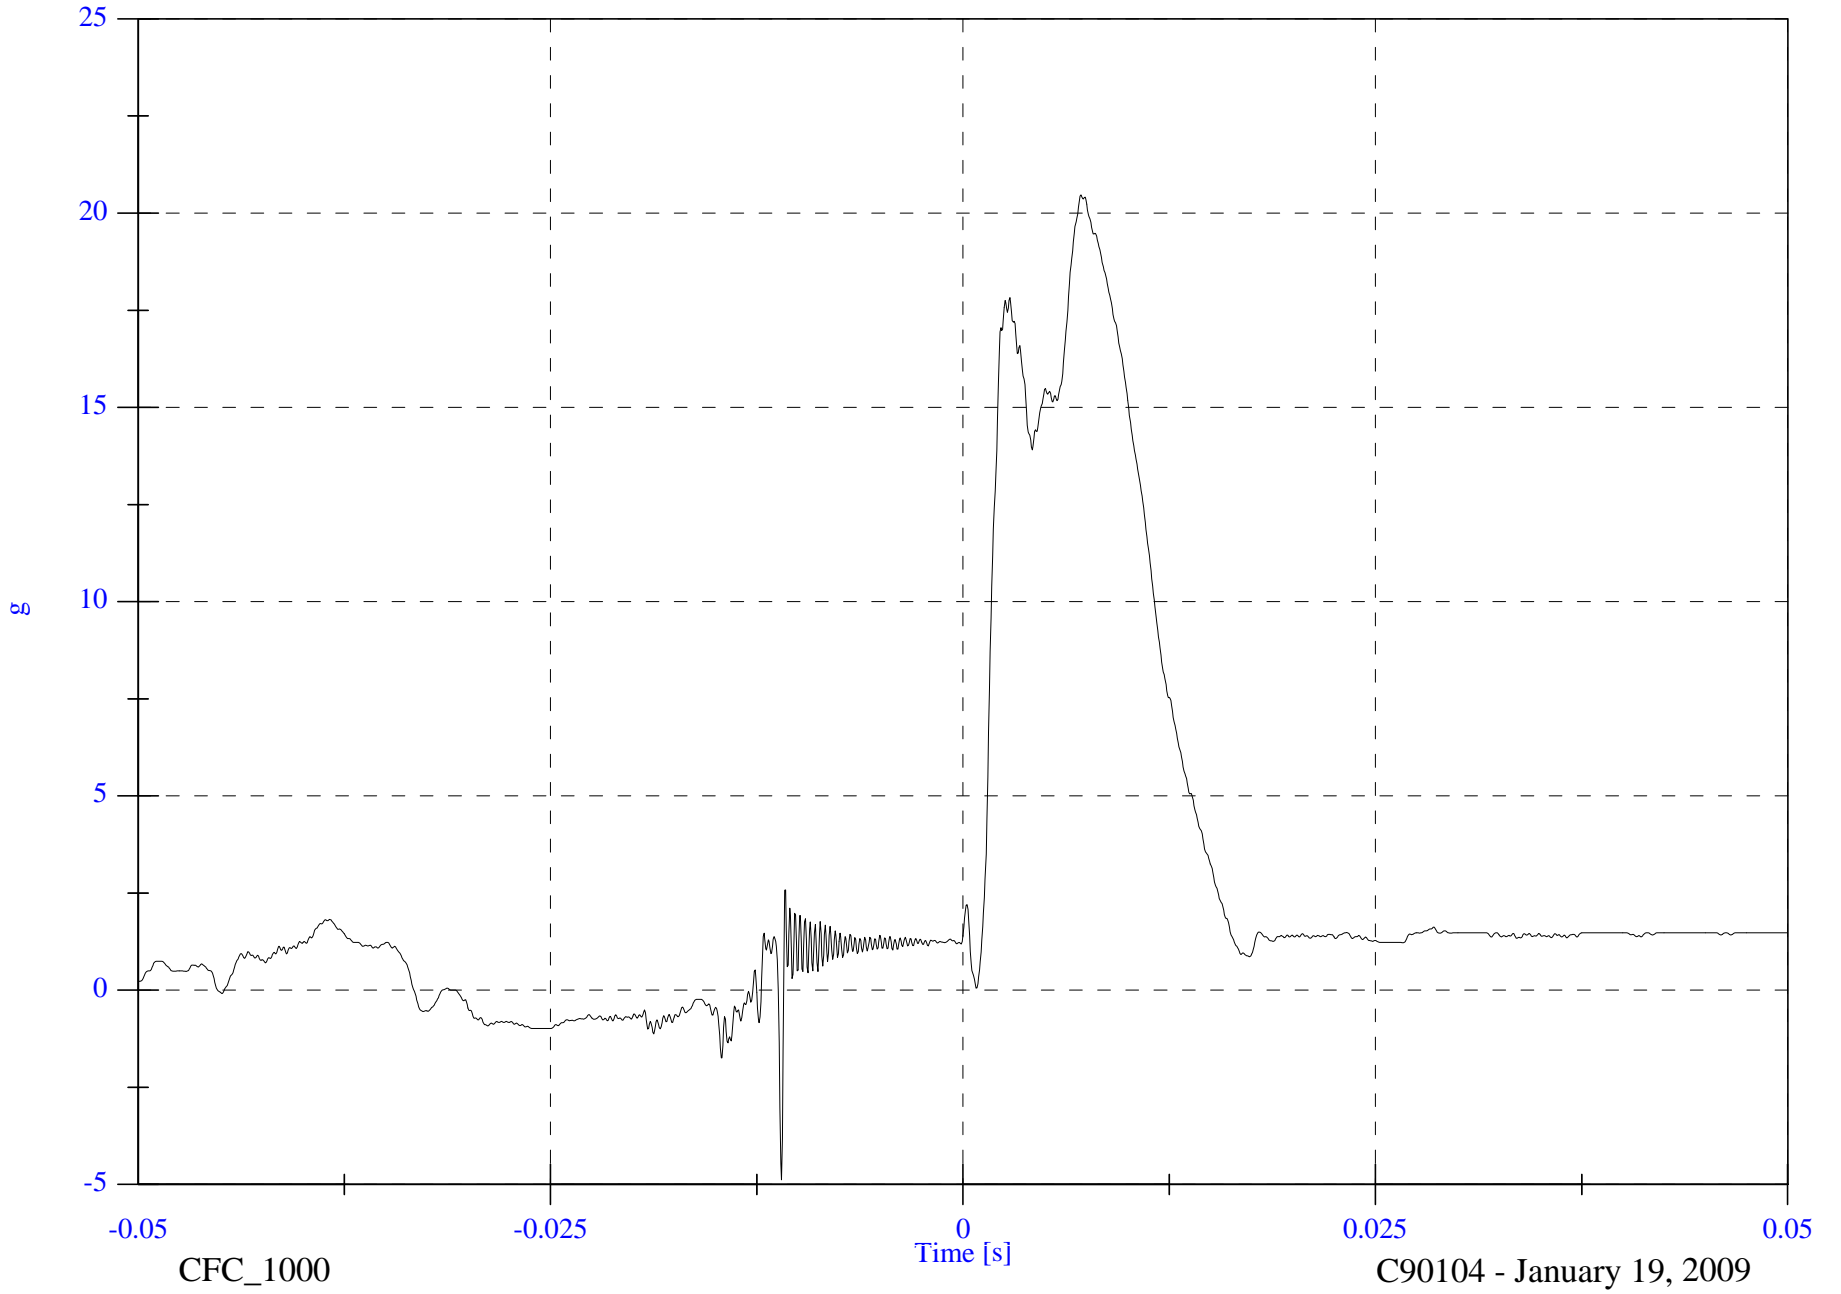
C90104 PASSENGER SIDE OP1 IMPACT PLOT #3

Min: -4.9 [g] at -0.011 [s]

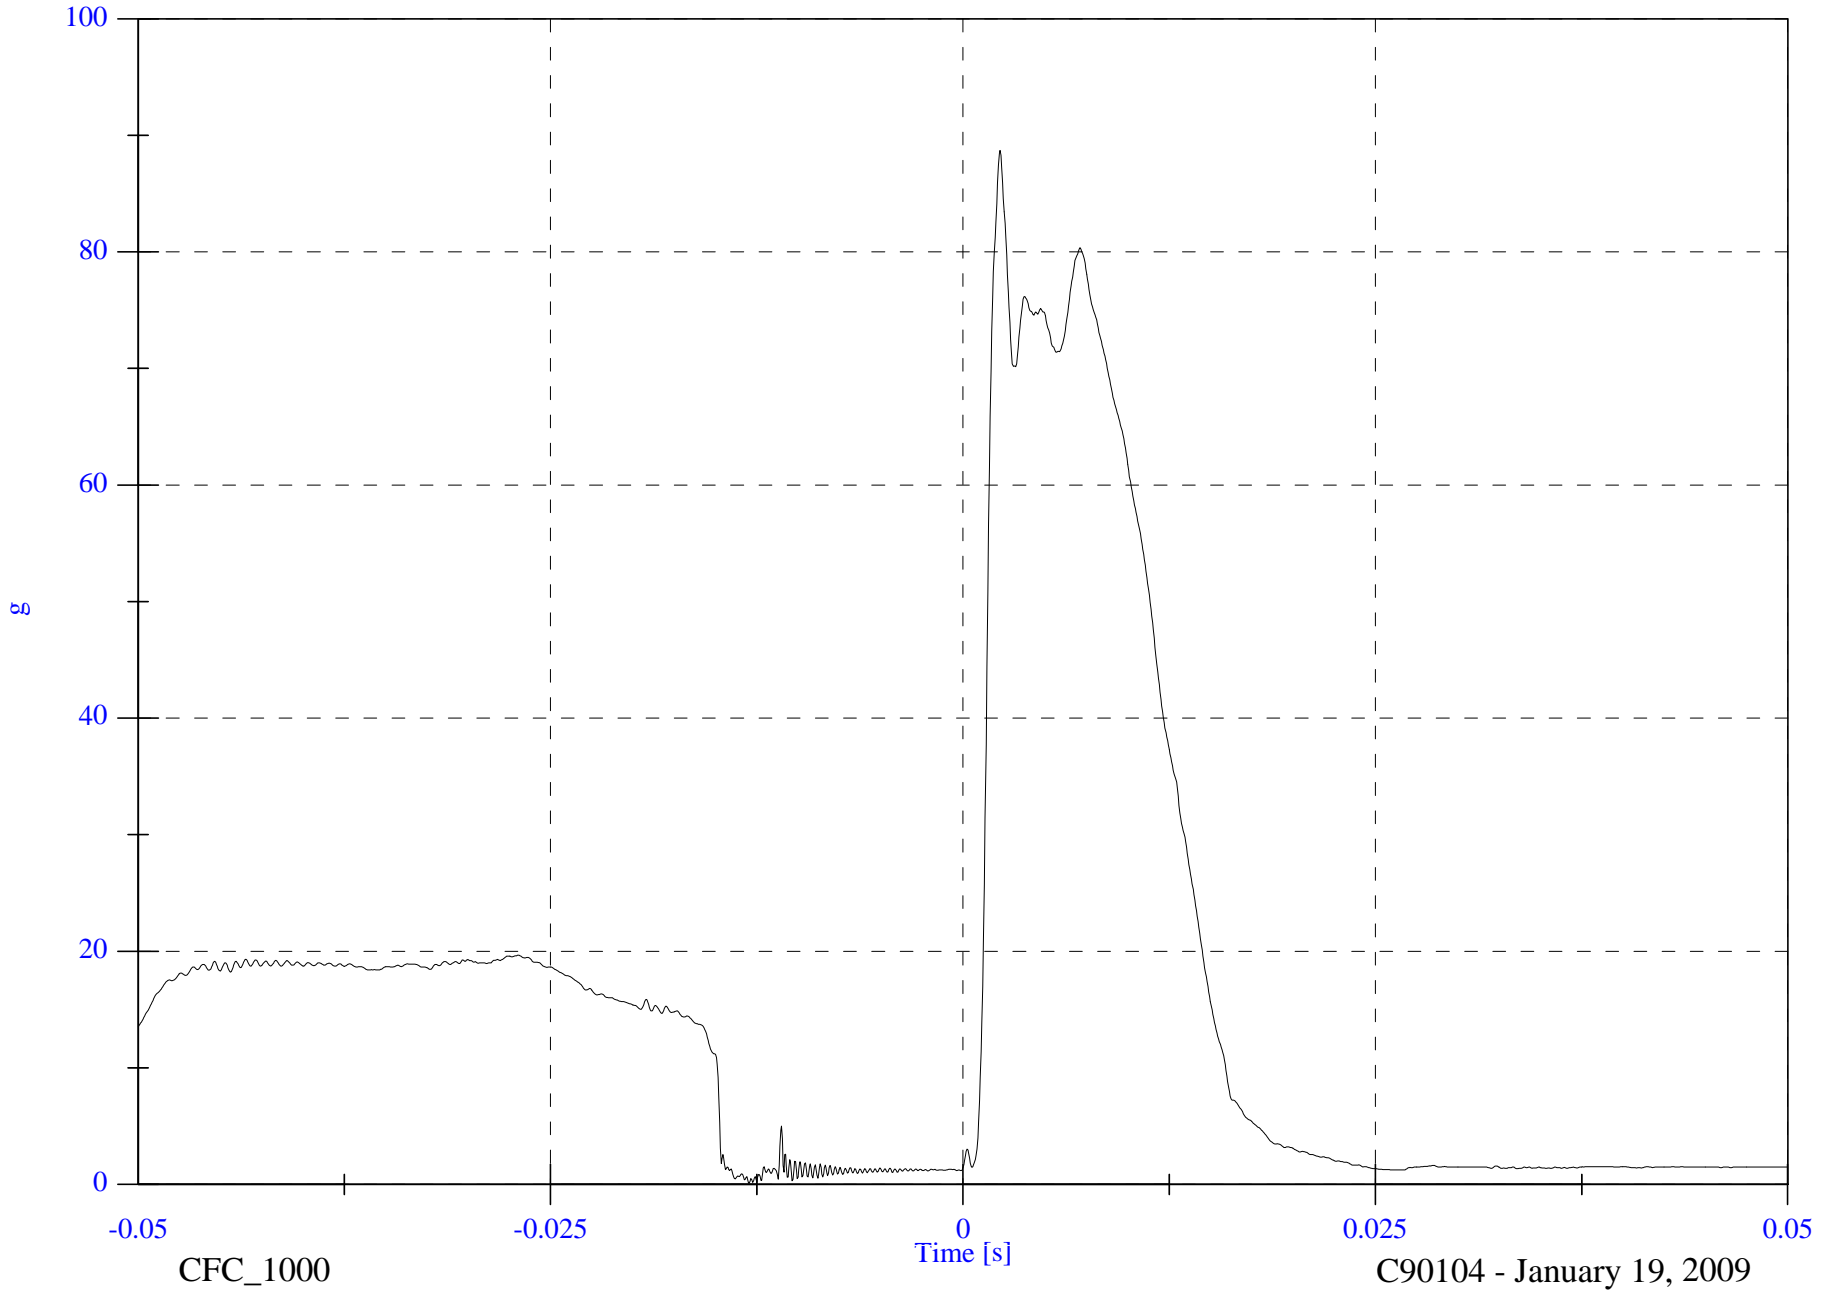
C90104 PASSENGER SIDE OP1 IMPACT PLOT #4

Min: 0.1 [g] at -0.013 [s]

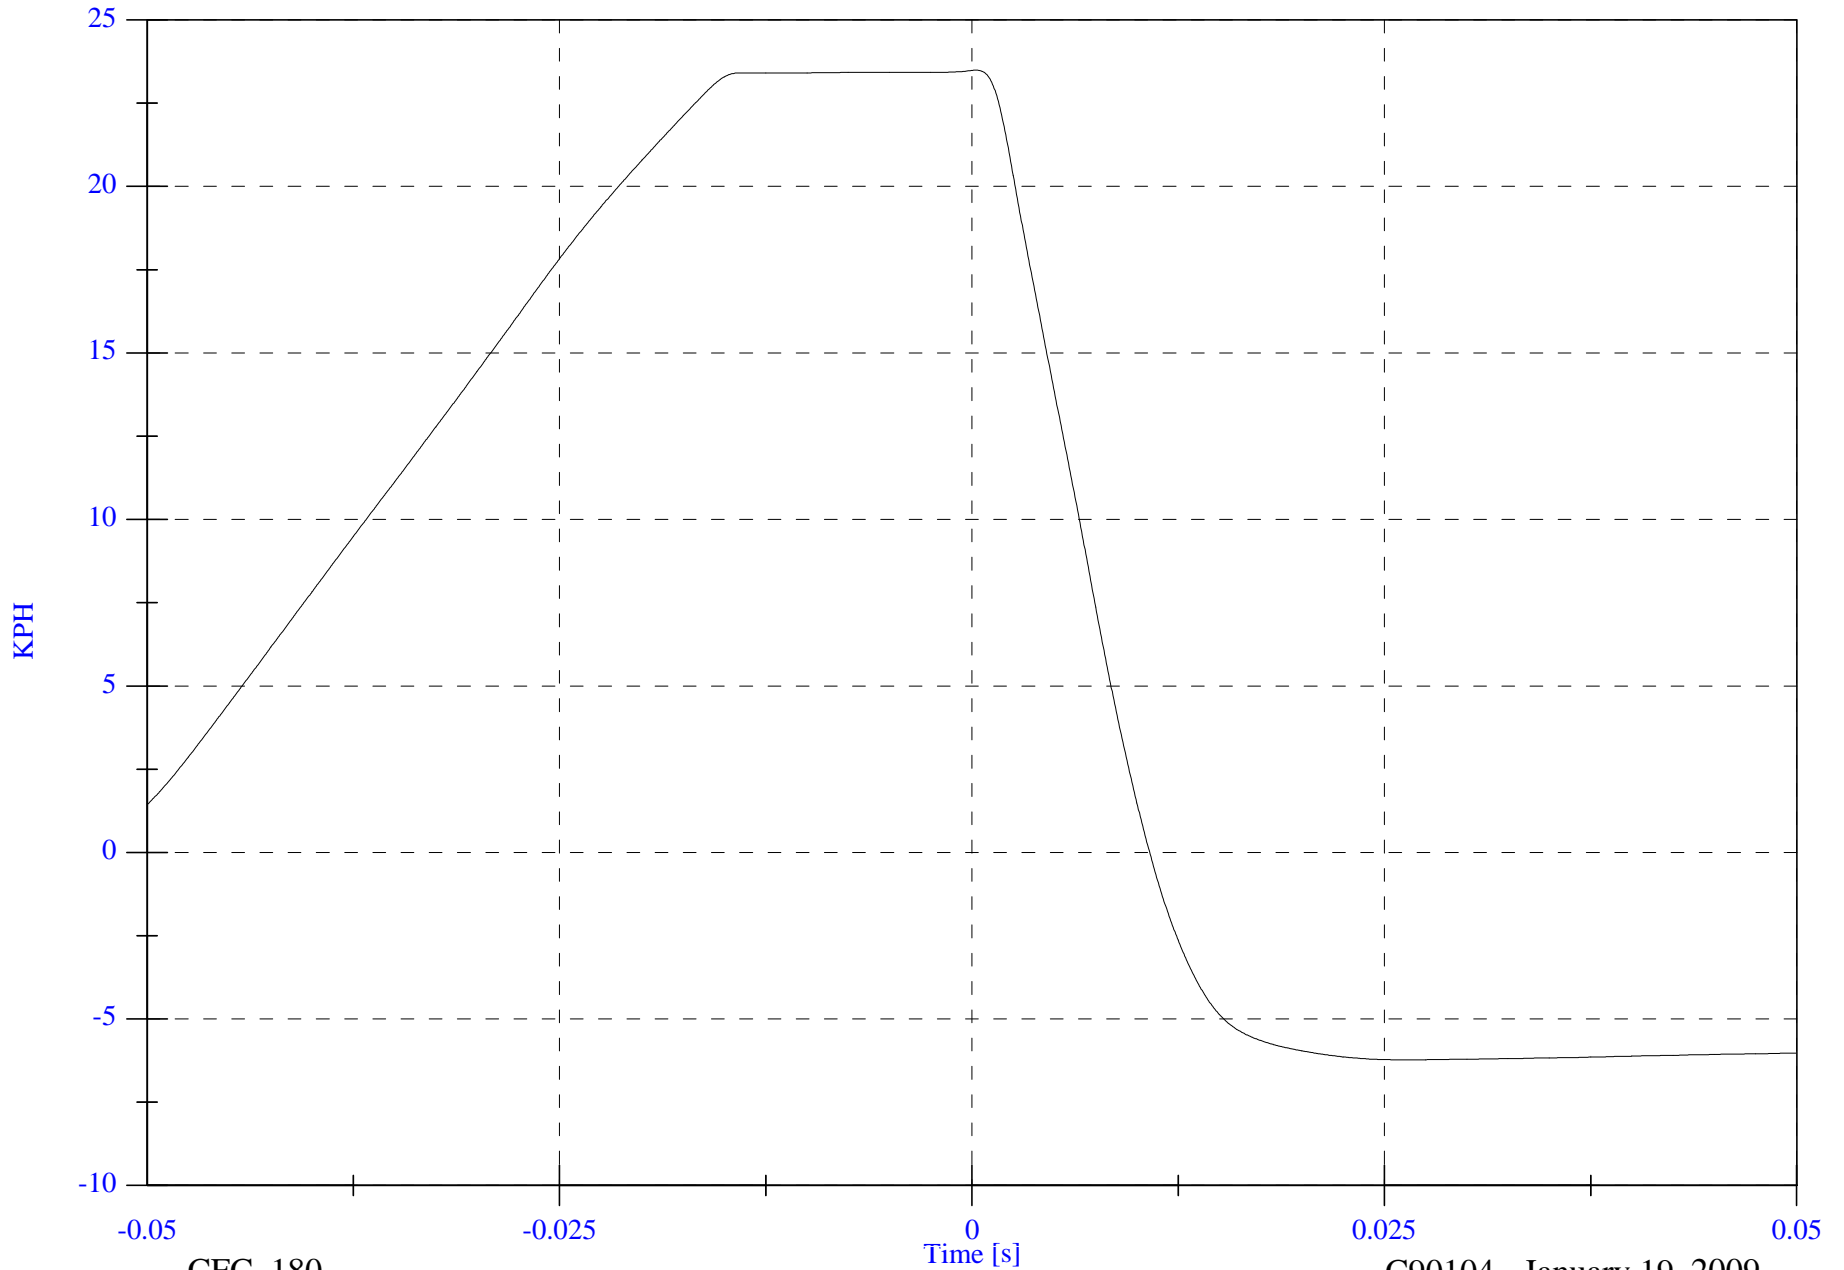
C90104 PASSENGER SIDE OP1 IMPACT PLOT #5

Max: 23.5 [KPH] at 0.000 [s]

### Headform Velocity

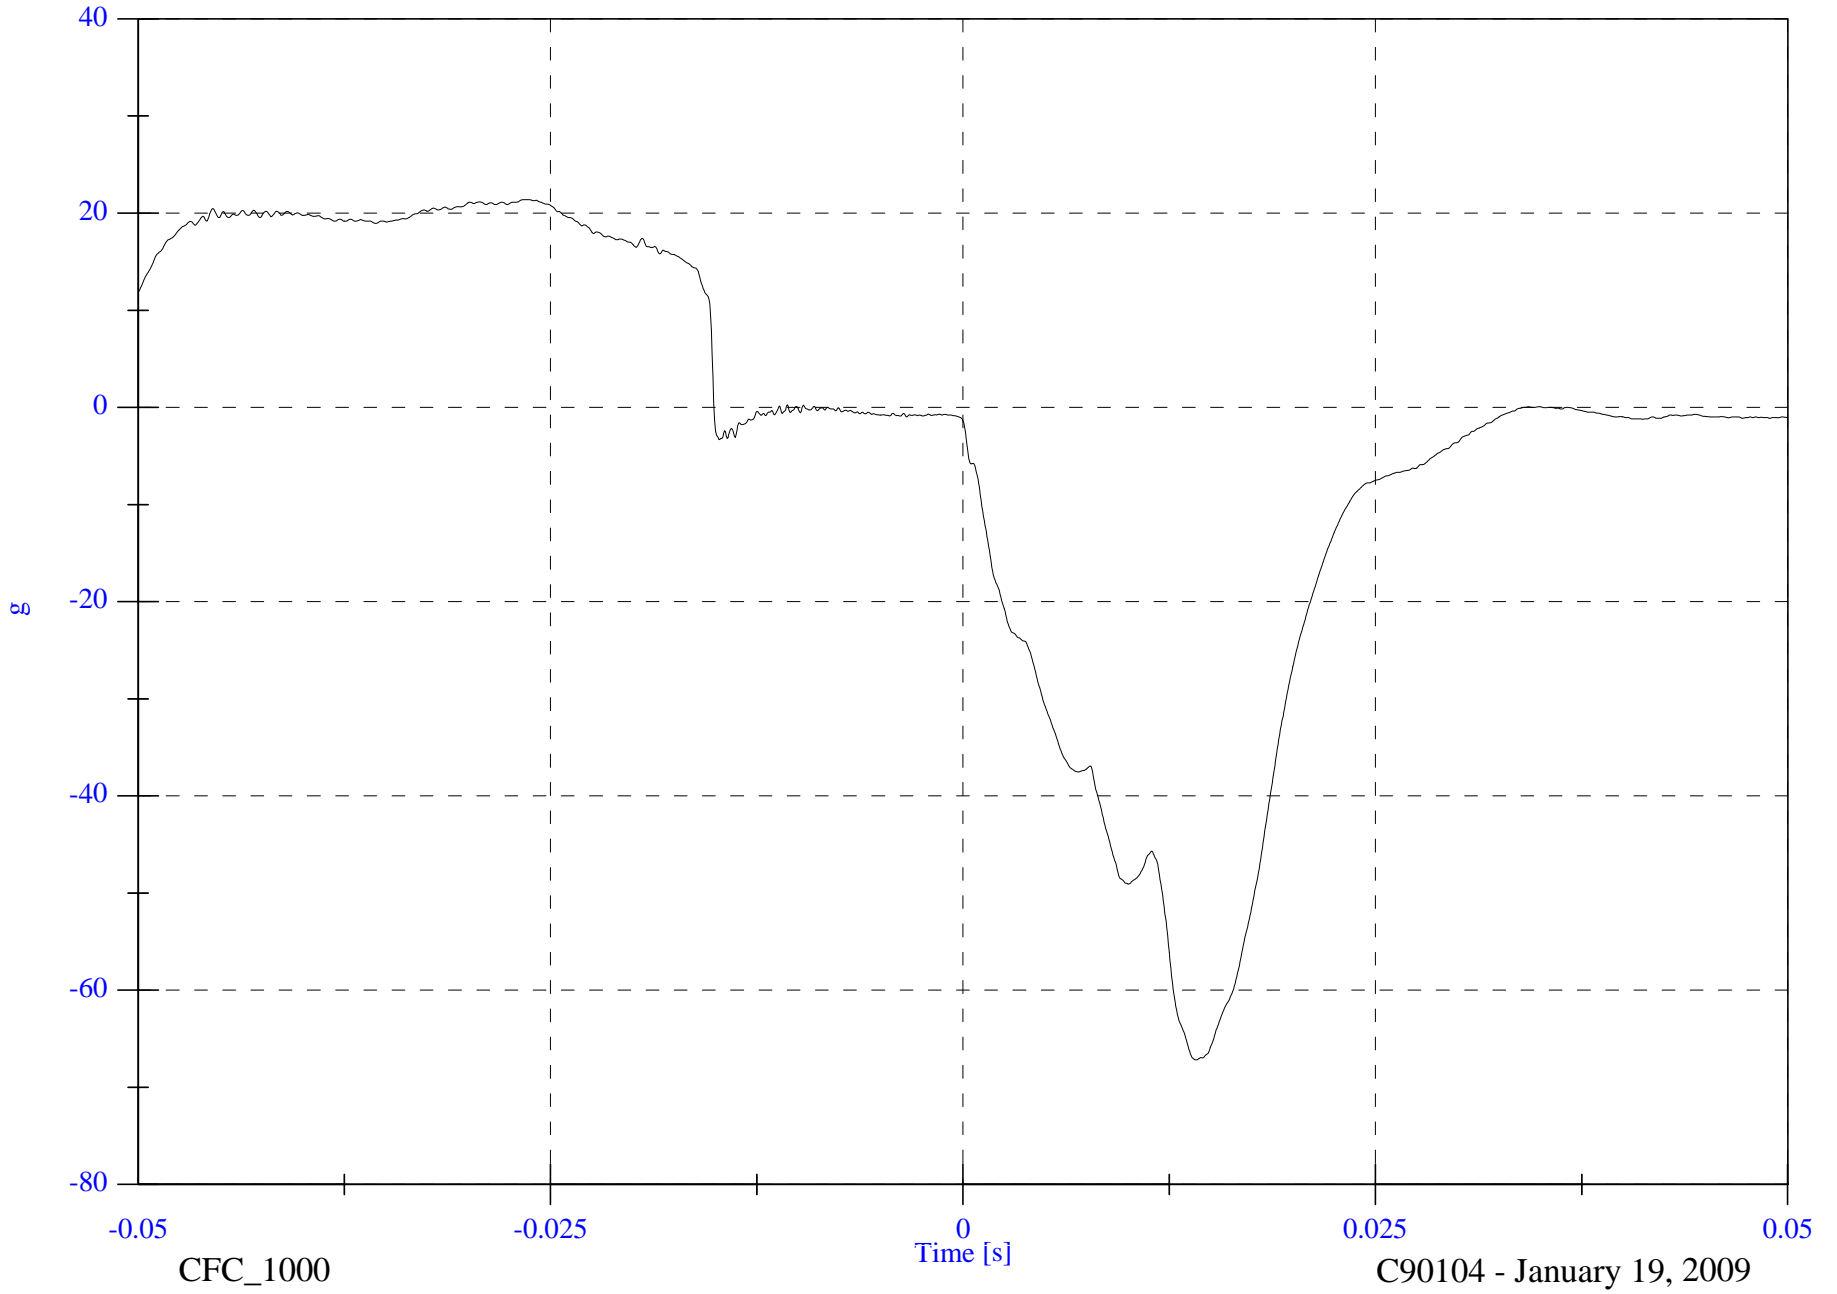
C90104 PASSENGER SIDE UROP IMPACT PLOT #1

Min: -67.2 [g] at 0.014 [s]

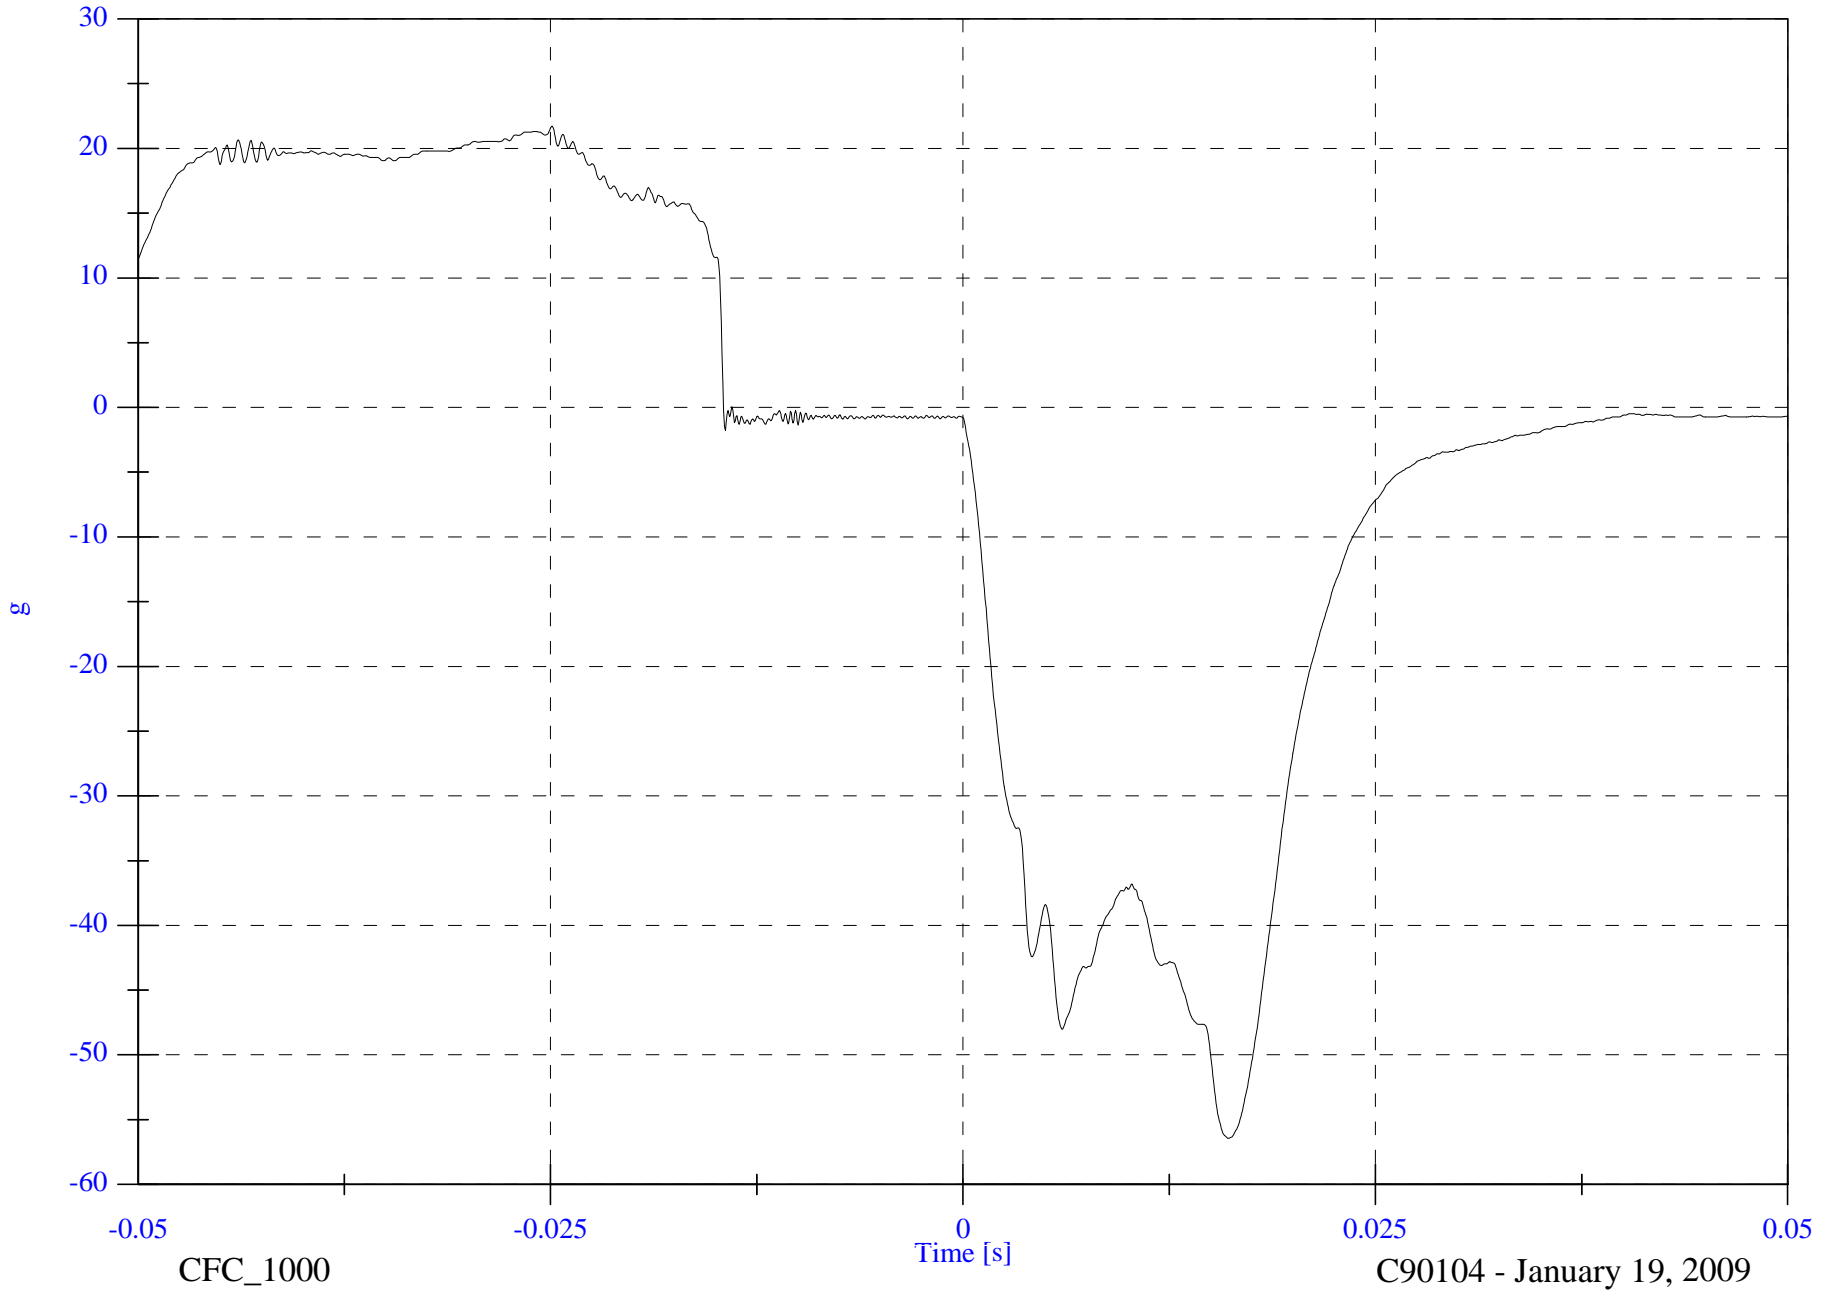
C90104 PASSENGER SIDE URREAR IMPACT PLOT #1

Min: -56.4 [g] at 0.016 [s]

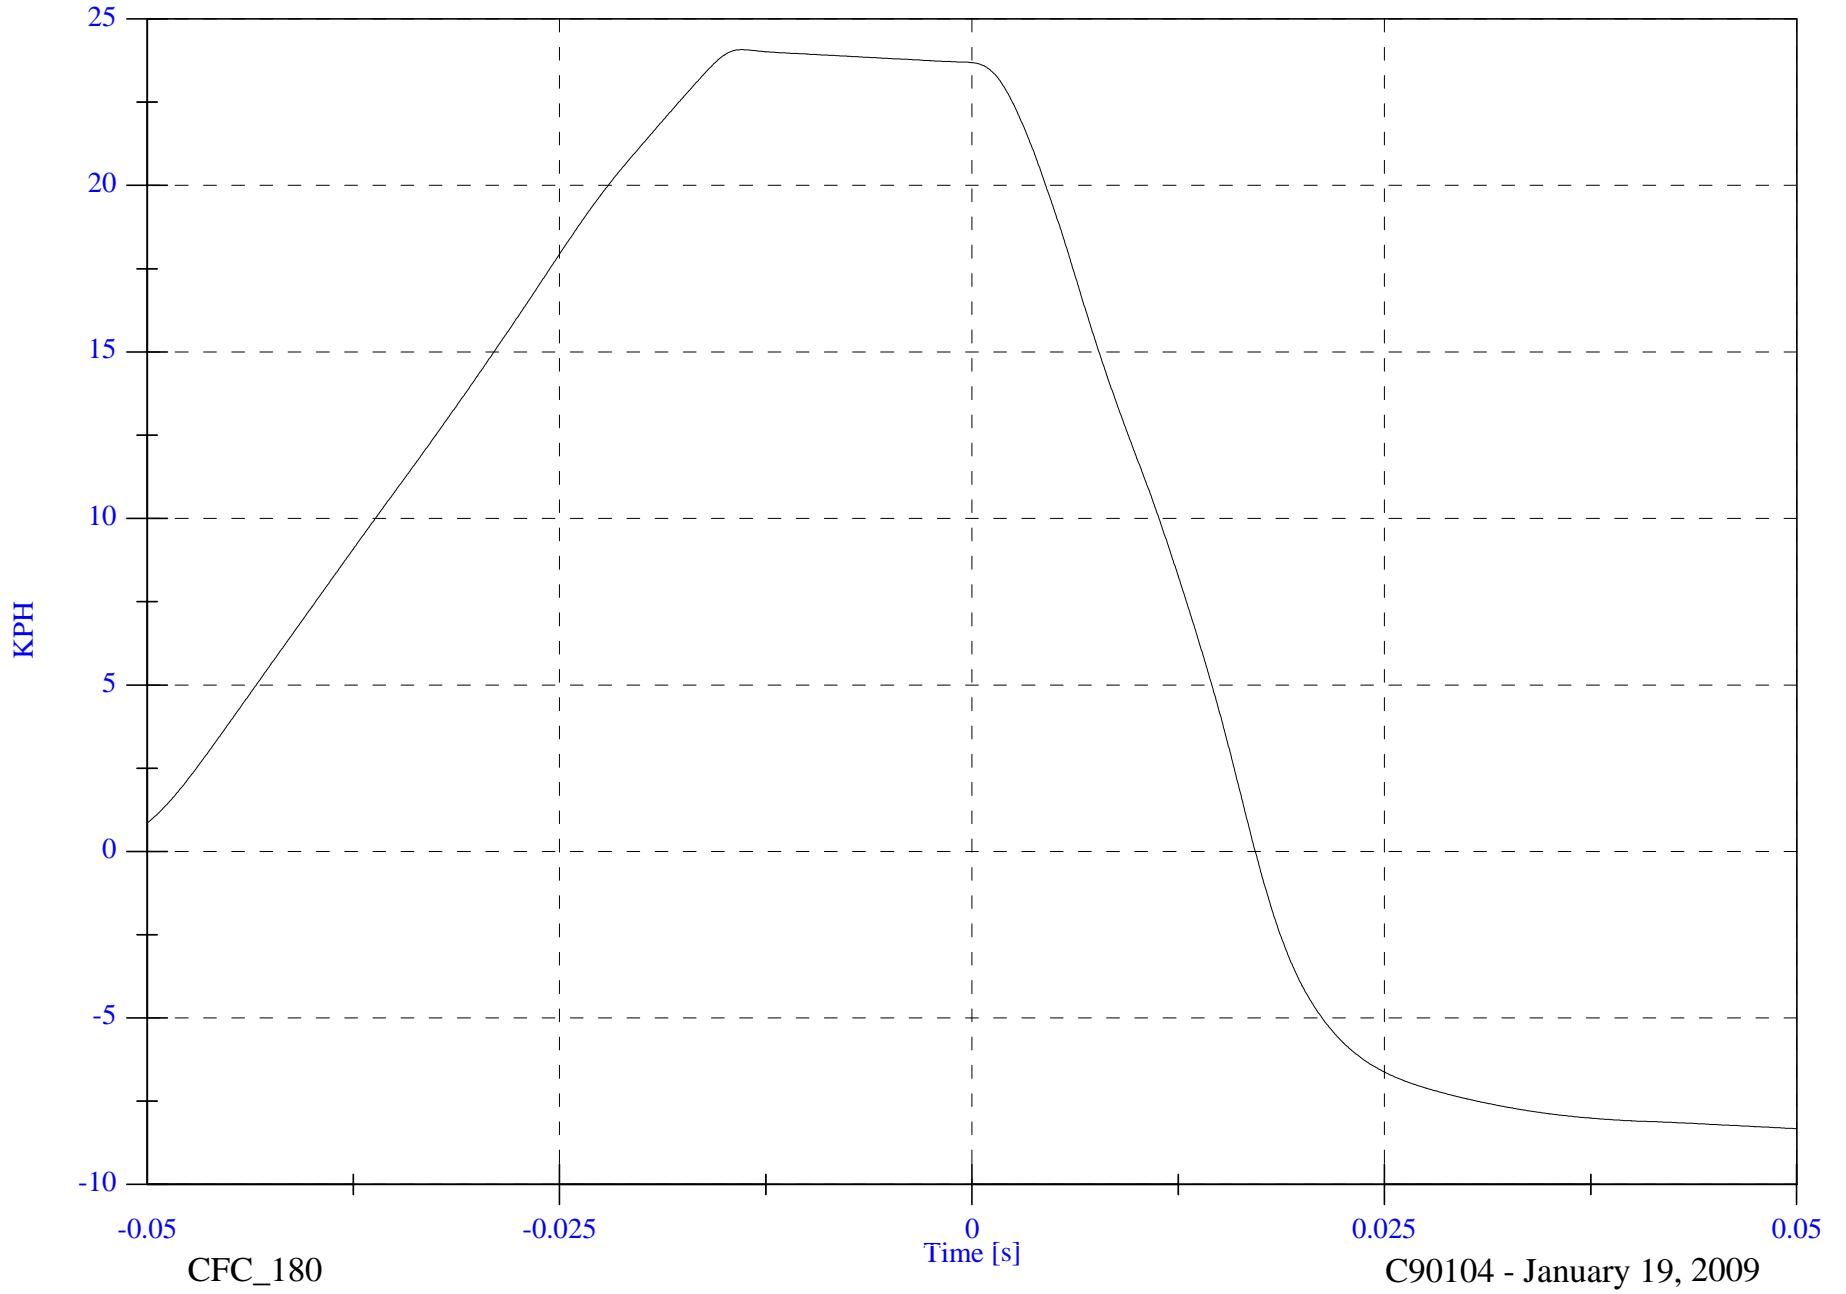
C90104 PASSENGER SIDE URREAR IMPACT PLOT #5

Max: 24.1 [KPH] at -0.014 [s]

Headform Velocity

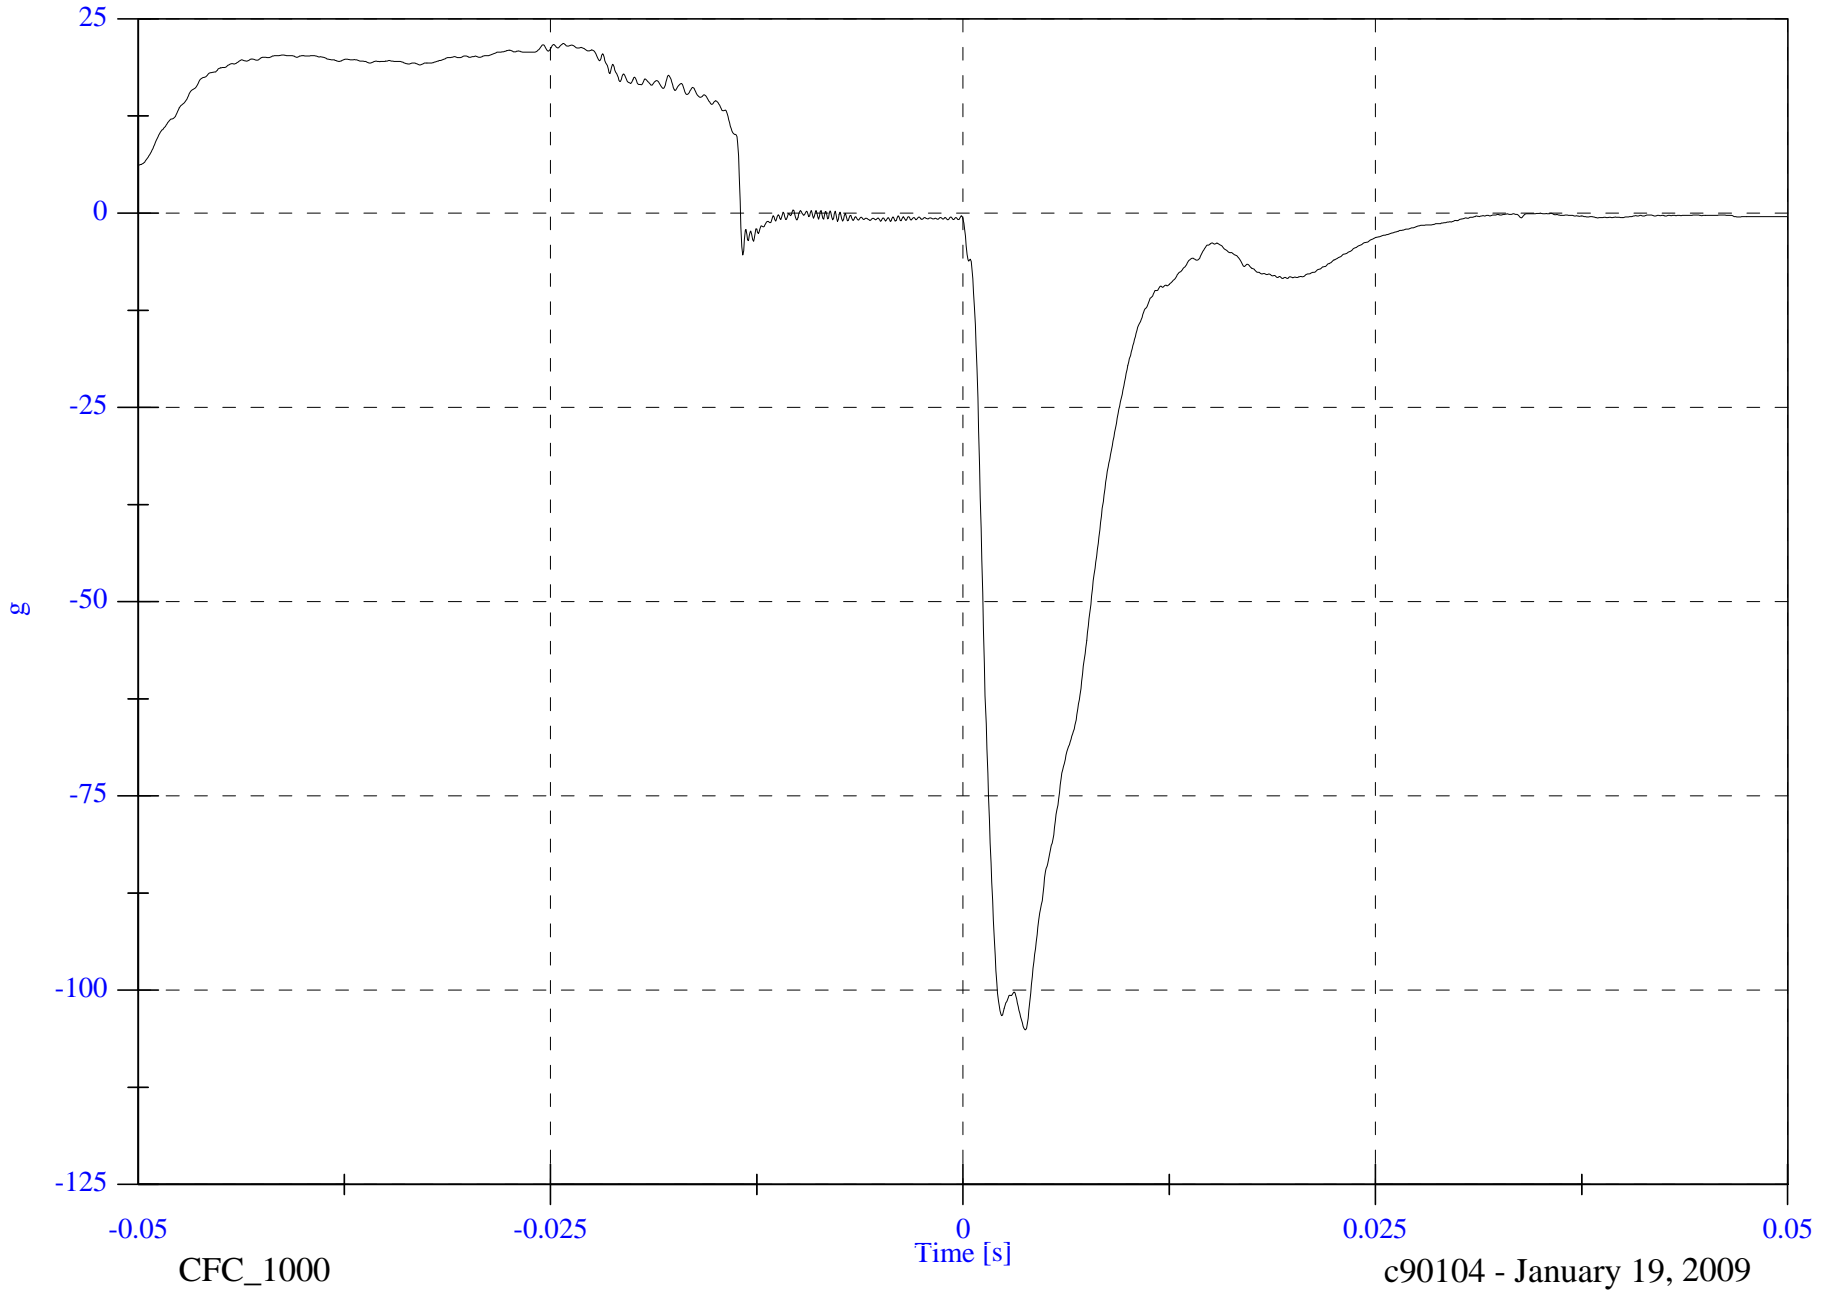
C90104 PASSENGER SIDE SR3 IMPACT PLOT #1

Min: -105.1 [g] at 0.004 [s]
